In the Matter of the Emergency Order to
UNITED STATES NAVY

For Emergency Change-In-Service and
Defueling of 20 Underground Storage
Tanks, Red Hill Bulk Fuel Storage Facility

WRITTEN TESTIMONY OF DAVID M.
NORFLEET; CERTIFICATE OF SERVICE

Report No.: O-AP-LIS / DNOR (10202111)
December 29, 2020

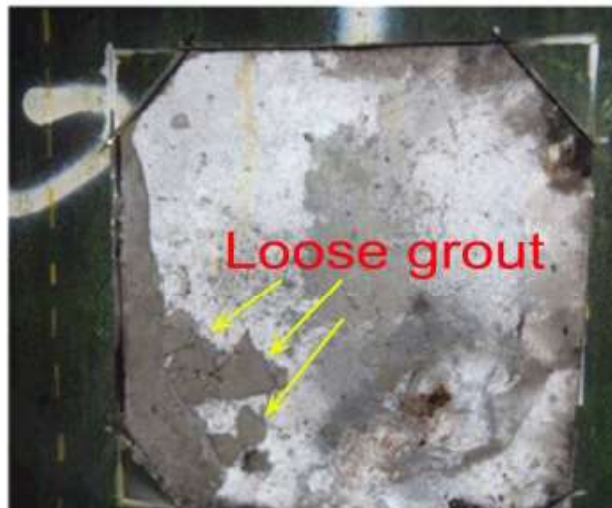
Since the grout was pressurized to 350 psi, it could have likely found its way to the steel concrete interface from the concrete-Gunite interface through any crevice or crack that may have formed. In one case, grout was found as far as 200 ft away from the tanks in an upper access tunnel [13]. The description of the tell-tale system, also indicates that crevices could exist between the tank wall and concrete layer [13]:

Figure 10: Loose grout behind coupon plate P6. From DT Results Report [1].

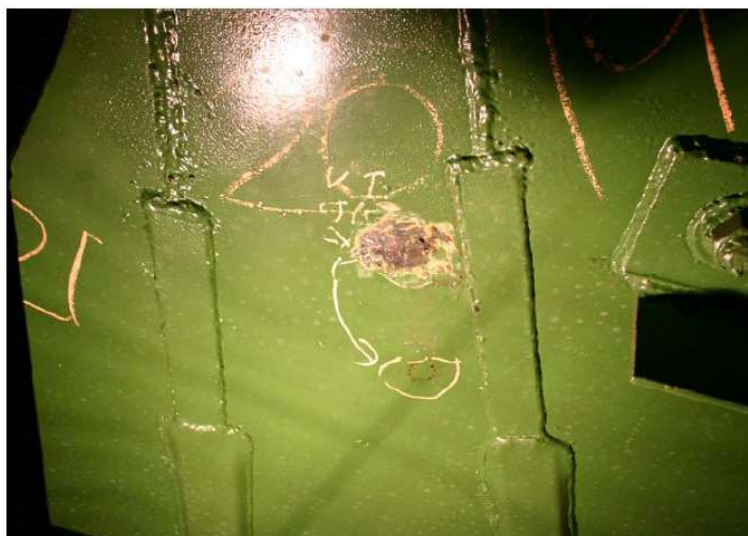
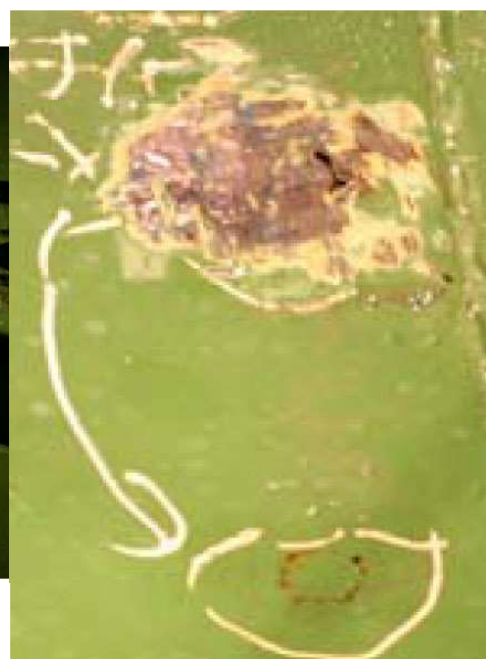
Figure 5 and Figure 6 are photographs documenting instances of through-hole anomalies. The morphology appears consistent with backside corrosion perforations.

Figure 5. Photographs extracted from the API Tank 16 Inspection Report (Photograph 8) showing "holes at the top of course F of the upper dome".

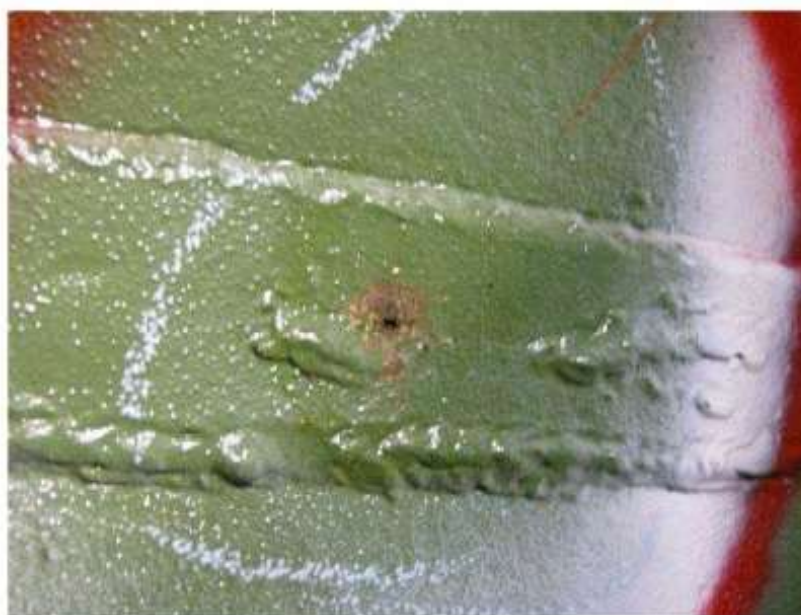
Flaw 347 through hole in strap

Figure 6. Photograph extracted from the API Tank 20 Inspection Report showing a through-wall hole.

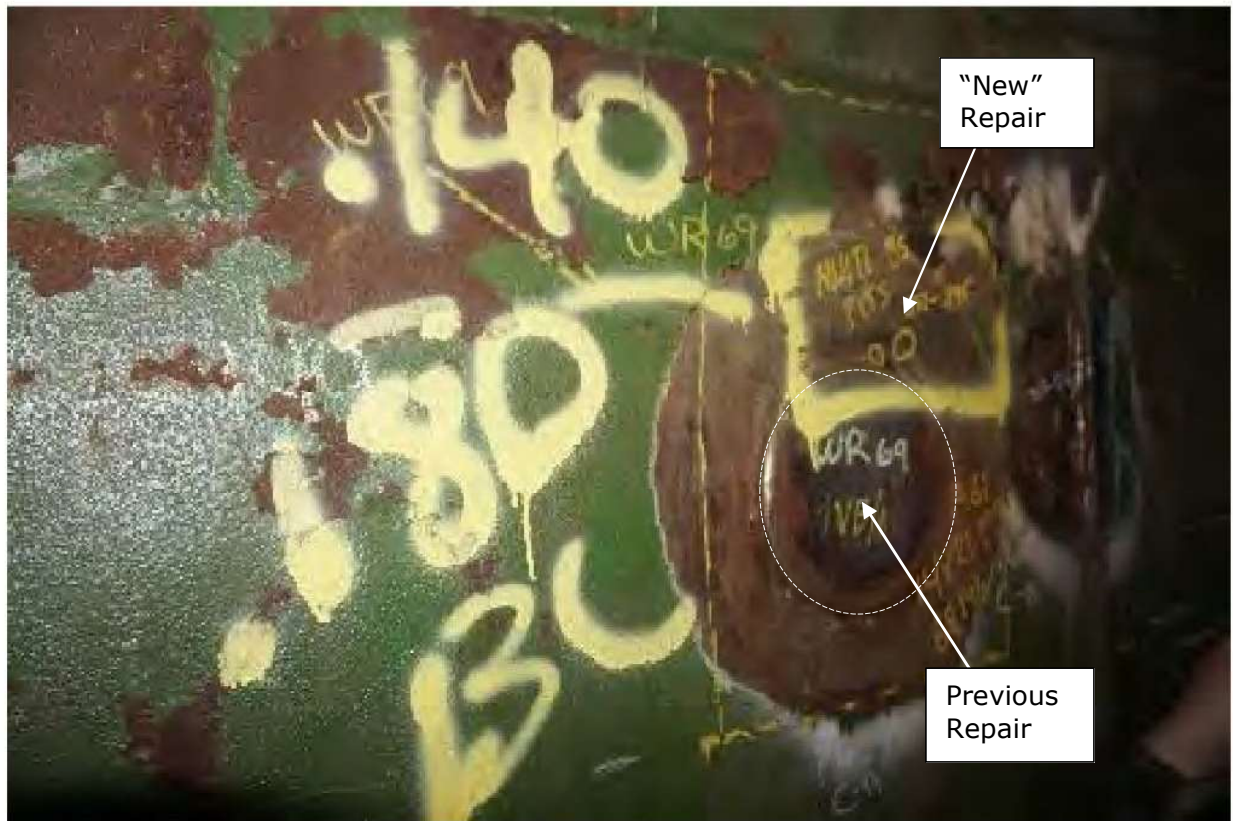
Photo 29: Backside Corrosion around existing patch plates

Another example illustrating the pervasive nature of unmitigated backside corrosion is shown in a photograph taken during the most recent (2017) inspection of Tank 5. The photograph shows a location of backside corrosion requiring repair that is directly adjacent to a previously repaired location. For all of the reasons highlighted in prior sections, corrosion will continue to occur, exposing additional areas that will eventually corrode and require repairs (if detected in time). The patch plates on top of patch plates will make detection and sizing of these corrosion features more difficult. Based on the Navy's recent NDE results from the destructive testing, more difficulty (less accuracy) will only lead to more leaks.

Figure 17. Photograph from the API inspection conducted on Tank 5 in 2017 showing backside corrosion (BC) below the repair threshold of 0.160 (requiring repair) adjacent to an area that was previously repaired with a patch plate.
