For Emergency Change-In-Service and  
Defueling of 20 Underground Storage  
Tanks, Red Hill Bulk Fuel Storage Facility

UPDATED WRITTEN TESTIMONY OF  
DAVID M. NORFLEET; CERTIFICATE OF  
SERVICE

Report No.: O-AP-LIS / DNOR (10202111)  
December 29, 2020

| Project Name: | Red Hill Bulk Fuel Storage Facility –<br>Contested Case Hearing | DNV GL USA, INC. (Oil and Gas)<br>Pipeline Services Department<br>Incident Investigation |

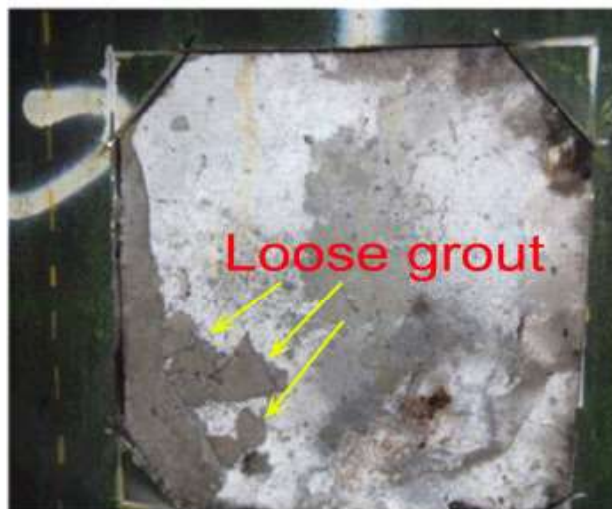
Since the grout was pressurized to 350 psi, it could have likely found its way to the steel concrete interface from the concrete-Gunitite interface through any crevice or crack that may have formed. In one case, grout was found as far as 200 ft away from the tanks in an upper access tunnel. The description of the tell-tale system, also indicates that crevices could exist between the tank wall and concrete layer:

Figure 10: Loose grout behind coupon plate P6. From DT Results Report [1].

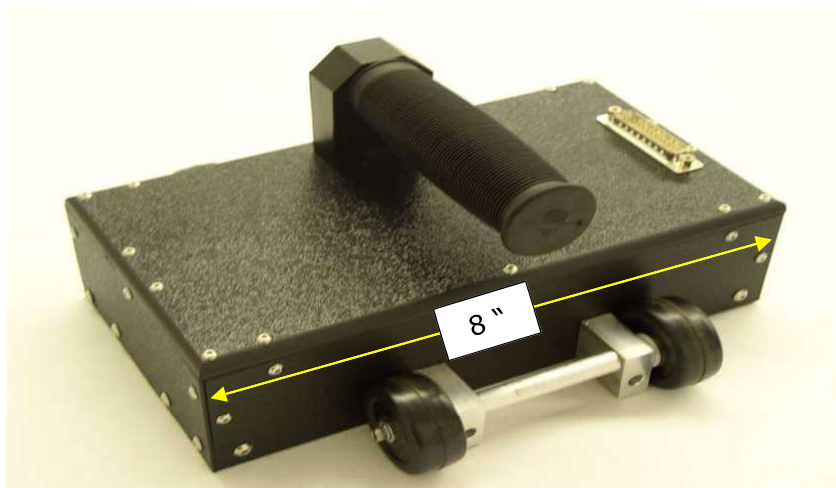
The inspection relies heavily on the skill of the operator and the accuracy of the hand-held scanners, which at the RHBFSF requires scanning huge areas for days at a time in physically challenging conditions. For example, the surface area scanned in Tank 15 in 2005 was 56,444 square feet; 82.8% of the total surface area of the UST. To put this into perspective this is roughly the size of a football field (57,600 square feet).

Figure 1. Photograph showing the 8-inch wide hand-held scanner used to perform LFET.

The hand-held LFET scanner used to scan a significant portion of that area is pictured Figure 1 and is described in the report to be 8 inches wide. The system is reported to be capable of detecting backside corrosion pits as small as 0.062 inches in diameter. The inspector is responsible for moving the hand scanner while monitoring the computer screen readout to detect flaws/ defects while working off a suspended scaffolding with the work area illuminated by artificial lights. In addition, per the testimony of Navy witness Mr. Frank Kern the inspector

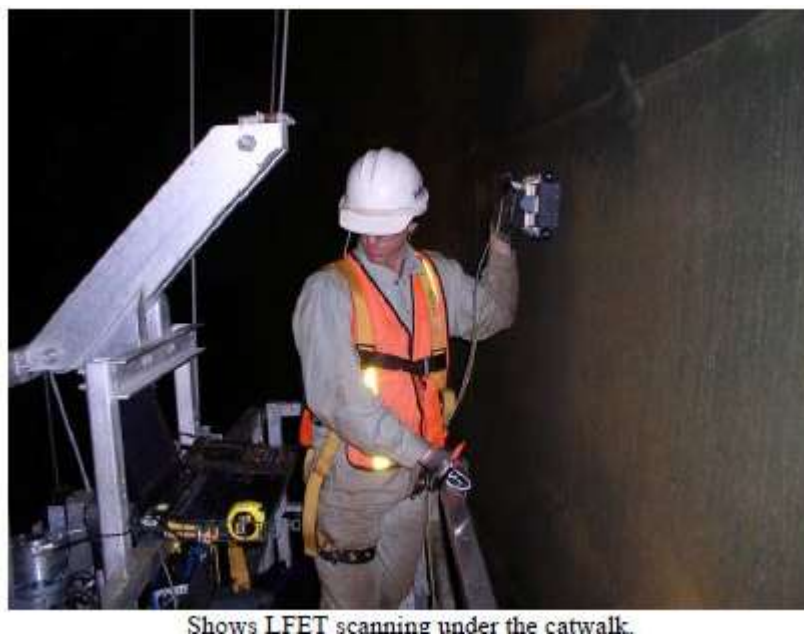
Figure 2. Photograph showing the application of the hand-held scanner used to perform LFET [B-190].

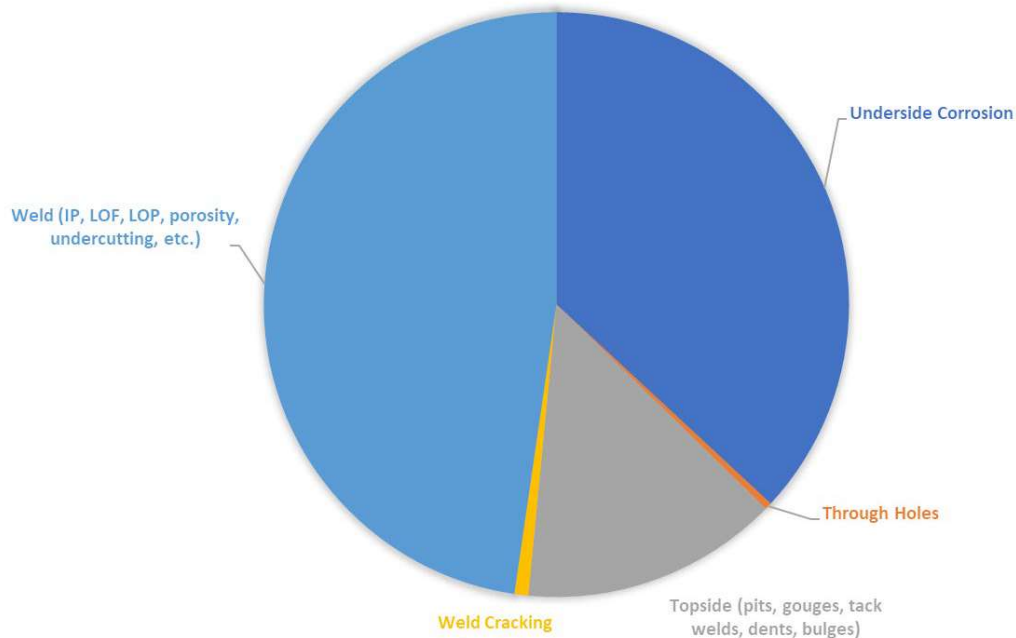
Figure 3. Chart showing the anomaly distribution identified during the API 653 inspections for Tanks 2, 5 (2010), 6, 15, 16, and 20.

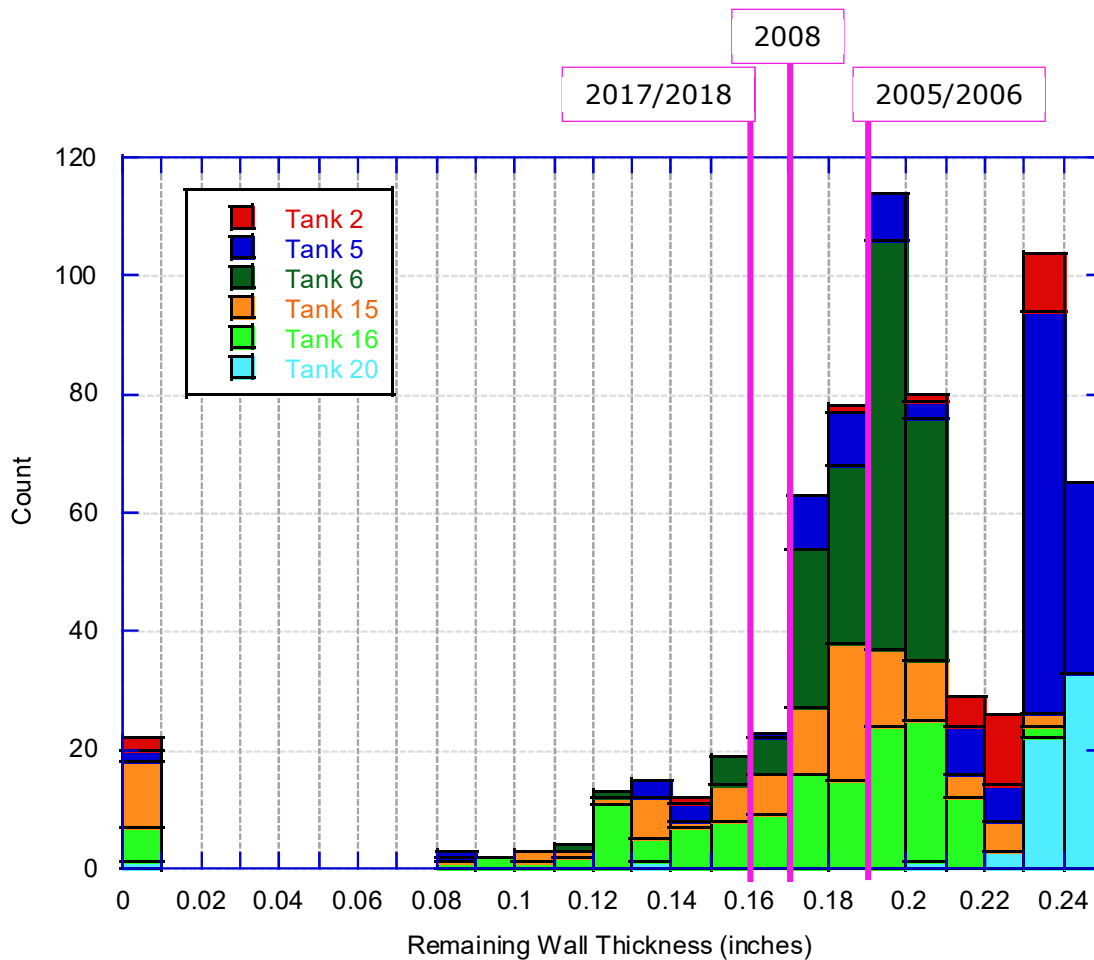
Figure 4 is a histogram showing the remaining wall thickness measured during the API 653 inspections for anomalies associated with backside corrosion on the barrel, upper and lower domes, and expansion/extension. Twenty-two (22) through-hole anomalies were identified, two on Tank 2, two on Tank 5, eleven on Tank 15, six on Tank 16, and one on Tank 20, and are included within the plot. Vertical lines have been added to the plot to indicate the repair thresholds that the Navy has used for the API inspections. There are multiple lines included because the Navy has been reducing its repair threshold (i.e., allowing the steel liners to get thinner and thinner before requiring repairs) over time. In 2005/2006, the Navy reported that it repaired everything less than 0.190 inches in remaining wall thickness. Currently, Navy processes call for repairs of everything less than 0.160 inches, excluding the bottom of the tank. Applying the 2005/2006 repair criteria to the total population of identified corrosion anomalies (663) results in 244 corrosion anomalies that would have been repaired, or 36.8% of total population. Applying the 2017/2018 (current) repair criteria results in 80 corrosion anomalies that would have been repaired or 12.1% of the total population.

Figure 4. Histogram showing the distribution of remaining wall thickness for anomalies classified as backside corrosion (and through wall) for the Barrel, Upper & Lower Domes, Expansion, and Extension. Pink lines correspond to the Repair Threshold in 2005/2006, 2008, and 2017/2018; i.e. everything to the left of these lines would have been repaired.

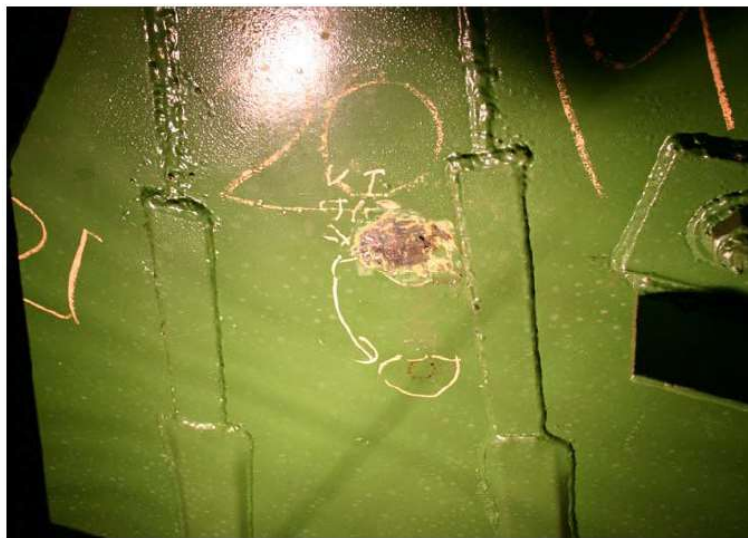
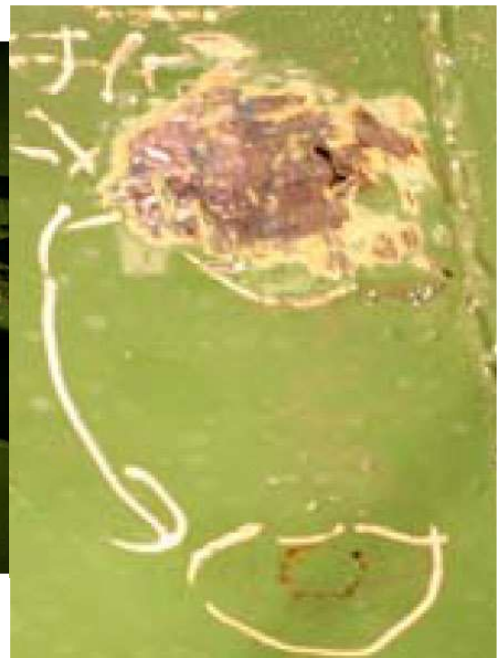
Figure 5 and Figure 6 are photographs documenting instances of through-hole anomalies. The morphology appears consistent with backside corrosion perforations.

Figure 5. Photographs extracted from the API Tank 16 Inspection Report (Photograph 8) showing "holes at the top of course F of the upper dome".

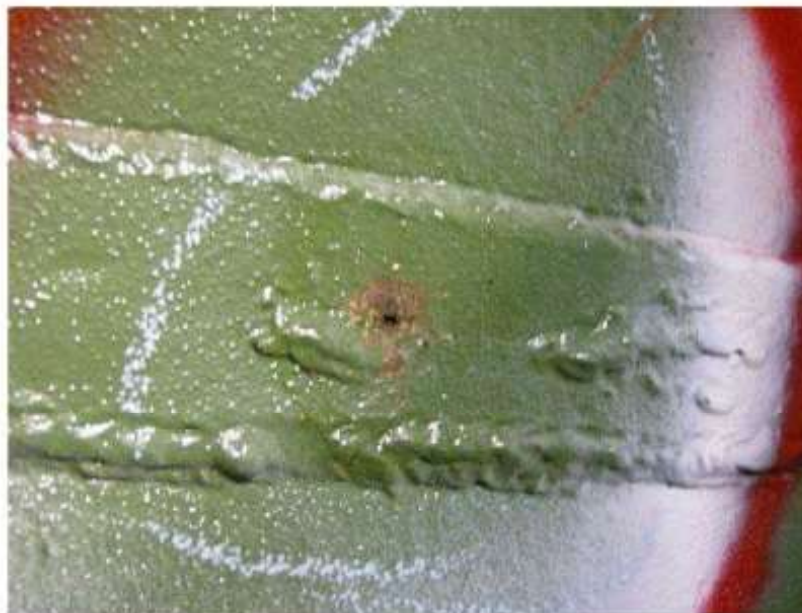
Flaw 347 through hole in strap

Figure 6. Photograph extracted from the API Tank 20 Inspection Report showing a through-wall hole.

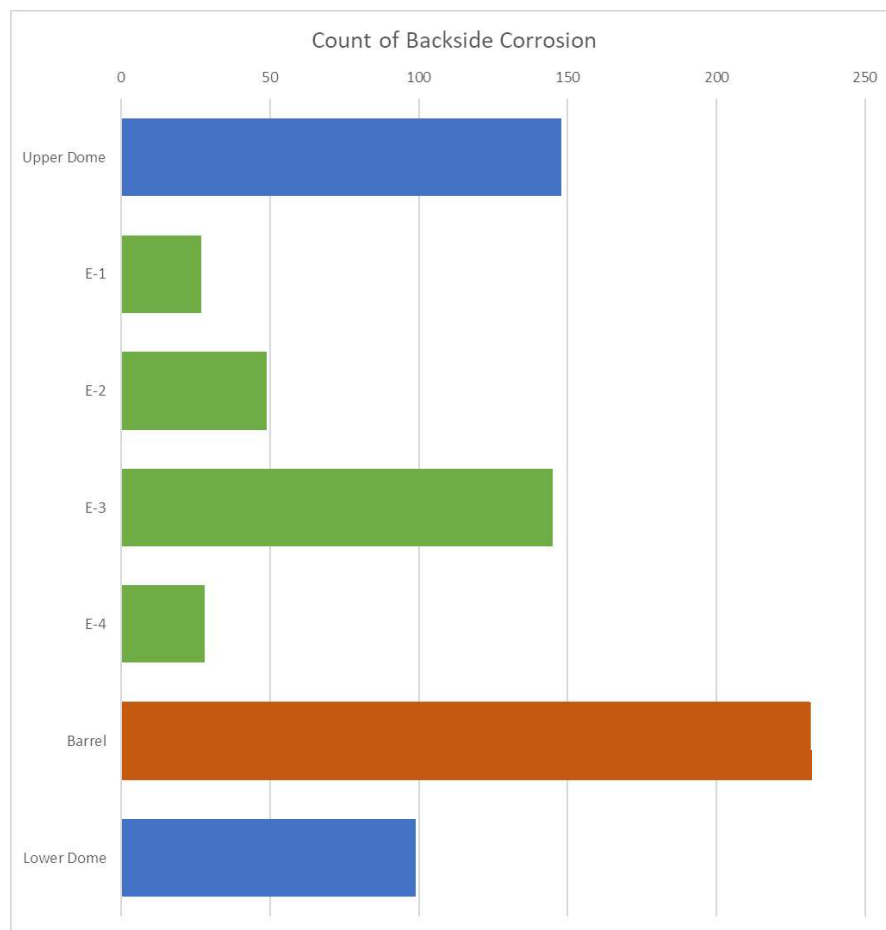
Figure 7 is a chart showing the vertical distribution of backside corrosion anomalies within the tanks for the barrel (Rows 1-28), upper and lower domes, and expansion/extension (Rows E1-E4). Backside corrosion anomalies persist along all vertical locations associated with the USTs. This is highlighted by examining the largest vertical section of the tank, the barrel; refer to Figure 8. The figure shows numerous backside corrosion anomalies present at all vertical locations, many of which are very deep. In fact, looking at anomalies with a reported remaining wall thicknesses of <0.125 inches ( <50% NWT; corresponding to a corrosion depth of >50%) illustrates that significant corrosion is occurring and can occur at all vertical locations throughout the USTs, refer to Figure 9. Therefore, all liner surfaces associated with the USTs require extensive inspection to detect and accurately size the areas of corrosion.

Figure 7. Chart showing the vertical distribution of backside corrosion anomalies within the upper dome, extension/expansion (E1, E2, E3, E4), barrel, and lower dome identified during the API 653 inspections.

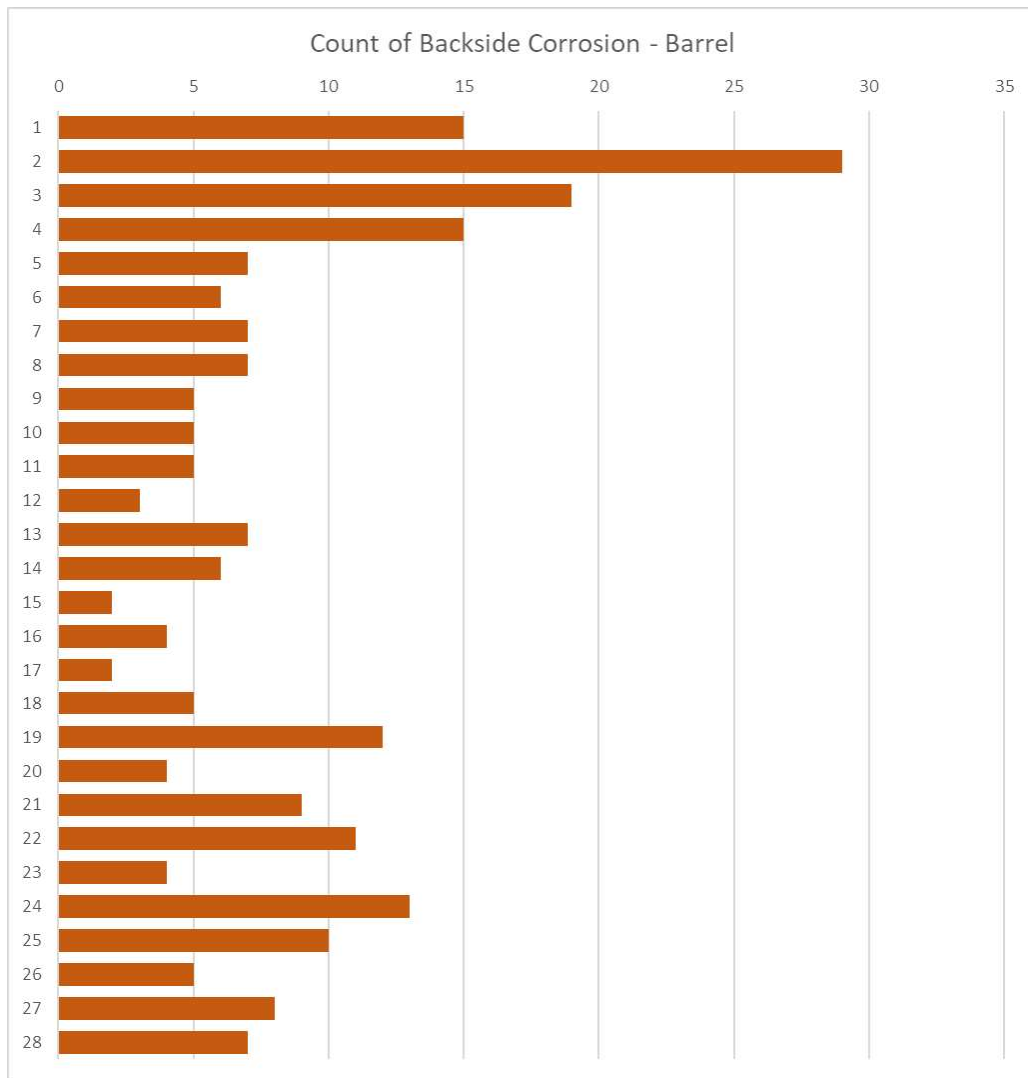
Figure 8. Chart showing the vertical distribution of backside corrosion anomalies within the barrel section identified during the API 653 inspections.

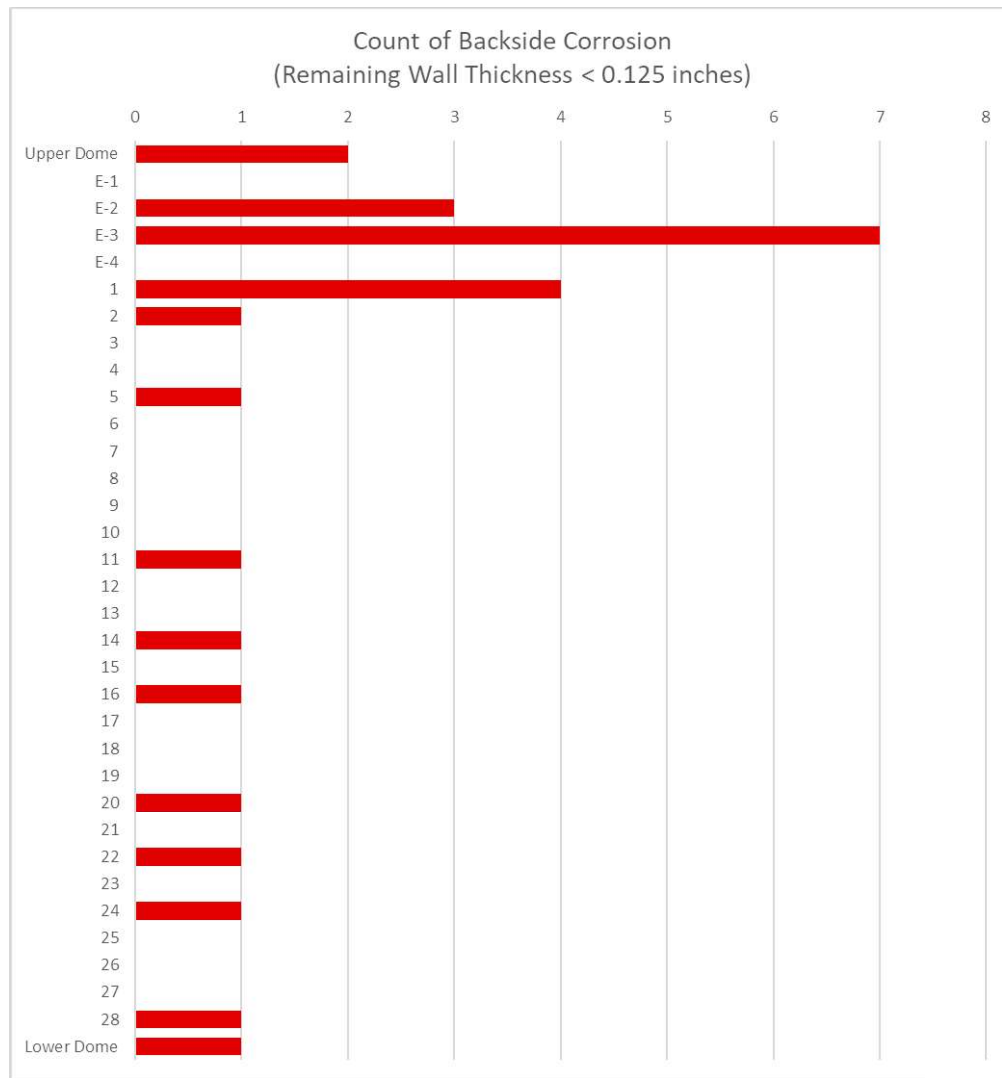
Figure 9. Chart showing the vertical distribution of backside corrosion anomalies with remaining wall thickness <0.125 inches ( <50% NWT) identified during the API 653 inspections.

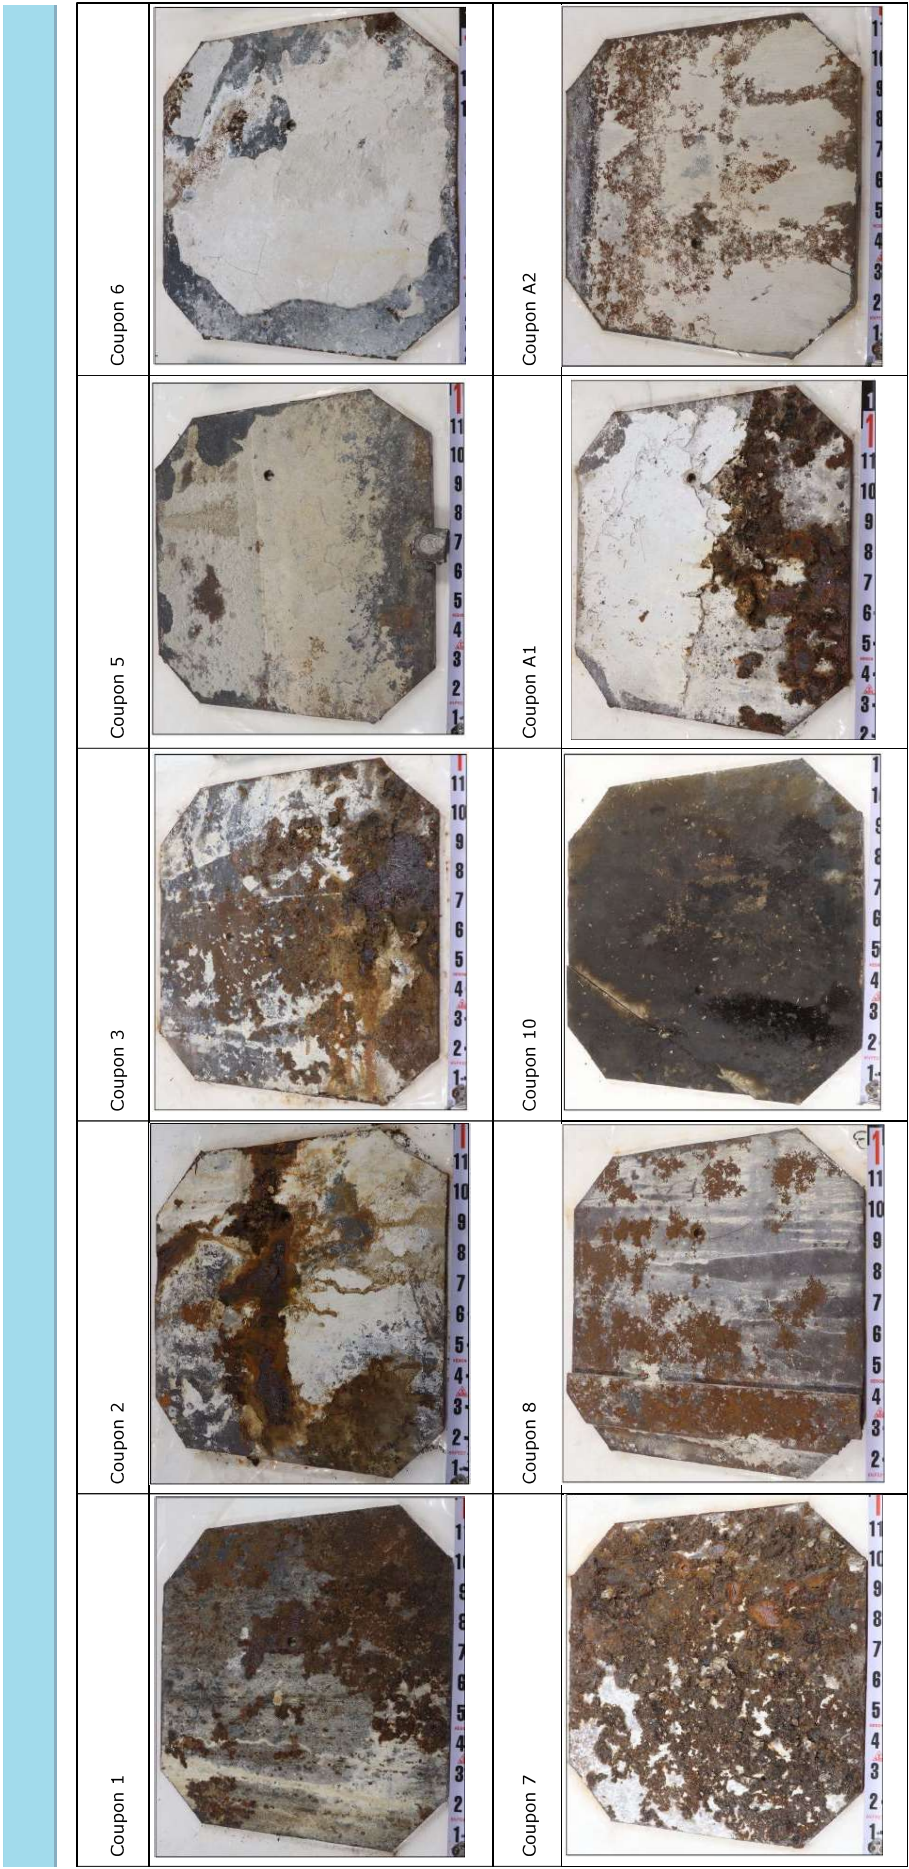
Figure 10. Photographs showing the undersides / backsides of the coupons removed from Tank 14 as part of the destructive analyses.

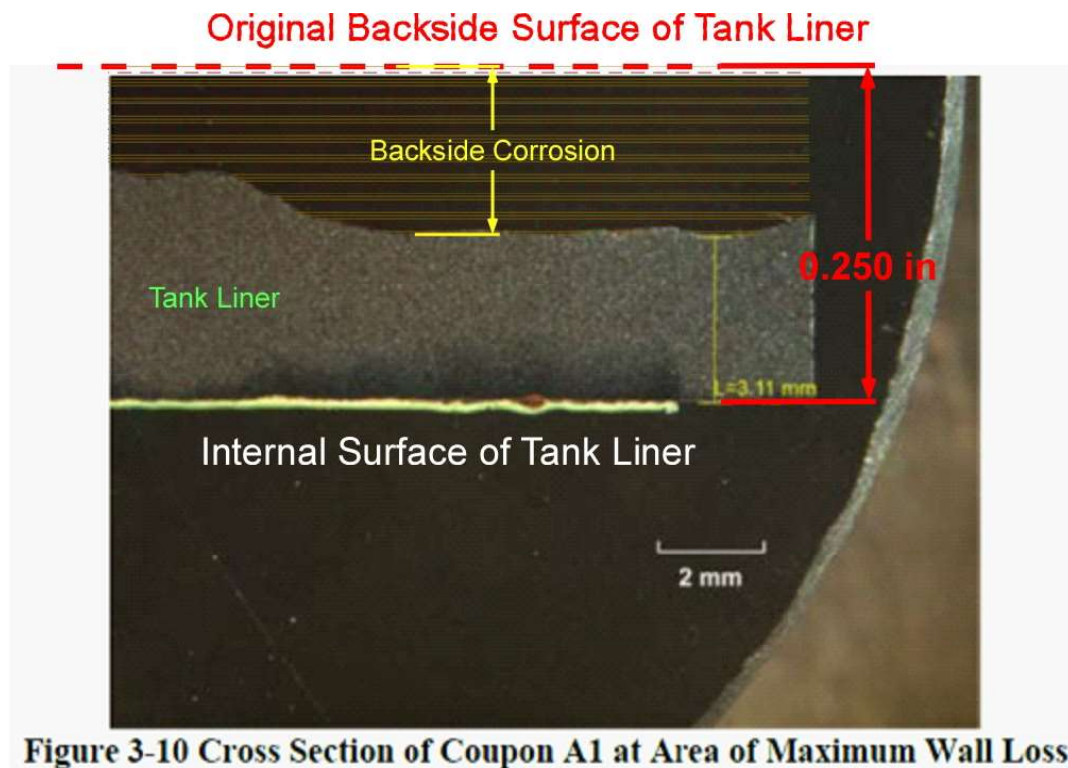
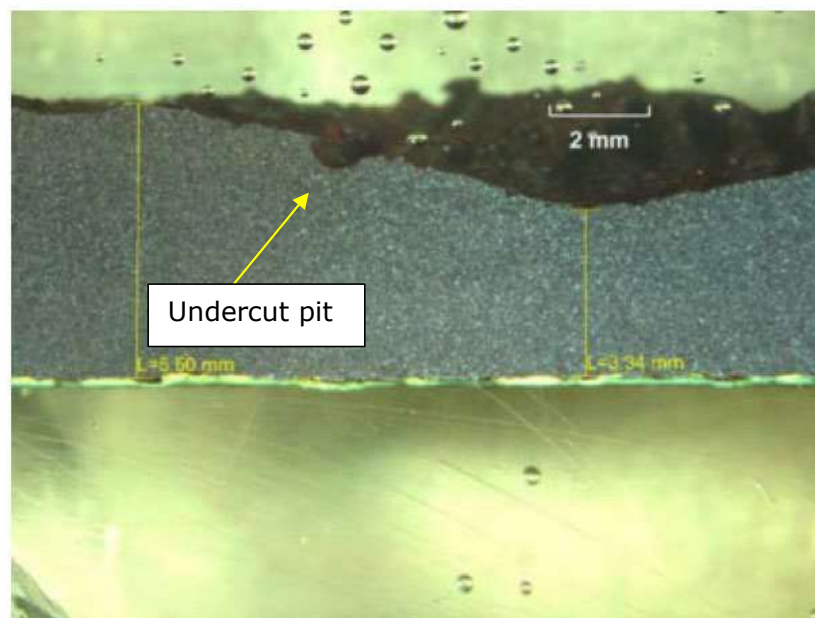
Figure 11. Photographs showing the metallographic cross-sections removed from Coupons A1 and 3. Annotations have been added to the original figures.

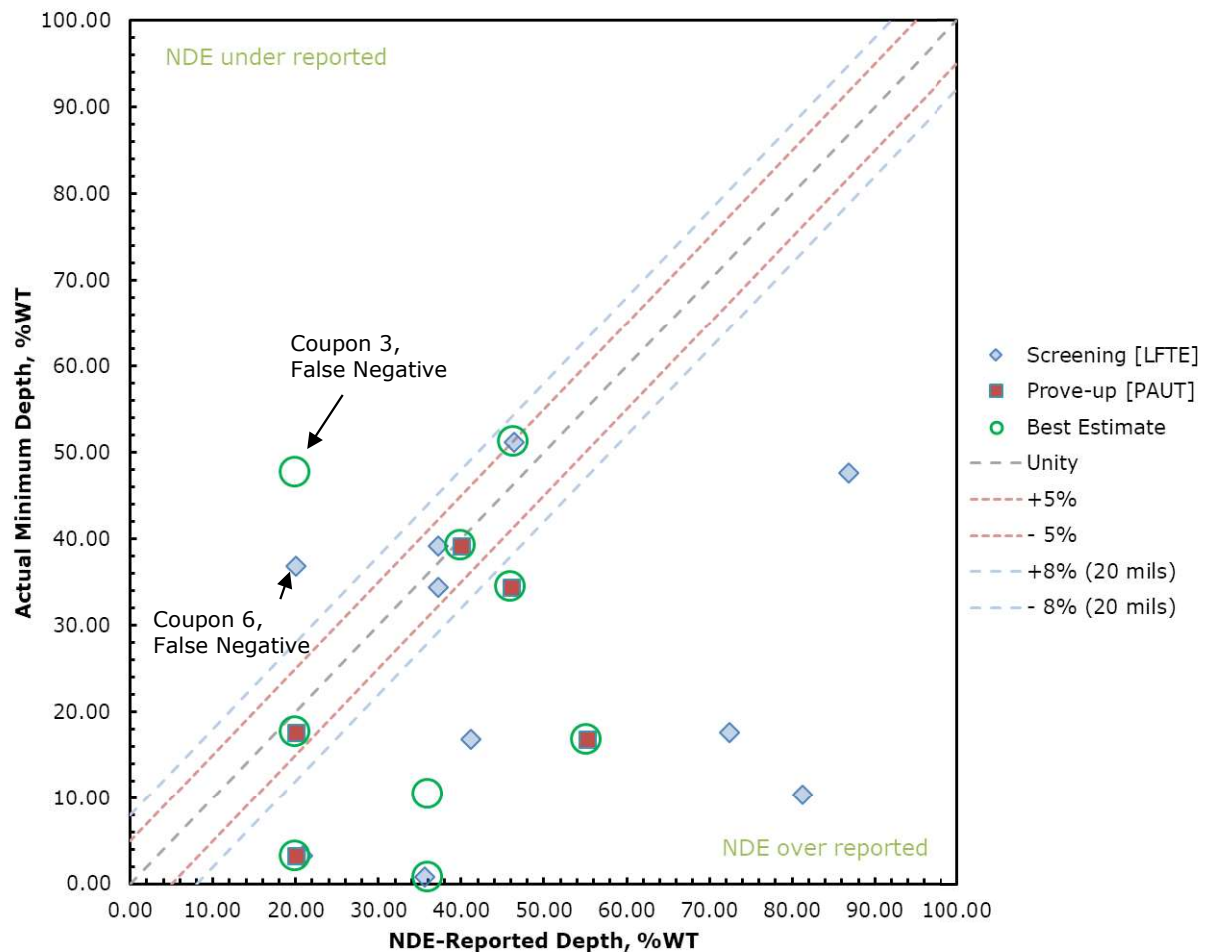
Figure 12. Unity plot comparing the results from the NDE to the actual measured corrosion depths, assuming a nominal wall thickness of 0.250 inches.

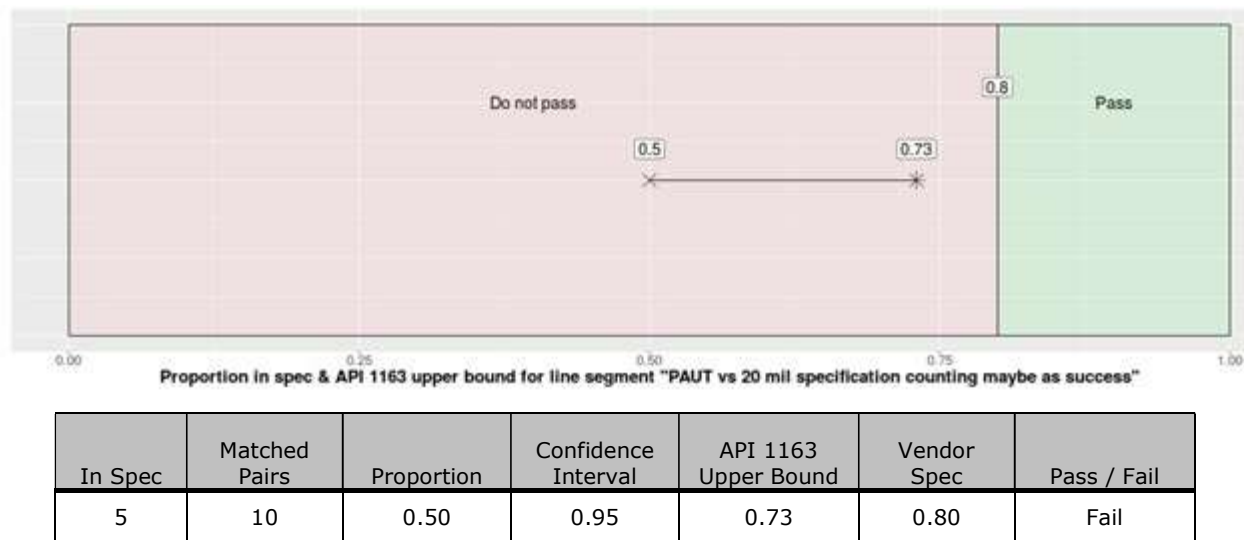
With the four "maybe" PAUT values in Table 4 considered to be within +/- 20 mils, five of ten are then within the 20 mils. The sample proportion within specification is  $5/10 = 0.5$  as seen in Figure 13 depicted by an "x" and called "Proportion" in the table below the plot. For the relatively small sample size of ten matched pairs, the one-tailed 95% confidence interval is wide with the upper bound at 0.73 that is labeled "API\_1163\_upper\_bound" below the plot. Since 0.73 is less than the specification limit of 0.80 (80% in specification), the portion of the measurements within specification fails and therefore, API 1163 is not passed. Graphically this is seen with the upper confidence interval bound 0.73 in the pink "Do not pass" part of the output.

Figure 14. API 1163 assessment of the performance of PAUT.

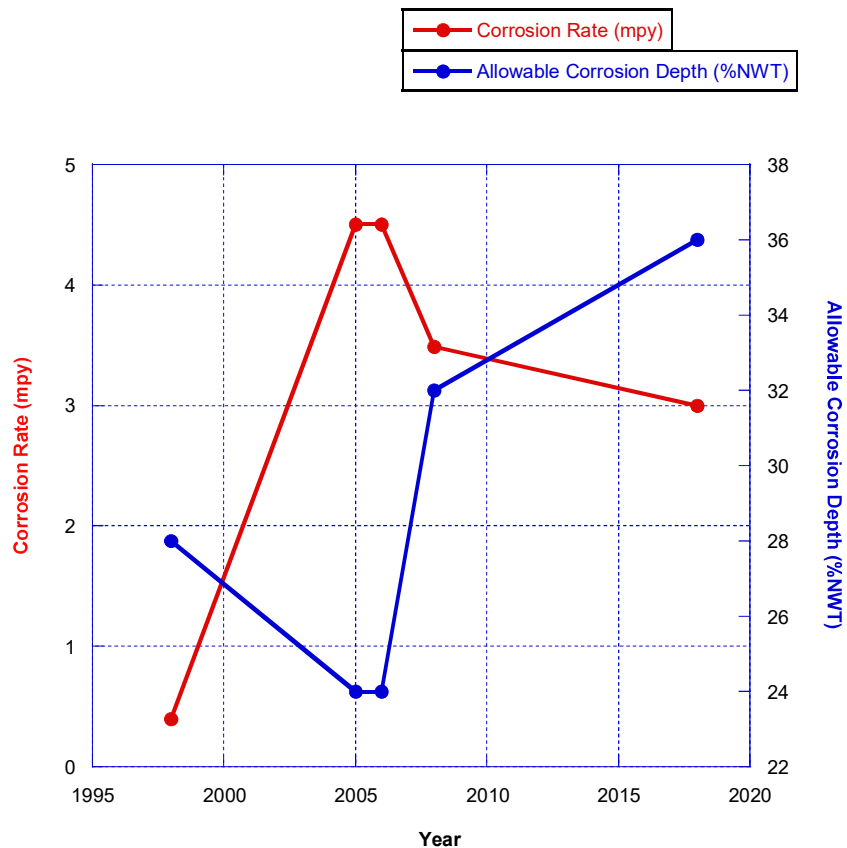
Figure 15 is a plot showing the historic corrosion growth rates and the Navy-defined acceptable corrosion depths for the USTs at the RHBFSF. It is clear that by selecting lower growth rates and higher acceptable corrosion depths, the Navy is allowing for an increased (longer) reinspection interval, and moving in a less-conservative direction, which is counter intuitive and goes against all industry norms for managing high risk, aging assets.

Figure 15. Plot showing the historic corrosion growth rates and allowable corrosion depths selected by the Navy for the USTs at the RHBFSF.

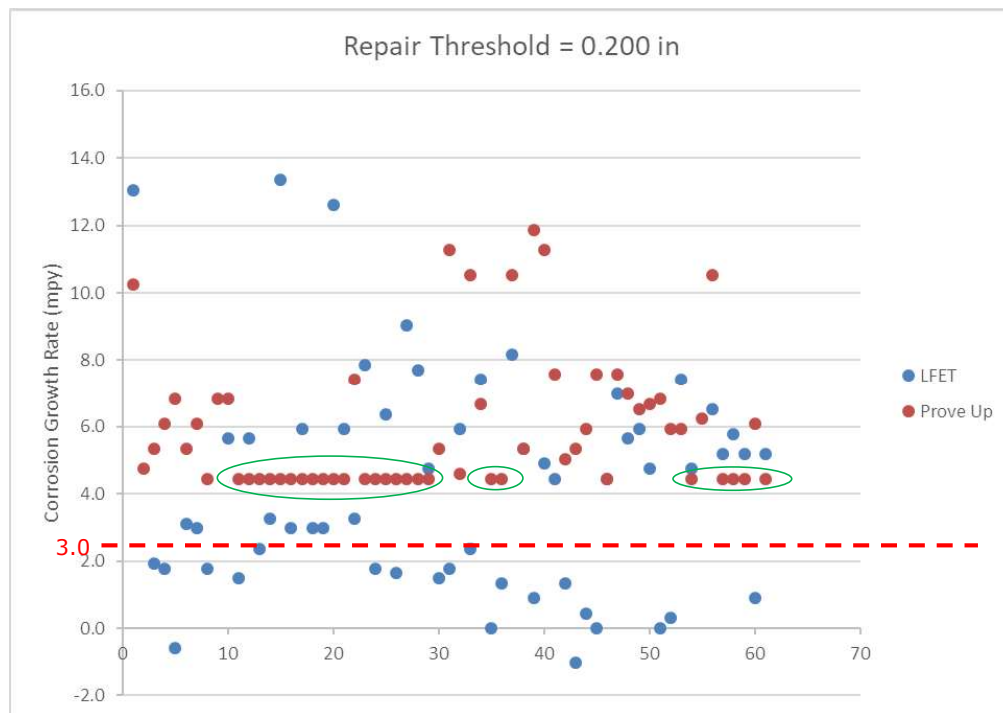
Essentially measuring the corrosion growth that has occurred over the 6.74 years between the measurements. Figure 16 is a plot of the calculated corrosion growth rates for the backside corrosion anomalies identified during the 2017 API inspection. The data show CGRs between 0 and 13.4 mpy, with an average of 5.1 mpy. The results indicate that the CGRs for the tank may be much higher than anticipated by the Navy (3 mpy) and/or illustrate the inaccuracies of the methods and practices the Navy is utilizing to assess backside corrosion on the USTs.

Figure 16. Plot showing the calculated corrosion growth rates for backside corrosion anomalies identified during the 2017 API 653 inspection for Tank 5. Navy's adopted corrosion growth rate tied to reinspection intervals. Note – Data circled in green correspond to measurements that were only reported as "<0.160", such that the data are lower bounds.

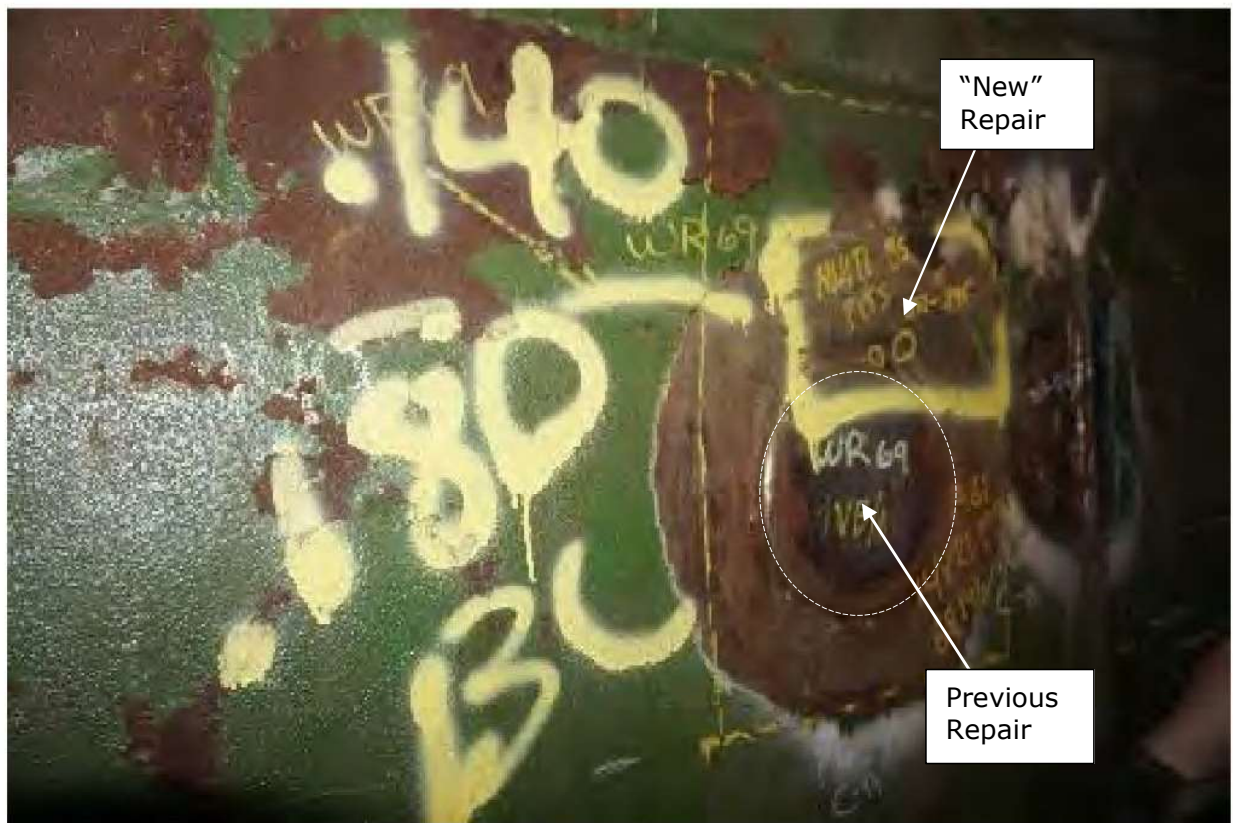
Another example illustrating the pervasive nature of unmitigated backside corrosion is shown in a photograph taken during the most recent (2017) inspection of Tank 5, refer to Figure 17. The photograph shows a location of backside corrosion requiring repair that is directly adjacent to a previously repaired location. For all of the reasons highlighted in prior sections, corrosion will continue to occur, exposing additional areas that will eventually corrode and require repairs (if detected in time). The patch plates on top of patch plates will make detection and sizing of these corrosion features more difficult. Based on the Navy's recent NDE results from the destructive testing, more difficulty (less accuracy) will only lead to more leaks.

Photo 29: Backside Corrosion around existing patch plates

Figure 17. Photograph from the API inspection conducted on Tank 5 in 2017 showing backside corrosion (BC) below the repair threshold of 0.160 (requiring repair) adjacent to an area that was previously repaired with a patch plate.

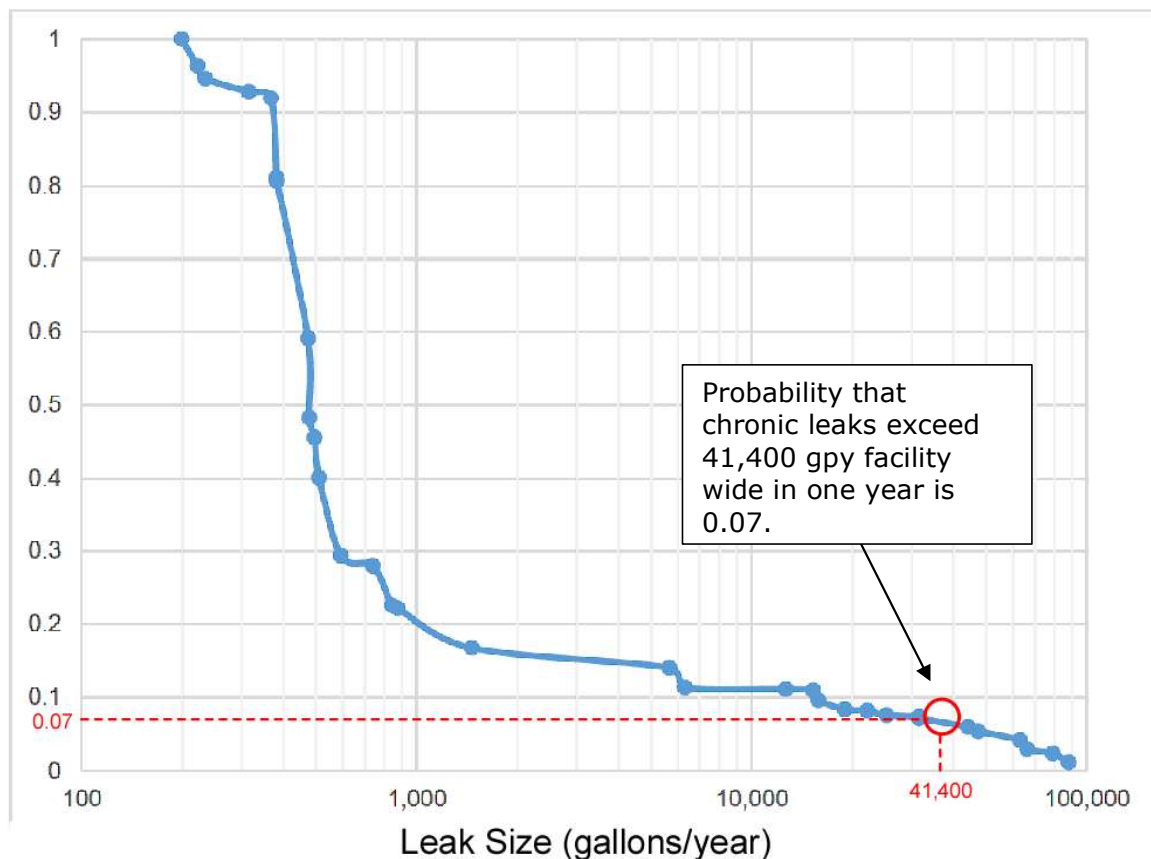
Certain chronic leaks could be detected by the currently installed continuous AFHE level monitoring system [B-15], which will alarm at a level decline of 0.5 inches and 0.75 inches. The first alarm corresponds to a leak of 2,456 gallons and the latter to 3,684 gallons. This leak detection is only feasible if the tank level is constant and no fuel is added or removed. An assessment of the AFHE system response for the Tank 5 release shows that the AFHE system required one month to identify the leak of 27,000 gallons (but potentially up to 39,312 gallons). [B-276] ABS did not use the predicted chronic leak rate from Fig 5-17 [B-15] as it is assumed they believe the AFHE system will trigger a Navy response, but the QRVA report is lacking documentation in this regard. ABS discussed this on p5-157 but also noted that, even if the tank level is not changed over several months, other tank activities, such as fuel sampling or water drainage would occur, and this would complicate detection by the AFHE system. The logic used by ABS in rejecting its own calculations (shown in ABS Fig 5-17 and reproduced in Figure 18) has not been adequately justified. Their analysis shows that exceeding a chronic leak threshold of 41,400 gpy has a probability of 0.07/year or once in 14 years.

Figure 18. Plot extracted from ABS Report showing the cumulative leak probability per year (y-axis) vs chronic leak size (x-axis).

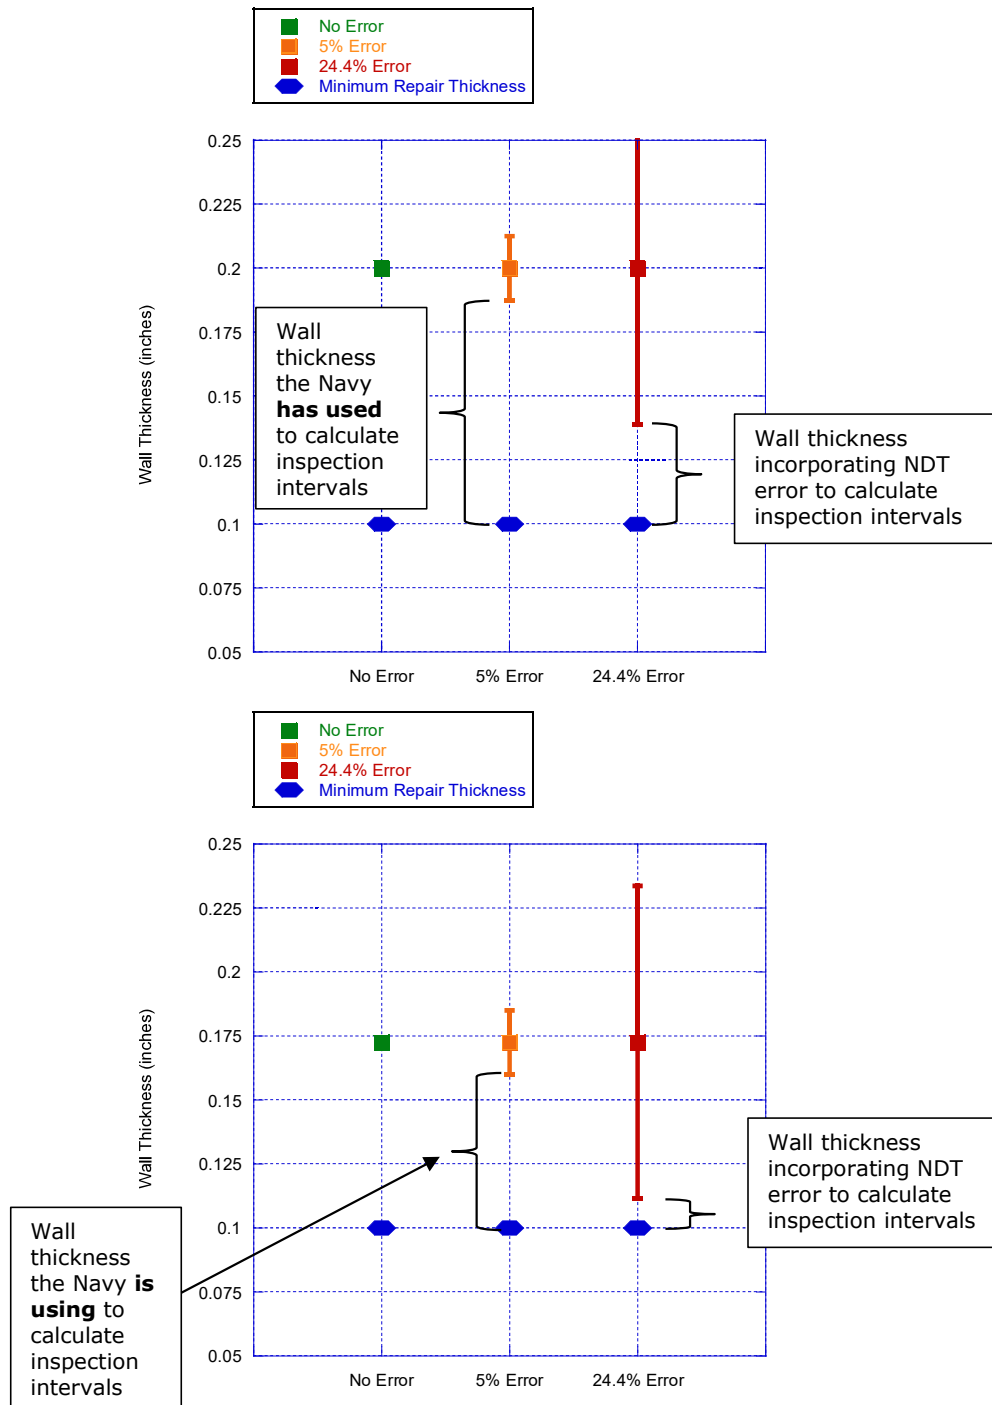
In summary, the Navy continues to reduce the repair threshold for its USTs even though they have demonstrated the inaccuracies of their inspection methodology. These inaccuracies combined with the resulted thinner wall left unrepaired increase the risk of unmitigated underside corrosion resulting in a through-wall defect and a release of stored materials to the environment. Thus, the Navy has not and cannot demonstrate that it can safely operate the RHBFSF USTs without fuel releases for the operational life of the tank system, a requirement not only in the State of Hawaii but for all other operators in the oil and gas industry.

Figure 19. Plots showing API Inspection repair thresholds from 2005/2006 (top) and 2017/2018 (bottom) incorporating error associated with the NDE measurements from Tank 14 destructive testing results.

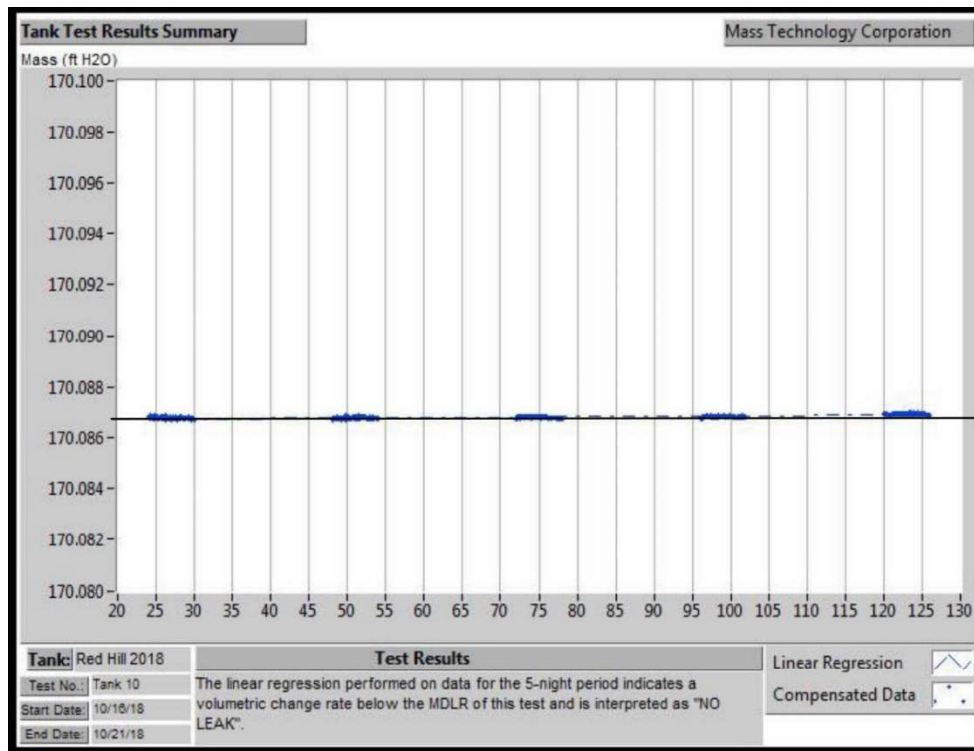
In addition, Figure 22 and Figure 23 are plots from the Navy's leak detection report that represent testing performed in 2018 for Tanks 10 and 11, respectively. The linear regression plots show the mass measurement (ft H<sub>2</sub>O) on the y-axis and time (hours) on the x-axis. Horizontal lines have been added to the plots. Comparing the deviations of the mass measurement to the horizontal lines, it is clear that there is a more pronounced "drift" of the measured values for Tank 11. A trend of this type of drift can be indicative of a leak in a tank. Given the redacted nature of the Navy's leak detection report, including the absence of the data itself, DNV GL is unable to conclusively determine the actual cause of the drift that appears to be depicted in this report. In fact, it is difficult to draw any conclusions without additional information, including contemporaneous temperature, pressure, and density monitoring data and the calculations, if any, used by Mass Technology to compensate for variations throughout the test. It is clear, however, that additional documentation is necessary to fully understand whether the Navy is able to detect a leak rate of 0.5 gph, and the Navy has not provided sufficient information in its permit application to do so.

Figure 22. Plot produced from tank tightness testing performed on Tank 10 in 2018.

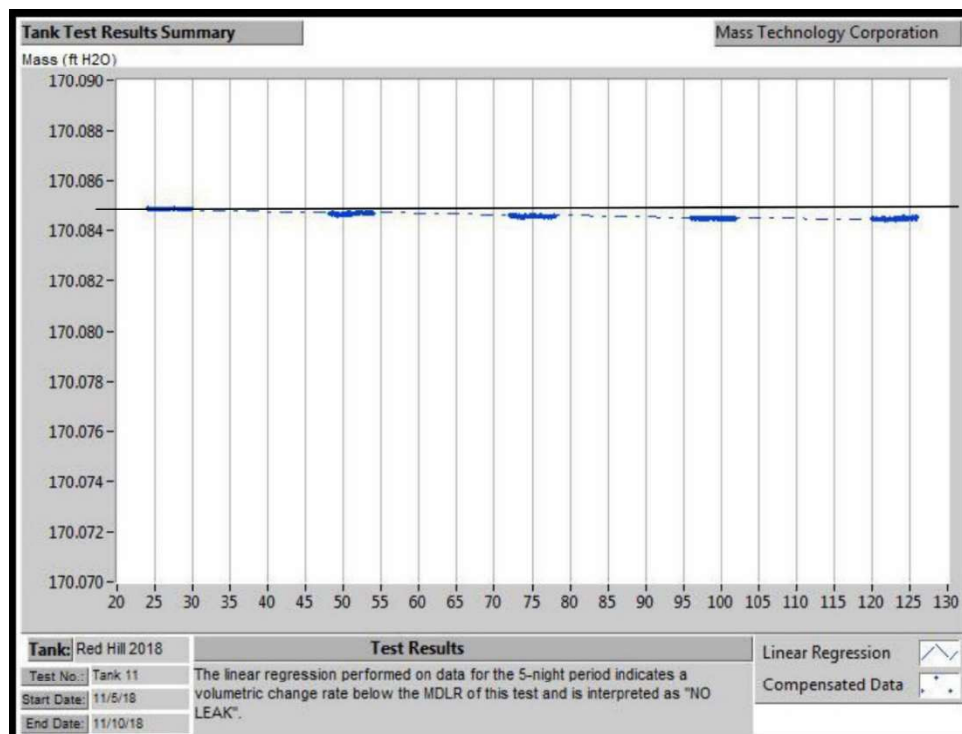
Figure 23. Plot produced from tank tightness testing performed on Tank 11 in 2018.
