Naval Audit Service

Audit Report

Department of the Navy Red Hill and Upper Tank Farm Fuel Storage Facilities

N2010-0049
16 August 2010

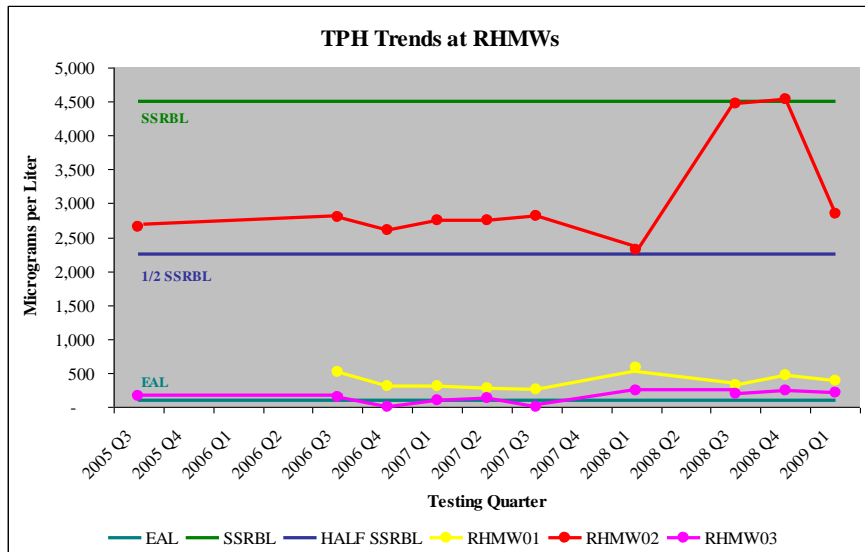
Figure 2

U.S. Navy Well 2254-01

In the 1st quarter of 2009, TPH contaminants were also detected at the Navy Well. Although the concentration that was detected was below the EAL,¹¹ this sampling event was the first time that TPH had been detected since the Navy began testing for the contaminant in 2006. As mentioned above, the recent detection of contaminants at the Navy Well may indicate migration

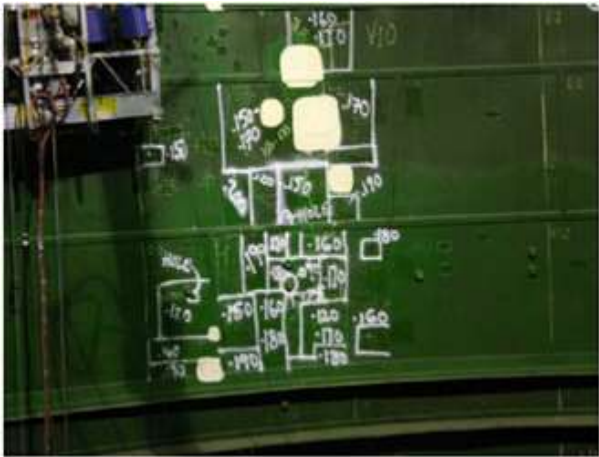
Figure 3: Tank 16 Exterior Corrosion Area

In addition to the defects noted on the interior of the five tanks, the modified-API 653 inspections identified 206 areas of exterior corrosion which had diminished the thickness of the tanks' liners. The corroded areas were caused by groundwater coming in contact with the tanks; however, given that previous inspection methodologies and testing equipment were not sufficient to detect these exterior defects, the corrosion was not previously identified. A NFESC corrosion engineer explained that this corrosion cannot be prevented at RH due to the construction of the tanks. However, inspection reports and subject matter experts indicate that the impact of this corrosion can be mitigated by

Figure 3: The inspection of Tank 16 revealed a cluster of exterior corrosion (23 flaws) and two through-holes within the cluster.

applying patch plates to the interior or by removing the corroded plates (see Figures 3 and 4). Until the current inspection cycle is completed, any previously undetected areas of exterior corrosion may continue to worsen, may cause the remaining tanks to be susceptible to through-holes, and could potentially result in future fuel releases.

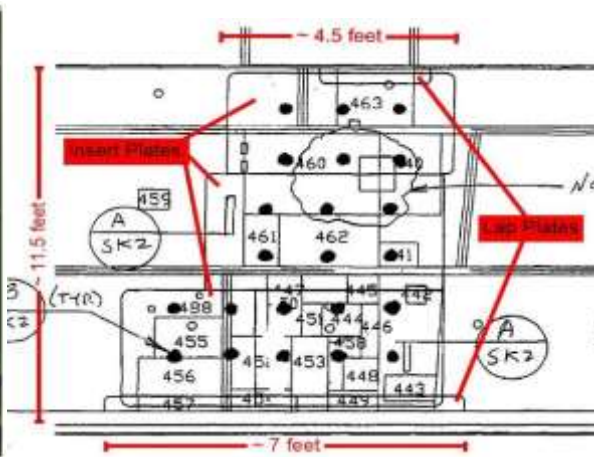
Figure 4: Tank 16 Repair Schematic

Figure 4: Repair schematic displays numbered flaws in figure 3, which required replacing the corroded original plates with four insert plates and three lap plates covering an area approximately 11.5 feet high and between 4.5 to almost 7 feet wide. Anchoring rods (represented by the black dots) are used to connect the plates to the concrete. Note: All insert and lap plates are not depicted in the schematic.
