**ENGINEERING SURVEY OF
U.S. NAVY PETROLEUM FACILITIES
AT PEARL HARBOR**

BECHTEL CORPORATION

12, May 1949

Subj: Engineering Survey of U. S. Navy Petroleum Facilities
at Pearl Harbor, Report on

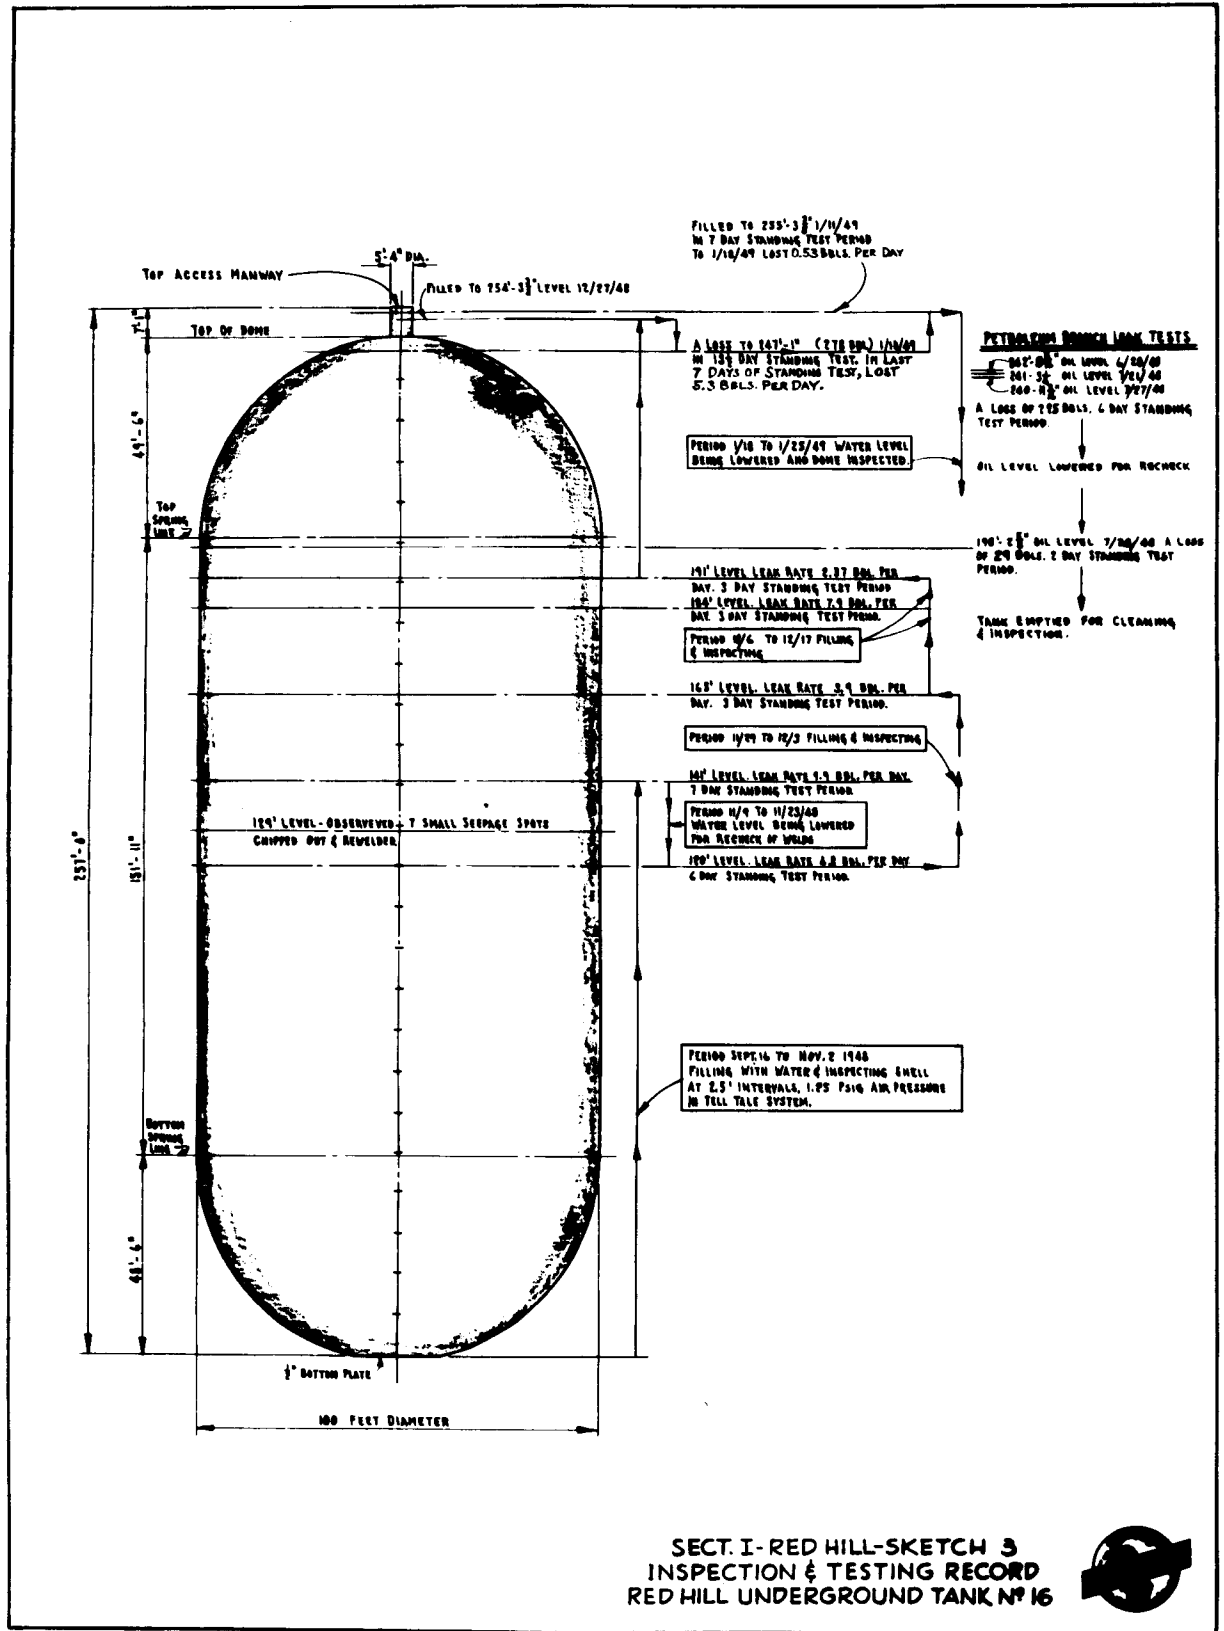
SECT. I- RED HILL-SKETCH 3
 INSPECTION & TESTING RECORD
 RED HILL UNDERGROUND TANK NO 16

Six seepages of water back into the tank at the 129 foot level were observed, which were due to pinholes in the welding.

The water was lowered to the 120 foot level, and the welds and walls were again examined both during lowering and raising of the water level. At the 129 foot level six points of water seepages through welds were noted. These were around patches which were used to cover the bolt holes where attachments for the waler forms were made. During the process of raising and lowering the water level, the welded seams which had been wire brushed became covered with a coating of hydrated ferric oxide.

The water level was raised to the 191 foot level. The inspection at two foot intervals was continued, and no points of leakage other than that noted at the 129 foot level were observed. The manway was closed, and the water level was raised to about the 256 foot level, which is in the entrance section of the top dome. This cylindrical section is approximately 5'-4" diameter. Standing tests during the period of December 27, 1948, to January 10, 1949, revealed the water level falling at the average rate of 37 barrels per day for 6-1/2 days. This leakage decreased to an average of 5.3 barrels per day during the last seven days of the period, with the water level standing at about the 247 foot level. The water level was raised to 255'-3" on January 11, and a seven day test indicated a leak rate averaging only 0.53 barrels per day. *original rate*

Repair points of seepage at the 129 foot level by rewelding when testing is complete on Tank 16.

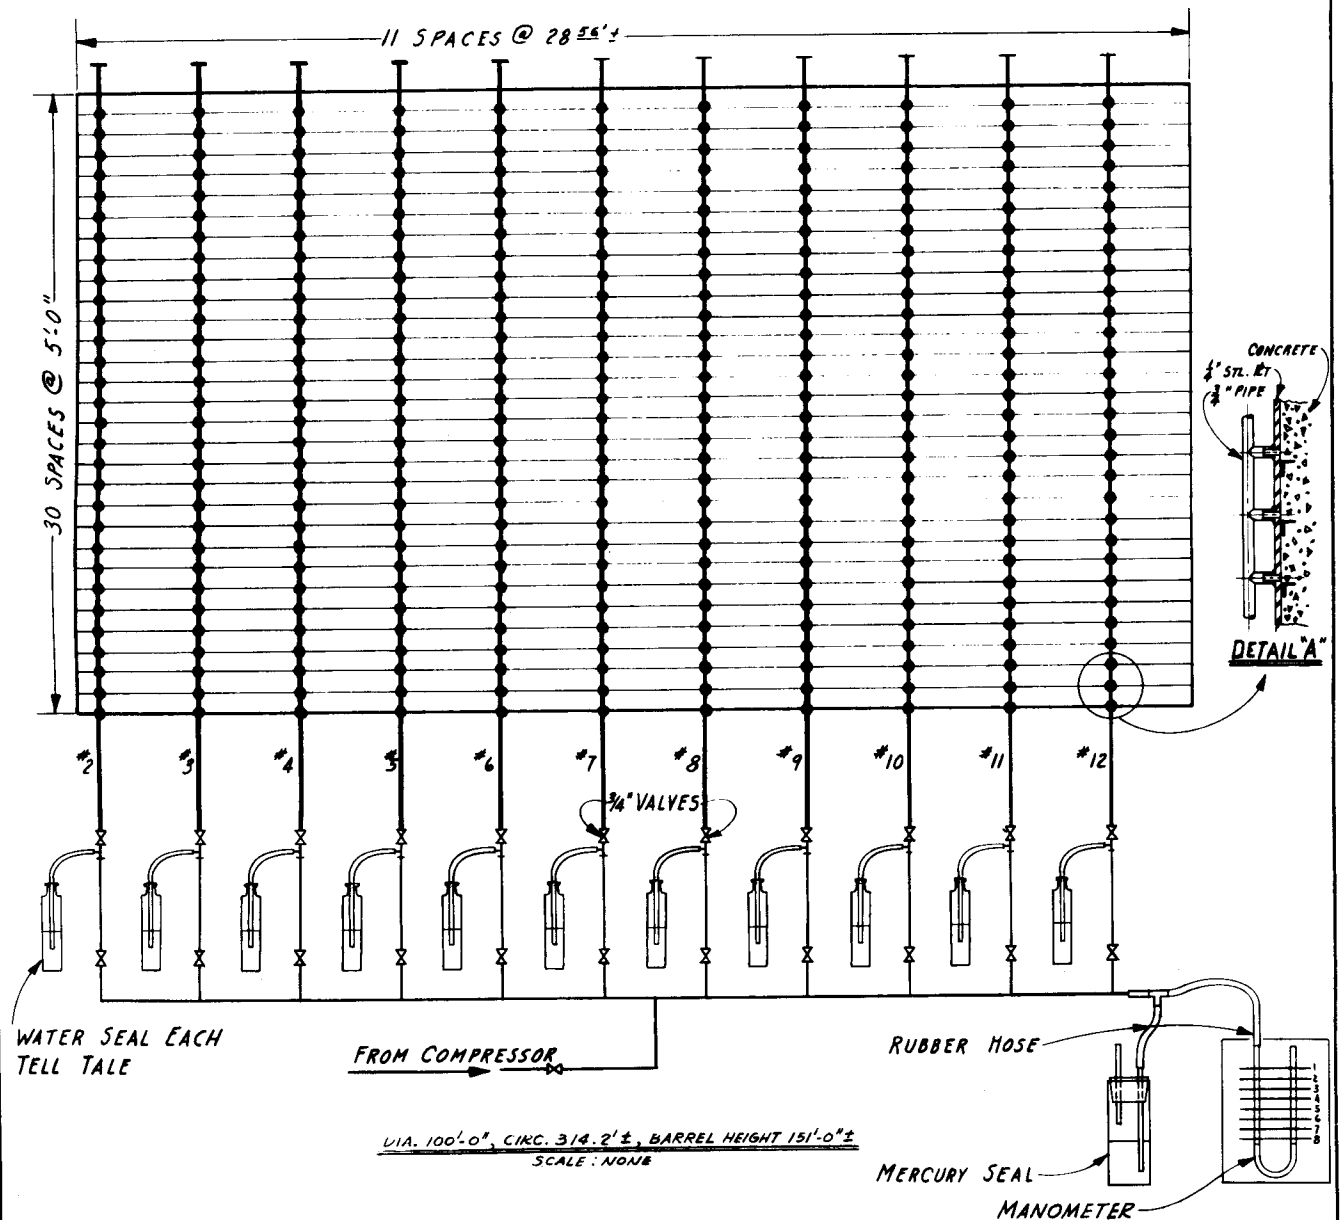
SECT. VI-RED HILL-SKETCH 6
DEVELOPMENT OF BARREL SECTION
SHOWING TELL TALES TANK NO 16

It has been determined that the tell-tale system is not reliable for either testing the welds, or denoting leakage. The automatic level and temperature indicating instruments are not functioning properly.

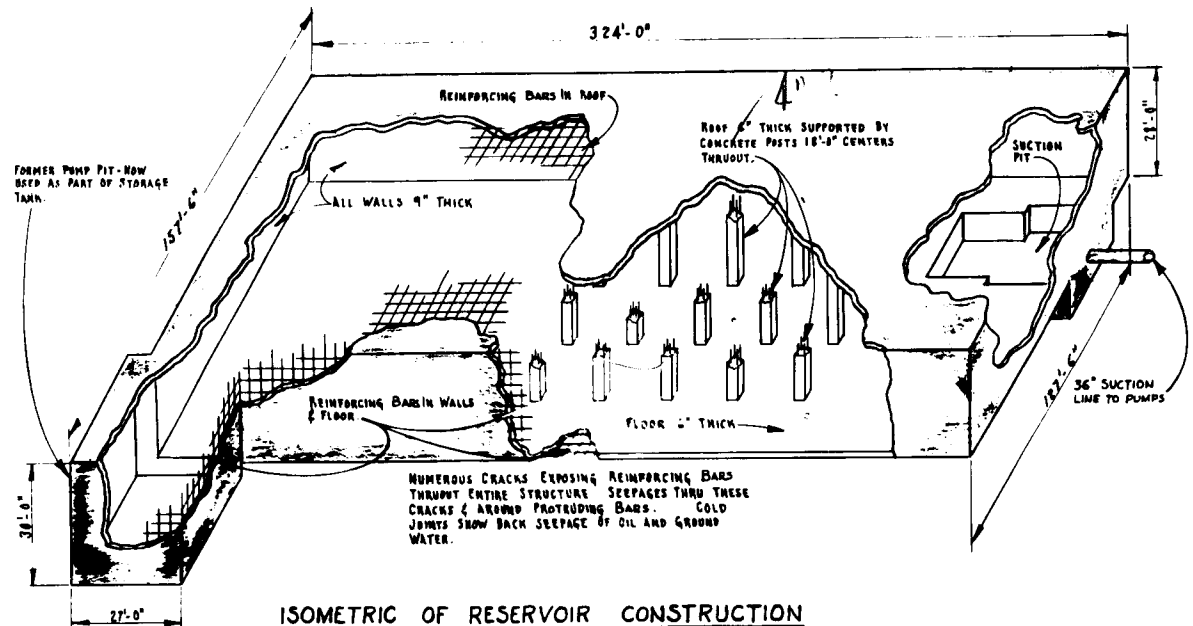
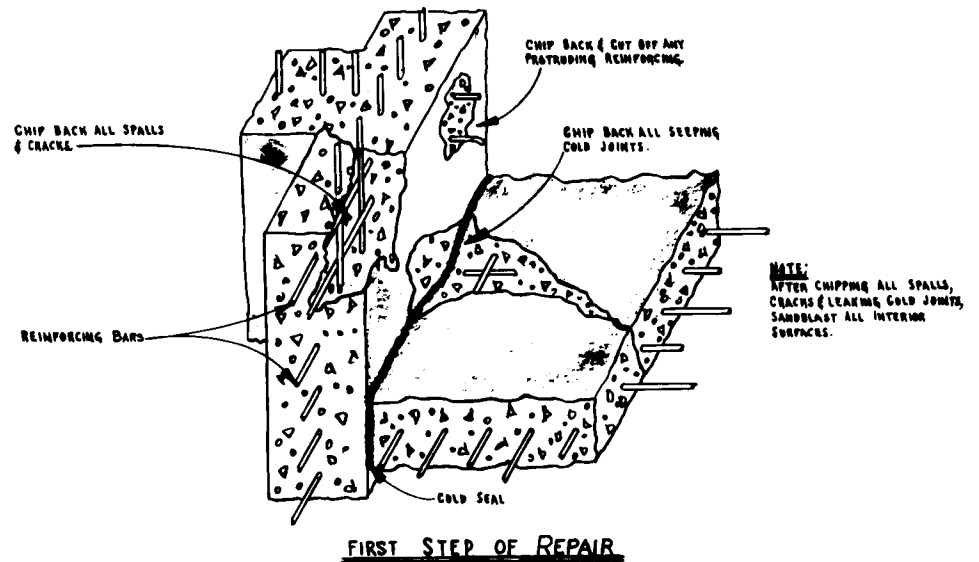
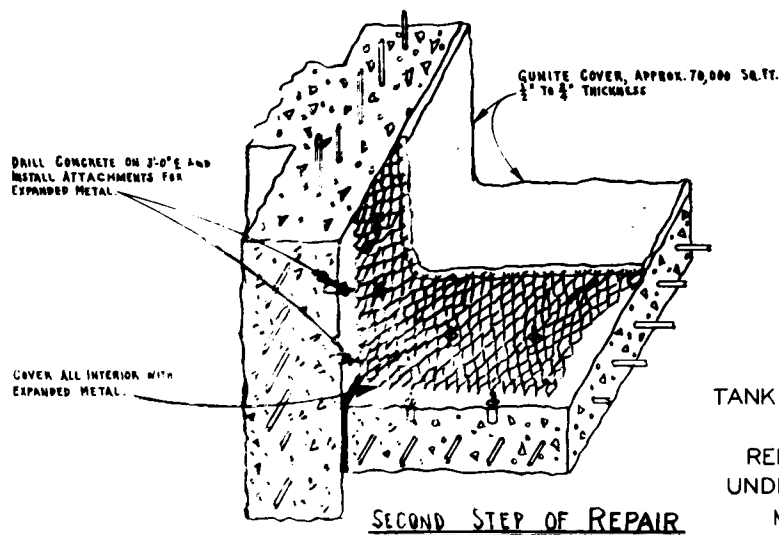
SECT. VI
TANK INSPECTION SKETCH 5
REPAIRS TO
REINFORCED CONCRETE
UNDERGROUND RESERVOIR
MIDDLE TANK FARM

The underground 195,000 barrel reinforced reservoir located in the Middle Tank Farm was constructed about 1920. Inspection revealed that the concrete was cracked in numerous places, and when empty the leakage rate back into the reservoir from the oil soaked ground was several barrels per day. This unit appears to be one of the major sources contributing to the oil underlying the Merry Point area of the Navy Yard.

Chip out all cracks, cut off protruding reinforcing bars, thoroughly clean, sand blast, apply expanded metal, and gunite interior surface of sides and floor. Report of inspection and sketch showing repair method are included in Section VI.

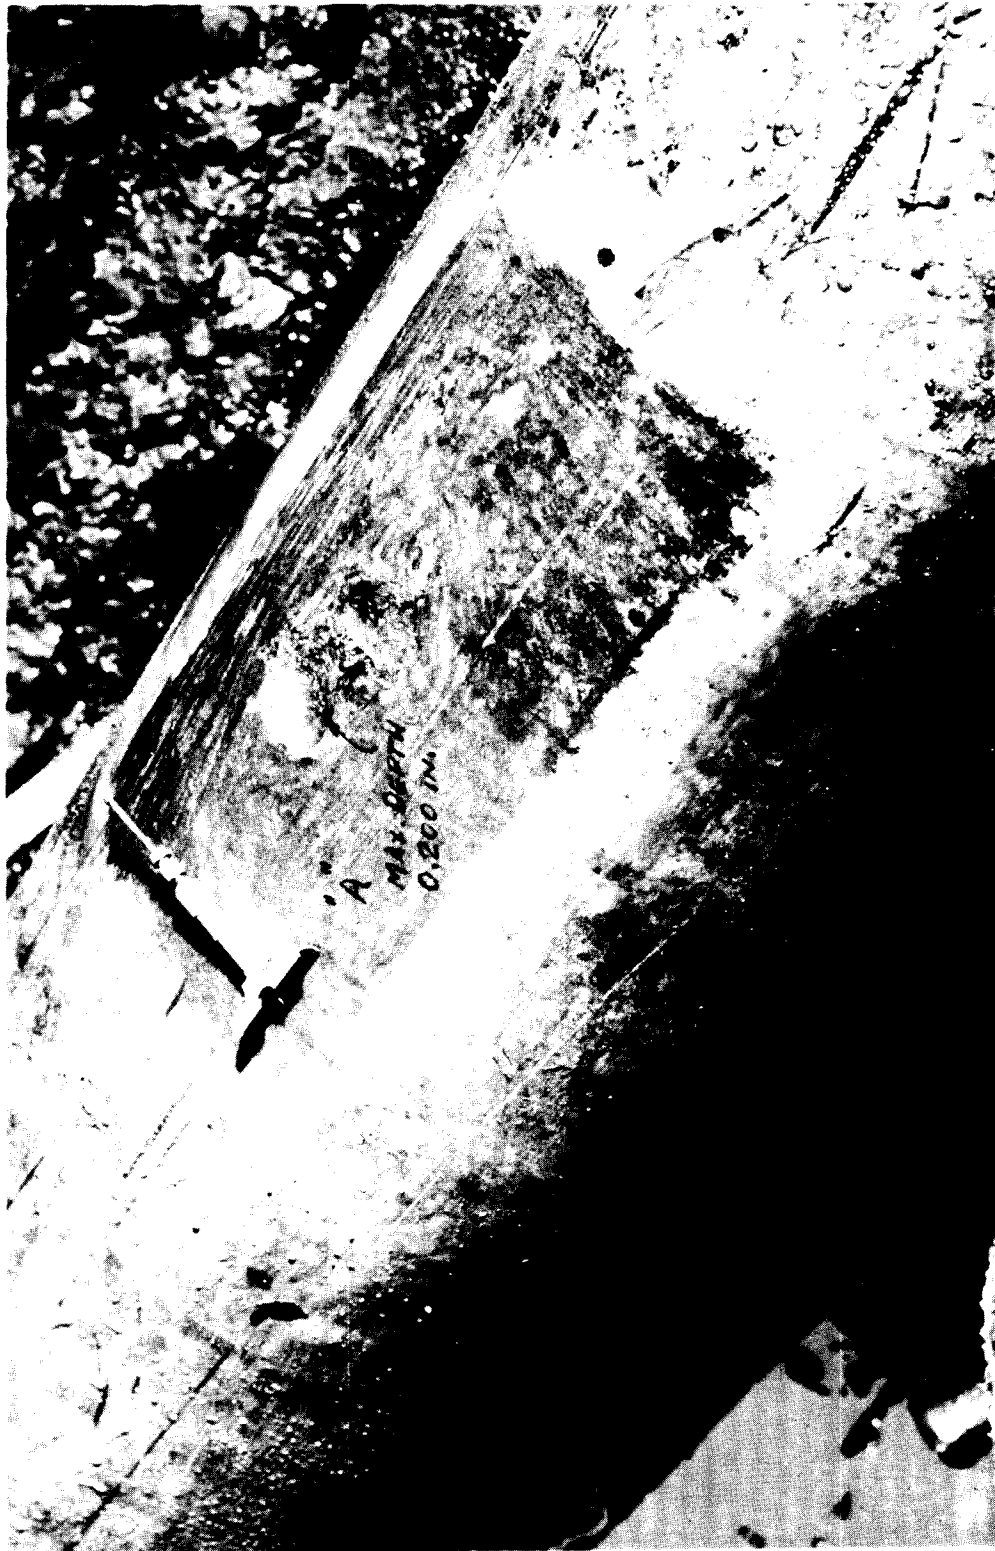
VI - 2

A history of rapid failures of piping in the Sub-Base area, and Supply Center indicated that in all probability these failures were electrolytic in nature. Leak tests were made and the leaking lines were exposed along Fierce Street. Examination of the leaks clearly indicated electrolytic corrosion due to stray currents. A survey was made and electrical measurements traced the source of these stray currents to the direct current

TYPICAL CORROSION OF BURIED FUEL AND
DIESEL OIL LINES IN SUBMARINE BASE AREA
COATING FAILURE, OIL SATURATED SOIL AND
ENVIRONMENT OF LINES ARE CLEARLY INDICATED
