DEPARTMENT OF THE NAVY
VICE CHIEF OF NAVAL OPERATIONS
2000 NAVY PENTAGON
WASHINGTON DC 20350-2000

FINAL ENDORSEMENT on RDML Christopher J. Cavanaugh, USN ltr 5830 of 14 Jan 22

Subj: COMMAND INVESTIGATION INTO THE 6 MAY 2021 AND 20 NOVEMBER 2021
INCIDENTS AT RED HILL BULK FUEL STORAGE FACILITY

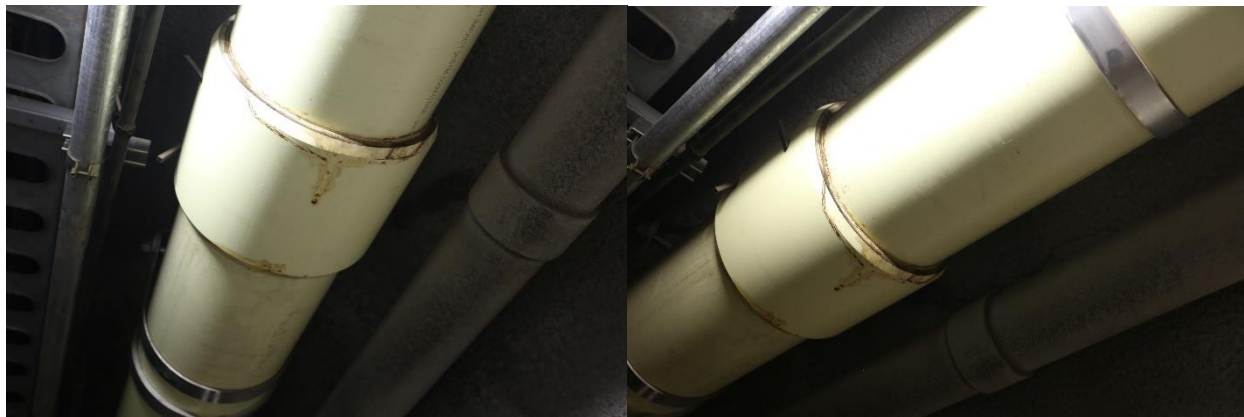
414. On 17 Mar 22, during a walkthrough of Red Hill, the supplement investigation team noted visual evidence of a foreign substance on the outside of the PVC AFFF retention line piping joints that appears to have seeped out.

Installed PVC AFFF Retention Line with Joint Seepage

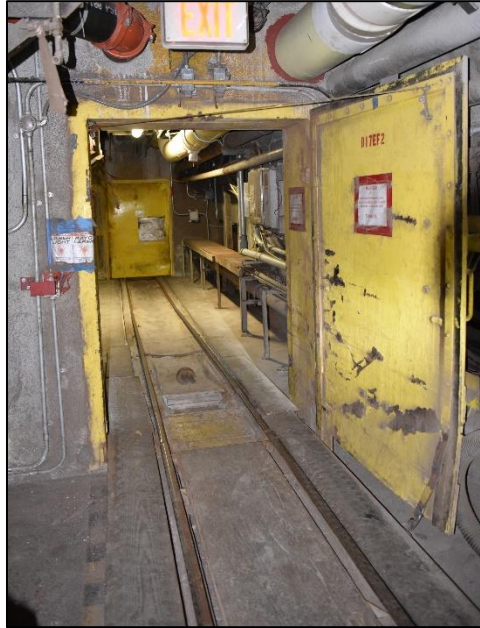
Figure 1: Image of open oil-tight door (foreground) and closed ventilation door on either side of the damaged fire suppression system low point drain valve. [Encl (169)]

178. After driving through the doorway, he again stopped the train and disembarked to close the ventilation control door. As he turned to close the door, he discovered liquid spraying from the low point drain of the fire suppression system retention line. He reported the leak immediately to the CRO. He recognized the source was a non-fuel system, first reporting it was from a sewage line, then fire suppression agent, then water. Finally, he reported the leak as water with a fuel smell. This line should have been empty. [Encls (83), (173)-(186)]
