DEPARTMENT OF HEALTH
Contested Case Hearing Re Red Hill Permit Application
19-UST-EA-01
Supplemental Testimony of Frank Kern

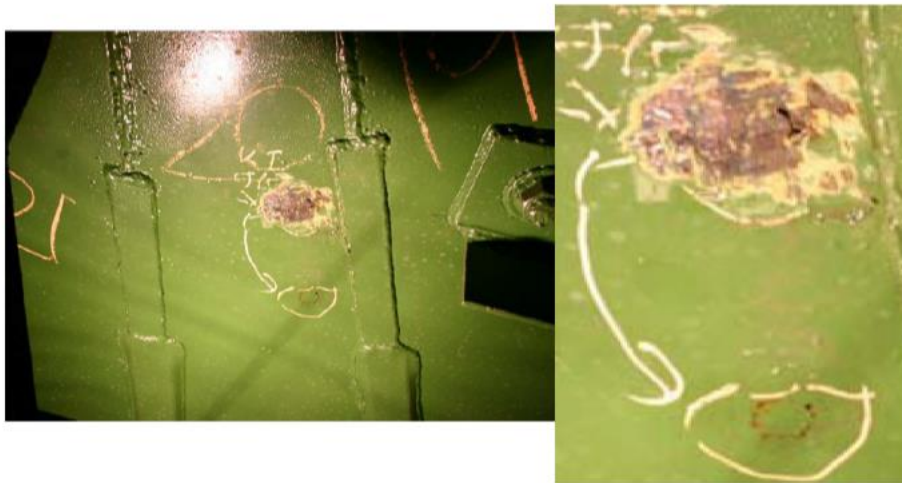
13. **Figures 5 and 6 from Page 22.**

Figure 5. Photographs extracted from the API Tank 16 Inspection Report (Photograph 8) showing "holes at the top of course F of the upper dome".

The DNV-GL report identifies inspection report findings termed “holes.” However the term “hole” has been inconsistently used over the years and does not always represent a passage from the interior to the exterior of the tank. For example, DNV –GL Figure 6 depicts a photograph from the Tank 20 report captioned “through-wall hole.” However a review of the Tank 20 report reveals the finding is located in the upper dome on a backer strip. Thus behind the backer strip sits ¼-inch liner plate material. The hole in the backer strip is a noted inspection finding but it is not a breach in the hydraulic boundary of the tank because of the liner plate. This means that while it will be repaired, it is not a “hole” through the tank liner. Figure 5 depicts a photograph from the Tank 16 report captioned “holes at the top of course F of the upper dome.” The Tank 16 report notes 4 holes in Course F which was reachable from the gauger’s gallery. Course F is a very small region at the extreme top of the tank. The upper tower connections are evident in the photograph and the plate boundary meridians are very close together. The holes are located approximately 50 feet

1 above the maximum fill height of the tank. This means that while they were repaired, they do not
2 represent a release risk because fuel does not reach them.

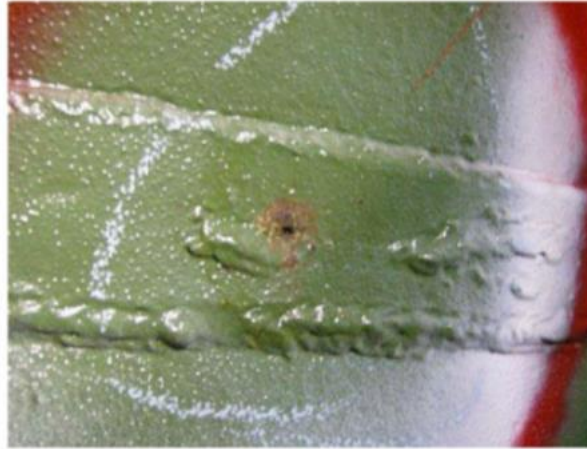
Flaw 347 through hole in strap

Figure 6. Photograph extracted from the API Tank 20 Inspection Report showing a through-wall hole.

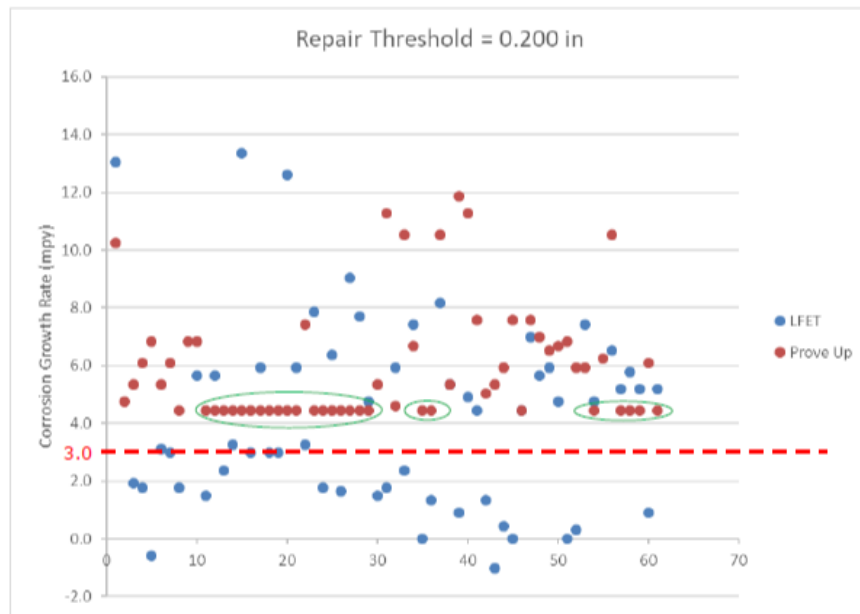
11
12 **18. Figure 16 at Page 48.**

Figure 16. Plot showing the calculated corrosion growth rates for backside corrosion anomalies identified during the 2017 API 653 inspection for Tank 5. Navy's adopted corrosion growth rate tied to reinspection intervals. Note – Data circled in green correspond to measurements that were only reported as "<0.160", such that the data are lower bounds.

The corrosion rates in Tank 5 presented in the DNV-GL report are based on a calculation which used an interval of 6.74 years. During warranty repairs to Tank 5, Willbros Government Services poorly performed work by overgrinding the metal. This resulted in metal loss not due to corrosion. The metal removal performed by Willbros Government Services is depicted typically in DNV-GL Figure 17 on Page 49, which shows a large area of ground metal surrounding a patch plate. 6.74 years should not be used as the corrosion rate calculation denominator in Tank 5 because the metal loss was not caused by corrosion, it was caused by a grinder. The rates reported in Figure 16 are not valid because they calculate a rate of metal loss due to corrosion when actually the metal loss was not due to corrosion.

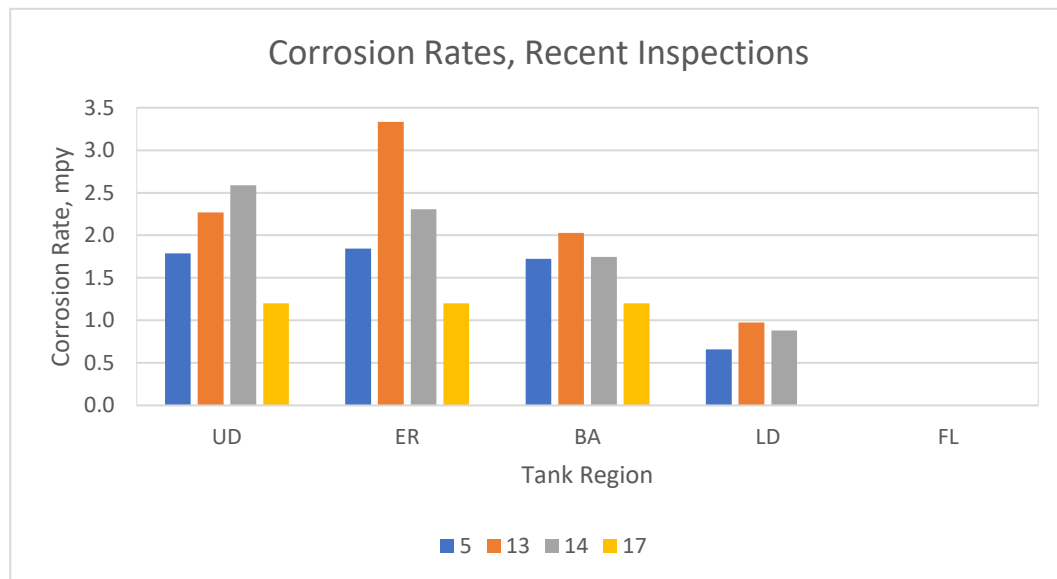
The chart below summarizes reported corrosion rates for inspections performed in 2017-2019 on Tanks 5, 13, 14, and 17. Data for all tanks region Floor, and data for Tank 17 region Lower Dome are not missing but instead were reported by the inspector to be negligible rates which is equivalent to zero.

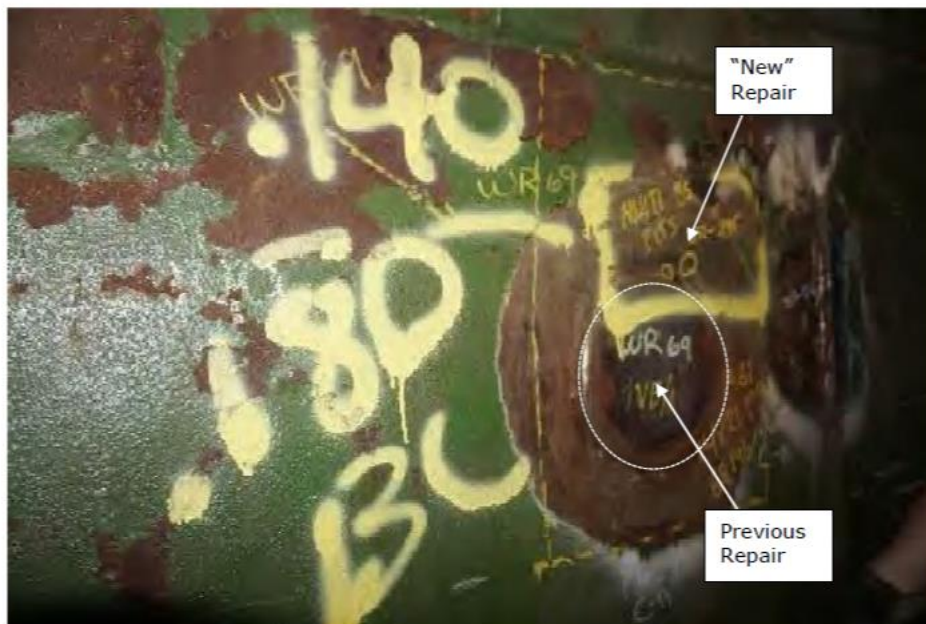
20. **Figure 17 at Page 49, Backside Corrosion around existing patch plates**

Photo 29: Backside Corrosion around existing patch plates

Figure 17. Photograph from the API inspection conducted on Tank 5 in 2017 showing backside corrosion (BC) below the repair threshold of 0.160 (requiring repair) adjacent to an area that was previously repaired with a patch plate.

1 DNV GL's Figure 17 is offered to depict a location of backside corrosion adjacent to a previous
2 repair and evidence of more corrosion. However the conditions depicted warrant contextualization
3 to understand actual conditions and clarify what actually was done.

4 The previous repair annotated WR69 on Figure 17 is a patch plate installed by Willbros
5 Government Services (WGS) during Tank 5 warranty repair work in 2016. The plate was used to
6 repair two non-corrosion related conditions which were a weld repair and a gouge. At the
7 conclusion of WGS warranty work, Navy re-inspected Tank 5 with an independent firm in a
8 manner consistent with the TIRM three-step process. During the re-inspection, metal surrounding
9 patch plate WR69 was found to have been over-ground and excessive metal had been removed.

10 The LFET technician detected the metal loss and marked the location for examination during the
11 second step of the inspection, which is the PAUT technician. The PAUT technician circled two
12 pits which were tool marks made during the grinding. During repair prove-up the decision was
13 made to remove WR69 patch plate and install a larger plate covering the entire area where
14 excessive metal had been removed. Exhibit N-080.

15
16 There was not metal loss due to corrosion at this location. Navy's re-inspection of the area
17 detected a human error (over-grinding) made by the same contractor, and the Navy three-step
18 process led to the identification of metal loss and subsequent repair, none of which was due to
19 backside corrosion. Exhibit N-105.

20
21 This poor practice which led to the defects depicted in Figure 17, became evident during the WGS
22 warranty phase. To mitigate against this type of practice from being repeated, Navy included

Paragraph 3.3.1 in Section 33 56 18.00 20, which is Attachment BE of the TIRM Procedures report. Exhibit N-008 at Page 18. The paragraph requires additional thickness measurements to be taken whenever plate grinding must occur. Should thickness be found to be reduced, repair is required.
