TANK 2 ENGINEERING REVIEW AND SUITABILITY FOR SERVICE EVALUATION

API 653 OUT-OF-SERVICE TANK INSPECTION BY OTHERS

**FISC PEARL HARBOR
RED HILL COMPLEX, HAWAII**

Final Report October 2008

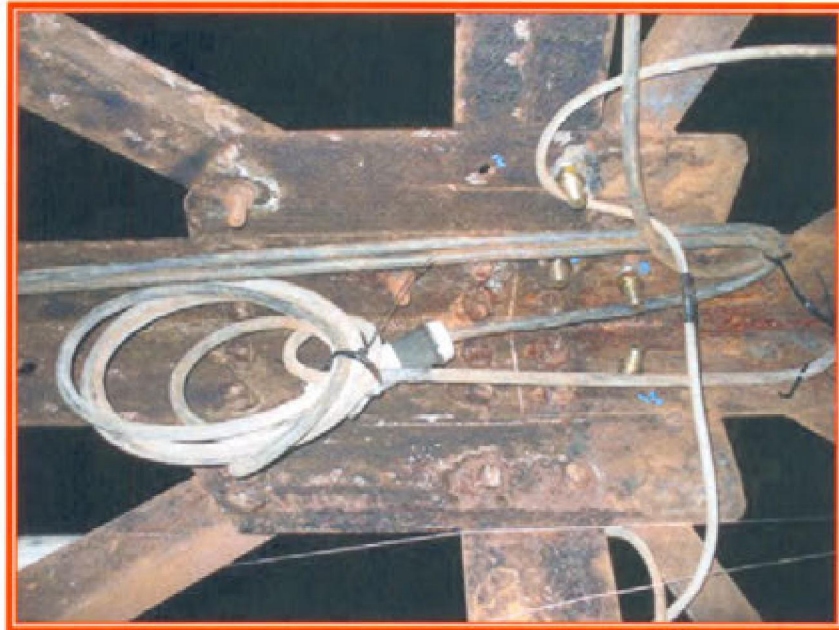
Photo #4: *Big holes on the framing members*

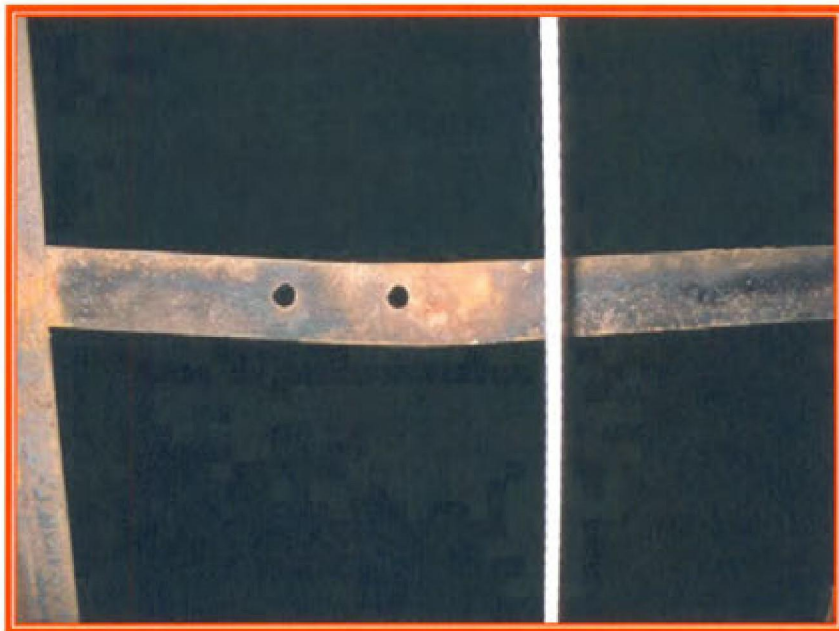
Photo #5: *Missing bolts*

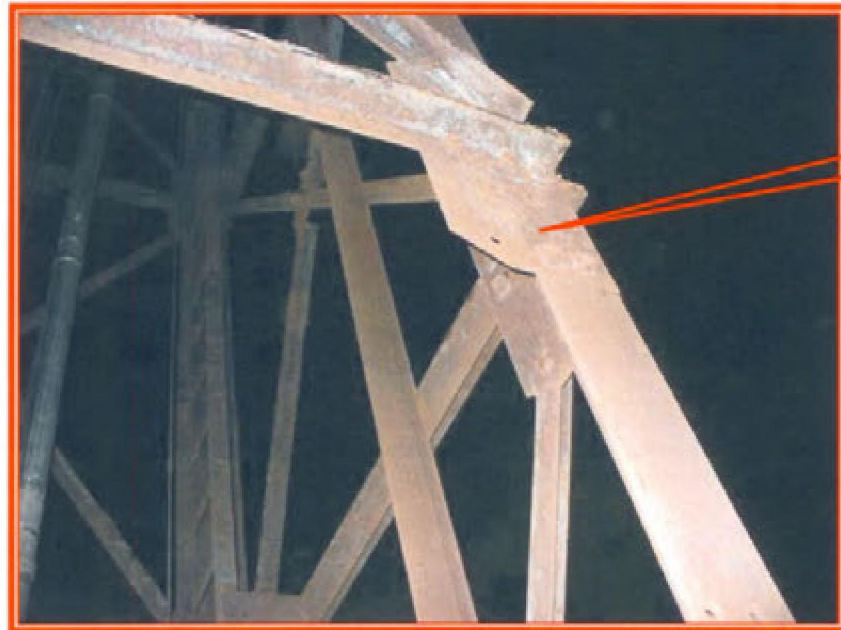
Photo #6: *Bent framing member*

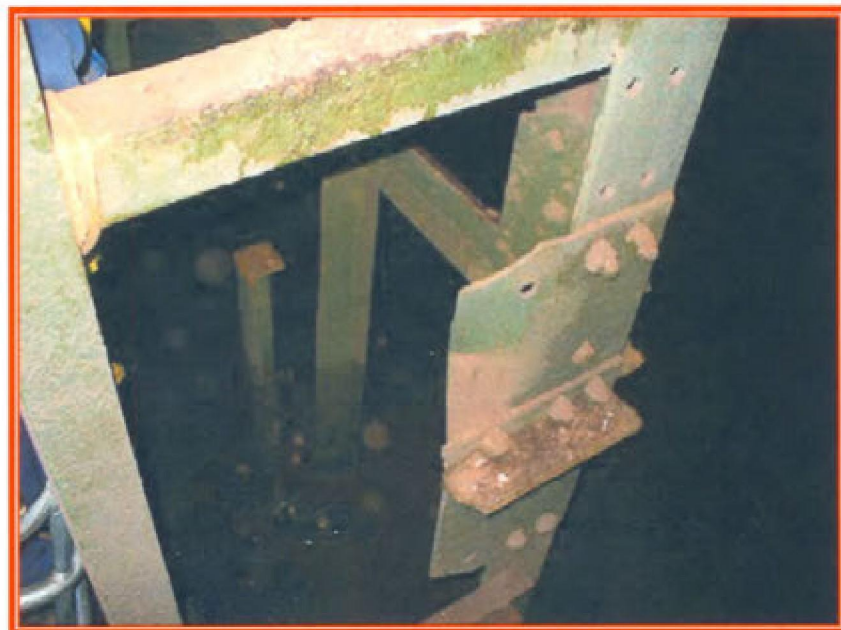
Photo #7: *Missing diagonal.*

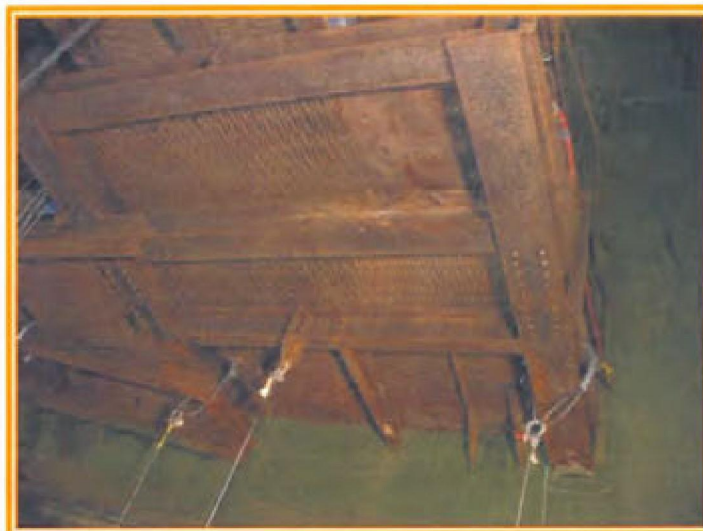
All framing members of the cat walk are in good condition (see photo #1 and #2). The welding of the major framing members to the tower steel wall are all in good condition (see photo #3 and #4) and are capable of providing fixed condition.

Photo #1: Cat walk framing by the tank entrance

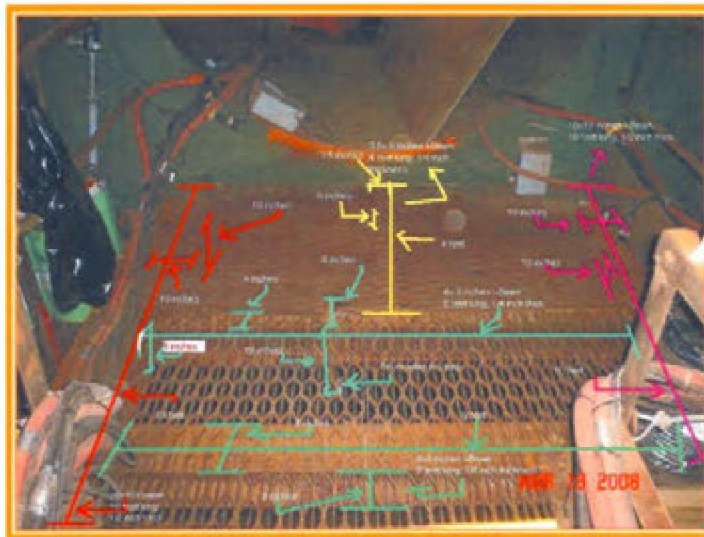
Photo #2: Cat walk framing members and connections in good condition

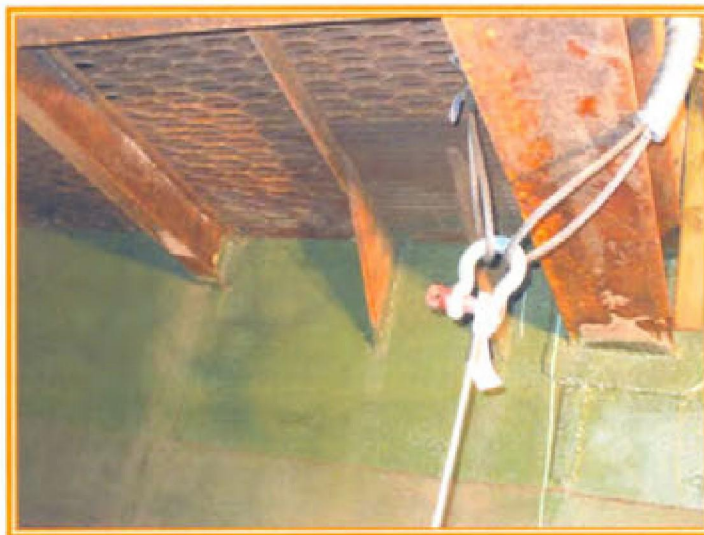
Photo #3: Weld of the major I-beam is in good condition

Our analysis indicates that the framing of the cat walk is able to support a live load of 200psf, and also to support the scaffold load of 2000lbs hung on the two points shown in photo #3.

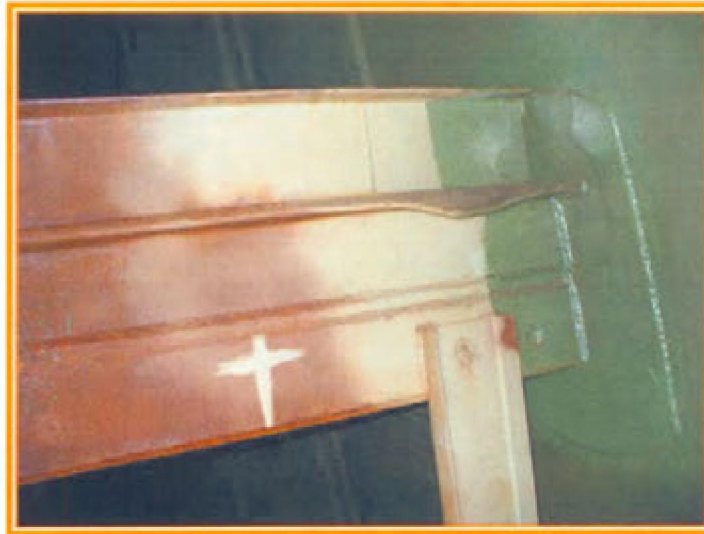
Photo #4: *Weld of the major I-beam is in good condition*

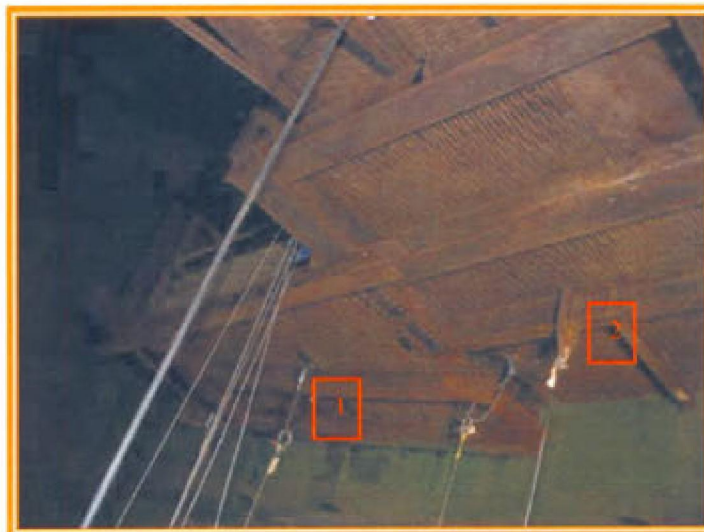
Photo #5: *Proposed scaffold will be hung on points 1 & 2*

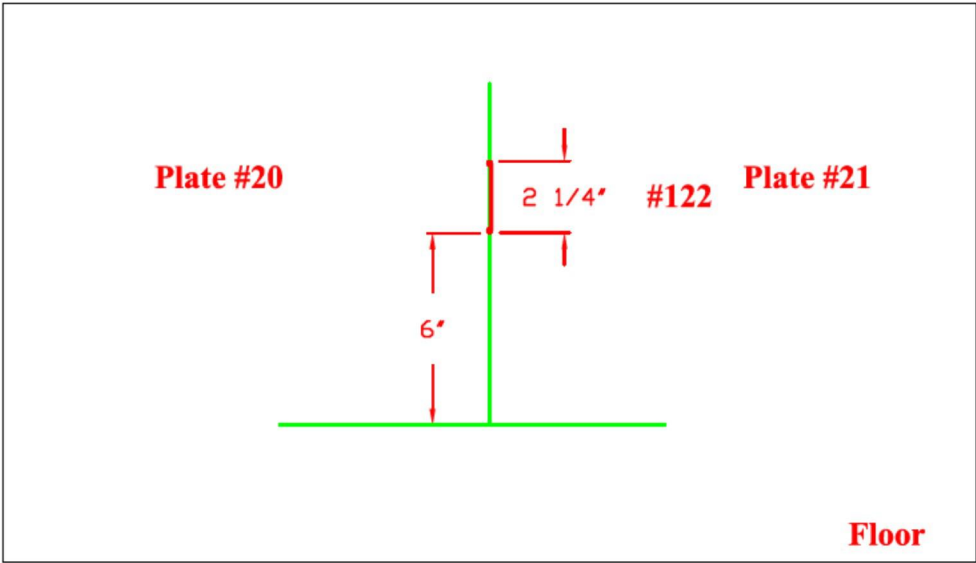
Flaw #122 - Lack of fusion
.192 depth 2 1/4" long (Right)

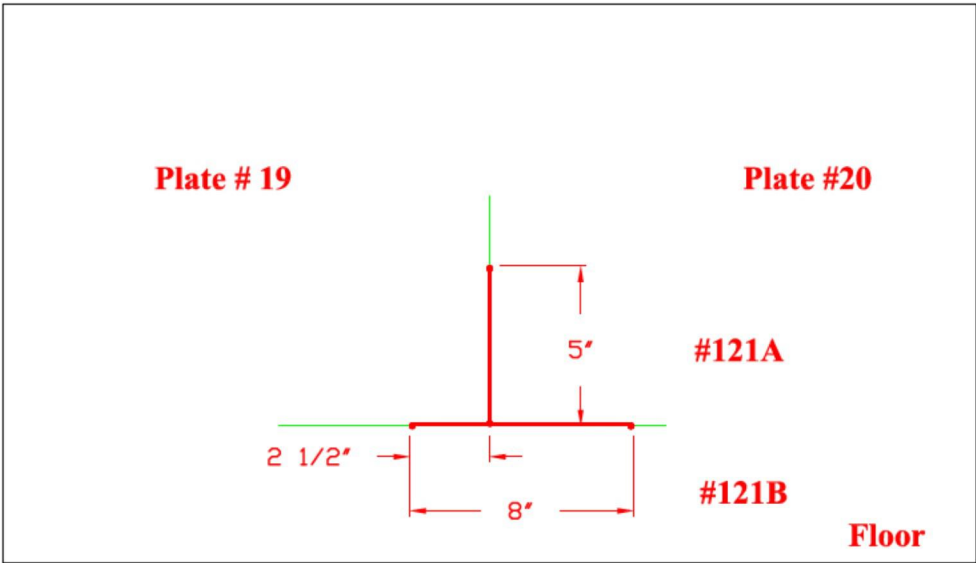
Tank Section: Floor/Shell
Quadrant: D
Course:
Plate: # 19 - 20

Flaw #121A - Intermittent crack
.238 depth 5" long (center)
Flaw #121B - Intermittent crack
.231 depth 8" long (top)

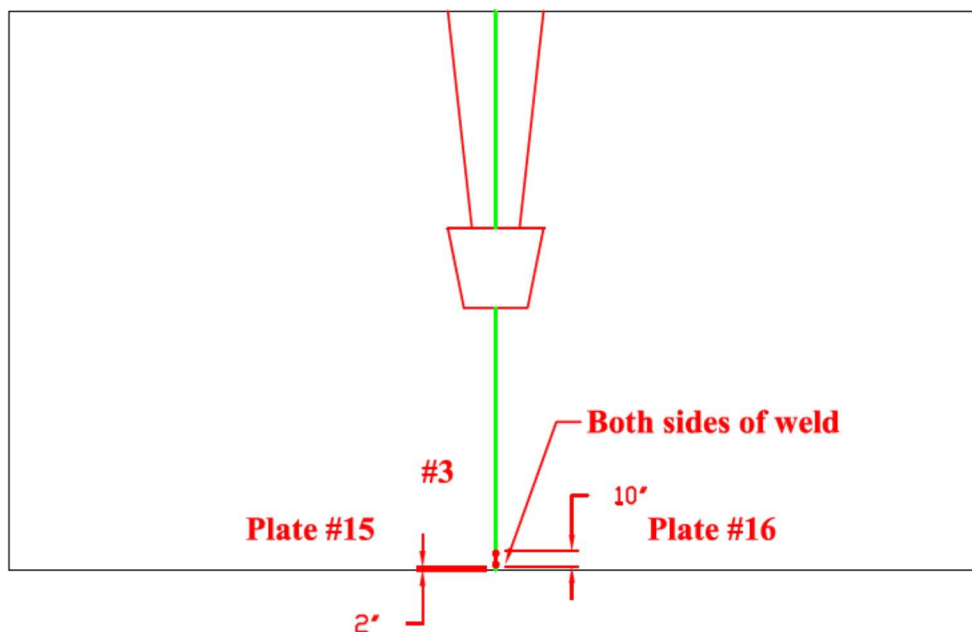
Flaw #3 - Intermittent crack
3A - .223" depth 10" long
(left side)
3B - .214" depth 10" long
(right side)

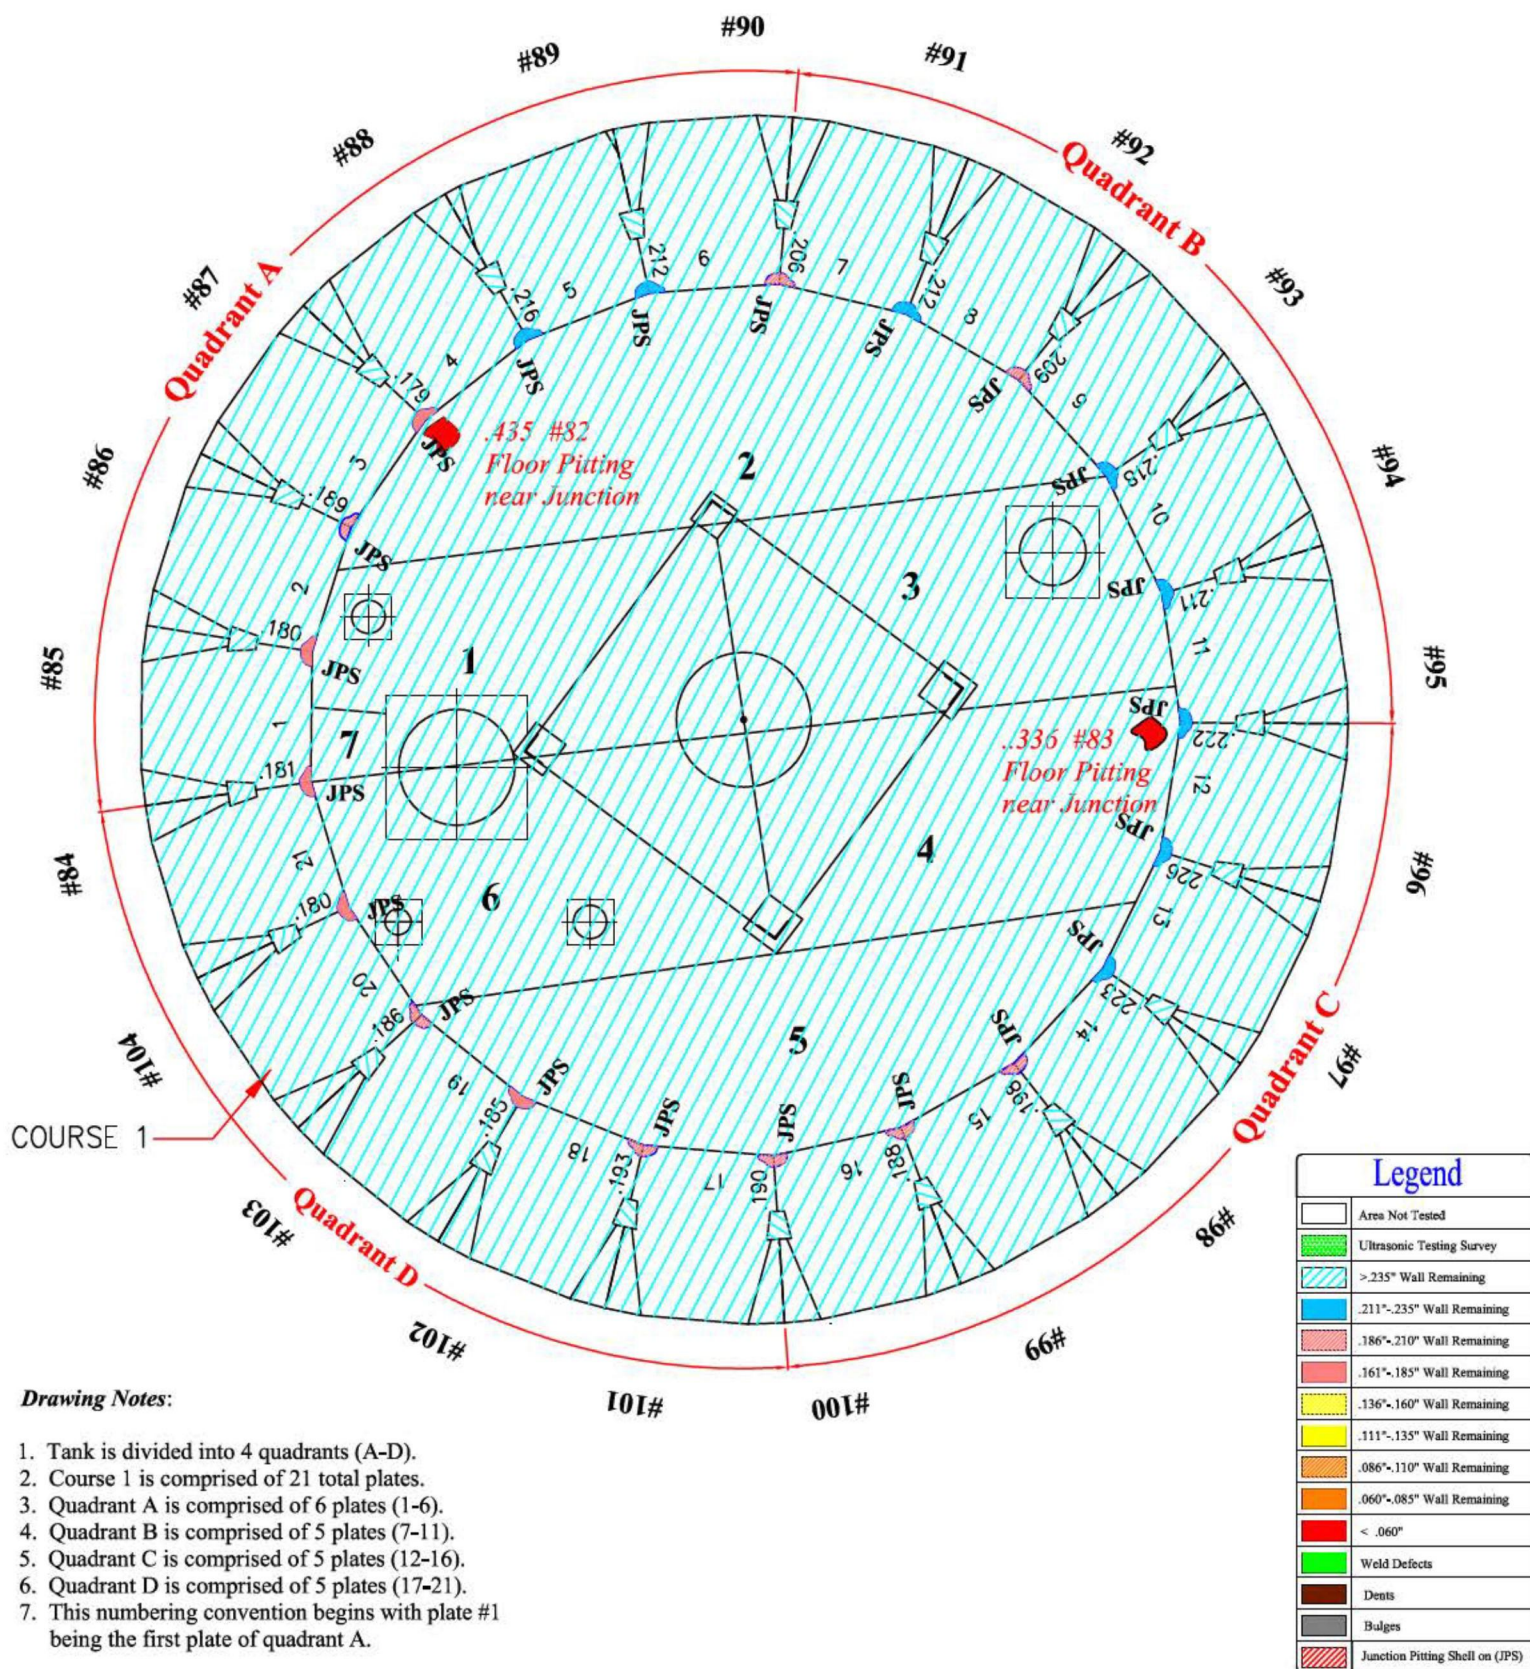
TANK # 2 - LOWER DOME - PITTING - FLOOR, COURSE 1

- TesTex's NDE report lists two locations of topside pitting in the floor of the lower dome (Flaws #82 and #83). The pitting is located in the 1/2" thick floor plate adjacent to the welded joint that joins the bottom course of the lower dome to the floor plate. As the pitting is close to the weld, EEI recommends the pitted areas be repaired by welding to fill the pits.

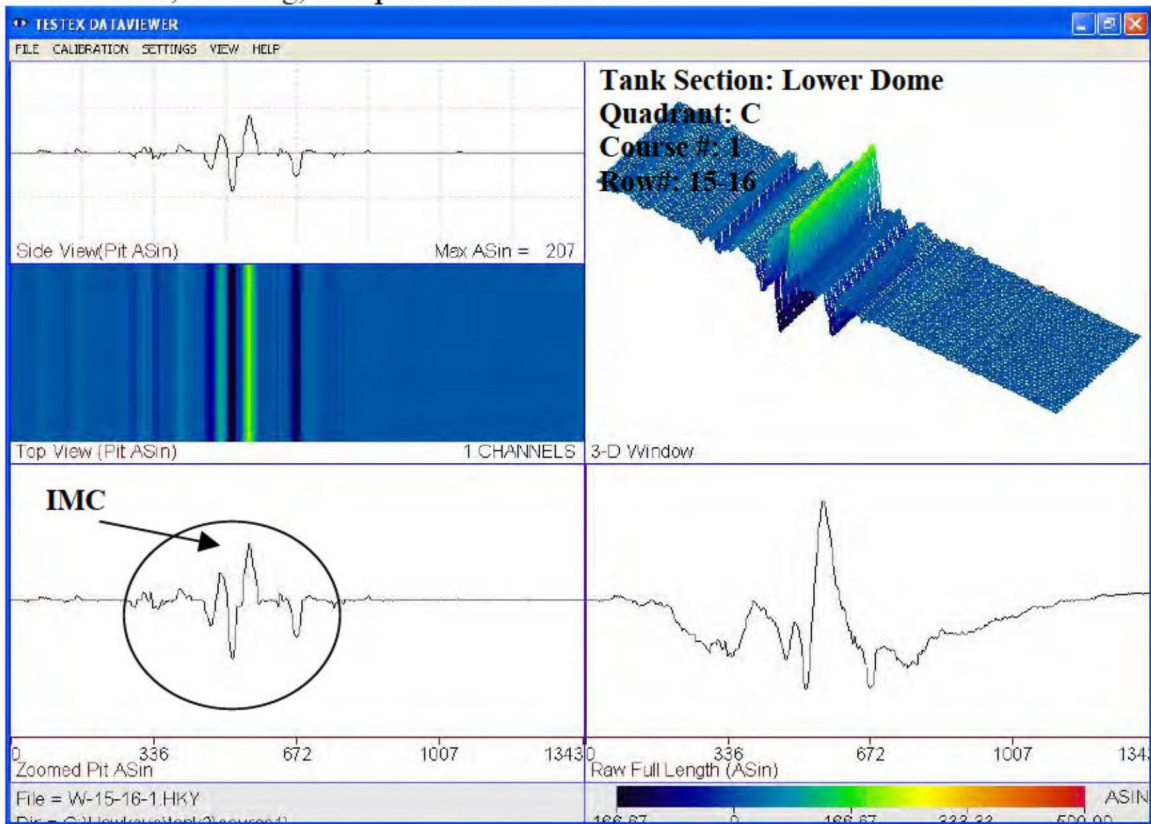
Flaw # 2A,B: The waveform above depicts intermitted cracking on both sides of the vertical weld, 10” long, at depths of .229” and .154”.

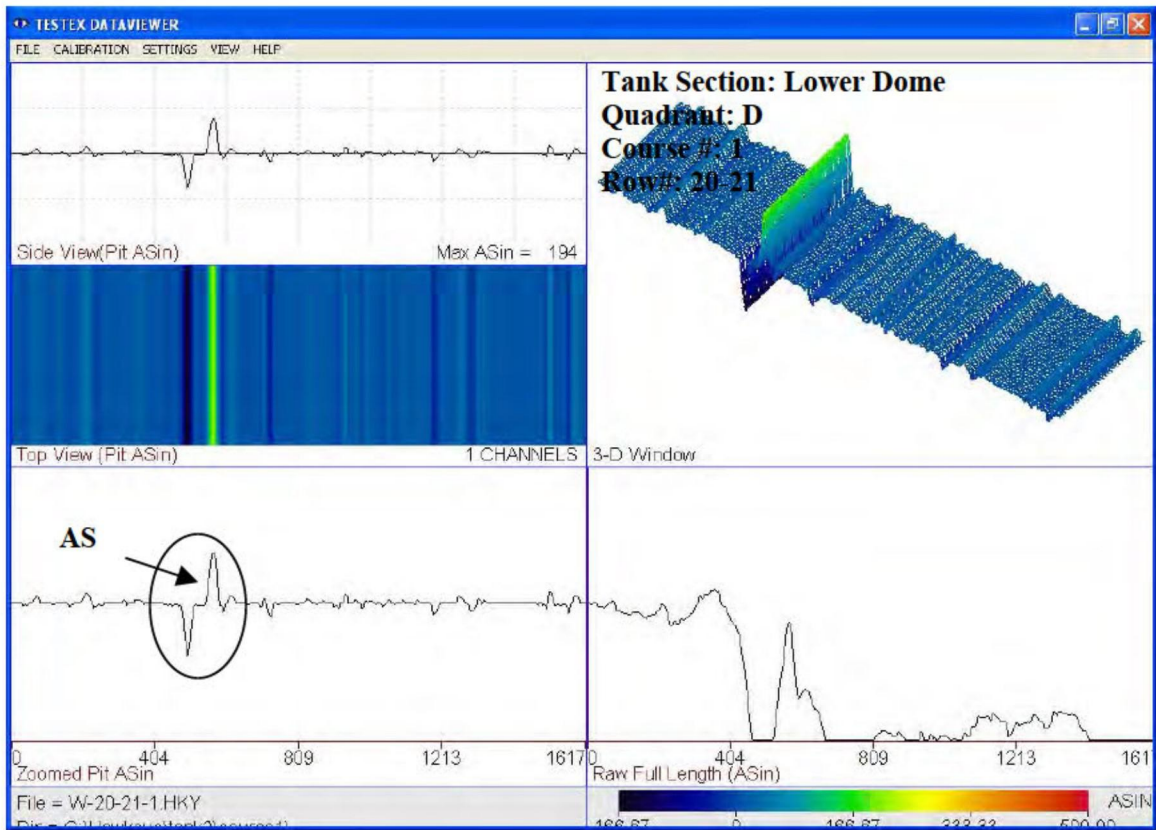
Flaw # 3A,B: The waveform above depicts intermitted cracking on both sides of the vertical weld, 10” long, at depths of .223” and .214”.

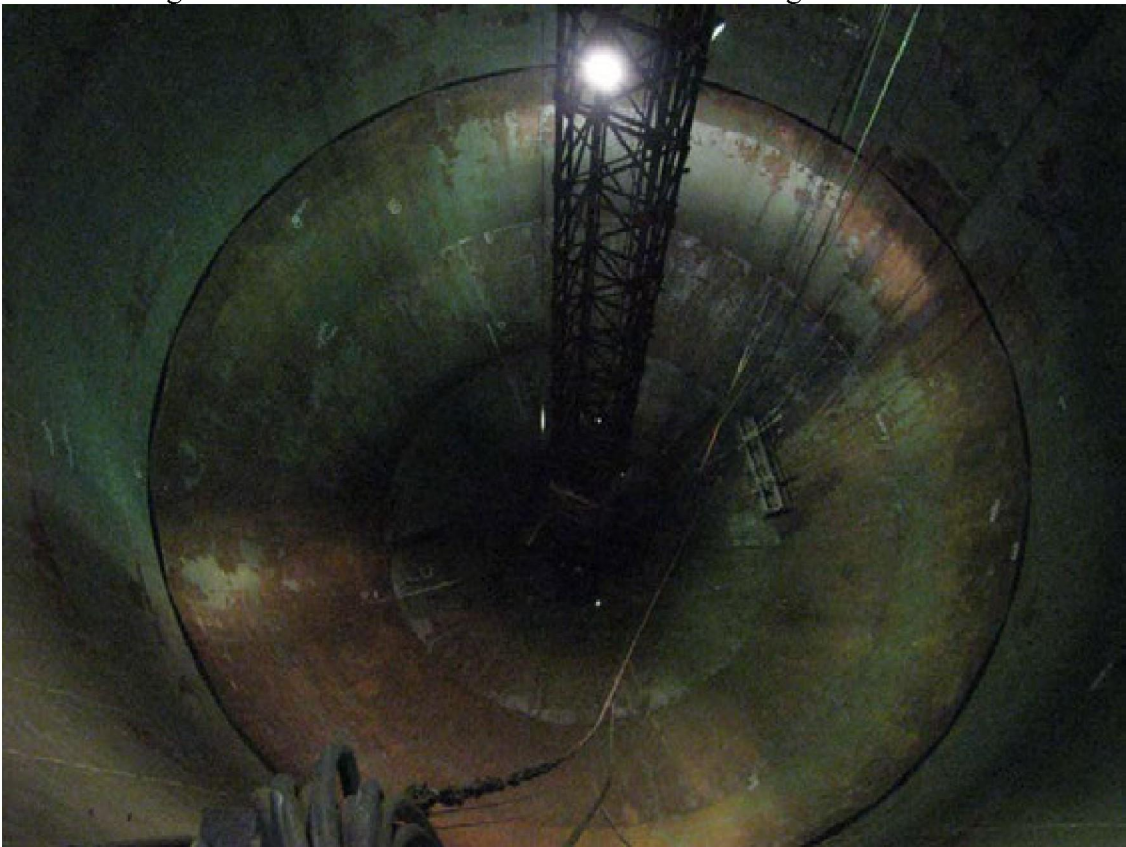
Lower dome view from above showing extensive coating failure.
