**MODIFIED API-653 OUT-OF-SERVICE
TANK 20
RED HILL**

December 5, 2008

Subject: Tank No. 20 Red Hill Fuel Facility

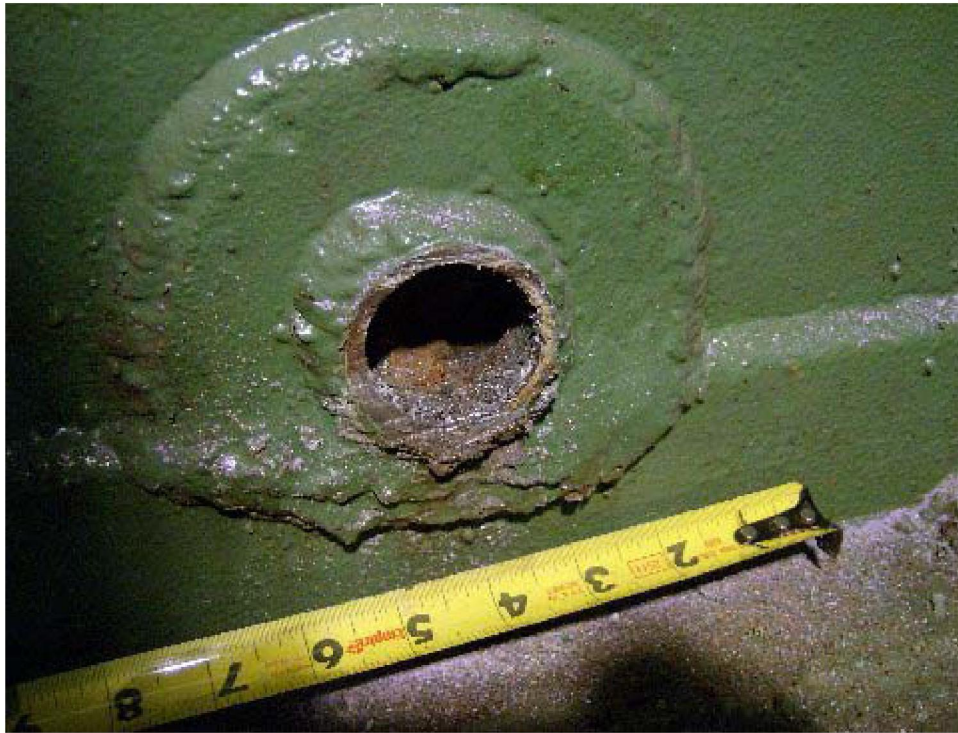
Transition from tank floor to the lower dome section

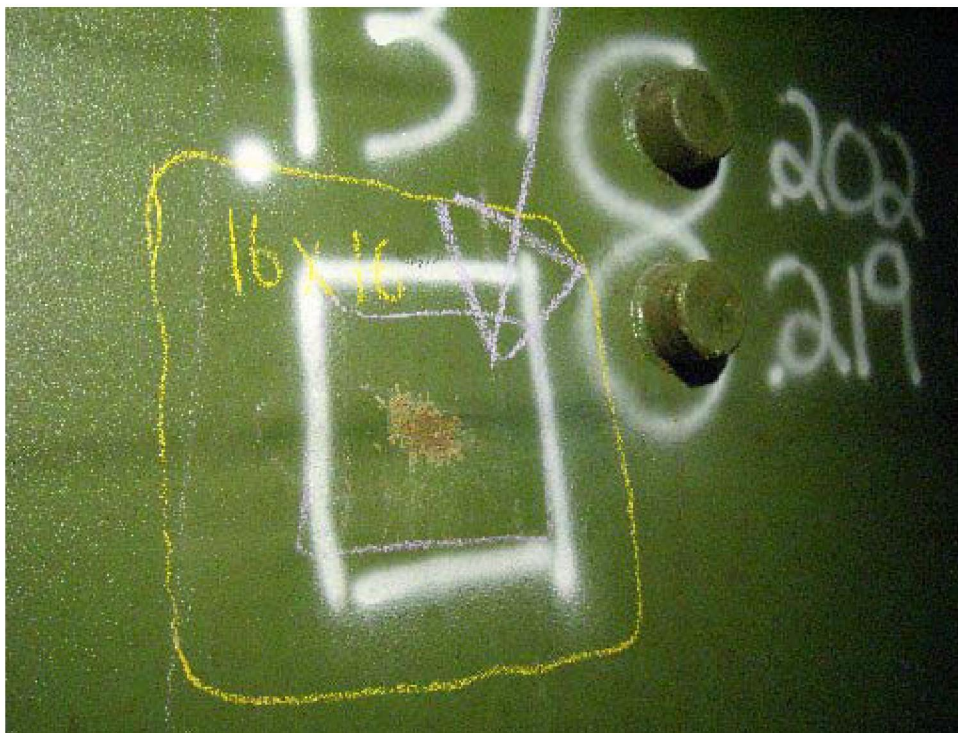
Approximately 600 1½” tank piping penetrations were noted throughout the tank. The piping was removed by mechanically cutting at the interior re-pad interface. Based on information provided to **Engineering & Inspections Hawaii, Inc.**, this condition will be addressed for repair recommendations by Engineering consultant; Enterprise Engineering, Inc.

One of approximately *Six Hundred* piping penetrations that were removed requiring repair

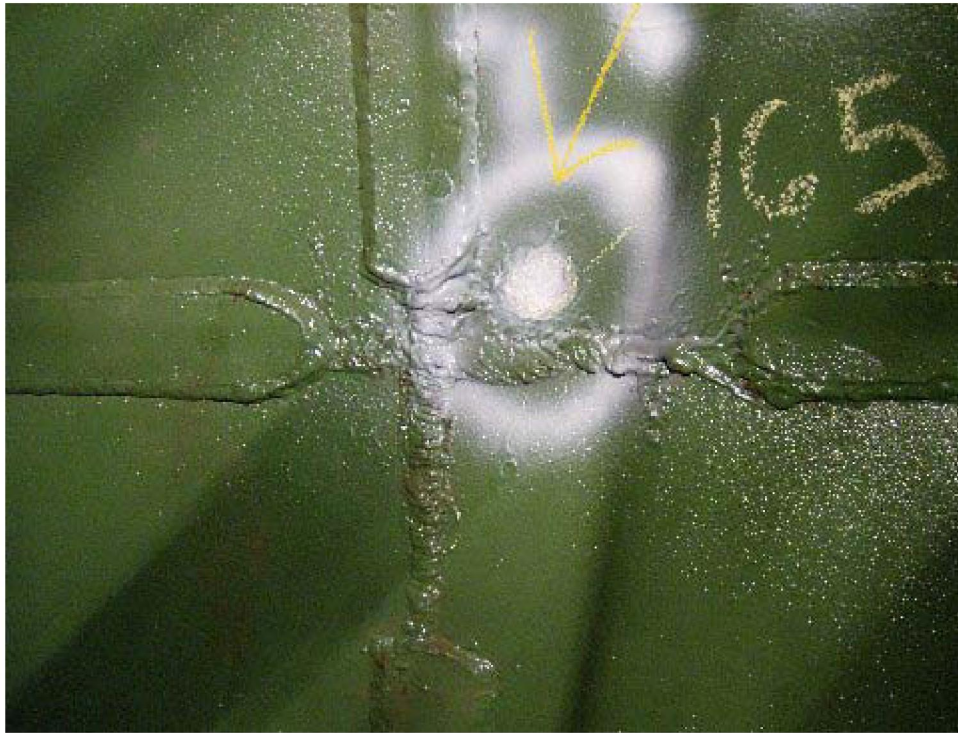
Location of Flaw 334 Underside corrosion at .137" requiring a 16" X 16" Lap Welded Patch

Flaw #329	Base Metal Arc Gouge; Expansion Joint; Repair by welding
Flaw #330	Base Metal Arc Gouge; Expansion Joint; Repair by welding
Flaw #334	Loss of Wall @ .137"; Expansion Joint; Repair by use of lap patch plate .250" thick, 16" x 16" with radius corners
Flaw #337	Lack of Fusion in weld; Upper Dome; Repair by welding
Flaw #341A/C	Lack of Fusion in weld; Upper Dome; Repair by welding
Flaw #345	Lack of Fusion in weld; Upper Dome; Repair by welding
Flaw #346A/B	Lack of Fusion in weld; Upper Dome; Repair by welding
Flaw #347	Through Hole on Strap; Upper Dome; Repair by welding
Flaw #351	Base Metal Arc Gouge; Upper Dome; Repair by welding

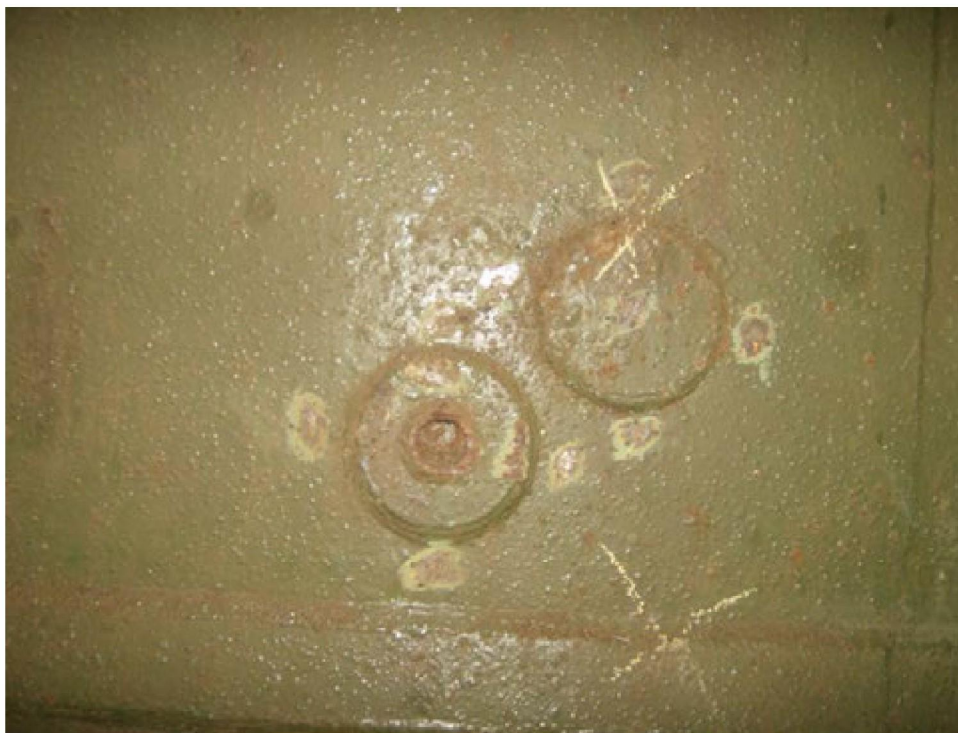
Flaw 304 Loss of Wall measured .165"

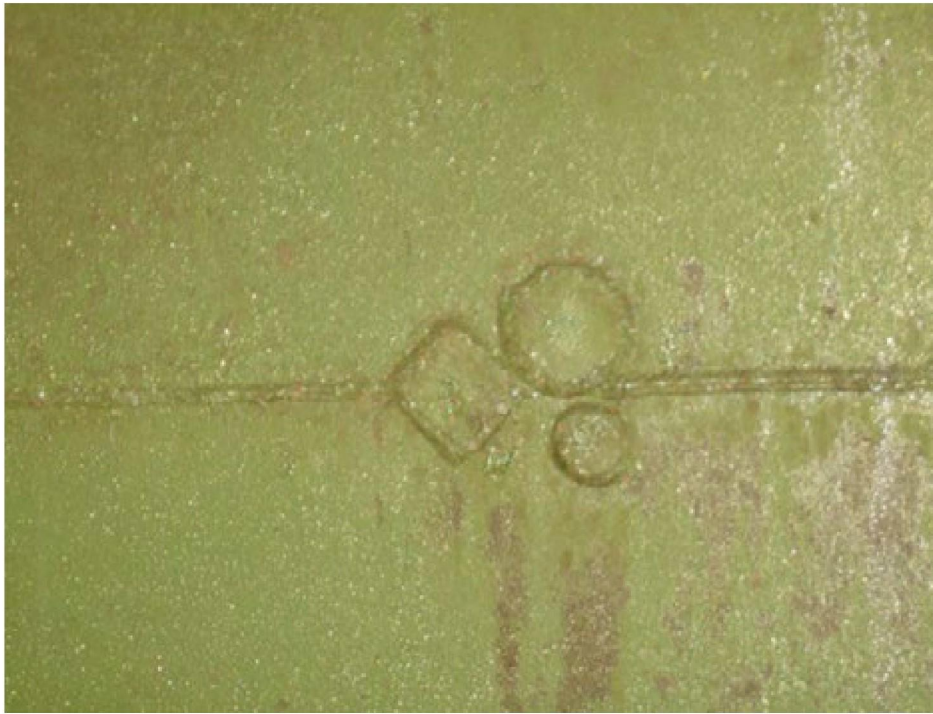
The tank has numerous areas of coating failure. Numerous areas of positive corrosion blooms were also noticed during this inspection. Some of the corrosion blooms were 1½” in diameter with visible pitting beneath the corrosion. The entire lower dome is affected by active corrosion holidays or coating holidays making proper inspection difficult. The area referenced as the tank lower dome has approximately 40% coating failure with exposure of the tank steel liner. The area known as the tank Barrel section was noted to have smaller areas of coating failure. The tank upper dome was noted to have the best areas of coating with only minimal failure.

Location of piping penetration removal; **Note:** Condition of Coating

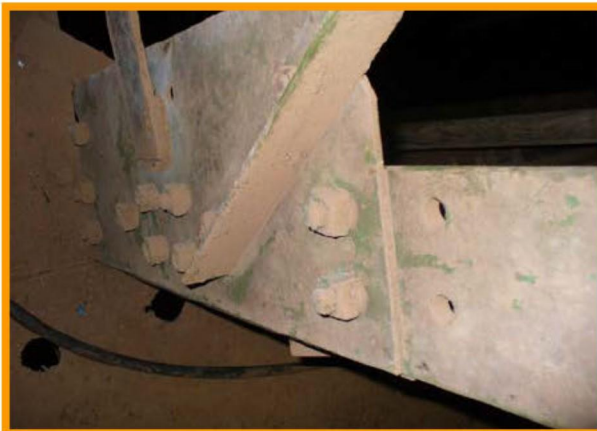
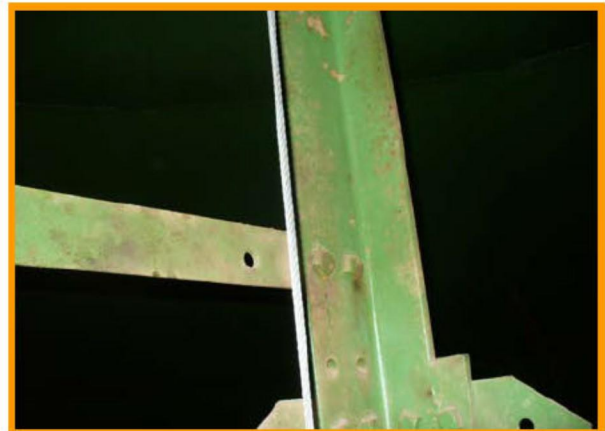
Upon inspection of the tower frame and boom, some horizontal and diagonal members were found to be missing, some bolts were found to be missing and some holes were found that needed to be covered by plates (see image #1 & #2)). The recommendations for the frame are summarized in the image #3 below:

Image 1: Showing Tank #20 Tower frame and boom missing members and bolts

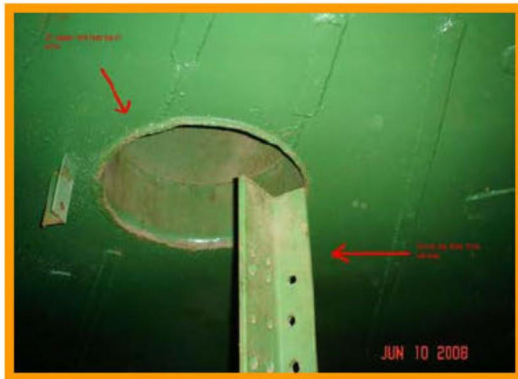
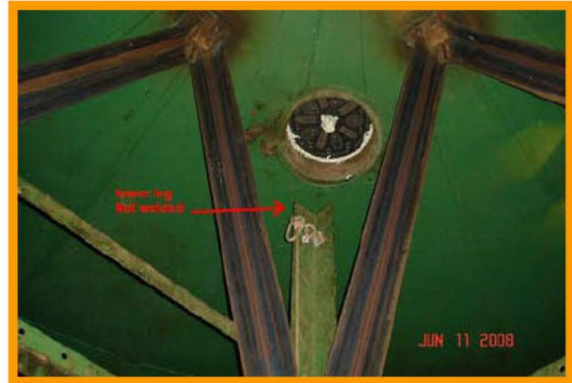
Tower legs were not supported by the tank at the top. These legs were welded to the tank for support and the missing braces were installed.

Image# 2: Showing Tank #20 Tower leg not welded to the tank.

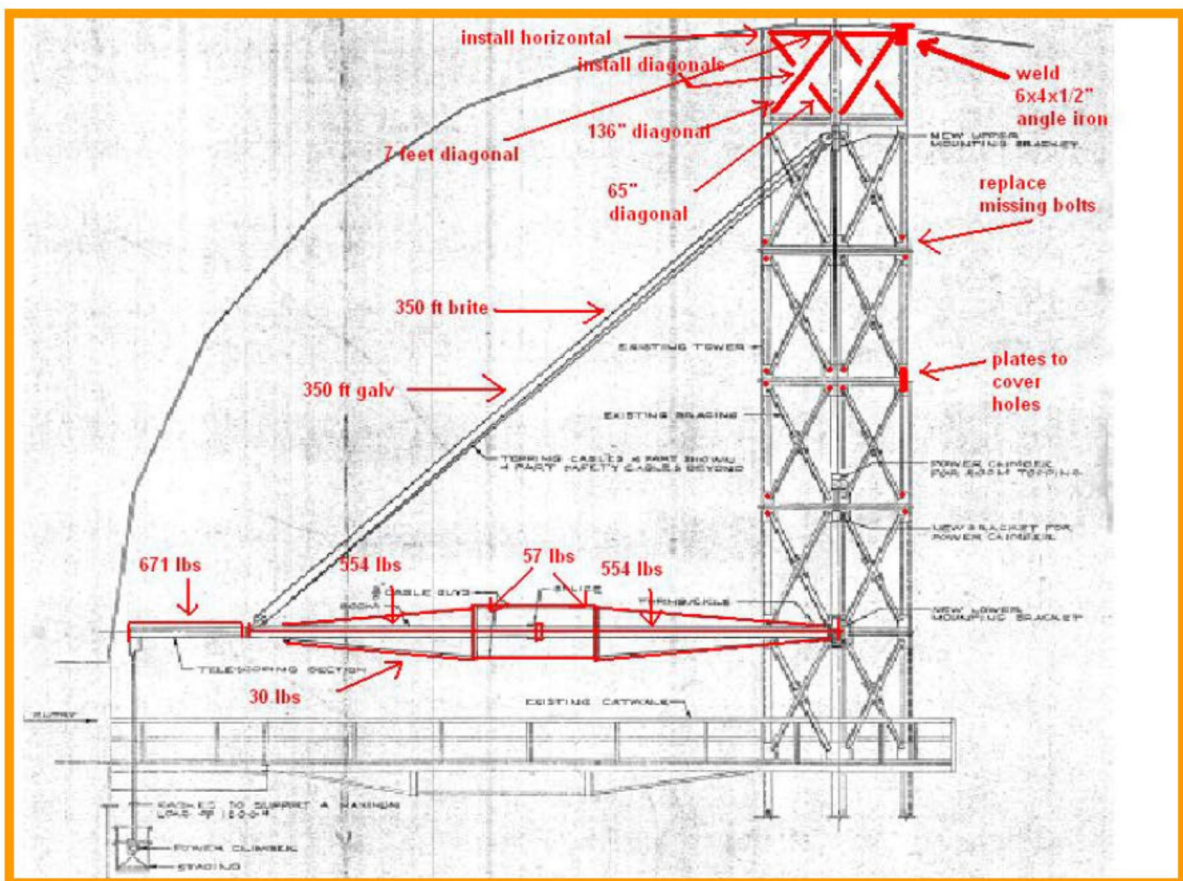
Image# 3: Showing Tank #20 Tower frame and boom recommendations

All above proposed changes were accomplished safely.

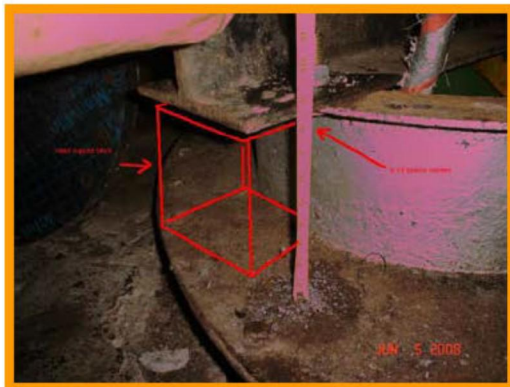
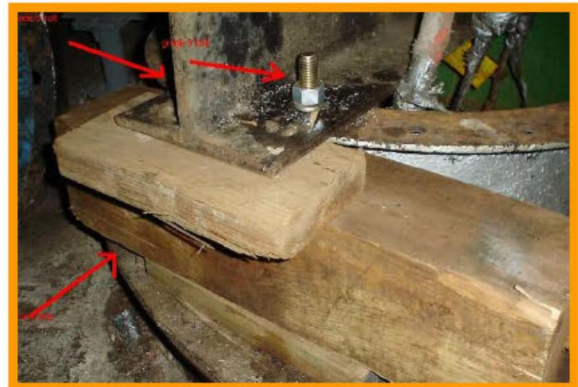
The beam supporting the spider hoist assembly was supported by the flange around the opening. This condition could produce buckling in the flange. Our recommendation was to cut off the excess length of the supporting beam and to provide blocking under the beam to avoid loading the flange. This was safely accomplished as seen in Image #5

Image# 5: Showing Tank #20 Top Anchor I-Beam shortened and supported.

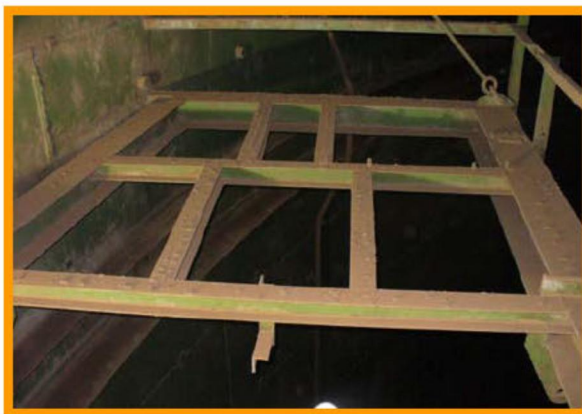
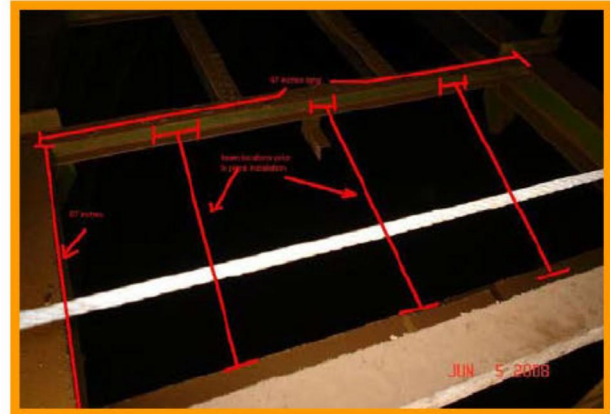
To use the framing adjacent to the entrance of the tank as a work platform, our recommendation was to install four horizontal beams prior to installing floor sheathing. The proposed beams would match the existing beam sizes. The platform condition and the recommendations are shown in Image #6 below.

Image# 6: Showing Tank #20 Work Platform and new beam installation recommendation .

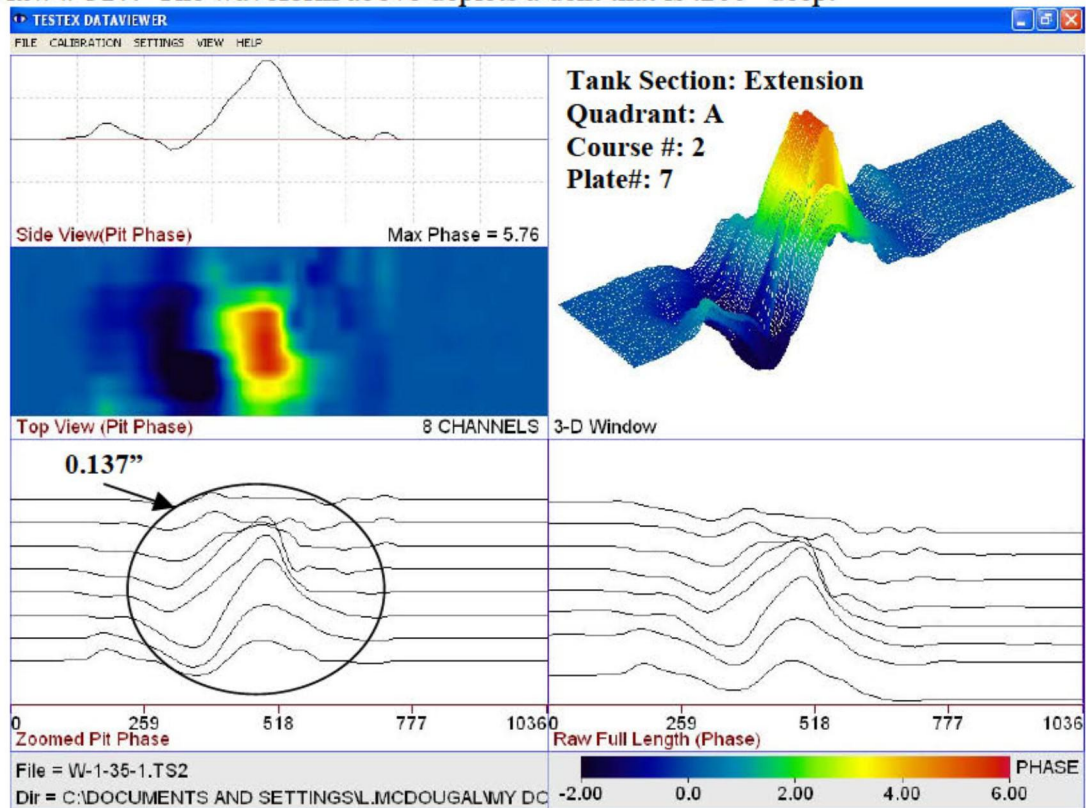
Flaw # 334: The waveform above depicts underside corrosion exhibiting 0.137" wall remaining.

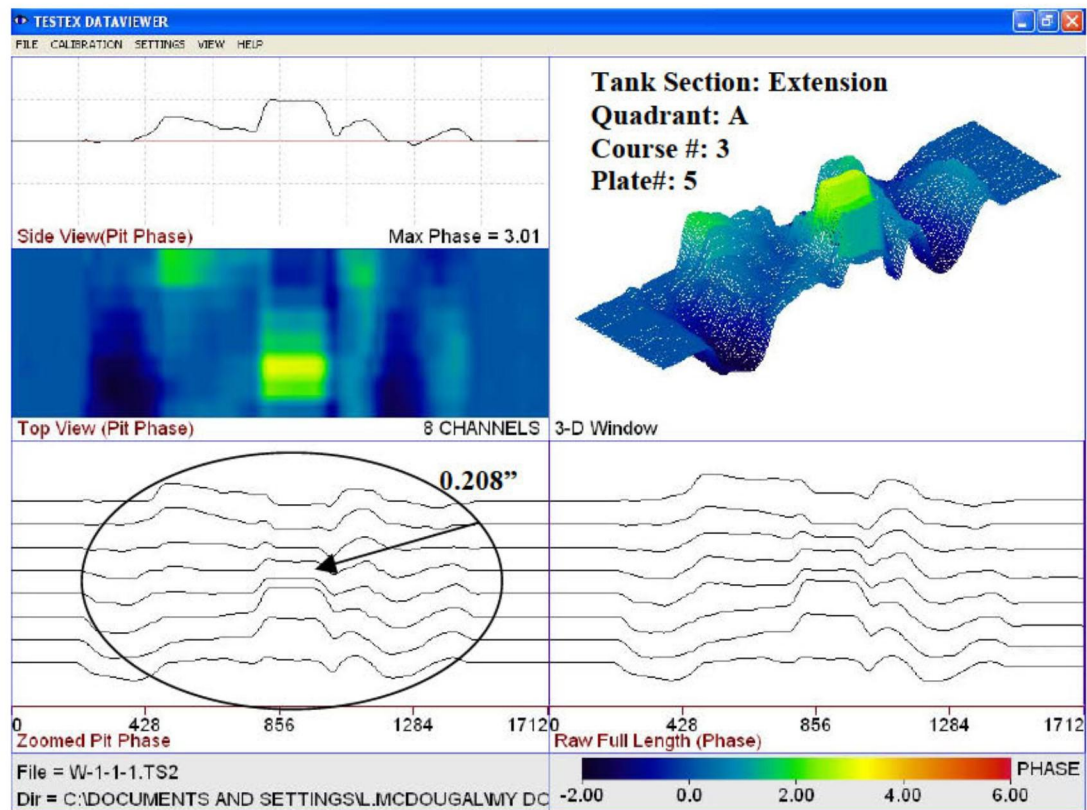
Flaw # 335: The waveform above depicts underside corrosion exhibiting 0.208" wall remaining.

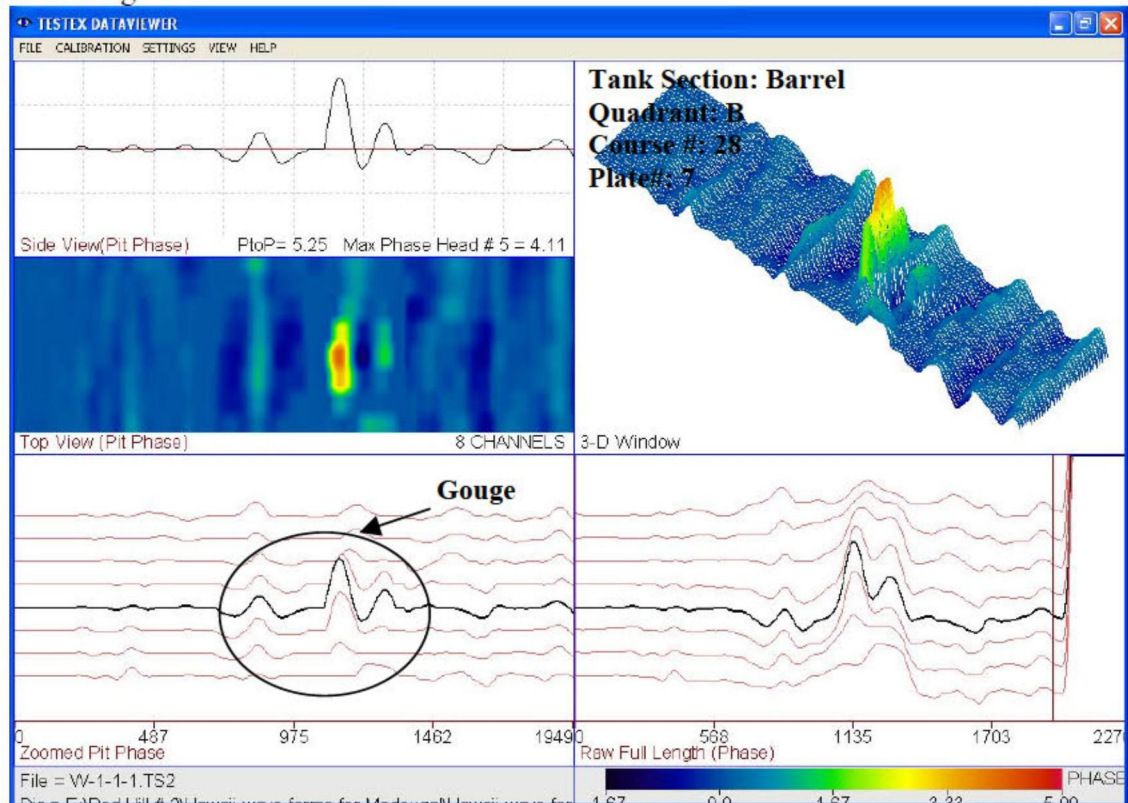
Flaw # 173: The waveform above depicts a gouge that is 0.140" deep.

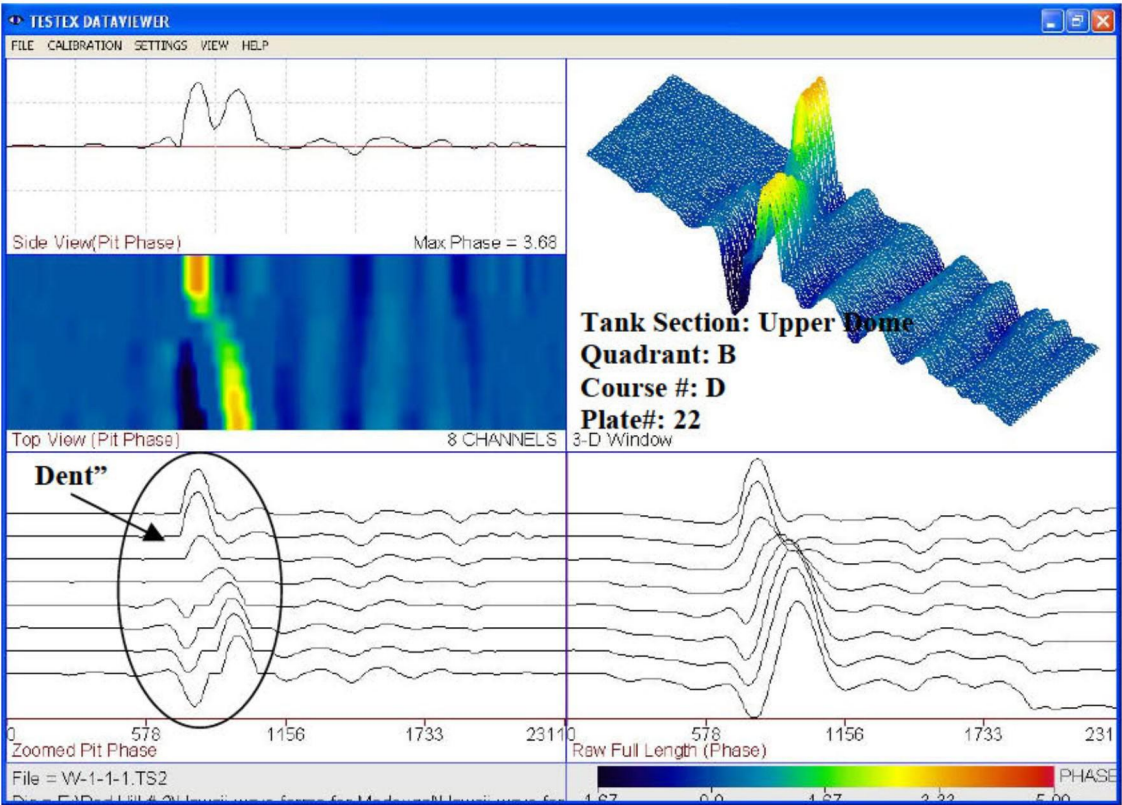
Flaw # 446: The waveform above depicts a dent that is .180” deep.

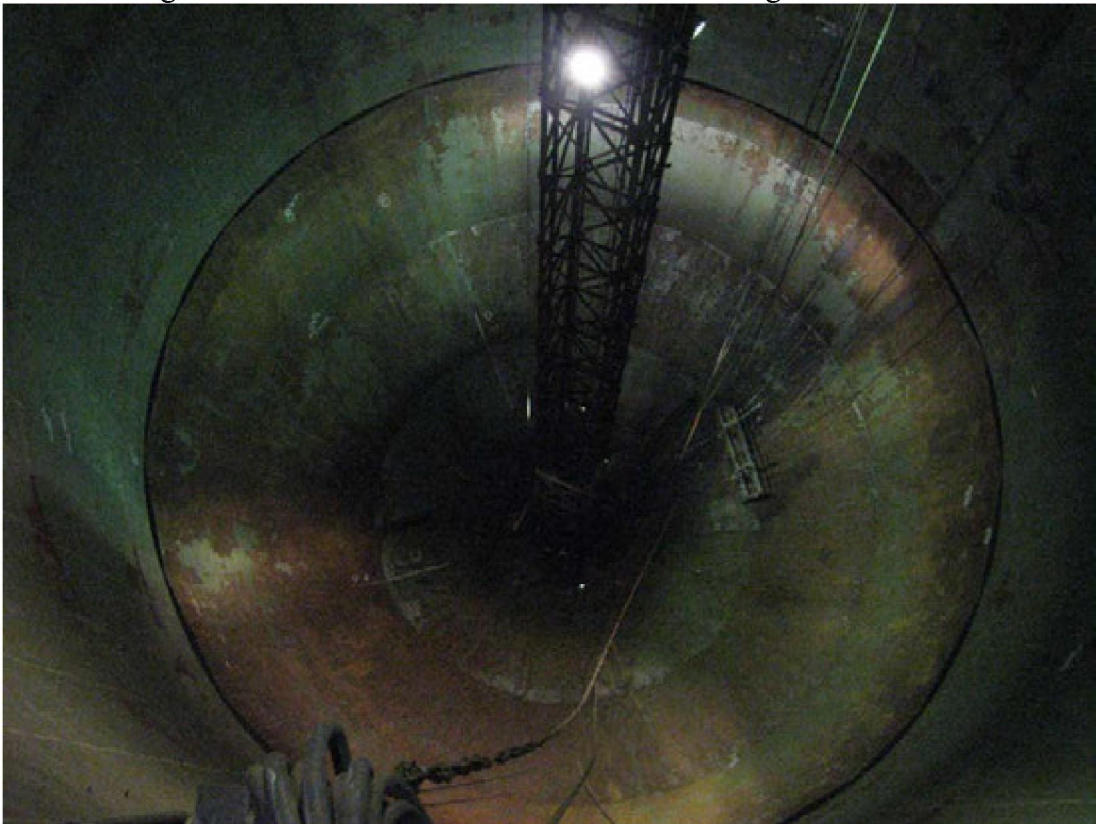
Lower dome view from above showing extensive coating failure.
