**Willbros Government Services ("WGS")**  
**DAILY PRODUCTION REPORT**  
 (ATTACH ADDITIONAL SHEETS IF NECESSARY)

Aug 05, 2010

**PROJECT TITLE**  
Clean, Inspect and Repair Fuel Tanks  
Redhill Complex, Pearl Harbor HI

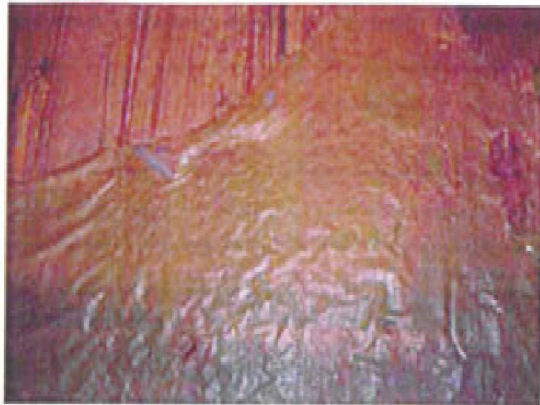
Areas on the tank's internal surfaces where paint or coating has blistered or disbonded is being exposed and removed during pressure washing. These chips, pieces or areas are being accumulated on the floor. The paint will be isolated, separated and put in drums for disposal.

Paint / Coating – Disbonded & blistered

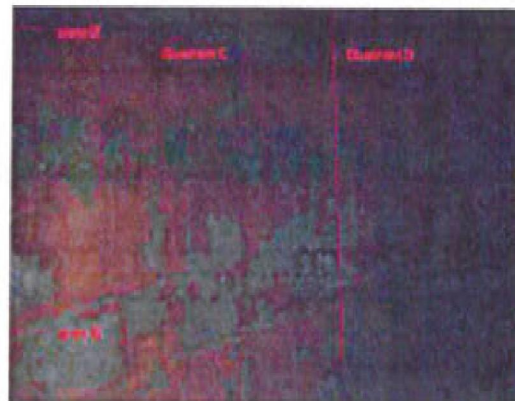
Paint – Areas of deteriorated top coat removed after pressure washing.

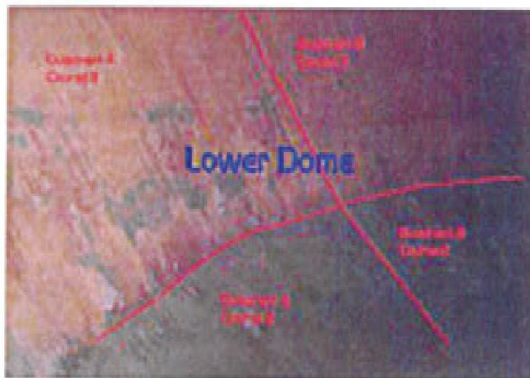
Paint – Areas of deteriorated top coat removed after pressure washing.

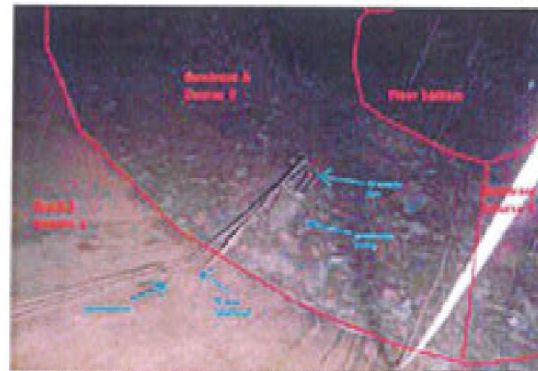
Paint / Coating – Chips and pieces along the bottom after pressure washing.

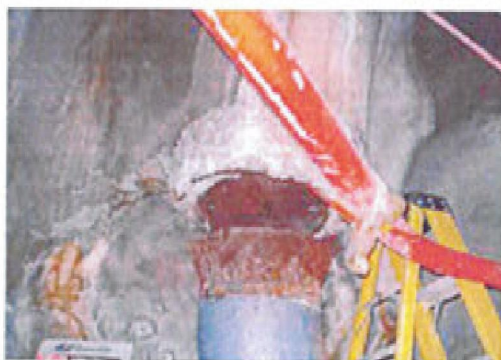
Ventilation System – Area repaired where foam was installed for ducting. Metal sheeting installed and sealed for ventilation process.
