Daily Coating Inspection Report

Project: Red Hill Tank 5 Tank Clean, Inspect,	Inspector: Frank Bringas			
Client: Willbros Contractor: Abhe		e and Svboda		
Client Contact: Mr. Joe Gilbert	4	Foreman: Robert Webster

Project: Red Hill Tank 5 Tank Clean, Inspect, Repair

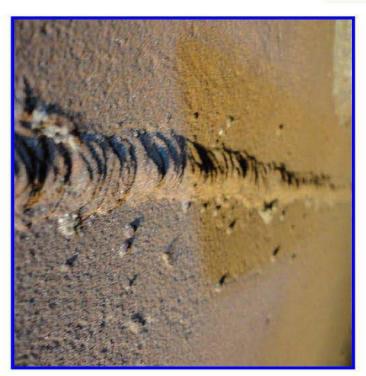
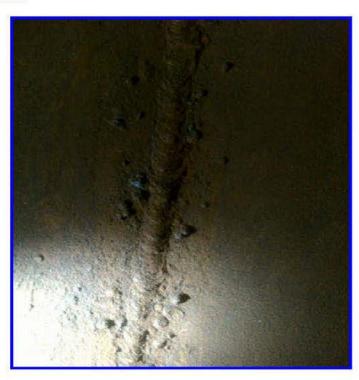
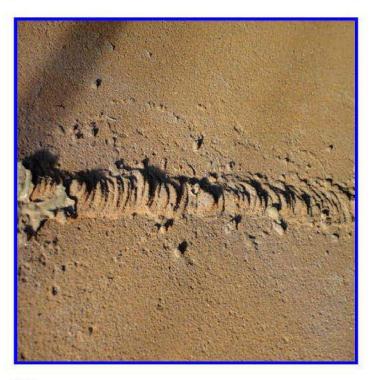
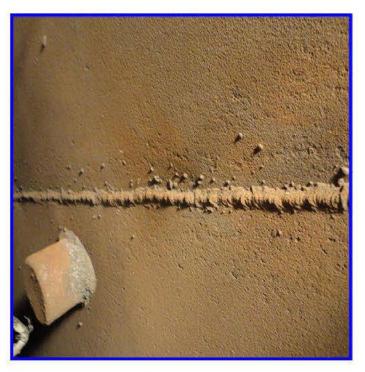
A pre-blast inspection of the bottom dome in Tank # 5 showed extensive weld spatter that measured up to approximately 5/16" high and 1/4" diameter. In addition, there are some areas along the welds where the weld spatter is over 1" away from the weld.

The welds, due to deterioration and other factors, have sharp irregular surfaces that protrude in several directions.

The extensive weld spatter and sharp edges on the welds could cause premature failure in the form of pinpoint corrosion.

I am recommending the application of one additional stripe coat of to all welds and the weld spatter that are within the 1" area as per the stripe coat definition in SSPC PA-1.

I am further recommending that the weld spatter that is beyond 1" away from the weld, receive two brush coats on those areas

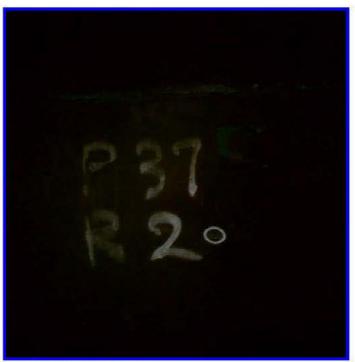
Location of one salt test

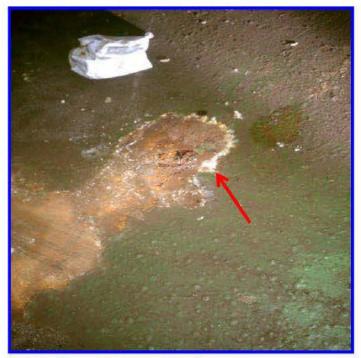
The contractor accomplished the soluble salt testing on various locations throughout the tank. No salts were detected on any surfaces with the exception of one test on the bottom flat part of the tank which measured 1 µg/cm. Upon further inspection of the lower flat part of the tank I noticed visible salts. Upon inquiry of why there would be salts in that area, I was told that a hydro test was conducted on a pipe using firemain (salt) water and some had leaked out due to improper purging of the line. The contamination appeared to be localized. The contractor cleaned the area with Chor-id but was not re-tested.

Visible salt on flat bottom of tank IR-1

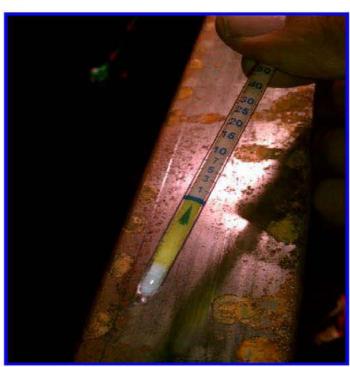
Result of one salt test

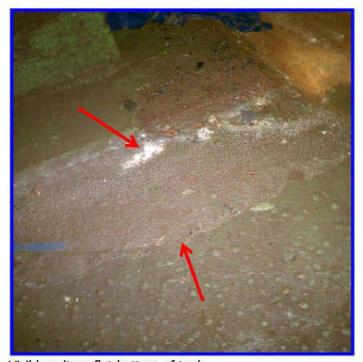
Visible salt on flat bottom of tank
CSI Coating Inspection Report Page 4

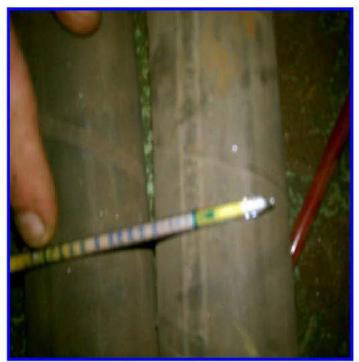
Location of one salt test

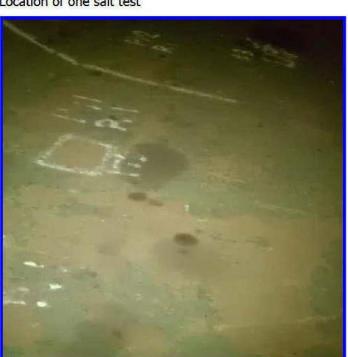
Grease spots that are clearly visible IR-1

After the salt test was completed I noticed spot of grease on the third course. In addition there was grease under the newly installed 4" and ½" pipes. I told the contractor that those areas would require proper cleaning and re-inspection prior to the commencement of any surface preparation.

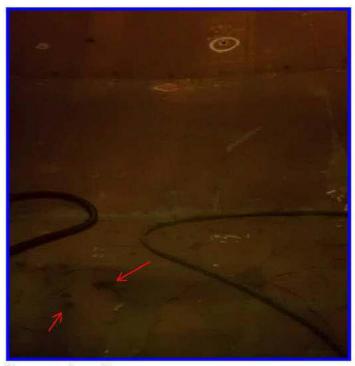
Grease spots on 3 course

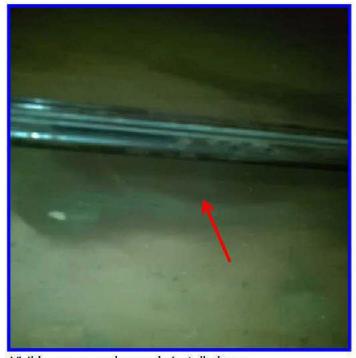
Visible grease under newly installed ppg
CSI Coating Inspection Report Page 4

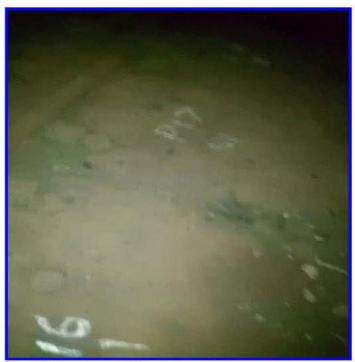
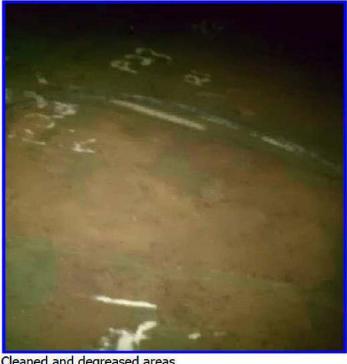
Cleaned and degreased areas

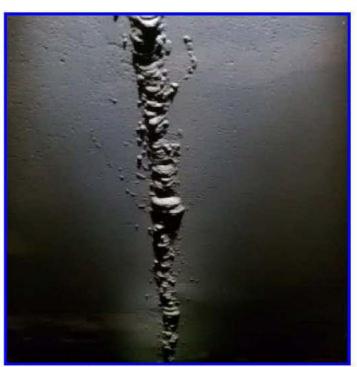
Length of weld with extensive weld spatter

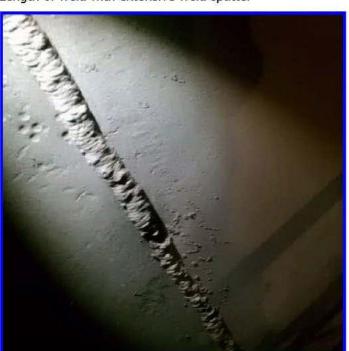
Length of weld with moderate to extensive weld spatter IR-1

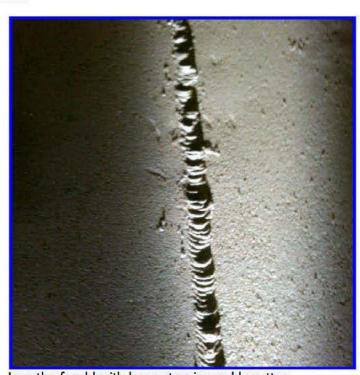
Length of weld with less extensive weld spatter

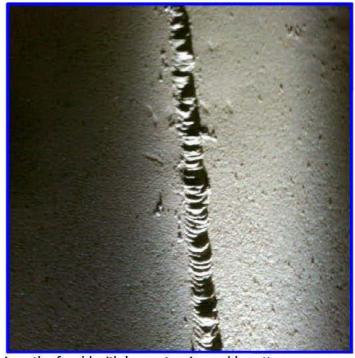
Length of weld with less extensive weld spatter
CSI Coating Inspection Report Page 4

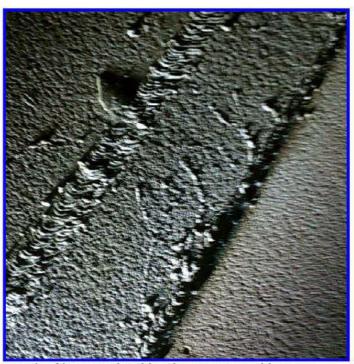
Length of horizontal weld with extensive weld spatter

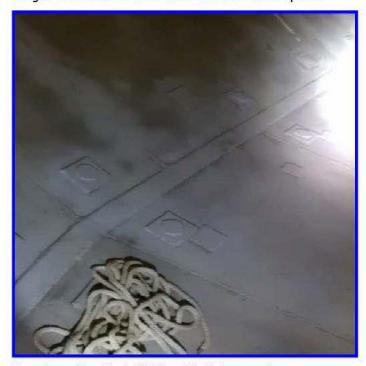
All vertical and horizontal welds were looked at. It must be noted that several 4"X4" plate were welded along the horizontal welds. These plates had weld spatter also.

Overview of welded 4"X4" welded plate on lower course IR-1

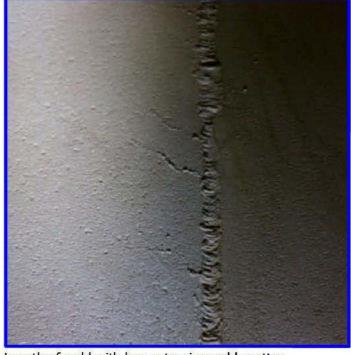
Length of weld with less extensive weld spatter
CSI Coating Inspection Report Page 5

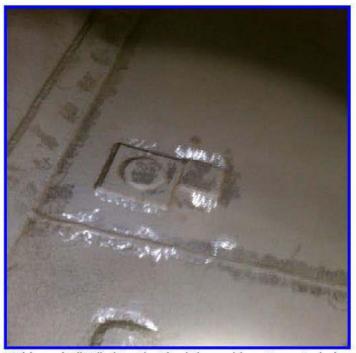
Welds and 4"X4" plate that had the weld spatter grinded off

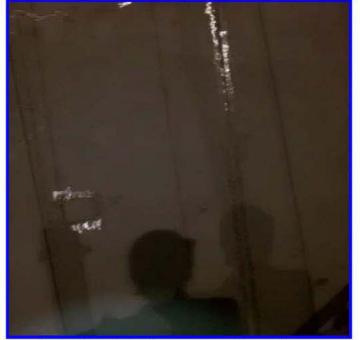
Length of weld with moderate to extensive weld spatter that had been grinded by the contractor

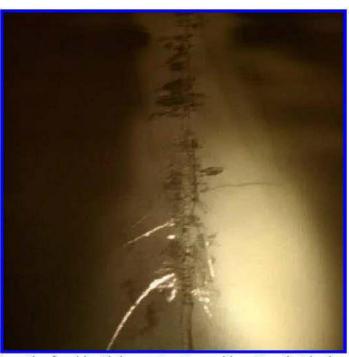
Length of weld with less extensive weld spatter that had been grinded

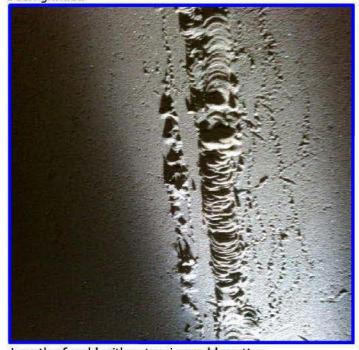
Length of weld with extensive weld spatter
CSI Coating Inspection Report Page 6
