# Naval Audit Service

## Audit Report

### Department of the Navy Red Hill and Upper Tank Farm Fuel Storage Facilities

**N2010-0049**  
**16 August 2010**

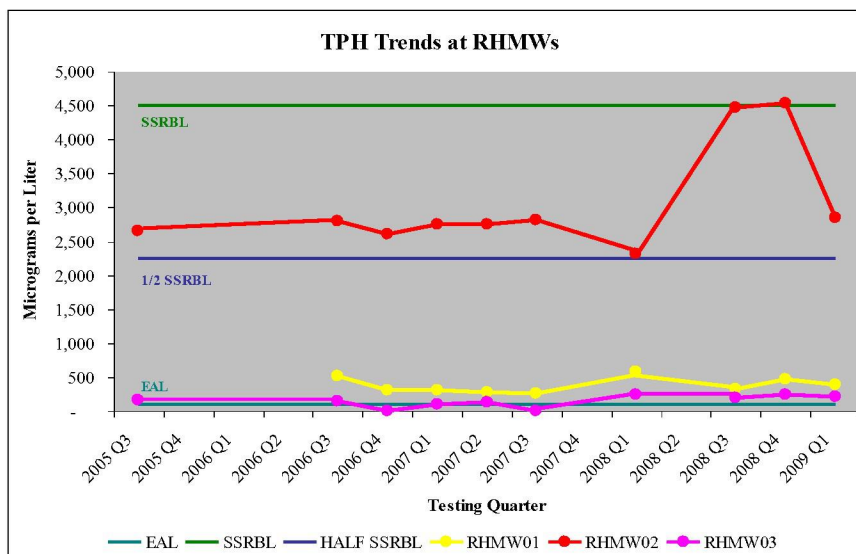
Figure 2

In the subsequent testing period, 4<sup>th</sup> quarter 2008, results showed that the concentration level had continued to increase and had exceeded the SSRBL. According to Naval Facilities Engineering Command (NAVFAC) Pacific risk assessments and groundwater flow models cited in the GPP, when levels of TPH exceed the SSRBL, contaminants could migrate from the RH facility and cause unacceptable contamination levels at the Navy Well pumping station.

In the 1<sup>st</sup> quarter of 2009, testing results revealed that TPH concentration levels at RHMW02 had decreased below the SSRBL. This decrease could potentially signify the migration of contaminants away from the RH facility as indicated by NAVFAC Pacific risk assessments which are addressed in the GPP.

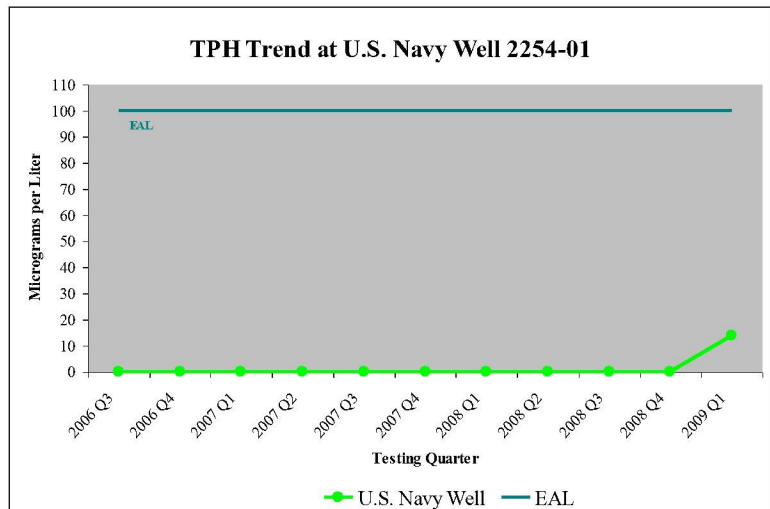
In the 1<sup>st</sup> quarter of 2009, TPH contaminants were also detected at the Navy Well. Although the concentration that was detected was below the EAL,<sup>11</sup> this sampling event was the first time that TPH had been detected since the Navy began testing for the contaminant in 2006. As mentioned above, the recent detection of contaminants at the Navy Well may indicate migration

of fuel released from RH. The detection of contaminants at the Navy Well pumping station poses an immediate risk to the potable water sources in the RH area. If the Navy Well becomes contaminated beyond acceptable levels, the Navy and the island of Oahu could potentially lose an important source of drinking water. If this occurs, the Pearl Harbor Water System would be reduced by approximately 24 percent. Further, the Navy would be responsible for providing an alternate water source at the Navy Well as indicated in the GPP.

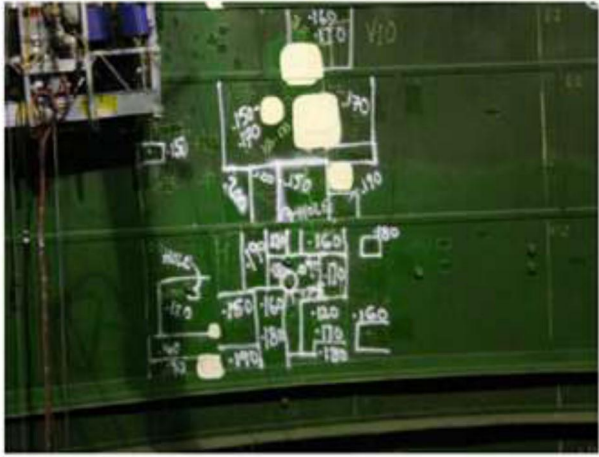
Figure 3: Tank 16 Exterior Corrosion Area

In addition to the defects noted on the interior of the five tanks, the modified-API 653 inspections identified 206 areas of exterior corrosion which had diminished the thickness of the tanks' liners. The corroded areas were caused by groundwater coming in contact with the tanks; however, given that previous inspection methodologies and testing equipment were not sufficient to detect these exterior defects, the corrosion was not previously identified. A NFESC corrosion engineer explained that this corrosion cannot be prevented at RH due to the construction of the tanks. However, inspection reports and subject matter experts indicate that the impact of this corrosion can be mitigated by

Figure 3: The inspection of Tank 16 revealed a cluster of exterior corrosion (23 flaws) and two through-holes within the cluster.

applying patch plates to the interior or by removing the corroded plates (see Figures 3 and 4). Until the current inspection cycle is completed, any previously undetected areas of exterior corrosion may continue to worsen, may cause the remaining tanks to be susceptible to through-holes, and could potentially result in future fuel releases.

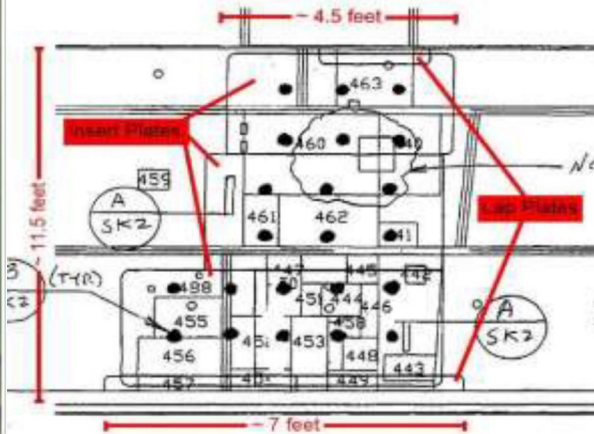
Figure 4: Tank 16 Repair Schematic

Figure 4: Repair schematic displays numbered flaws in figure 3, which required replacing the corroded original plates with four insert plates and three lap plates covering an area approximately 11.5 feet high and between 4.5 to almost 7 feet wide. Anchoring rods (represented by the black dots) are used to connect the plates to the concrete. Note: All insert and lap plates are not depicted in the schematic.
