**ENGINEERING SURVEY OF  
U.S. NAVY PETROLEUM FACILITIES  
AT PEARL HARBOR**

12, May 1949

Subj: Engineering Survey of U. S. Navy Petroleum Facilities  
at Pearl Harbor, Report on

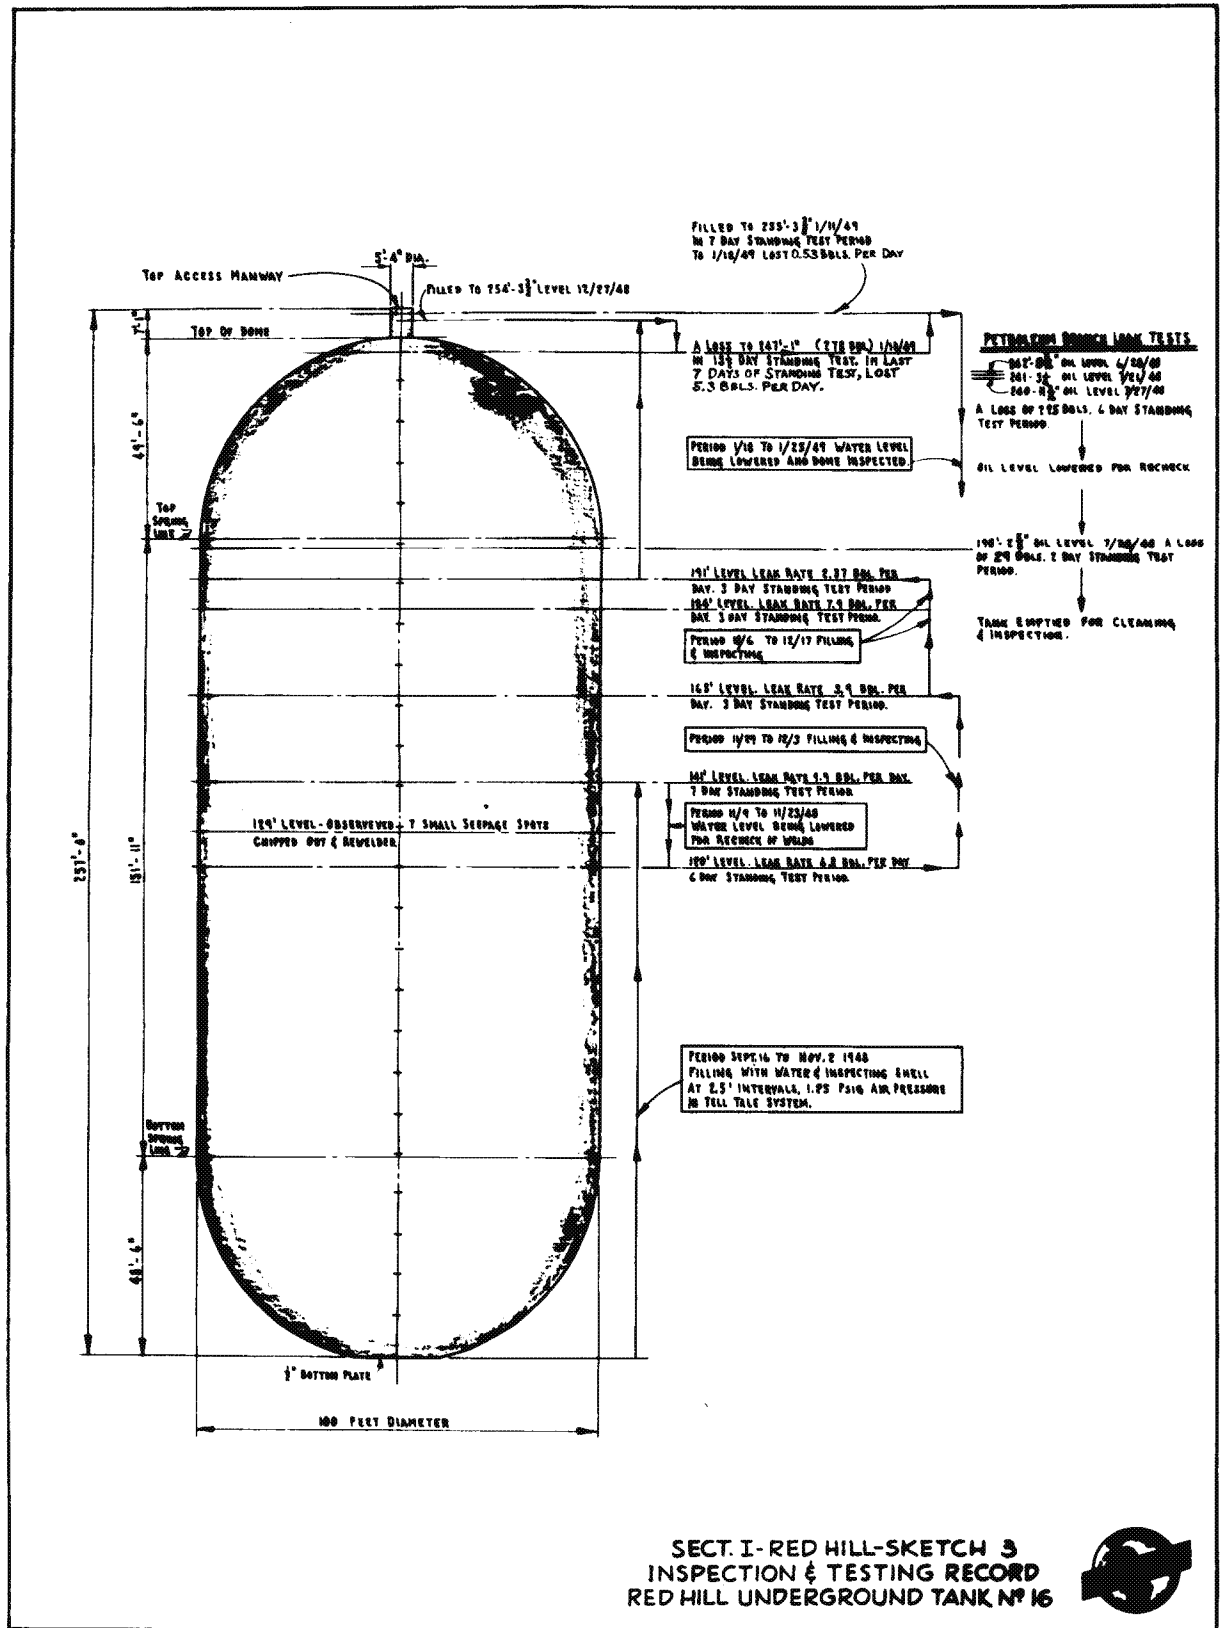
SECT. I- RED HILL-SKETCH 3  
INSPECTION & TESTING RECORD  
RED HILL UNDERGROUND TANK NO 16

After an earth disturbance on June 28, 1948, and previous to our inspection, gaging during the period June 28 to July 21, indicated a loss of 14 inches, or approximately 850 barrels. The suction and discharge valves were blanked off with the oil level standing at 241'-3-1/4" and a six day test conducted over the period July 21 to July 27. Careful hand gaging during this test indicated a loss of 37.4 barrels per day. The level was then lowered to 198' - 2-5/8" and a two day test was conducted. This indicated a loss of 14.5 barrels per day at this level. The tank was then emptied. The total leakage indicated during the entire period was in the order of 1100 barrels. Results of this and subsequent tests are indicated in accompanying Red Hill Sketch 3.

The water was lowered to the 120 foot level, and the welds and walls were again examined both during lowering and raising of the water level. At the 129 foot level six points of water seepages through welds were noted. These were around patches which were used to cover the bolt holes where attachments for the waler forms were made. During the process of raising and lowering the water level, the welded seams which had been wire brushed became covered with a coating of hydrated ferric oxide.

The water level was raised to the 191 foot level. The inspection at two foot intervals was continued, and no points of leakage other than that noted at the 129 foot level were observed. The manway was closed, and the water level was raised to about the 256 foot level, which is in the entrance section of the top dome. This cylindrical section is approximately 5'-4" diameter. Standing tests during the period of December 27, 1948, to January 10, 1949, revealed the water level falling at the average rate of 37 barrels per day for 6-1/2 days. This leakage decreased to an average of 5.3 barrels per day during the last seven days of the period, with the water level standing at about the 247 foot level. The water level was raised to 255'-3" on January 11, and a seven day test indicated a leak rate averaging only 0.53 barrels per day. *original rate*

Repair points of seepage at the 129 foot level by rewelding when testing is complete on Tank 16.

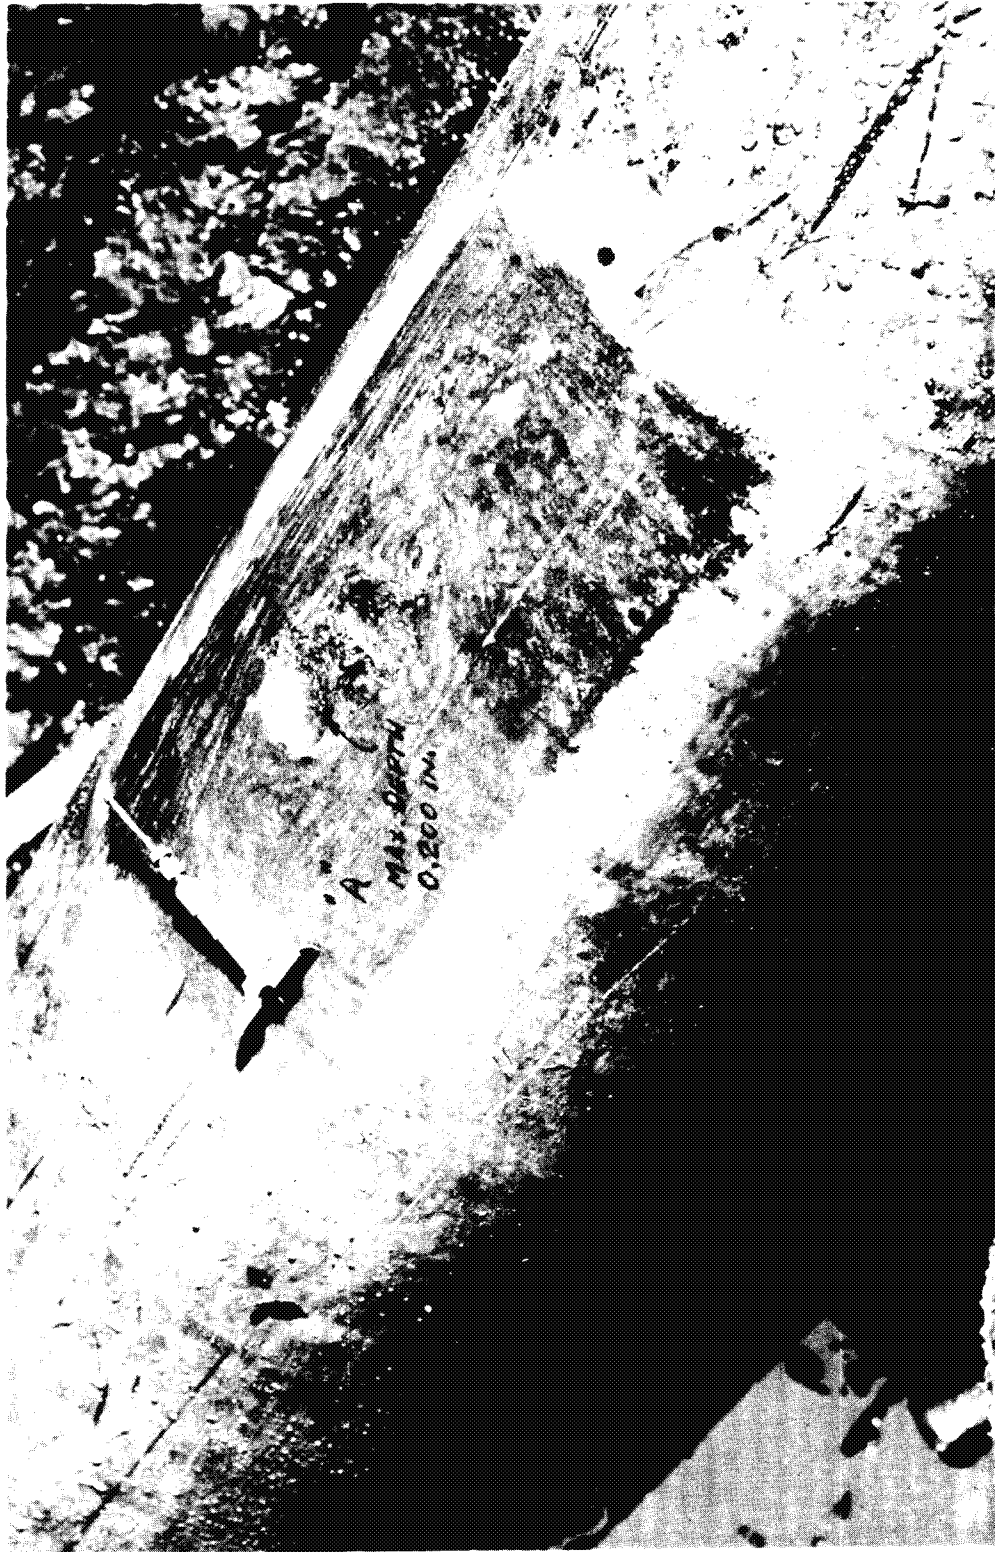
VI - 2

A history of rapid failures of piping in the Sub-Base area, and Supply Center indicated that in all probability these failures were electrolytic in nature. Leak tests were made and the leaking lines were exposed along Fierce Street. Examination of the leaks clearly indicated electrolytic corrosion due to stray currents. A survey was made and electrical measurements traced the source of these stray currents to the direct current

TYPICAL CORROSION OF BURIED FUEL AND  
DIESEL OIL LINES IN SUBMARINE BASE AREA  
COATING FAILURE, OIL SATURATED SOIL AND  
ENVIRONMENT OF LINES ARE CLEARLY INDICATED

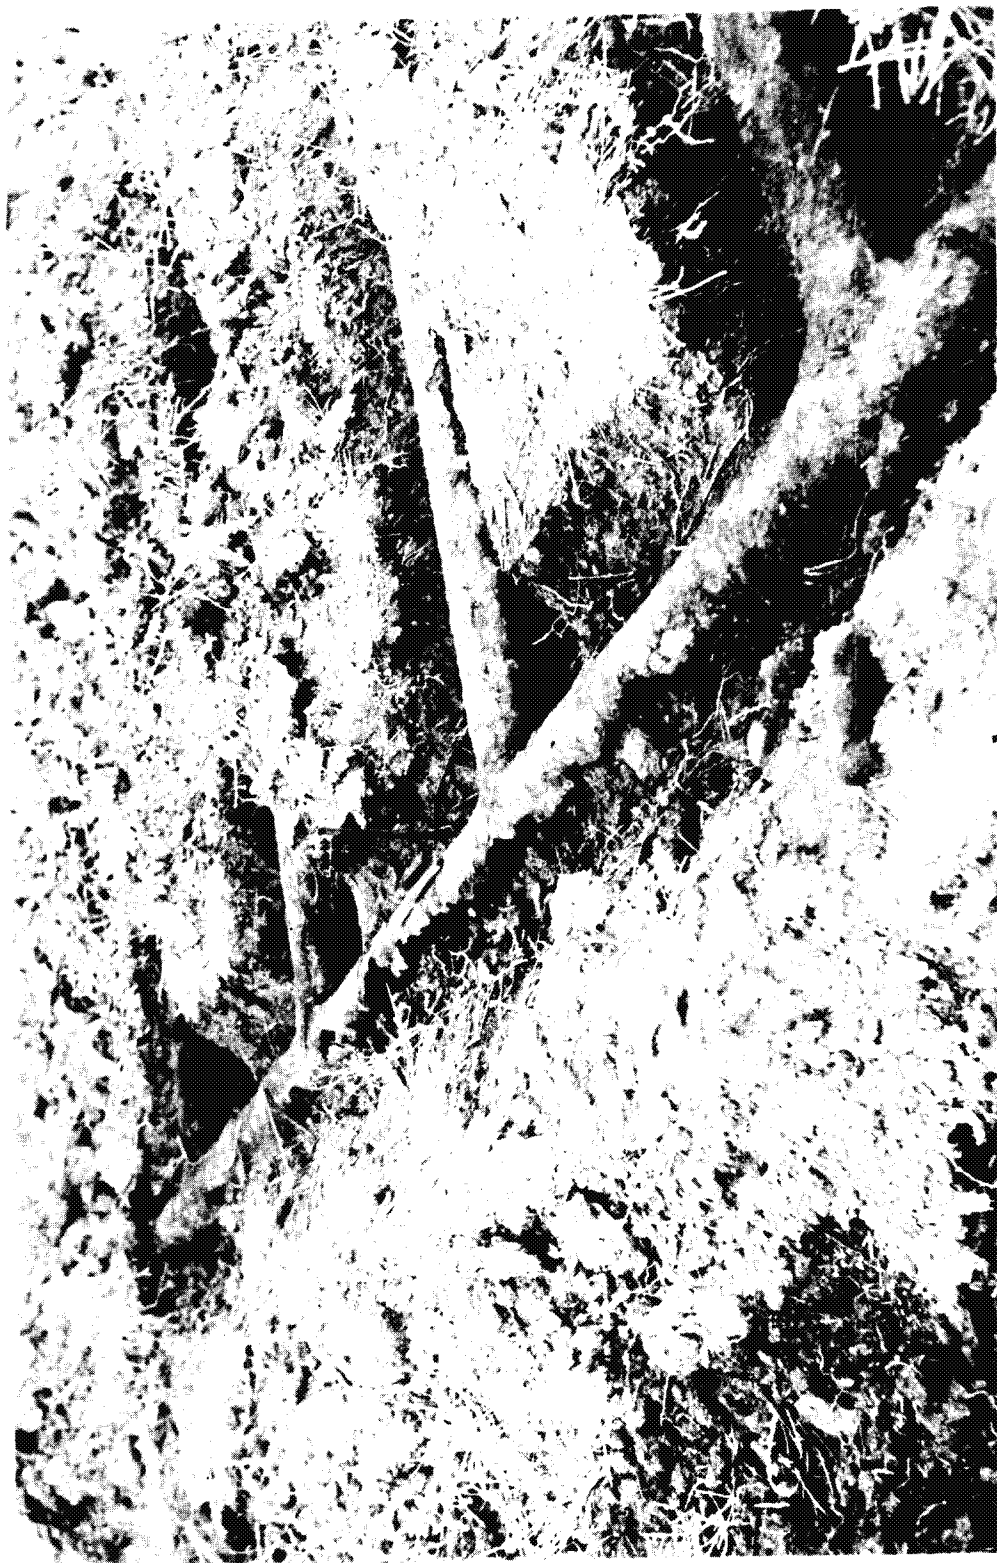
VI - 5

ANODE BED AT HALAWA STREAM SHOWING LOSS  
OF METAL AFTER FIVE YEARS OPERATION.  
CATHODIC PROTECTION PROVIDED OIL LINES  
SUPPLY CENTER AREA.
