## **WILLBROS GOVERNMENT SERVICES (U.S.), LLC**

Date: 10/30/14  
Subject: Potential Free Product Recovery Notes

## Potential Free Product Reclamation Photo's

| TASK ORDER #: | N 62583-09-D-0132/003 | PROJECT TITLE: | CLEAN, INSPECT & REPAIR TANKS 5 & 17 RED HILL COMPLEX |

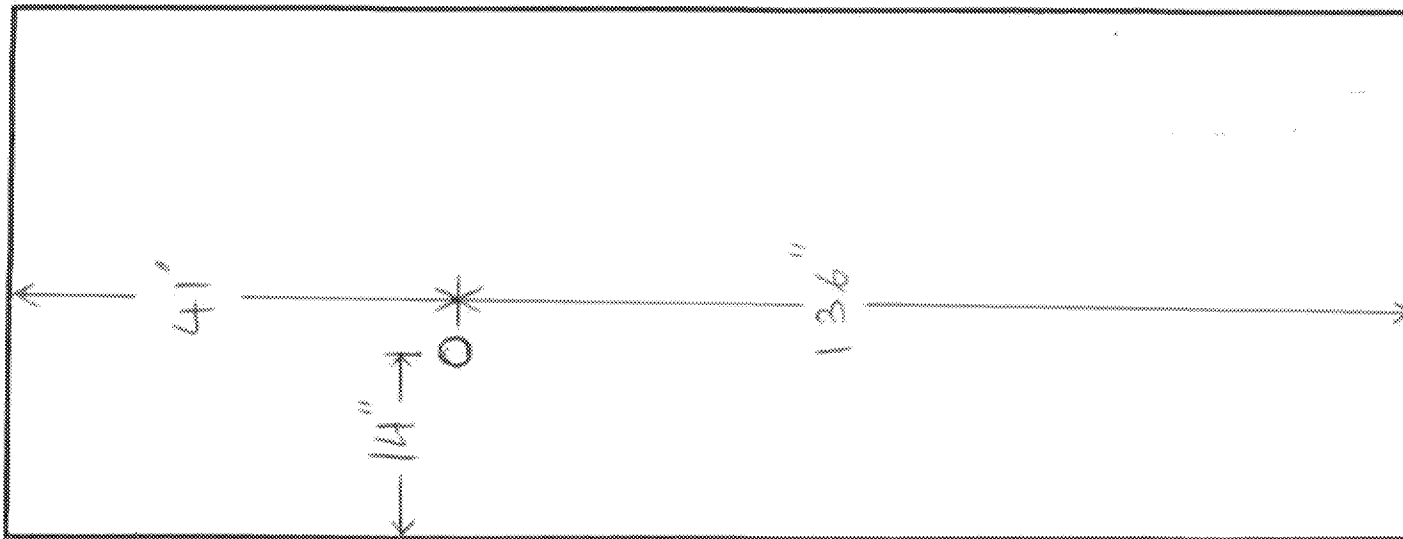
| Description: | Tank # 5 | Row or Course - LOWER DOME C1 | Sheet No - 001 Plate 2 |

This area was chosen because of its relation to 32" issue / receipt lines exiting the tank to lower level. Sounding located a hollow spot.

- 1) Course C1 Plate 2
- 2) Dry / no liquid (1/8" clearance behind plate)
- 3) Readings: LEL- 4%, O2- 12% VOC- 895 ppm
- 4) Dry / no liquid
- 5) Readings: LEL- 0%, O2- 20.9% VOC- 0 ppm

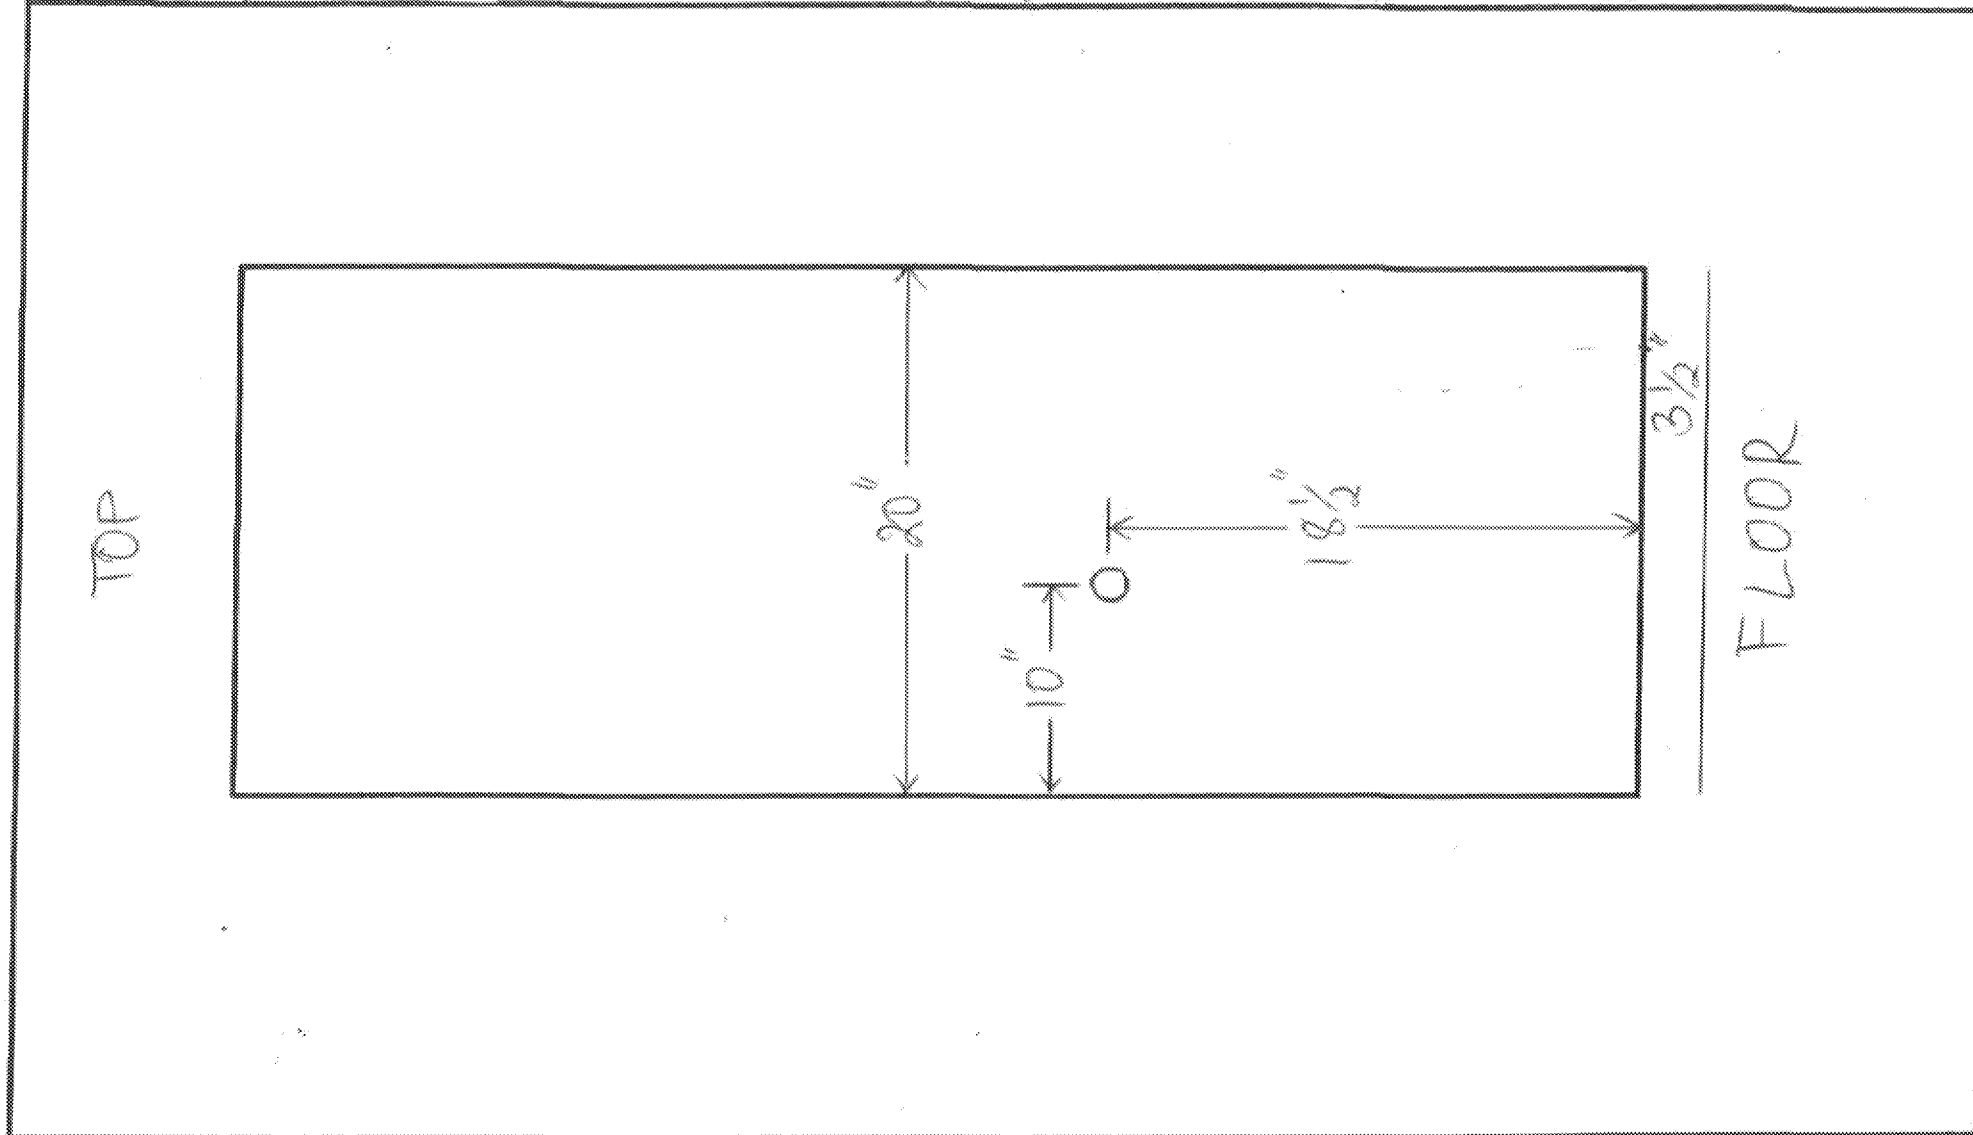
| Description: | Tank # 5 | Row or Course - Lower DOME CL | Sheet No - 002 Plate 20 |

This area was chosen because of its relation to 18" issue / receipt lines exiting the tank to lower level. Sounding located a hollow spot.

- 1) Course C1 Plate 20
- 2) Dry / no liquid (1/8" clearance behind plate)
- 3) Readings: LEL- 8%, O2- 7% VOC- 963 ppm
- 4) Dry / no liquid
- 5) Readings: LEL- 0%, O2- 20.9% VOC- 0 ppm

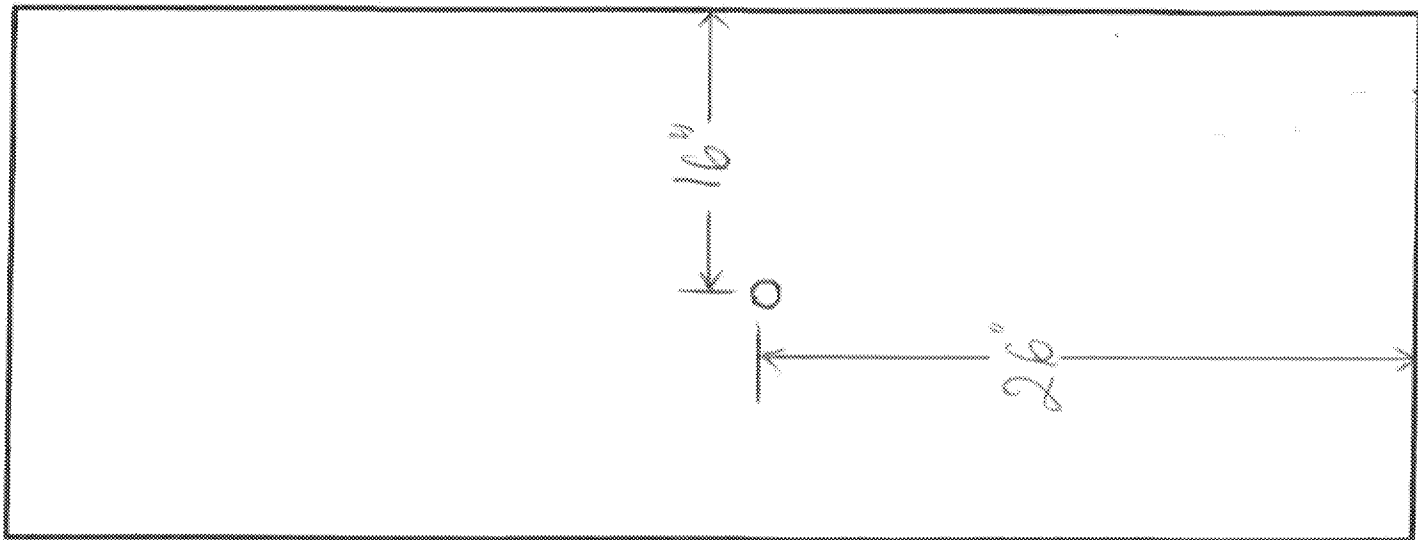
| Description: | Tank # 5 | Row or Course - 4D C2 | Sheet No - 603 Plate 42 |

This area was chosen because of its position in the tank and sounding located a hollow spot.

- 1) Course C2 Plate 42
- 2) Dry / no liquid (1/8" clearance behind plate)
- 3) Readings: LEL- 7%, O2- 9% VOC- 907 ppm
- 4) Dry / no liquid
- 5) Readings: LEL- 0%, O2- 20.9% VOC- 0 ppm

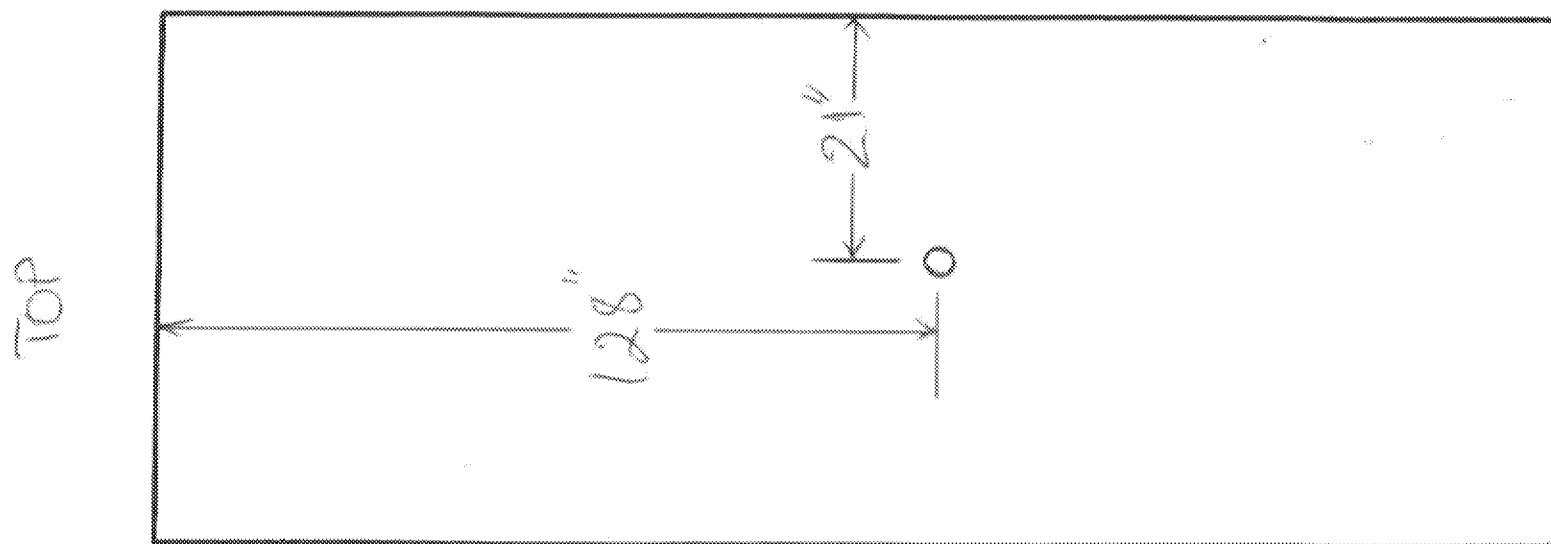
| Description: | Tank # 5 | Row or Course - LOWGE DONE C3 | Sheet No - 004 Plate 60 |

This area was chosen because of its position in the tank and sounding located a hollow spot.

- 1) Course C3 Plate 60
- 2) Dry / no liquid (3/4" clearance behind plate)
- 3) Readings: LEL- 6%, O2- 13% VOC- 748 ppm
- 4) Dry / no liquid
- 5) Readings: LEL- 0%, O2- 20.9% VOC- 0 ppm

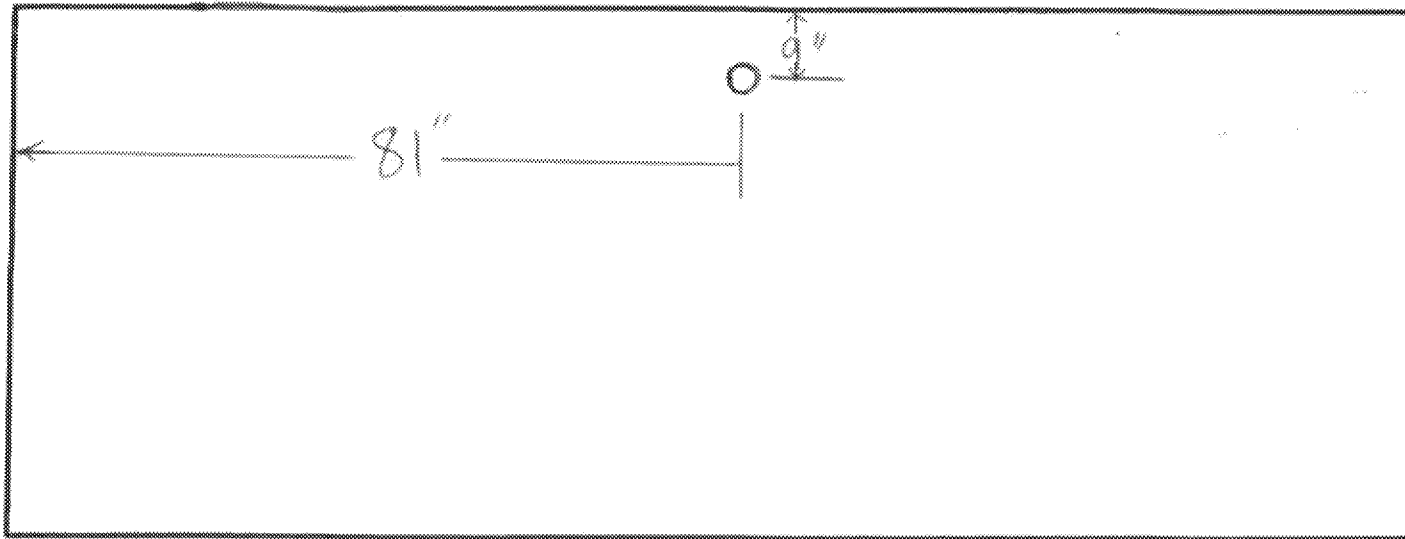
| Description: | Tank # 5 | Row or Course - # 8 | Sheet No - 005 Plate 12 |

This area was chosen because of its position in the tank, sounding located a hollow spot, plate bulging and relation to previous repair WP403.

- 1) Course 8 Plate 12
- 2) Dry / no liquid (1/8" clearance behind plate)
- 3) Readings: LEL- 7%, O2- 14% VOC- 813 ppm
- 4) Dry / no liquid
- 5) Readings: LEL- 0%, O2- 20.9% VOC- 0 ppm

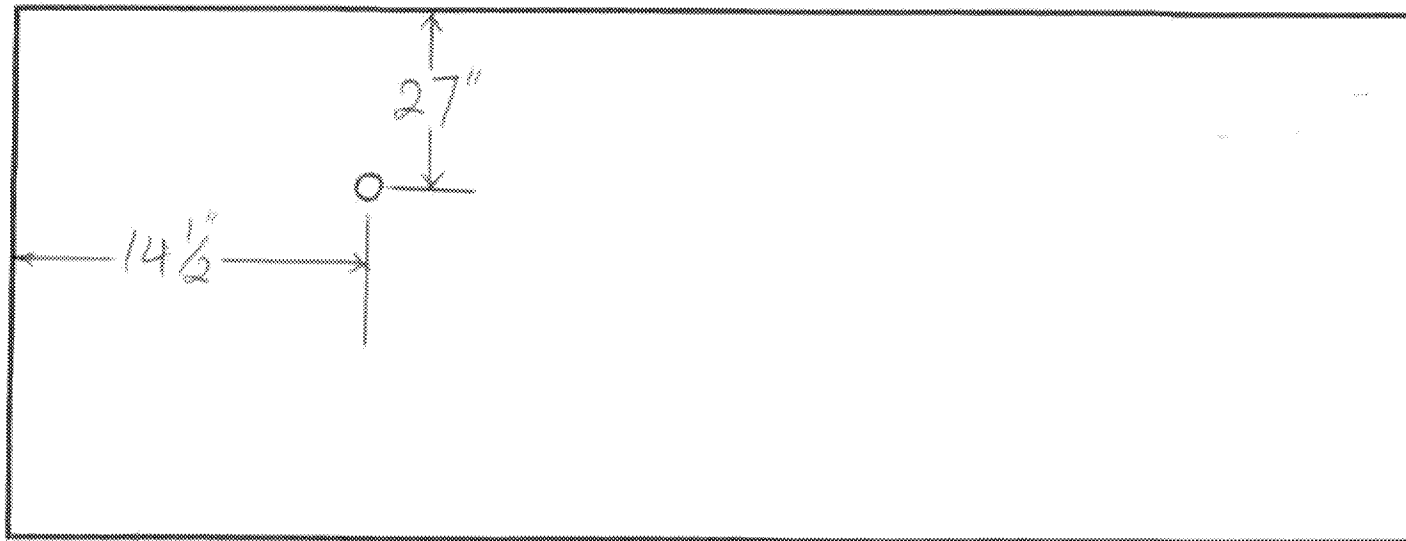
| Description: | Tank # 5 | Row or Course - # 26 | Sheet No - 006 Plate 15 |

This area was chosen because of its position in the tank; sounding located a hollow spot, and relation to previous repairs WP383, WP379, and WP381.

- 1) Course 26 Plate 15
- 2) Dry / no liquid (1/4" clearance behind plate)
- 3) Readings: LEL- 5%, O2- 11% VOC- 827 ppm
- 4) Dry / no liquid
- 5) Readings: LEL- 0%, O2- 20.9% VOC- 0 ppm

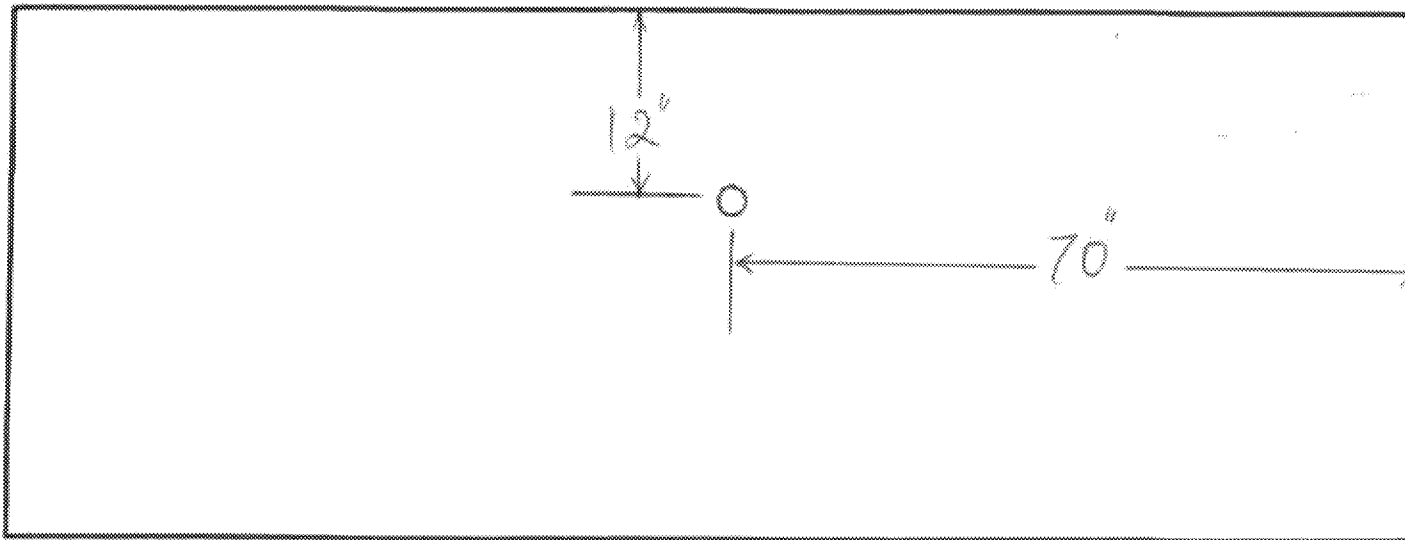
| Description: | Tank # 5 | Row or Course - E2 | Sheet No - 007 plate 16 |

This area was chosen because of its position in the tank; sounding located a hollow spot, and relation to previous repairs WP076, WP077, and WP078.

- 1) Course E2 Plate 16
- 2) Dry / no liquid (3/4" clearance behind plate)
- 3) Readings: LEL- 9%, O2- 12% VOC- 984 ppm
- 4) Dry / no liquid
- 5) Readings: LEL- 0%, O2- 20.9% VOC- 0 ppm

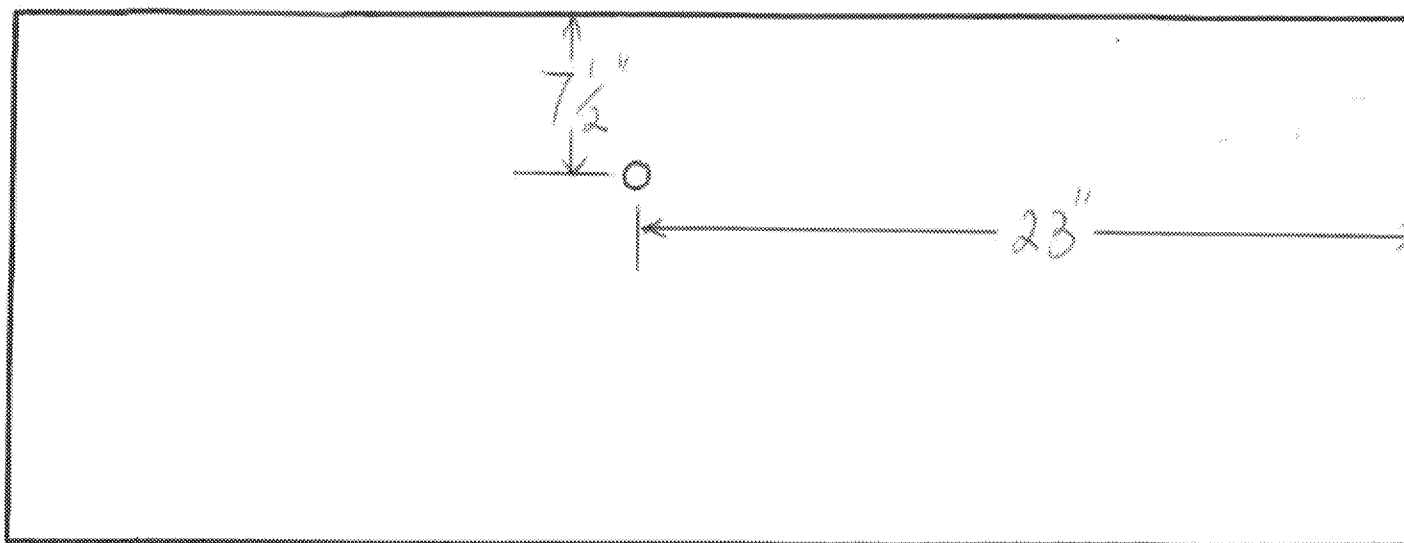
| Description: | Tank # 5 | Row or Course - E 4 | Sheet No - 008 Plate 13 |

This area was chosen because of its position in the tank, sounding located a hollow spot, and growth out of WP075.

- 1) Course E4 Plate 13
- 2) Dry / no liquid (1/16" clearance behind plate)
- 3) Readings: LEL- 0%, O2- 19% VOC- 40 ppm
- 4) Mist of dust & moisture- volume not relevant or collectable
- 5) Readings: LEL- 0%, O2- 20.9% VOC- 0 ppm

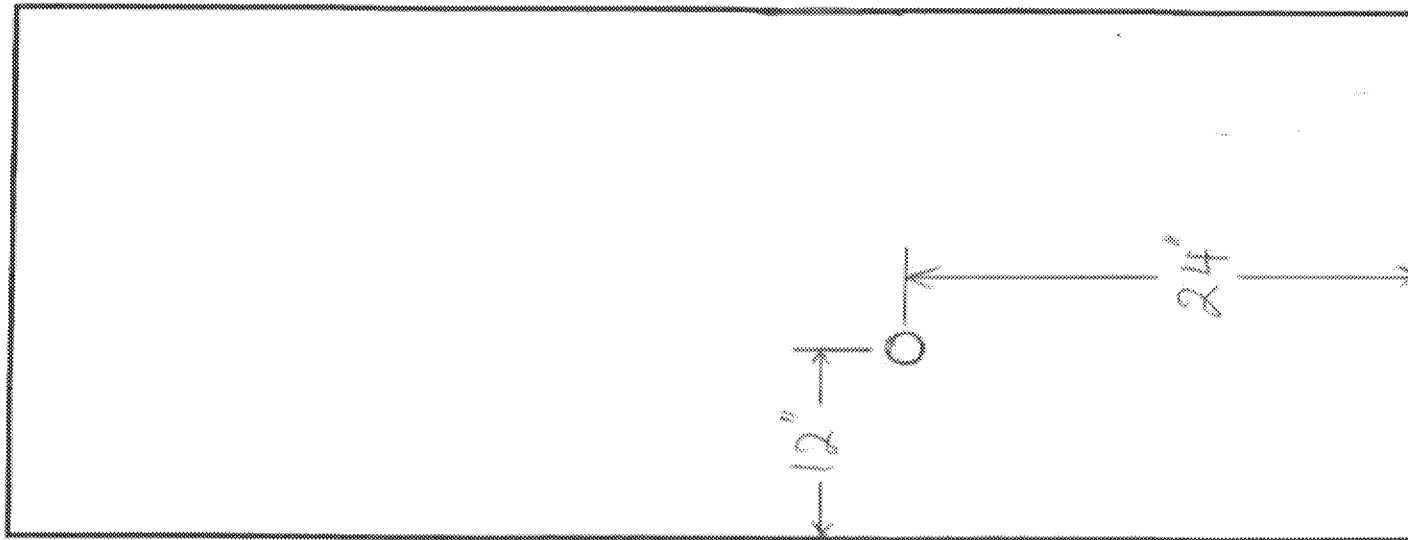
| Description: | Tank # 5 | Row or Course - A | Sheet No - 009 Plate 68 |

This area was chosen because of previously failed LT which indicated the possible presence of fuel.

- 1) Course A Plate 68
- 2) Dry / no liquid (1/16" clearance behind plate)
- 3) Readings: LEL- 2%, O2- 18% VOC- 300 ppm
- 4) Mist of dust & moisture- volume not relevant or collectable
- 5) Readings: LEL- 0%, O2- 20.9% VOC- 0 ppm

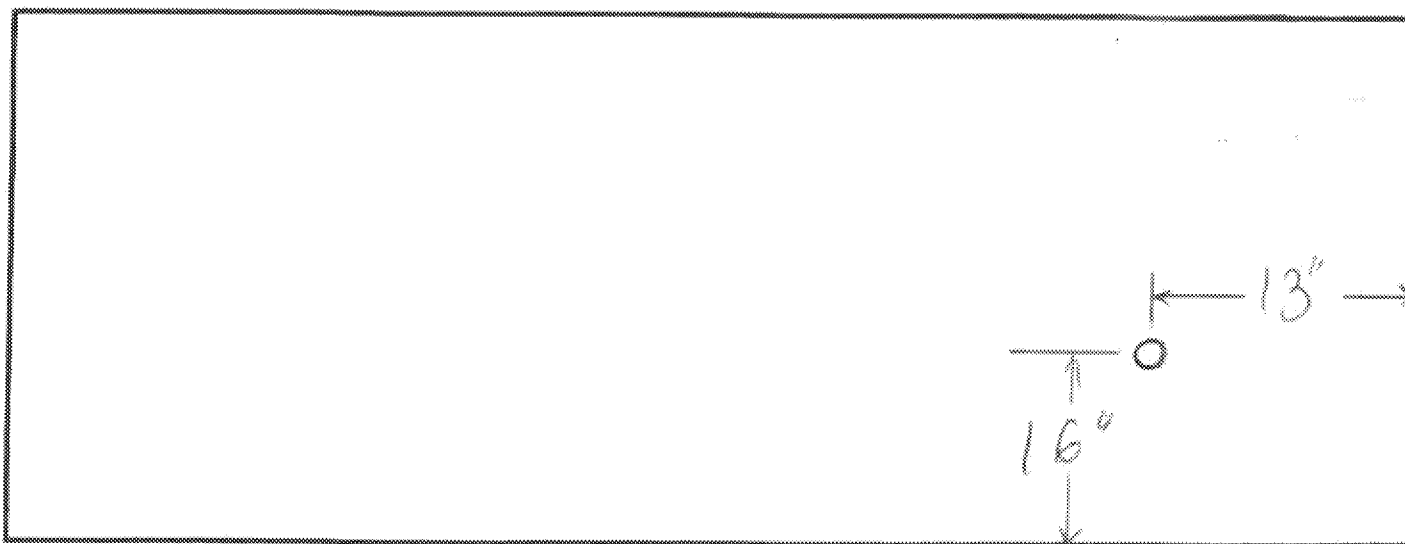
| Description: | Tank # 5 | Row or Course - # 3 | Sheet No - 010 Plate 3 |

This area was chosen because of its position in the tank, sounding located a hollow spot, and relation to previous repairs.

- 1) Course 3 Plate 3
- 2) Dry / no liquid (1/16" clearance behind plate)
- 3) Readings: LEL- 7%, O2- 13% VOC- 780 ppm
- 4) Dry / no liquid
- 5) Readings: LEL- 0%, O2- 20.9% VOC- 0 ppm

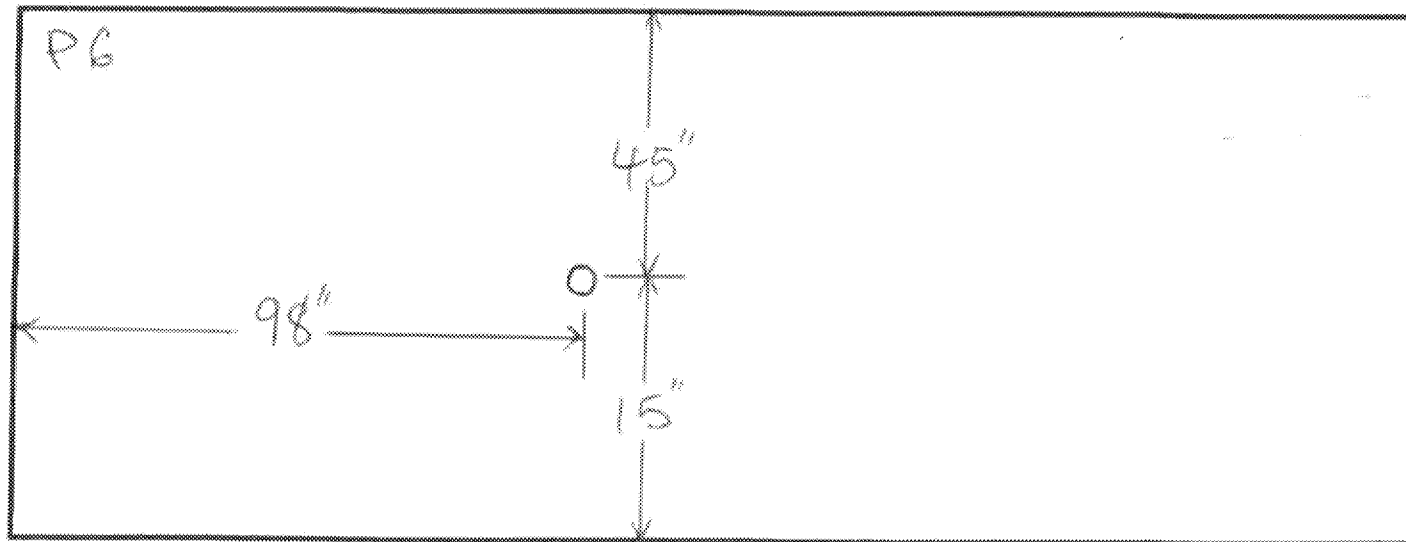
| Description: | Tank # 5 | Row or Course - 3 11 | Sheet No - 071 Plate 6 |

This area was chosen because of previous failed LT and repair plate (WP301) had been removed.

- 1) Course 11 Plate 6
- 2) Dry / no liquid (1/16" clearance behind plate)
- 3) Readings: LEL- 6%, O2- 11% VOC- 800 ppm
- 4) Dry / no liquid
- 5) Readings: LEL- 0%, O2- 20.9% VOC- 400 ppm

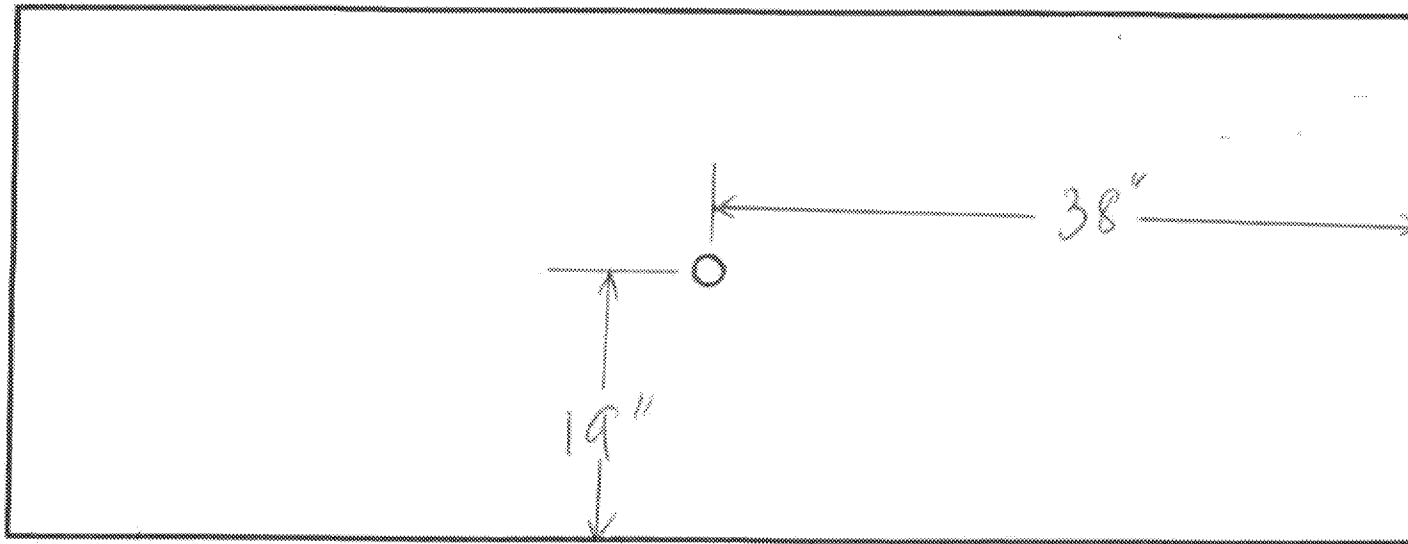
| Description: | Tank # 5 | Row or Course - E3 | Sheet No - 012 Plate 6 |

This area was chosen because of its position in the tank, sounding located a hollow spot, plate bulging and relation to previous repair.

- 1) Course 11 Plate 6
- 2) Dry / no liquid (1/8" clearance behind plate)
- 3) Readings: LEL- 9%, O2- 7% VOC- 1000 ppm
- 4) Dry / no liquid
- 5) Readings: LEL- 0%, O2- 20.9% VOC- 39 ppm

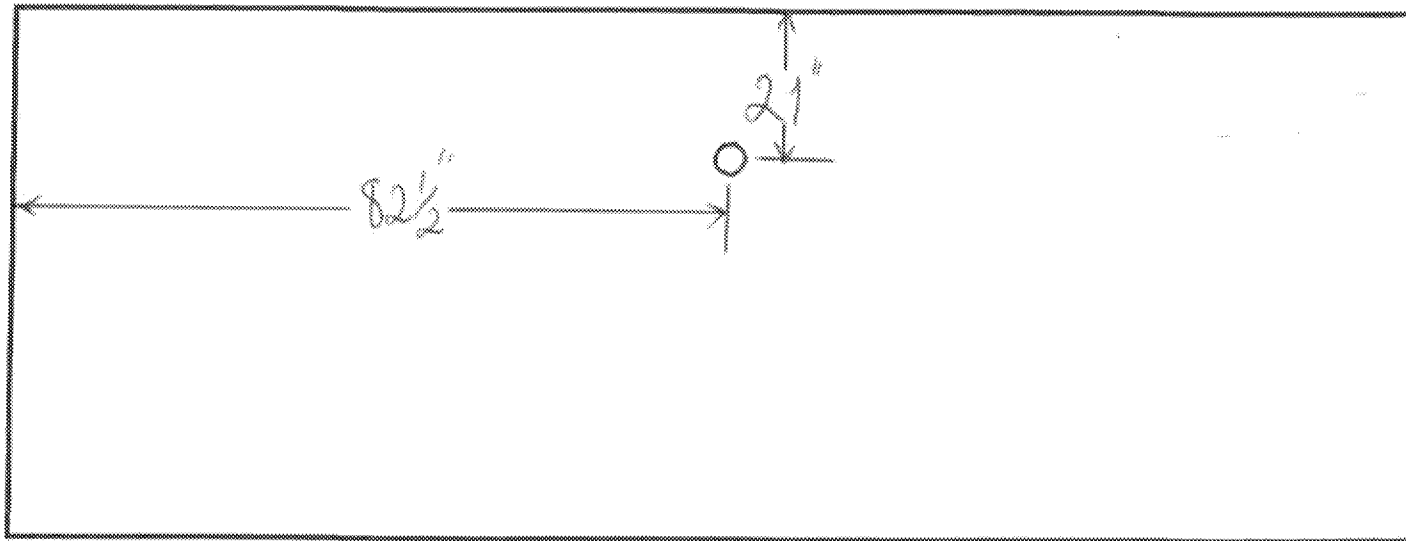
| Description: | Tank # 5 | Row or Course - E 2 | Sheet No - 013 Plate 3 |

This area was chosen because of its position in the tank, sounding located a hollow spot and relation to previous repair.

- 1) Course E2 Plate 3
- 2) Dry / no liquid (1/4" clearance behind plate)
- 3) Readings: LEL- 4%, O2- 16% VOC- 850 ppm
- 4) Dry / no liquid
- 5) Readings: LEL- 0%, O2- 20.9% VOC- 37 ppm

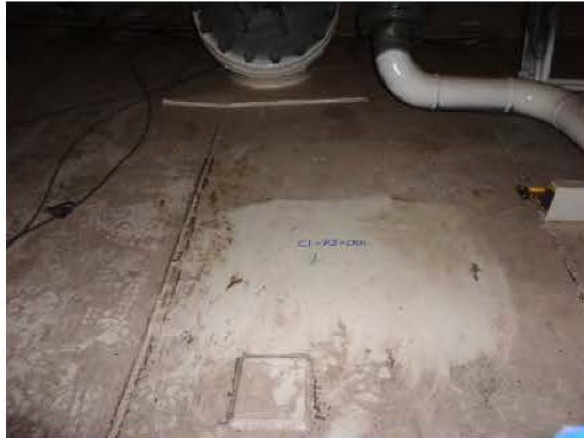
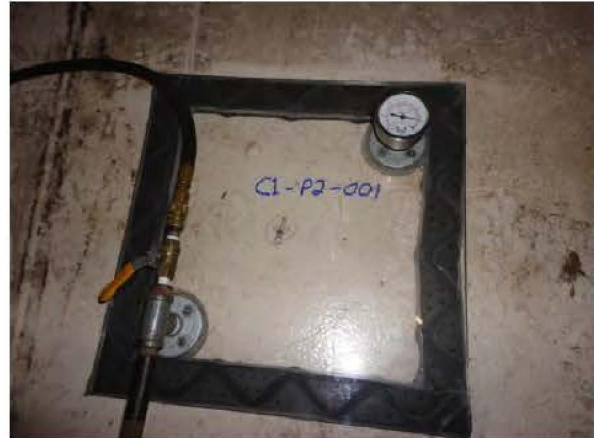
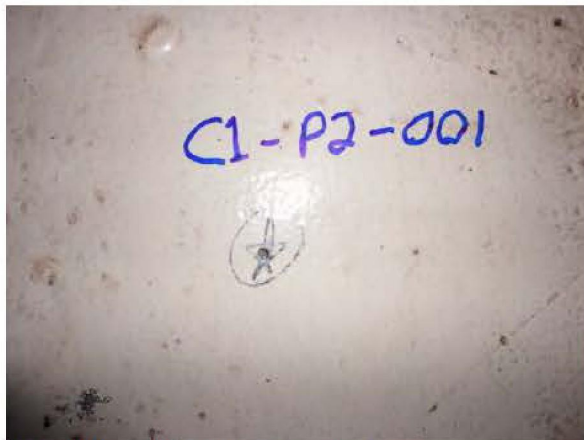
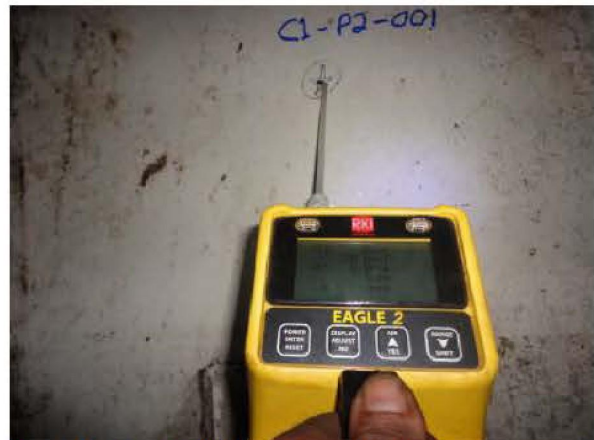
Port 001- C1 Plate 2; Located

Port 001- C1 Plate 2; Vacuumed

Port 001- C1 Plate 2; Drilled

Port 001- C1 Plate 2; Air Monitoring

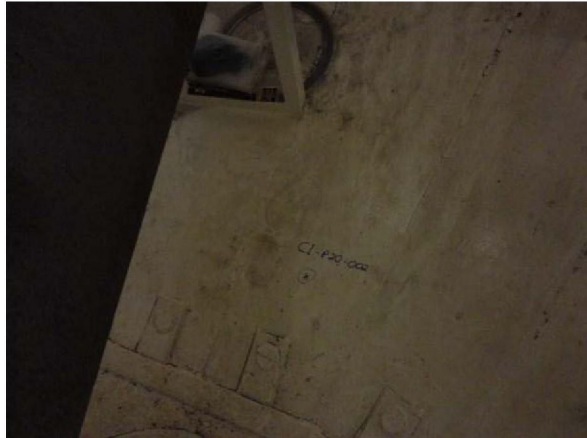
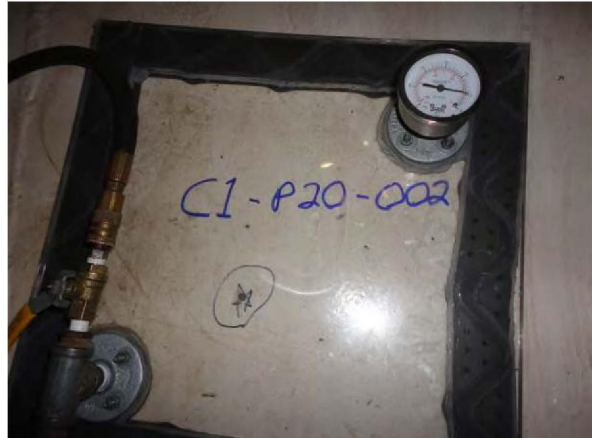
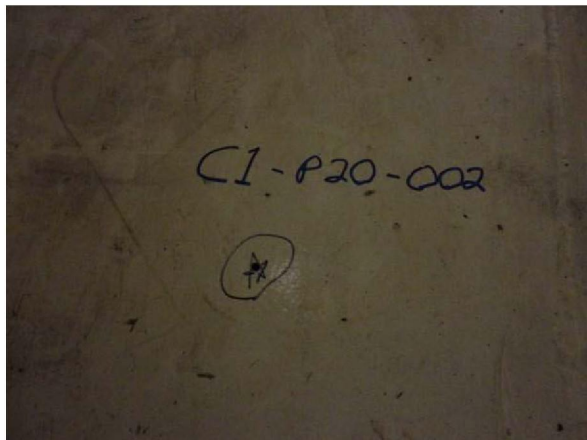
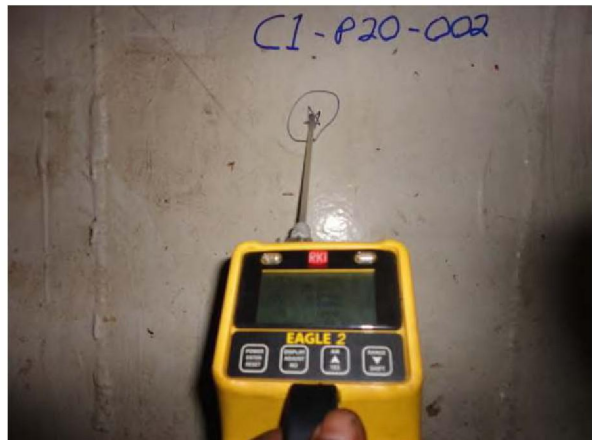
Port 002- C1 Plate 20; Located

Port 002- C1 Plate 20; Vacuumed

Port 002- C1 Plate 20; Drilled

Port 002- C1 Plate 20; Air Monitoring

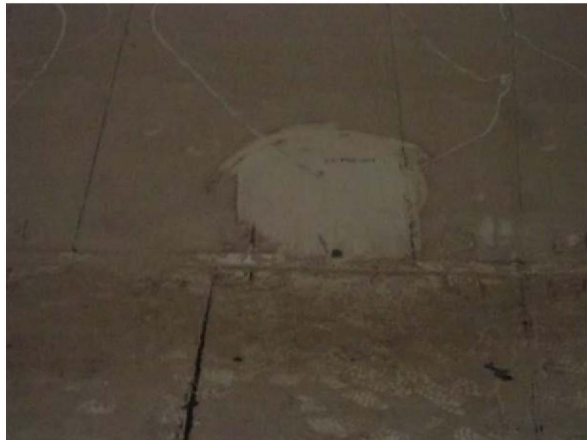
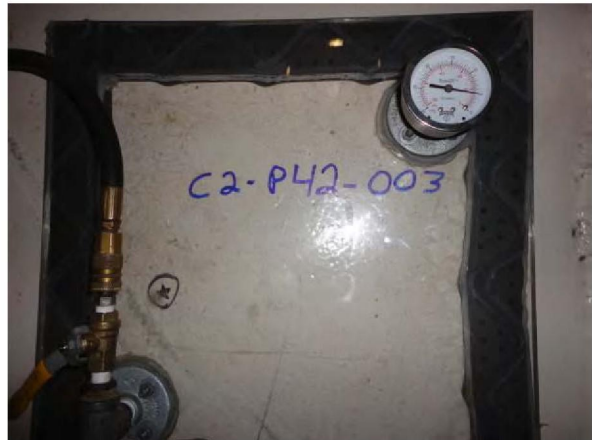
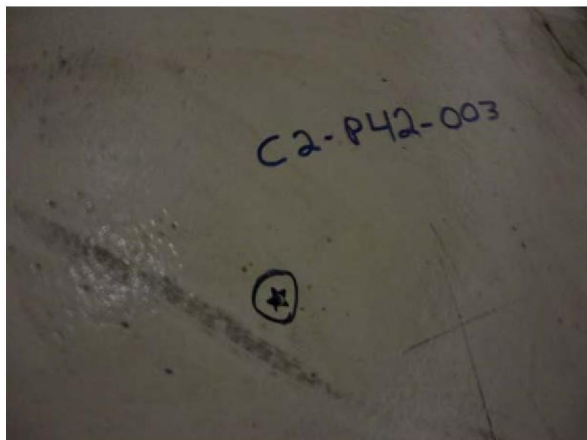
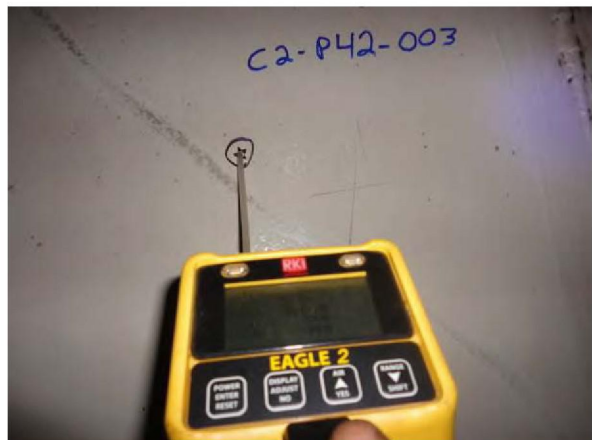
Port 003- C2 Plate 42; Located

Port 003- C2 Plate 42; Vacuumed

Port 003- C2 Plate 42; Drilled

Port 003- C2 Plate 42; Air Monitoring

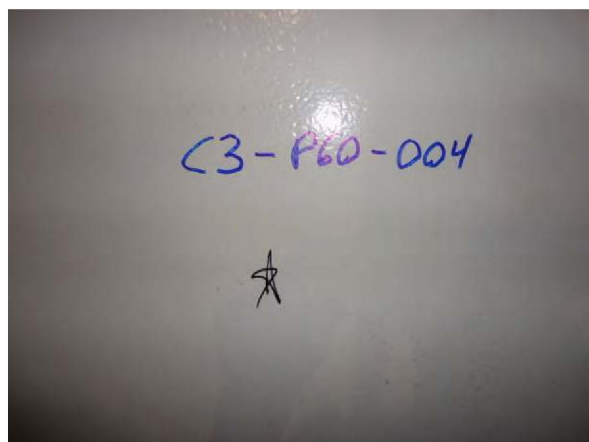
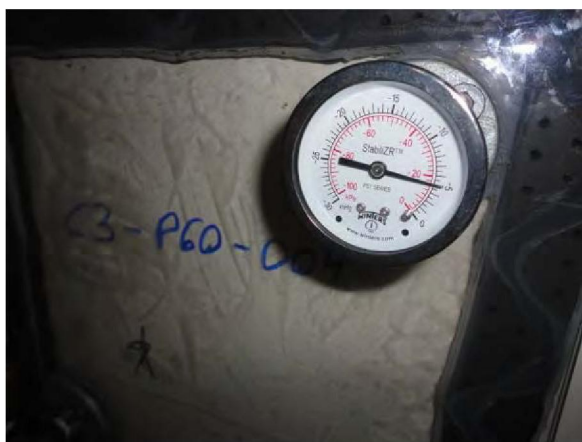
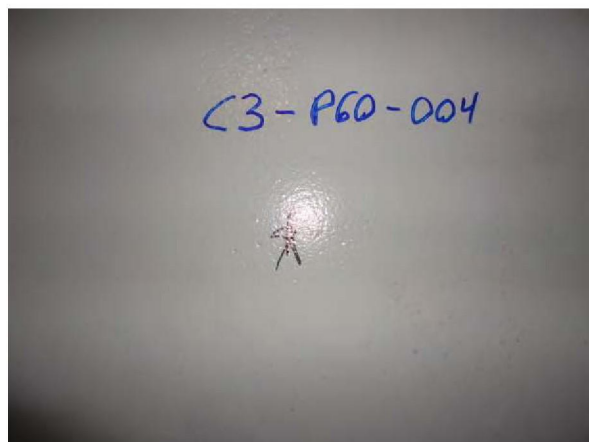
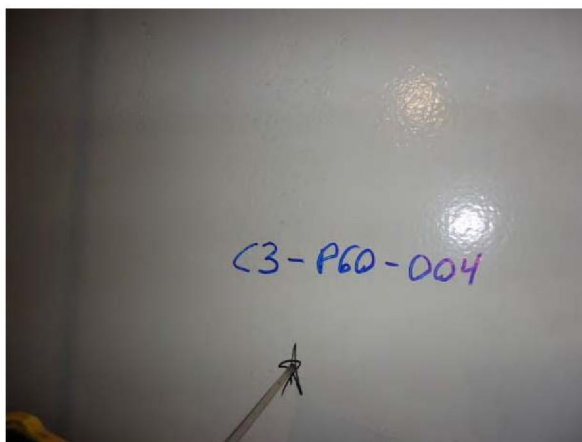
Port 004- C3 Plate 60; Located

Port 004- C3 Plate 60; Vacuumed

Port 004- C3 Plate 60; Drilled

Port 004- C3 Plate 60; Air Monitoring

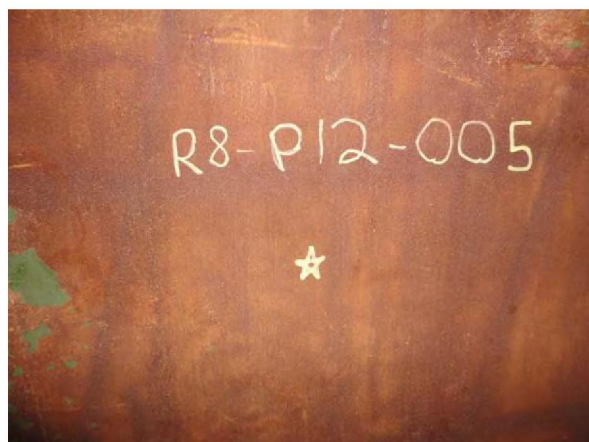
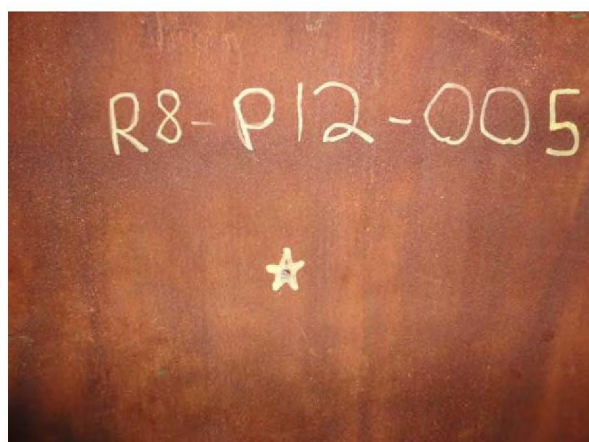
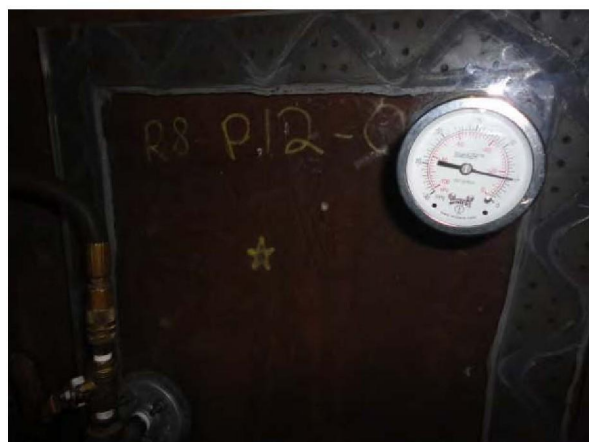
Port 005- R8 Plate 12; Located

Port 005- R8 Plate 12; Drilled

Port 005- R8 Plate 12; Vacuumed

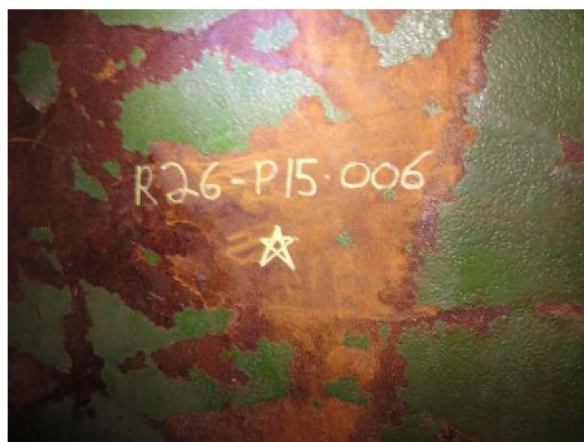
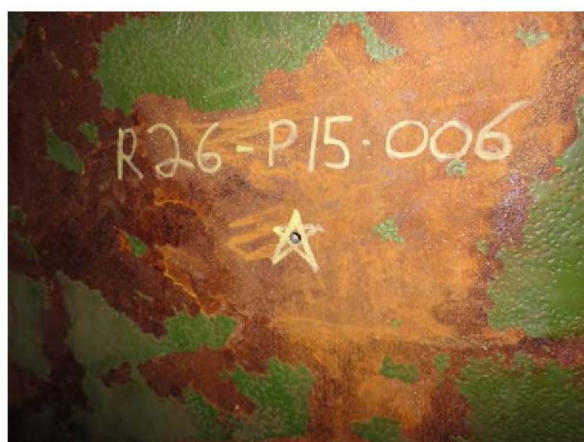
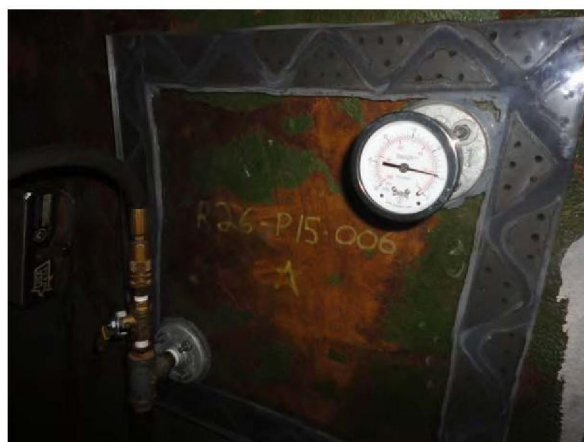
Port 006- R26 Plate 15; Located

Port 006- R26 Plate 15; Drilled

Port 006- R26 Plate 15; Vacuumed

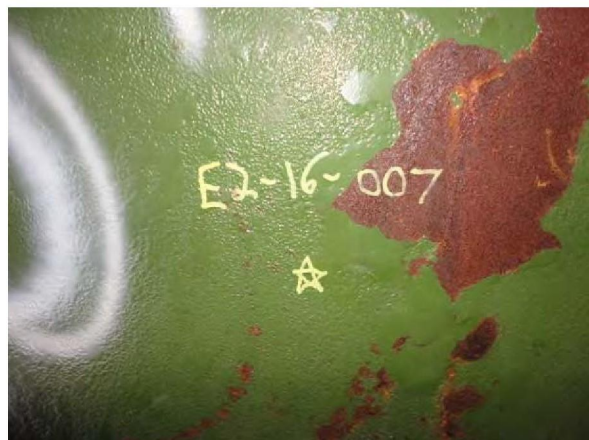
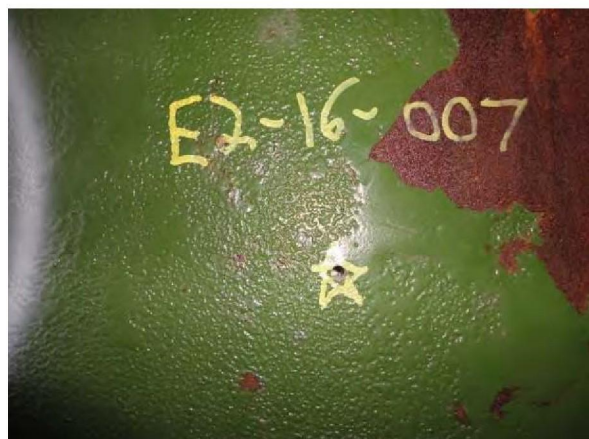
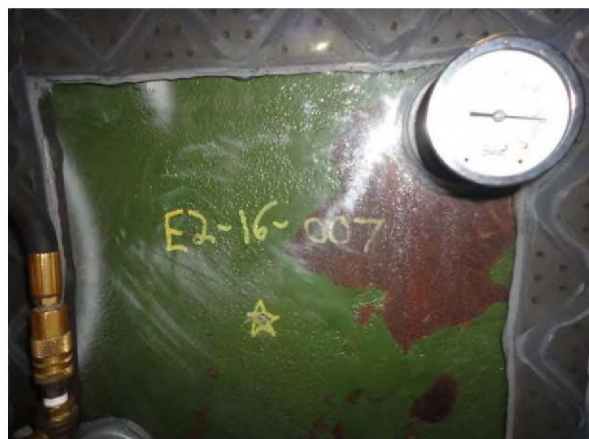
Port 007- E2 Plate 16; Located

Port 007- E2 Plate 16; Drilled

Port 007- E2 Plate 16; Vacuumed

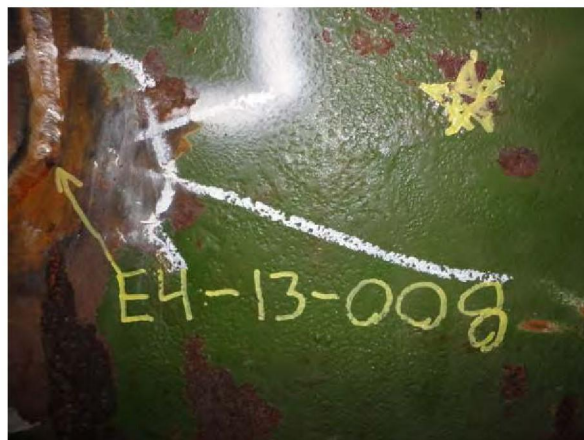
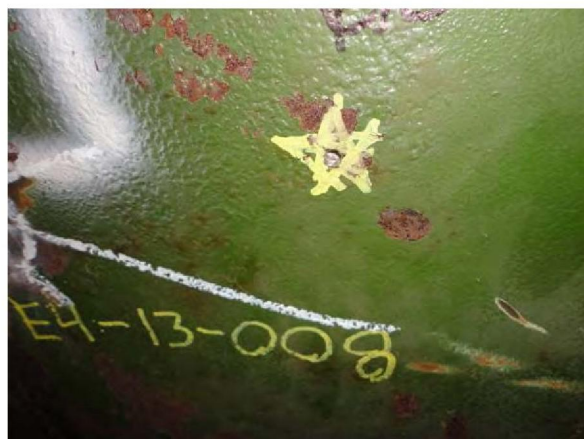
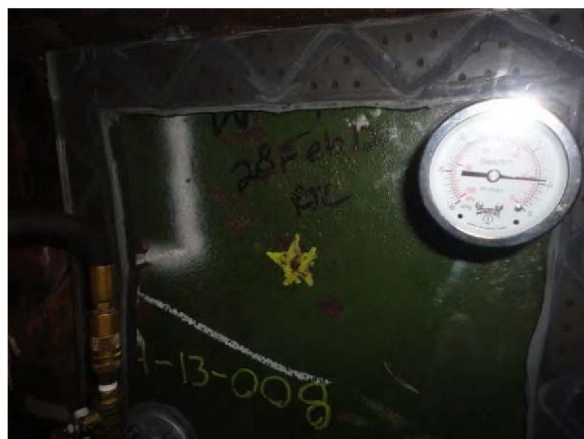
Port 008- E4 Plate 13; Located

Port 008- E4 Plate 13; Drilled

Port 008- E4 Plate 13; Vacuumed

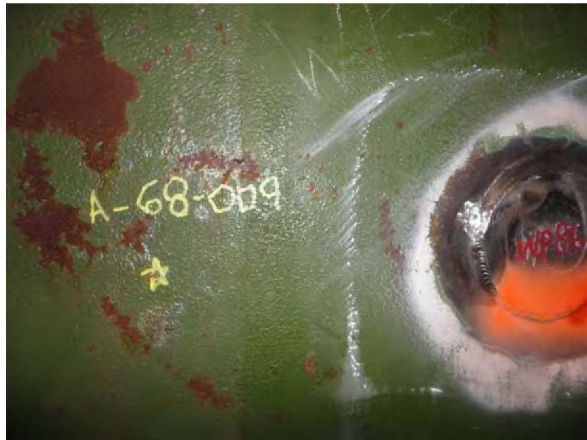
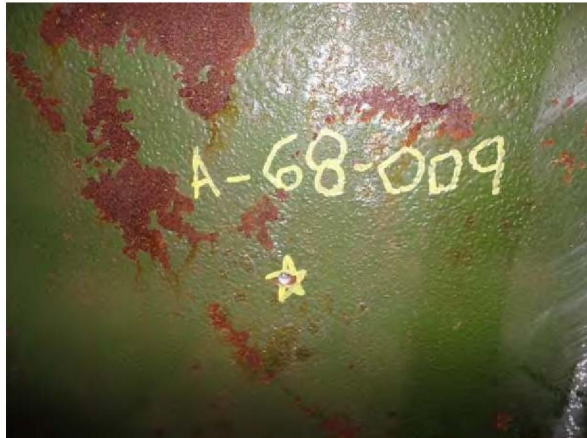
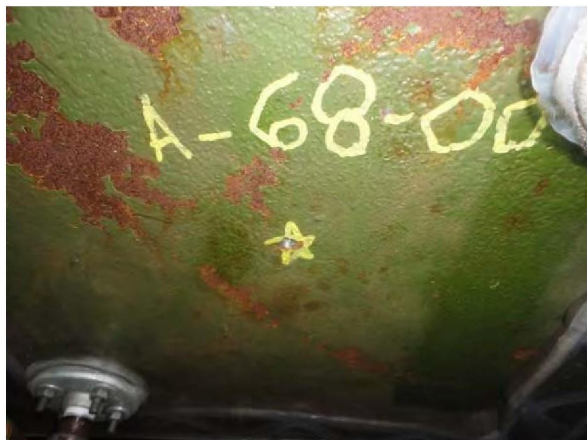
Port 009- A Plate 68; Located

Port 009- A Plate 68; Drilled

Port 009- A Plate 68; Vacuumed

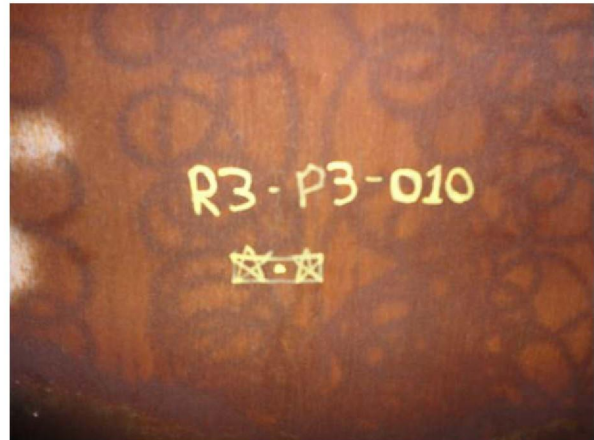
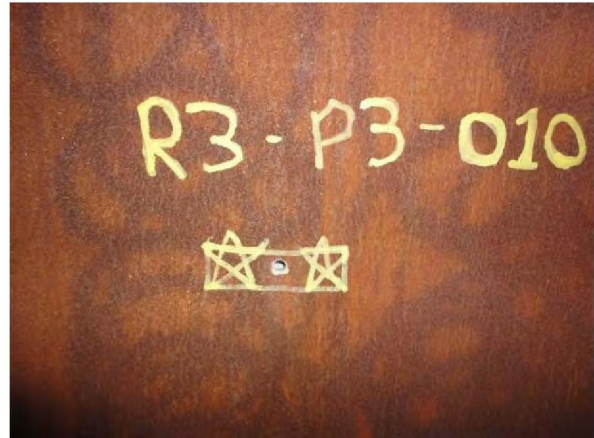
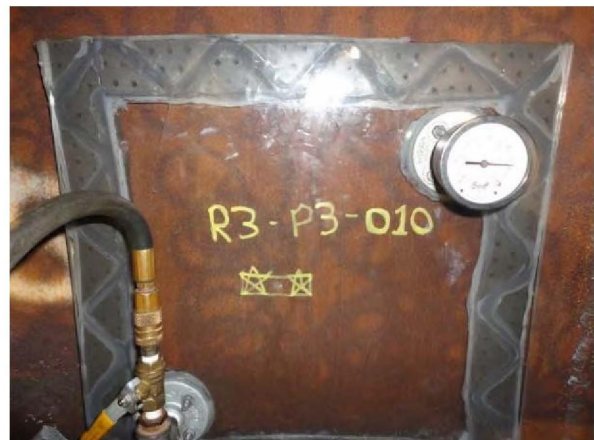
Port 010- R3 Plate 3; Located

Port 010- R3 Plate 3; Drilled

Port 010- R3 Plate 3; Vacuumed

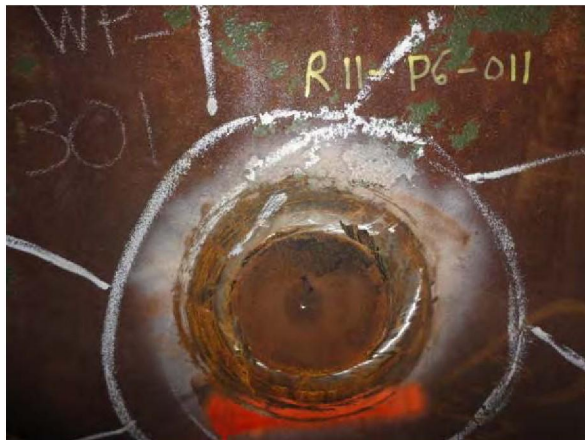
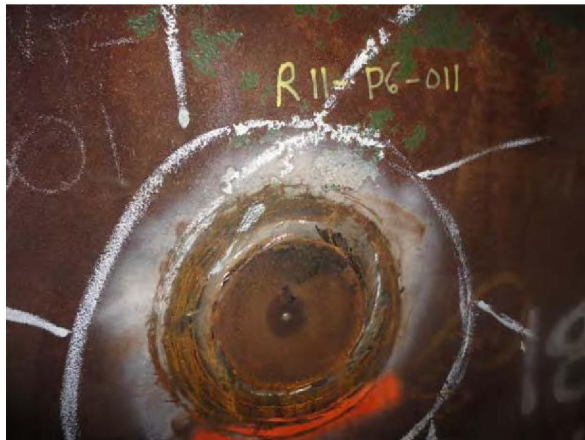
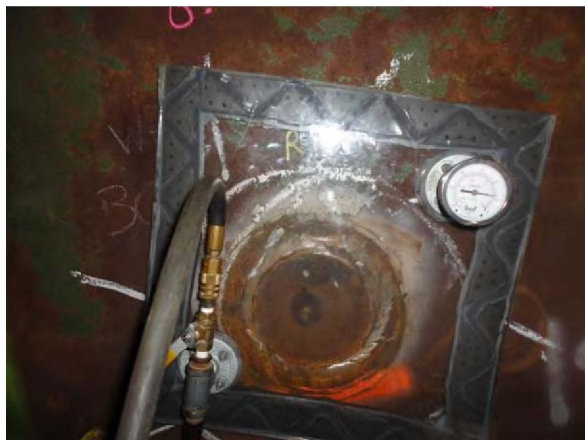
Port 011- R11 Plate 6; Located

Port 011- R11 Plate 6; Under WP301

Port 011- R11 Plate 6; Vacuumed
