## **WILLBROS GOVERNMENT SERVICES (U.S.), LLC**

Date: 10/30/14  
Subject: Potential Free Product Recovery Notes

## Potential Free Product Reclamation Photo's

| TASK ORDER #: | N 62583-09-D-0132/003 | PROJECT TITLE: | CLEAN, INSPECT & REPAIR TANKS 5 & 17 RED HILL COMPLEX |

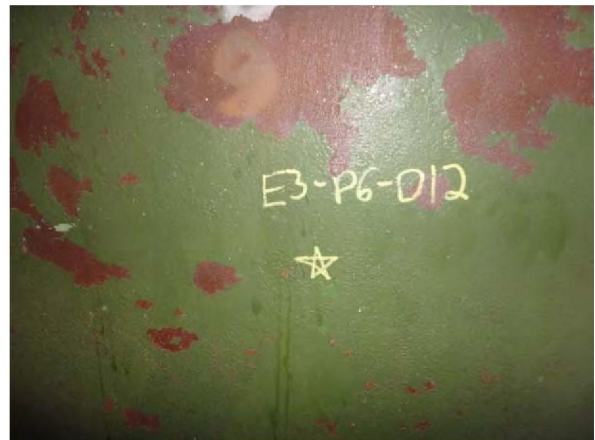
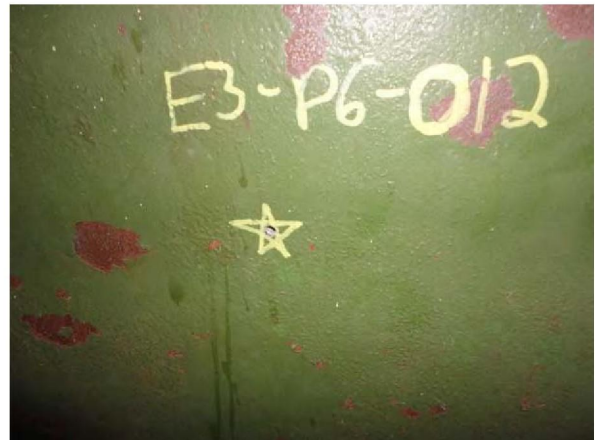
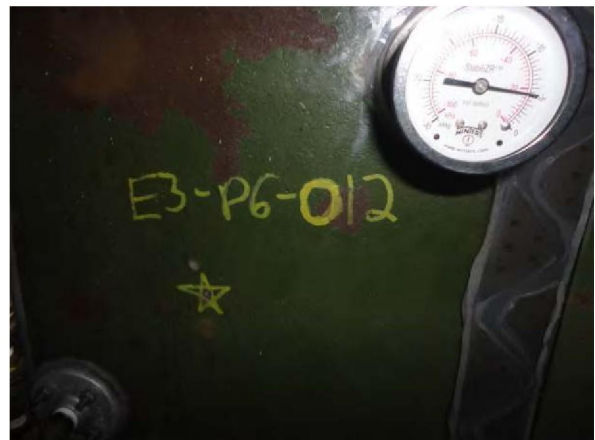
Port 012- E3 Plate 6; Located

Port 012- E3 Plate 6; Drilled

Port 012- E3 Plate 6; Vacuumed

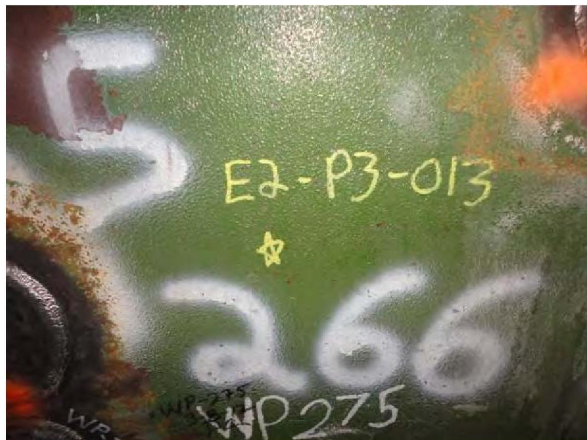
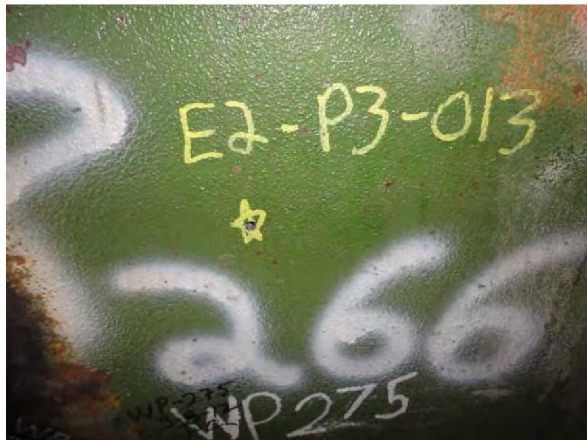
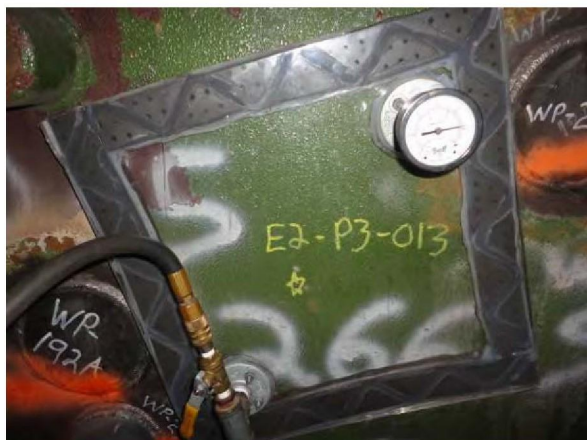
Port 013- E2 Plate 3; Located

Port 013- E2 Plate 3; Drilled

Port 013- E2 Plate 3; Vacuumed
