DEPARTMENT OF THE NAVY

SUBJECT: ADMINISTRATIVE ORDER ON CONSENT (AOC) STATEMENT OF WORK (SOW) SECTION 5 CORROSION AND METAL FATIGUE PRACTICES, DESTRUCTIVE TESTING RESULTS REPORT, RED HILL BULK FUEL STORAGE FACILITY (RED HILL), JOINT BASE PEARL HARBOR-HICKAM, OAHU, HAWAII

In 2018, ten coupons were removed from Tank 14, so that a metallurgical and corrosion analysis of the coupons could be undertaken, with the primary aim of validating non-destructive examination (NDE) results. The steel coupons, concrete powder samples, and corrosion product were submitted to a certified third-party laboratory to perform this analysis.

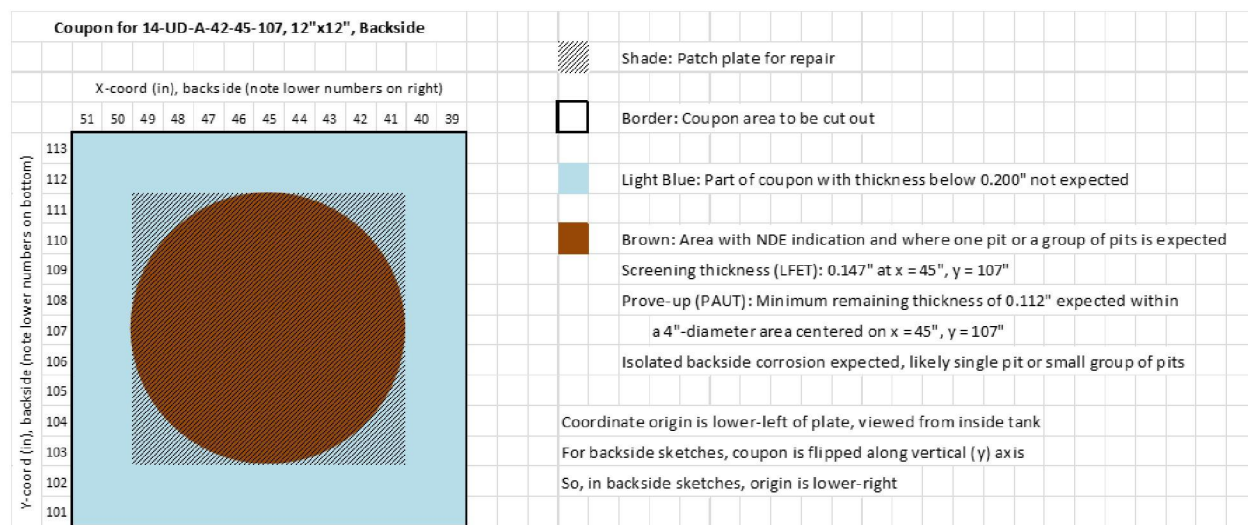
Figure 4-1 Expected Results from NDE Spreadsheet Data, Coupon 1

Destructive testing found pitting and minimum wall thickness of 0.208 inch. Remaining wall thickness greater than expected (208 mils vs. 112 mils). This deviation exceeded the 20 mils accuracy range for pitting.

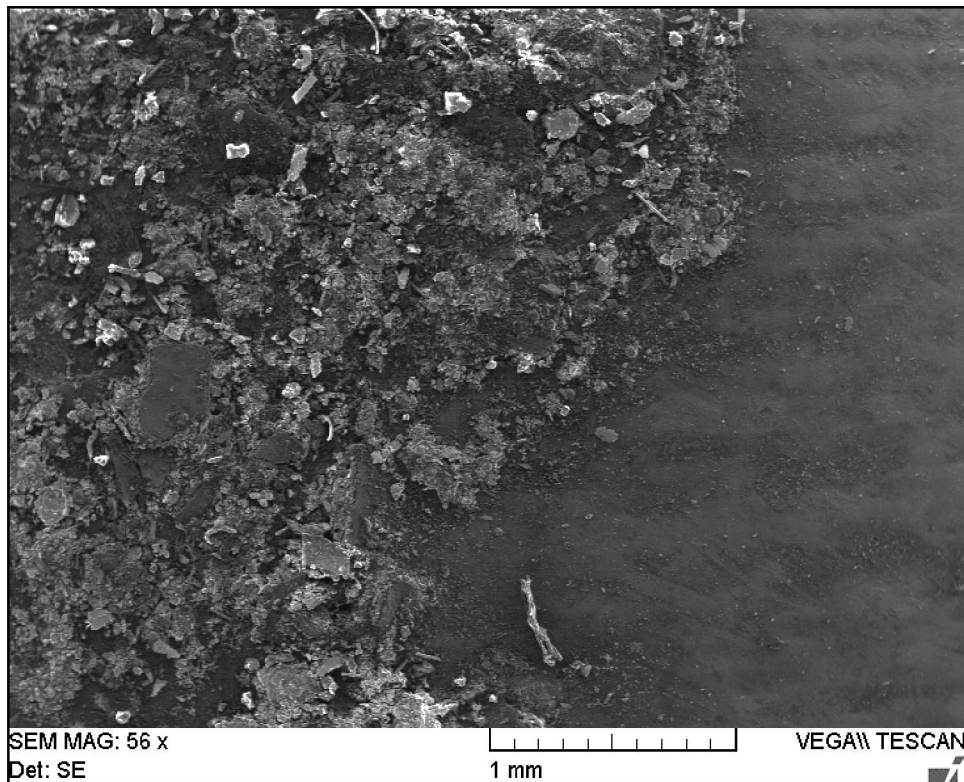
Figure 62. A representative SEM image of the surface of a specimen excised from Coupon 10 labeled as 10-1, prior to cleaning. No pit was observed in this location. (SEM, 33X)

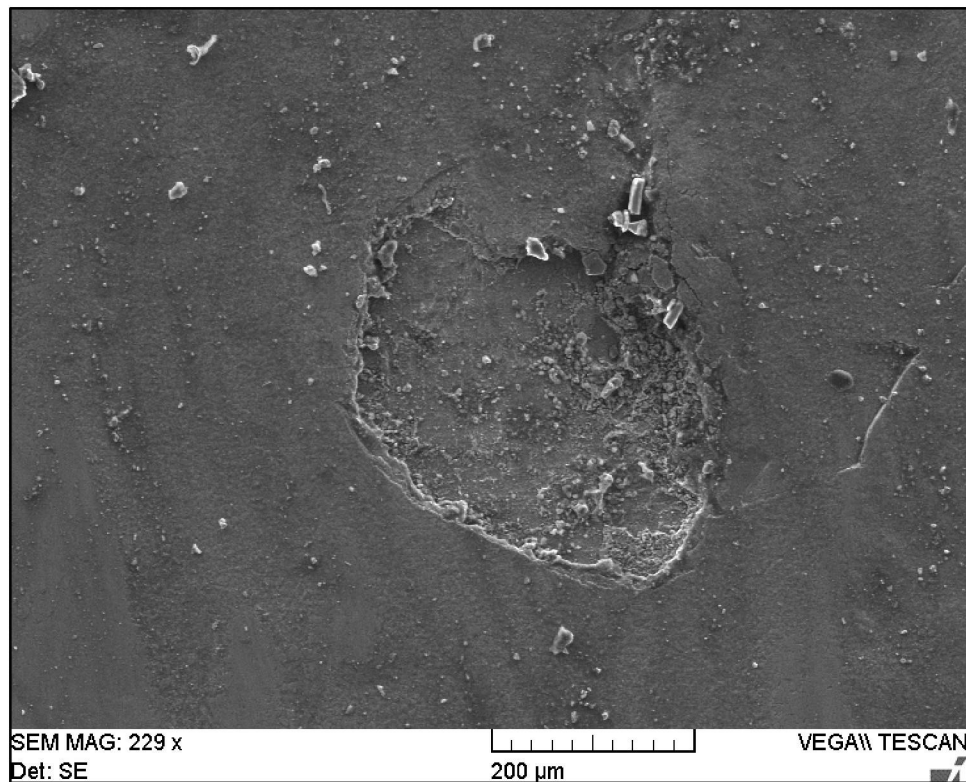
Figure 63. A representative SEM image of a pit on a specimen excised from Coupon 10 labeled as 10-2, prior to cleaning. (SEM, 135X)

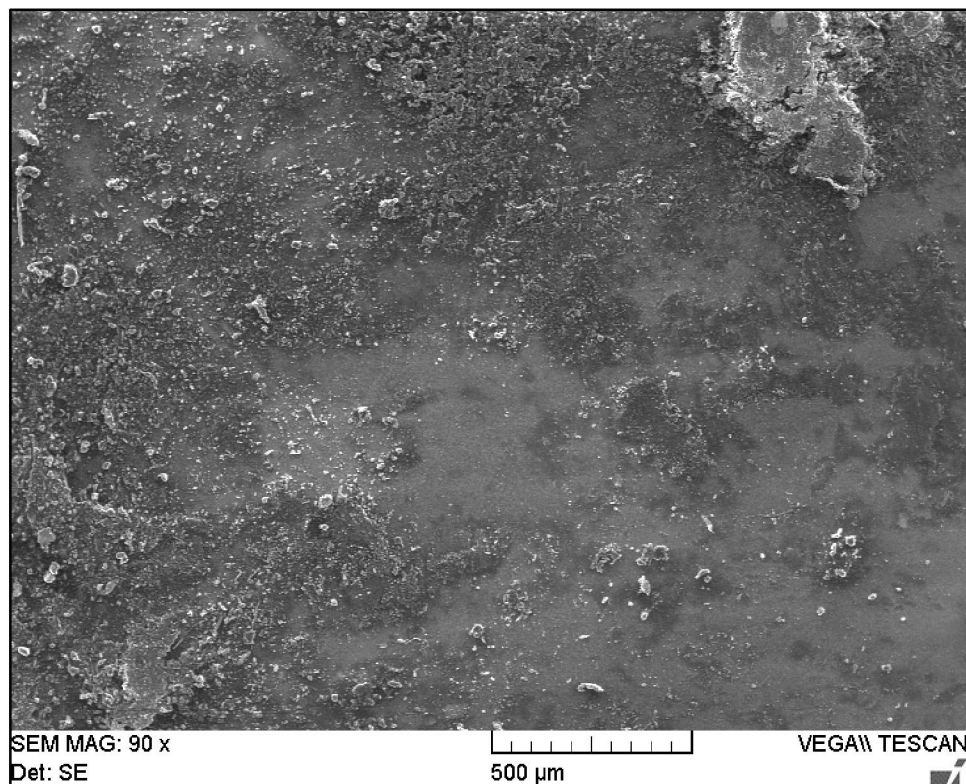
Figure 64. A representative SEM image of the surface on a specimen excised from Coupon 10 labeled as 10-3, prior to cleaning. No pit was observed in this location. (SEM, 53X)

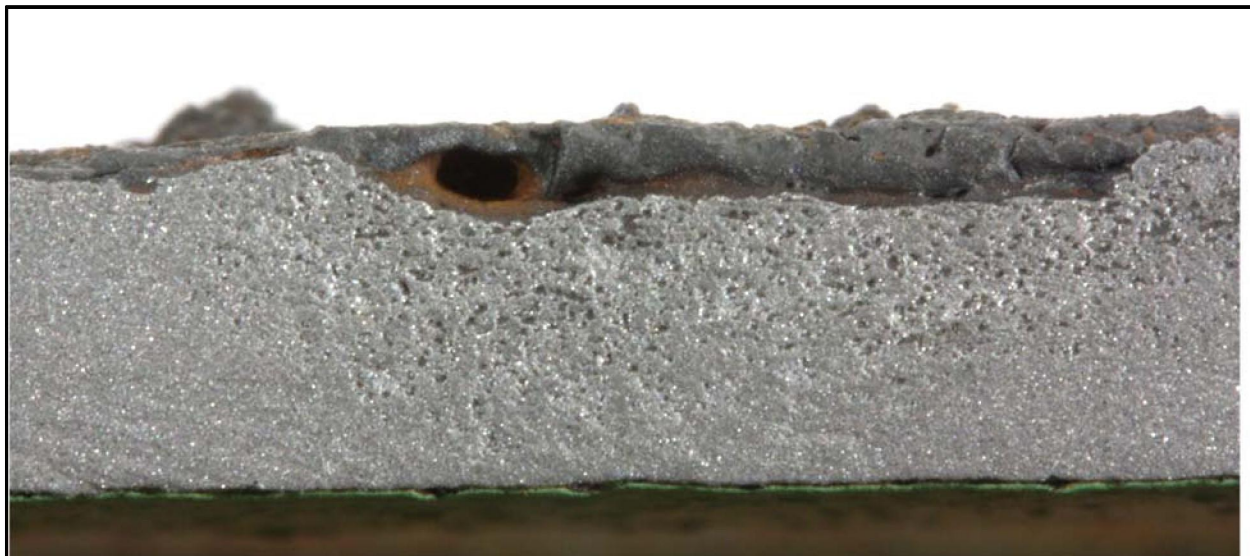
Figure A-4. Detail of the sandblasted edge on 3/20/19 in the same location as shown in the picture below. The sandblasting revealed that the feature was not a corrosion pit, as shiny metal was revealed when the red-colored staining was removed. There was an unusual appearance to the edge in this location, as though the sectioned edge had been superficially altered by heat associated with sectioning or some other post-sectioning reaction (atmospheric corrosion or corrosive media attack). That alteration gave the appearance of a deep corrosion pit.

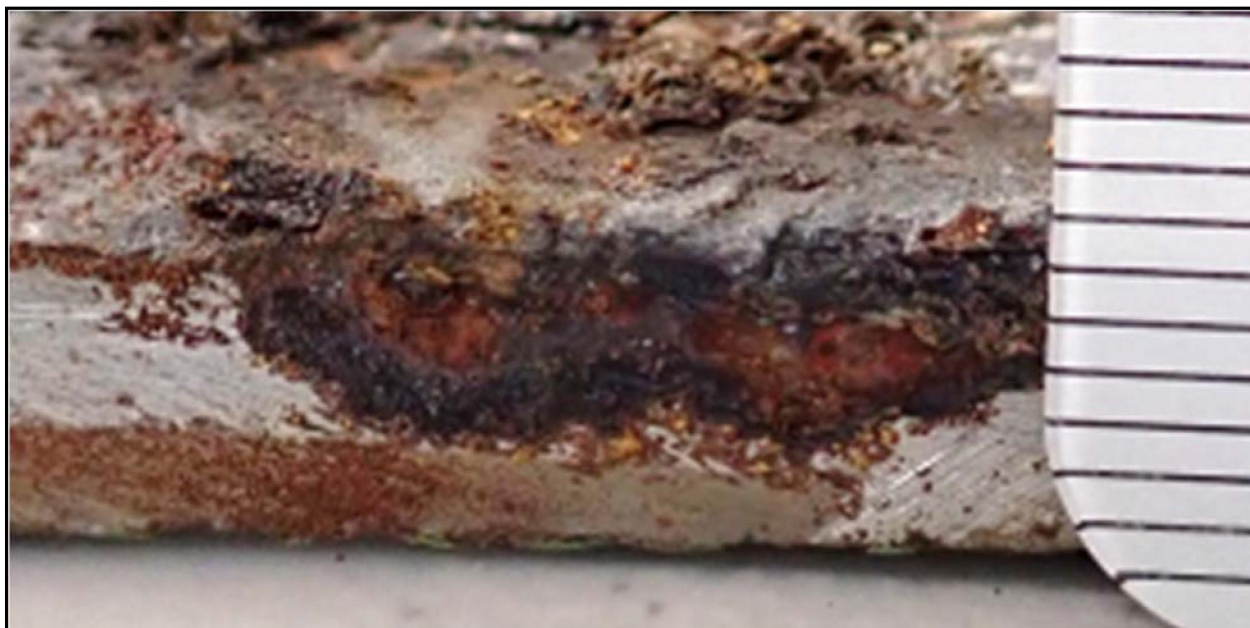
Figure A-5. The same area is shown in an image provided prior to shipping Coupon #7 to IMR (provided to IMR on March 13, 2019). What appeared to be a deep corrosion pit was actually rust-colored staining of the edge surface
