BOARD OF WATER SUPPLY

Subject: Honolulu Board of Water Supply (BWS) Comments on the Red Hill Bulk Fuel Storage Facility (RHBFSF), Scope of Work for Destructive Testing Supplement – Destructive Testing Plan, Supplement to Administrative Order on Consent (AOC) and Statement of Work (SOW) Section 5.3.2, dated June 1, 2018 and Our Inspection on June 25, 2018 of Coupons Removed from Tank 14.

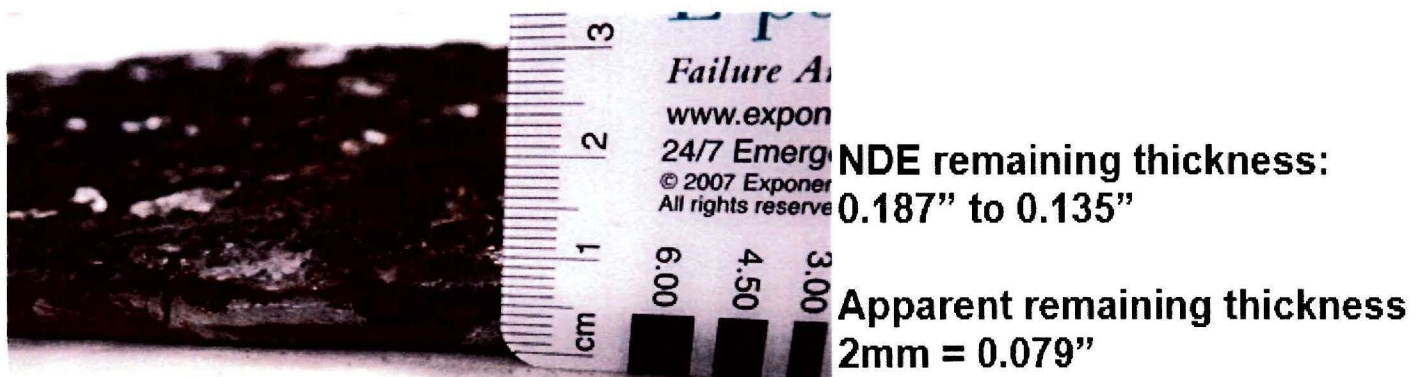
1. Presence of substantial backside corrosion — There were areas of substantial corrosion on the backside (non-fuel wetted side) of the ¼-inch thick steel plate lining the tank (Figure 1, for example).

Furthermore, our visual observations of some coupons suggest that the actual defect depth was greater than measured by either NDE technique. For example, Coupon #7 measurements indicated a remaining wall of either 0.157-inches or 0.135-inches whereas the cut edge of this coupon appears to show a minimum

remaining wall of 0.079-inches (see Figure 1). These are our observations, and we look forward to reviewing the results of the independent testing laboratory for confirmation.

Figure 1: Coupon No. 7 viewed from the cut edge shows the corrosion and staining on the backside against the concrete. Remaining wall appears to be about 2 mm or 0.079-inches.

3. Grind each of the four edges of the coupons flat and perpendicular to the plate faces in order to accurately document the minimum remaining wall thickness on each edge.

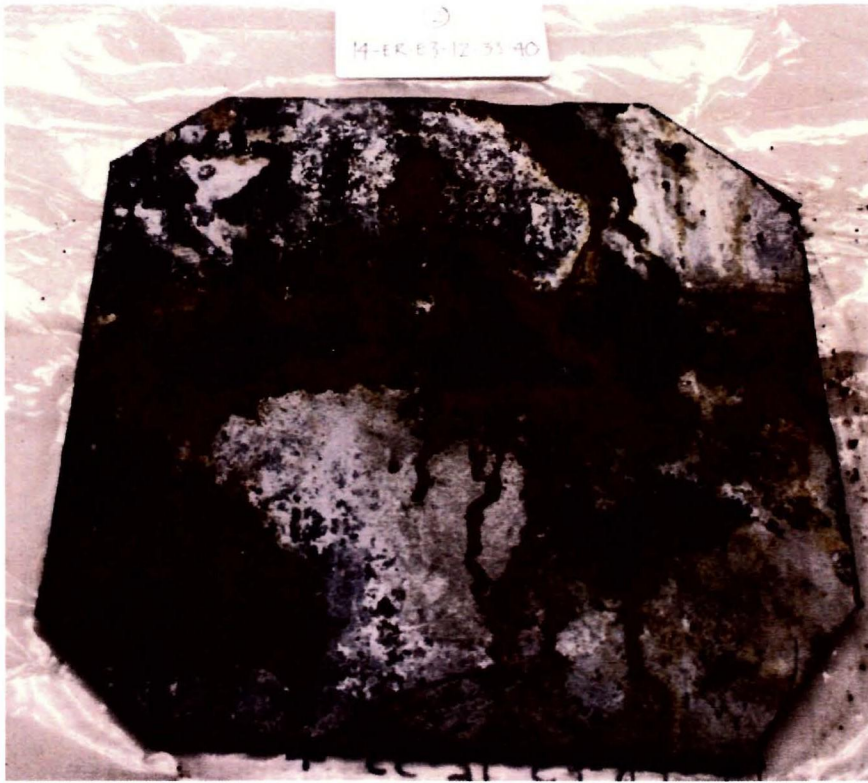
2. Staining on Backside of Steel — Deposits on the backside of some coupons suggest hydrocarbon-staining and should be tested for presence of released product (Figure 2, for example).
3. Non-Destructive Evaluation (NDE) Technique Underestimates Remaining Wall Thickness — Corrosion pit depths measured on the cut specimen edges suggest that NDE techniques were not able to locate and measure the thinnest wall of the coupon. For instance, the scale shown in Figure 1 indicates the wall along the edge of Coupon No. 2 has thinned to about 0.079-inches (reduced from 0.25-inches thick when new). However, the two NDE techniques (screening and Prove-up) predicted the thinnest area of this coupon to be 0.187-inches and 0.135-inches, respectively, underestimating the measured thickness by 51%.

Figure 2: Backside of Coupon No. 2 - The dark horizontal stain is likely corrosion product and/or hydrocarbon stains. Drip seen running down backside.

1. Collect samples of corrosion product and stains for scanning electron microscopy (SEM/EDS) and Fourier Transform Infrared (FTIR) spectroscopy prior to any cutting or grinding.
