**SUBJECT: DESTRUCTIVE ANALYSIS OF 10 STEEL COUPONS REMOVED FROM
RED HILL FUEL STORAGE TANK NO. 14, PURSUANT TO SECTION 5.3
OF THE ADMINISTRATIVE ORDER ON CONSENT STATEMENT OF
WORK, RED HILL BULK FUEL STORAGE FACILITY, JOINT BASE PEARL
HARBOR-HICKAM, OAHU, HAWAII**

Destructive Analysis of 10 Steel Coupons Removed from Red Hill Fuel Storage Tank #14

REPORT No. 201801967

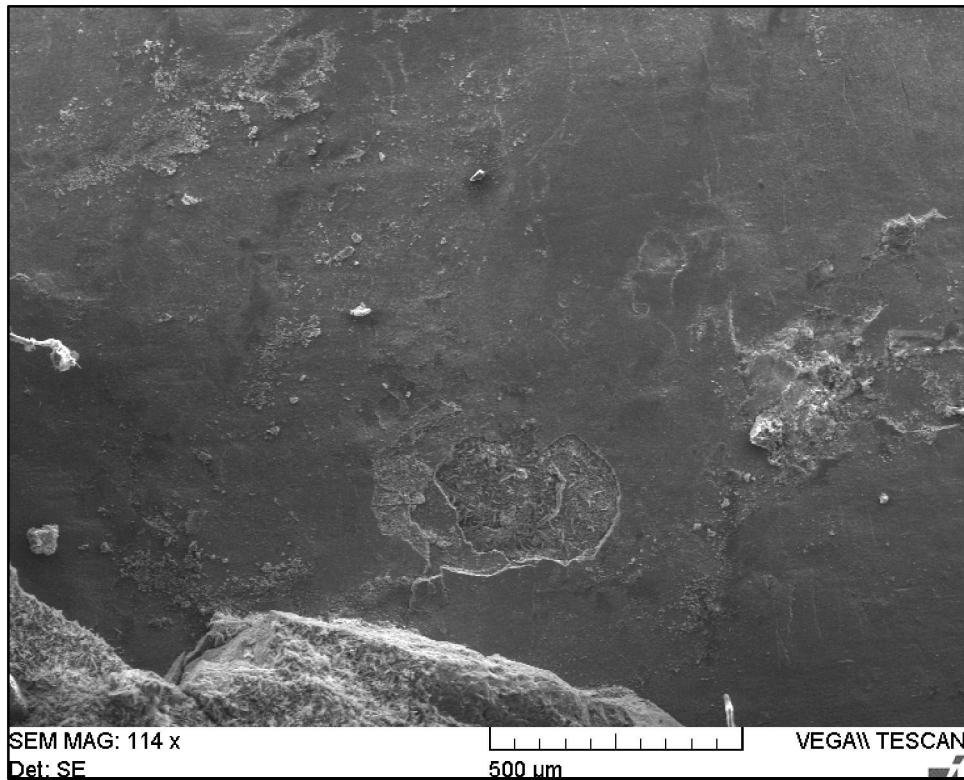
Figure 51. A representative SEM image of a pit on a specimen excised from Coupon 5 labeled as 5-2, prior to cleaning. (SEM, 67X)

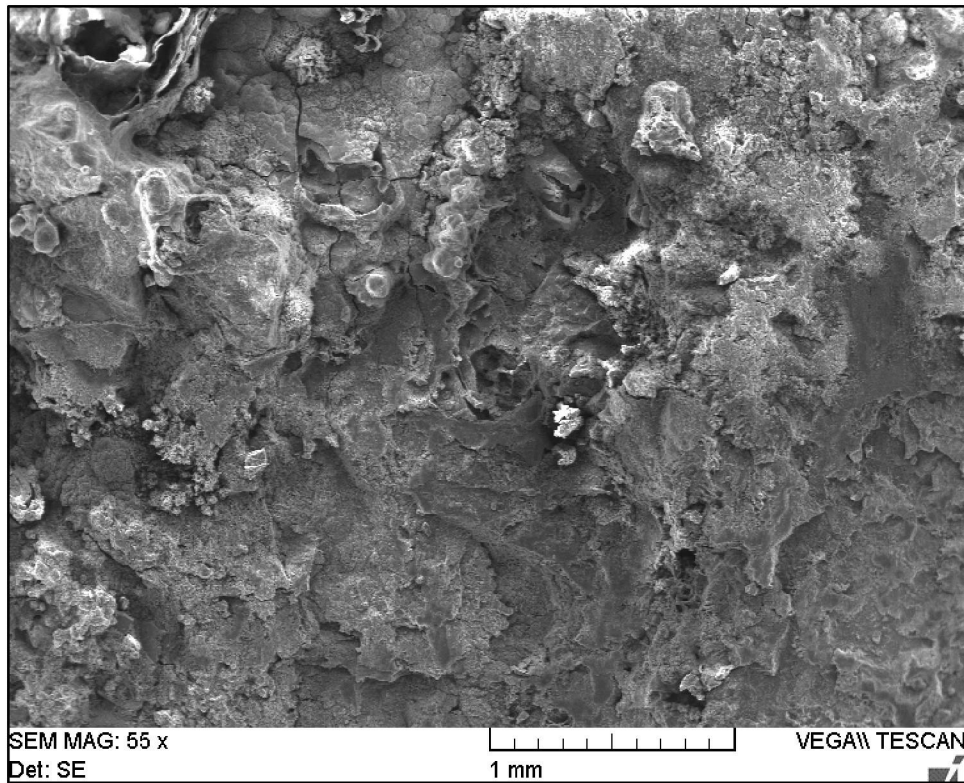
Figure 55. A representative SEM image of a pit on a specimen excised from Coupon 6 labeled as 6-3, prior to cleaning. (SEM, 32X)

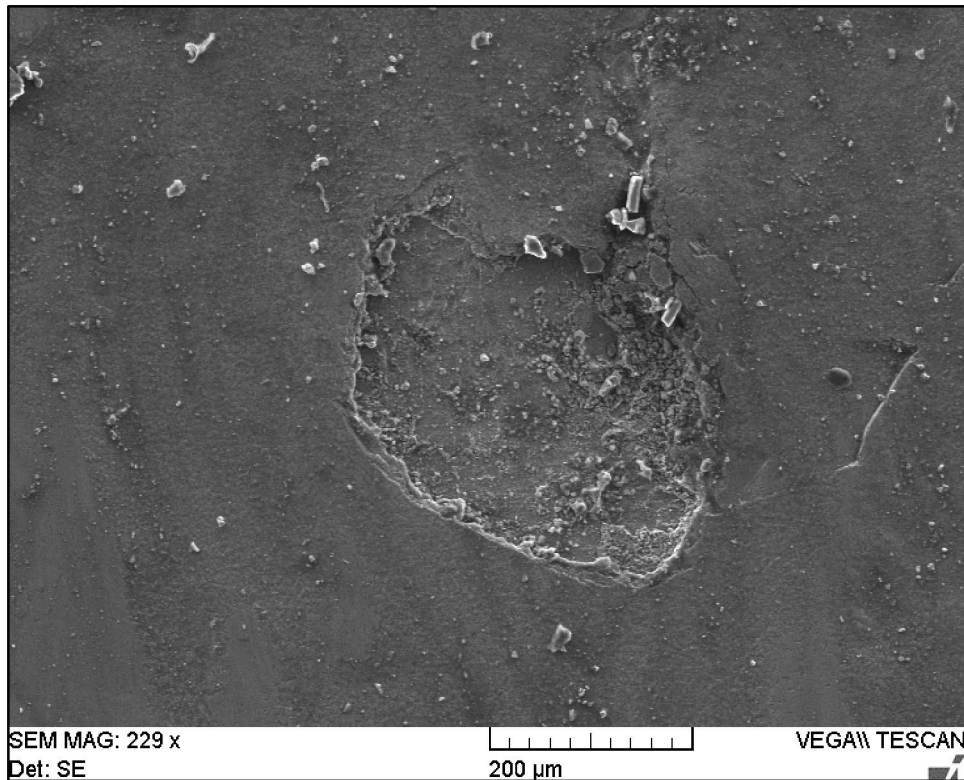
Figure 63. A representative SEM image of a pit on a specimen excised from Coupon 10 labeled as 10-2, prior to cleaning. (SEM, 135X)

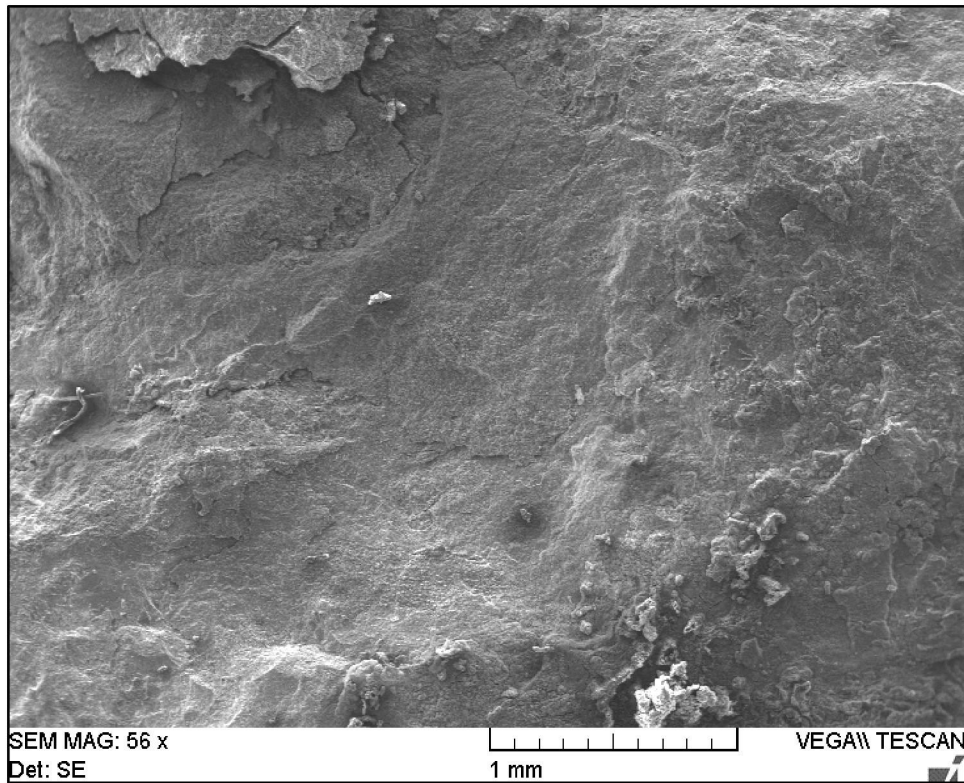
Figure 65. A representative SEM image of a pit on a specimen excised from Coupon A-1 labeled as A1-1, prior to cleaning. (SEM, 33X)

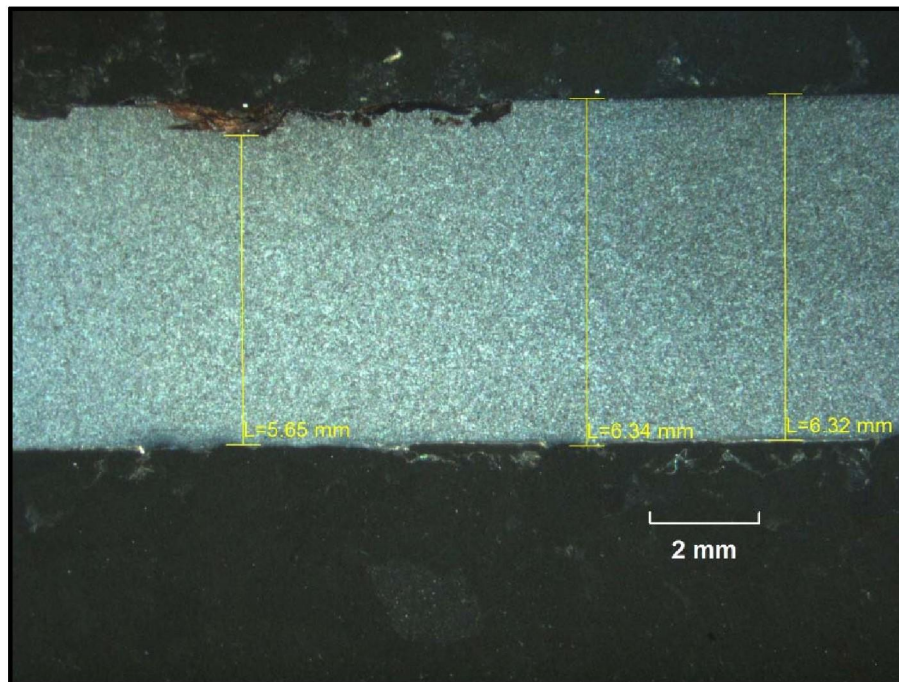
Figure 180. The prepared metallographic cross-section from Sample 1-1 is shown during examination with a stereomicroscope. The thickest location(s) are shown, as well as the thickness remaining underneath the deepest observed pit. (7X)

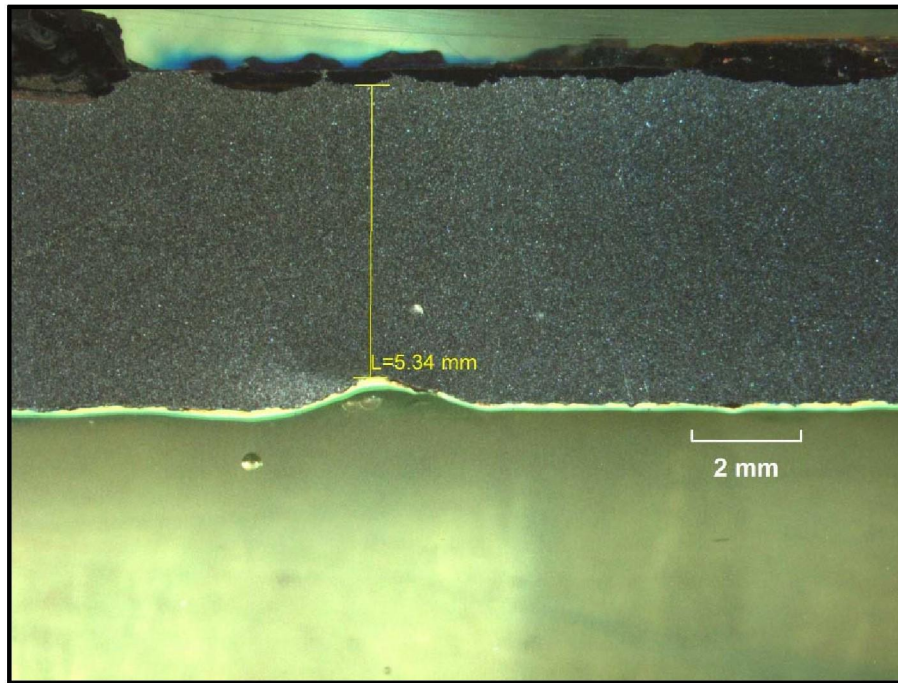
Figure 181. The prepared metallographic cross-section from Sample 1-3 is shown during examination with a stereomicroscope. The thickest remaining wall is shown. Note that the reduction in wall thickness was due to a depression on the painted face of the specimen. (7X)

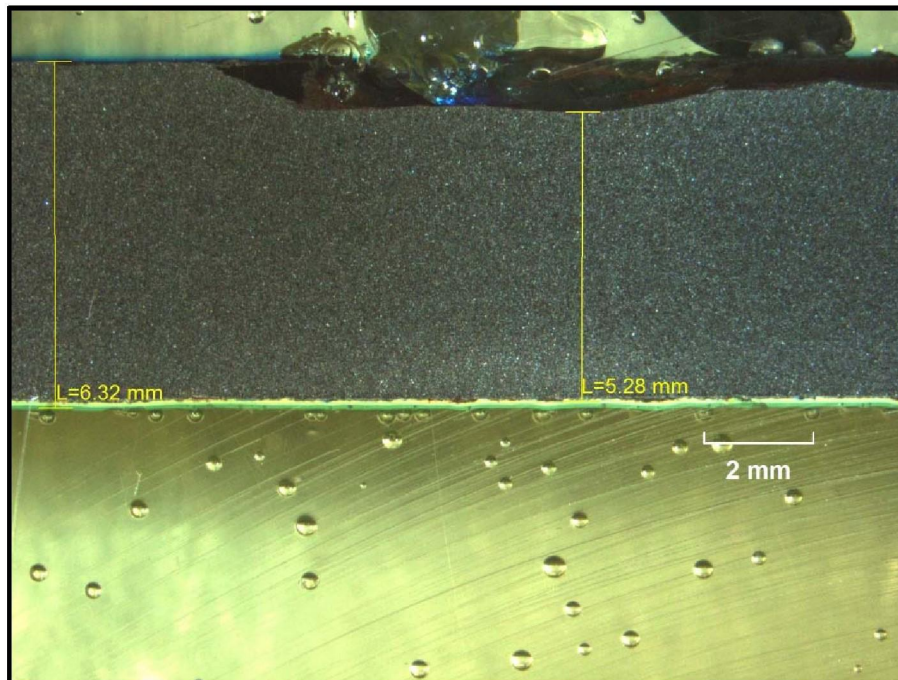
Figure 182. The prepared metallographic cross-section from Sample 1-4 is shown during examination with a stereomicroscope. The thickest location(s) are shown, as well as the thickness remaining underneath the deepest observed pit. (7X)

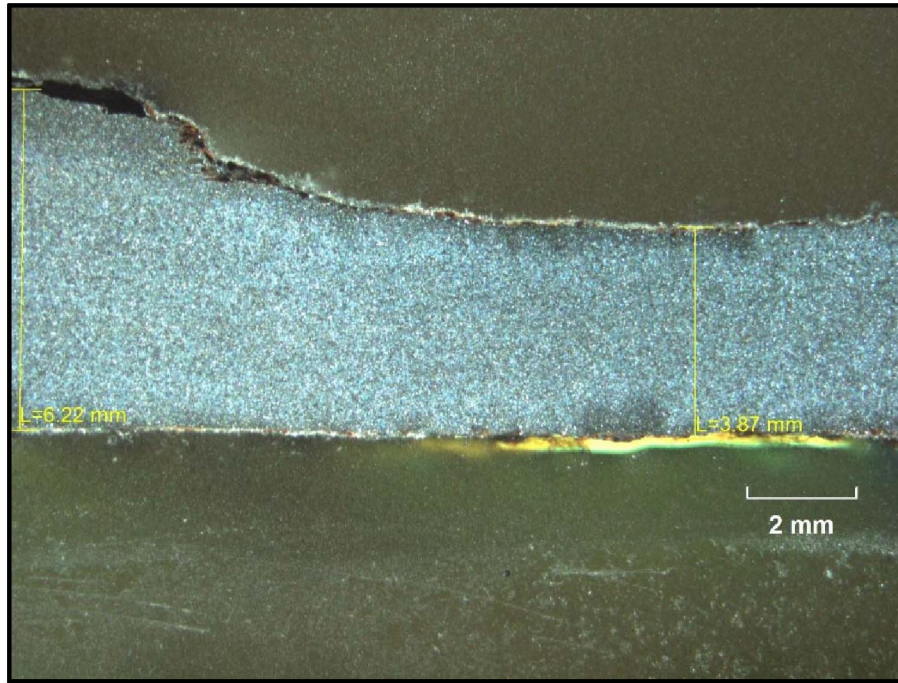
Figure 183. The prepared metallographic cross-section from Sample 2-1 is shown during examination with a stereomicroscope. The thickest location(s) are shown, as well as the thickness remaining underneath the deepest observed pit. (7X)

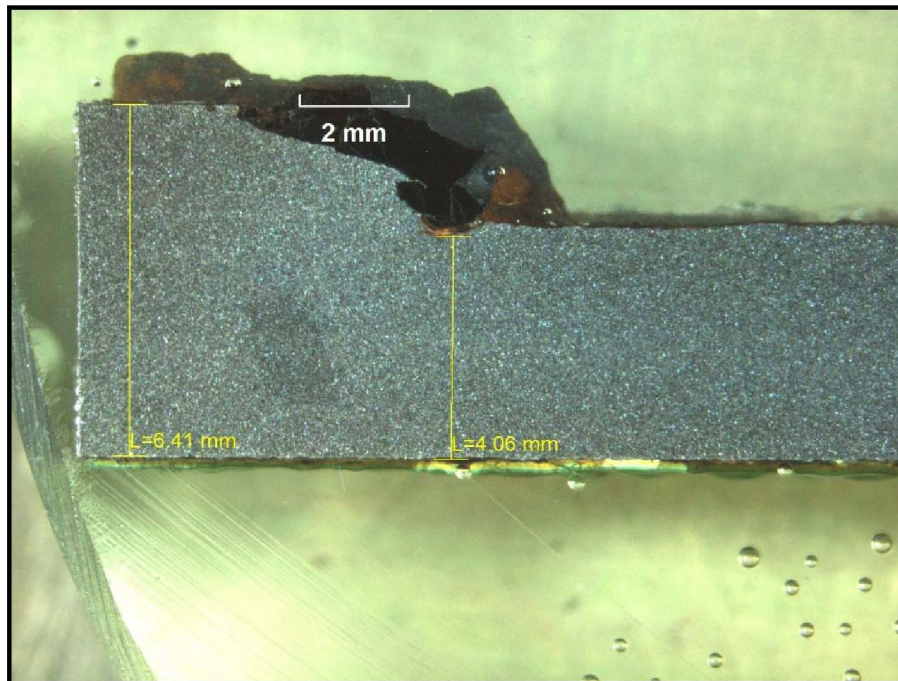
Figure 184. The prepared metallographic cross-section from Sample 2-2 is shown during examination with a stereomicroscope. The thickest location(s) are shown, as well as the thickness remaining underneath the deepest observed pit. (7X)

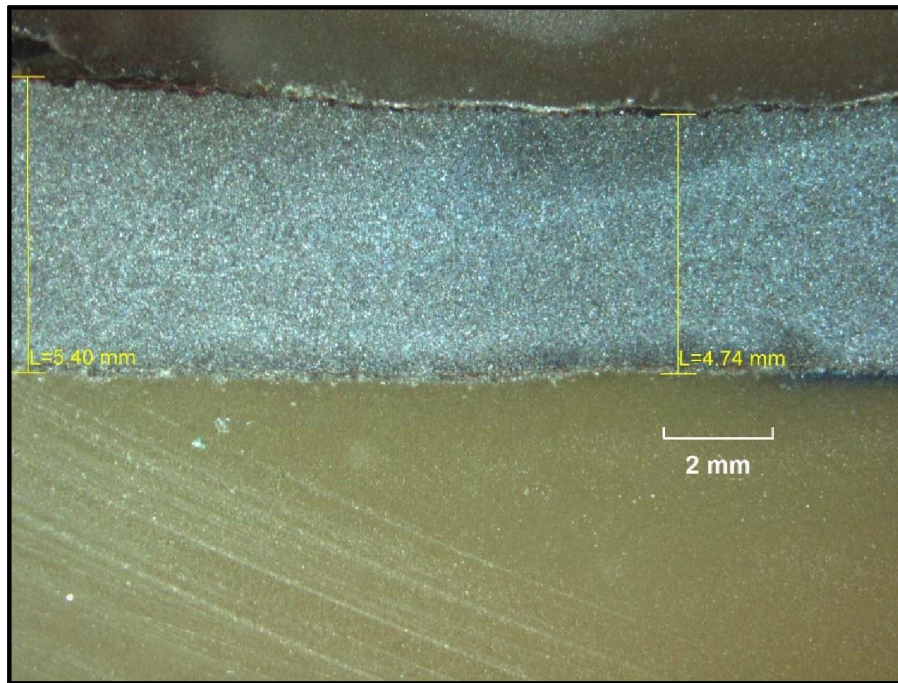
Figure 185. The prepared metallographic cross-section from Sample 2-3 is shown during examination with a stereomicroscope. The thickest location(s) are shown, as well as the thickness remaining underneath the deepest observed pit. (7X)

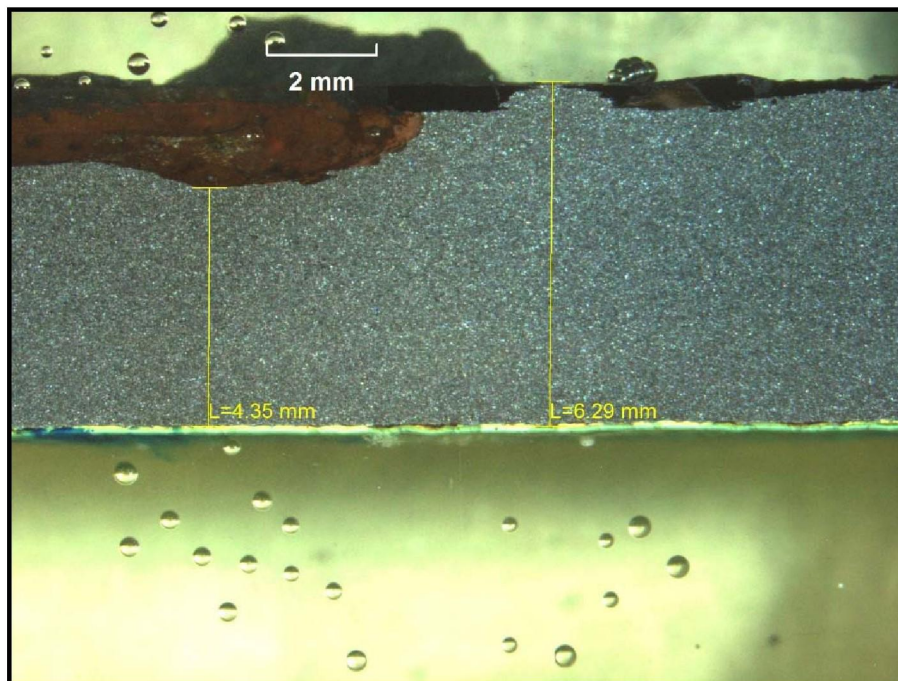
Figure 186. The prepared metallographic cross-section from Sample 3-1 is shown during examination with a stereomicroscope. The thickest location(s) are shown, as well as the thickness remaining underneath the deepest observed pit. (7X)

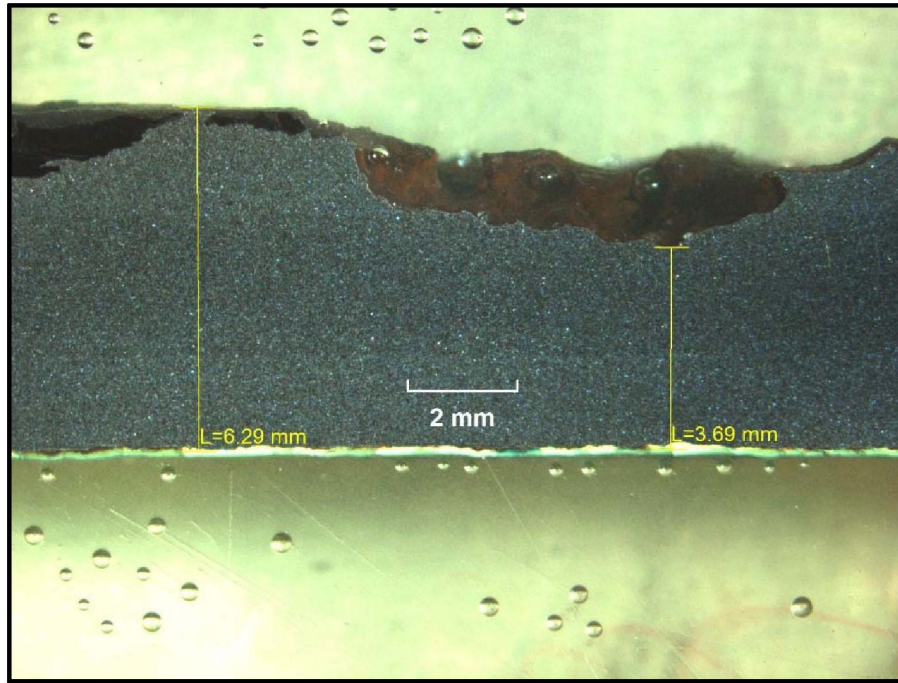
Figure 187. The prepared metallographic cross-section from Sample 3-2 is shown during examination with a stereomicroscope. The thickest location(s) are shown, as well as the thickness remaining underneath the deepest observed pit. (7X)

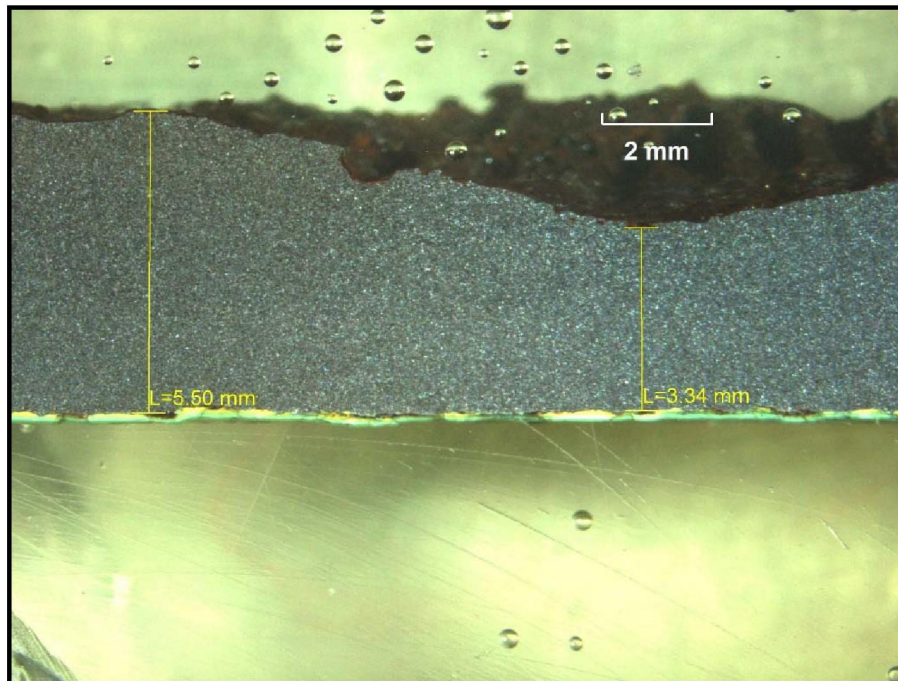
Figure 188. The prepared metallographic cross-section from Sample 3-3 is shown during examination with a stereomicroscope. The thickest location(s) are shown, as well as the thickness remaining underneath the deepest observed pit. (7X)

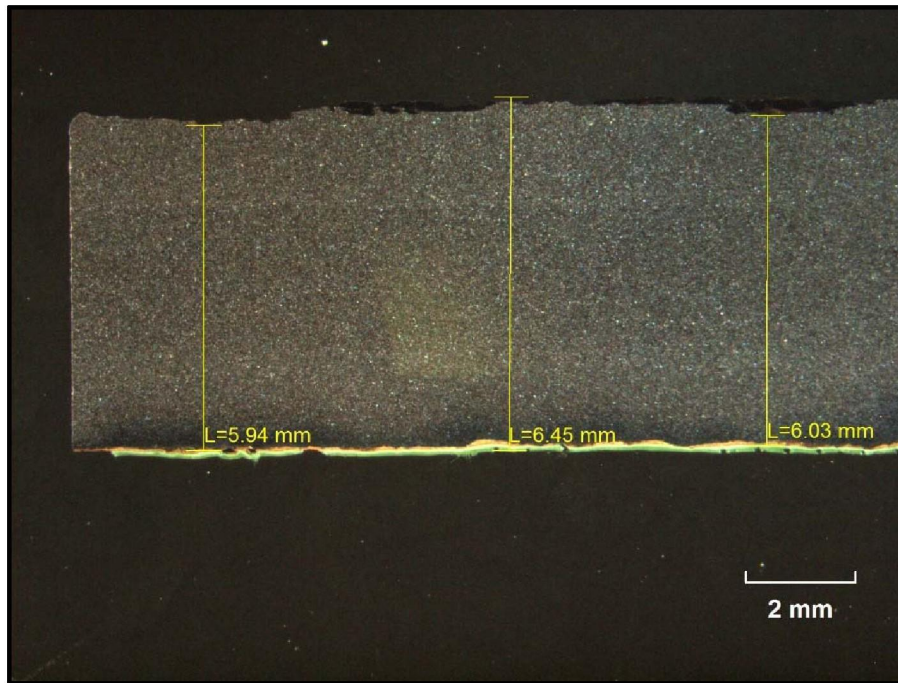
Figure 189. The prepared metallographic cross-section from Sample 3-4 is shown during examination with a stereomicroscope. The thickest location(s) are shown, as well as the thickness remaining underneath the deepest observed pit. (7X)

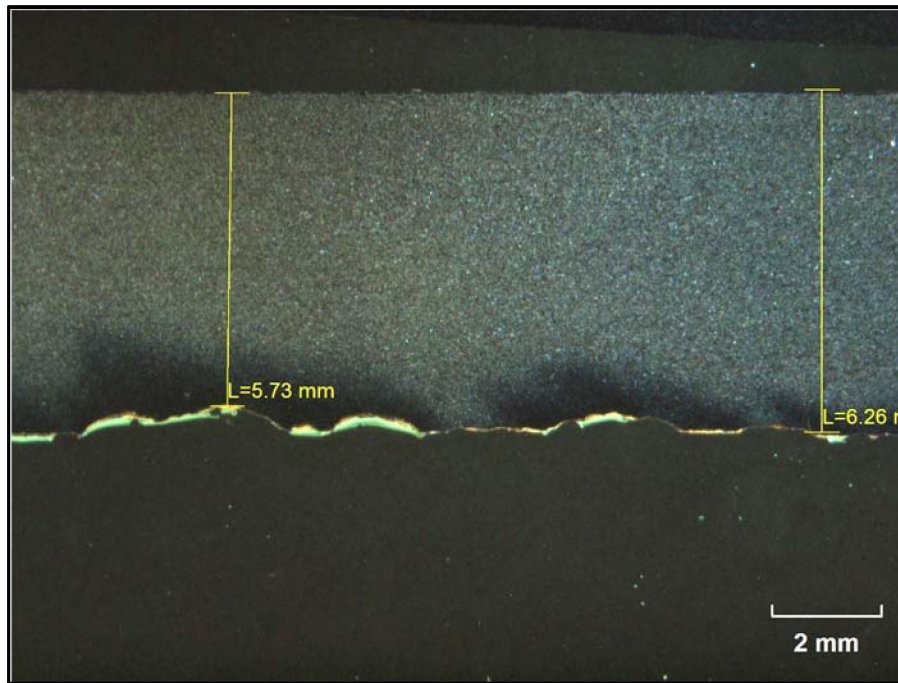
③ Suspected NDT inspection indication was a depression on the painted face of Sample 5-4. No pits observed.

Figure 191. The prepared metallographic cross-section from Sample 5-4 is shown during examination with a stereomicroscope. The thickest remaining wall is shown. Note that the reduction in wall thickness was due to a depression on the painted face of the specimen. (7X)

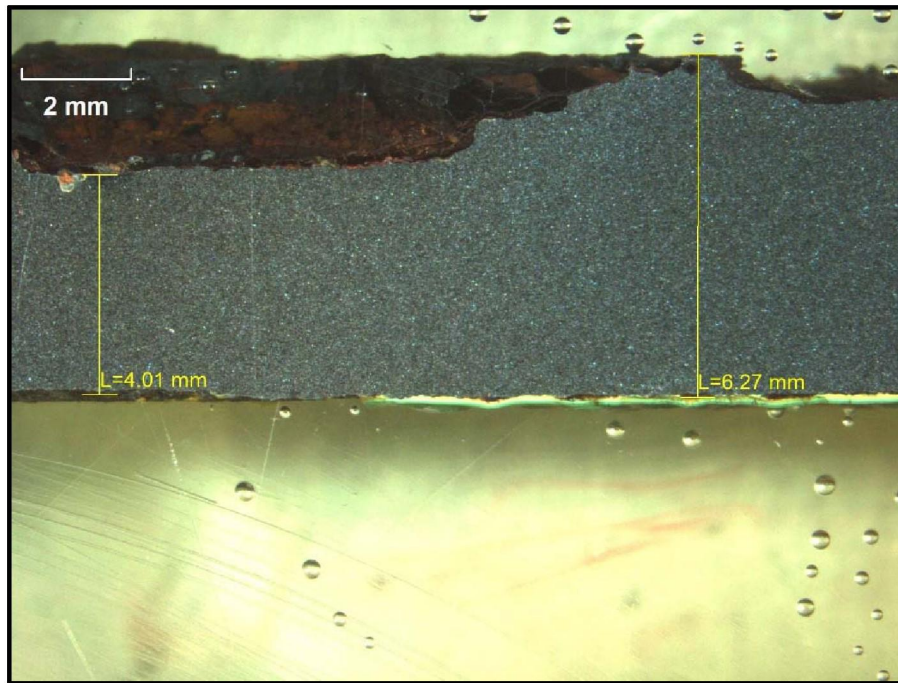
Figure 193. The prepared metallographic cross-section from Sample 6-1 is shown during examination with a stereomicroscope. The thickest location(s) are shown, as well as the thickness remaining underneath the deepest observed pit. (7X)

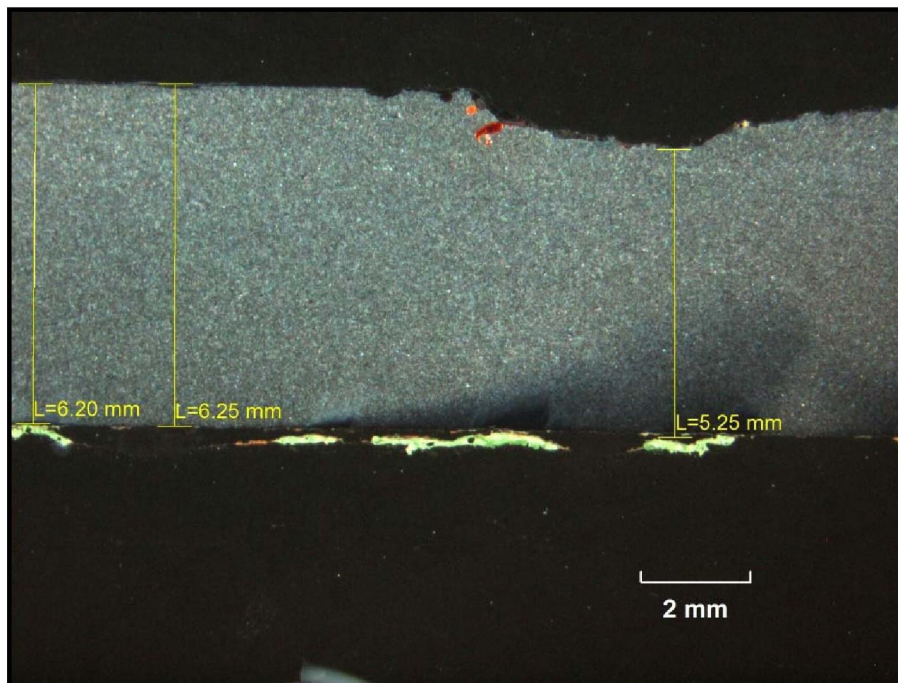
Figure 194. The prepared metallographic cross-section from Sample 6-2 is shown during examination with a stereomicroscope. The thickest location(s) are shown, as well as the thickness remaining underneath the deepest observed pit. (7X)

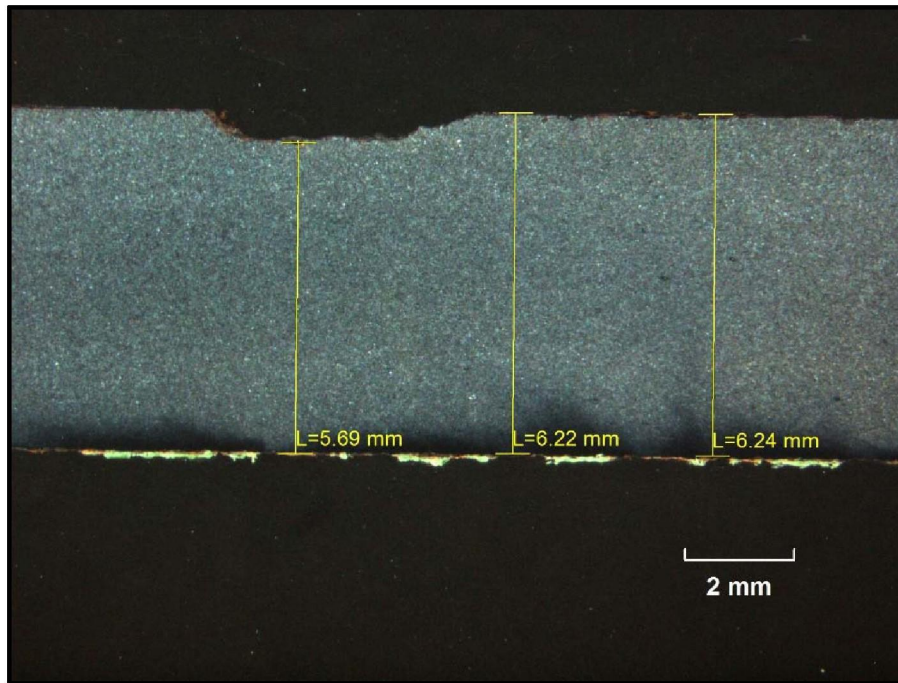
Figure 195. The prepared metallographic cross-section from Sample 6-3 is shown during examination with a stereomicroscope. The thickest location(s) are shown, as well as the thickness remaining underneath the deepest observed pit. (7X)

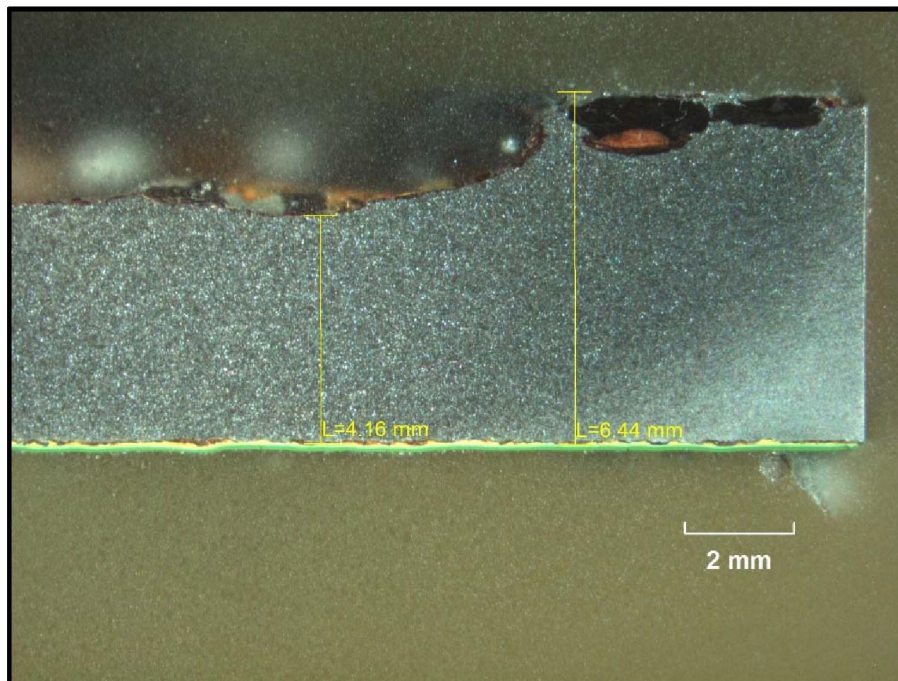
Figure 196. The prepared metallographic cross-section from Sample 7-1 is shown during examination with a stereomicroscope. The thickest location(s) are shown, as well as the thickness remaining underneath the deepest observed pit. (7X)

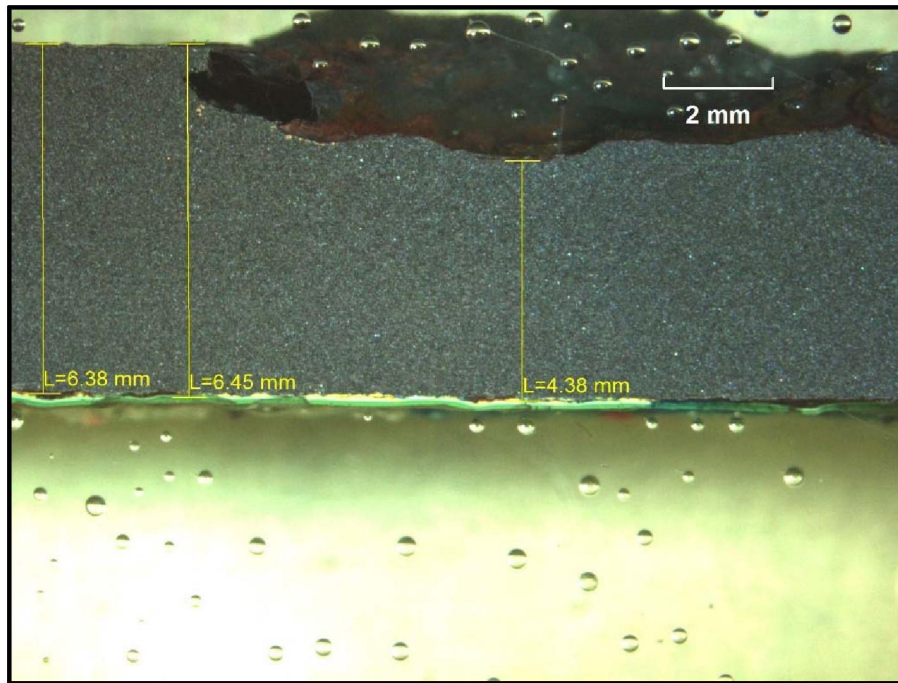
Figure 197. The prepared metallographic cross-section from Sample 7-3 is shown during examination with a stereomicroscope. The thickest location(s) are shown, as well as the thickness remaining underneath the deepest observed pit. (7X)

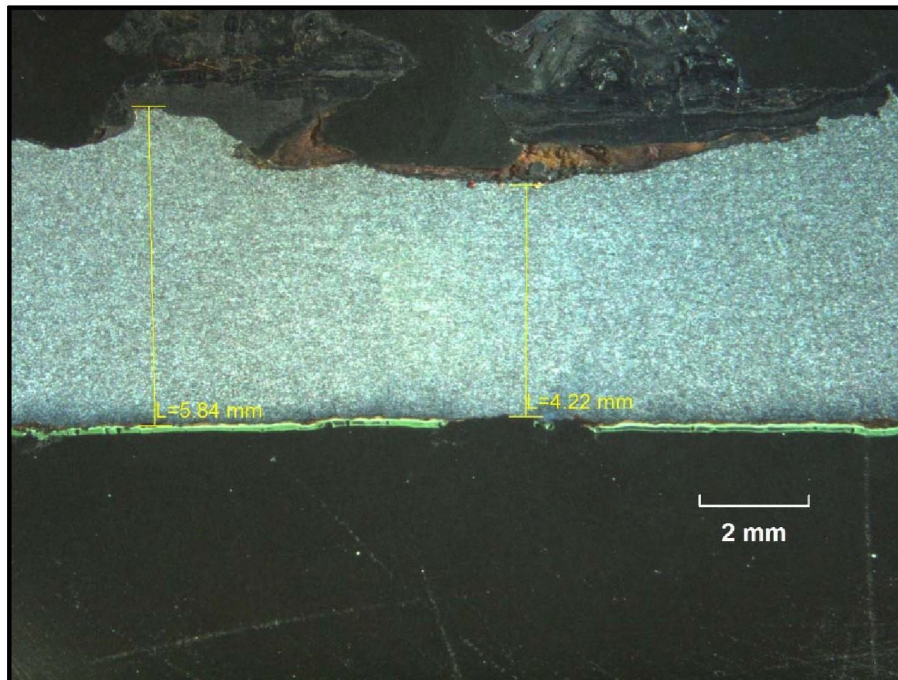
Figure 198. The prepared metallographic cross-section from Sample 7-4 is shown during examination with a stereomicroscope. The thickest location(s) are shown, as well as the thickness remaining underneath the deepest observed pit. (7X)

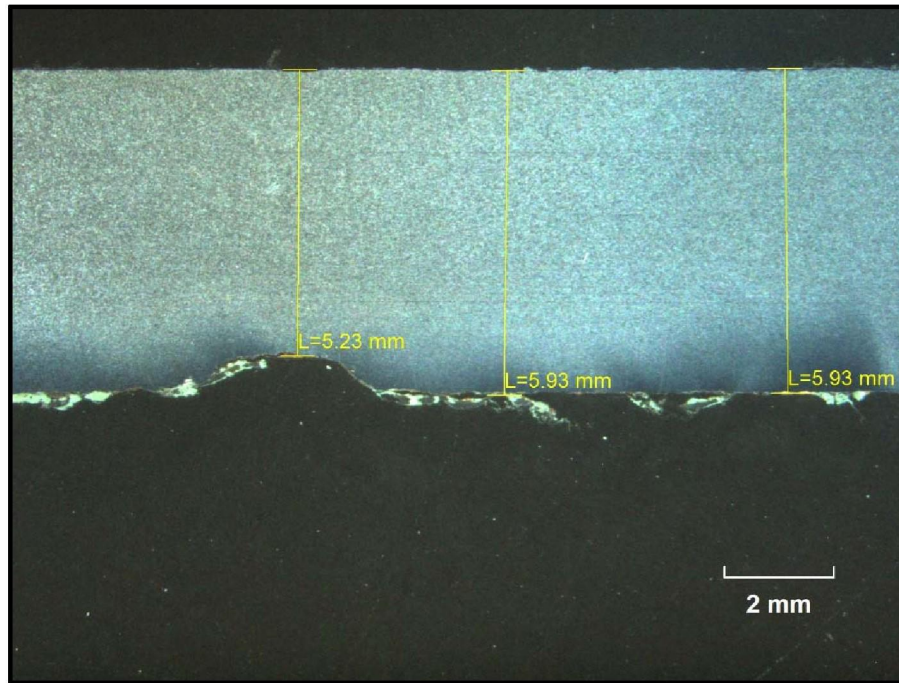
④ This is the weld-repaired plate section. Sample 8-3 exhibited a depression or pit on the painted surface.

Figure 199. The prepared metallographic cross-section from Sample 8-3 is shown during examination with a stereomicroscope. The thickest remaining wall is shown. Note that the reduction in wall thickness was due to a depression on the painted face of the specimen. (7X)

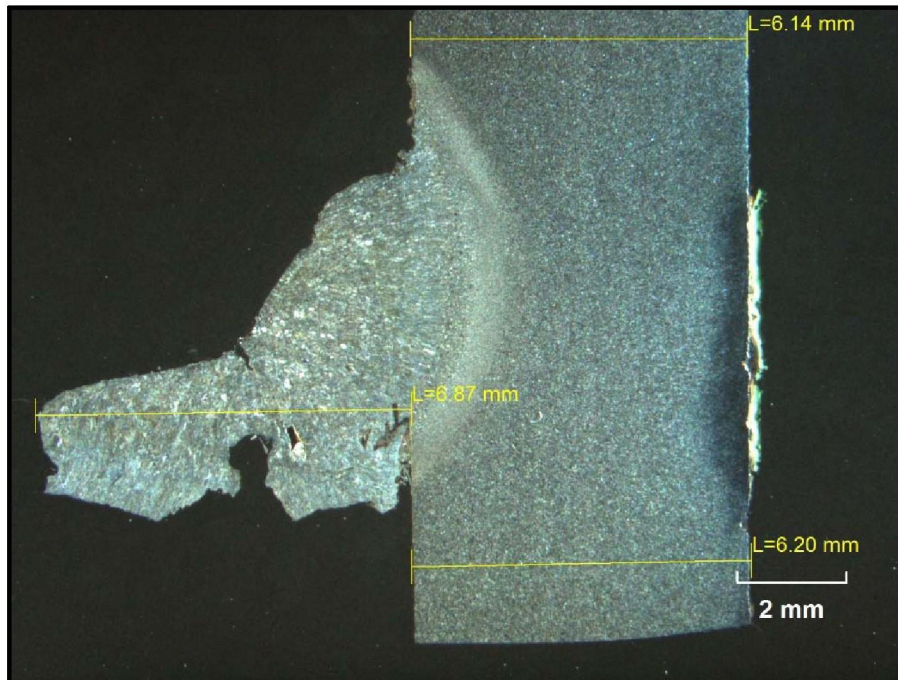
⑤ No pits observed. Suspected NDT inspection indication was a weld nugget on the interior surface of the coupon (thick area) on Sample 10-4.

Figure 202. The prepared metallographic cross-section from Sample 10-4 is shown during examination with a stereomicroscope. Image is rotated 90° from other images. The anomaly detected during NDE was likely the weld nugget on the interior surface of the coupon (left). No pitting or significant wall loss was observed. (7X)

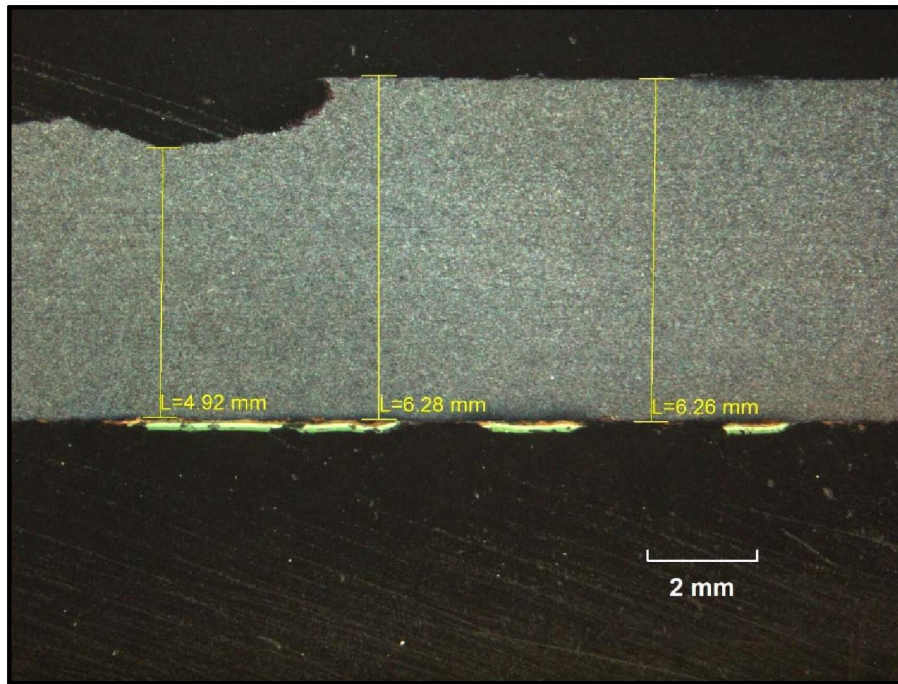
Figure 203. The prepared metallographic cross-section from Sample A1-1 is shown during examination with a stereomicroscope. The thickest location(s) are shown, as well as the thickness remaining underneath the deepest observed pit. (7X)

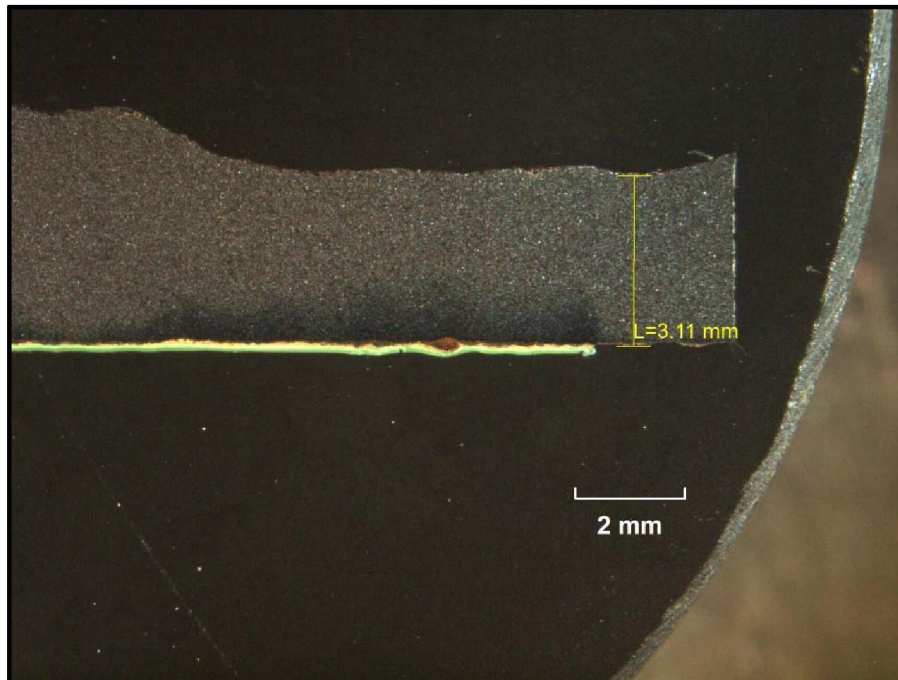
Figure 204. The prepared metallographic cross-section from Sample A1-4 is shown during examination with a stereomicroscope. The thickness remaining underneath the deepest observed pit is shown. (7X)

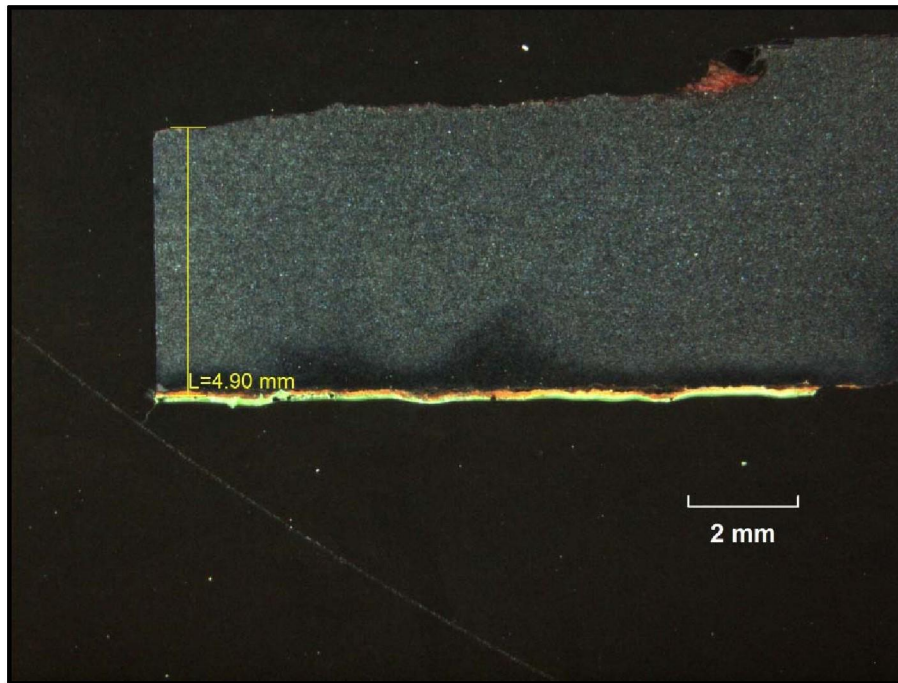
Figure 205. The prepared metallographic cross-section from Sample A1-5 is shown during examination with a stereomicroscope. The thickness remaining underneath the deepest observed pit is shown. (7X)

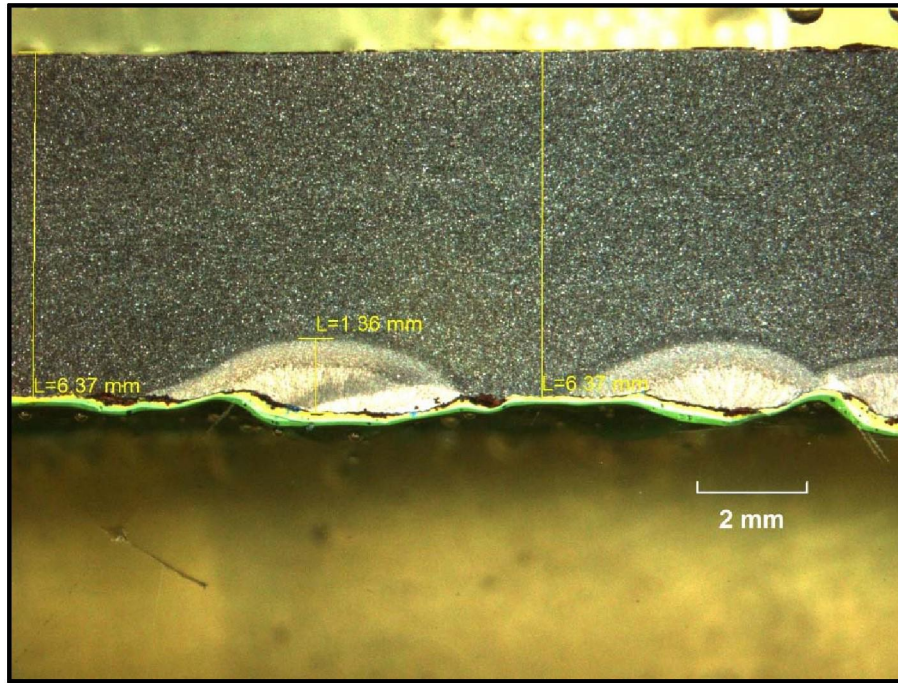
⑥ No pits observed. Suspected NDT inspection indications are areas of melting on the painted face, underneath the paint on Sample A2-4.

Figure 207. The prepared metallographic cross-section from Sample A2-4 is shown during examination with a stereomicroscope. The NDE indication was most likely locations of melting/re-solidification underneath the painted surface. No pitting was observed. (7X)

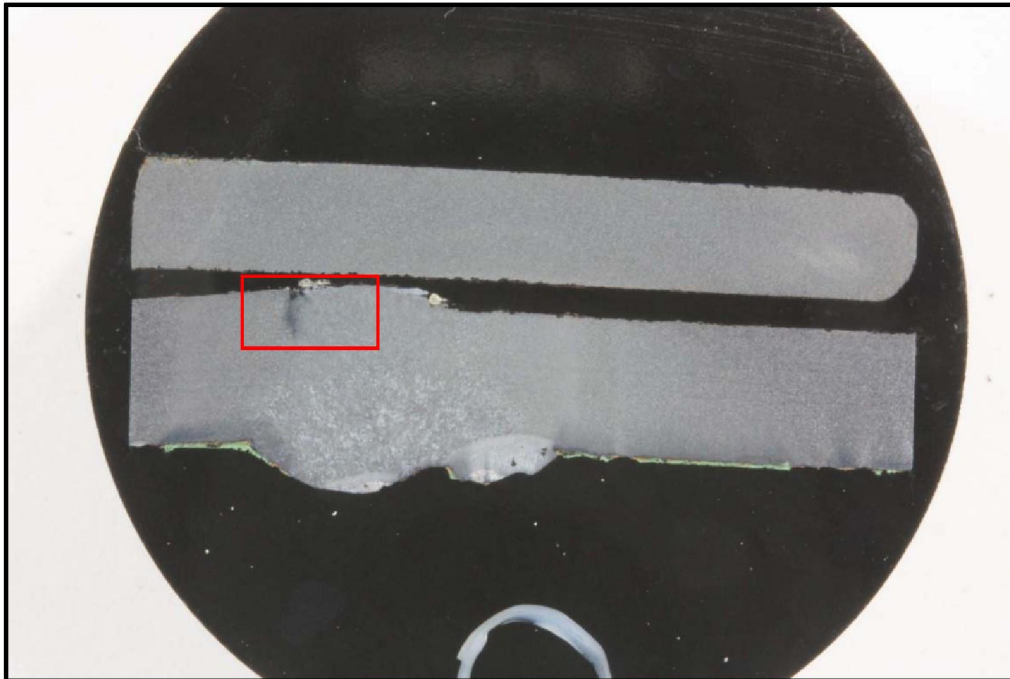
Coupon 8 exhibited what is presumed to be a prior weld repair and/or addition of a backing plate, where a patch was made on the tank wall. Representative images of the welds are presented as Figures 208 through 213. A full weld evaluation is outside the scope of this effort. The results are thus provided for information only.

Figure 208. The prepared metallographic cross-section through welded sample 8-1 is shown in an overall view. The painted exterior surface is along the bottom section. The area identified by the red box is shown in the next figure at higher magnification.
