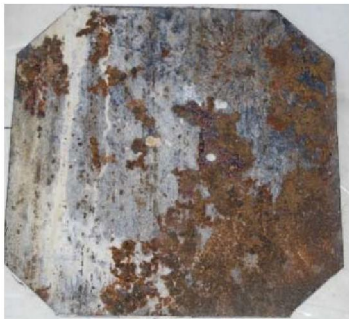
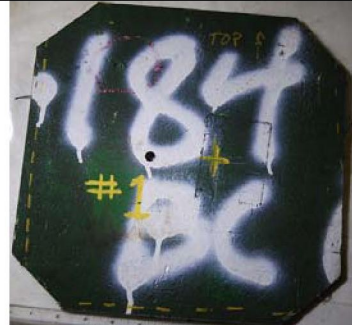
COUPON SPECIFICS		
Coupon ID	1	1
Coupon Location	14-UD-A-42-45-107	
Coupon Dimensions	12" * 12"	
Coupon Thickness	¼" (NDE: minimum 0.147")	
Locations of Welds	None	
ON SITE VISUAL EXAMINATION		
Checks	Observations	
	Exterior	Interior
Deposits, Coatings, Debris	Deposits	Standard coating with paint
Scale	None	None
Observed Biological Material	None	None
Wet or Dry	Wet	Dry
Smell	Damp, burnt	Burnt
Presence of petroleum product between steel and concrete surface, and on or above the leg of the angle backer bar embedded in the concrete	No	No
Provide a sketch of the coupon showing all indications. Provide ID#s for all indications on coupon and compare with NDE expected results sketch

Corrosion found, as expected, but no pits

Presence of corrosion	Yes	No
Isolated pitting	No	No
Isolated pitting within areas of general corrosion	No	No
Linked pitting within areas of general corrosion	No	No
Identify color of corrosion products	Brown	N/A

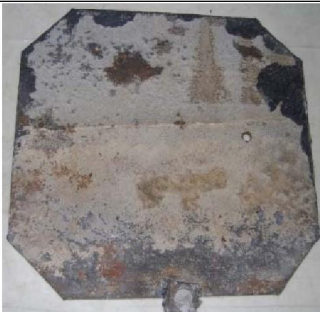
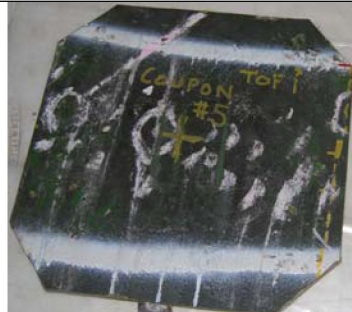
COUPON SPECIFICS		
Coupon ID	5	<div style="font-size: 2em; text-align: center;">5</div> (no prove-up-phase thickness)
Coupon Location	14-BA-26-15-15-8	
Coupon Dimensions	12" * 12"	
Coupon Thickness	¼" (NDE: minimum 0.047")	
Locations of Welds	None	
ON SITE VISUAL EXAMINATION		
Checks	Observations	
	Exterior	Interior
Deposits, Coatings, Debris	Concrete layer, thin	Standard coating
Scale	None	None
Observed Biological Material	None	None
Wet or Dry	Dry	Dry
Smell	Burnt	Burnt
Presence of petroleum product between steel and concrete surface, and on or above the leg of the angle backer bar embedded in the concrete	No	No
Provide a sketch of the coupon showing all indications. Provide ID#s for all indications on coupon and compare with NDE expected results sketch

Corrosion found, as expected (writing says "horiz bulge")

Presence of corrosion	Yes	No
Isolated pitting	No	No
Isolated pitting within areas of general corrosion	No	No

Linked pitting within areas of general corrosion	No	No
Identify color of corrosion products	Brown	N/A
Identify if selected attack at welds	N/A	N/A
Provide photo documentation with a minimum resolution of 2560 x 1920 of the coupon, front and back.

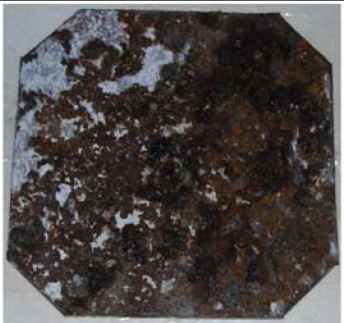
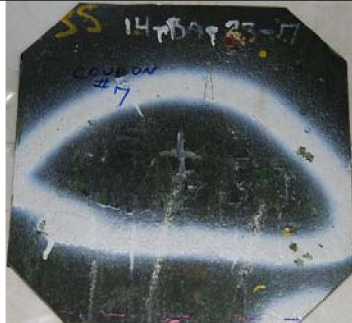
COUPON SPECIFICS		
Coupon ID	7	7
Coupon Location	14-BA-23-7-38-49	
Coupon Dimensions	12" * 12"	
Coupon Thickness	¼" (NDE: minimum 0.157")	
Locations of Welds	None	
ON SITE VISUAL EXAMINATION		
Checks	Observations	
	Exterior	Interior
Deposits, Coatings, Debris	Lots of general corrosion	Standard coating
Scale	Yes, thick, varied	None
Observed Biological Material	None	None
Wet or Dry	Wet	Dry
Smell	Burnt, damp	Burnt
Presence of petroleum product between steel and concrete surface, and on or above the leg of the angle backer bar embedded in the concrete	No	No
Provide a sketch of the coupon showing all indications. Provide ID#s for all indications on coupon and compare with NDE expected results sketch

Lots of corrosion found, as expected

Presence of corrosion	Yes	Yes
Isolated pitting	Yes	No
Isolated pitting within areas of general corrosion	Yes	No
Linked pitting within areas of general corrosion	No	No
Identify color of corrosion products	Brown, black	Brown

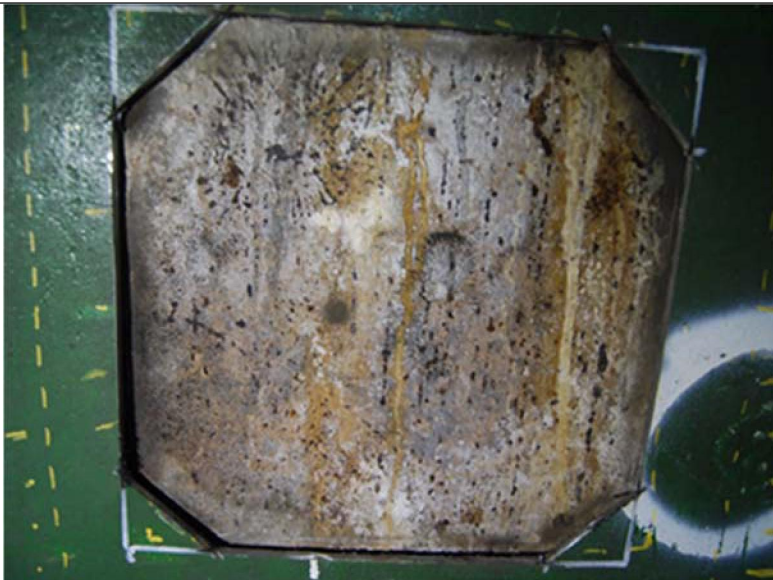
6/20/2018: 1400		
CONCRETE SAMPLE SPECIFICS		
Sample ID	1	1
Sample Location	14-UD-A-42-45-107	
Sample Dimensions	12X12 INCHES	
ON SITE VISUAL EXAMINATION		
Checks	Observations	
	Exterior	Units
Void space between concrete and liner (if any)	1/8" Void on left side, no voids in all other areas	
Biological Materials	None	
Wet or Dry	Dry	
Smell	None	
Temperature	76.9	F
Surface pH	9 to 9.5	
Structure to Electrolyte	-0.252	Volts/CSE
Concrete Resistivity	26.4 Horizontal 31.1 Vertical	k-ohm-cm k-ohm-cm
General Condition	Excellent, sound concrete with some discoloration and no cracks and no delamination

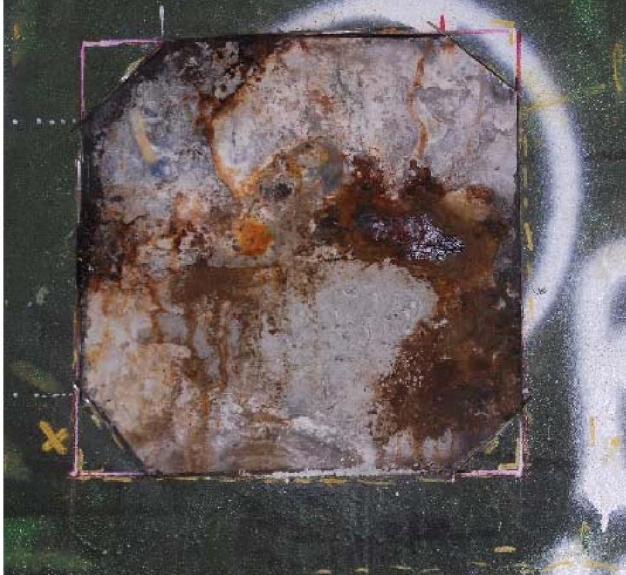
Sample ID	2	2
Sample Location	14-ER-E3-12-33-40	
Sample Dimensions	12X12 INCHES

Checks	Observations	
	Exterior	Units
Void space between concrete and liner (if any)	1/8" void at upper left side. Otherwise no voids.	
Biological Materials	None	
Wet or Dry	Slightly damp	
Smell	Musty, no fuel	
Temperature	80.0	F
Surface pH	10-11 corroded area 11-12 non-corroded area	
Structure to Electrolyte	-0.380	Volts/CSE
Concrete Resistivity	19.0 Horizontal 17.5 Vertical	k-ohm-cm k-ohm-cm
General Condition	Good sound condition with some minor spalling and corrosion product. Coupon took some hammering to remove

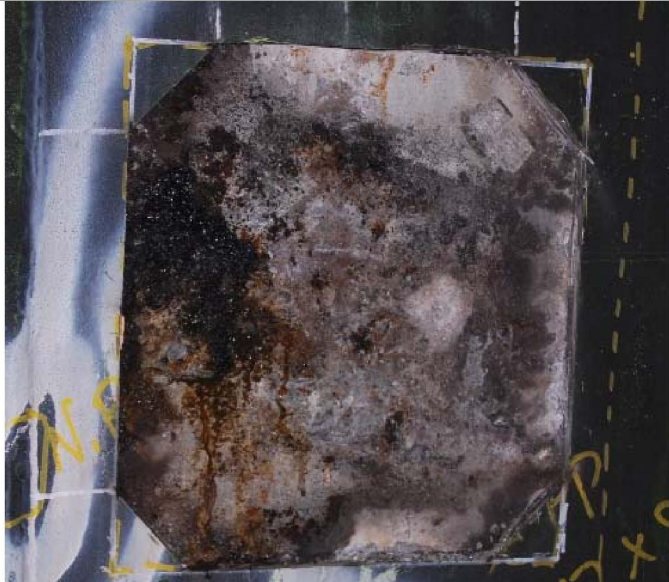
Sample ID	3	3
Sample Location	14-ER-E3-13-7-18	
Sample Dimensions	12X12 INCHES

Checks	Observations	
	Exterior	Units
Void space between concrete and liner (if any)	On left side, uneven corrosion product and a 1/16-inch void. Otherwise, no voids.	
Biological Materials	None	
Wet or Dry	Mostly dry, with some damp spots	
Smell	None	
Temperature	79.3	F
Surface pH	11-12 dry areas, 7-8 in areas with corrosion product	
Structure to Electrolyte	-0.488	Volts/CSE
Concrete Resistivity	27.8 Horizontal 31.2 Vertical	K-Ohm-cm
General Condition	Good, with some corrosion products. Corrosion product was black on the left side, and brown in some other areas. Concrete was hard and difficult to drill for powder samples. Coupons required some hammering and prying to remove after cutting.

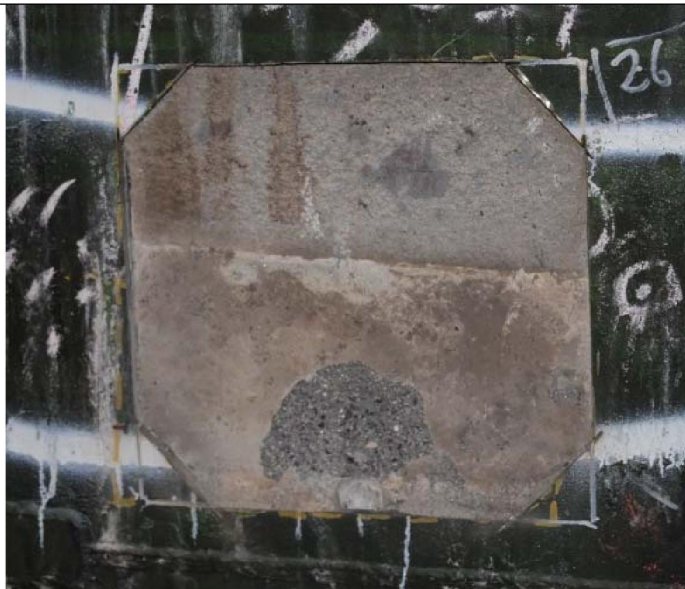
6/20/2018: 0800		
CONCRETE SAMPLE SPECIFICS		
Sample ID	5	5
Sample Location	14-DA-26-15-15-8	
Sample Dimensions	12X12 INCHES	
ON SITE VISUAL EXAMINATION		
Checks	Observations	
	Exterior	Units
Void space between concrete and liner (if any)	1/16" Void on top right side, no voids in all other areas	
Biological Materials	None	
Wet or Dry	Dry	
Smell	None	
Temperature	78.5	F
Surface pH	11-12	
Structure to Electrolyte	-0.220	Volts/CSE
Concrete Resistivity	19.1 Horizontal 22.0 Vertical	k-ohm-cm k-ohm-cm
General Condition	Excellent, sound concrete

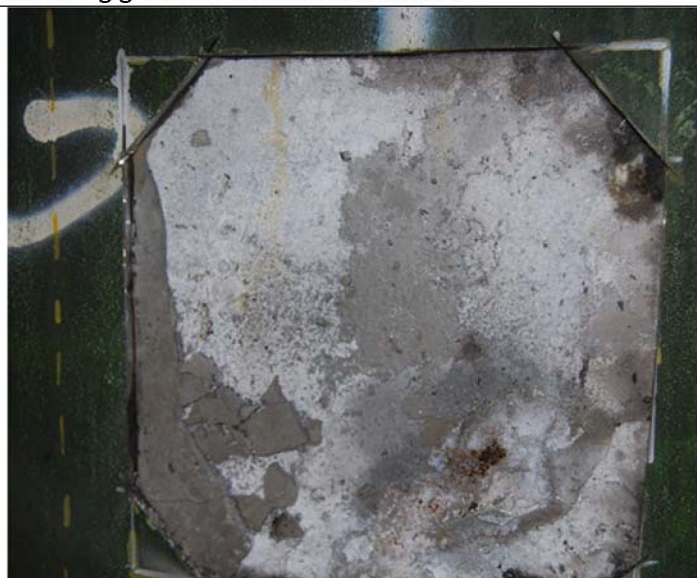
6/21/2018: 1100		
CONCRETE SAMPLE SPECIFICS		
Sample ID	6	6
Sample Location	14-BA-24-8-36-30	
Sample Dimensions	12X12 INCHES	
ON SITE VISUAL EXAMINATION		
Checks	Observations	
	Exterior	Units
Void space between concrete and liner (if any)	None, however some loose adhering grout present	
Biological Materials	None	
Wet or Dry	Dry	
Smell	None	
Temperature	77.4F	F
Surface pH	12.5	
Structure to Electrolyte	-0.387	Volts/CSE
Concrete Resistivity	Horizontal = 387 Vertical = 359	k-ohm-cm k-ohm-cm
General Condition	Concrete is sound, no delamination. There is loose adhering grout on left side and middle

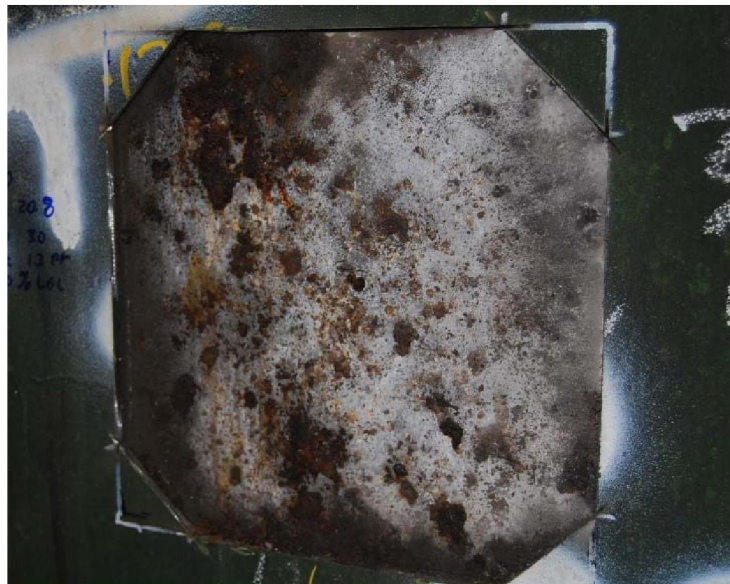
6/21/2018: 1030		
CONCRETE SAMPLE SPECIFICS		
Sample ID	7	7
Sample Location	14-BA-23-7-38-49	
Sample Dimensions	12X12 INCHES	
ON SITE VISUAL EXAMINATION		
Checks	Observations	
	Exterior	Units
Void space between concrete and liner (if any)	3/8" void on left side. 1/16" void on top right otherwise no voids	
Biological Materials	None	
Wet or Dry		
Smell	none	
Temperature	77.5F	F
Surface pH	9- 10	
Structure to Electrolyte		Volts/CSE
Concrete Resistivity	Horizontal = 39.3 Vertical = 42.4	k-ohm-cm k-ohm-cm
General Condition	Concrete is sound with no delamination or cracks. Some brown and black corrosion products on concrete

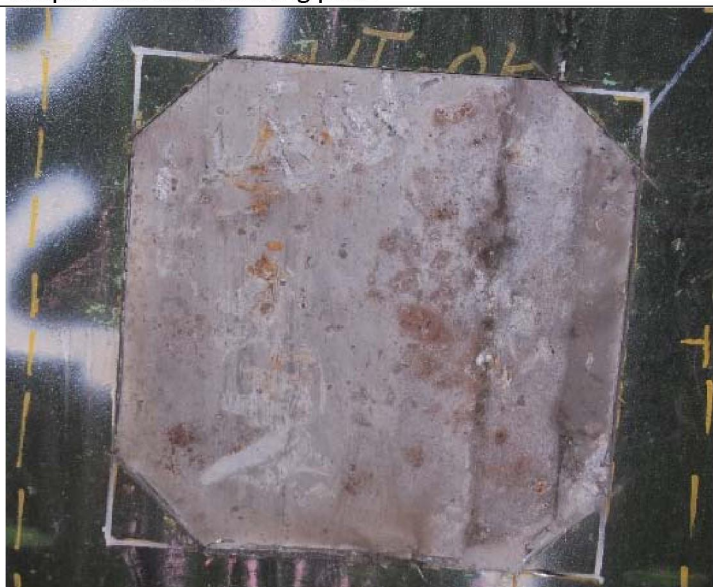
6/20/2018: 1400		
CONCRETE SAMPLE SPECIFICS		
Sample ID	8	8
Sample Location	14-BA-20-13-23-4	
Sample Dimensions	12X12 INCHES	
ON SITE VISUAL EXAMINATION		
Checks	Observations	
	Exterior	Units
Void space between concrete and liner (if any)	1/16" Void on left side, no voids in all other areas	
Biological Materials	None	
Wet or Dry	Dry	
Smell	None	
Temperature	80.0	F
Surface pH	11-12	
Structure to Electrolyte	-0.248	Volts/CSE
Concrete Resistivity	30.9 Horizontal 27.5 Vertical	k-ohm-cm k-ohm-cm
General Condition	Excellent, sound concrete with no cracks or delamination. Coupon had steel backing plate

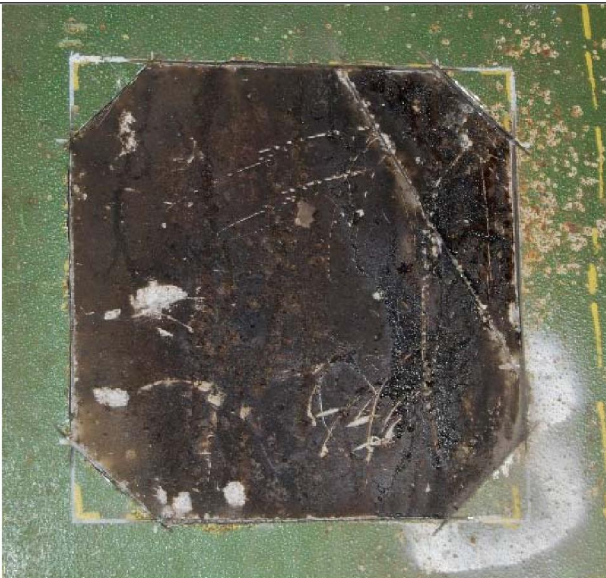
6/21/2018: 0930		
CONCRETE SAMPLE SPECIFICS		
Sample ID	10	10
Sample Location	14-LD-3-9-24-215	
Sample Dimensions	12X12 INCHES	
ON SITE VISUAL EXAMINATION		
Checks	Observations	
	Exterior	Units
Void space between concrete and liner (if any)	None	
Biological Materials	None	
Wet or Dry	Dry	
Smell	Smells like coal tar	
Temperature	77.6	F
Surface pH	12-12.5	
Structure to Electrolyte	-0.181	Volts/CSE
Concrete Resistivity	27.3 Horizontal 38.1 Vertical	k-ohm-cm k-ohm-cm
General Condition	Excellent, sound concrete with no cracks or delamination. Coupon had to be cut into two pieces to remove. What appears to be coal tar coating present on backside of coupon and concrete.

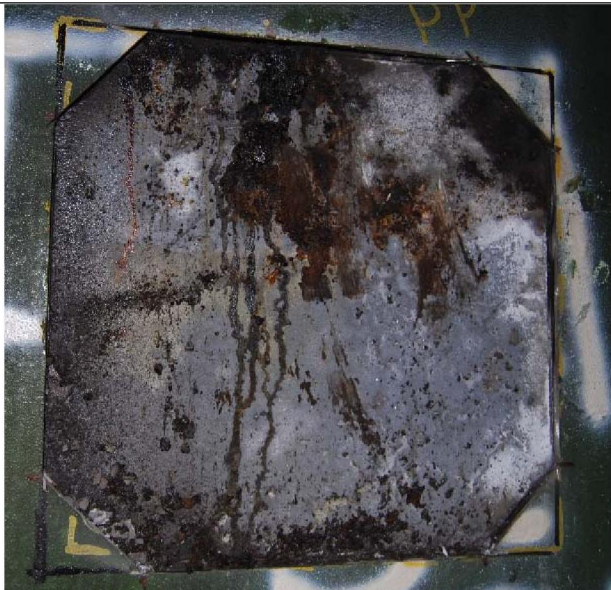
6/20/2018: 1100		
CONCRETE SAMPLE SPECIFICS		
Sample ID	A1	A1
Sample Location	14-BA-23-9-95-50	
Sample Dimensions	12X12 INCHES	
ON SITE VISUAL EXAMINATION		
Checks	Observations	
	Exterior	Units
Void space between concrete and liner (if any)	1/8" Void on left side, no voids in all other areas	
Biological Materials	None	
Wet or Dry	Mostly dry with damp areas around corrosion product	
Smell	None	
Temperature	77.5	F
Surface pH	11-12 in dry areas, 7-8 in corroded area	
Structure to Electrolyte	-0.448 (dry area) -0.432 (damp area w. corrosion products)	Volts/CSE
Concrete Resistivity	32.9 Horizontal 37.0 Vertical	k-ohm-cm
General Condition	Good condition with sound concrete, no cracks or delamination. Corrosion products are present on concrete.
