SUBJECT: ADMINISTRATIVE ORDER ON CONSENT (AOC) STATEMENT OF WORK (SOW) SECTION 5 CORROSION AND METAL FATIGUE PRACTICES, DESTRUCTIVE TESTING RESULTS REPORT, RED HILL BULK FUEL STORAGE FACILITY (RED HILL), JOINT BASE PEARL HARBOR-HICKAM, OAHU, HAWAII

In 2018, ten coupons were removed from Tank 14, so that a metallurgical and corrosion analysis of the coupons could be undertaken, with the primary aim of validating non-destructive examination (NDE) results. The steel coupons, concrete powder samples, and corrosion product were submitted to a certified third-party laboratory to perform this analysis.

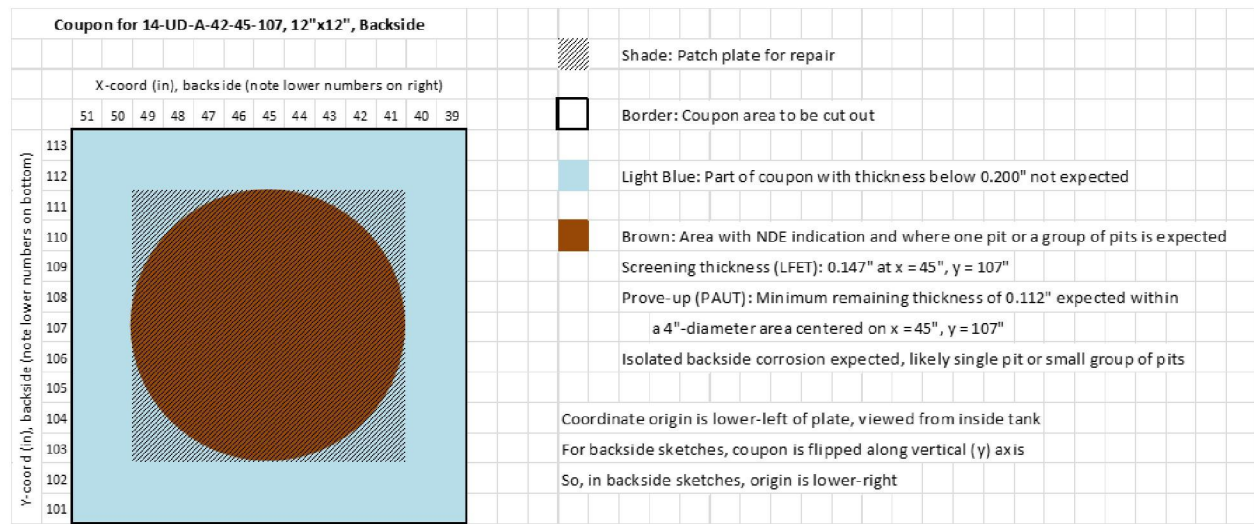
Figure 4-1 Expected Results from NDE Spreadsheet Data, Coupon 1

Destructive testing found pitting and minimum wall thickness of 0.208 inch. Remaining wall thickness greater than expected (208 mils vs. 112 mils). This deviation exceeded the 20 mils accuracy range for pitting.

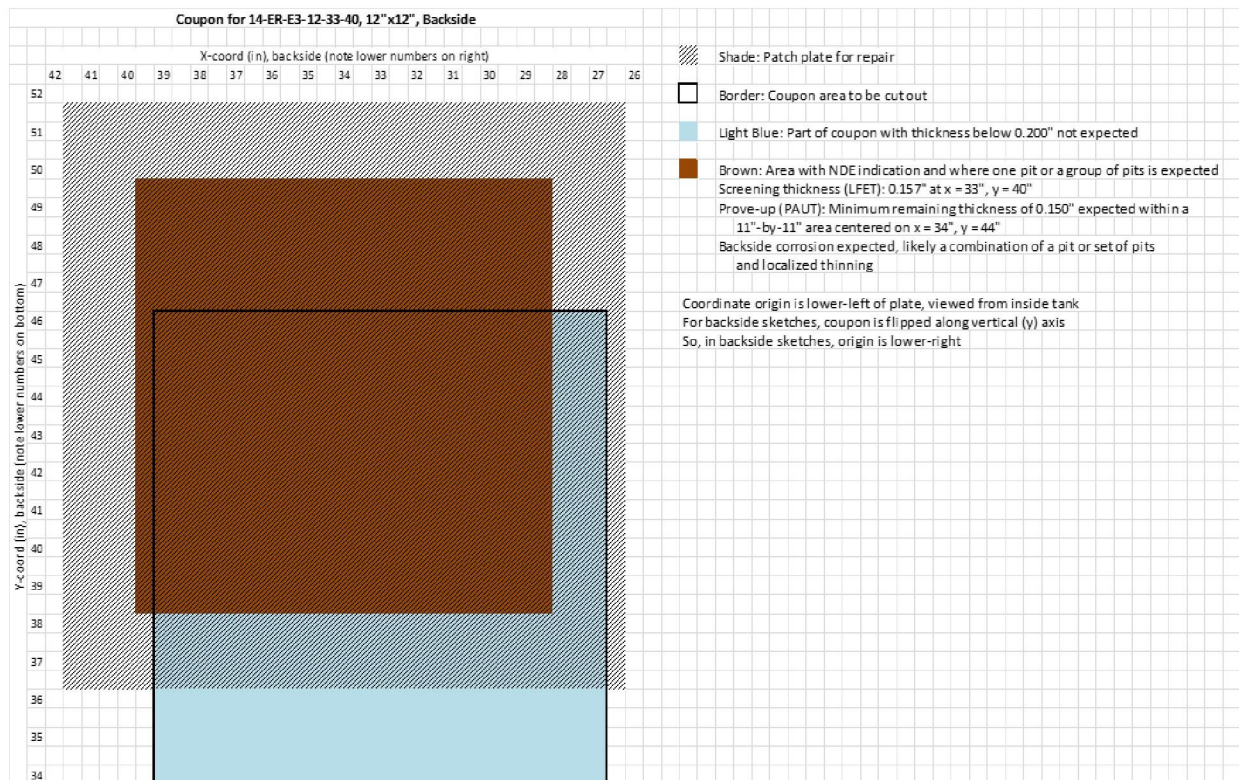
Figure 4-3 Expected Results from NDE Spreadsheet Data, Coupon 2

Remaining wall thickness as expected (152 mils vs. 150 mils). The LFET result fell within the 20 mils accuracy range for pitting.

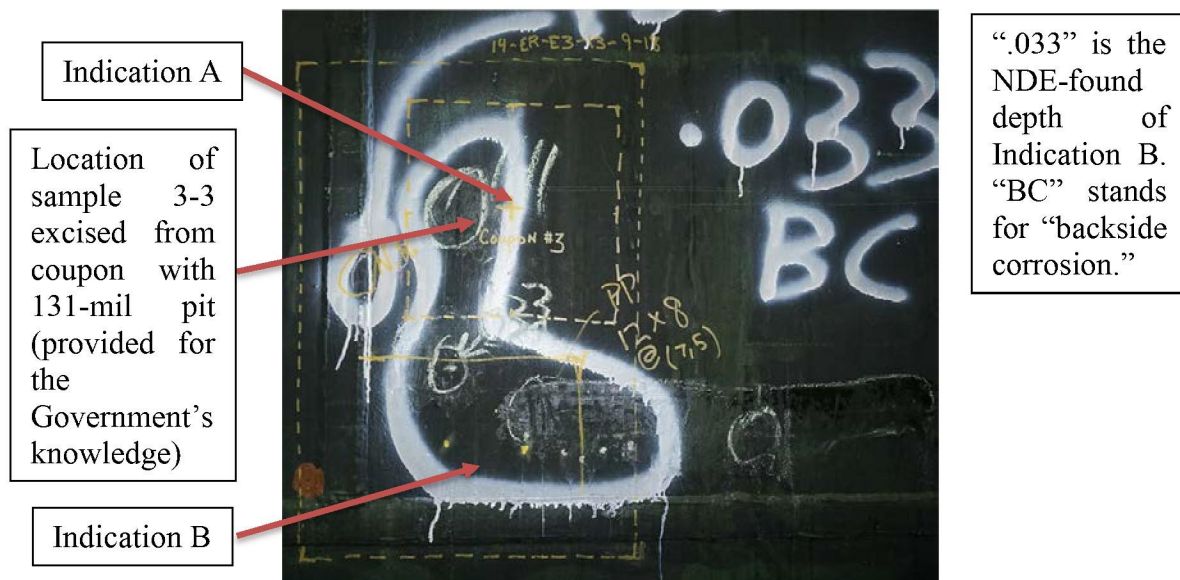
Figure 4-7 Location of Coupon 3 Prior to Removal

Laboratory results from Coupon 3 showed an area of remaining thickness of 131 mils, which is actionable. This thickness is within the layout area of Indication B.

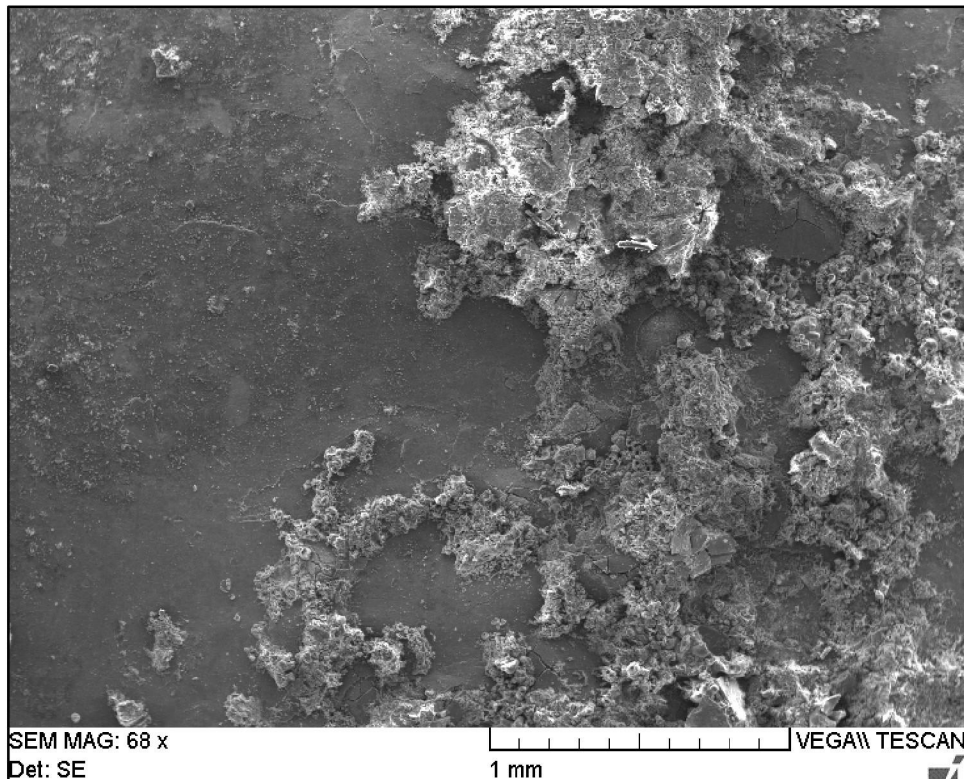
Figure 50. A representative SEM image of the specimen excised from Coupon 5 labeled as 5-1, prior to cleaning. No pits observed. (SEM, 40X)

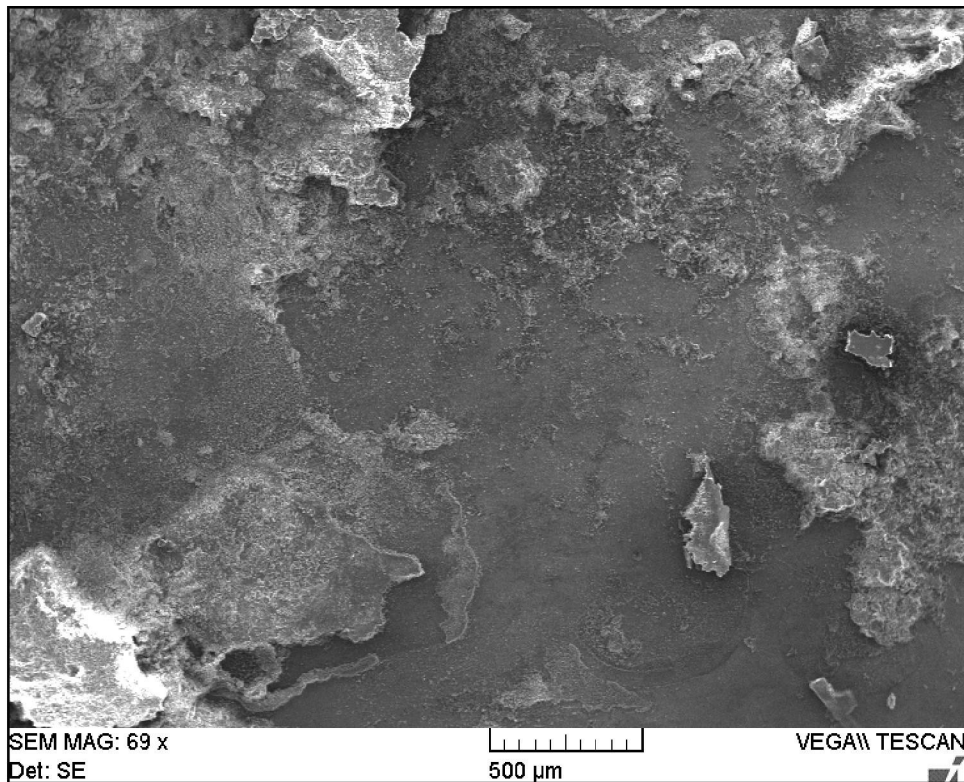
Figure 54. A representative SEM image the surface of a specimen excised from Coupon 6 labeled as 6-2, prior to cleaning. No pit was observed in this location. (SEM, 40X)

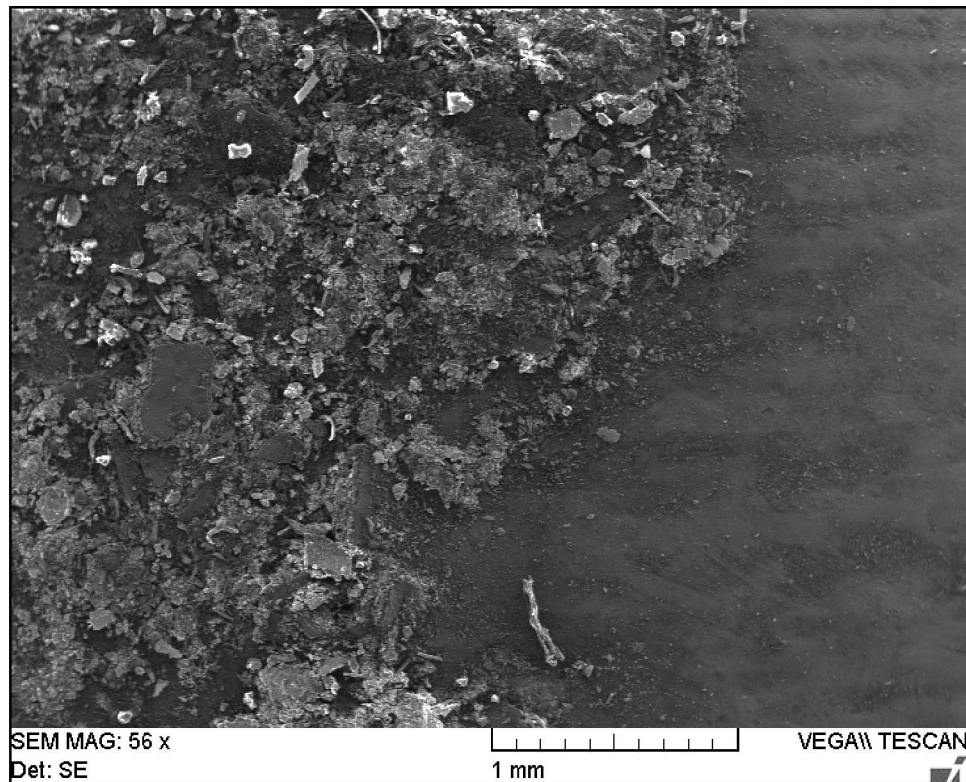
Figure 62. A representative SEM image of the surface of a specimen excised from Coupon 10 labeled as 10-1, prior to cleaning. No pit was observed in this location. (SEM, 33X)

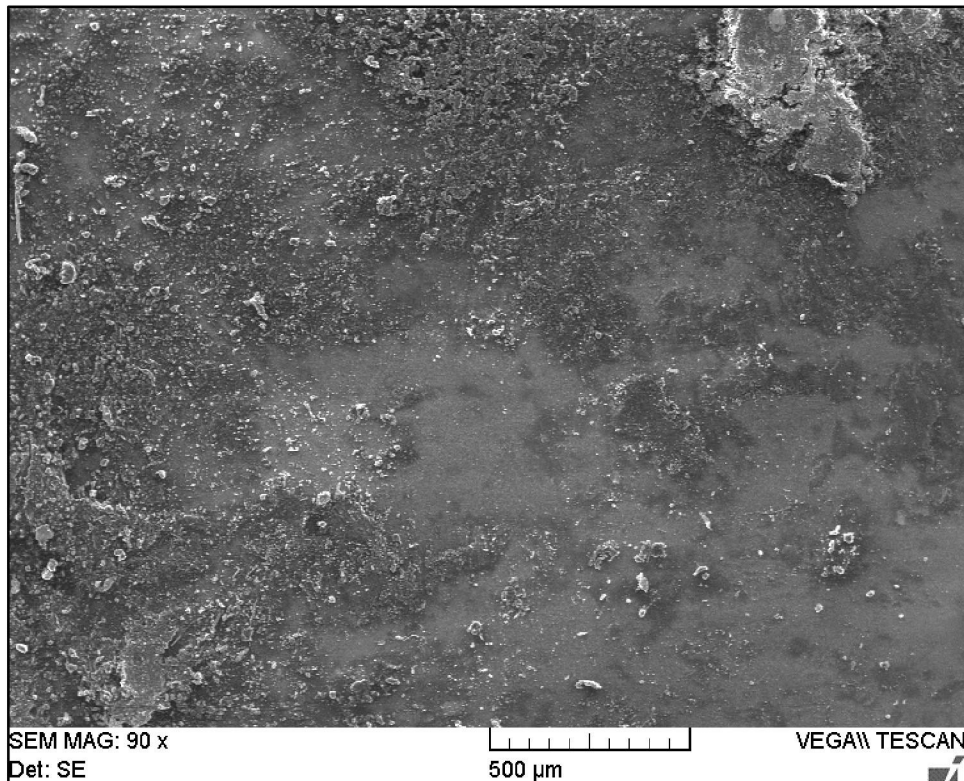
Figure 64. A representative SEM image of the surface on a specimen excised from Coupon 10 labeled as 10-3, prior to cleaning. No pit was observed in this location. (SEM, 53X)

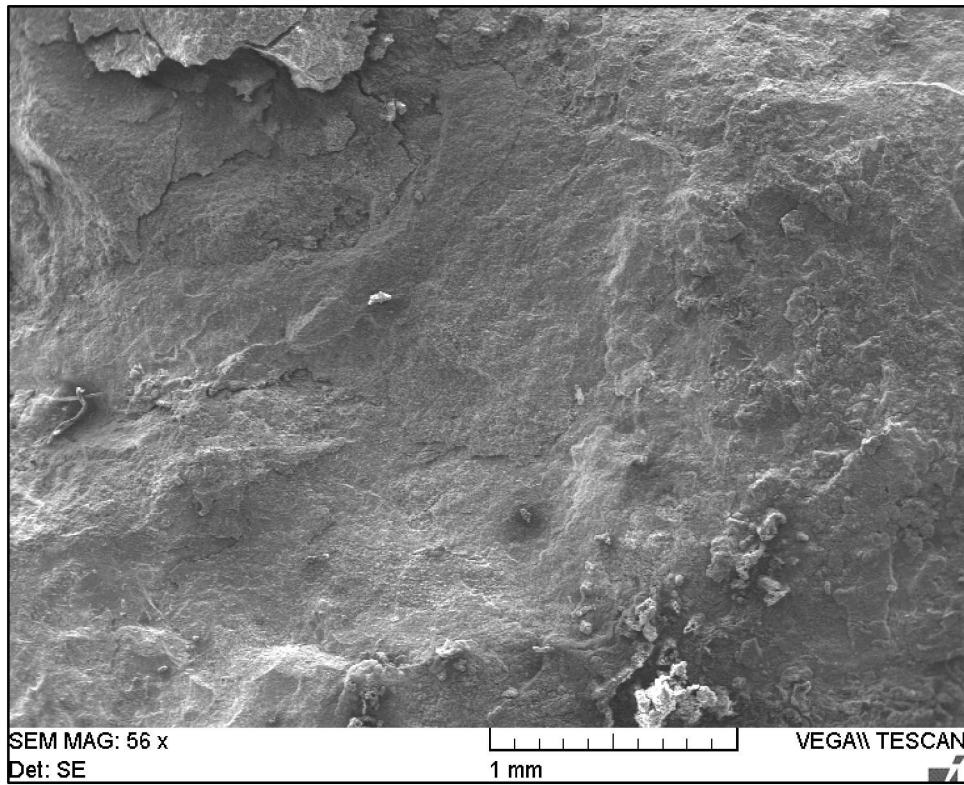
Figure 65. A representative SEM image of a pit on a specimen excised from Coupon A-1 labeled as A1-1, prior to cleaning. (SEM, 33X)

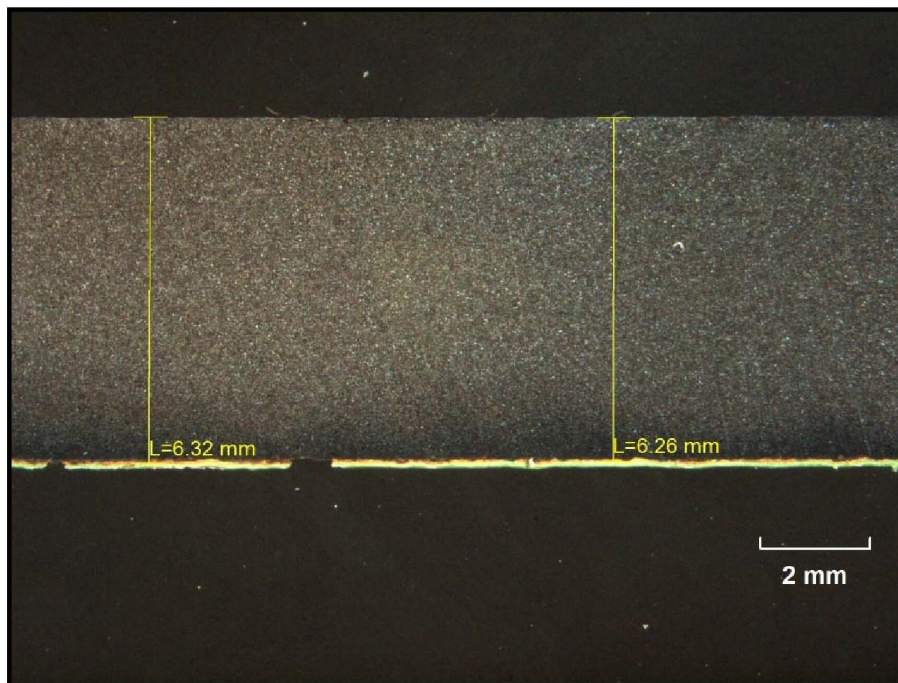
Figure 190. The prepared metallographic cross-section from Sample 5-1 is shown during examination with a stereomicroscope. No significant corrosion was observed. (7X)

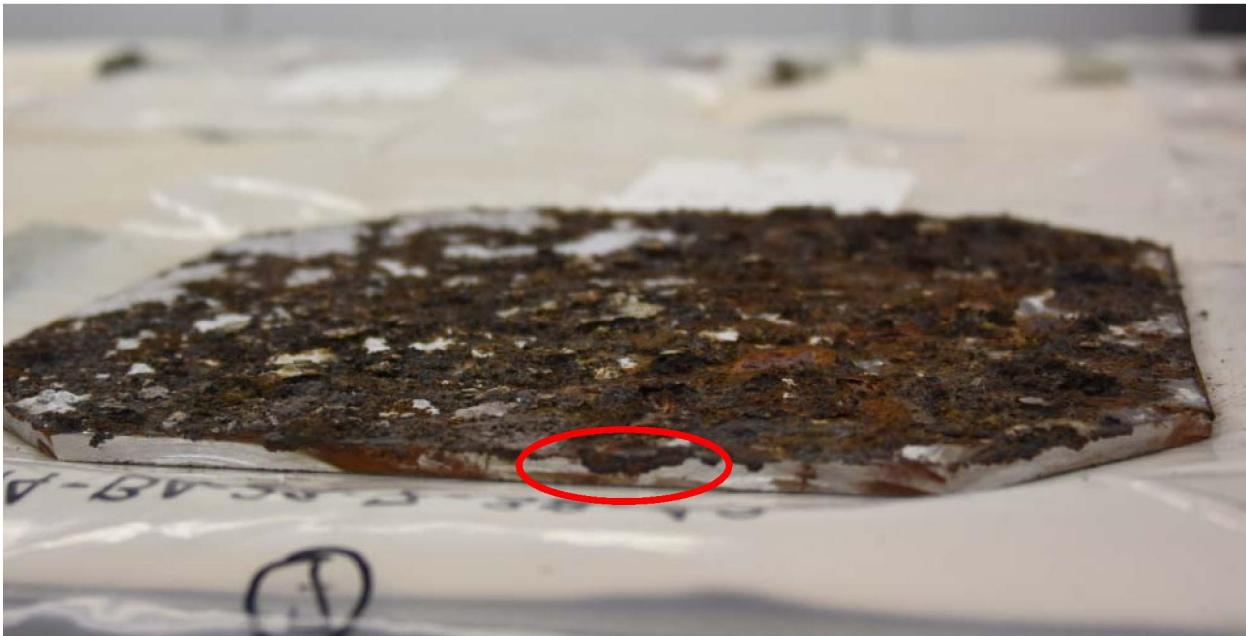
Figure A-1. Image provided by Robert Jamond on 3/20/19. This image was taken of the edge of Coupon #7 after extraction from Tank #14 and prior to shipping to IMR. The red circle identifies an area-of-concern identified prior to shipment of the coupon to IMR.

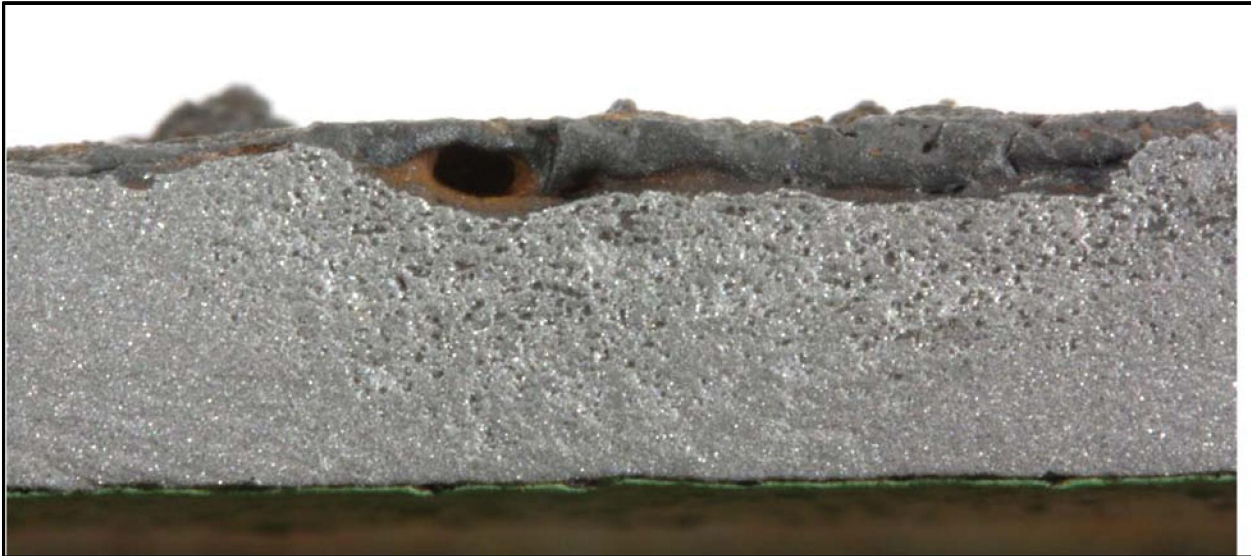
Figure A-4. Detail of the sandblasted edge on 3/20/19 in the same location as shown in the picture below. The sandblasting revealed that the feature was not a corrosion pit, as shiny metal was revealed when the red-colored staining was removed. There was an unusual appearance to the edge in this location, as though the sectioned edge had been superficially altered by heat associated with sectioning or some other post-sectioning reaction (atmospheric corrosion or corrosive media attack). That alteration gave the appearance of a deep corrosion pit.

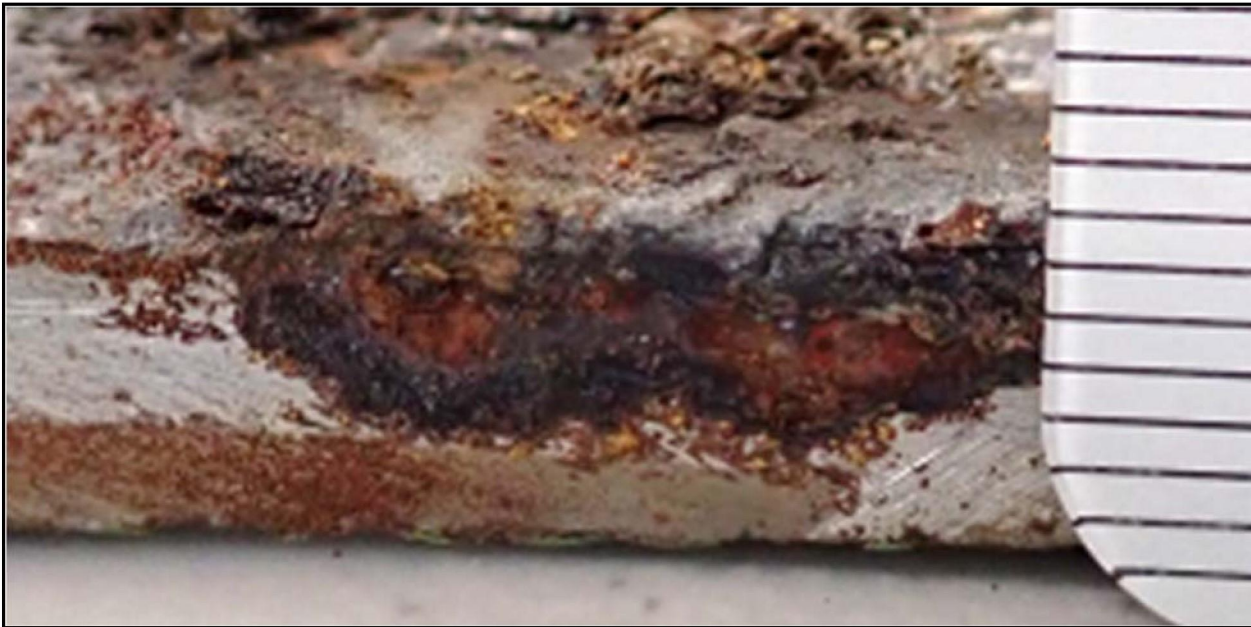
Figure A-5. The same area is shown in an image provided prior to shipping Coupon #7 to IMR (provided to IMR on March 13, 2019). What appeared to be a deep corrosion pit was actually rust-colored staining of the edge surface
