**SUBJECT: DESTRUCTIVE ANALYSIS OF 10 STEEL COUPONS REMOVED FROM  
RED HILL FUEL STORAGE TANK NO. 14, PURSUANT TO SECTION 5.3  
OF THE ADMINISTRATIVE ORDER ON CONSENT STATEMENT OF  
WORK, RED HILL BULK FUEL STORAGE FACILITY, JOINT BASE PEARL  
HARBOR-HICKAM, OAHU, HAWAII**

## **Destructive Analysis of 10 Steel Coupons Removed from Red Hill Fuel Storage Tank #14**

**REPORT No. 201801967**

December 17, 2018

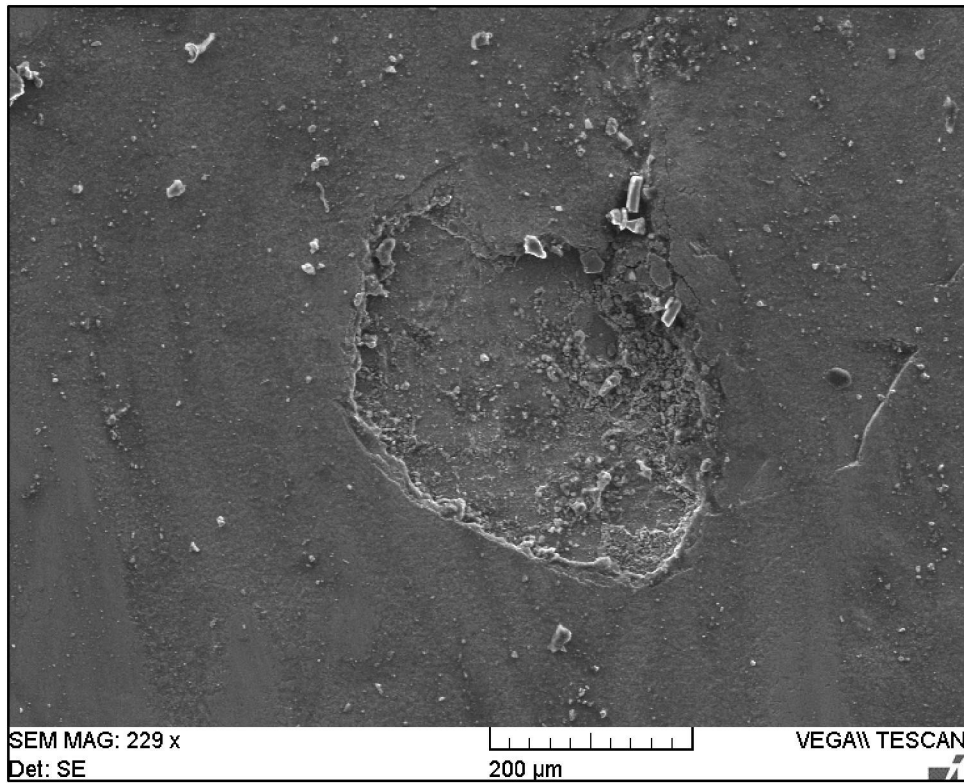
**Figure 63.** A representative SEM image of a pit on a specimen excised from Coupon 10 labeled as 10-2, prior to cleaning. (SEM, 135X)

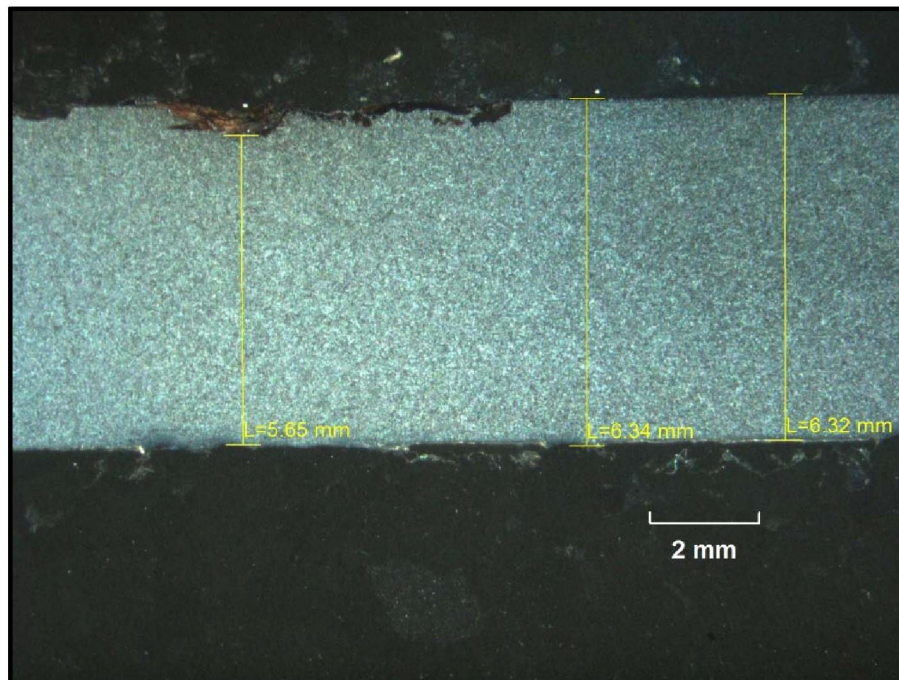
**Figure 180.** The prepared metallographic cross-section from Sample 1-1 is shown during examination with a stereomicroscope. The thickest location(s) are shown, as well as the thickness remaining underneath the deepest observed pit. (7X)

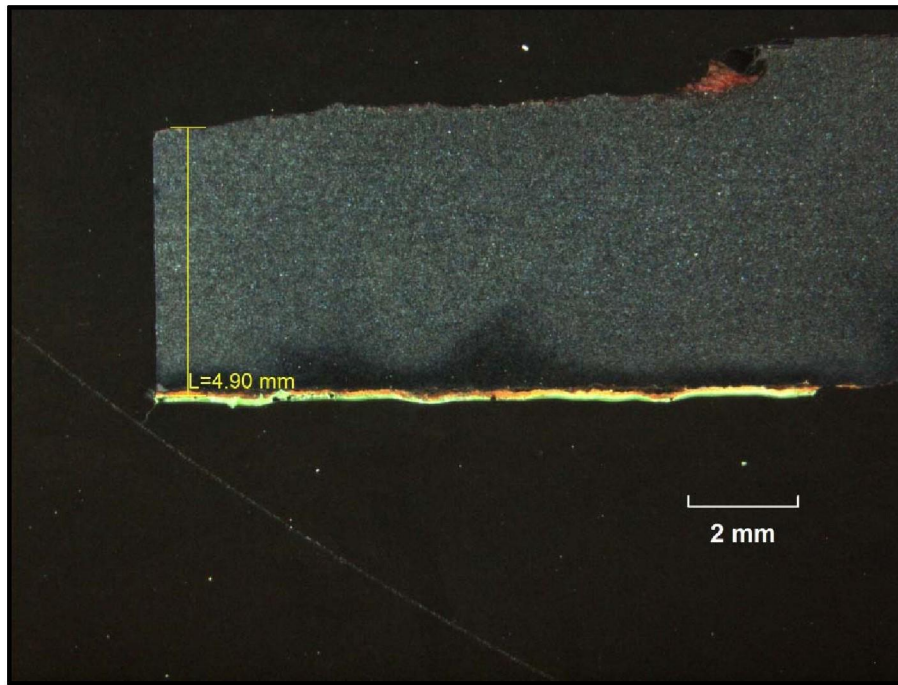
**Figure 205.** The prepared metallographic cross-section from Sample A1-5 is shown during examination with a stereomicroscope. The thickness remaining underneath the deepest observed pit is shown. (7X)

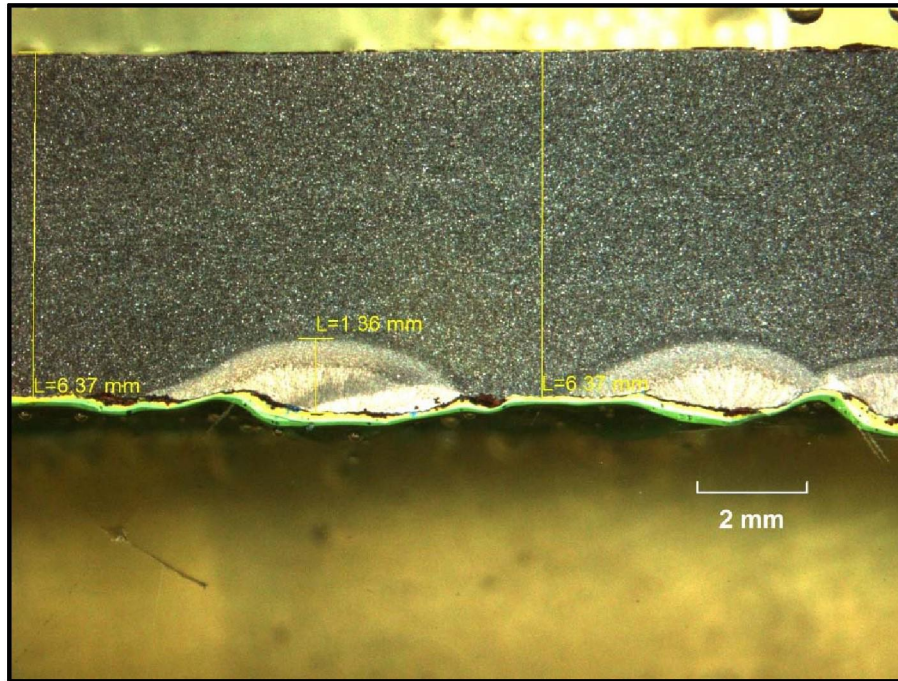
⑥ No pits observed. Suspected NDT inspection indications are areas of melting on the painted face, underneath the paint on Sample A2-4.

**Figure 207.** The prepared metallographic cross-section from Sample A2-4 is shown during examination with a stereomicroscope. The NDE indication was most likely locations of melting/re-solidification underneath the painted surface. No pitting was observed. (7X)
