Engineering Report

Red Hill Tank #10

**Naval Supply Center
Pearl Harbor, Hawaii**

**PRL 96-21
Emergency Repairs for Red Hill Tanks**

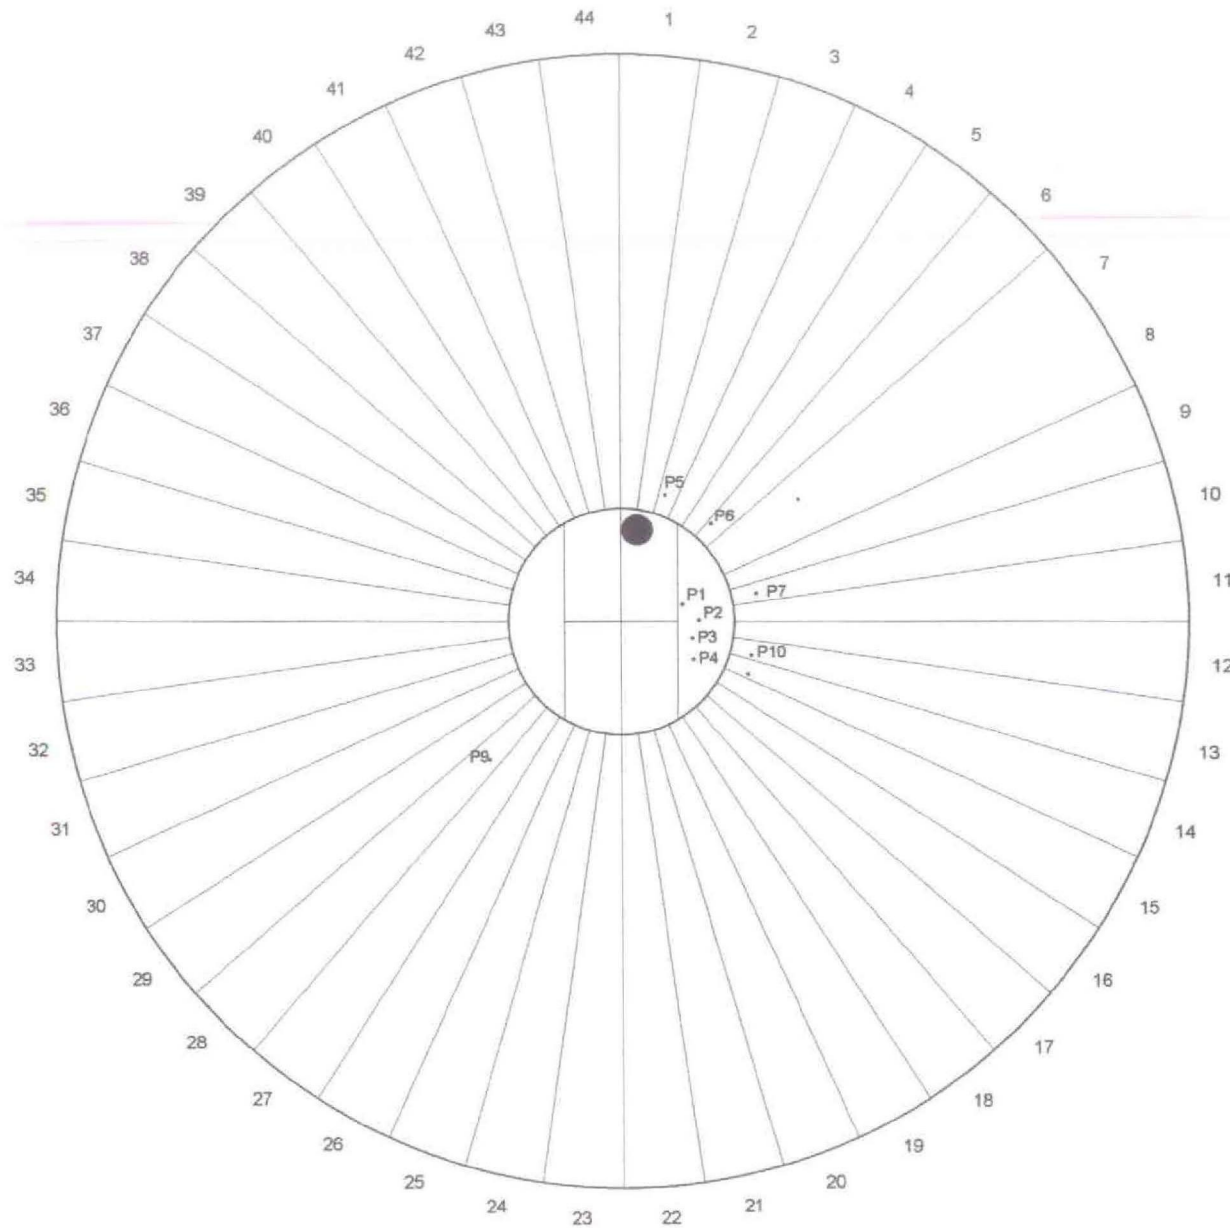
Bottom Layout with Pit Indications

P1 = 0.08
P2 = 0.09
P3 = 0.10
P4 = 0.07
P5 = 0.07
P6 = 0.06
P7 = 0.09
P8 = 0.11
P9 = 0.12
P10 = 0.11

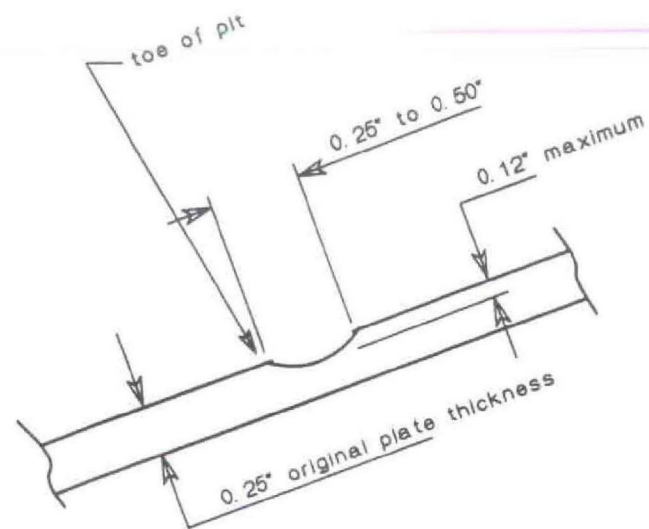
SECTION VIEW AT TYPICAL PIT

Twenty pits were identified and measured on the first ascending plates in the area to be coated at the bottom of tank #10. The deepest pit measured 0.12 inches. A sketch showing the dimensions of a typical pit is shown below.

- 4.0 Pitting at the bottom of tank #16 was similar to #10 and did not require the scheduled repairs. However the sharp edges at the toe of pit caused problems with the coating application. To correct this problem on tank #10 Mid Atlantic Environmental advises smoothing the sharp edge mechanically or by applying primer coat with a stiff brush as proscribed by NAVFAC SPECIFICATION N62472-96-C-1356, Section 09970, 3.9.5, Application of Polyurethane Coating System, which states, "For blasted areas which are pitted, work the wash primer into the crevices, and pits with a stiff brush (100 mm brush cut 25mm long, for example)"

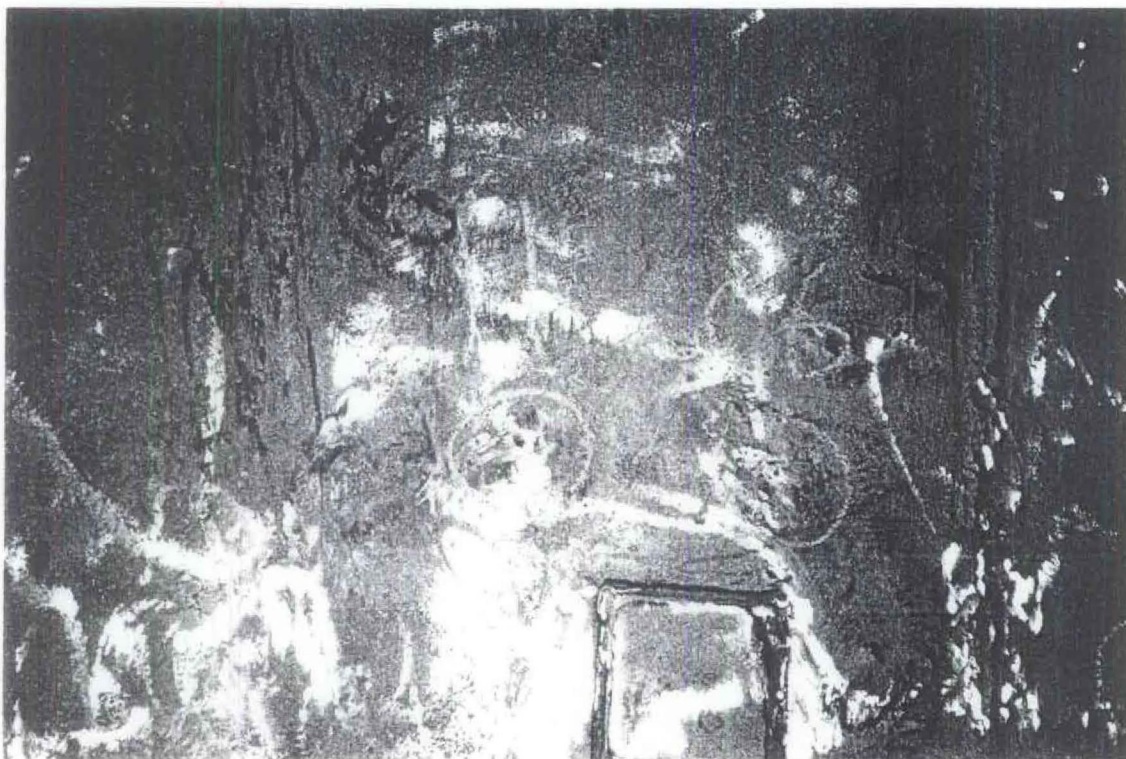
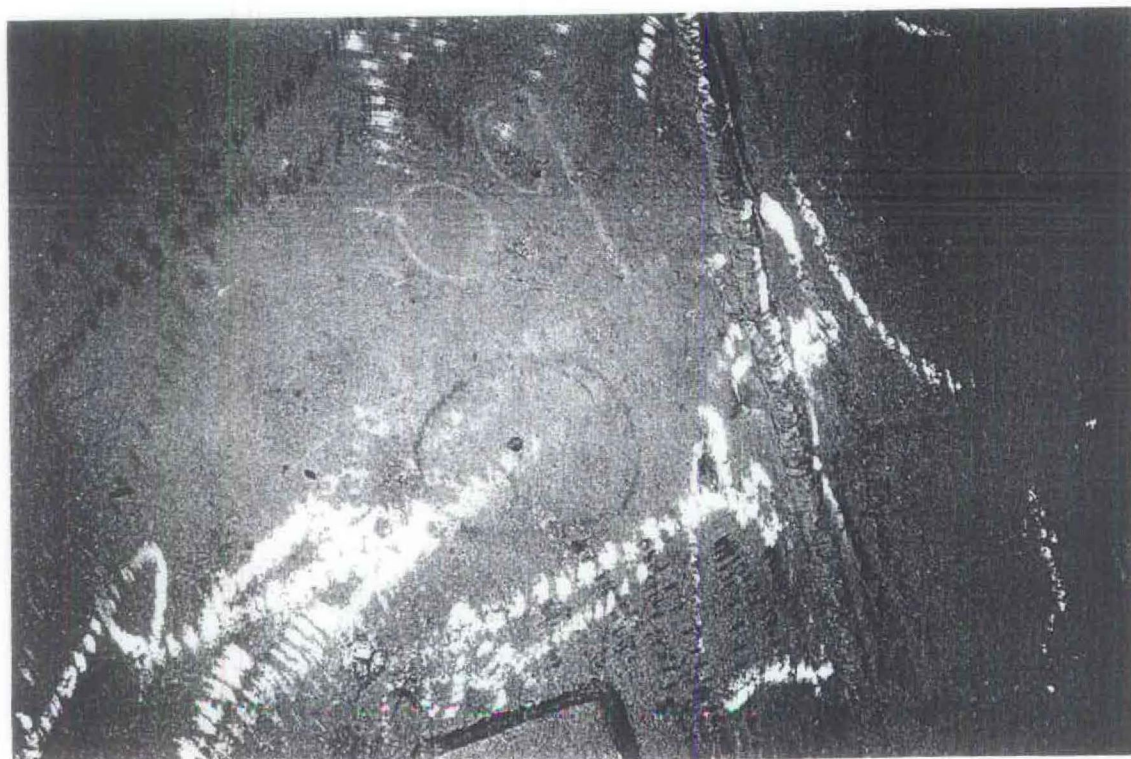
PICTURES SHOWING PITTING ON FIRST ASCENDING PLATES

- 3.0 Only pits over 0.06 inches deep were identified. Twenty pitted areas were identified and measured in the first ascending plates of the lower dome. The deepest pit recorded on the ascending plates was 0.12 inches. The metal thickness at the identified pits is greater than 0.10 and the scheduled repair by providing a welded patch plate over the pit is not applicable and no repair is necessary to maintain the integrity of the tank. (The method of repair specified by contract is provided on sheet M-9 of NAVFAC DWG. NO. 7927658, REPAIR TYPE 1.)
