**RECOMMENDED REPAIRS**

| TYPE 7 REPAIR | | | |
|---|---|---|---|
| EMERGENCY REPAIRS FOR RED HILL TANKS | | | |

**Dames & Moore**  
Emergency Repairs For Red Hill Tanks at the Fleet Industrial & Supply Center  
Contract No. N62742-96-C-1356

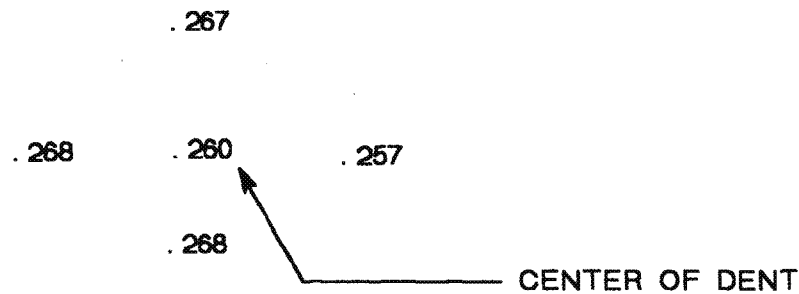
| TYPE 7 REPAIR | | | |
|---|---|---|---|
| Repair No.: 001 | | File: 10r001 | |

NOTE: DENT OCCURED BEFORE PAINTING. PAINT REPAIR NOT NECESSARY

| TYPE 7 REPAIR | | | |

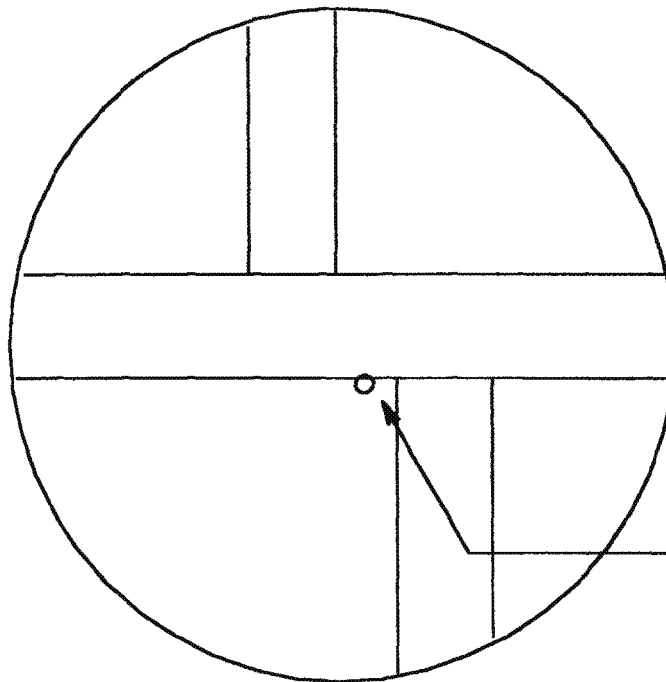
| LTR | DESCRIPTION | BY | DATE |
|---|---|---|---|
| Repair No. : 003 | | File: 10r003 | |

No Leak Detected

NO LEAK DETECTED - NO ADDITIONAL  
REPAIRS REQUIRED PER T. KITCHEN  
2-16-98

no repair required

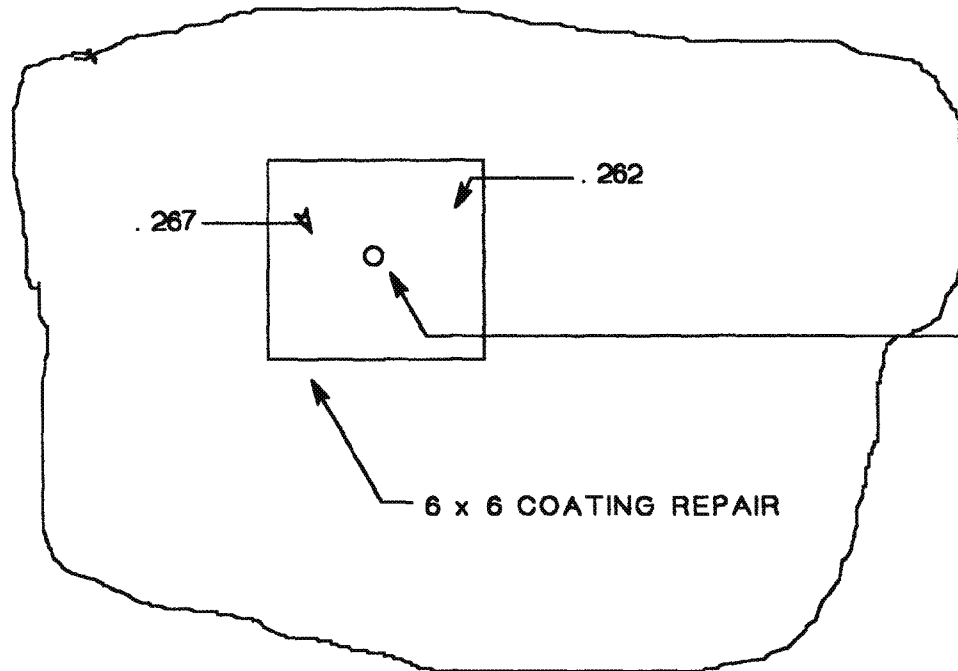
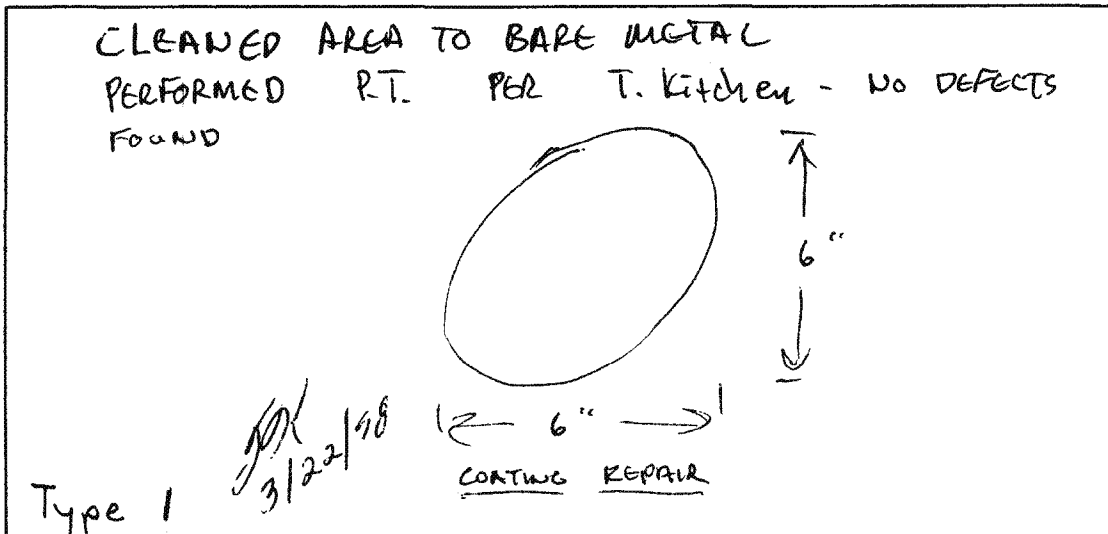
| Repair No. 011 | | File 10r011 | |

NO LEAK DETECTED CHANGE TO COATING REPAIR

#### TYPE 1 REPAIR

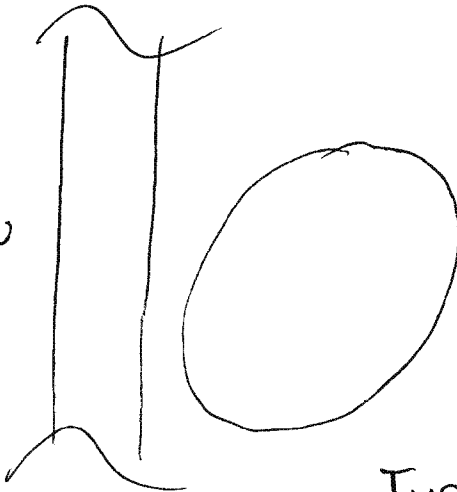
| LTR | DESCRIPTION | BY | DATE |
|---|---|---|---|
| Repair No. : 040 | | File: 10udr040 | |

POSSIBLE LEAK -PT TESTED NO LEAK  
COATING REPAIR 50 SQUARE INCHES

| <p>CLEANED TO<br/>BARE METAL &amp;<br/>PERFORMED PT<br/>PER T. KITCHEN</p> <p>NO DEFECTS<br/>FOUND</p> <p>COATING REPAIR</p> | |

#### TYPE 8 REPAIR

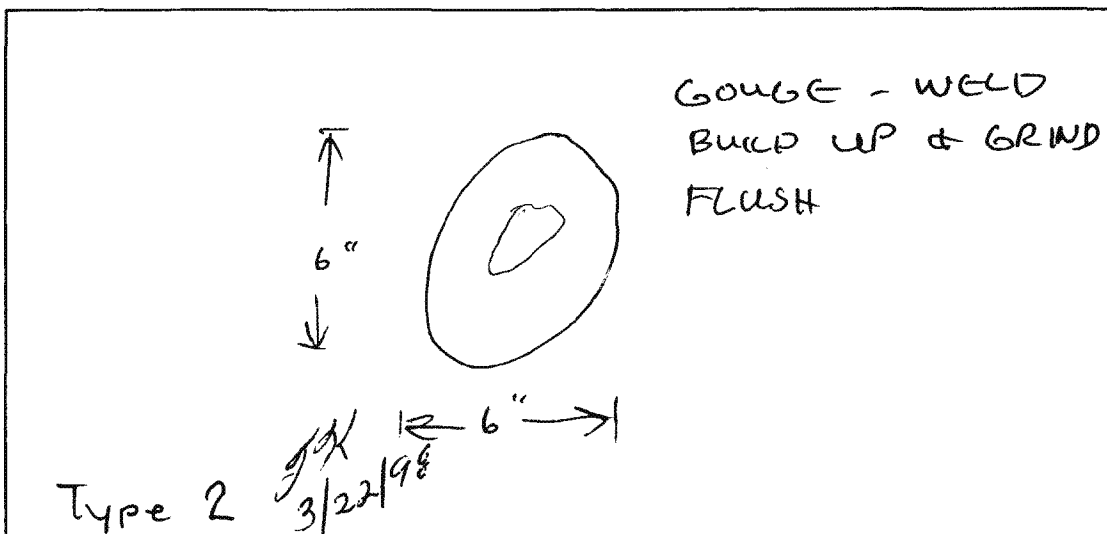
| O I | ORIGINAL ISSUE | M M | 2/20/98 |
|---|---|---|---|
| Repair No.: 050 | | File: 10r050 | |

No Leak

36 SQUARE INCH COATING REPAIR

Repair Type 2

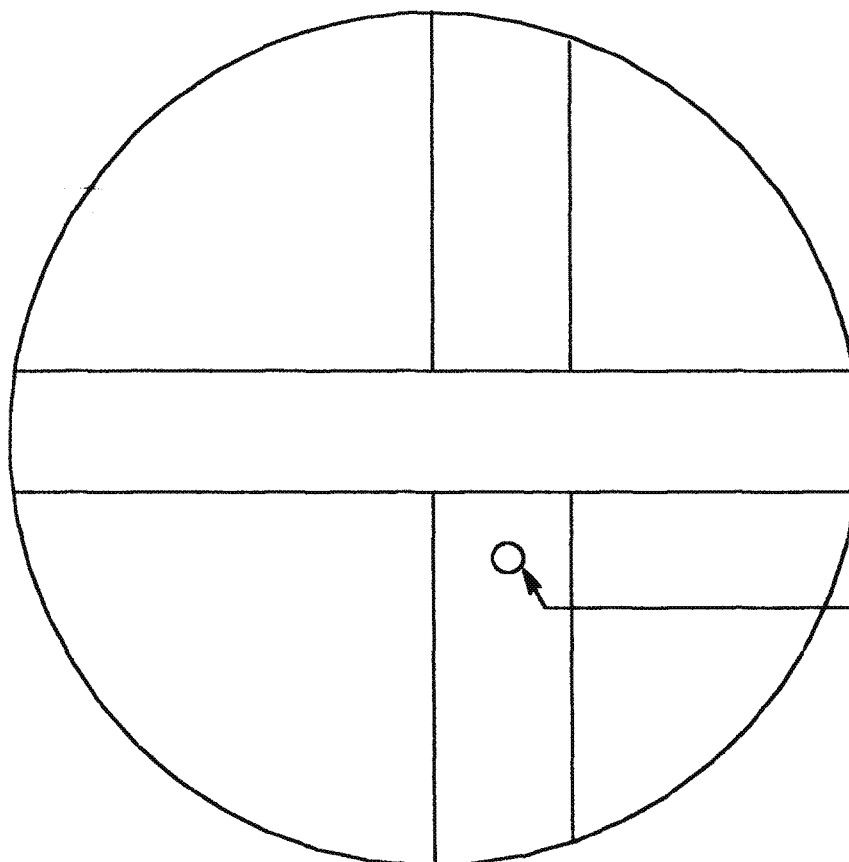
| LTR | DESCRIPTION | BY | DATE |
|---|---|---|---|
| Repair No. 080 | | File 10r080 | |

No Leak Detected

## NO REPAIR REQUIRED
