LTR	DESCRIPTION	BY	DATE
REVISIONS			
MID ATLANTIC ENVIRONMENTAL			
EMERGENCY REPAIRS FOR RED HILL TANKS			
Tank #10			
Repair No.: 090		File: 10r090	
Upper dome		Quadrant: A	
Course: B & C		Plate: 1 & 2	
Drawn by: M. Moulton		Date: 12/20/97

**Dames & Moore**  
Emergency Repairs For Red Hill Tanks at the Fleet Industrial & Supply Center  
Contract No. N62742-96-C-1356

**Repair Record**

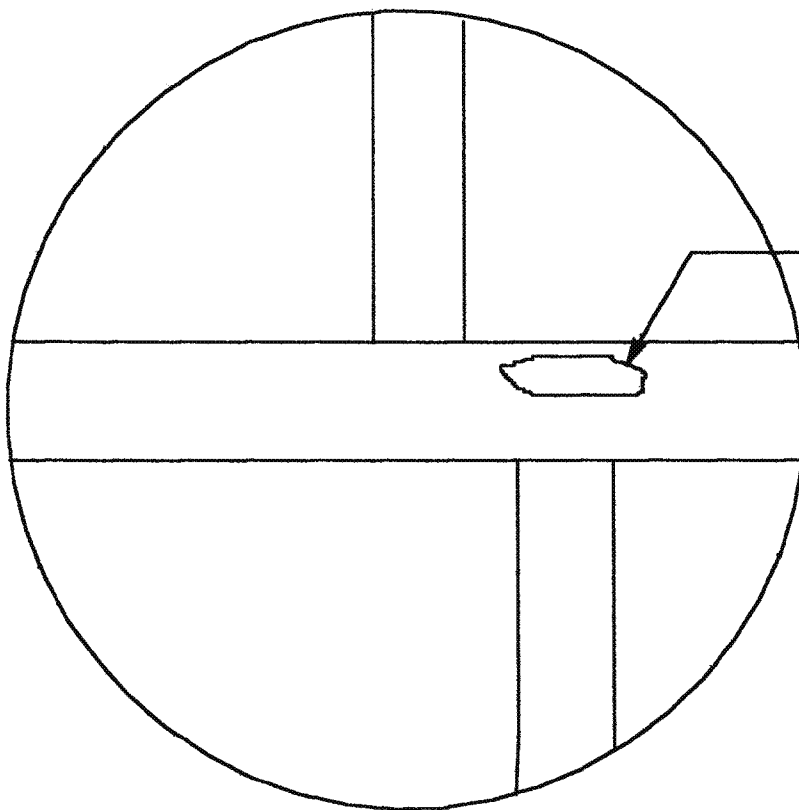
Repair Type 8

Needlegun and recoat

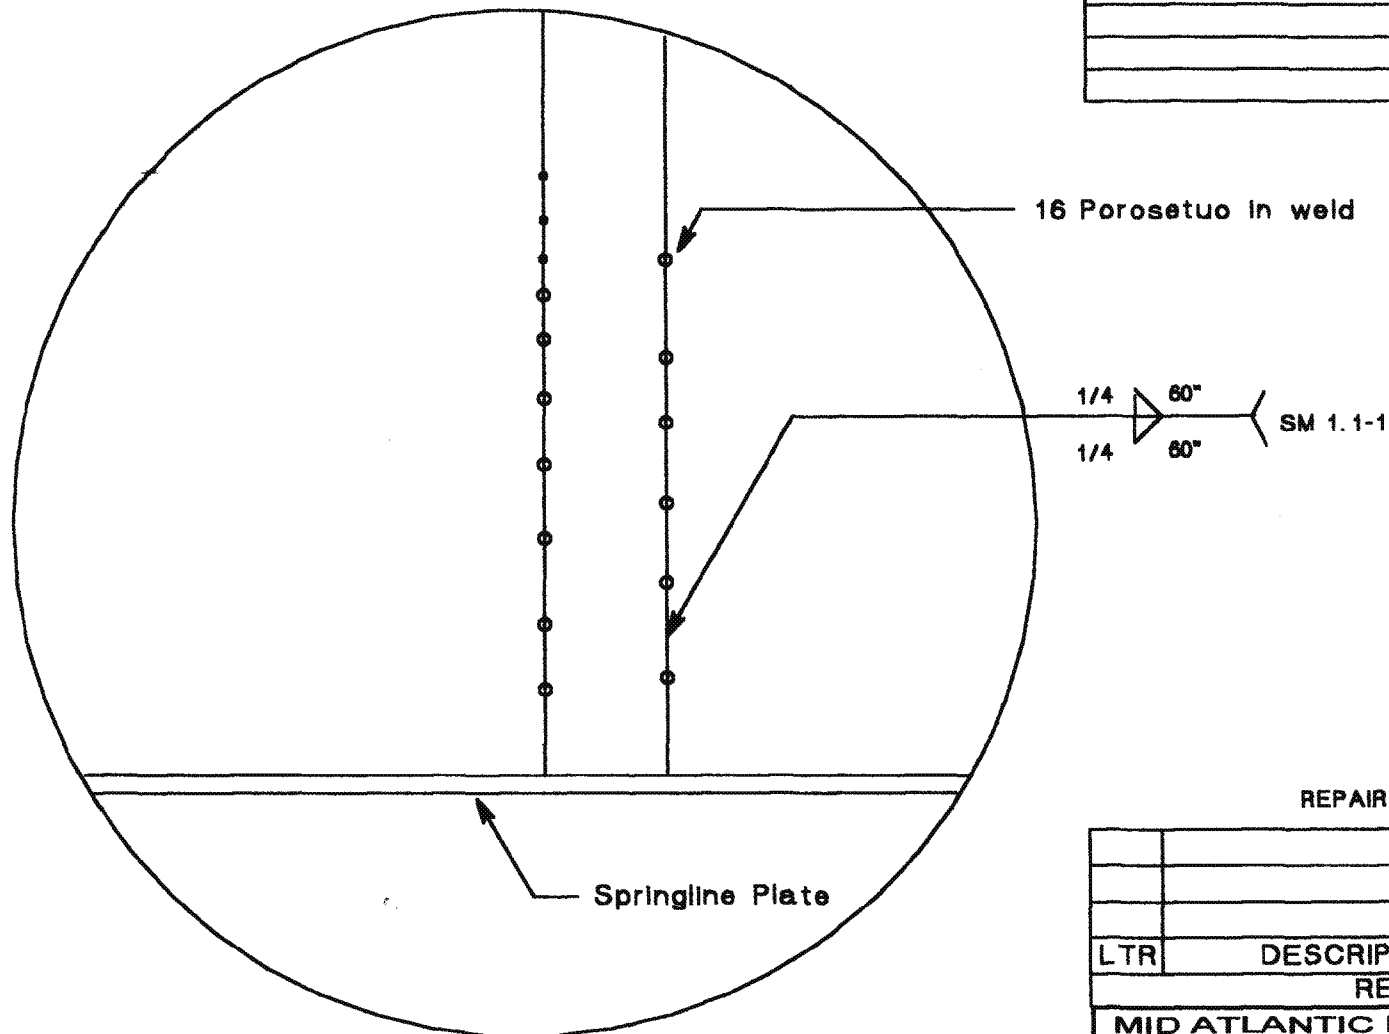
LTR	DESCRIPTION	BY	DATE
REVISIONS			
MID ATLANTIC ENVIRONMENTAL			
EMERGENCY REPAIRS FOR RED HILL TANKS			
Tank #10			
Repair No.: 100		File: 10r100	
Upper dome		Quadrant: A	
Course: A		Plate: 1 & 2	
Drawn by: M. Moulton		Date: 12/20/97

#### REPAIR TYPE 11

Weld Repair

NDT Performed: Visual ☒ Vacuum Box ☒ Dye Penetrant ☒

Date Accepted: 2/26/98

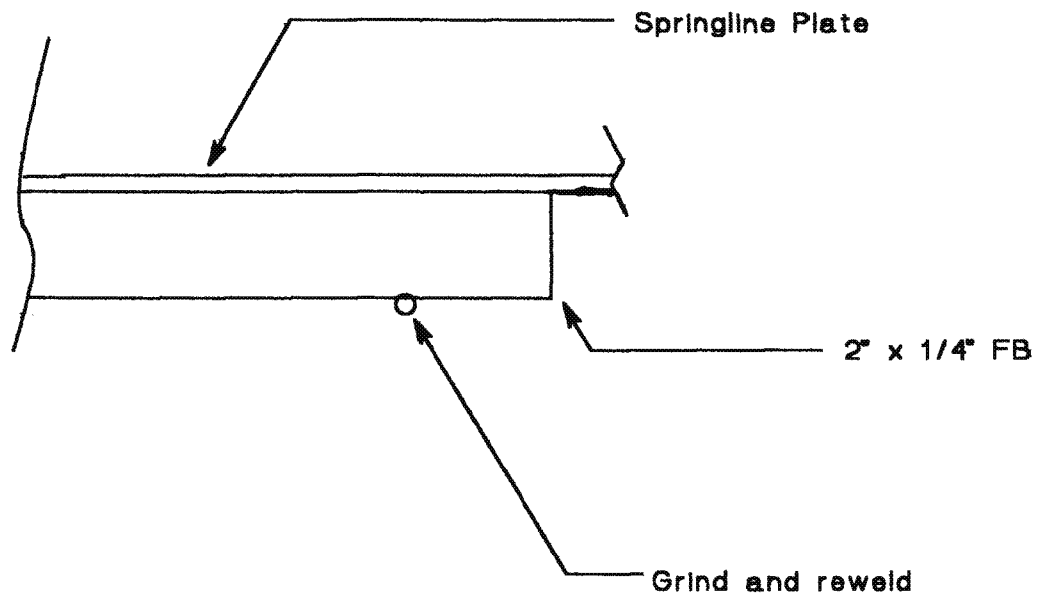
O I	ORIGINAL ISSUE	M M	2/20/98
LTR	DESCRIPTION	BY	DATE
REVISIONS			
MID ATLANTIC ENVIRONMENTAL			
EMERGENCY REPAIRS FOR RED HILL TANKS			
Tank #10			
Repair No. 120		File 10r120	
Upper dome		Quadrant A	
Course A		Plate 3	
Drawn By: M. Moulton		Date: 2/20/98

Repair Type 10

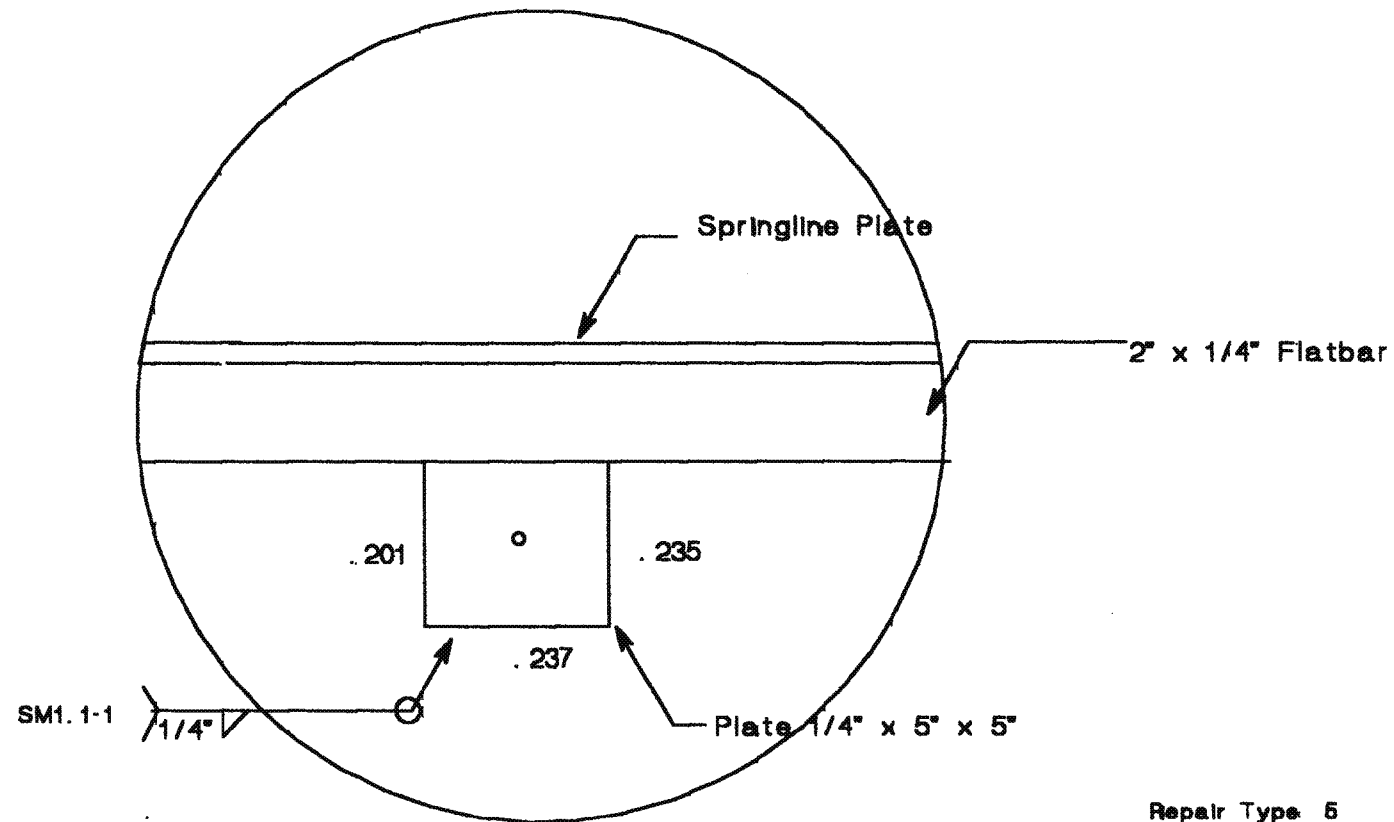
O I	ORIGINAL ISSUE	M M	2/20/98
LTR	DESCRIPTION	BY	DATE
REVISIONS			
MID ATLANTIC ENVIRONMENTAL			
EMERGENCY REPAIRS FOR RED HILL TANKS			
Tank #10			
Repair No. 130		File 10-130	
Upper dome		Quadrant A	
Course A		Plate 3	
Drawn By: M. Moulton		Date: 2/20/98

Repair Type 5

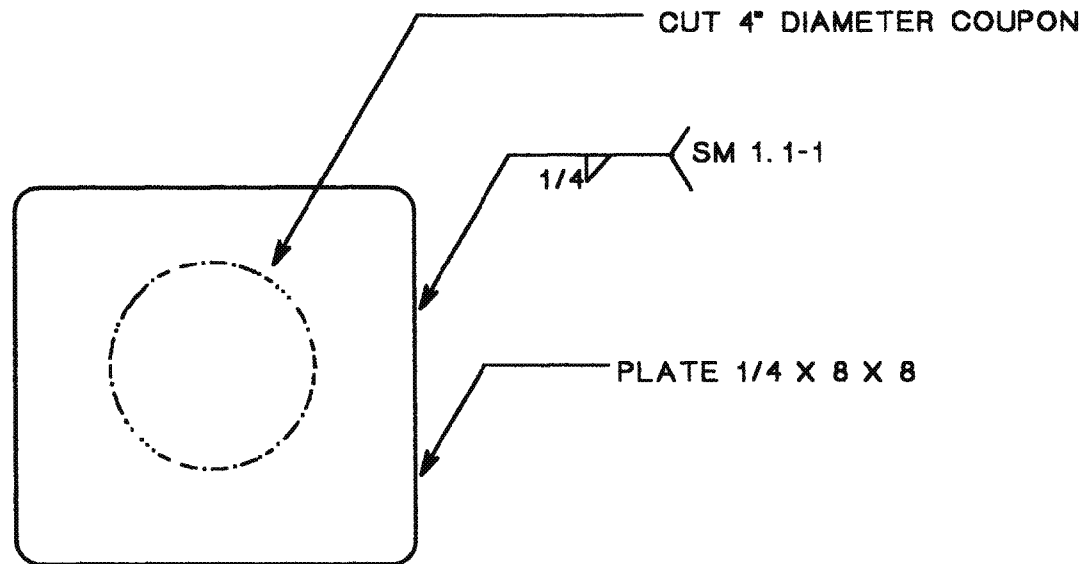
LTR	DESCRIPTION	BY	DATE
REVISIONS			
MID ATLANTIC ENVIRONMENTAL			
EMERGENCY REPAIRS FOR RED HILL TANKS			
Tank #10			
Repair No. 131		File 10r131	
Upper dome		Quadrant A	
Course C		Plate 5	
Drawn by: Tom Kitchen		Date: 2/20/98

#### TYPE 6 REPAIR

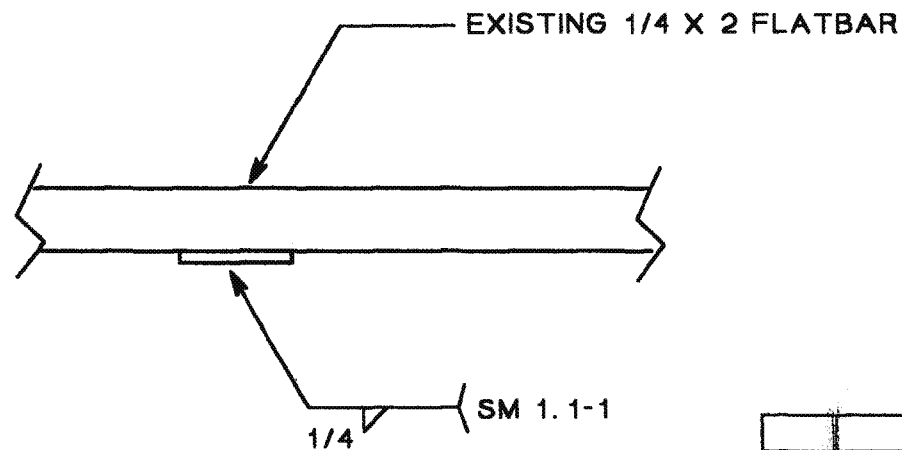
LTR	DESCRIPTION	BY	DATE
REVISIONS			
MID ATLANTIC ENVIRONMENTAL			
EMERGENCY REPAIRS FOR RED HILL TANKS			
Tank #10			
Repair No.: 150		File: 10-150	
Upper dome		Quadrant: A	
Course: A & B		Plate: 4	
Drawn by: Tom Kitchen		Date: 2/20/98

#### TYPE 10 REPAIR

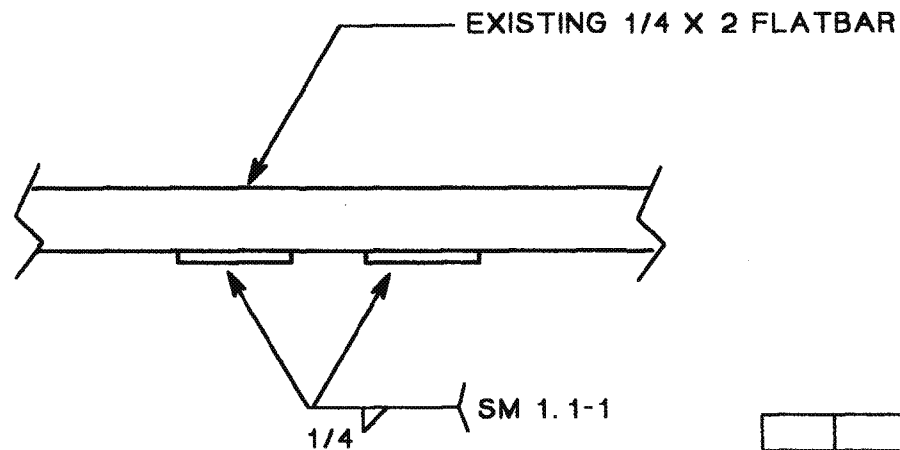
LTR	DESCRIPTION	BY	DATE
REVISIONS			
MID ATLANTIC ENVIRONMENTAL			
EMERGENCY REPAIRS FOR RED HILL TANKS			
Tank #10			
Repair No.: 160		File: 10r160	
Upper dome		Quadrant: A	
Course: A		Plate: 5	
Drawn by: Tom Kitchen		Date: 2/20/98

#### TYPE 10 REPAIR

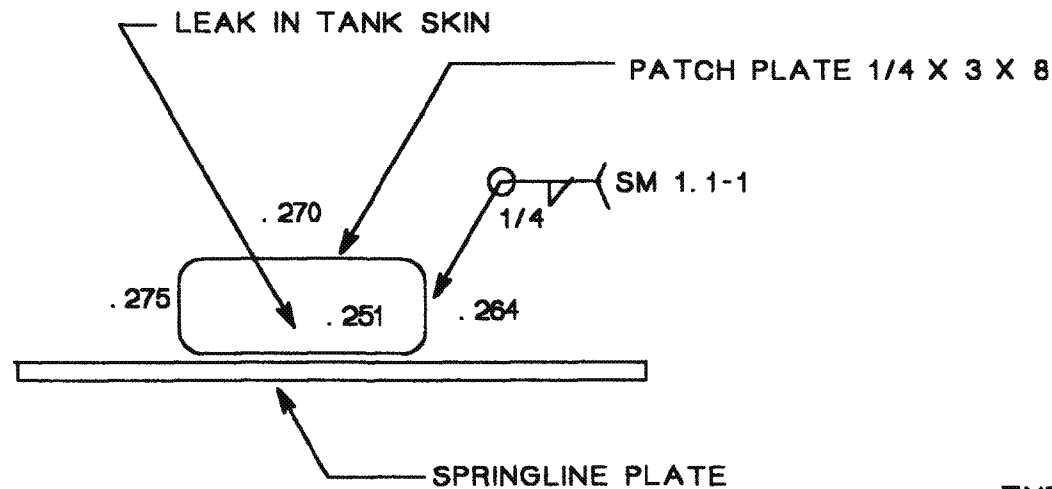
LTR	DESCRIPTION	BY	DATE
REVISIONS			
MID ATLANTIC ENVIRONMENTAL			
EMERGENCY REPAIRS FOR RED HILL TANKS			
Tank #10			
Repair No. 170		File 10udr170	
Upper dome		Quadrant A	
Course A		Plate 5	
Drawn by: Tom Kitchen		Date: 2/20/98

#### TYPE 5 REPAIR

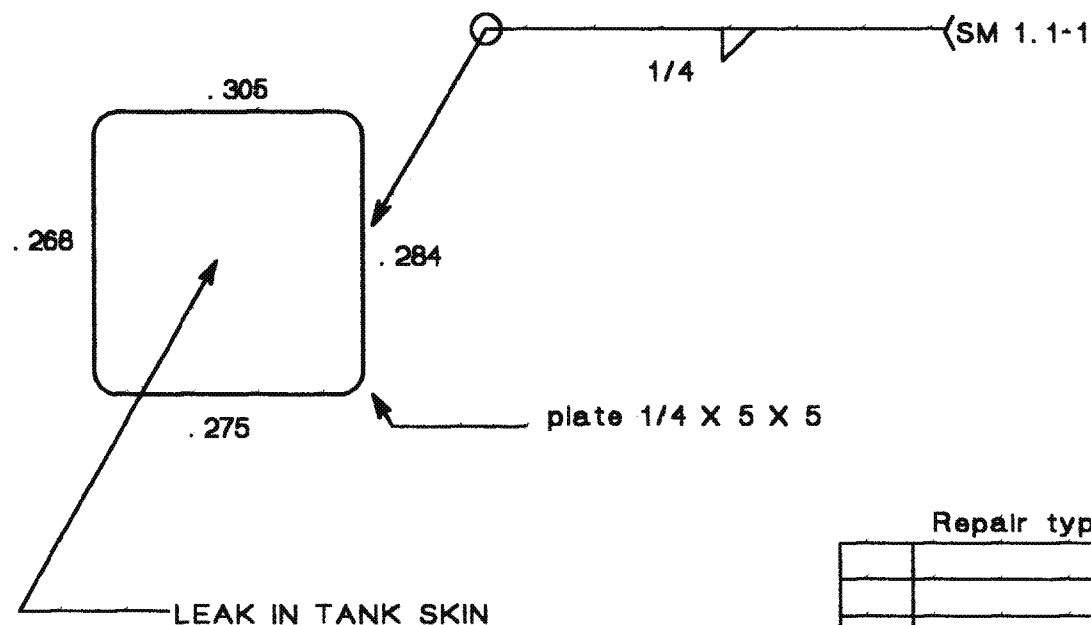
LTR	DESCRIPTION	BY	DATE
REVISIONS			
MID ATLANTIC ENVIRONMENTAL			
EMERGENCY REPAIRS FOR RED HILL TANKS			
Tank #10			
Repair No. 180		File 10-180	
Upper dome		Quadrant B	
Course EXTENSION		Plate 9	
Drawn by: Tom Kitchen		Date: 4/28/98

#### Repair type 5

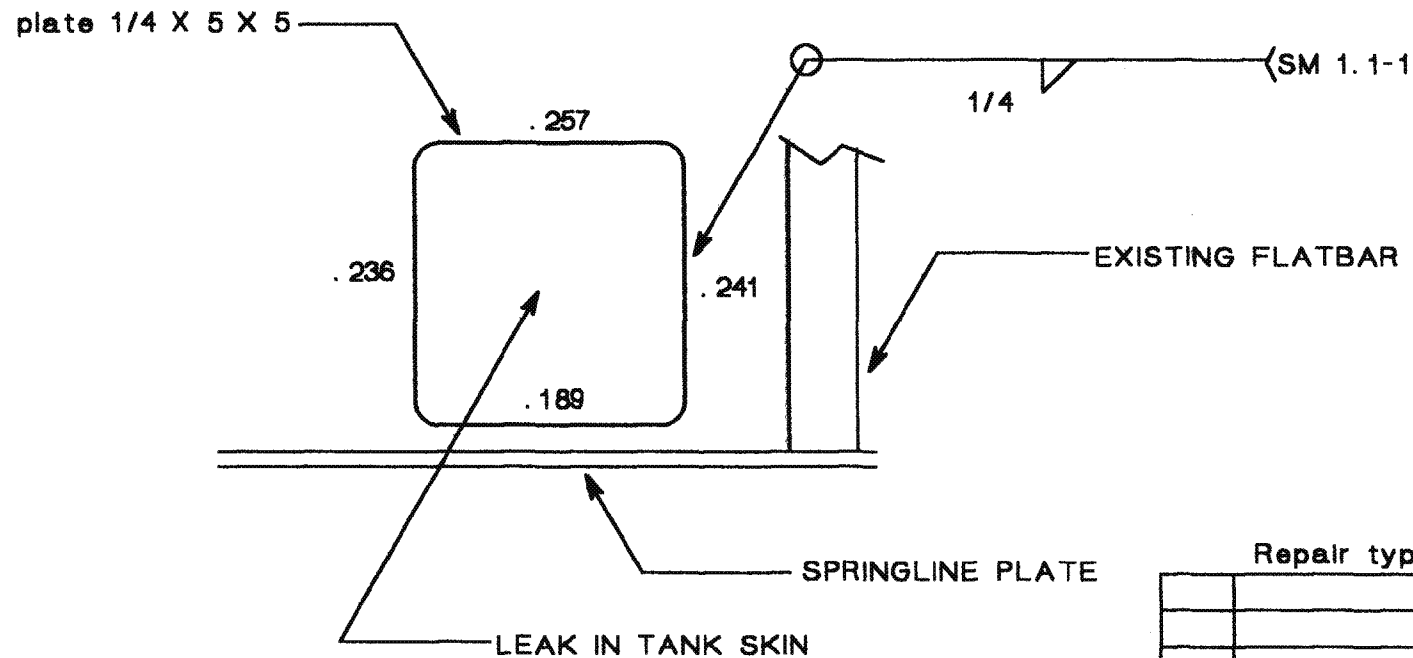
LTR	DESCRIPTION	BY	DATE
REVISIONS			
MID ATLANTIC ENVIRONMENTAL			
EMERGENCY REPAIRS FOR RED HILL TANKS			
Tank #10			
Repair No. 190		File 10-190	
Upper dome		Quadrant B	
Course EXTENSION		Plate 9	
Drawn by: Tom Kitchen		Date: 4/28/98

#### Repair type 5

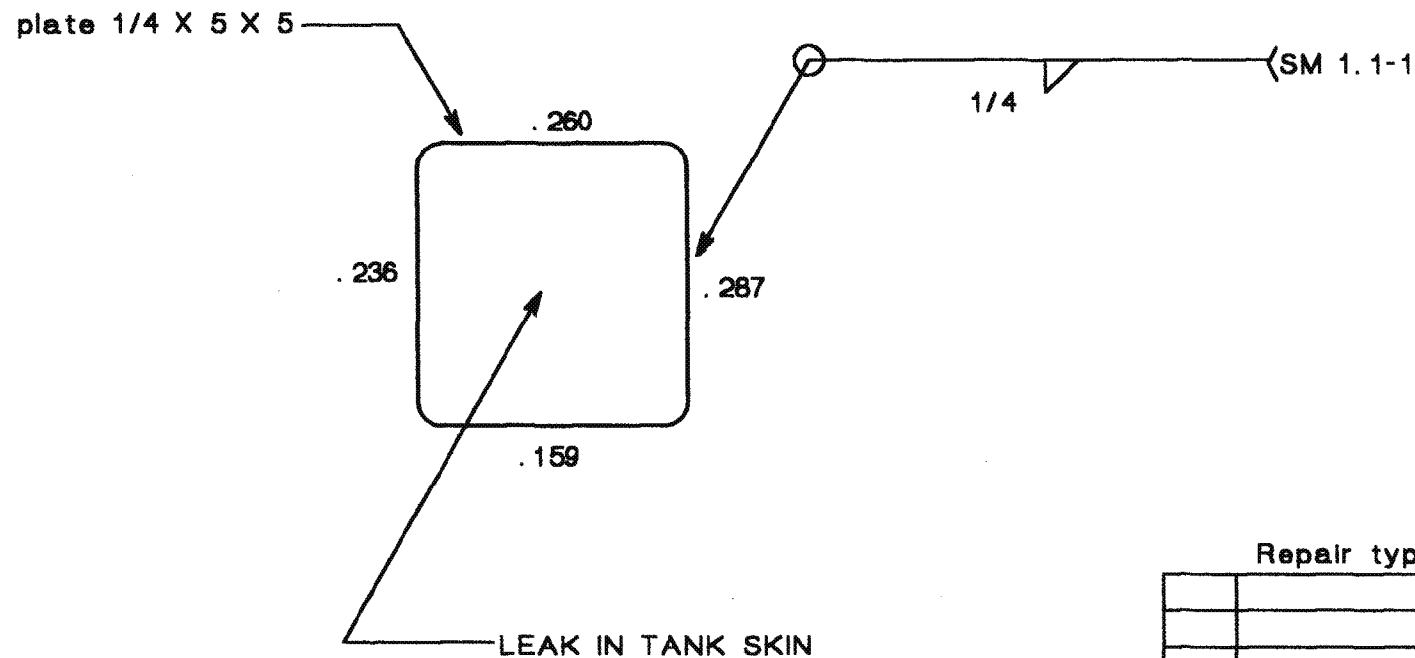
LTR	DESCRIPTION	BY	DATE
REVISIONS			
MID ATLANTIC ENVIRONMENTAL			
EMERGENCY REPAIRS FOR RED HILL TANKS			
Tank #10			
Repair No. 200		File 10r200	
Upper dome		Quadrant B	
Course EXTENSION		Plate 10	
Drawn by: Tom Kitchen		Date: 4/28/98

#### Repair type 5

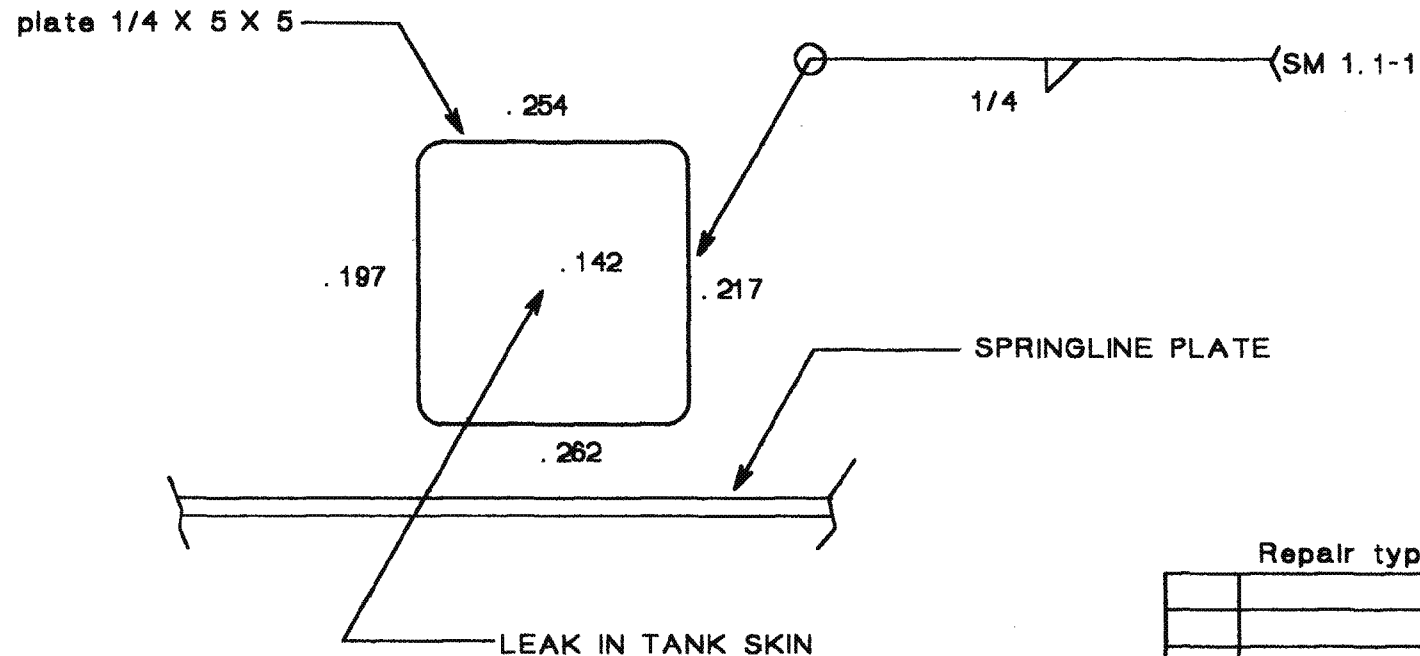
LTR	DESCRIPTION	BY	DATE
REVISIONS			
MID ATLANTIC ENVIRONMENTAL			
EMERGENCY REPAIRS FOR RED HILL TANKS			
Tank #10			
Repair No. 210	File 10r210		
Upper dome	Quadrant B		
Course EXTENSION	Plate 10		
Drawn by: Tom Kitchen	Date: 4/28/98

## Repair type 5

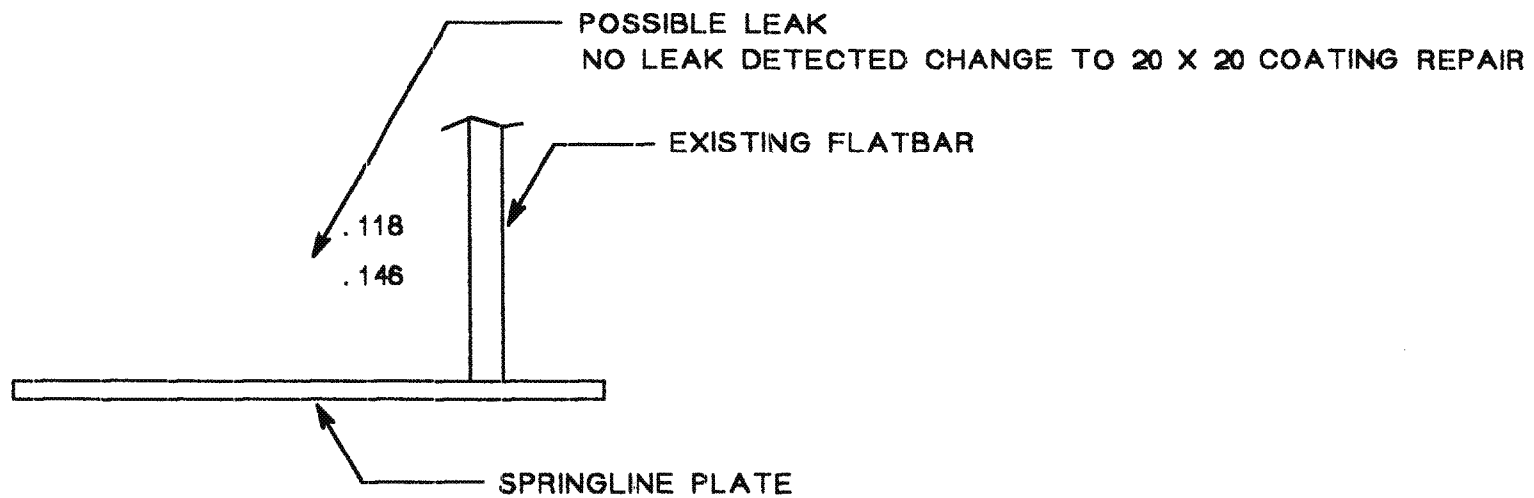
LTR	DESCRIPTION	BY	DATE
REVISIONS			
MID ATLANTIC ENVIRONMENTAL			
EMERGENCY REPAIRS FOR RED HILL TANKS			
Tank #10			
Repair No. 220		File 10udr220	
Upper dome		Quadrant B	
Course EXTENSION		Plate 11	
Drawn by: Tom Kitchen		Date: 5/13/98

#### TYPE 8 REPAIR

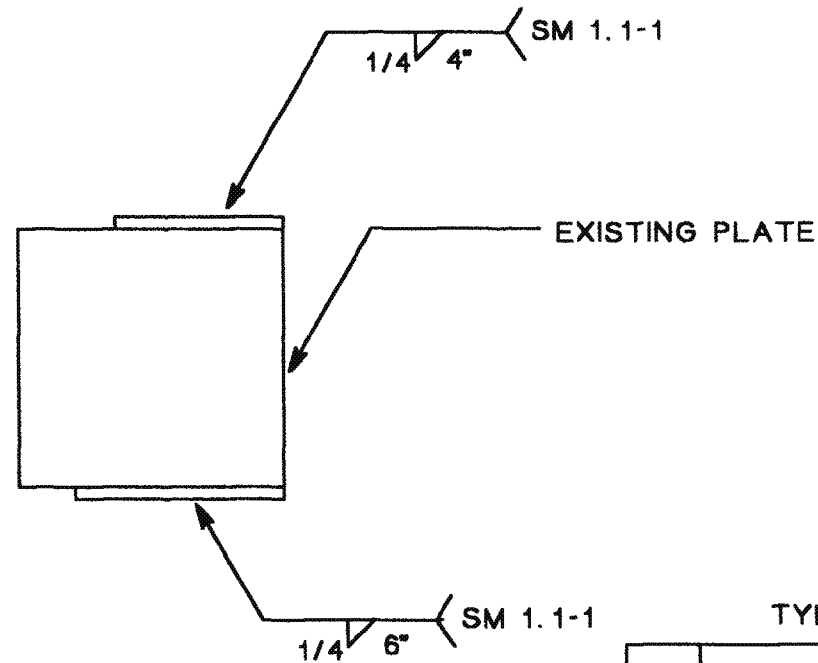
LTR	DESCRIPTION	BY	DATE
REVISIONS			
MID ATLANTIC ENVIRONMENTAL			
EMERGENCY REPAIRS FOR RED HILL TANKS			
Tank #10			
Repair No.: 230		File: 10r230	
Cylinder		Quadrant: B	
Course: 1		Plate: 11	
Drawn by: Tom Kitchen		Date: 5/13/98

#### TYPE 10 REPAIR

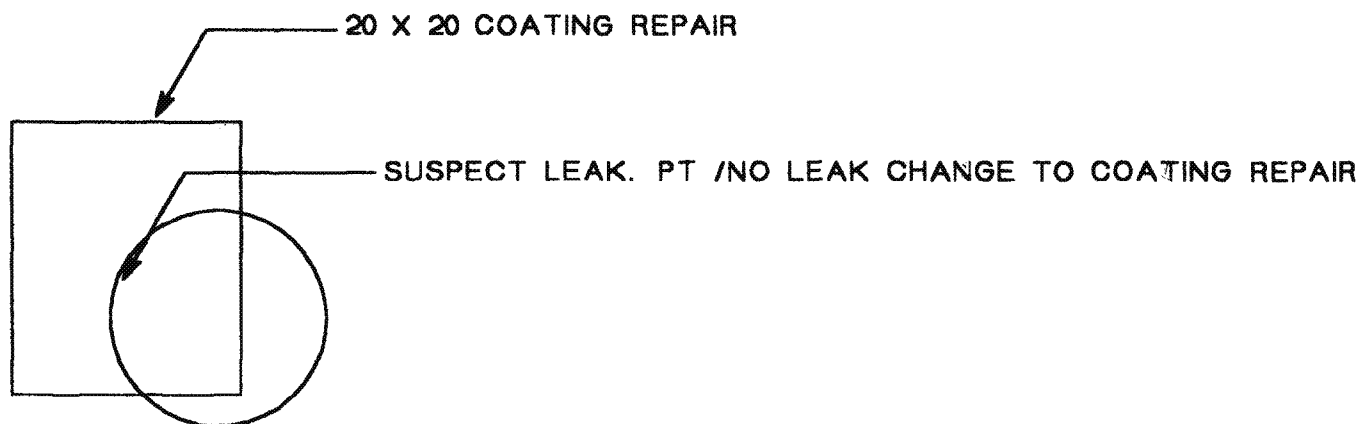
LTR	DESCRIPTION	BY	DATE
REVISIONS			
MID ATLANTIC ENVIRONMENTAL			
EMERGENCY REPAIRS FOR RED HILL TANKS			
Tank #10			
Repair No. 250		File 10r250	
Upper dome		Quadrant B	
Course EXTENSION		Plate 9	
Drawn by: Tom Kitchen		Date: 5/13/98

#### TYPE 8 REPAIR

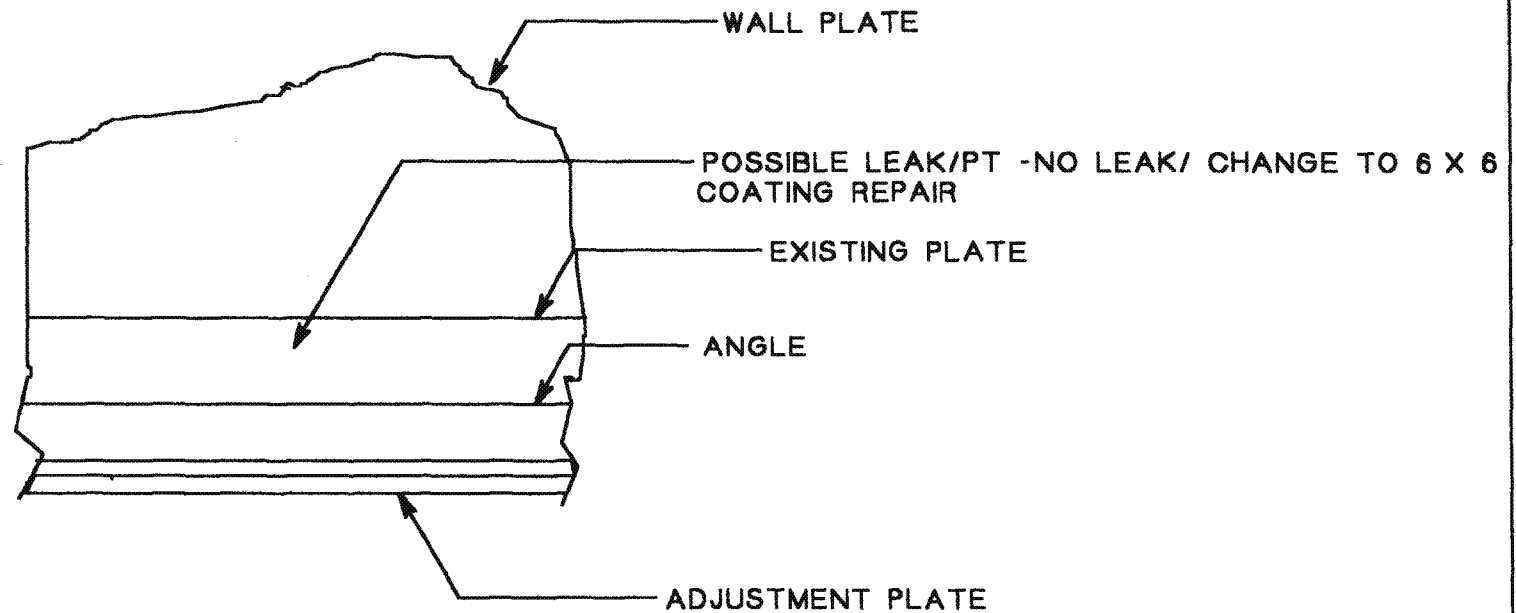
LTR	DESCRIPTION	BY	DATE
REVISIONS			
MID ATLANTIC ENVIRONMENTAL			
EMERGENCY REPAIRS FOR RED HILL TANKS			
Tank #10			
Repair No.: 260		File: 10-260	
Upper dome		Quadrant: B	
Course: EXTENSION		Plate: 9	
Drawn by: Tom Kitchen		Date: 5/13/98

#### TYPE 8 REPAIR
