LTR	DESCRIPTION	BY	DATE
<b>REVISIONS</b>			
<b>MID ATLANTIC ENVIRONMENTAL</b>			
<b>EMERGENCY REPAIRS FOR RED HILL TANKS</b>			
<b>Tank #10</b>			
Repair No. : 270	File:10r270		
Upper dome	Quadrant: B		
Course: EXTENSION	Plate: 10		
Drawn by: Tom Kitcher	Date: 5/13/98

**Dames & Moore**  
Emergency Repairs For Red Hill Tanks at the Fleet Industrial & Supply Center  
Contract No. N62742-96-C-1356

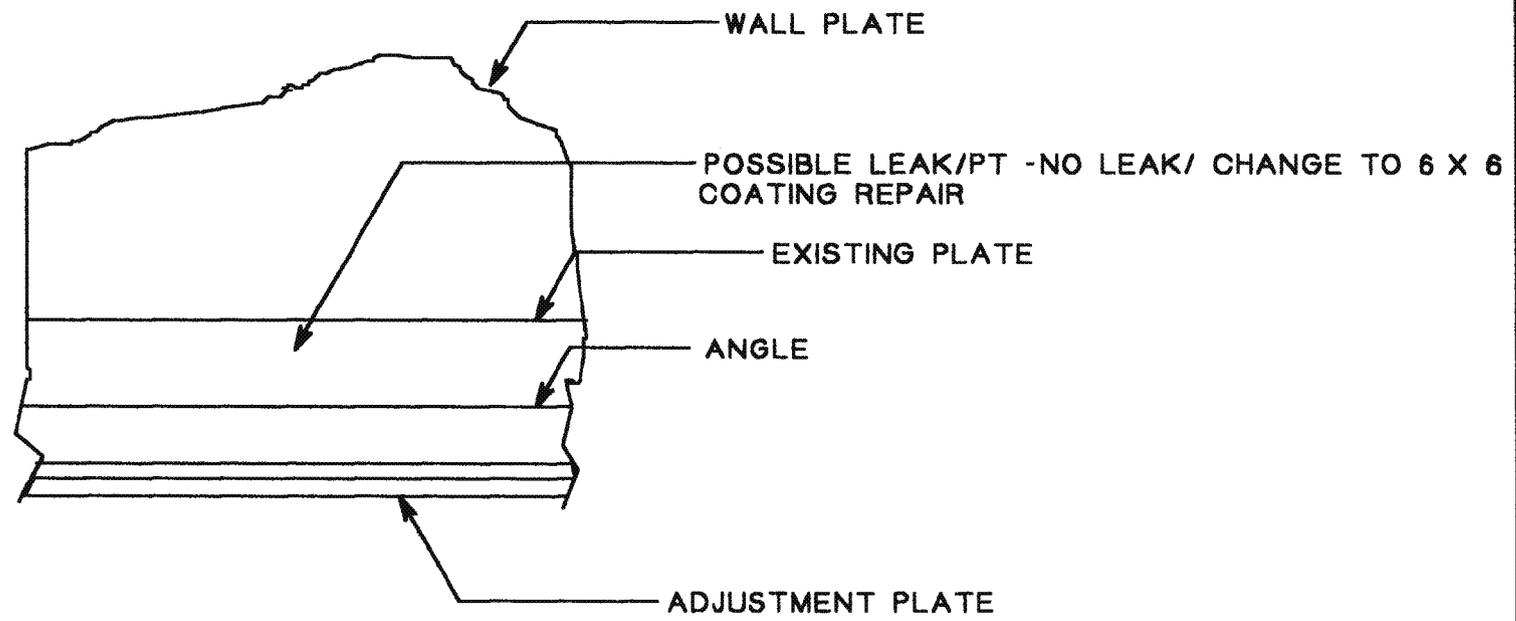
**TYPE 8 REPAIR**

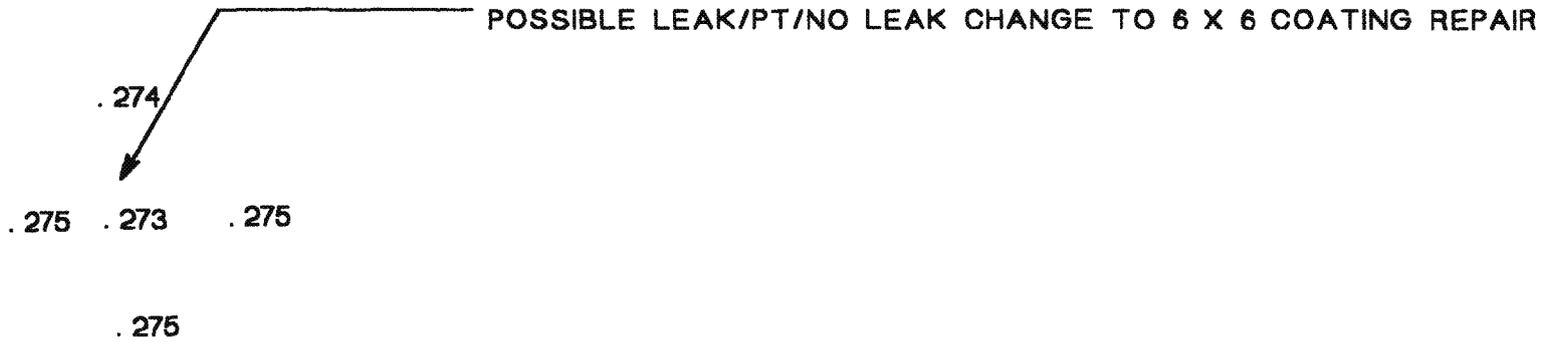
TYPE 8 REPAIR

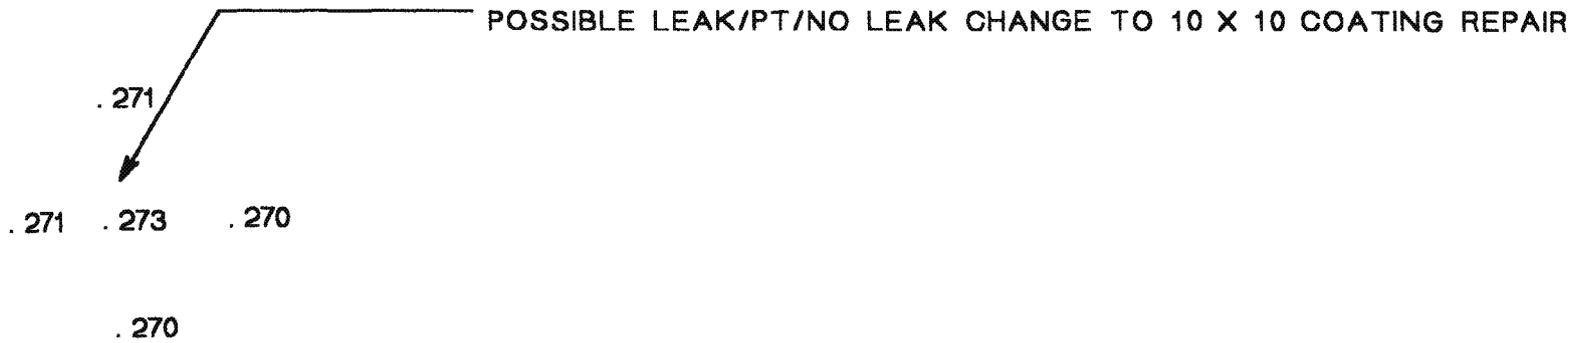
TYPE 8 REPAIR

CLEAN TO BARE METAL + PERFORM P.T.  
PER T. Kitchen

NO DEFECTS FOUND Type 8 JJK  
3/22/98

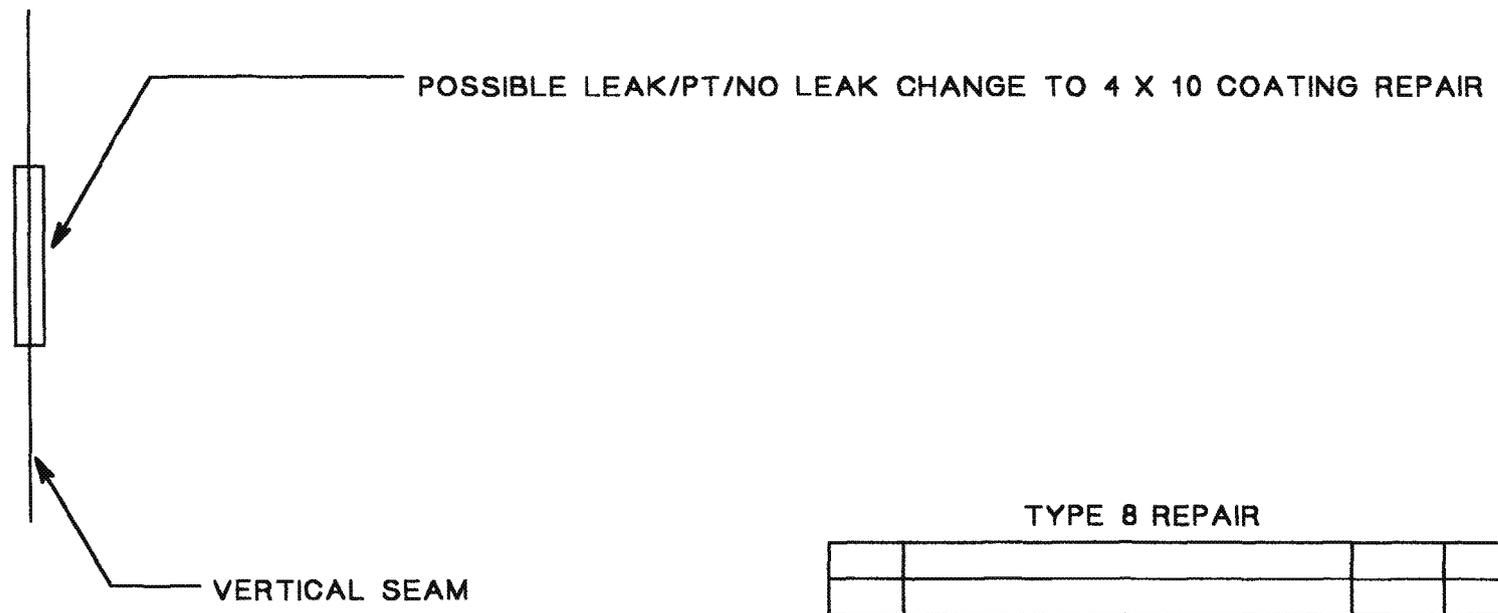
**TYPE 8 REPAIR**

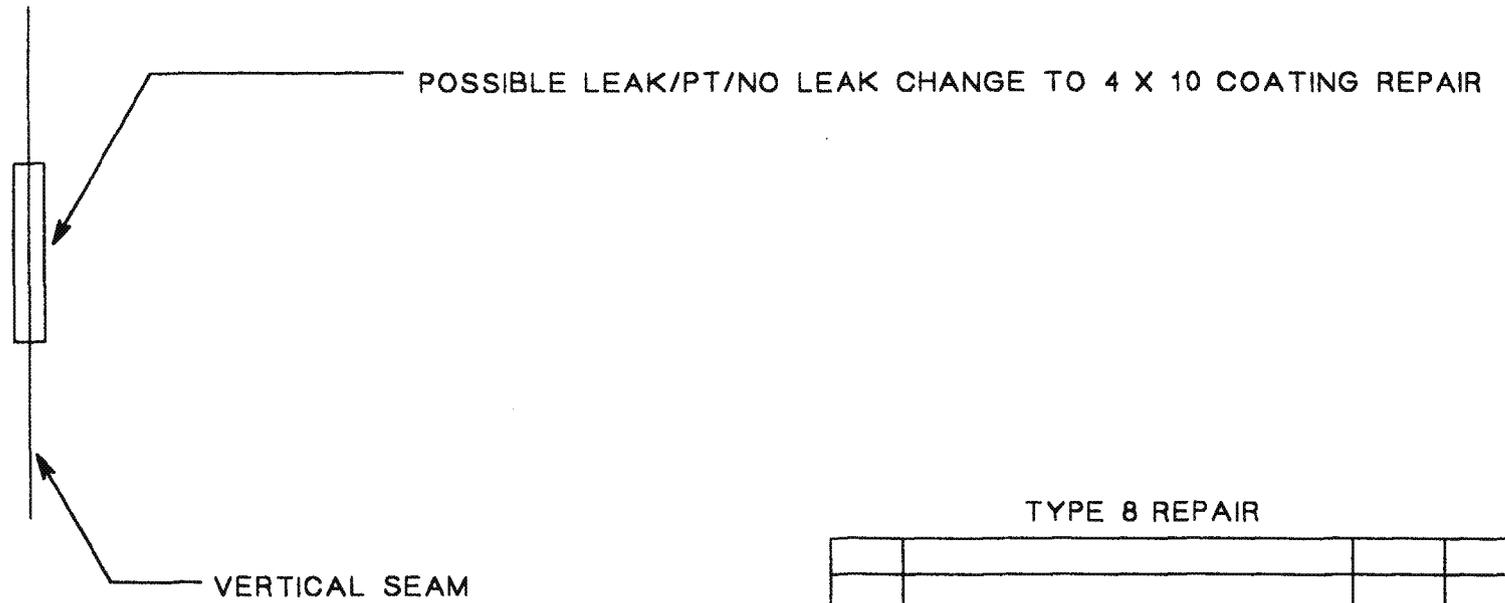
TYPE 8 REPAIR

CLEAN TO BARE METAL & PERFORM P.T.  
PER T. KITCHEN

NO DEFECTS FOUND    Type 8    *JW* 3/22/98
