LTR	DESCRIPTION	BY	DATE
REVISIONS			
MID ATLANTIC ENVIRONMENTAL			
EMERGENCY REPAIRS FOR RED HILL TANKS			
Tank #10			
Repair No.: 340		File: 10r340	
Lower dome		Quadrant: A	
Course: 1		Plate: 3	
Drawn by: Tom Kitchen		Date: 5/13/98

**Emergency Repairs For Red Hill Tanks at the Fleet Industrial & Supply Center**  
Contract No. N62742-96-C-1356

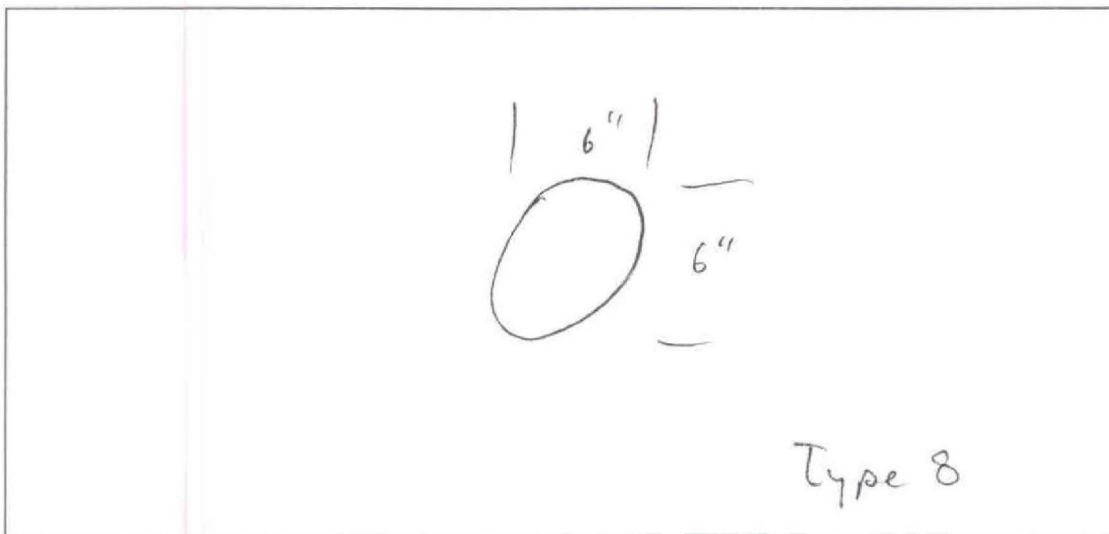
Tank No.: 10      Repair No.: 341      Type: 8      Location: A

6 X 6 COATING REPAIR

TYPE 8 REPAIR

Coating Type: Epoxy

Surface Preparation: ☒ Primer Coat: ☒ Intermediate Coat: ☒ Final Coat: ☒

NDT Performed: Visual: ✓ DFT: ✓ Average DFT: 8 mils - 15 mils

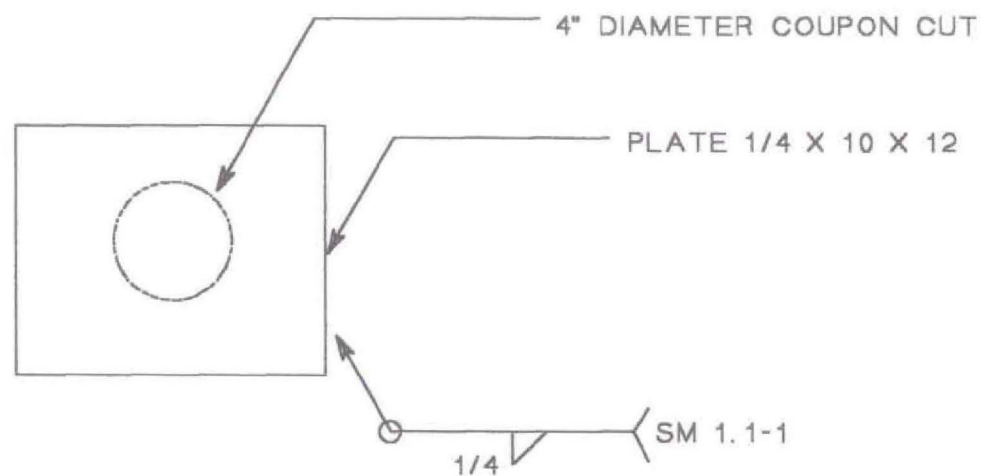
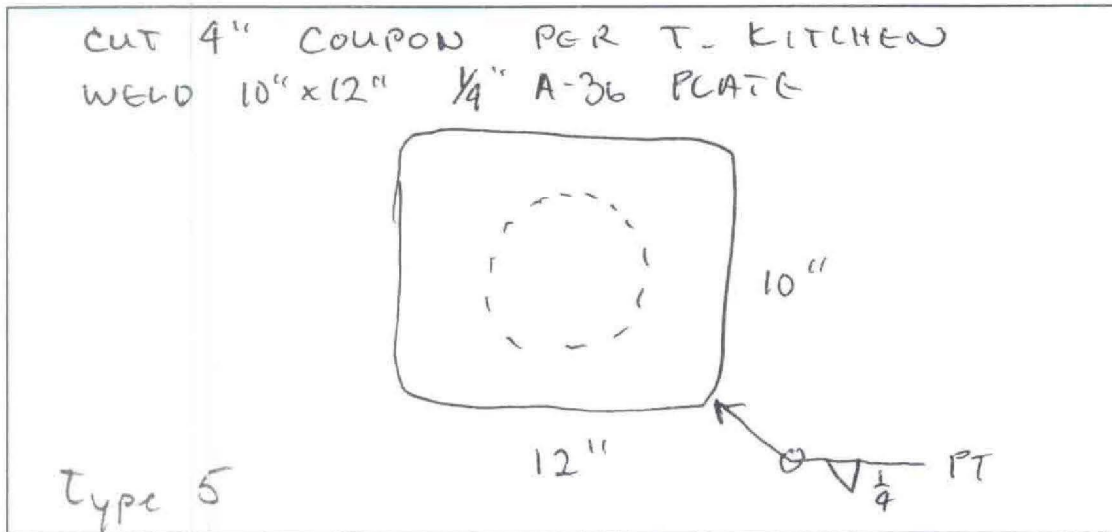
Tank No.: 10      Repair No.: 342      Type: 5      Location: B

#### TYPE 5 REPAIR

Weld Repair

WPS No.: SMI.1-1

NDT Performed:      Visual ☒      Vacuum Box ☐      Dye Penetrant ☒

Coating Type: Epoxy

Surface Preparation: ☒      Primer Coat: ☒      Intermediate Coat: ☒      Final Coat: ☒

NDT Performed:      Visual: ☒      DFT: ☒      Average DFT: 8 mils - 15 mils

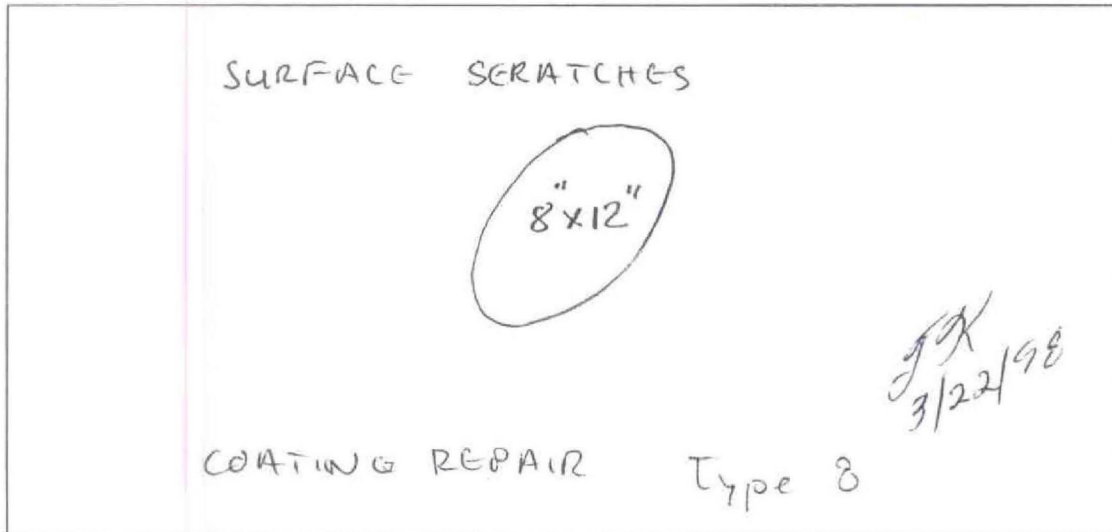
Tank No.: 10 Repair No.: 410 Type: 2 Location: A

8 X 12 COATING REPAIR

TYPE 8 REPAIR

Coating Type: Epoxy

Surface Preparation: ☒ Primer Coat: ☒ Intermediate Coat: ☒ Final Coat: ☒

NDT Performed: Visual: ☒ DFT: ☒ Average DFT: 13 mils - 20 mils

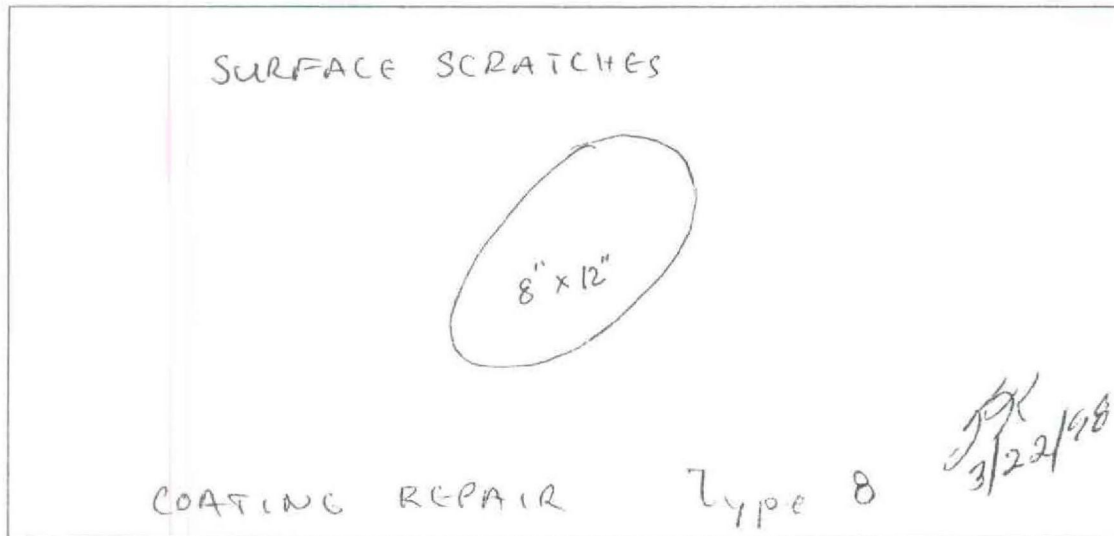
Tank No.: 10 Repair No.: 420 Type: 2 Location: A

8 X 12 COATING REPAIR

TYPE 8 REPAIR

Coating Type: Epoxy

Surface Preparation: ☒ Primer Coat: ☒ Intermediate Coat: ☒ Final Coat: ☒

NDT Performed: Visual: ☒ DFT: ☒ Average DFT: 13 mils - 20 mils

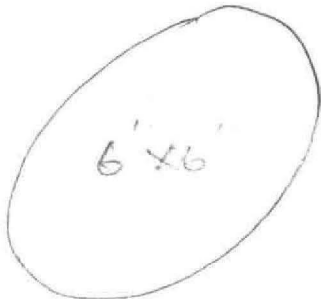
Tank No.: 10      Repair No.: 620      Type: 8      Location: C

SURFACE SCRATCHES

COATING REPAIR

Coating Type: Epoxy

Surface Preparation: ✓ Primer Coat: ✓ Intermediate Coat: ✓ Final Coat: ✓

NDT Performed: Visual: ✓ DFT: ✓ Average DFT: 13 m/s - 20 m/s

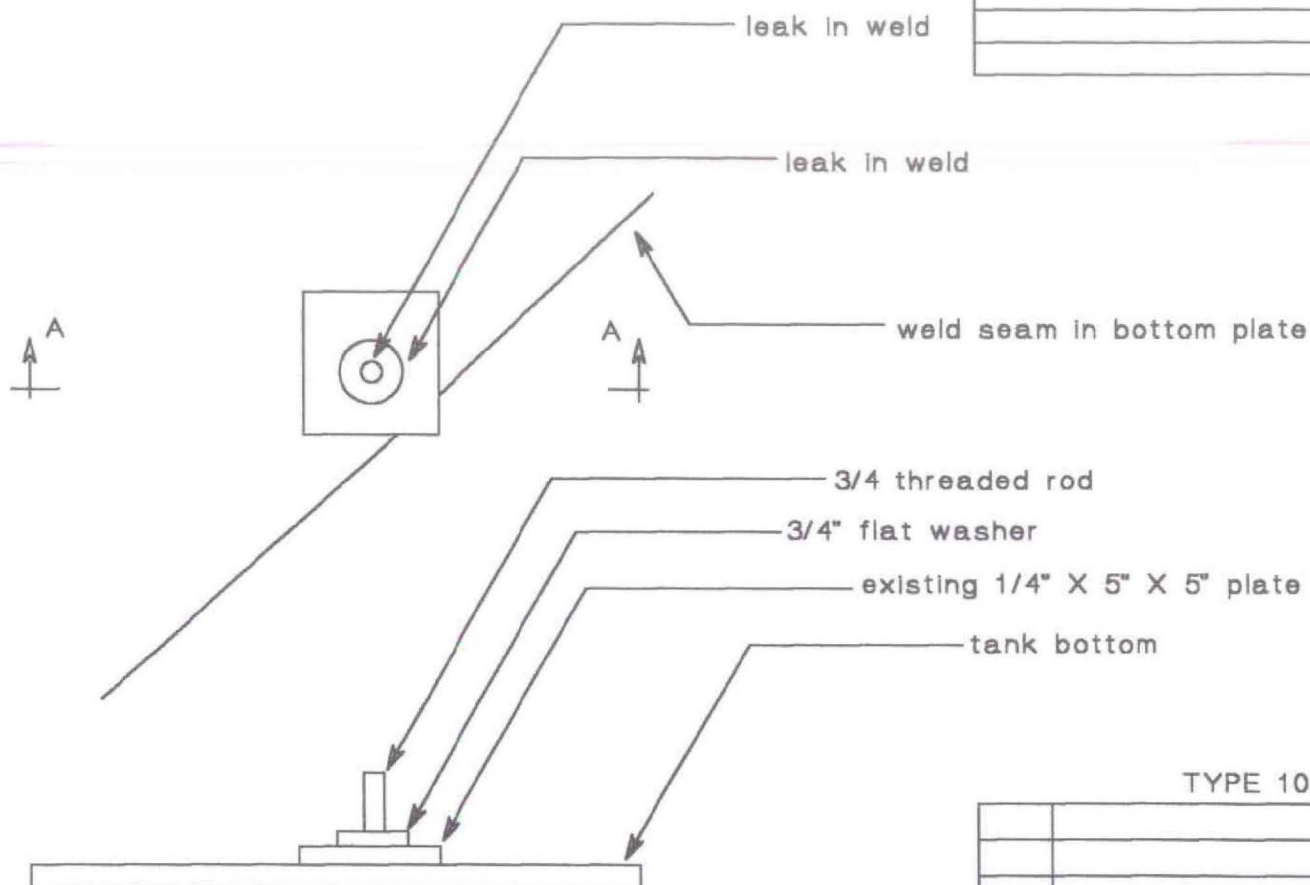
Tank No.: 10 Repair No.: 621 Type: \_\_\_\_\_ Location: Tank Bottom  
@ PL 17/18

#### TYPE 10 REPAIR

WPS No.: Sm1.1-1

NDT Performed: Visual ☒ Vacuum Box ☒ Dye Penetrant ☐

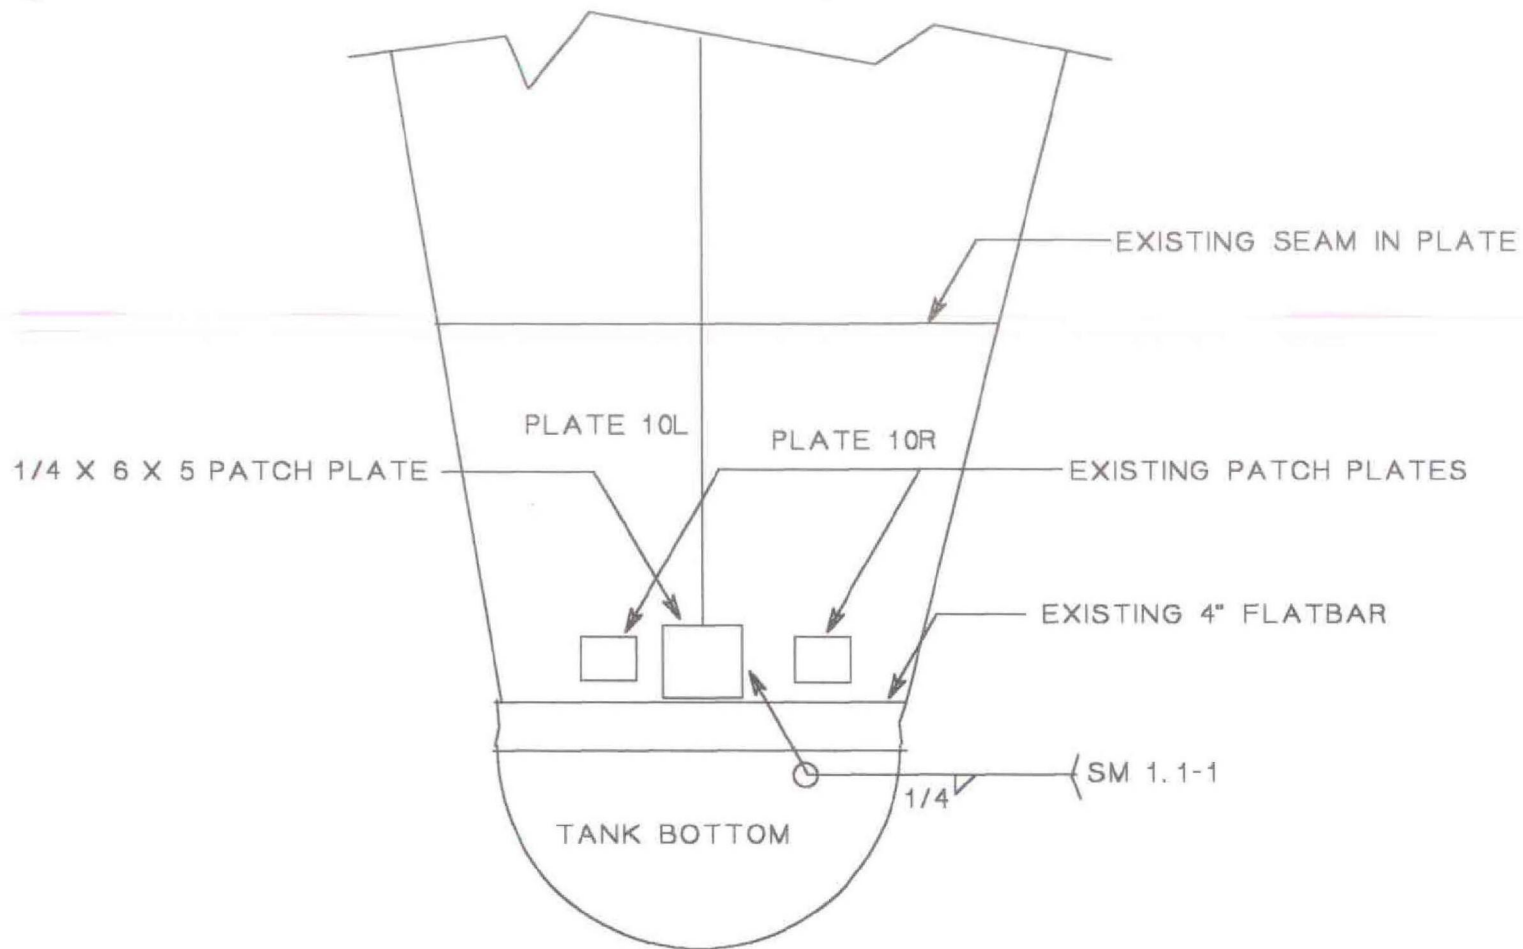
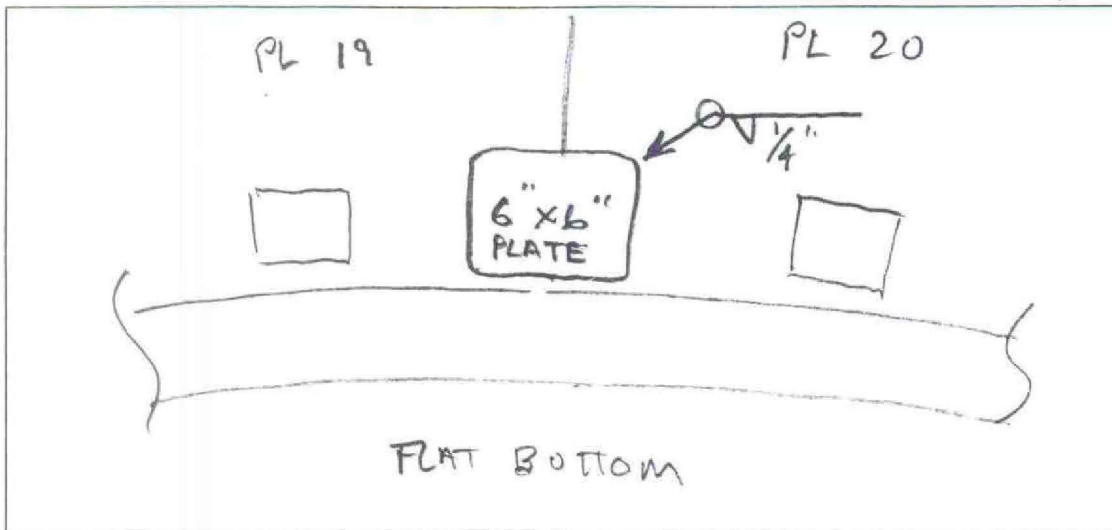
Tank No.: 10    Repair No.: 622    Type: 5    Location: Tank Bottom  
@ PL 19/20

#### TYPE 3 REPAIR

WPS No.: SM1.1-1

NDT Performed:                      Visual ☒                      Vacuum Box ☒                      Dye Penetrant ☐

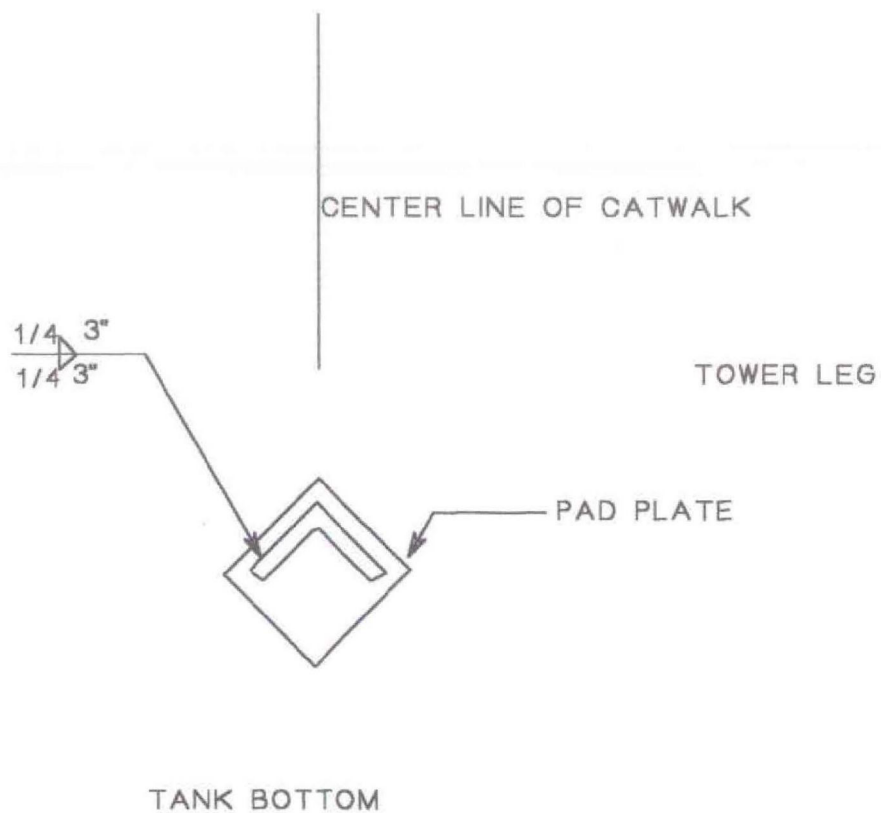
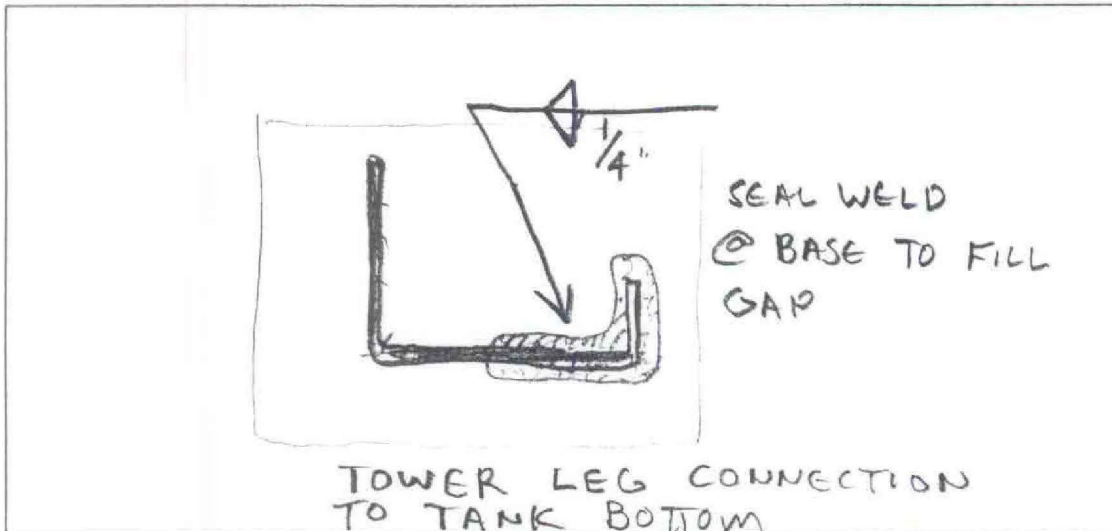
Tank No.: 10    Repair No.: 623    Type: \_\_\_\_\_    Location: Tank Bottom  
@ PL 1/2

#### TYPE 10 REPAIR

WPS No.: SML-1-1

NDT Performed:                      Visual ☒    Vacuum Box \_\_\_\_\_    Dye Penetrant \_\_\_\_\_

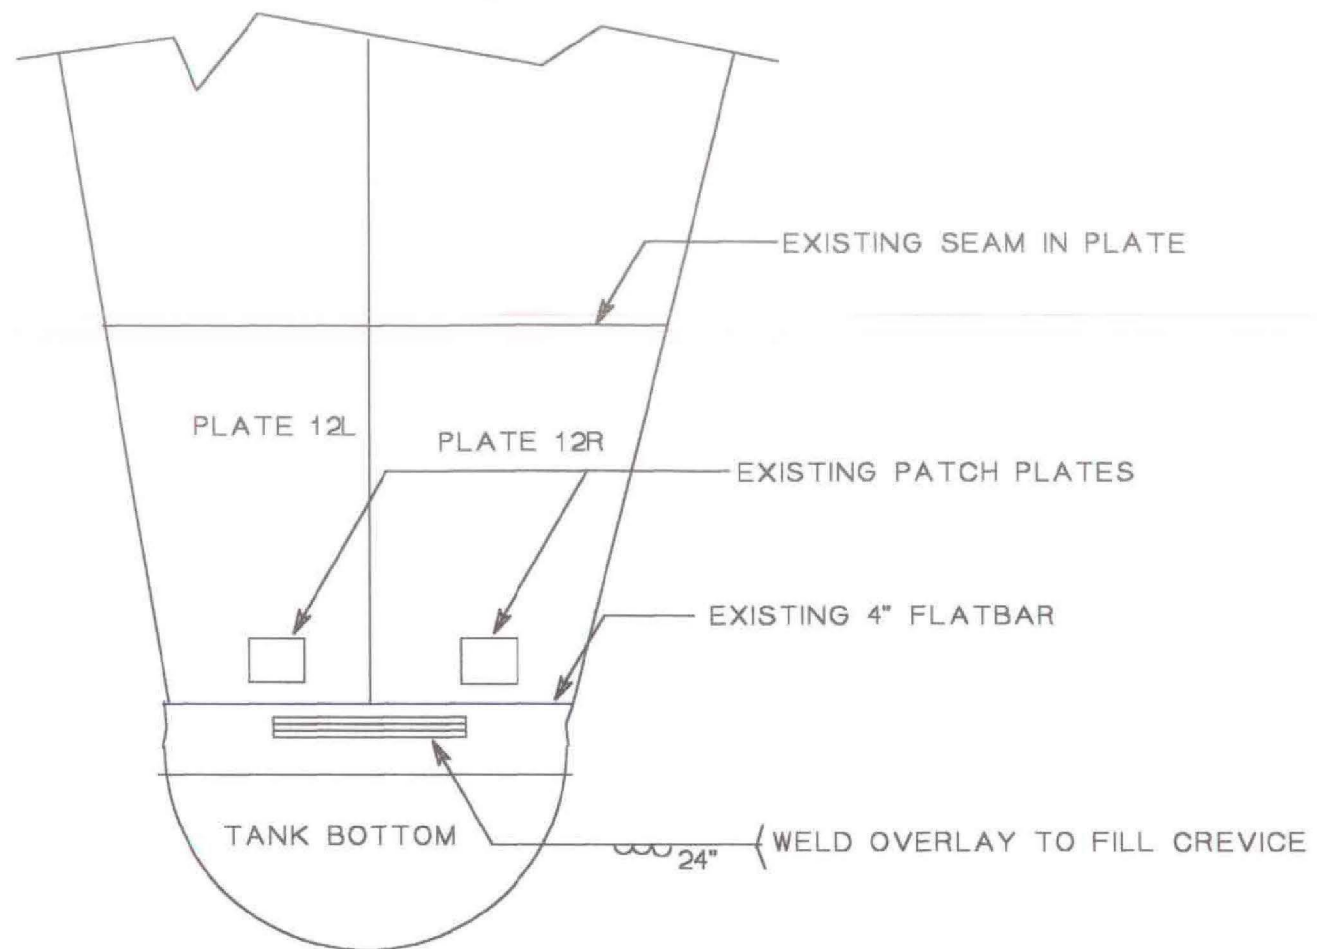
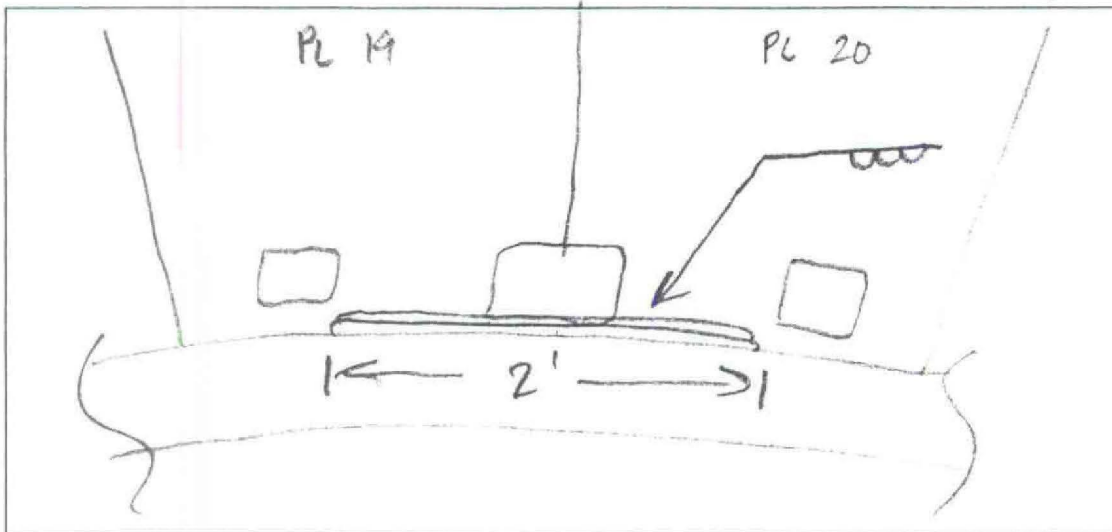
Tank No.: 10    Repair No.: 624    Type: \_\_\_\_\_    Location: Tank Bottom  
@ PL 19/20

#### TYPE 10 REPAIR

WPS No.: Sm1.1-1

NDT Performed:                      Visual ☒                      Vacuum Box ☒                      Dye Penetrant \_\_\_\_\_

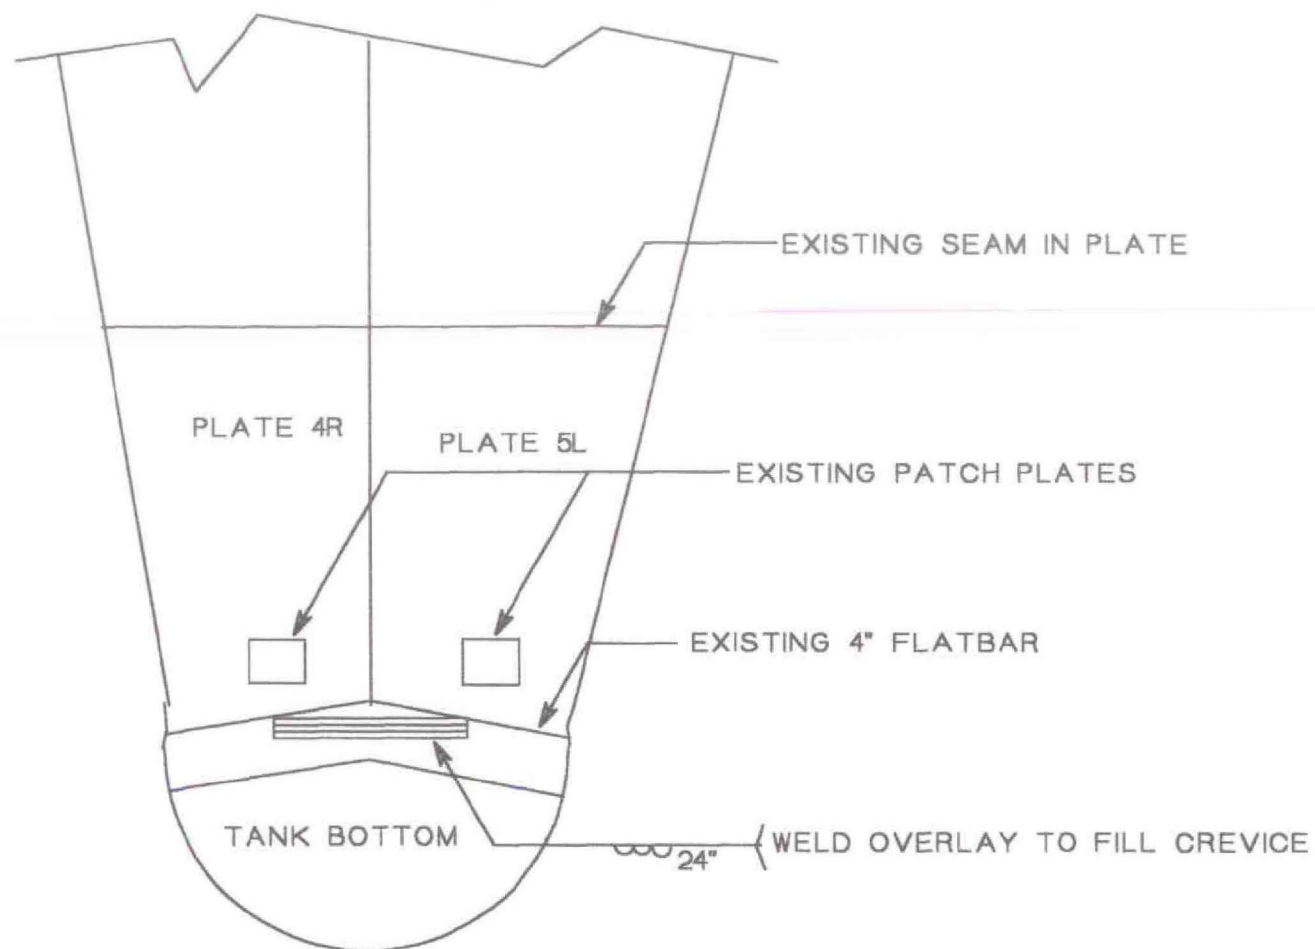
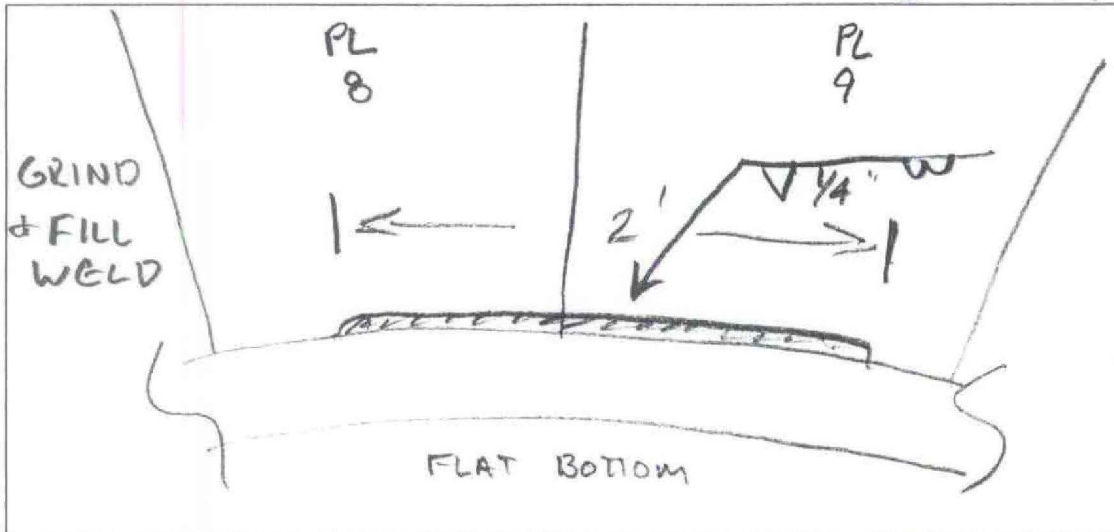
Tank No.: 10    Repair No.: 625    Type: \_\_\_\_\_    Location: Tank Bottom  
@ PL 8/9

#### TYPE 10 REPAIR

WPS No.: SM1.1-1

NDT Performed:                      Visual ☒                      Vacuum Box ☒                      Dye Penetrant \_\_\_\_\_

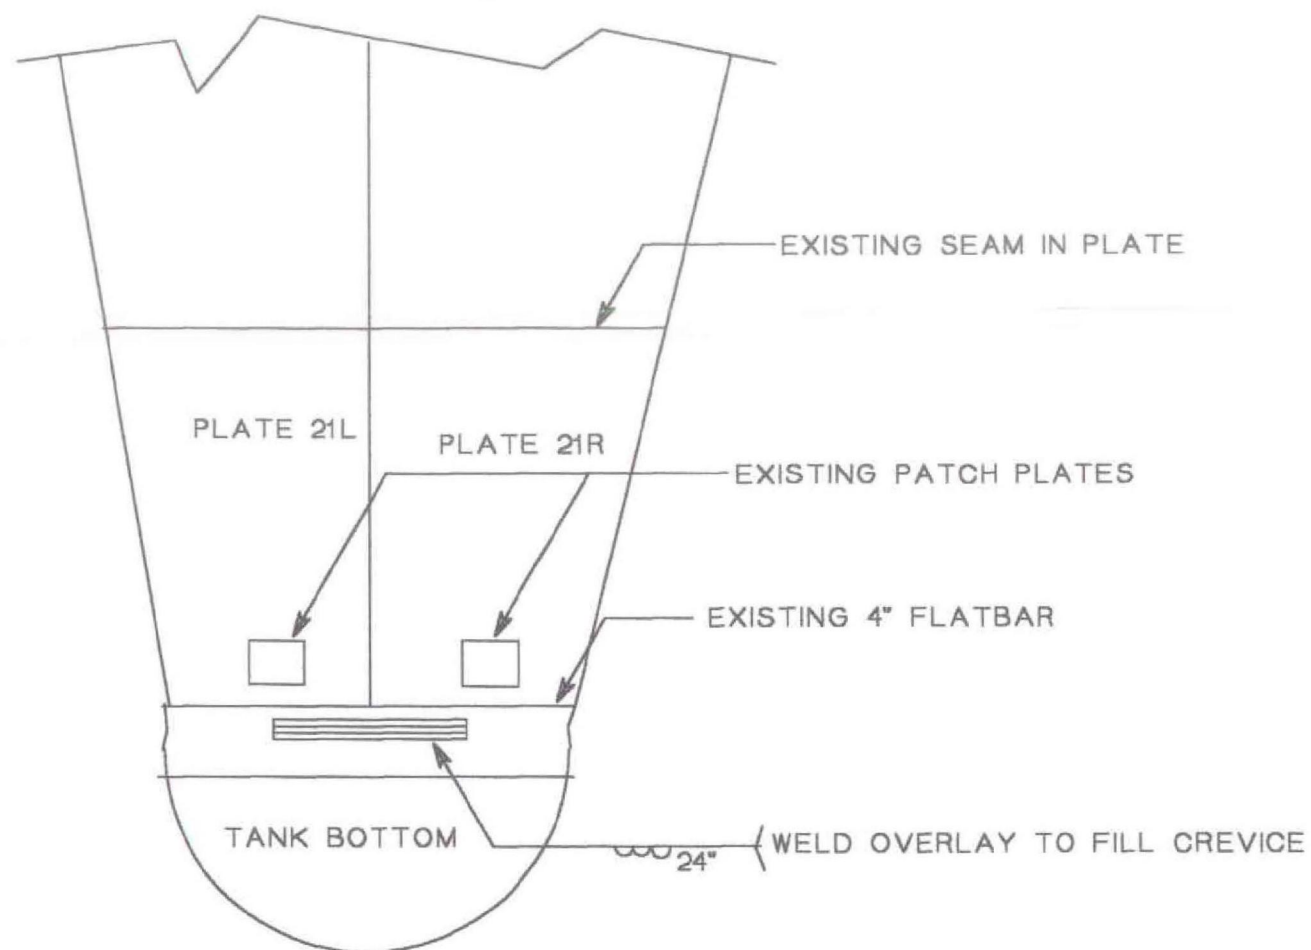
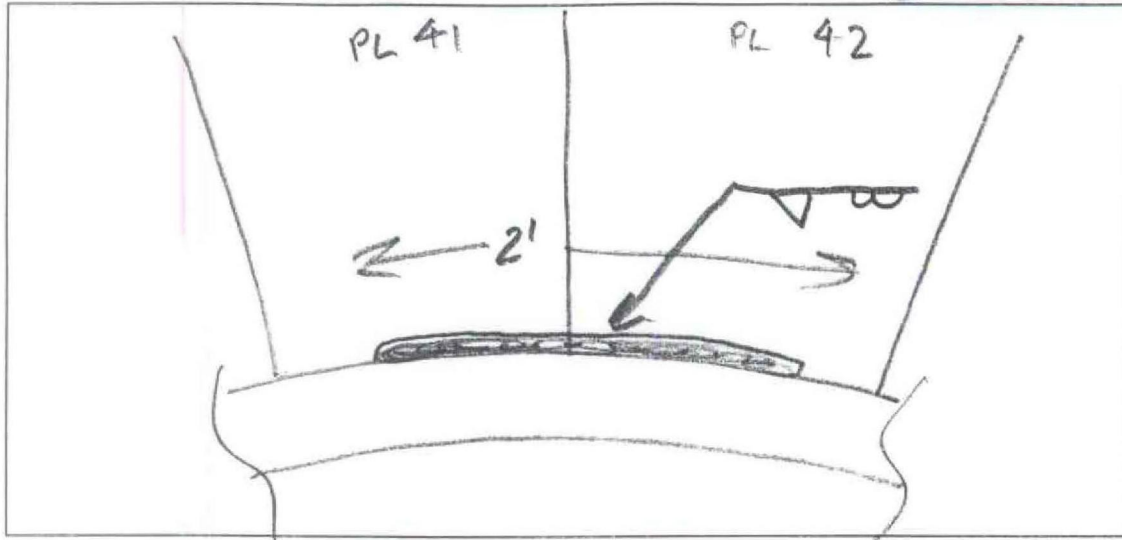
Tank No.: 10 Repair No.: 626 Type: \_\_\_\_\_ Location: Tank Bottom  
@ PL 41/42

# TYPE 10 REPAIR

WPS No.: SM1.1-1

NDT Performed: Visual ☒ Vacuum Box ☒ Dye Penetrant ☐

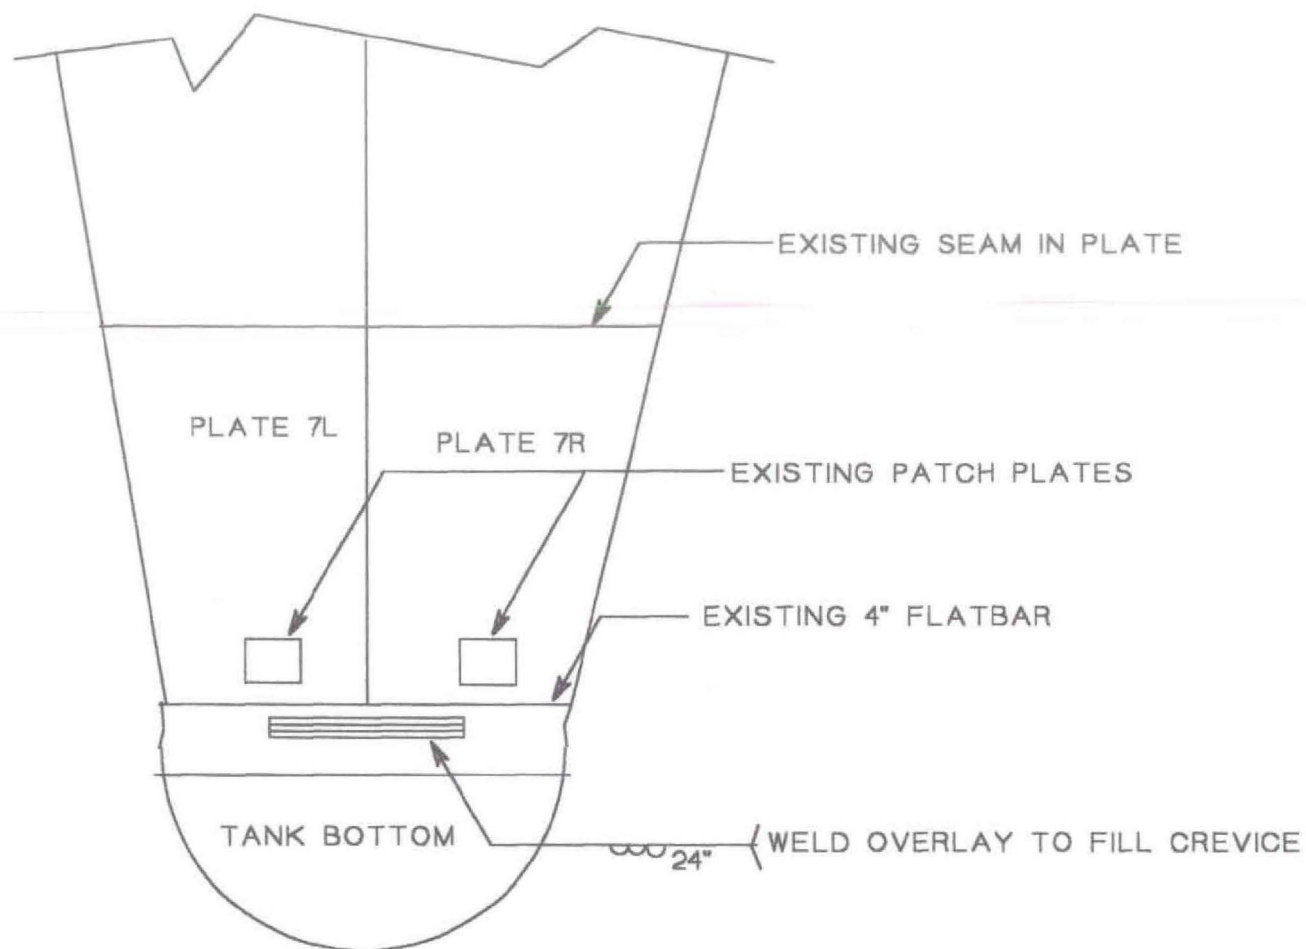
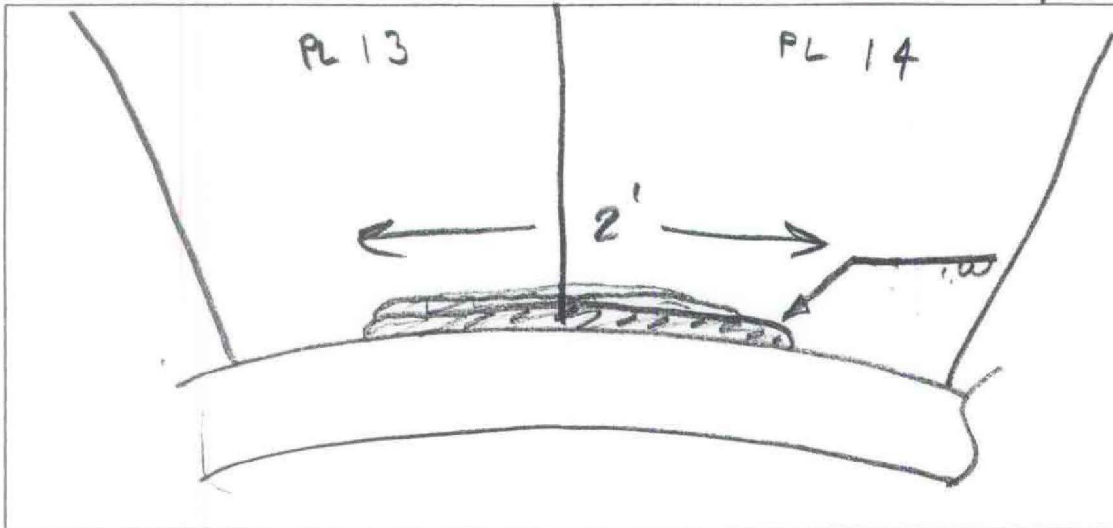
Tank No.: 10    Repair No.: 627    Type: \_\_\_\_\_    Location: Tank Bottom  
@ PL 13/14

#### TYPE 10 REPAIR

WPS No.: SM1.1-1

NDT Performed:                      Visual ☒                      Vacuum Box ☒                      Dye Penetrant \_\_\_\_\_

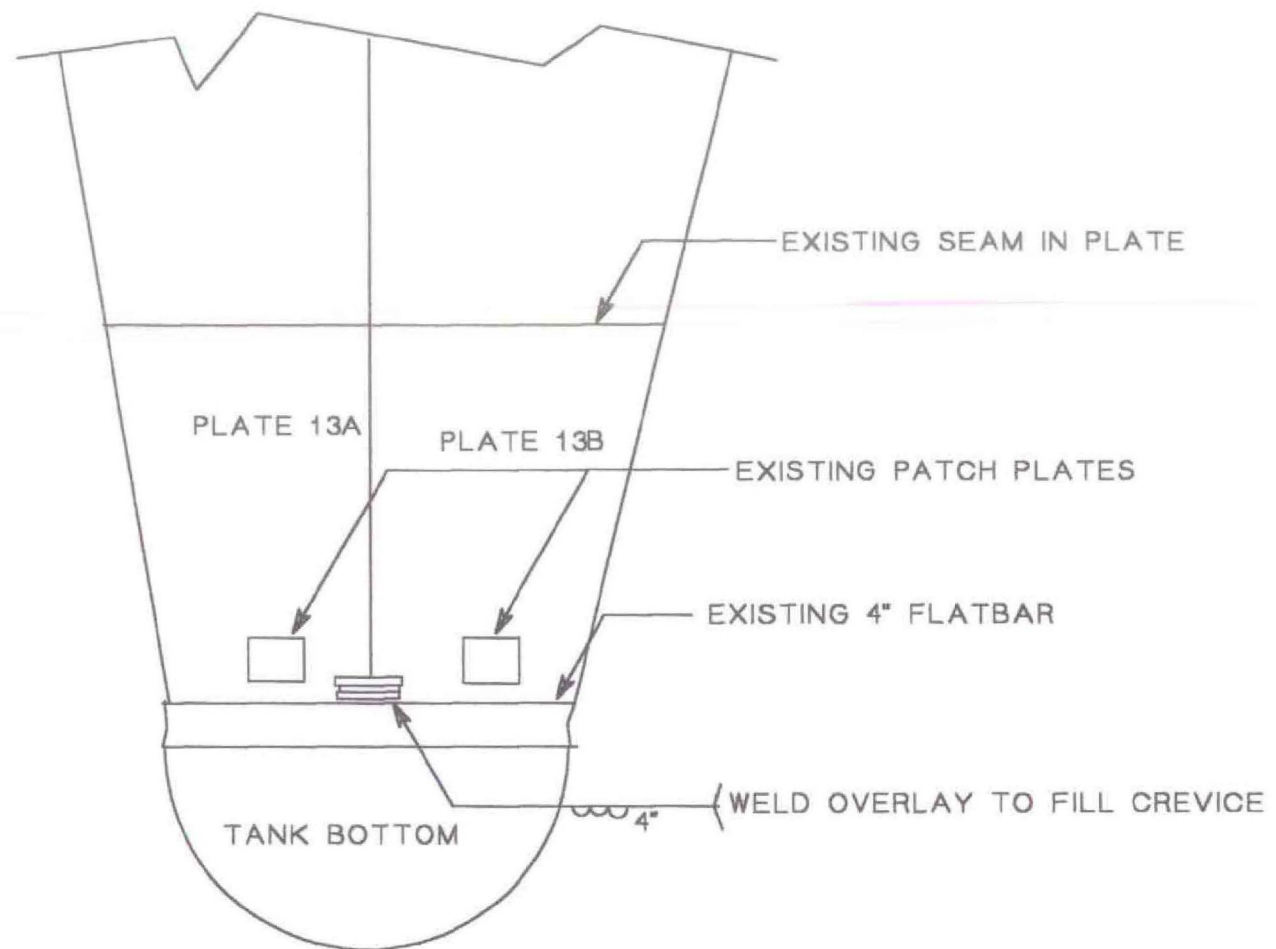
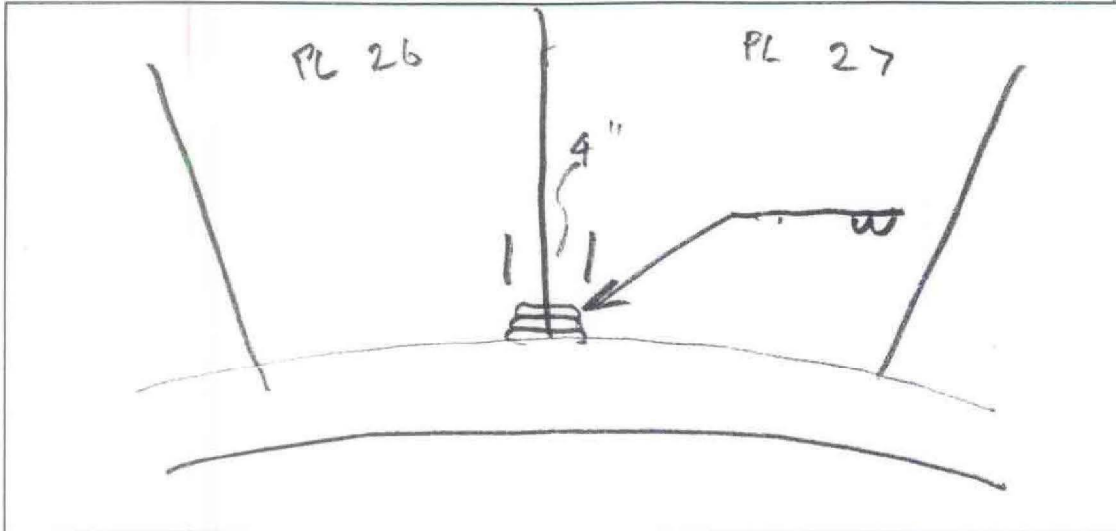
Tank No.: 10 Repair No.: 628 Type: \_\_\_\_\_ Location: Tank Bottom  
@ PL 26/27

#### TYPE 10 REPAIR

WPS No.: SMI.1-1

NDT Performed: Visual ☒ Vacuum Box ☒ Dye Penetrant ☐

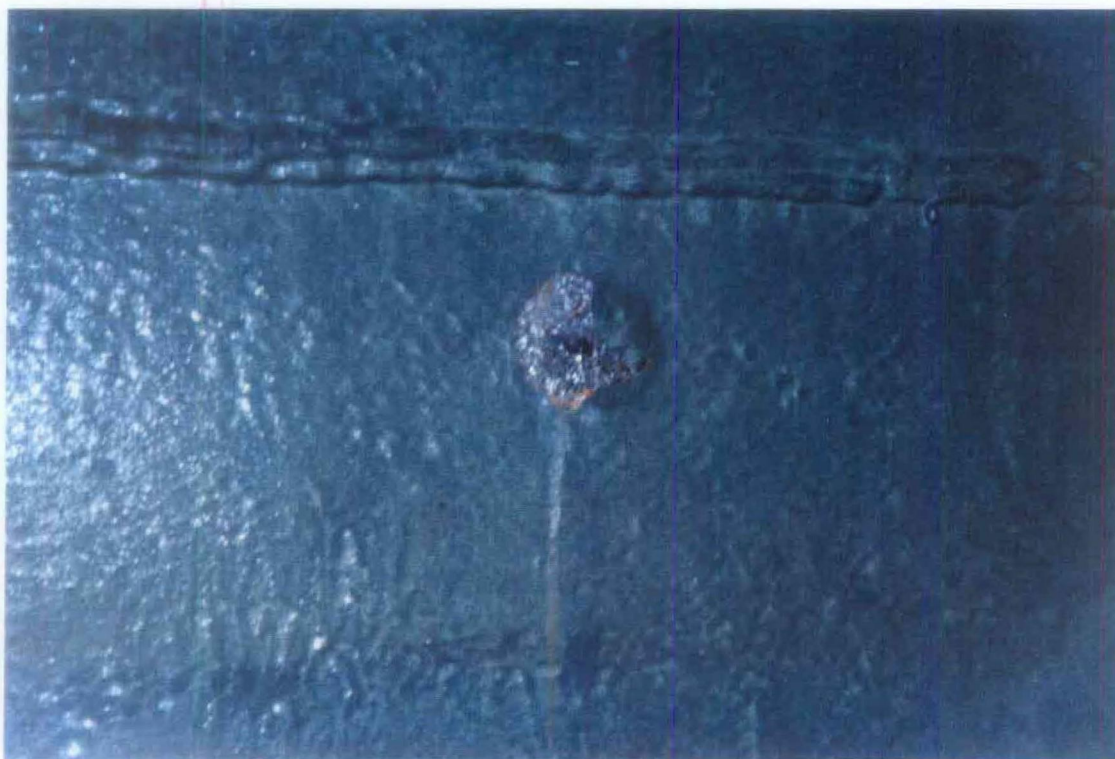
**PICTURE OF HOLE IN TANK WALL CAUSED BY BACKSIDE  
CORROSION**

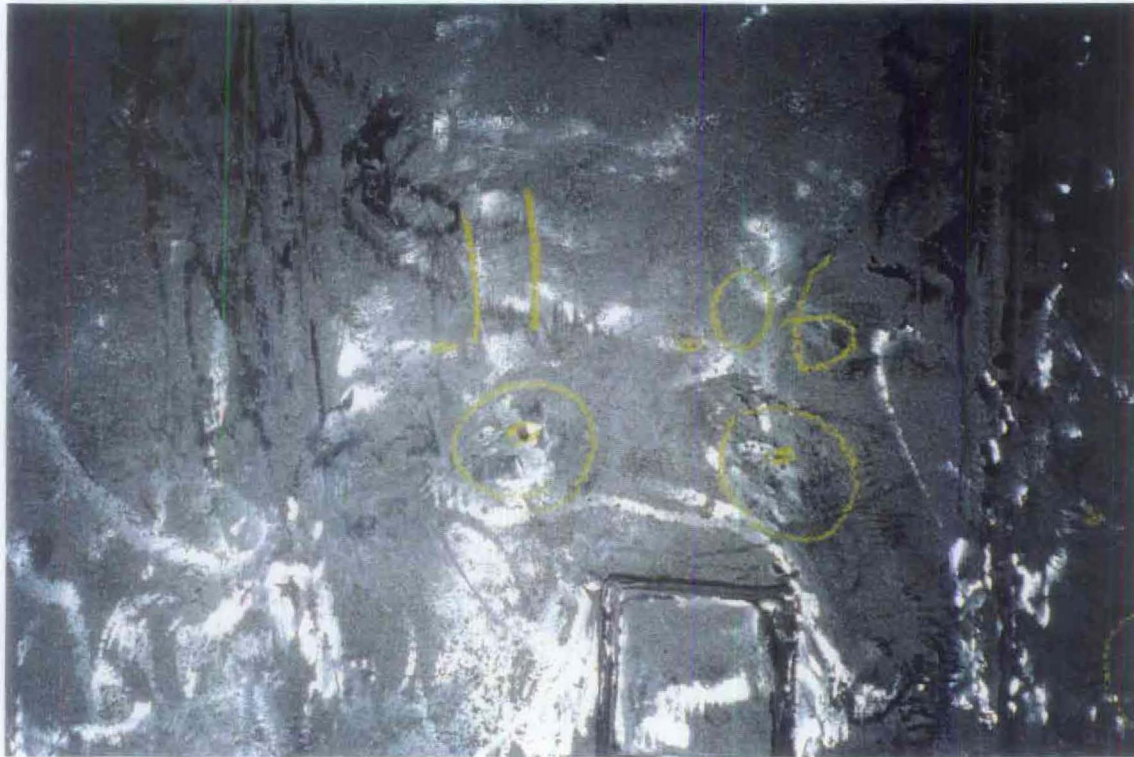
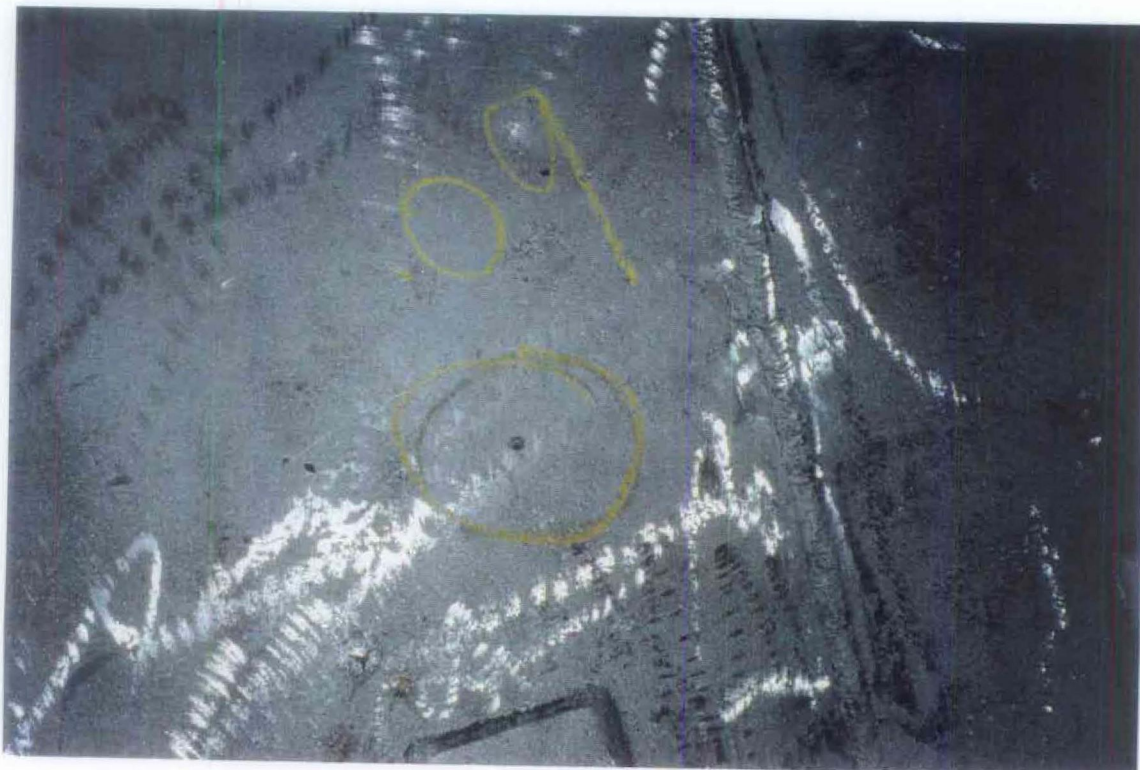
**PICTURE OF PITTING ON FIRST ASCENDING PLATES AT  
BOTTOM OF TANK #10**
