2.1 Mid Atlantic Environmental, Inc. conducted an inspection on Tank #8 at the Red Hill Underground Storage Facility, Pearl Harbor, Hawaii. This inspection was conducted in accordance with the scope of work identified by Contract Number N00604-97-R-0013, PRL 96-21, titled "Emergency Repair for Red Hill Tanks."

RED HILL TANK NO. 8  
PRODUCT: DFM

OI		TK	
LTR	DESCRIPTION	BY	DATE
REVISIONS			
MID ATLANTIC ENVIRONMENTAL			
EMERGENCY REPAIRS FOR RED HILL TANKS			
Tank #8			
Floor Layout		File #8fll0	
Tank bottom			
Drawn By: T. Kitchen		Date: 7/20/98

**Bottom Layout with Pit Indications**

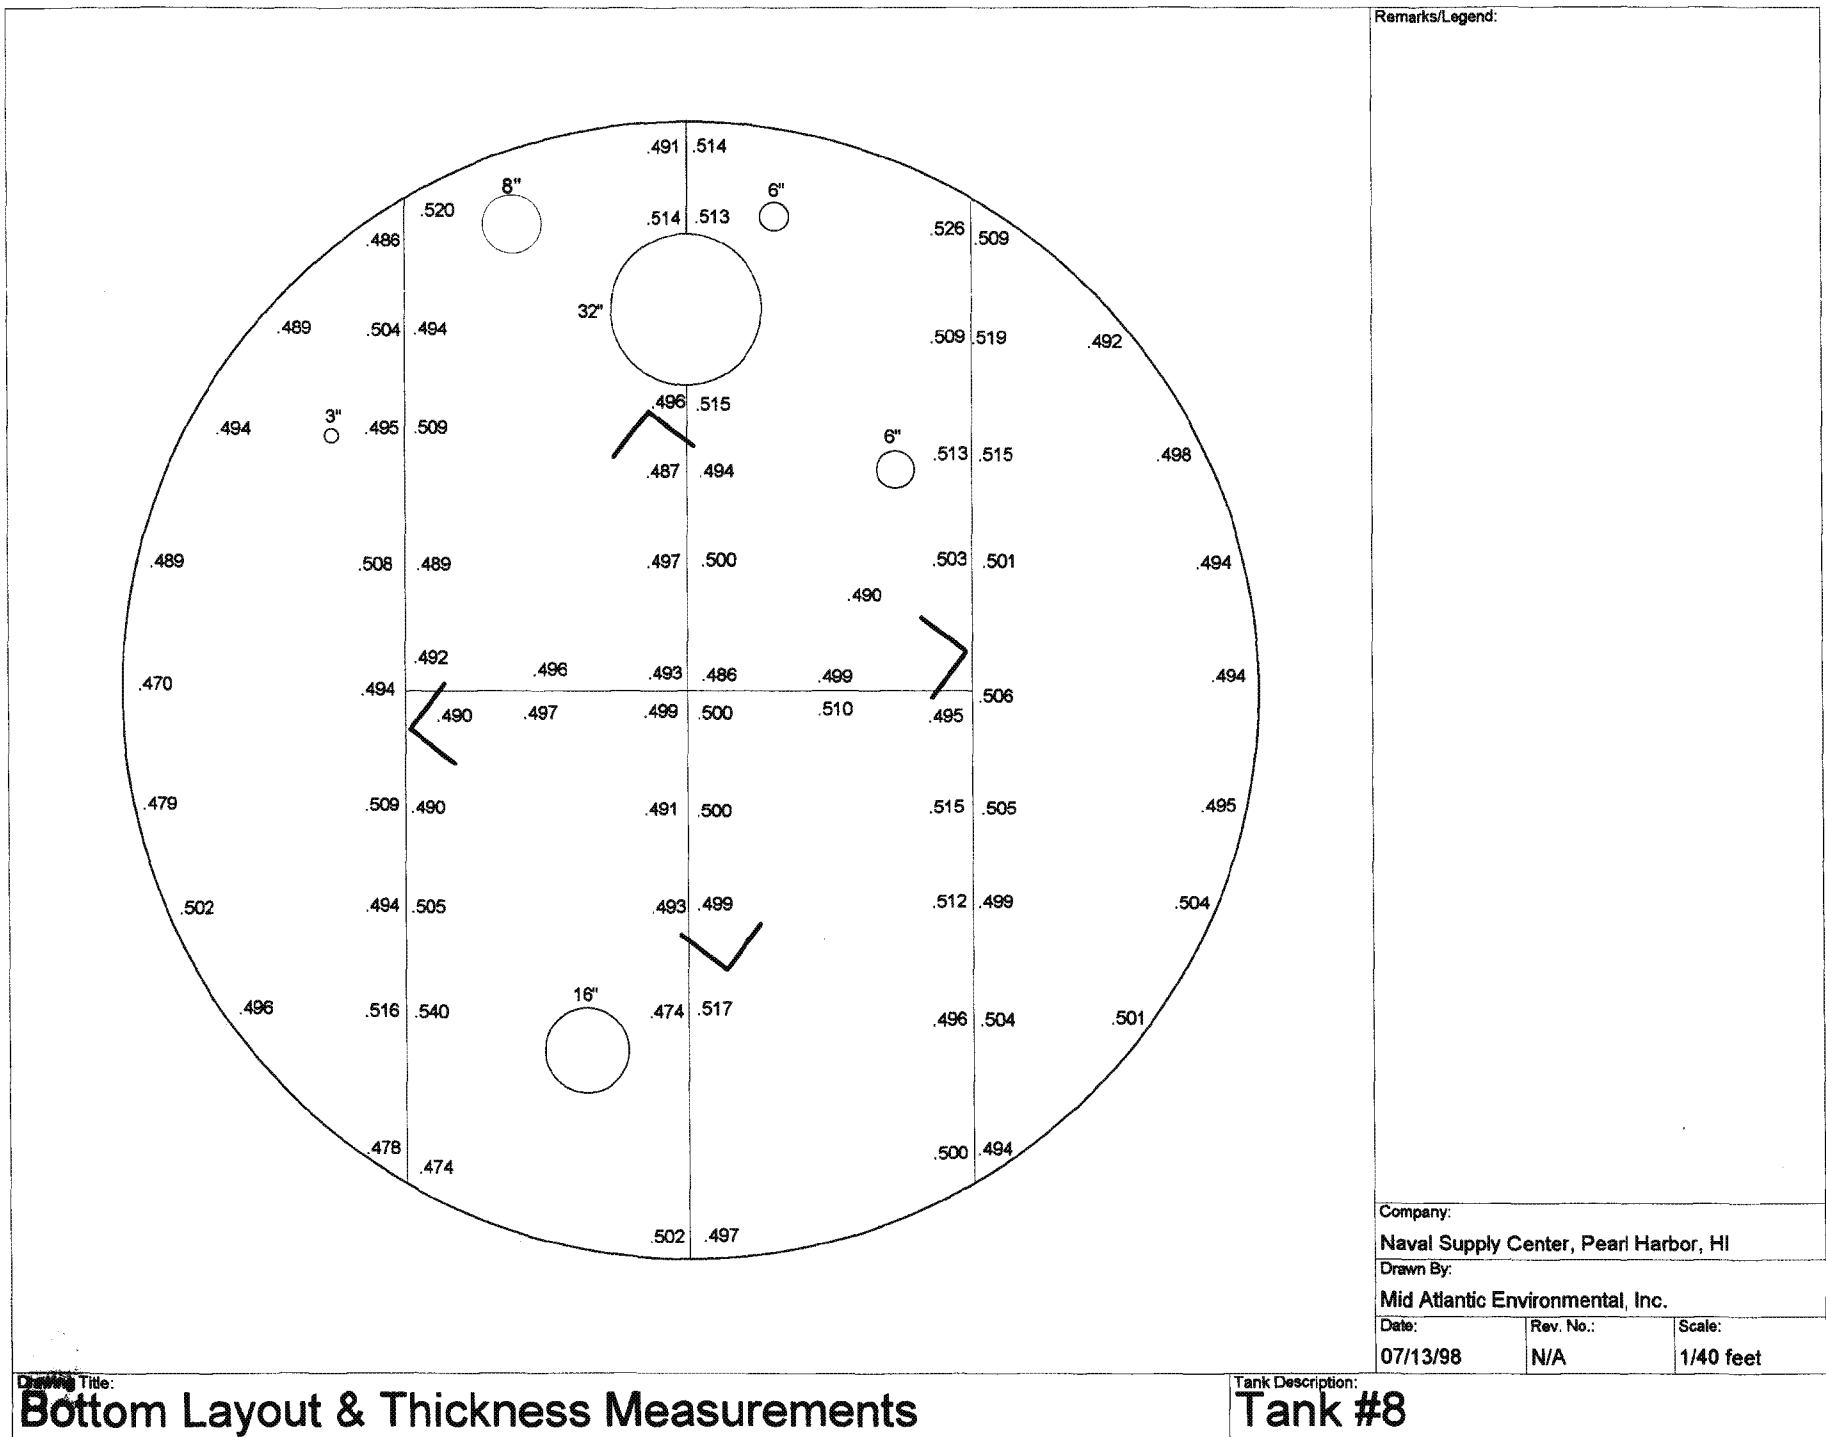
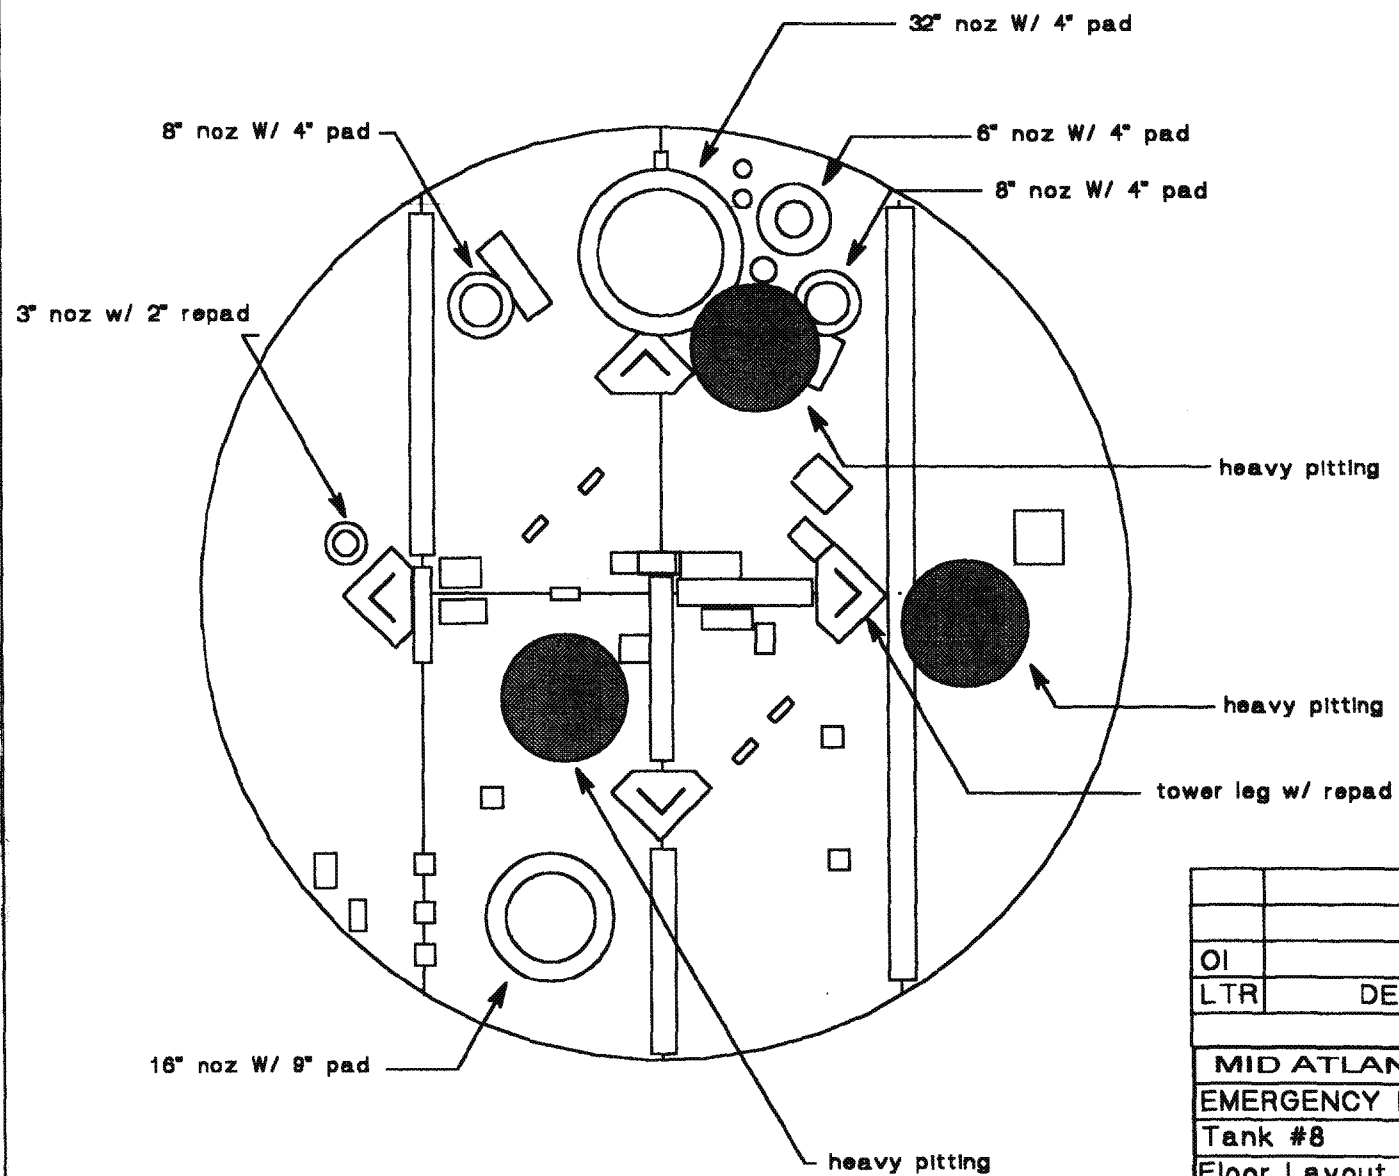
7.2.1 The original bottom thickness was determined to be 0.500 inches and the first ascending plate to be 0.250 inches. The ultrasonic thickness measurements taken determined that backside corrosion in this area is not a problem. Pitting on the bottom plates is widespread and the enclosed drawing shows that many patch plates had been added in the past. Although pitting is widespread it is not a problem since the remaining metal thickness is well within the 0.10 inches of metal required by API Standard 653 by the next inspection. Also the coating to be applied to the tank bottom should prevent any increase in pit depth. Although pitting is not a problem with regard to structural integrity, it did present a problem regarding the coating to be applied. Pictures of this pitting are included with this report. The surface contamination test results yielded 0% ferrous salts, 32 ppm NaCl and a pH level of 7. These results are within the limits set forth in the KTA SCAN Kit technical data and the NACE technical committee report on Surface Preparation of Contaminated Steel Surfaces. The Caustic Soda test of the tank bottom indicated that all Flame Sprayed Aluminum had been removed. By visual inspection, scattered pitting was observed on the tank bottom and first ascending plates. The deeper pits were measured and recorded on the Bottom Layout With Pit Indications drawing.

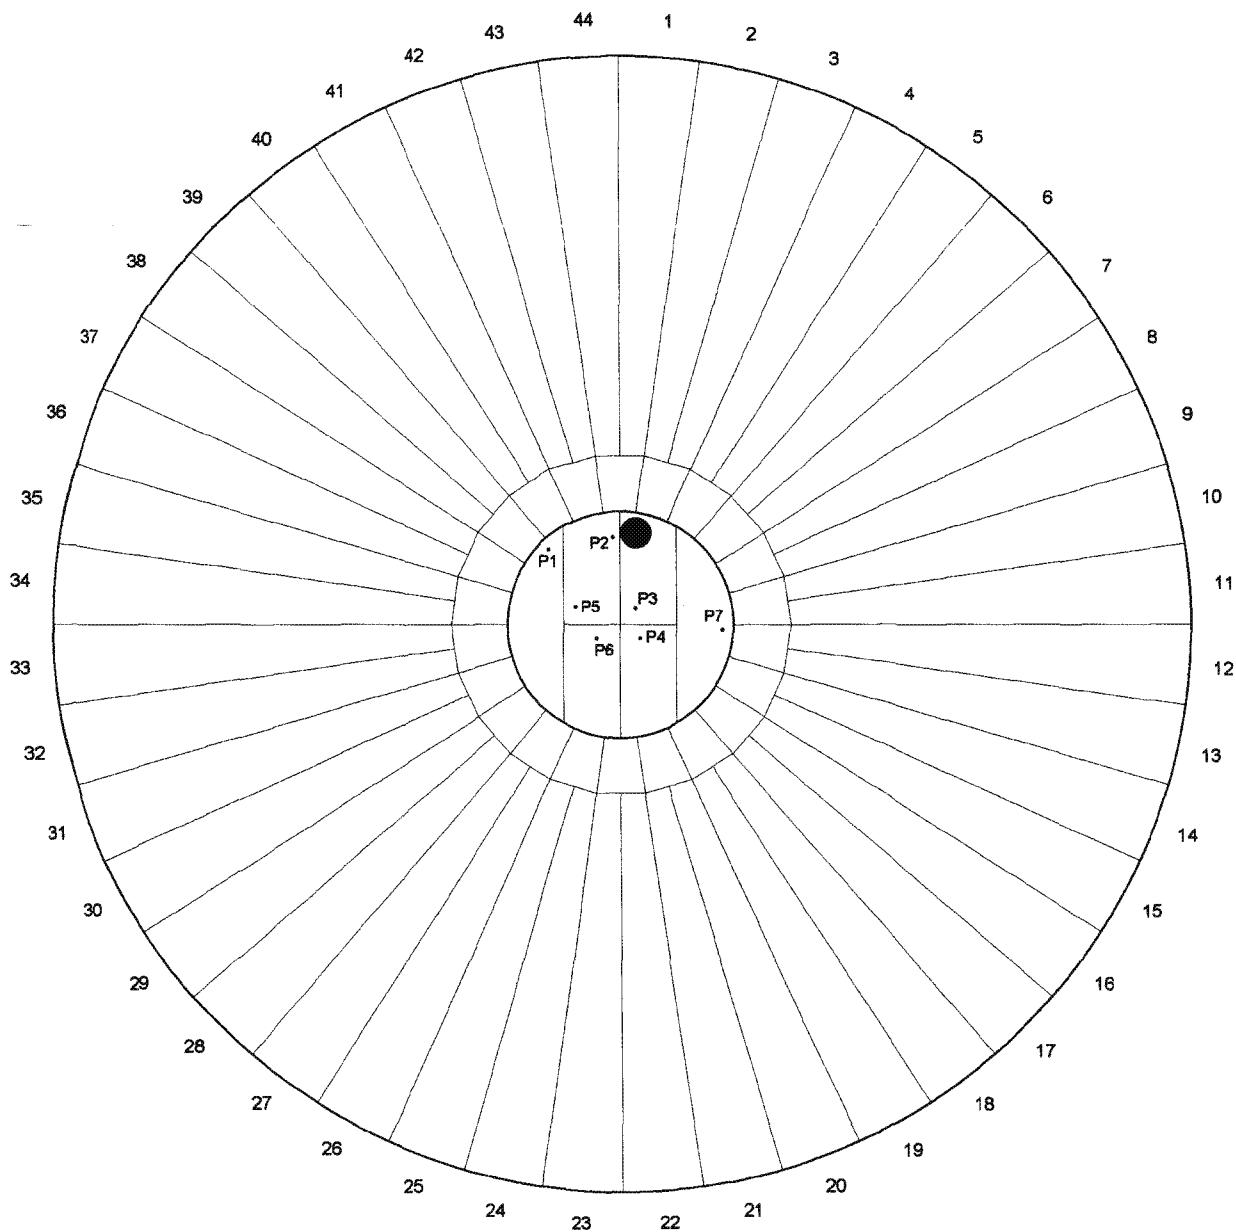
Remarks/Legend: Pitting was general over 30% of bottom

Pit Depth in inches:

P1 = 0.15  
P2 = 0.11  
P3 = 0.09  
P4 = 0.12  
P5 = 0.09  
P6 = 0.09  
P7 = 0.12
