**Section 9**  
**RECOMMENDED REPAIRS**

MID ATLANTIC ENVIRONMENTAL	
EMERGENCY REPAIRS FOR RED HILL TANKS	
Tank #8 AS BUILT DRAWINGS	
Repair No.: 001	File: 8R001
UPPER DOME	Quadrant: D
Course: EXTENSION	PLATE: 22
Drawn by: Tom Kitchen	Date: 5/4/98

**Dames & Moore**  
Emergency Repairs For Red Hill Tanks at the Fleet Industrial & Supply Center  
Contract No. N62742-96-C-1356

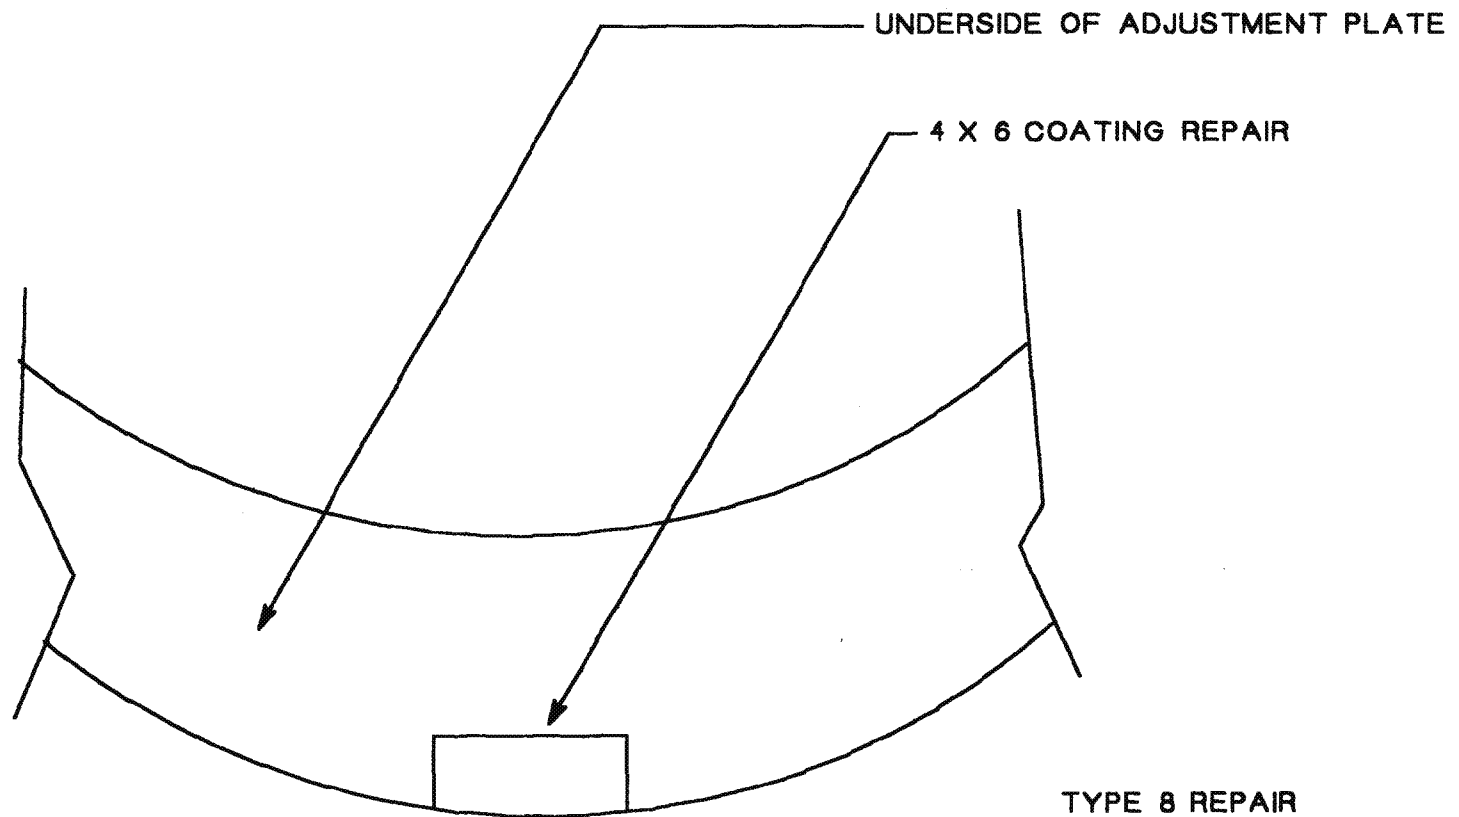
NOTE: AREA ~~EAS~~ FOUND TO BE GROUND TO BARE METAL

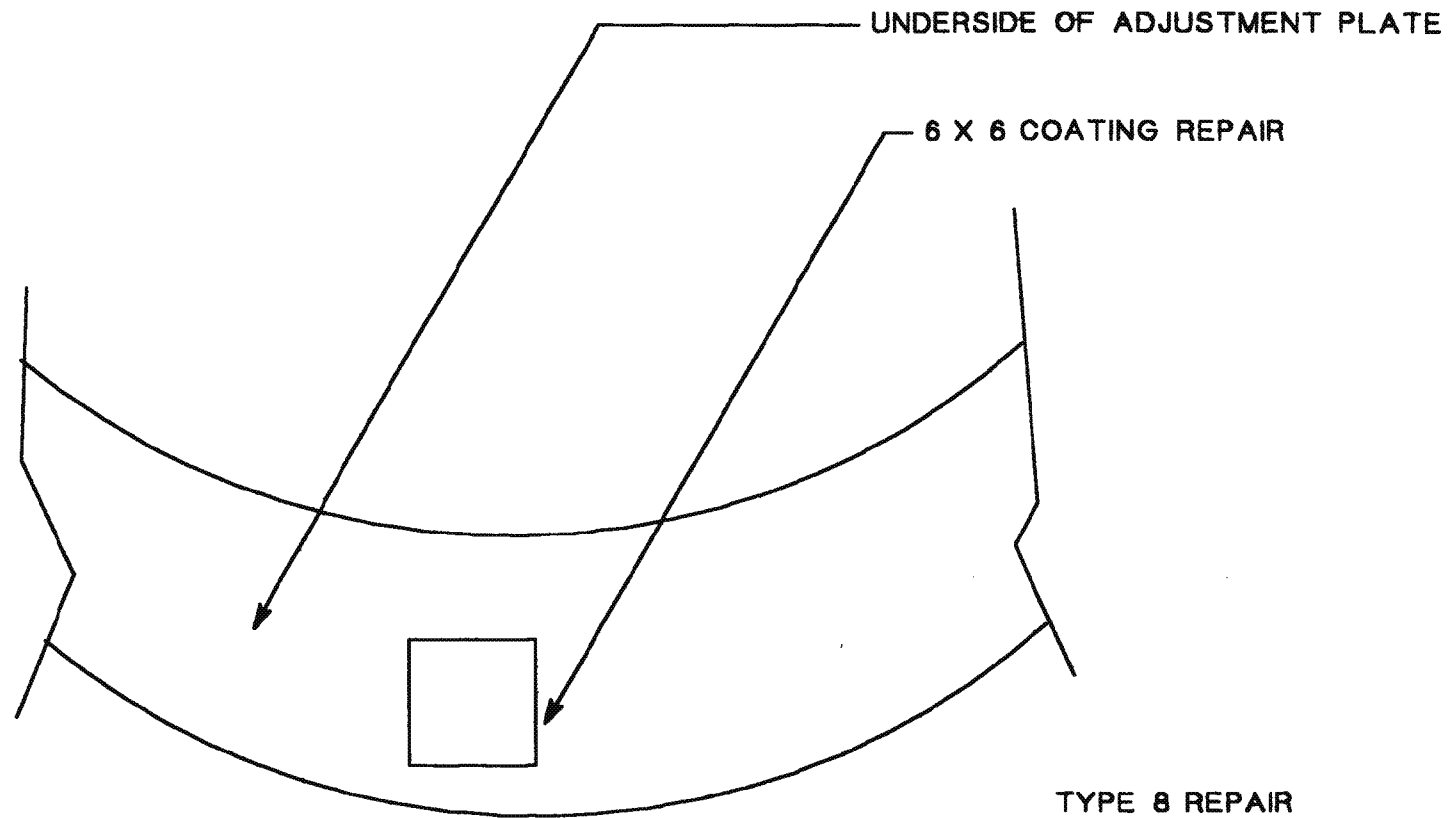
NOTE: AREA EAS FOUND TO BE GROUND TO BARE METAL

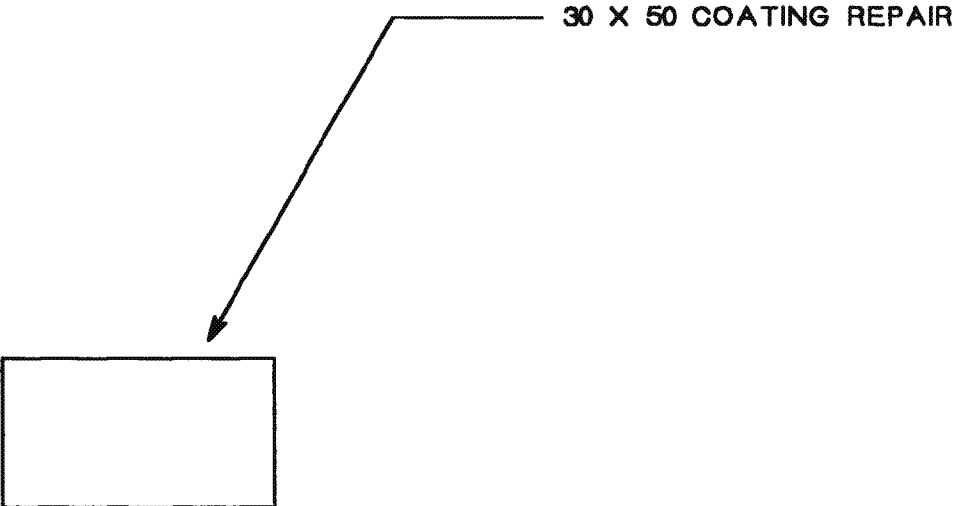
MID ATLANTIC ENVIRONMENTAL	
EMERGENCY REPAIRS FOR RED HILL TANKS	
Tank #8 AS BUILT DRAWING	
Repair No. : 004	File # 8004
LOWER DOME	Quadrant: <del>B</del> ← OK
Course: 2	PLATE: 18
Drawn by: Tom Kitchen	Date: 5/4/98

REPAIR COATING FAILURE PER T. KITCHEN CORROSION BLISTERS

APPROXIMATELY 1 SQUARE METER	PLATE 18 COURSE 2 L.D.

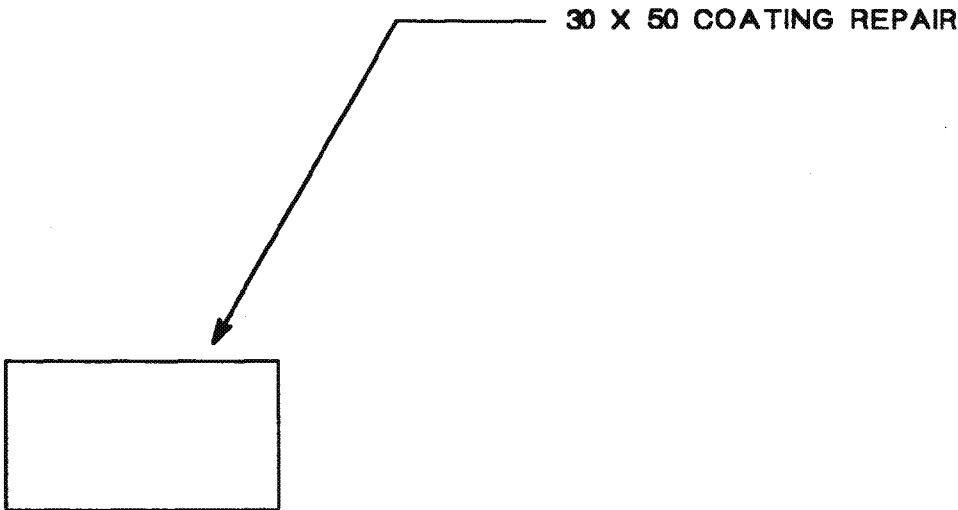
MID ATLANTIC ENVIRONMENTAL	
EMERGENCY REPAIRS FOR RED HILL TANKS	
Tank #8 AS BUILT DRAWING	
Repair No.: 005	File #: 8-005
LOWER DOME	Quadrant: D
Course: 2	PLATE: 18
Drawn by: Tom Kitchen	Date: 5/4/98

REPAIR COATING FAILURE PER T. KITCHEN CORROSION BLISTERS

APPROXIMATELY 1 SQUARE METER	PLATE 18 COURSE 2 L.D.

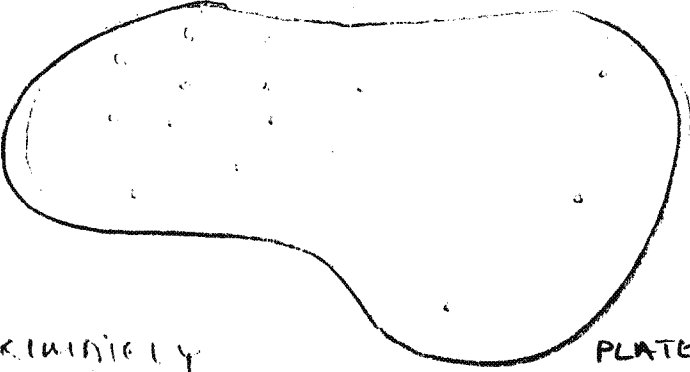
REPAIR COATING FAILURE PER T. KITCHEN CORROSION BLISTERS

APPROXIMATELY 1 SQUARE METER	PLATE 13 L.D. COURSE 2

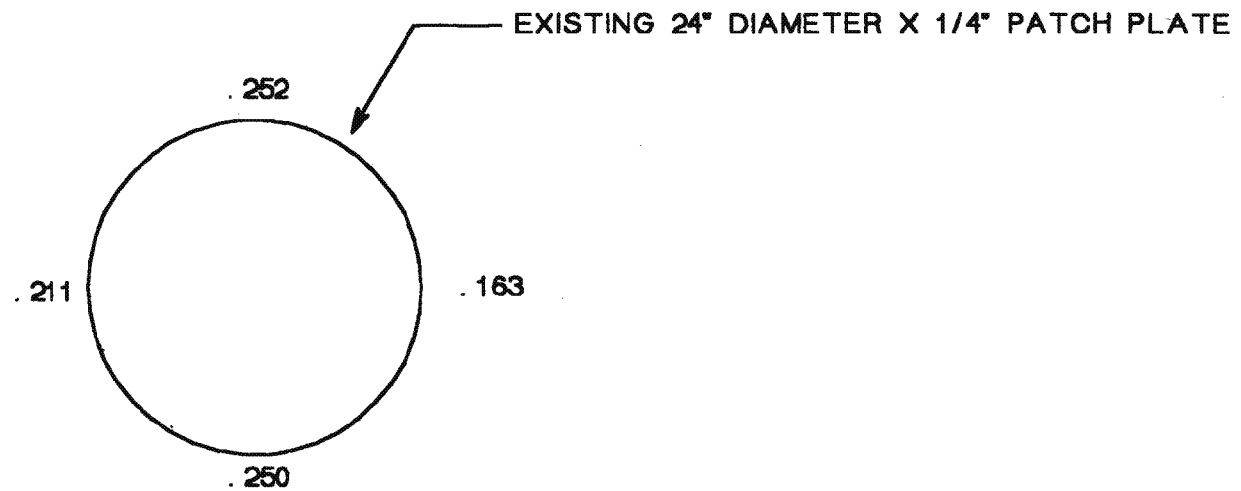
MID ATLANTIC ENVIRONMENTAL	
EMERGENCY REPAIRS FOR RED HILL TANKS	
Tank #8 AS BUILT DRAWING	
Repair No. 010	File # 8010
CYLINDER	Quadrant C
Course 11	PLATE 14
Drawn by Tom Kitchen	Date 5/4/98

UT READINGS AT EDGE OF PLATE INDICATE GOOD METAL  
NO REPAIR NECESSARY
