**Dames & Moore**  
Emergency Repairs For Red Hill Tanks at the Fleet Industrial & Supply Center  
Contract No. N62742-96-C-1356

Repair Record

MID ATLANTIC ENVIRONMENTAL	
EMERGENCY REPAIRS FOR RED HILL TANKS	
Tank #8 RECOMMENDED REPAIR DRAWING	
Repair No.: 014	File: 8r014
LOWER DOME	Quadrant: B
Course: 3	PLATE: 10
Drawn by: Tom Kitchen	Date: 5/4/98

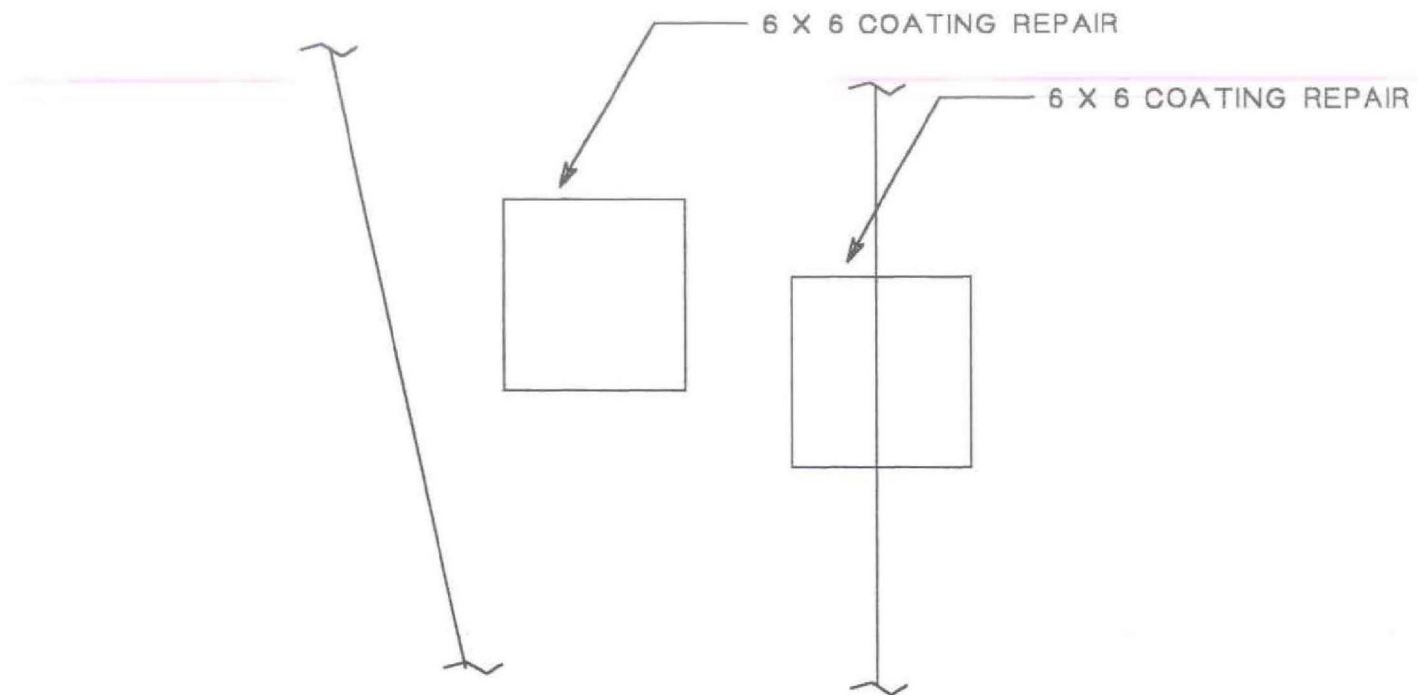
DEFECT INSPECTED BY TK & JF 3/16/98

TYPE 9 REPAIR

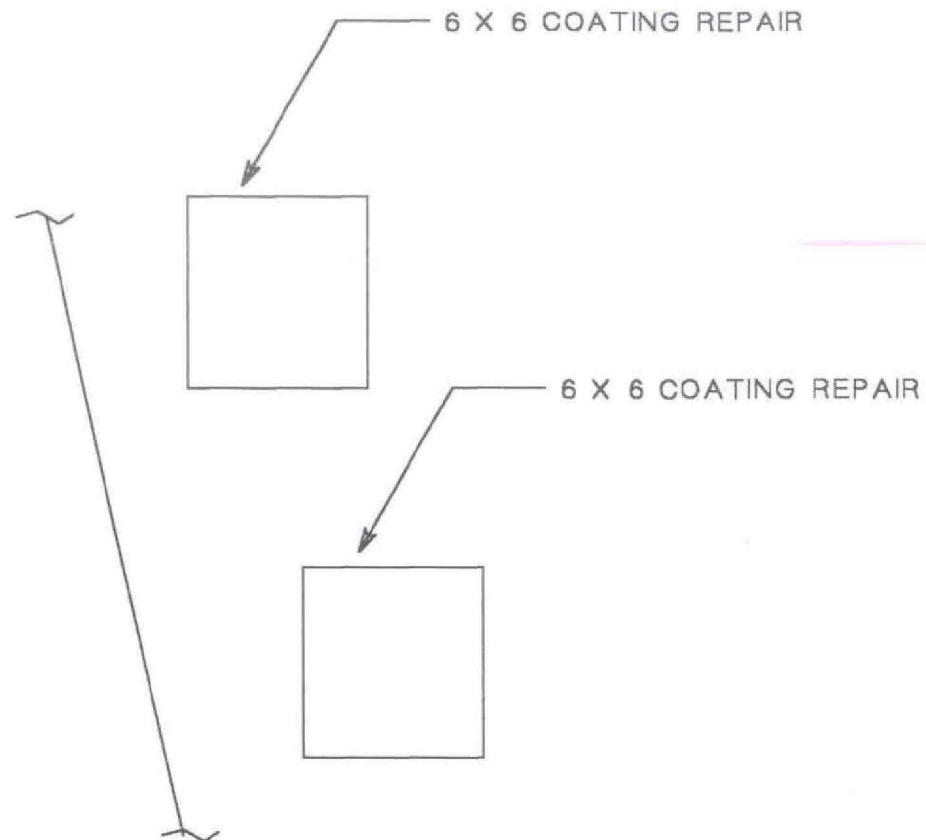
MID ATLANTIC ENVIRONMENTAL	
EMERGENCY REPAIRS FOR RED HILL TANKS	
Tank #8 RECOMMENDED REPAIR DRAWING	
Repair No.: 015	File: 8r015
LOWER DOME	Quadrant: B
Course: 3	PLATE: 10
Drawn by: Tom Kitchen	Date: 5/4/98

DEFECT INSPECTED BY TK & JF 3/16/98

TYPE 8 REPAIR

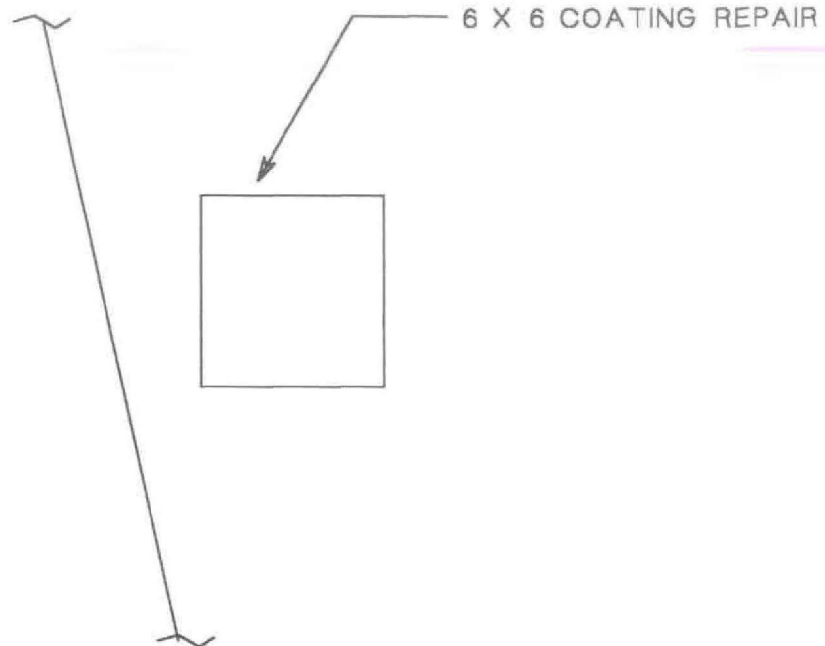
MID ATLANTIC ENVIRONMENTAL	
EMERGENCY REPAIRS FOR RED HILL TANKS	
Tank #8 RECOMMENDED REPAIR DRAWING	
Repair No.: 016	File: 8r016
LOWER DOME	Quadrant: B
Course: 3	PLATE: 19
Drawn by: Tom Kitchen	Date: 5/4/98

DEFECT INSPECTED BY TK & JF 3/16/98

TYPE 8 REPAIR

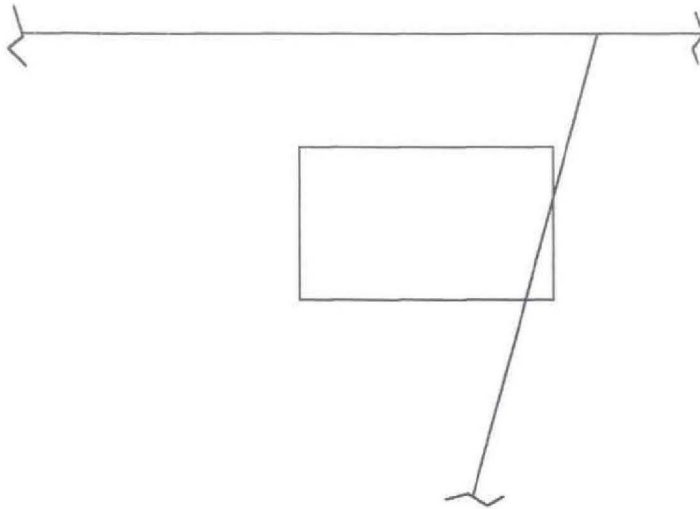
MID ATLANTIC ENVIRONMENTAL	
EMERGENCY REPAIRS FOR RED HILL TANKS	
Tank #8 RECOMMENDED REPAIR DRAWING	
Repair No.: 017	File: 8r017
LOWER DOME	Quadrant: B
Course: 3	PLATE: 8
Drawn by: Tom Kitchen	Date: 5/4/98

DEFECT INSPECTED BY TK & JF 3/16/98

6 X 8 COATING REPAIR

TYPE 8 REPAIR

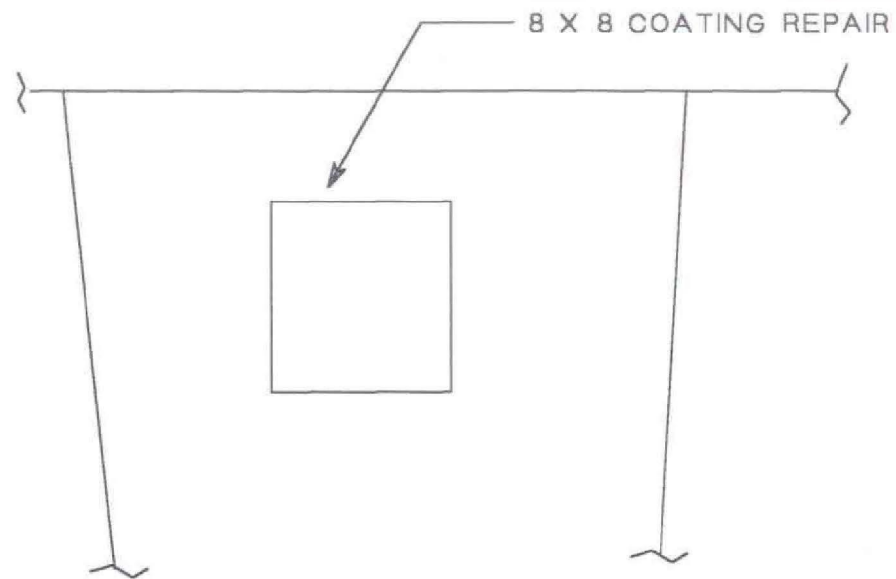
MID ATLANTIC ENVIRONMENTAL	
EMERGENCY REPAIRS FOR RED HILL TANKS	
Tank #8 RECOMMENDED REPAIR DRAWING	
Repair No.: 018	File: 8r018
LOWER DOME	Quadrant: B
Course: 2	PLATE: 10
Drawn by: Tom Klitchen	Date: 5/4/98

DEFECT INSPECTED BY TK & JF 3/16/98

TYPE 8 REPAIR

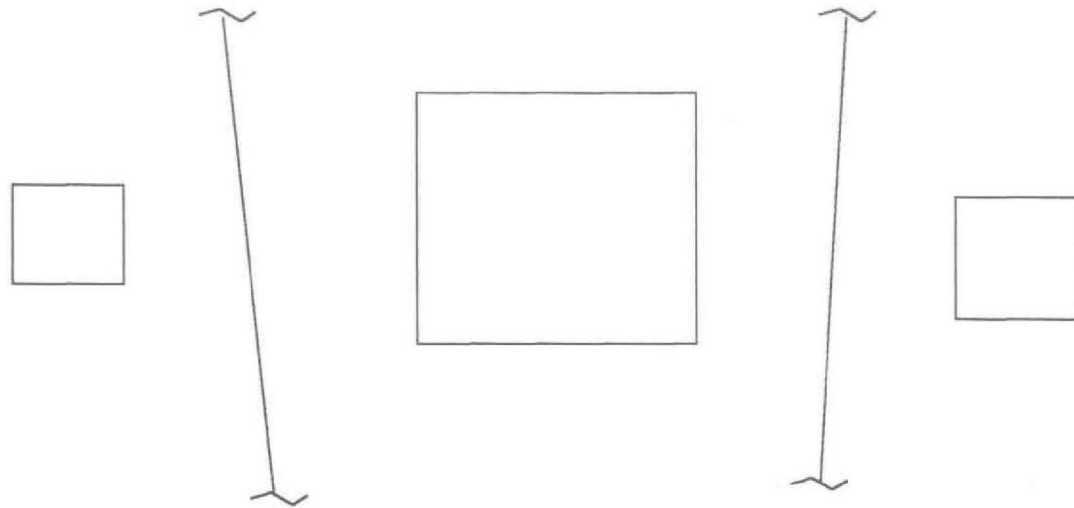
MID ATLANTIC ENVIRONMENTAL	
EMERGENCY REPAIRS FOR RED HILL TANKS	
Tank #8 RECOMMENDED REPAIR DRAWING	
Repair No.: 019 & 020	File: 8r019
LOWER DOME	Quadrant: B
Course: 2	PLATE: 11
Drawn by: Tom Kitchen	Date: 5/4/98

DEFECT INSPECTED BY TK & JF 3/16/98

SCATTERED BLISTERS APPROXIMATE AREA OF COATING  
REPAIR EQUAL 2 SQUARE METERS

TYPE 8 REPAIR

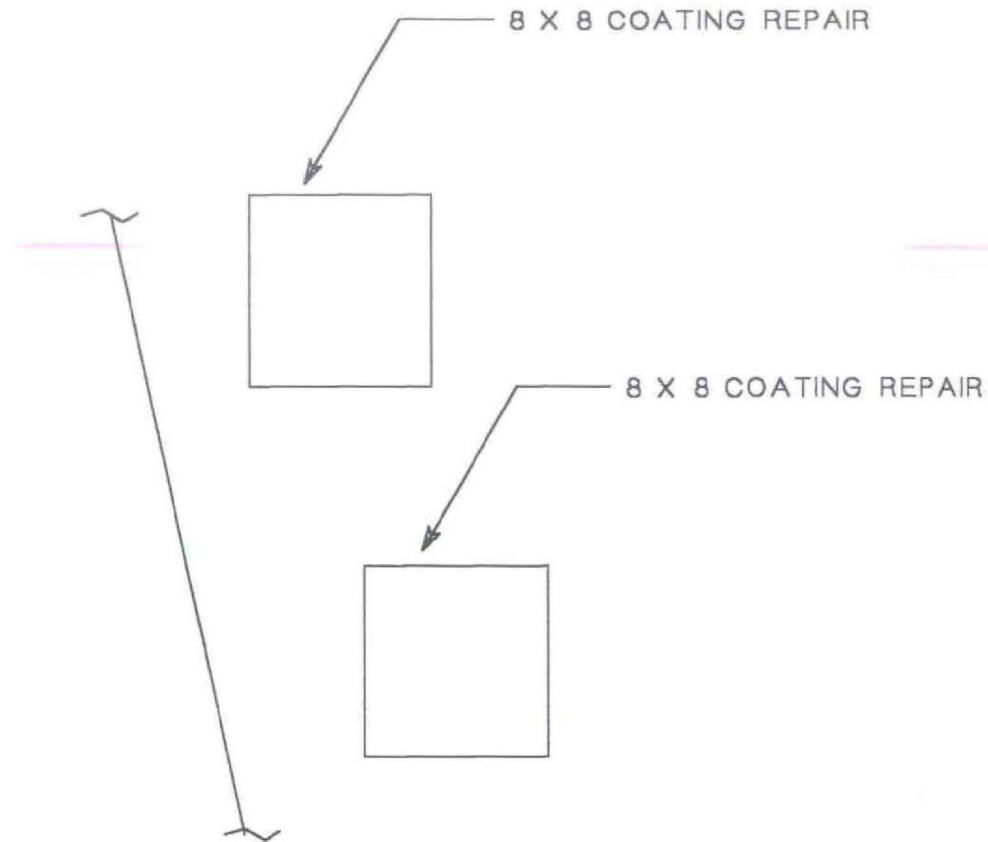
MID ATLANTIC ENVIRONMENTAL	
EMERGENCY REPAIRS FOR RED HILL TANKS	
Tank #8 RECOMMENDED REPAIR DRAWING	
Repair No.: 021	File: 8r021
LOWER DOME	Quadrant: A
Course: 2	PLATE: 2
Drawn by: Tom Kitchen	Date: 5/4/98

DEFECT INSPECTED BY TK & JF 3/16/98

TYPE 8 REPAIR

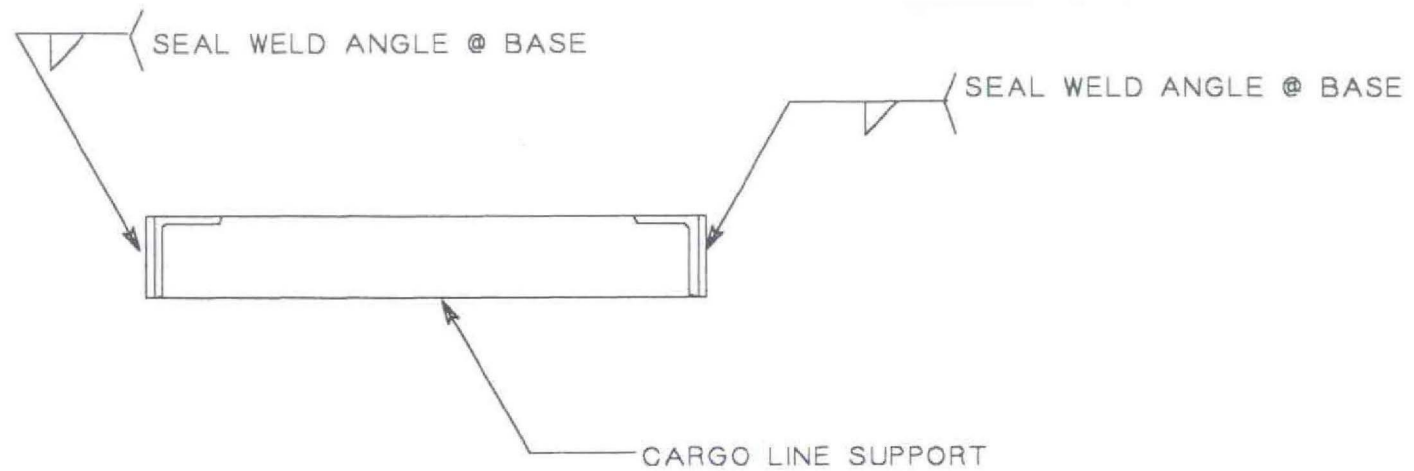
MID ATLANTIC ENVIRONMENTAL	
EMERGENCY REPAIRS FOR RED HILL TANKS	
Tank #8 RECOMMENDED REPAIR DRAWING	
Repair No.: 022	File: Br022
LOWER DOME	Quadrant: B
Course: 1	PLATE: 12
Drawn by: Tom Kitchen	Date: 7/1/98

TYPE 10 REPAIR

Weld Repair

WPS No.: SM1.1-1

Repair Acceptable: John Barkell

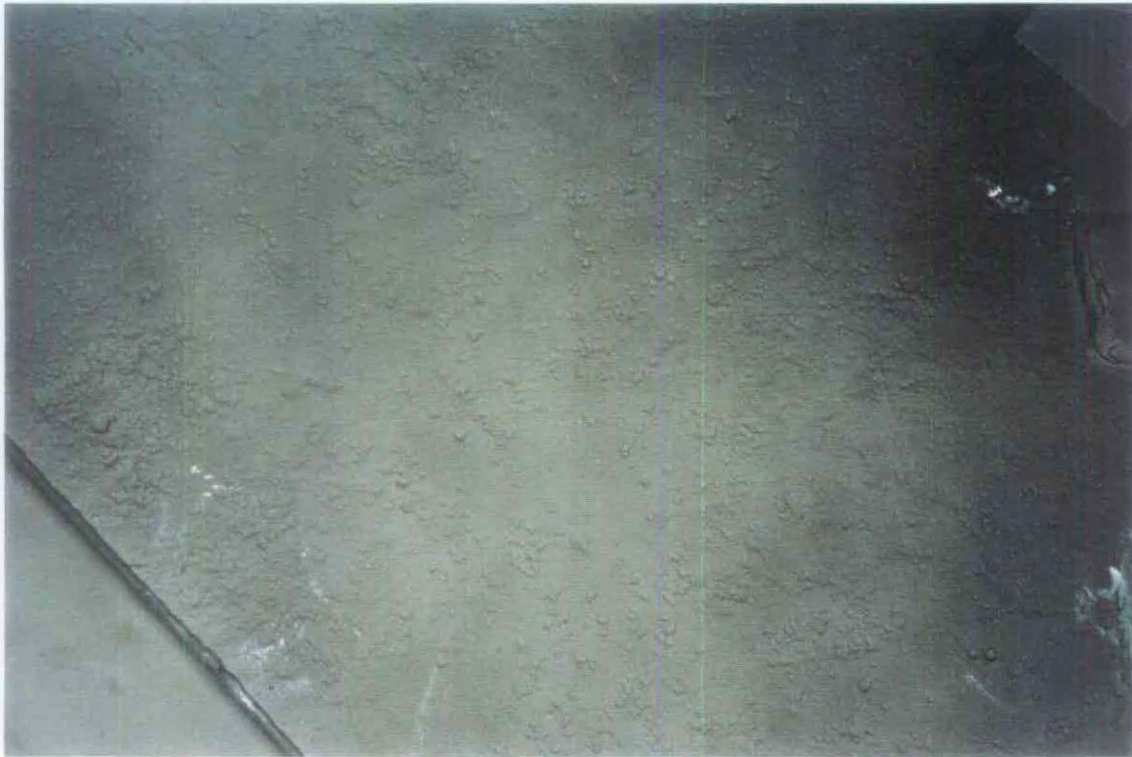
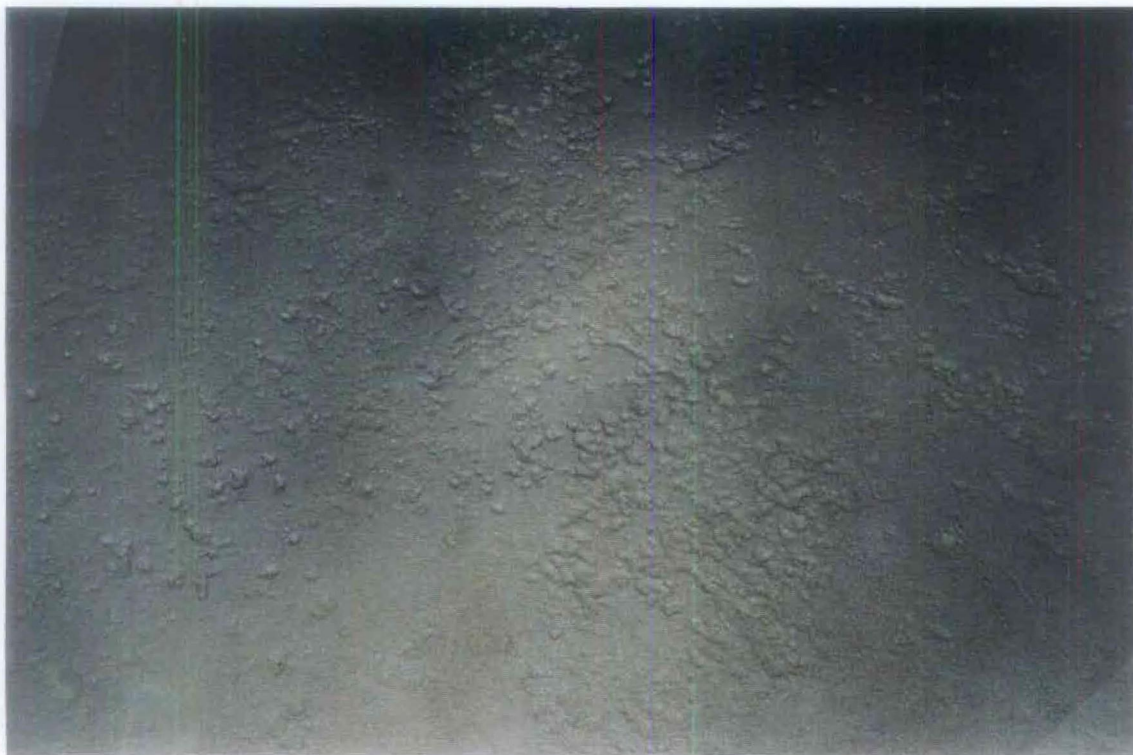
**PICTURES OF PITTING AT BOTTOM OF TANK**
