2.1 Mid Atlantic Environmental, Inc. conducted an inspection on Tank #8 at the Red Hill Underground Storage Facility, Pearl Harbor, Hawaii. This inspection was conducted in accordance with the scope of work identified by Contract Number N00604-97-R-0013, PRL 96-21, titled "Emergency Repair for Red Hill Tanks."

RED HILL TANK NO. 7
PRODUCT: DFM

Tank #7

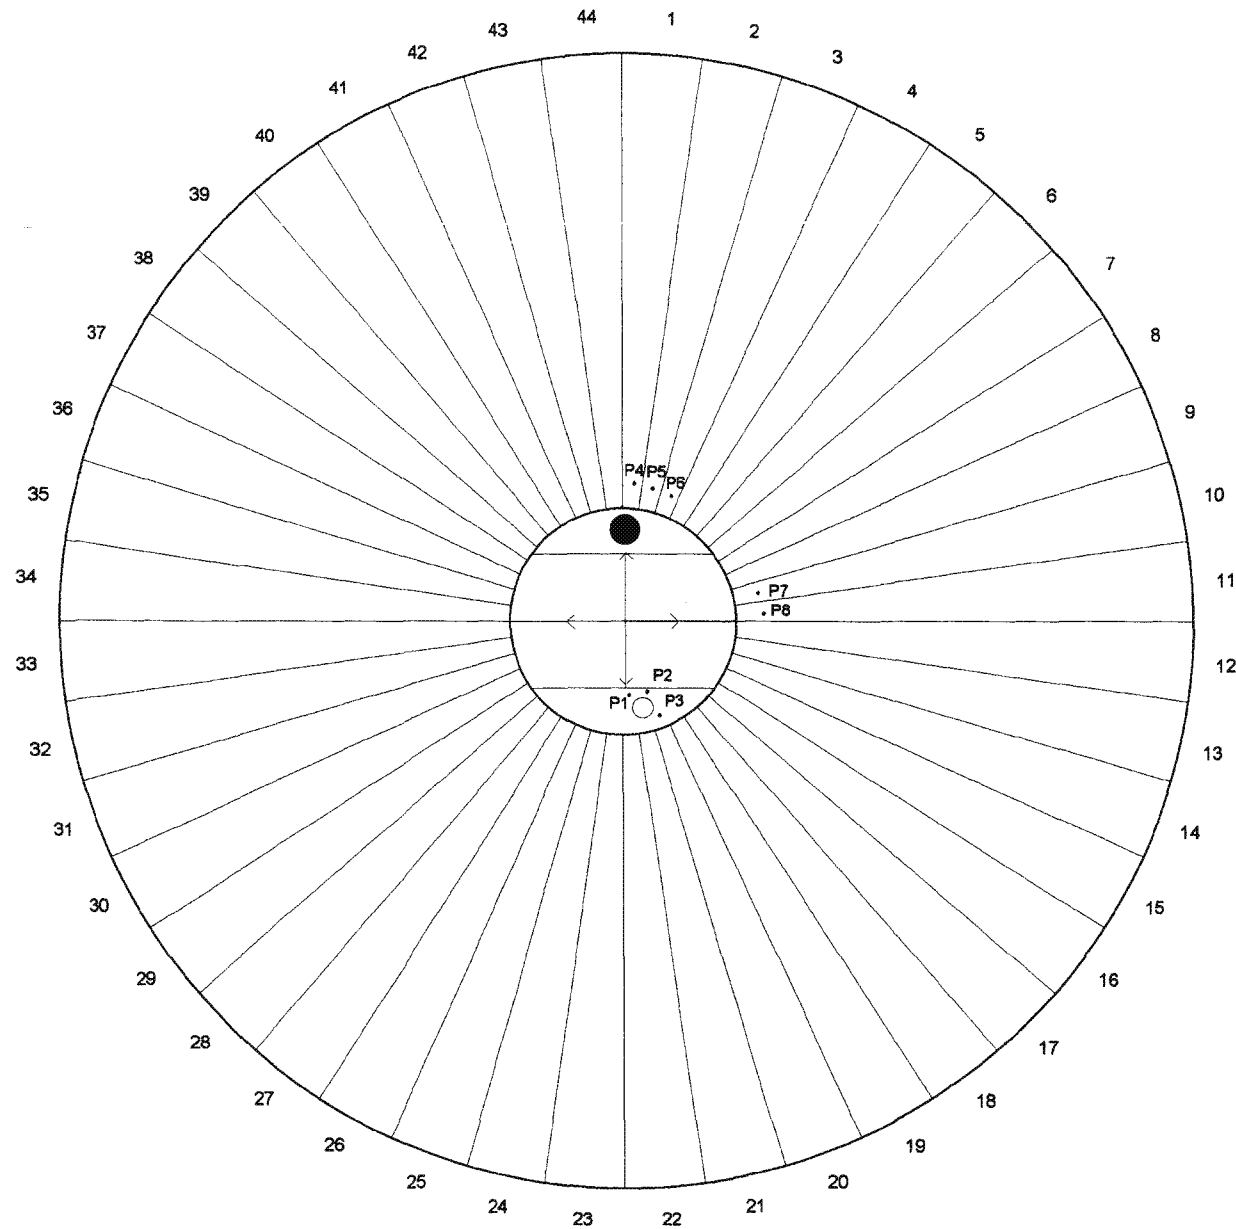
Bottom Layout with Pit Indications

7.2.1 The original bottom thickness was determined to be 0.500 inches and the first ascending plate to be 0.250 inches. The ultrasonic thickness measurements taken determined that backside corrosion in this area is not a problem. Pitting is not a problem since the remaining metal thickness is well within the 0.10 inches of metal required by API Standard 653 by the next inspection. Also the coating to be applied to the tank bottom should prevent any increase in pit depth. Although pitting is not a problem with regard to structural integrity, it did present a problem regarding the coating to be applied. Pictures of this pitting are included with this report. The surface contamination test results yielded 0% ferrous salts, 32 ppm NaCl and a pH level of 7. These results are within the limits set forth in the KTA SCAN Kit technical data and the NACE technical committee report on Surface Preparation of Contaminated Steel Surfaces. The Caustic Soda test of the tank bottom indicated that all Flame Sprayed Aluminum had been removed. By visual inspection, scattered pitting was observed on the tank bottom and first ascending plates. The deeper pits were measured and recorded on the Bottom Layout With Pit Indications drawing.

P1 = 0.120
P2 = 0.160
P3 = 0.120
P4 = 0.119
P5 = 0.075
P6 = 0.071
P7 = 0.090
P8 = 0.125
