**Section 9**

**RECOMMENDED REPAIRS**

| EMERGENCY REPAIRS FOR RED HILL TANKS | |

**Dames & Moore**  
Emergency Repairs For Red Hill Tanks at the Fleet Industrial & Supply Center  
Contract No. N62742-96-C-1356

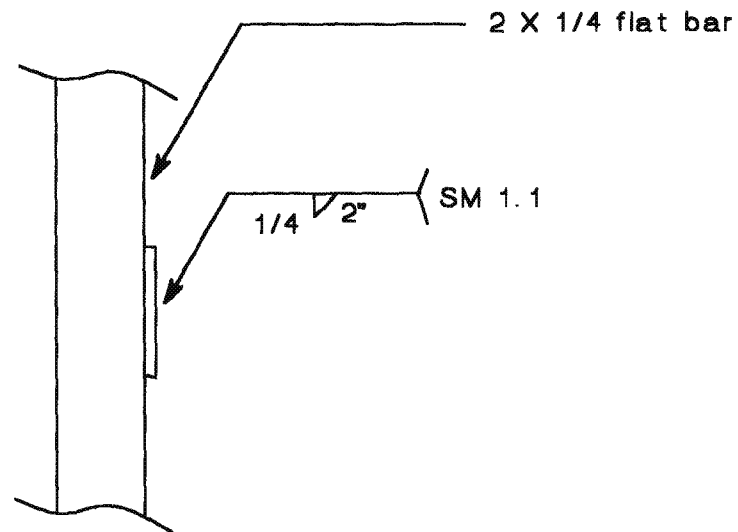
| Repair No.: 001 | File: 7r001 |

INSPECTED 3/27/98 BY JF & TK

TYPE 10 REPAIR

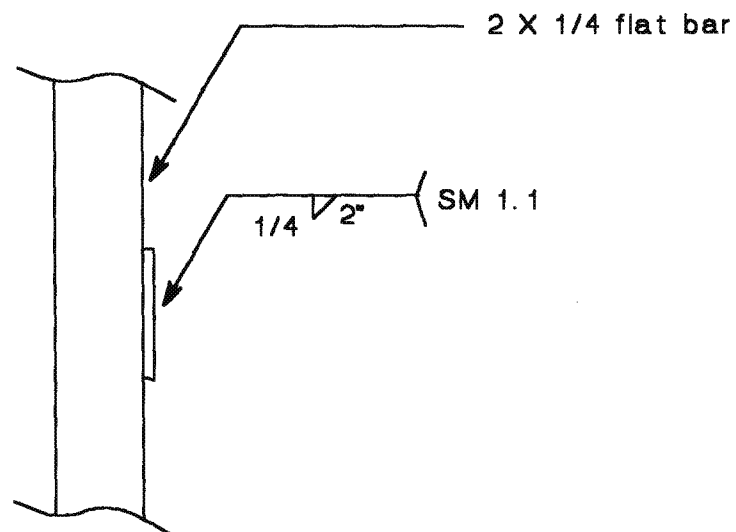
| Repair No.: 002 | File: 7r002 |

INSPECTED 3/27/98 BY JF & TK

TYPE 10 REPAIR

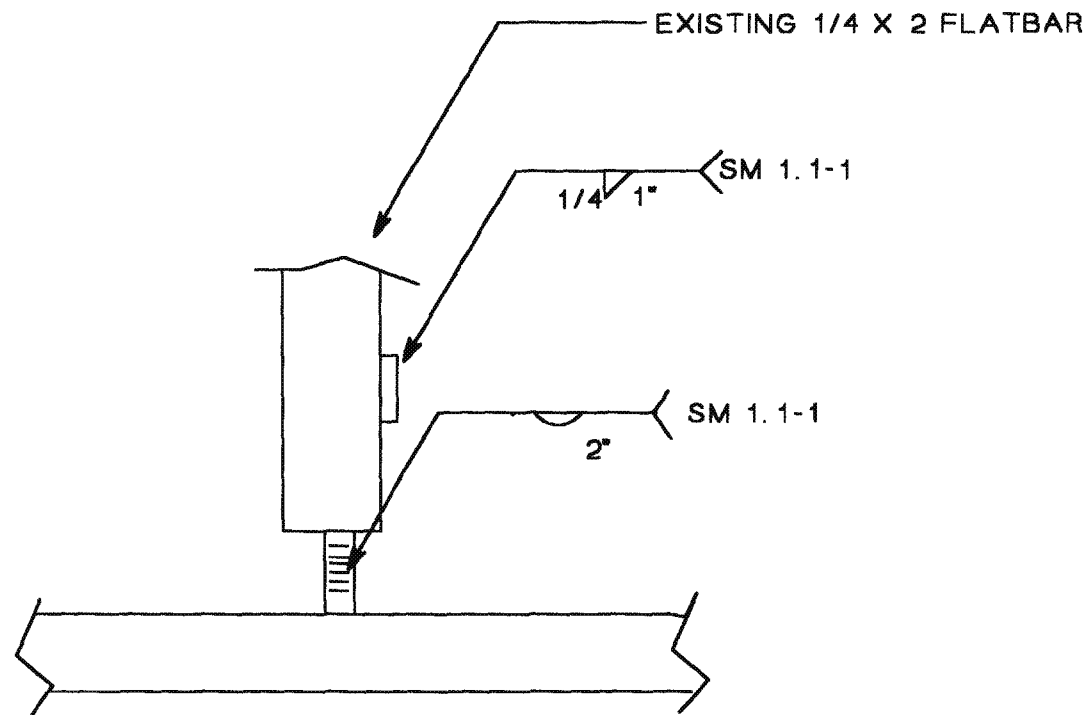
| Repair No.: 003 | File: 7R003 |

DEFECT INSPECTED 3/27/98 BY JF & TK

TYPE 10 REPAIR

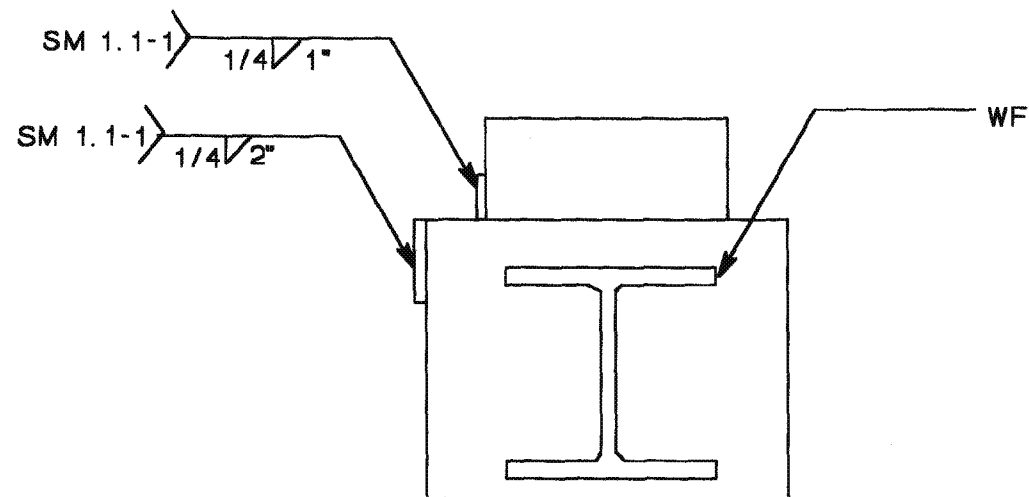
| Repair No.: 004 | File: 7R004 |

Defect Inspected 3/27/98 by JF 7 TK

TYPE 10 REPAIR

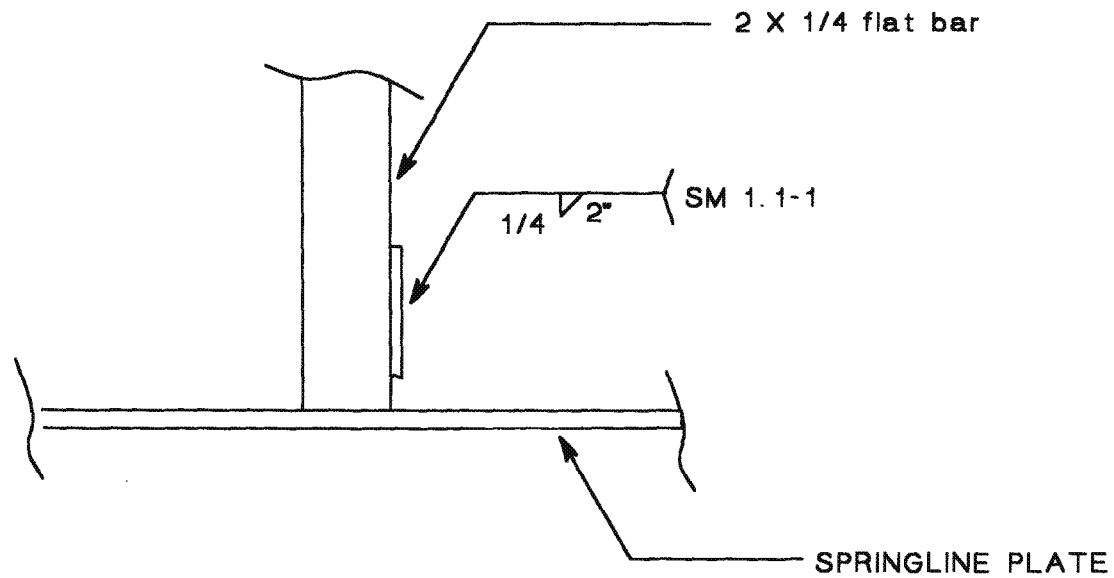
| Repair No.: 005 | File: 7R005 |

Inspected 3/27/98 by JF & TK

TYPE 10 REPAIR

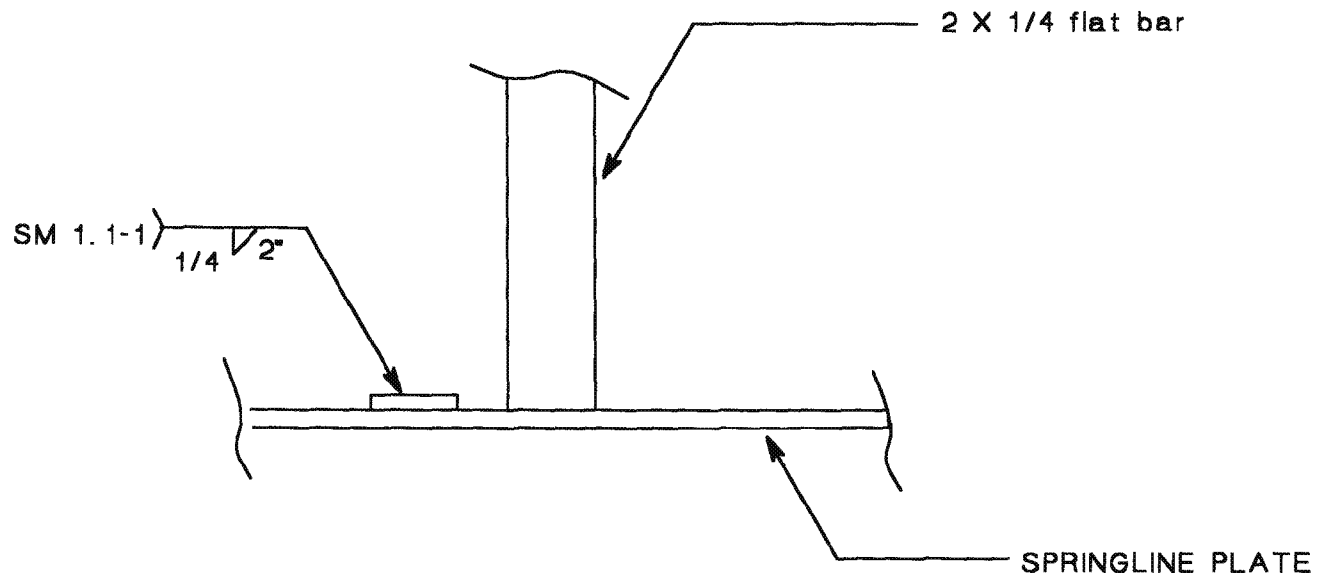
| Repair No.: 006 | File: 7R006 |

Inspected 3/27/98 by JF & TK

TYPE 10 REPAIR

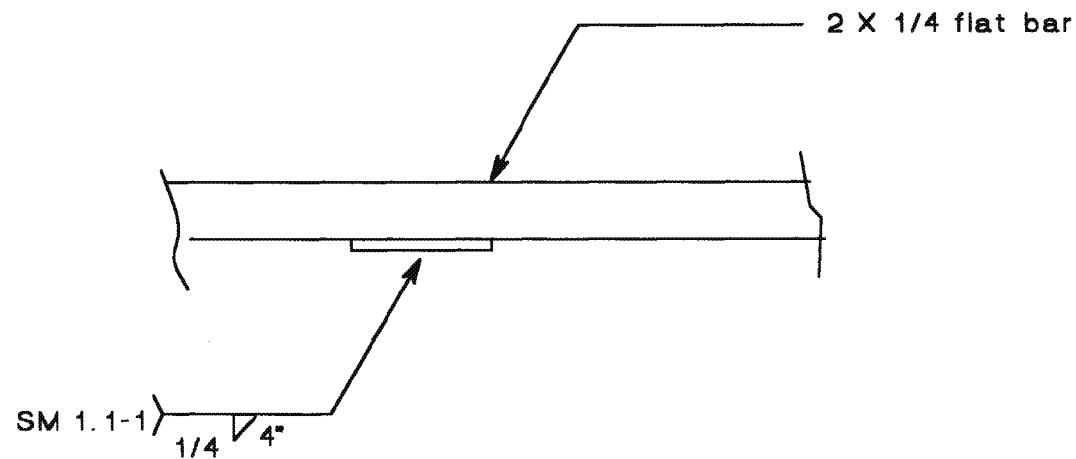
| Repair No.: 007 | File: 7R007 |

Inspected 3/27/98 by JF & TK

TYPE 10 REPAIR

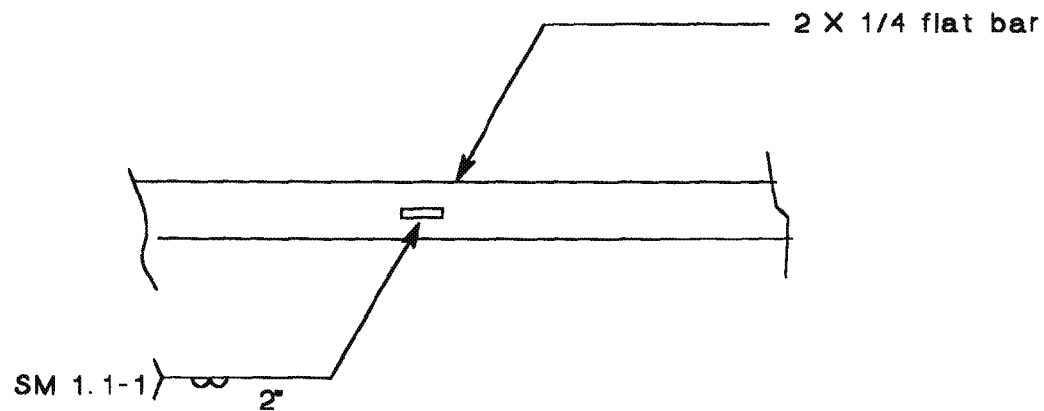
| Repair No.: 008 | File: 7R008 |

Inspected 3/27/98 by JF & TK

TYPE 10 REPAIR

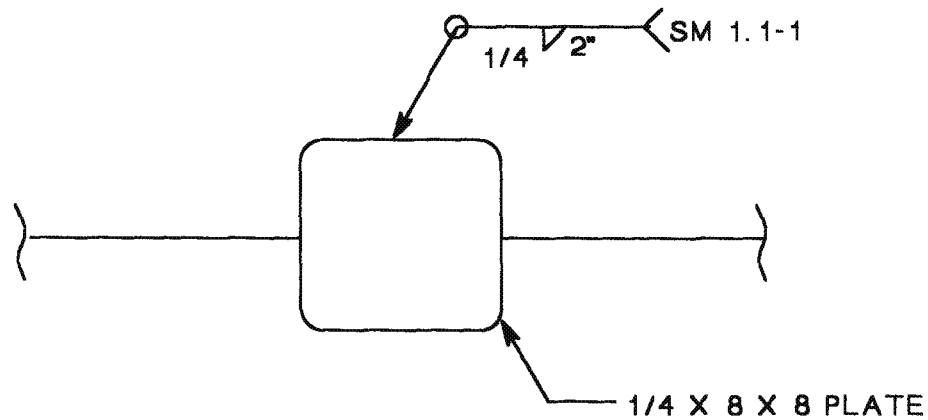
| Repair No.: 009 | File: 7R009 |

Inspected 3/27/98 by JF & TK

TYPE 5 REPAIR

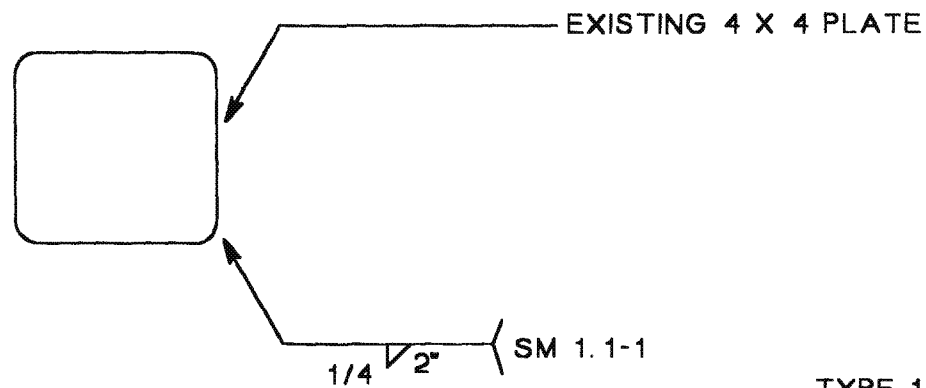
| Repair No.: 010 | File: 7R010 |

Inspected 3/27/98 by JF & TK

TYPE 10 REPAIR

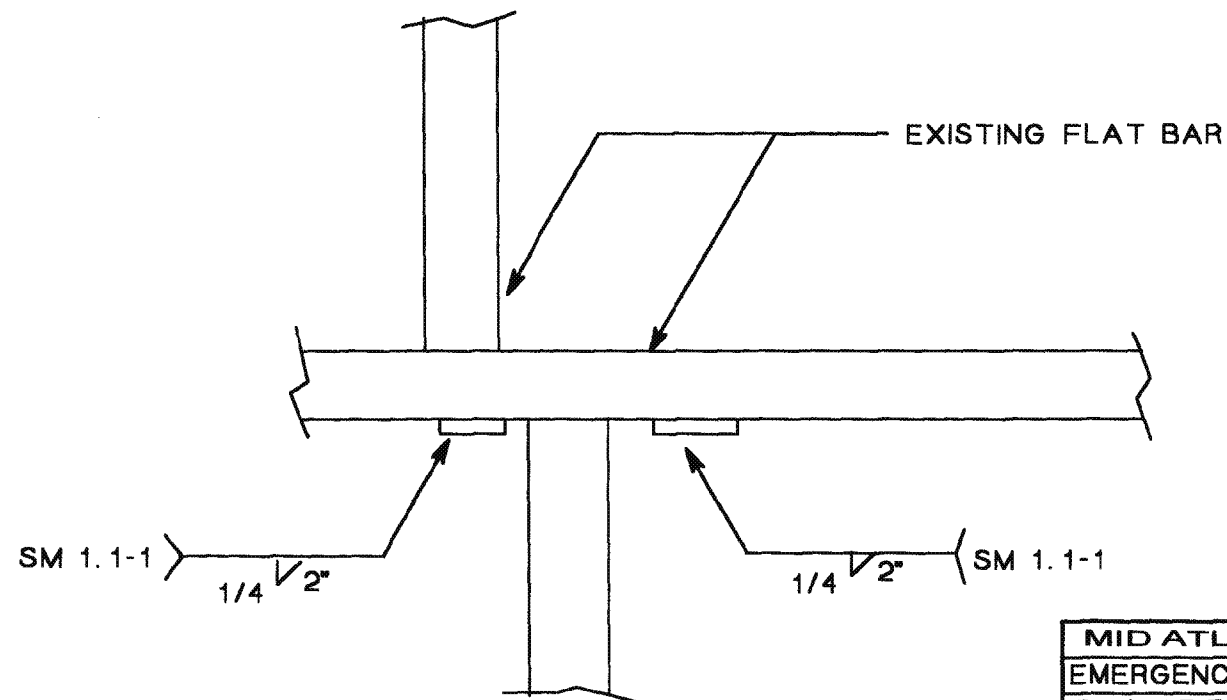
| Repair No. 011 | File 7R011 |

Inspected 3/27/98 by JF & TK

TYPE 10 REPAIR

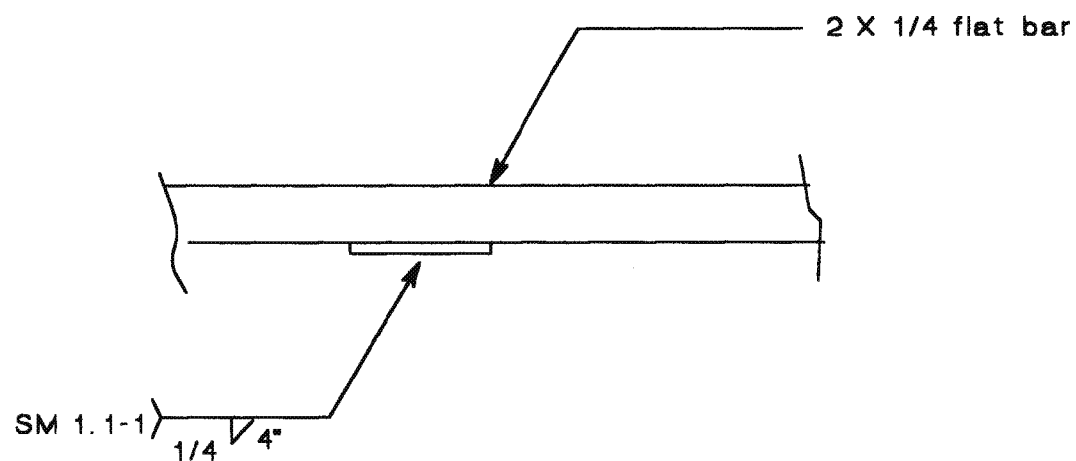
| Repair No.: 012 | File: 7R012 |

Inspected 3/27/98 by JF & TK

TYPE 10 REPAIR

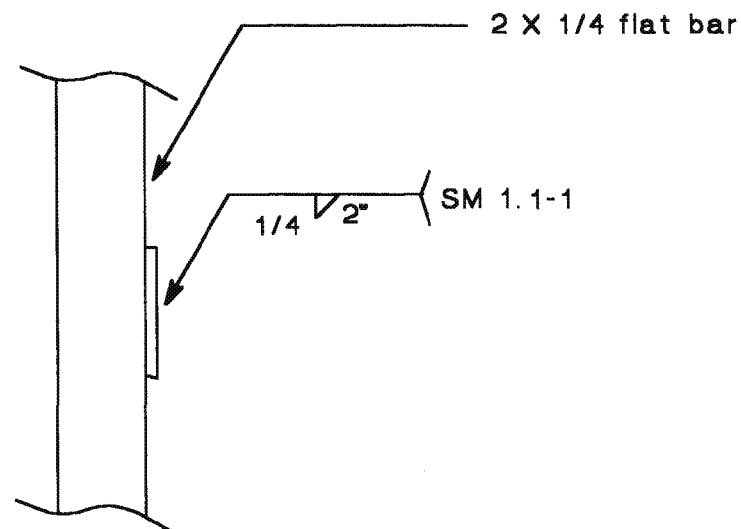
| Repair No.: 013 | File: 7R013 |

Inspected 3/27/98 by JF & TK

TYPE 10 REPAIR

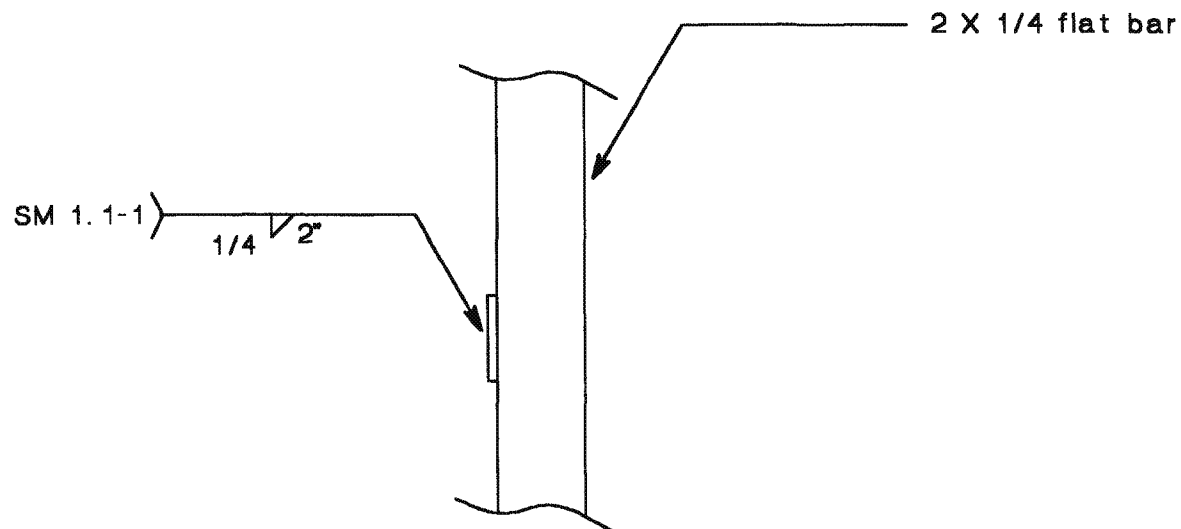
| Repair No. : 014 | File: 7R014 |

Inspected 3/27/98 by JF & TK

TYPE 10 REPAIR

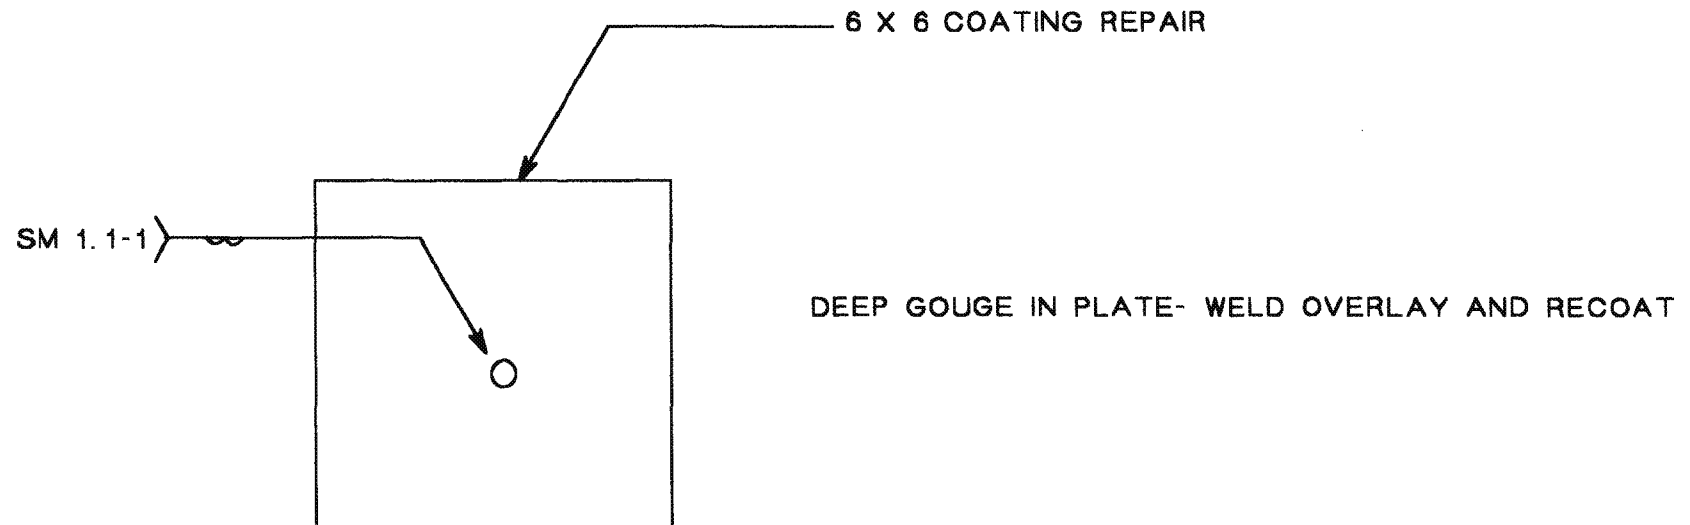
| Repair No.: 015 | File: 7R015 |

Inspected 3/27/98 by JF & TK

TYPE 2 REPAIR
