MID ATLANTIC ENVIRONMENTAL	
EMERGENCY REPAIRS FOR RED HILL TANKS	
Tank #7 RECOMMENDED REPAIR DRAWINGS	
Repair No. : 016	File: 7R016
Upper Dome	Quadrant: D
Course: A	Plate: 21
Drawn by: Tom Kitchen	Date: 5/4/98

**Dames & Moore**  
Emergency Repairs For Red Hill Tanks at the Fleet Industrial & Supply Center  
Contract No. N62742-96-C-1356

**Repair Record**

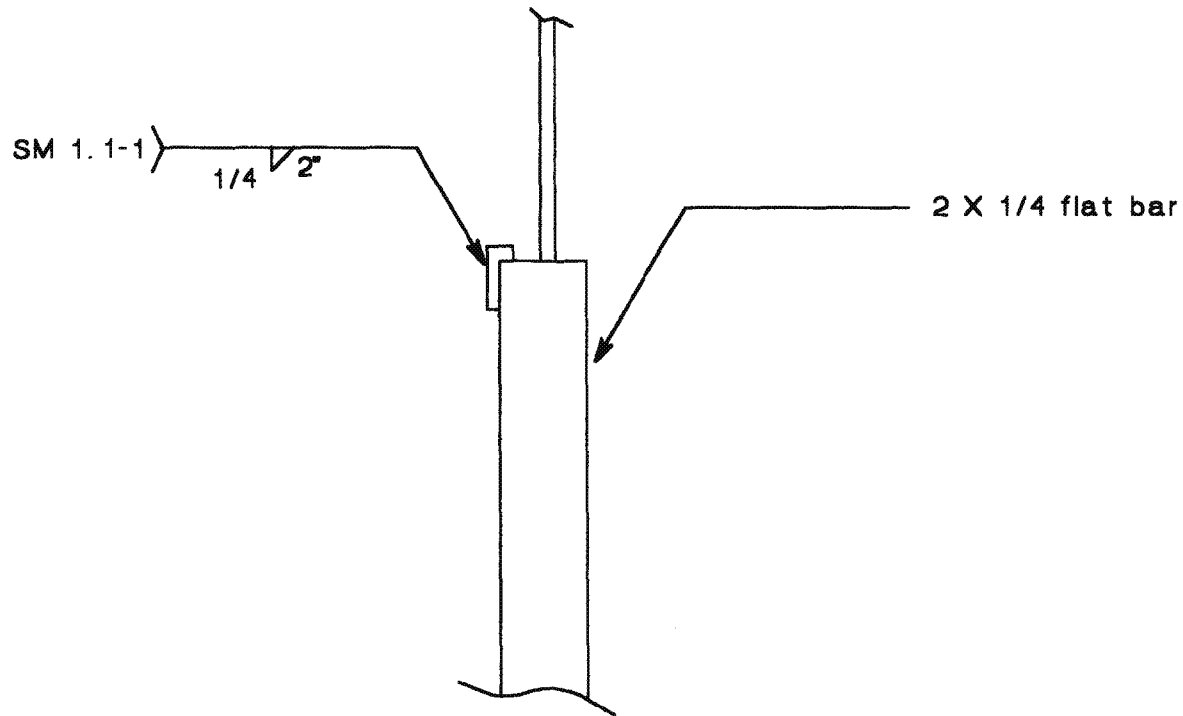
TYPE 10 REPAIR

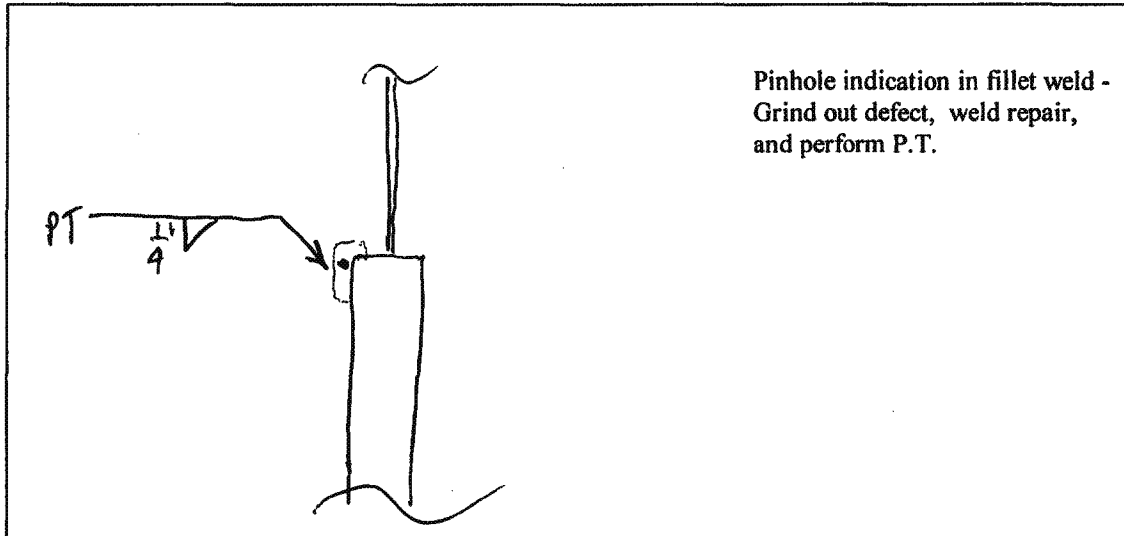
Sketch of Repair Area

Tank No.: 7    Repair No.: 016    Type: 10    Location: D21-A

Weld Repair

WPS No.: SM1.1-1

NDT Performed:                      Visual ☒    Vacuum Box ☐    Dye Penetrant ☒

Coating Repair

Coating Type: Epoxy

NDT Performed:                      Visual: ☒    DFT: ☒    Average DFT: 8-15 mils

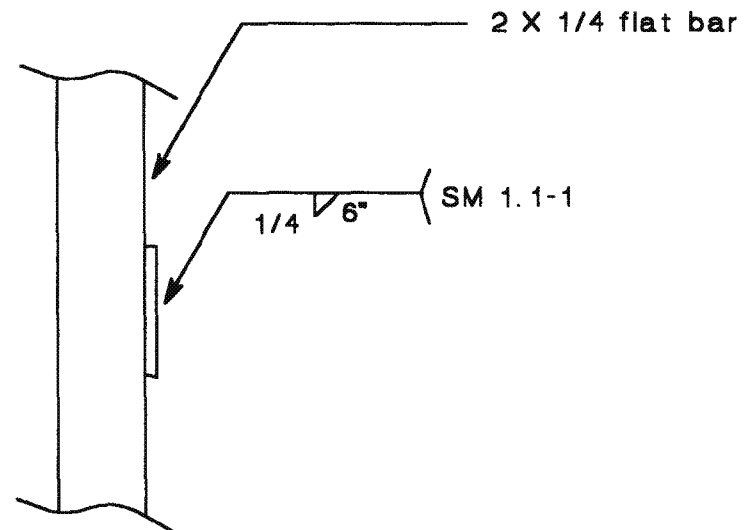
TYPE 10 REPAIR

MID ATLANTIC ENVIRONMENTAL	
EMERGENCY REPAIRS FOR RED HILL TANKS	
Tank #7 RECOMMENDED REPAIR DRAWINGS	
Repair No.: 017	File: 7R017
Upper Dome	Quadrant: D
Course: A	Plate: 19
Drawn by: Tom Kitchen	Date: 5/4/98

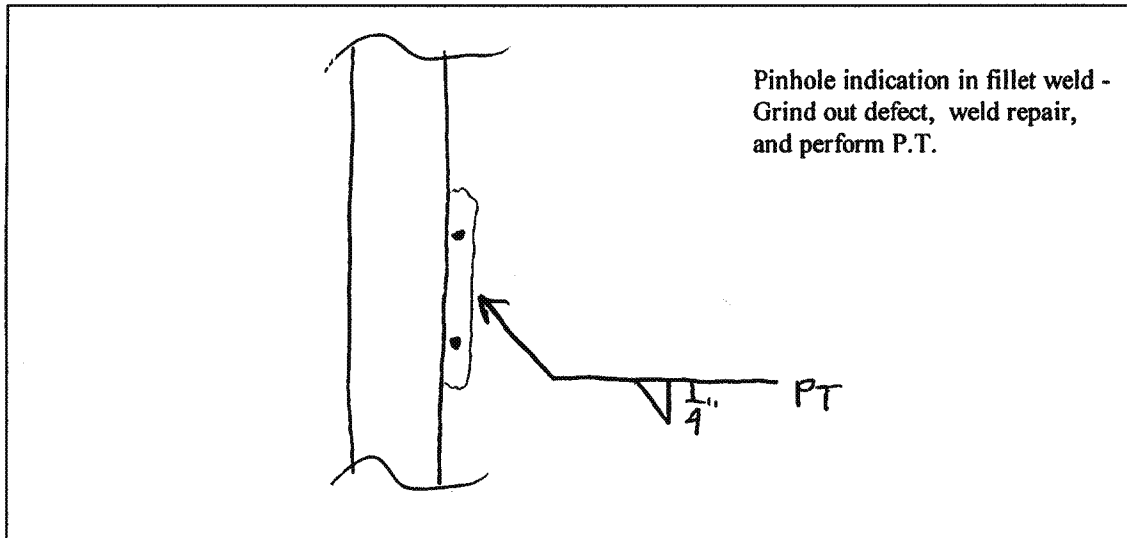
Sketch of Repair Area

Tank No.: 7 Repair No.: 017 Type: 10 Location: D19-A

Weld Repair

WPS No.: SM1.1-1

NDT Performed: Visual ☒ Vacuum Box ☐ Dye Penetrant ☒

Coating Repair

Coating Type: Epoxy

NDT Performed: Visual: ☒ DFT: ☒ Average DFT: 8-15 mils

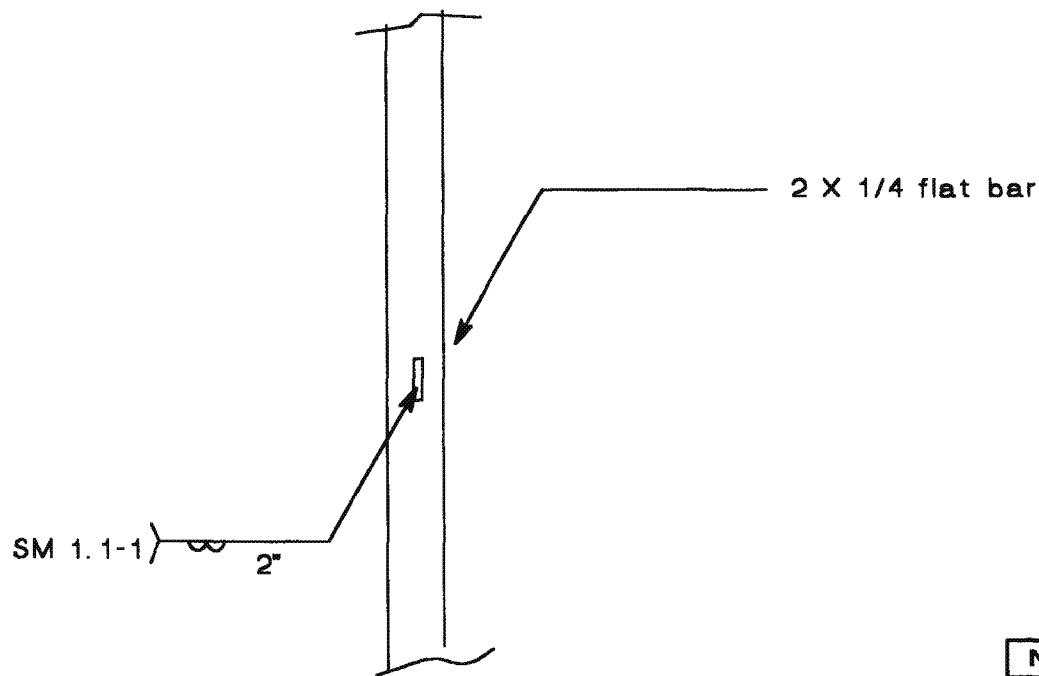
TYPE 10 REPAIR

MID ATLANTIC ENVIRONMENTAL	
EMERGENCY REPAIRS FOR RED HILL TANKS	
Tank #7 RECOMMENDED REPAIR DRAWING	
Repair No. : 018	File: 7R018
Upper Dome	Quadrant: D
Course: A	Plate: 19
Drawn by: Tom Kitchen	Date: 5/4/98

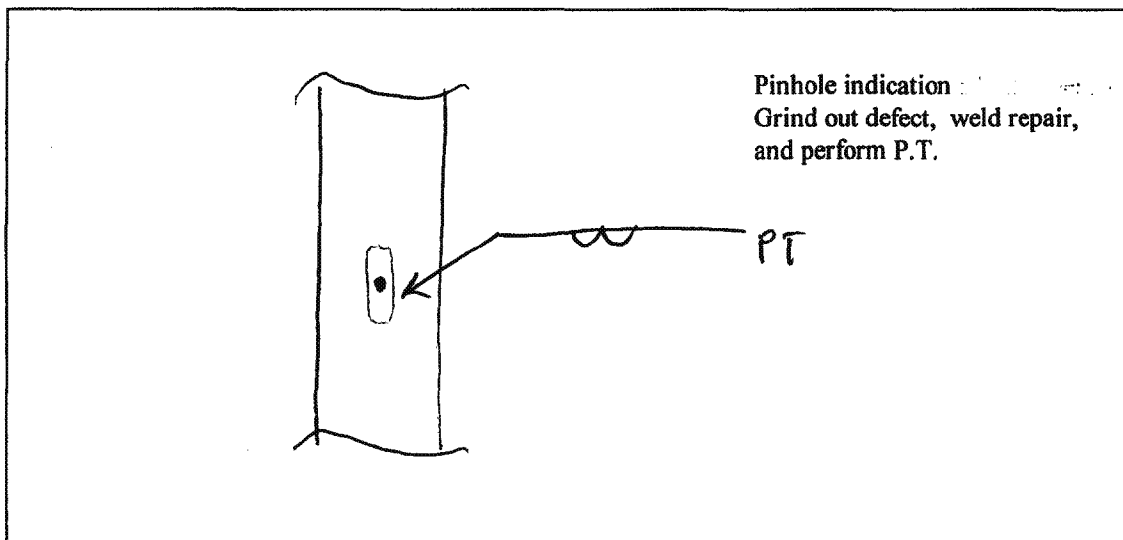
Sketch of Repair Area

Tank No.: 7 Repair No.: 018 Type: 10 Location: D19-A

Weld Repair

WPS No.: SM1.1-1

NDT Performed: Visual ☒ Vacuum Box ☐ Dye Penetrant ☒

Coating Repair

Coating Type: Epoxy

NDT Performed: Visual: ☒ DFT: ☒ Average DFT: 8-15 mils

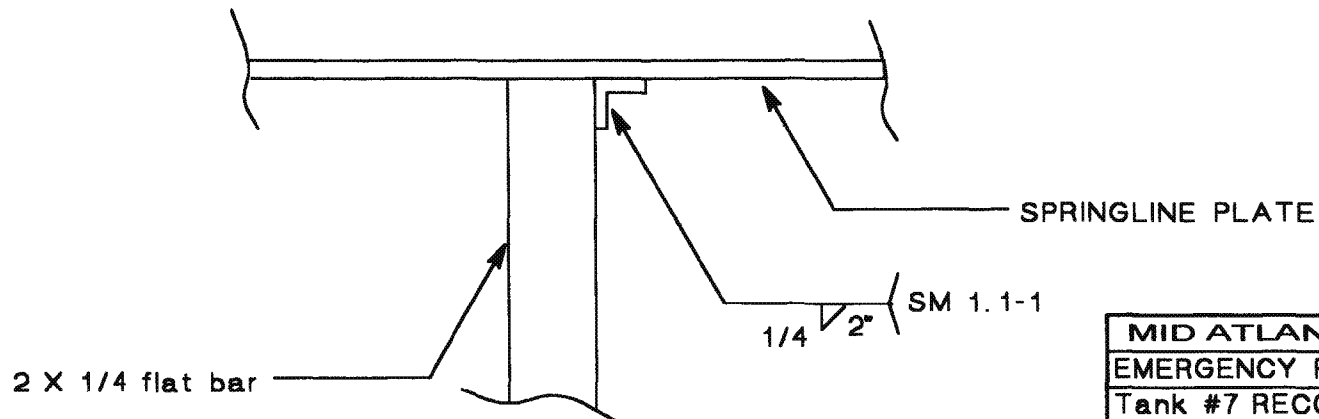
TYPE 10 REPAIR

MID ATLANTIC ENVIRONMENTAL	
EMERGENCY REPAIRS FOR RED HILL TANKS	
Tank #7 RECOMMENDED REPAIR DRAWING	
Repair No. 019	File 7R019
Upper Dome	Quadrant C
Course EXTENSION	Plate 18
Drawn by Tom Kitchen	Date 5/4/98

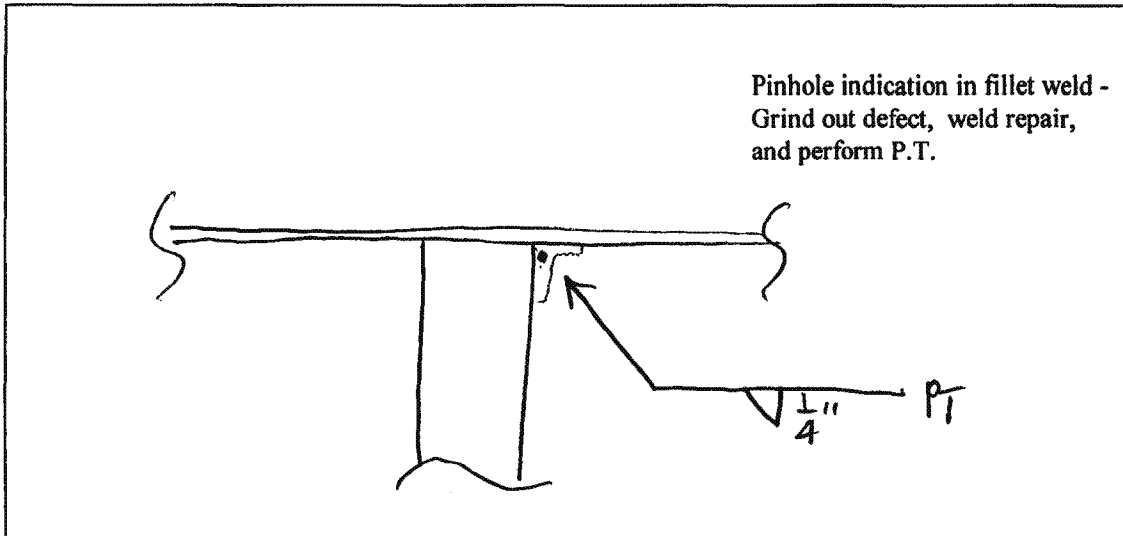
Sketch of Repair Area

Tank No.: 7 Repair No.: 019 Type: 10 Location: C18-EXT

Weld Repair

WPS No.: SM1.1-1

NDT Performed: Visual ☒ Vacuum Box ☐ Dye Penetrant ☒

Coating Repair

Coating Type: Epoxy

NDT Performed: Visual: ☒ DFT: ☒ Average DFT: 8-15 mils

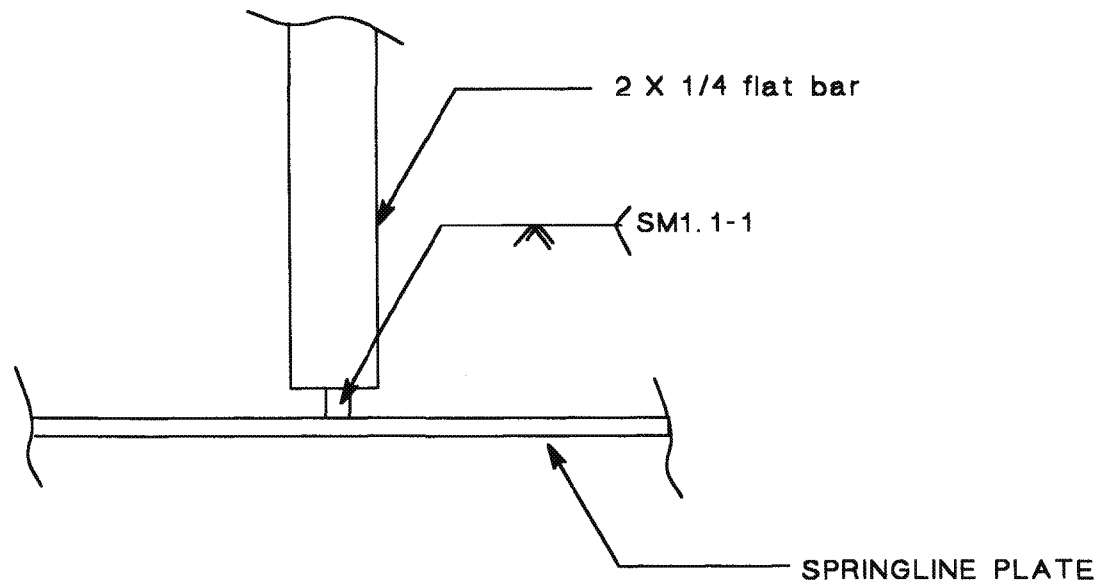
TYPE 10 REPAIR

MID ATLANTIC ENVIRONMENTAL	
EMERGENCY REPAIRS FOR RED HILL TANKS	
Tank #7 RECOMMENDED REPAIR DRAWING	
Repair No.: 020	File: 7R020
Upper Dome	Quadrant: C
Course: A	Plate: 18
Drawn by: Tom Kitchen	Date: 5/4/98

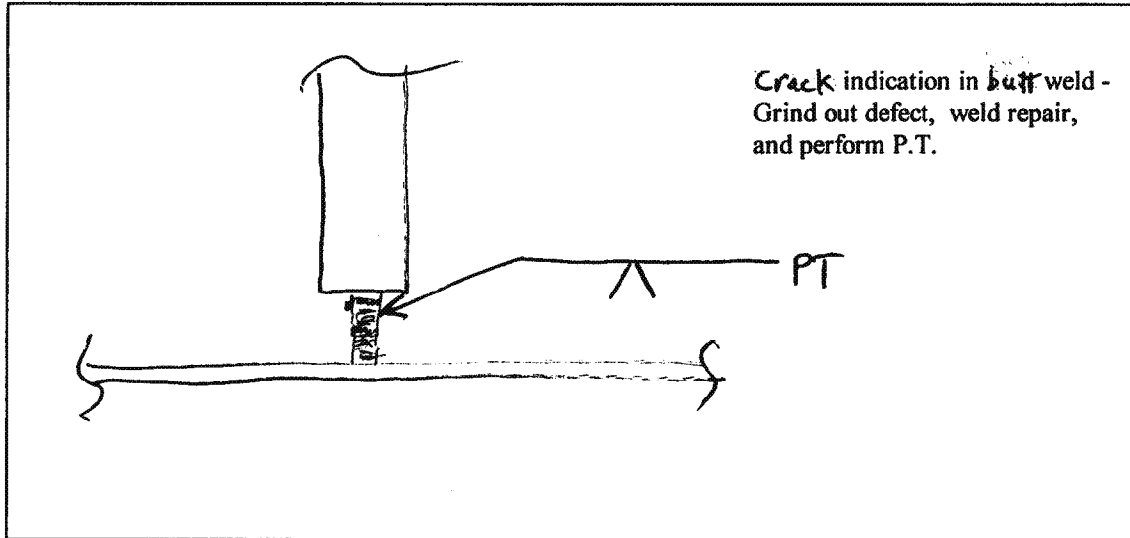
Sketch of Repair Area

Tank No.: 7 Repair No.: 020 Type: 9 Location: C10-A

Weld Repair

WPS No.: SM1.1-1

NDT Performed: Visual ☒ Vacuum Box ☐ Dye Penetrant ☒

Coating Repair

Coating Type: Epoxy

NDT Performed: Visual: ☒ DFT: ☒ Average DFT: 8-15 mls

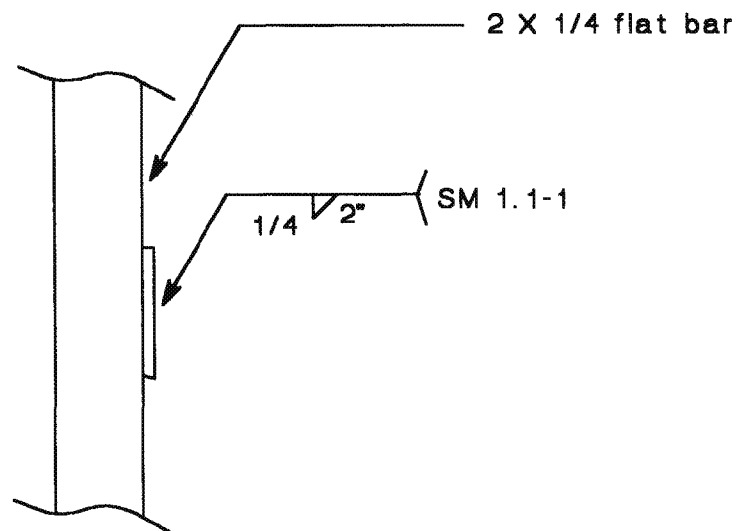
TYPE 10 REPAIR

MID ATLANTIC ENVIRONMENTAL	
EMERGENCY REPAIRS FOR RED HILL TANKS	
Tank #7 RECOMMENDED REPAIR DRAWINGS	
Repair No.: 021	File: 7R021
Upper Dome	Quadrant: C
Course: A	Plate: 1C
Drawn by: Tom Kitchen	Date: 5/4/98

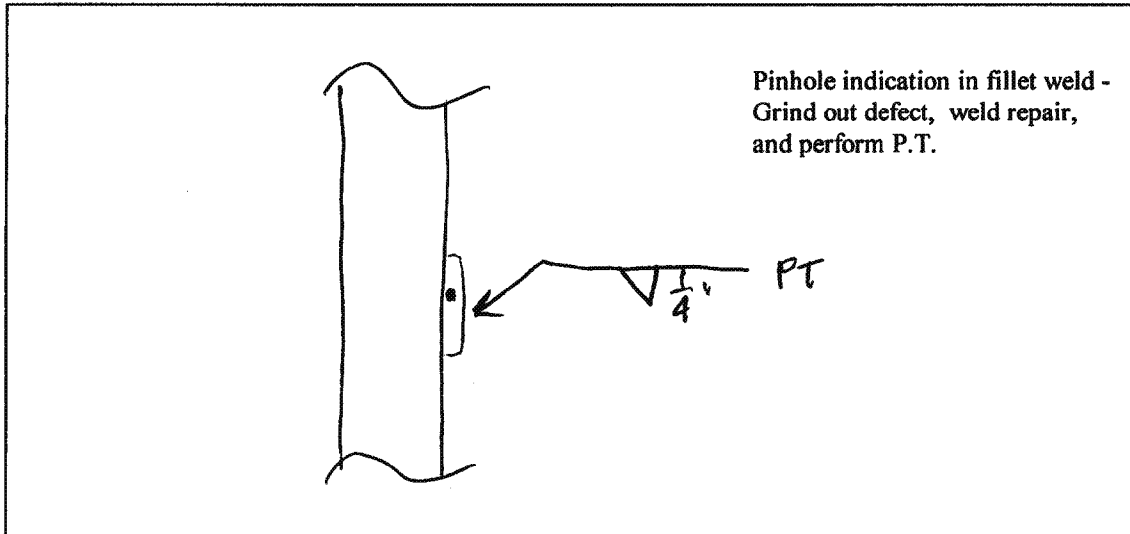
Sketch of Repair Area

Tank No.: 7 Repair No.: 021 Type: 10 Location: C16-A

Weld Repair

WPS No.: SM1.1-1

NDT Performed: Visual ☒ Vacuum Box ☐ Dye Penetrant ☒

Coating Repair

Coating Type: Epoxy

NDT Performed: Visual: ☒ DFT: ☒ Average DFT: 8-15 mils

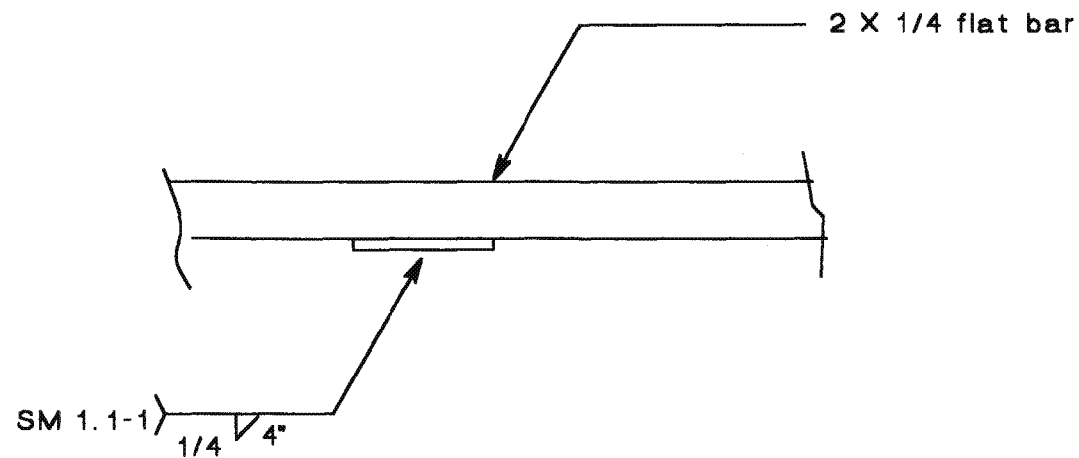
TYPE 10 REPAIR

MID ATLANTIC ENVIRONMENTAL	
EMERGENCY REPAIRS FOR RED HILL TANKS	
Tank #7 RECOMMENDED REPAIR DRAWING	
Repair No.: 022	File: 7R022
Upper Dome	Quadrant: C
Course: EXTENSION	Plate: 18
Drawn by: Tom Kitchen	Date: 5/4/98

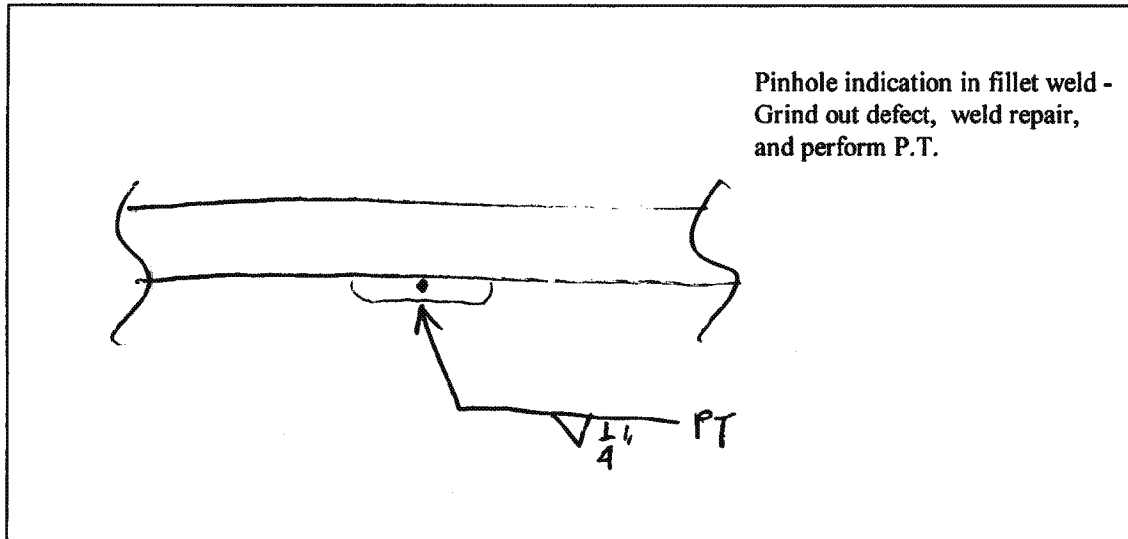
Sketch of Repair Area

Tank No.: 7 Repair No.: 022 Type: 10 Location: C18 - EXT

Weld Repair

WPS No.: SM1.1-1

NDT Performed: Visual ☒ Vacuum Box ☐ Dye Penetrant ☒

Coating Repair

Coating Type: Epoxy

NDT Performed: Visual: ☒ DFT: ☒ Average DFT: 8-15 m/s

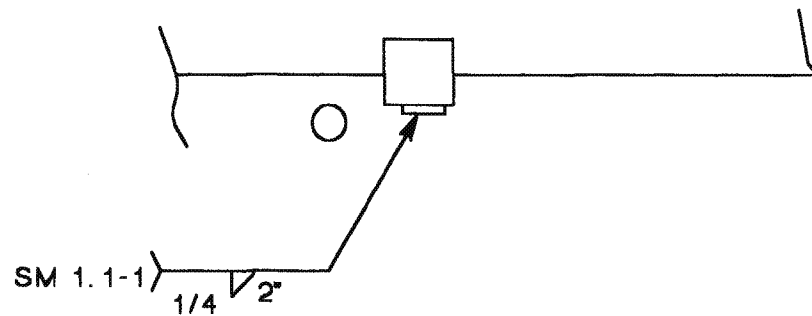
TYPE 10 REPAIR

MID ATLANTIC ENVIRONMENTAL	
EMERGENCY REPAIRS FOR RED HILL TANKS	
Tank #7 RECOMMENDED REPAIR DRAWING	
Repair No.: 023	File: 7R023
CYLINDER	Quadrant: D
Course: 6	Plate: 21
Drawn by: Tom Kitchen	Date: 5/4/98

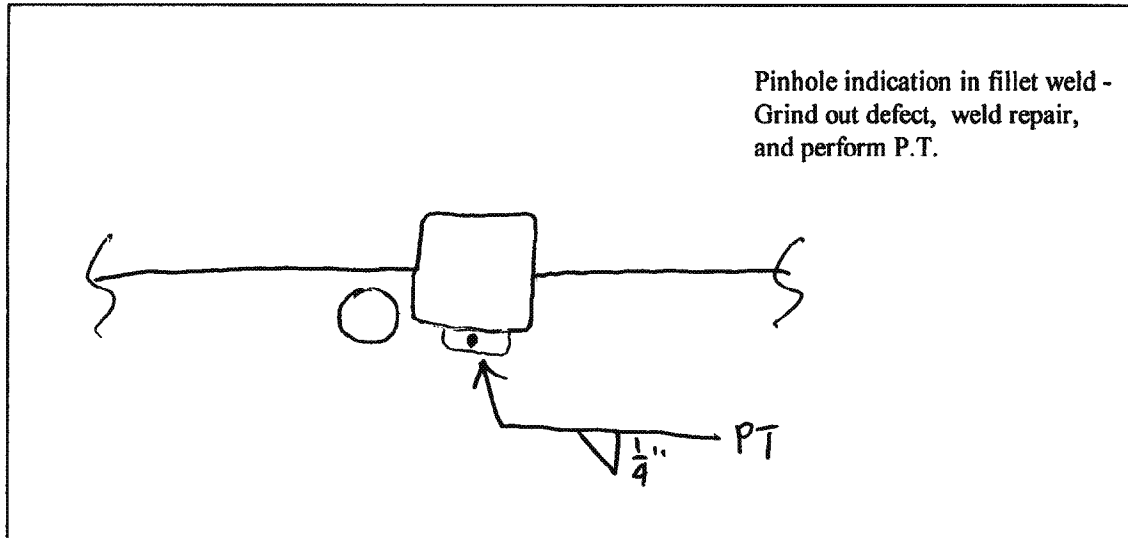
Sketch of Repair Area

Tank No.: 7 Repair No.: 023 Type: 10 Location: D21-06

Weld Repair

WPS No.: SM1.1-1

NDT Performed: Visual ☒ Vacuum Box ☐ Dye Penetrant ☒

Coating Repair

Coating Type: Epoxy

NDT Performed: Visual: ☒ DFT: ☒ Average DFT: 8-15 mils

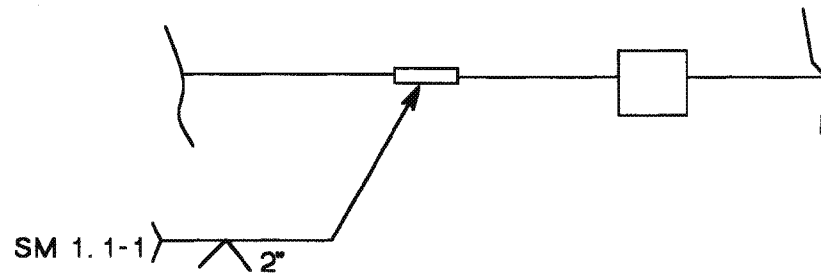
TYPE 9 REPAIR

MID ATLANTIC ENVIRONMENTAL	
EMERGENCY REPAIRS FOR RED HILL TANKS	
Tank #7 RECOMMENDED REPAIR DRAWING	
Repair No.: 024	File: 7R024
CYLINDER	Quadrant: C
Course: 10	Plate: 12
Drawn by: Tom Kitchen	Date: 5/4/98

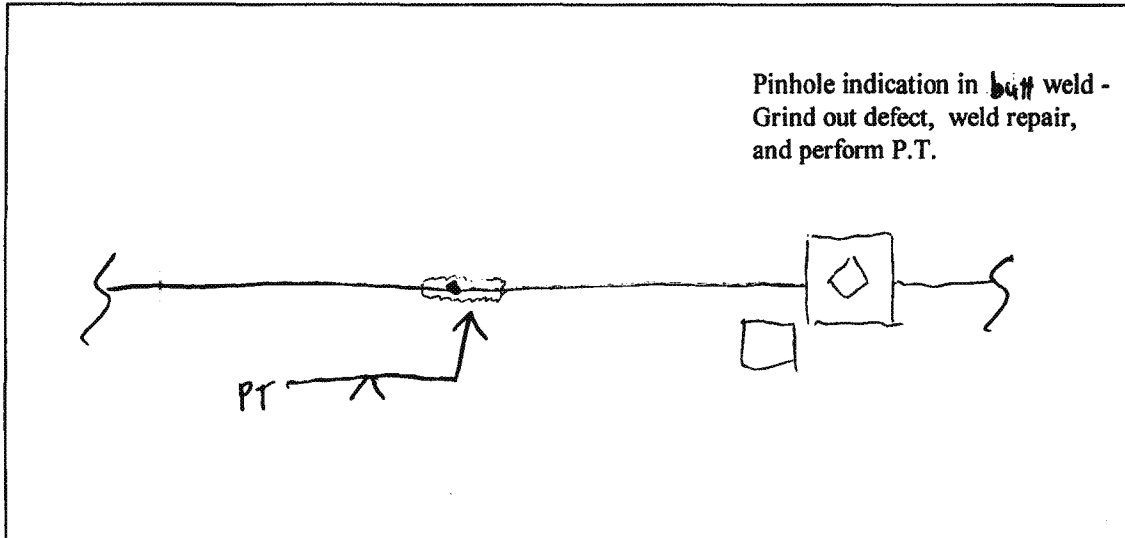
Sketch of Repair Area

Tank No.: 7    Repair No.: 024    Type: 9    Location: D12-10

Weld Repair

WPS No.: SM1.1-1

NDT Performed:                      Visual ☒    Vacuum Box ☐    Dye Penetrant ☒

Coating Repair

Coating Type: Epoxy

NDT Performed:                      Visual: ☒    DFT: ☒    Average DFT: 8-15 mils

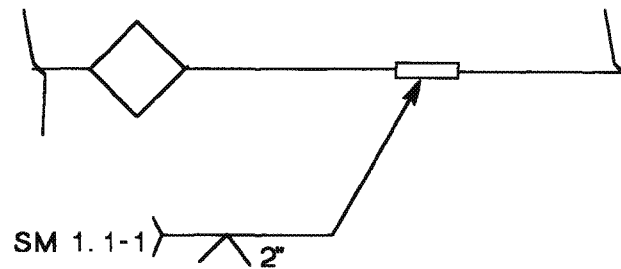
TYPE 9 REPAIR

MID ATLANTIC ENVIRONMENTAL	
EMERGENCY REPAIRS FOR RED HILL TANKS	
Tank #7 RECOMMENDED REPAIR DRAWING	
Repair No.: 025	File: 7R025
CYLINDER	Quadrant: D
Course: 13	Plate: 21
Drawn by: Tom Kitchen	Date: 5/4/98

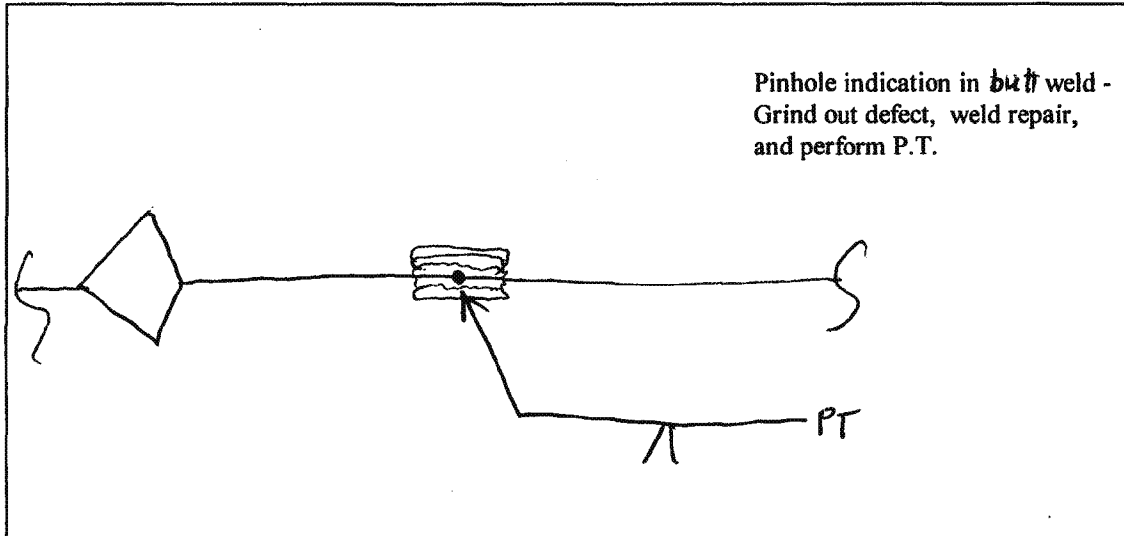
Sketch of Repair Area

Tank No.: 7 Repair No.: 025 Type: 9 Location: D21-13

Weld Repair

WPS No.: SM1.1-1

NDT Performed: Visual ☒ Vacuum Box ☐ Dye Penetrant ☒

Coating Repair

Coating Type: Epoxy

NDT Performed: Visual: ☒ DFT: ☒ Average DFT: 8-15 mils

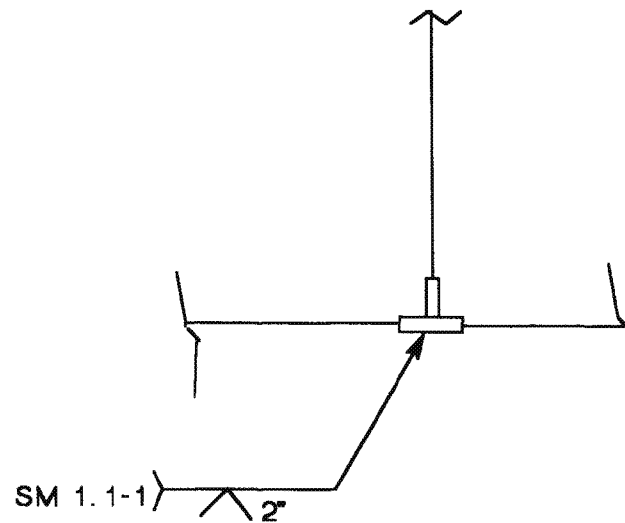
TYPE 9 REPAIR

MID ATLANTIC ENVIRONMENTAL	
EMERGENCY REPAIRS FOR RED HILL TANKS	
Tank #7 RECOMMENDED REPAIR DRAWING	
Repair No. 026	File 7R026
CYLINDER	Quadrant D
Course 13	Plate 21
Drawn by Tom Kitchen	Date 5/4/98

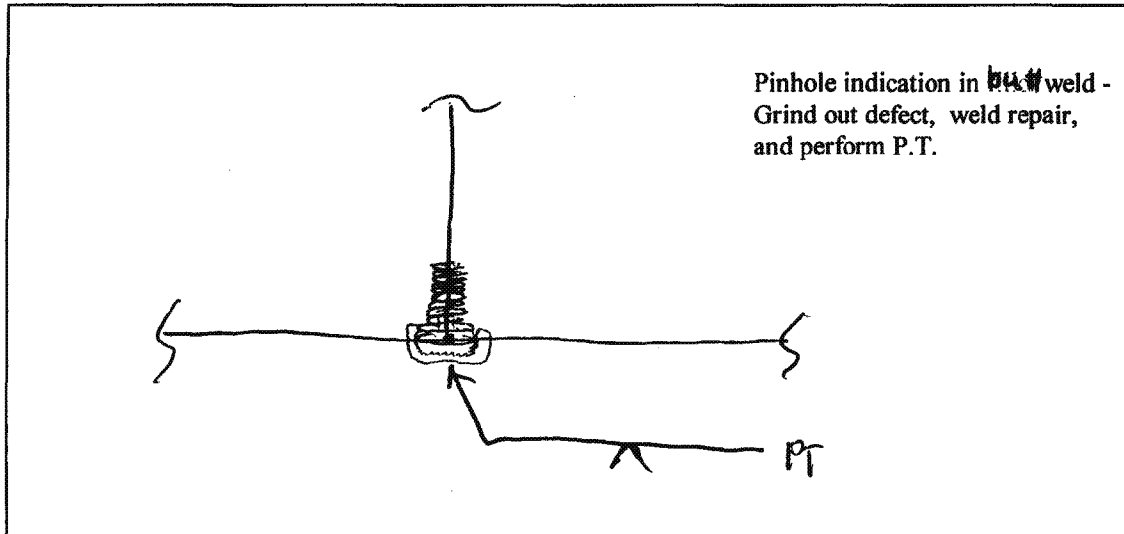
Sketch of Repair Area

Tank No.: 7 Repair No.: 026 Type: 9 Location: D21-13

Weld Repair

WPS No.: SM1.1-1

NDT Performed: Visual ☒ Vacuum Box ☐ Dye Penetrant ☒

Coating Repair

Coating Type: Epoxy

NDT Performed: Visual: ☒ DFT: ☒ Average DFT: 8-15 mils

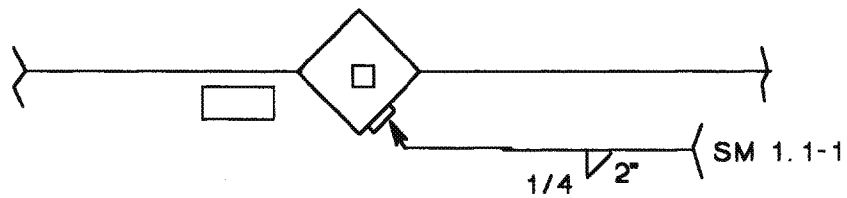
TYPE 10 REPAIR

MID ATLANTIC ENVIRONMENTAL	
EMERGENCY REPAIRS FOR RED HILL TANKS	
Tank #7 RECOMMENDED REPAIR DRAWINGS	
Repair No.: 027	File: 7R027
CYLINDER	Quadrant: D
Course: 13	Plate: 21
Drawn by: Tom Kitchen	Date: 5/4/98

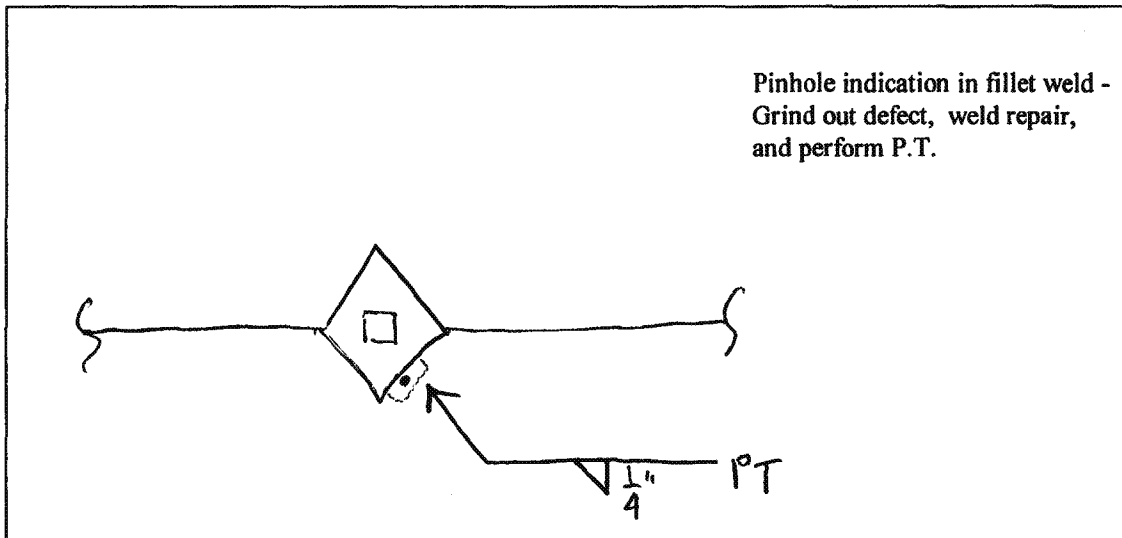
Sketch of Repair Area

Tank No.: 7 Repair No.: 027 Type: 10 Location: D21-13

Weld Repair

WPS No.: SM1.1-1

NDT Performed: Visual ☒ Vacuum Box ☐ Dye Penetrant ☒

Coating Repair

Coating Type: Epoxy

NDT Performed: Visual: ☒ DFT: ☒ Average DFT: 8-15 mils

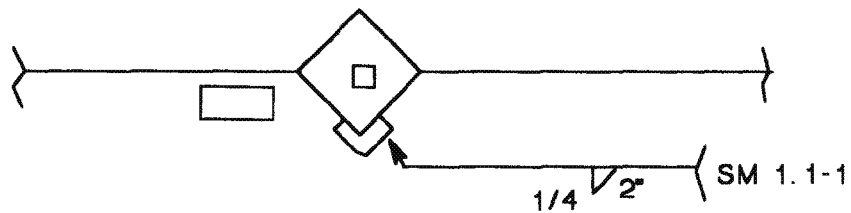
TYPE 10 REPAIR

MID ATLANTIC ENVIRONMENTAL	
EMERGENCY REPAIRS FOR RED HILL TANKS	
Tank #7 RECOMMENDED REPAIR DRAWINGS	
Repair No. 028	File 7R028
CYLINDER	Quadrant D
Course 16	Plate 21
Drawn by Tom Kitchen	Date 5/4/98

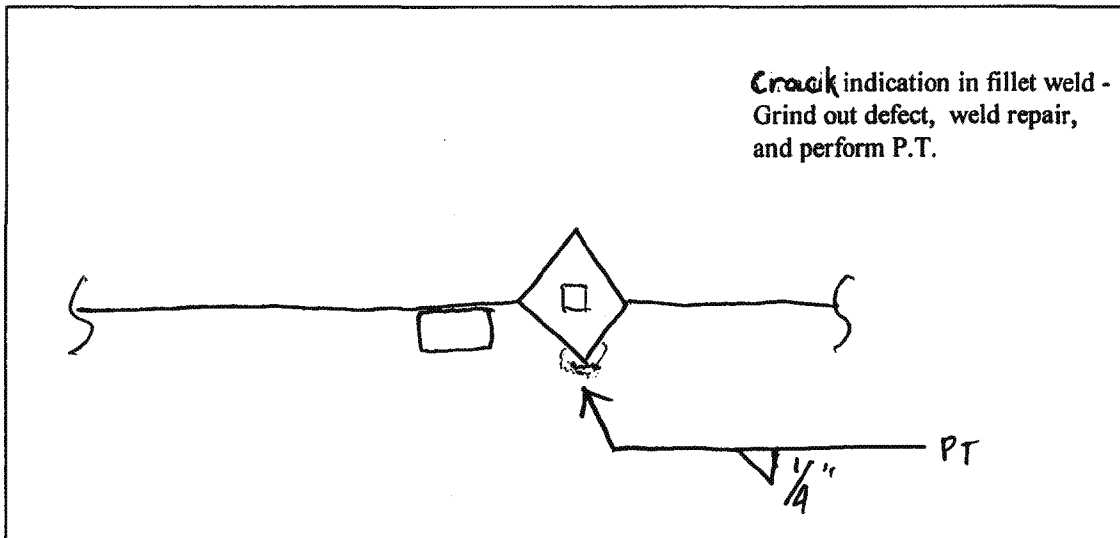
Tank No.: 7 Repair No.: 028 Type: 10 Location: D21-16

Weld Repair

WPS No.: SM1.1-1

NDT Performed:

Coating Repair

Coating Type: Epoxy

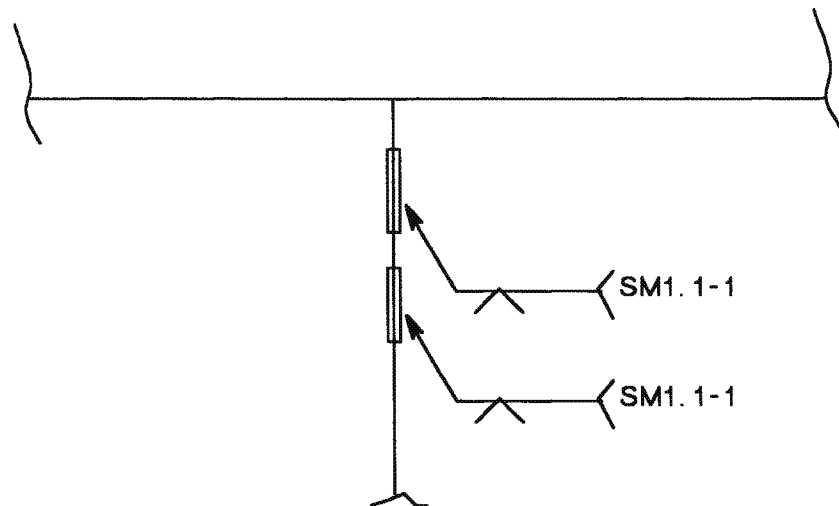
TYPE 10 REPAIR

MID ATLANTIC ENVIRONMENTAL	
EMERGENCY REPAIRS FOR RED HILL TANKS	
Tank #7 RECOMMENDED REPAIR DRAWING	
Repair No.: 029	File: 7R029
CYLINDER	Quadrant: D
Course: 14	Plate: 22
Drawn by: Tom Kitchen	Date: 5/4/98

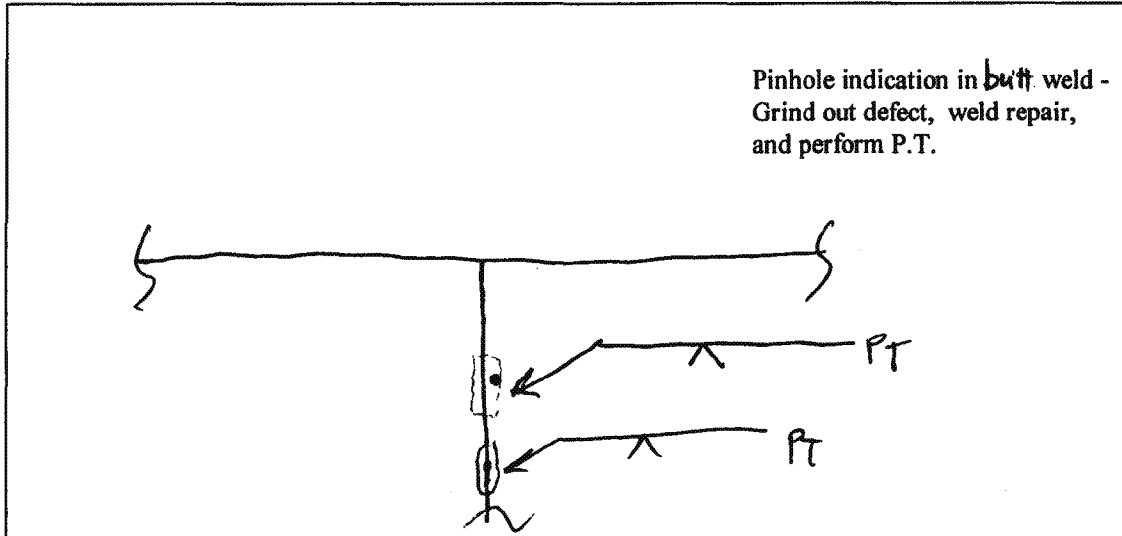
Sketch of Repair Area

Tank No.: 7 Repair No.: 029 Type: 90 Location: C 19-22

Weld Repair

WPS No.: SM1.1-1

NDT Performed: Visual ☒ Vacuum Box ☐ Dye Penetrant ☒

Coating Repair

Coating Type: Epoxy

NDT Performed: Visual: ☒ DFT: ☒ Average DFT: 8.15 m.l.s

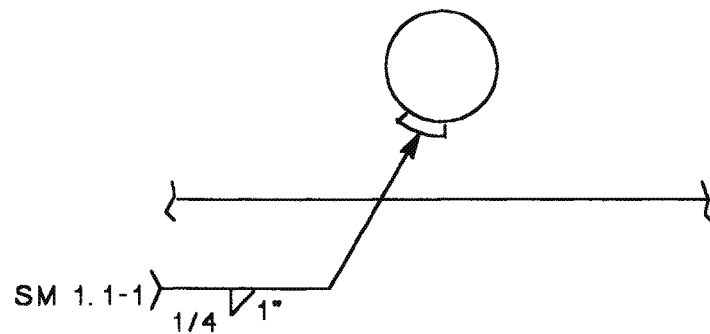
TYPE 10 REPAIR

MID ATLANTIC ENVIRONMENTAL	
EMERGENCY REPAIRS FOR RED HILL TANKS	
Tank #7 RECOMMENDED REPAIR DRAWING	
Repair No. 030	File 7R030
cylinder	Quadrant C
Course 25	Plate 15
Drawn by Tom Kitchen	Date 5/4/98

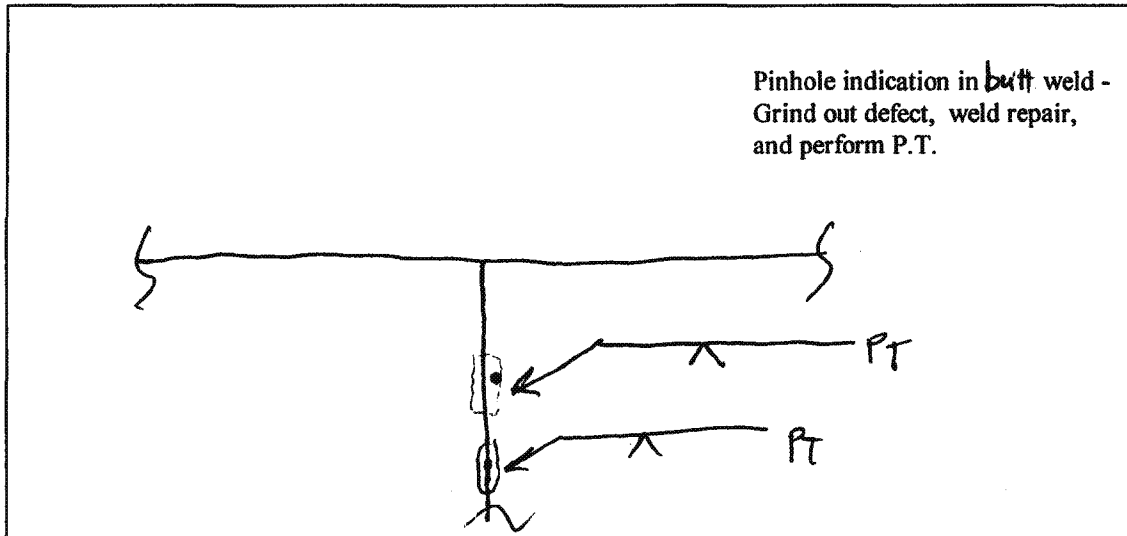
Sketch of Repair Area

Tank No.: 7 Repair No.: 029 Type: 90 Location: C 14-22

Weld Repair

WPS No.: SM1.1-1

NDT Performed: Visual ☒ Vacuum Box ☐ Dye Penetrant ☒

Coating Repair

Coating Type: Epoxy

NDT Performed: Visual: ☒ DFT: ☒ Average DFT: 8.15 m.l.s

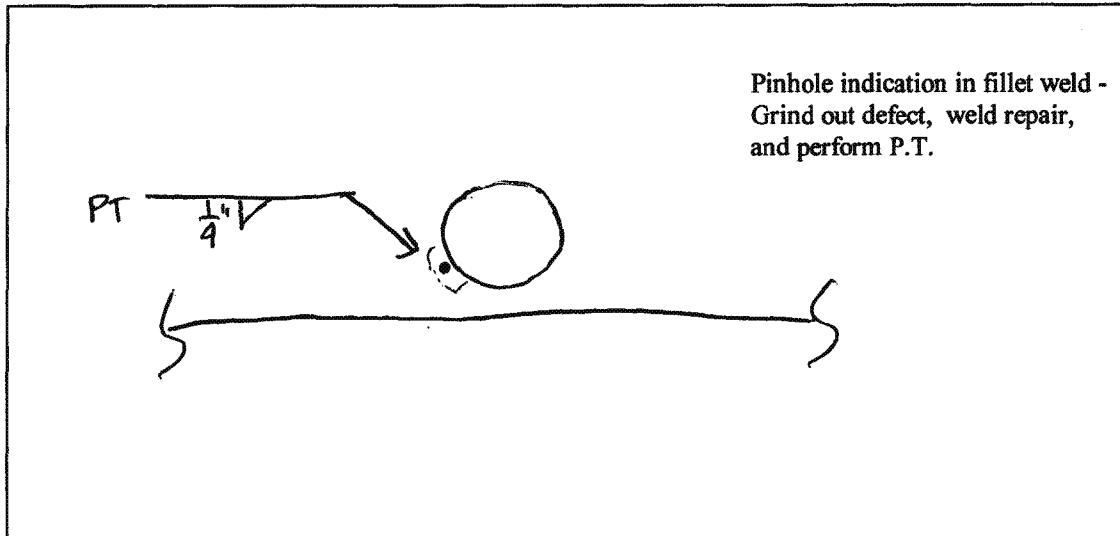
Sketch of Repair Area

Tank No.: 7 Repair No.: 030 Type: 10 Location: C-15 - 25

Weld Repair

WPS No.: SM1.1-1

NDT Performed: Visual ☒ Vacuum Box ☐ Dye Penetrant ☒

Coating Repair

Coating Type: Epoxy

NDT Performed: Visual: ☒ DFT: ☒ Average DFT: 8-15 mils
