MID ATLANTIC ENVIRONMENTAL	
EMERGENCY REPAIRS FOR RED HILL TANKS	
Tank #7 RECOMMENDED REPAIR DRAWING	
Repair No. 031	File 7R031
cylinder	Quadrant C
Course 24	Plate 15
Drawn by Tom Kitchen	Date 5/4/98

Dames & Moore
Emergency Repairs For Red Hill Tanks at the Fleet Industrial & Supply Center
Contract No. N62742-96-C-1356

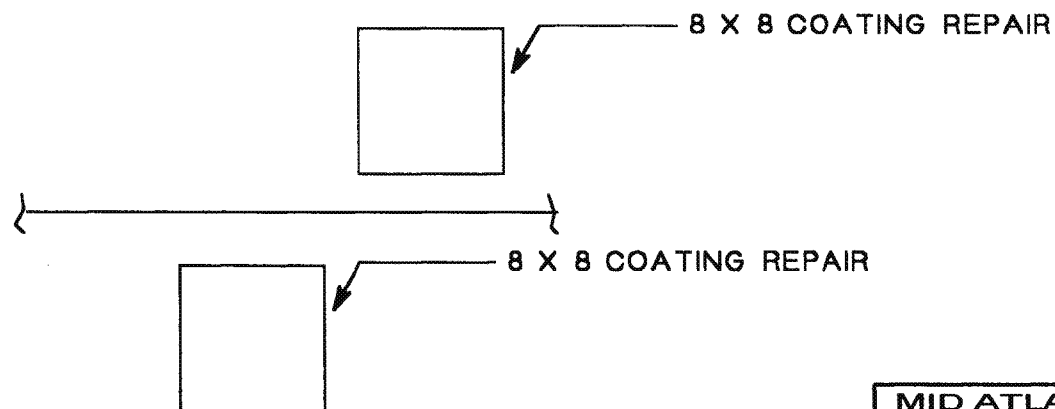
TYPE 8 REPAIR

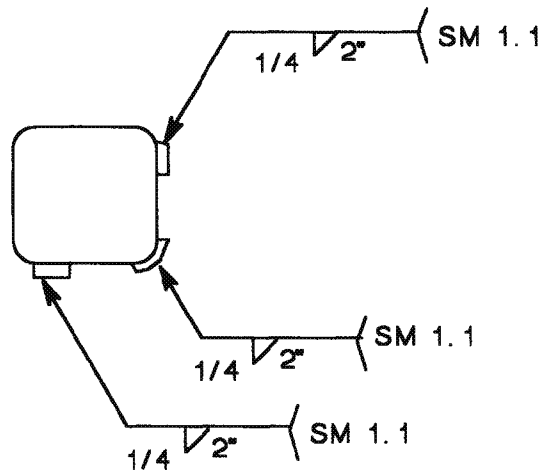
MID ATLANTIC ENVIRONMENTAL	
EMERGENCY REPAIRS FOR RED HILL TANKS	
Tank #7 RECOMMENDED REPAIR DRAWINGS	
Repair No.: 032	File: 7r032
CYLINDER	Quadrant: C
Course: 28	Plate: 18
Drawn by: Tom Kitchen	Date: 5/4/98

TYPE 10 REPAIR

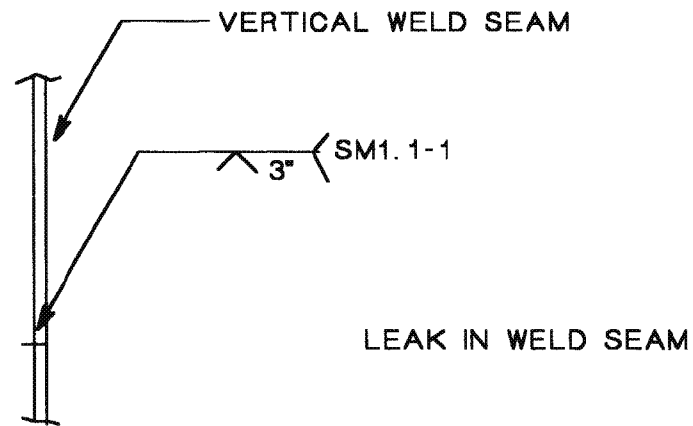
MID ATLANTIC ENVIRONMENTAL	
EMERGENCY REPAIRS FOR RED HILL TANKS	
Tank #7 RECOMMENDED REPAIR DRAWING	
Repair No.: 033	File: 7R033
Lower Dome	Quadrant: D
Course: 3	Plate: 21
Drawn by: Tom Kitchen	Date: 5/4/98

TYPE 10 REPAIR

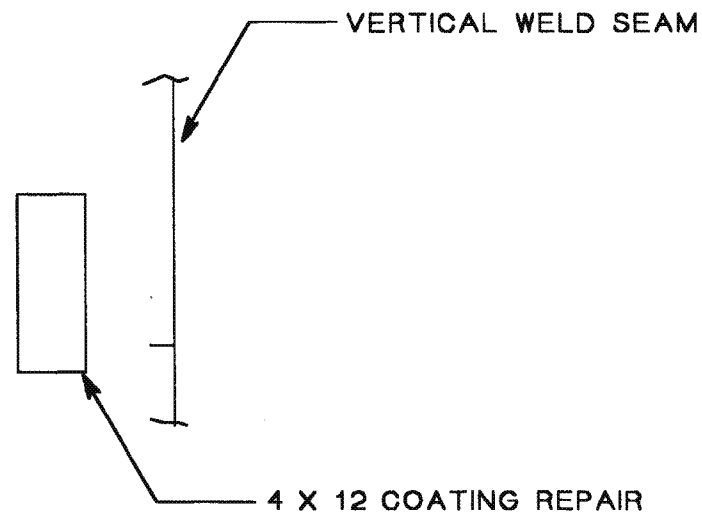
MID ATLANTIC ENVIRONMENTAL	
EMERGENCY REPAIRS FOR RED HILL TANKS	
Tank #7 RECOMMENDED REPAIR DRAWING	
Repair No. 034	File 7R034
Lower Dome	Quadrant C
Course 3	Plate 17
Drawn by Tom Kitchen	Date 5/4/98

TYPE 8 REPAIR

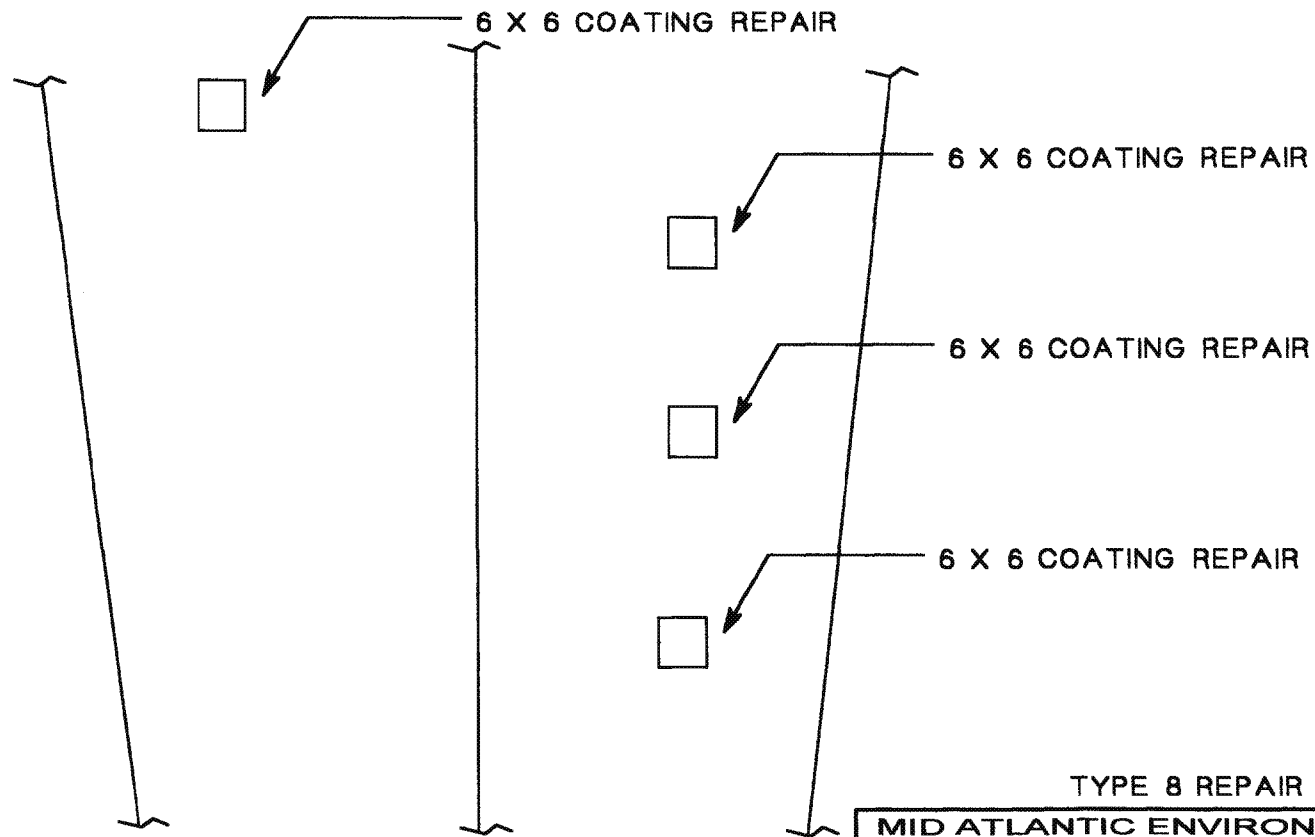
MID ATLANTIC ENVIRONMENTAL	
EMERGENCY REPAIRS FOR RED HILL TANKS	
Tank #7 RECOMMENDED REPAIR DRAWING	
Repair No.: 036	File: 7R036
Lower Dome	Quadrant: C
Course: 2	Plate: 18
Drawn by: Tom Klitcher	Date: 5/4/98

TYPE 8 REPAIR

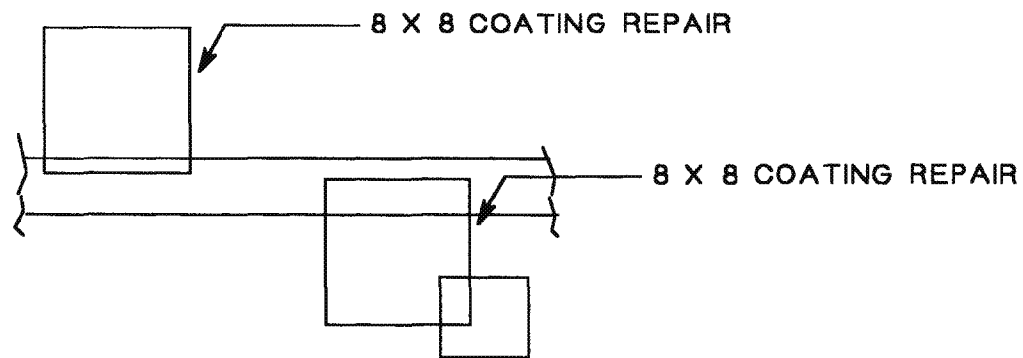
MID ATLANTIC ENVIRONMENTAL	
EMERGENCY REPAIRS FOR RED HILL TANKS	
Tank #7 RECOMMENDED REPAIR DRAWING	
Repair No. 037	File 7R037
LOWER DOME	Quadrant C
Course 2 & 3	Plate 15
Drawn by Tom Kitchen	Date 5/4/98

TYPE 8 REPAIR

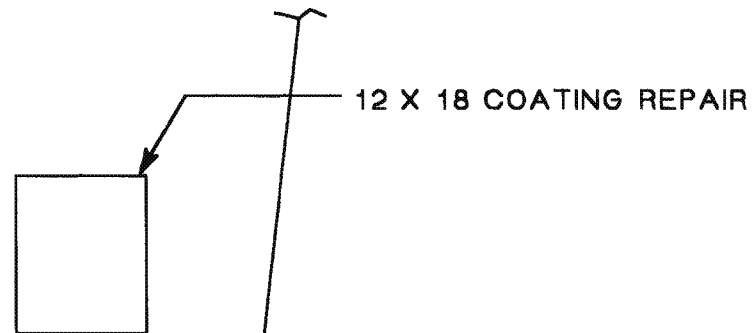
MID ATLANTIC ENVIRONMENTAL	
EMERGENCY REPAIRS FOR RED HILL TANKS	
Tank #7 RECOMMENDED REPAIR DRAWING	
Repair No. 038	File 7R038
Lower Dome	Quadrant D
Course 2	Plate 21
Drawn by Tom Kitchen	Date 5/4/98

TYPE 8 REPAIR

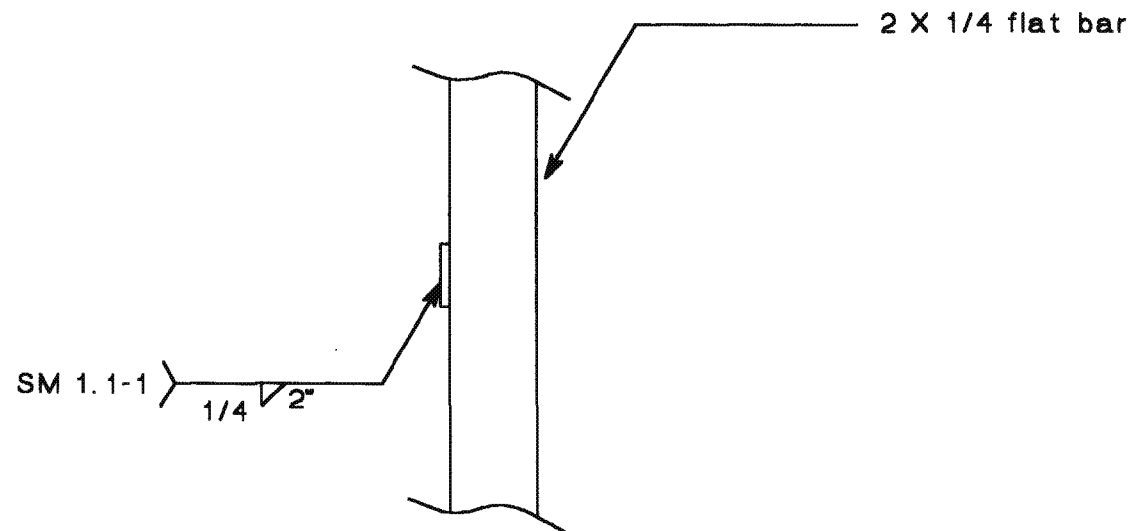
MID ATLANTIC ENVIRONMENTAL	
EMERGENCY REPAIRS FOR RED HILL TANKS	
Tank #7 RECOMMENDED REPAIR DRAWINGS	
Repair No. 039	File 7R039
Upper Dome	Quadrant A
Course B	Plate 3
Drawn by Tom Kitchen	Date 5/4/98

TYPE 10 REPAIR

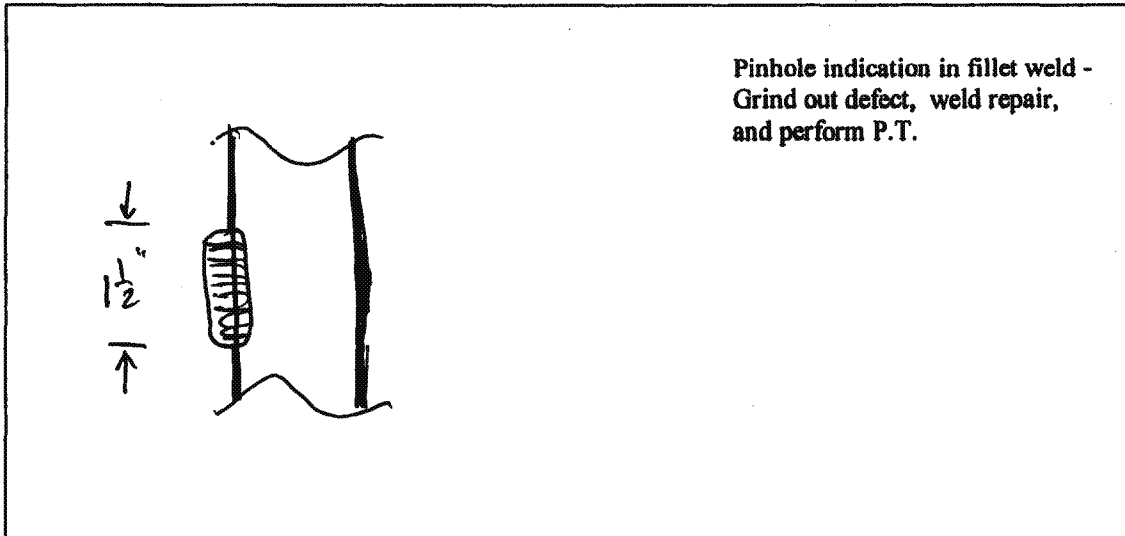
Tank No.: 7 Repair No.: 039 Type: 10 Location: A3-B

Pinhole indication in fillet weld -
Grind out defect, weld repair,
and perform P.T.

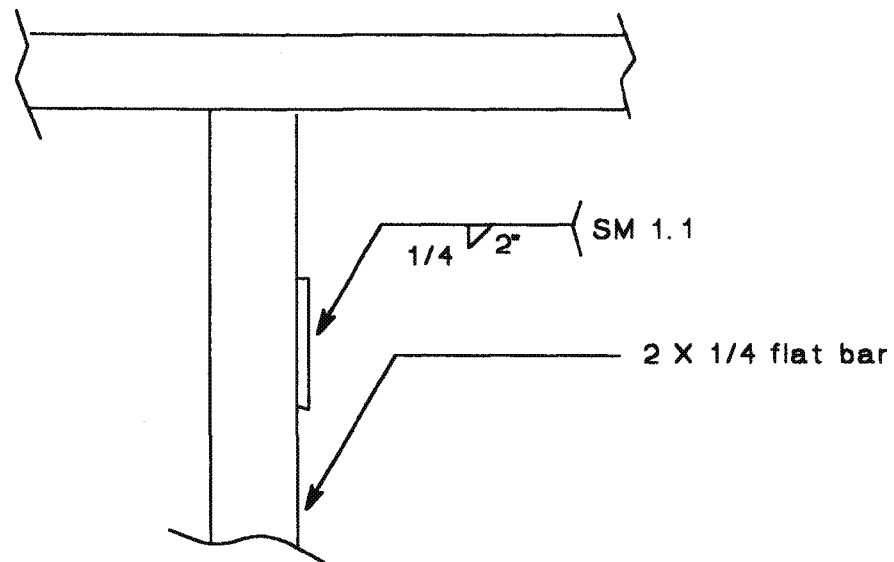
MID ATLANTIC ENVIRONMENTAL	
EMERGENCY REPAIRS FOR RED HILL TANKS	
Tank #7 RECOMMENDED REPAIR DRAWINGS	
Repair No.: 040	File: 7r040
Upper Dome	Quadrant: A
Course: B	Plate: 9
Drawn by: Tom Kitchen	Date: 5/4/98

TYPE 10 REPAIR

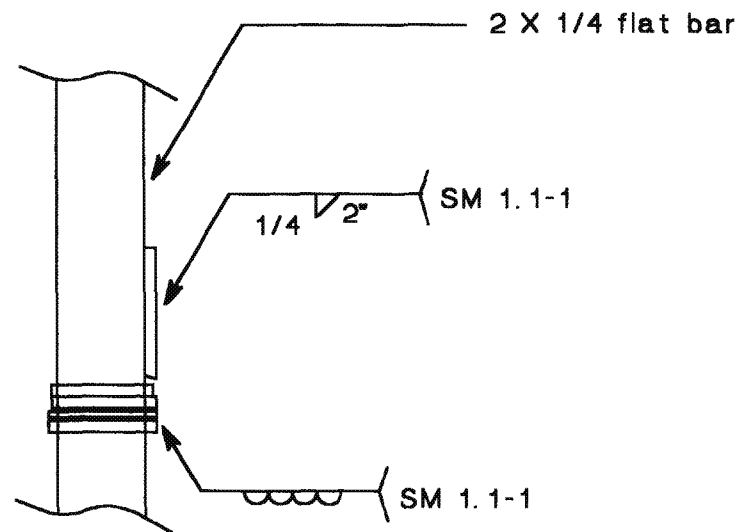
MID ATLANTIC ENVIRONMENTAL	
EMERGENCY REPAIRS FOR RED HILL TANKS	
Tank #7 RECOMMENDED REPAIR DRAWINGS	
Repair No. : 041	File: 7r041
Upper Dome	Quadrant: a
Course: 7	Plate: 2
Drawn by: Tom Kitchen	Date: 5/4/98

TYPE 10 REPAIR

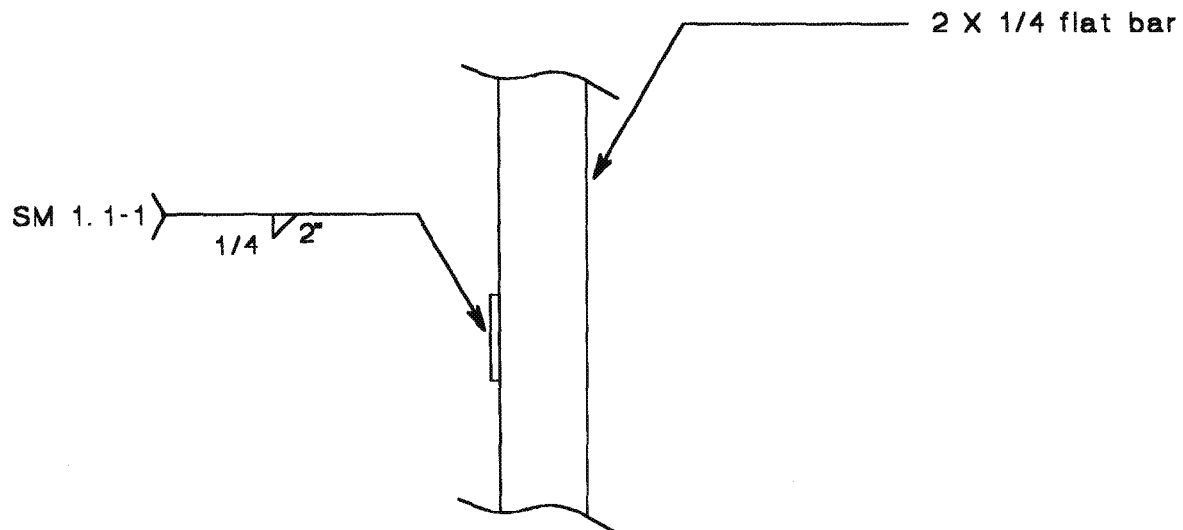
MID ATLANTIC ENVIRONMENTAL	
EMERGENCY REPAIRS FOR RED HILL TANKS	
Tank #7 RECOMMENDED REPAIR DRAWINGS	
Repair No.: 042	File: 7R042
Upper Dome	Quadrant: A
Course: A	Plate: 3
Drawn by: Tom Kitchen	Date: 5/4/98

TYPE 10 REPAIR

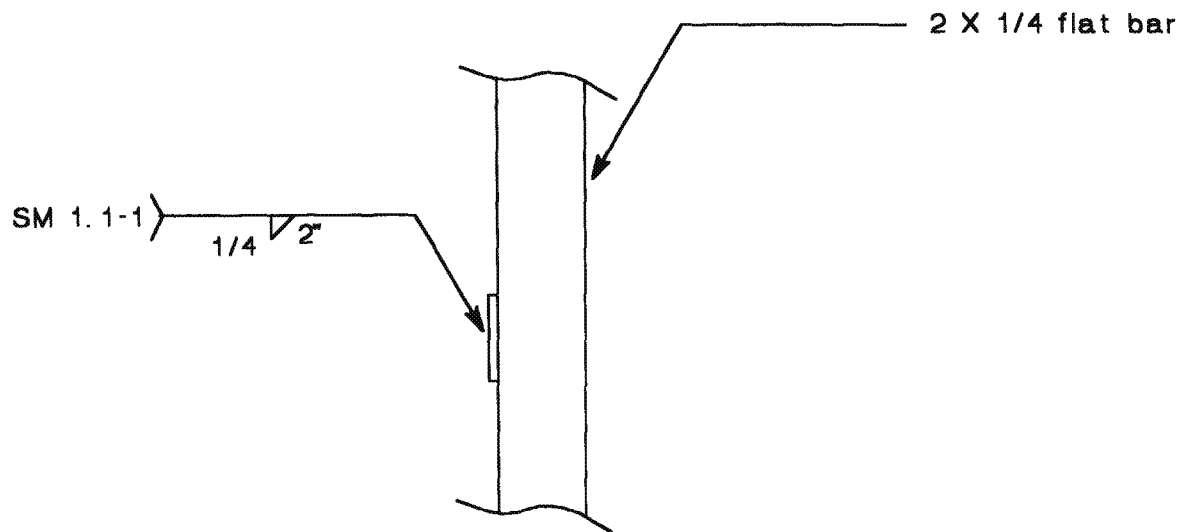
MID ATLANTIC ENVIRONMENTAL	
EMERGENCY REPAIRS FOR RED HILL TANKS	
Tank #7 RECOMMENDED REPAIR DRAWINGS	
Repair No.: 043	File: 7R043
Upper Dome	Quadrant: A
Course: A	Plate: 3
Drawn by: Tom Kitchen	Date: 5/4/98

TYPE 10 REPAIR

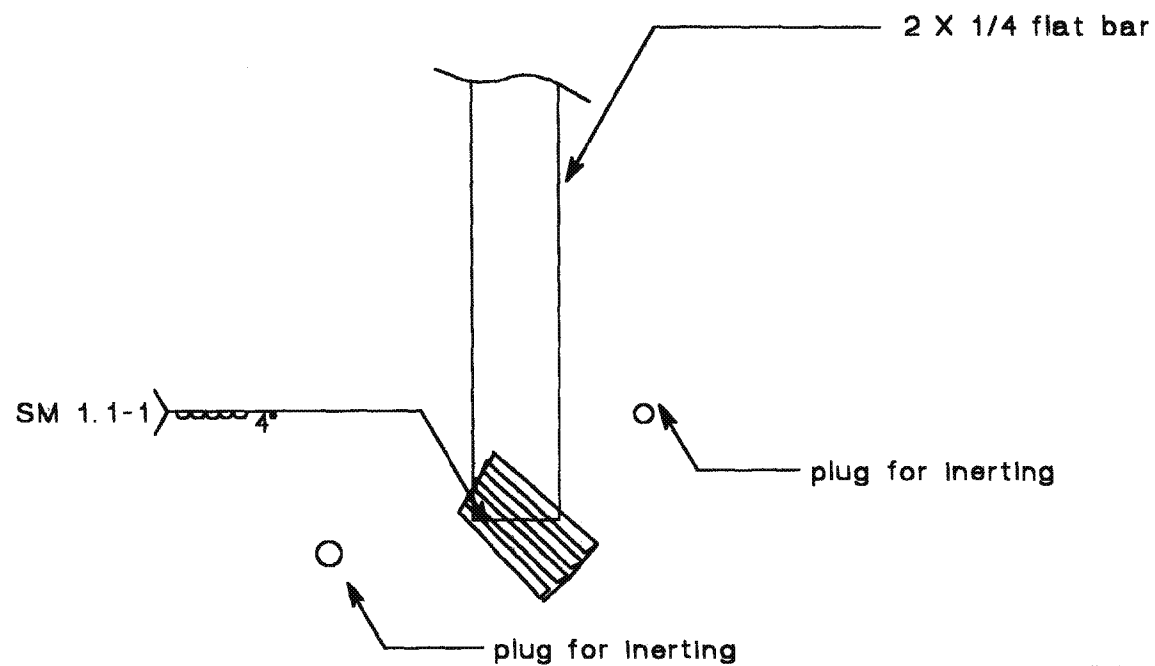
MID ATLANTIC ENVIRONMENTAL	
EMERGENCY REPAIRS FOR RED HILL TANKS	
Tank #7 RECOMMENDED REPAIR DRAWINGS	
Repair No. 044	File 7R044
Upper Dome	Quadrant A
Course A	Plate 3
Drawn by: Tom Kitchen	Date: 5/4/98

TYPE 10 REPAIR

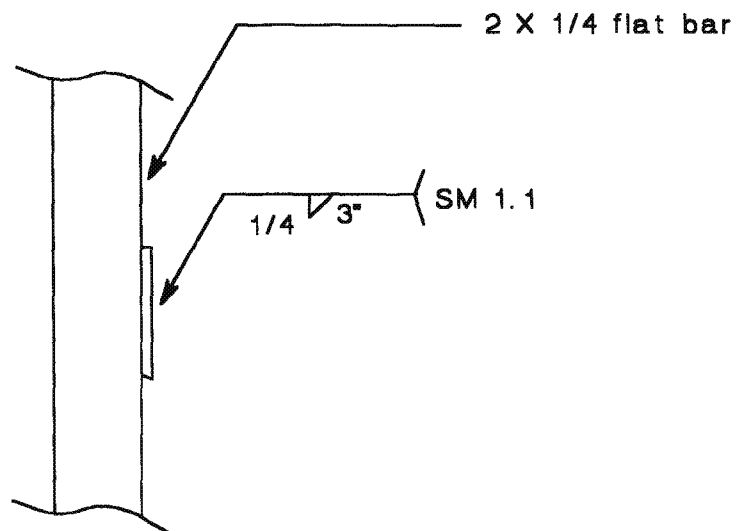
MID ATLANTIC ENVIRONMENTAL	
EMERGENCY REPAIRS FOR RED HILL TANKS	
Tank #7 RECOMMENDED REPAIR DRAWINGS	
Repair No.: 045	File: 7r045
Upper Dome	Quadrant: A
Course: A	Plate: 4
Drawn by: Tom Kitchen	Date: 5/4/98

TYPE 10 REPAIR
