MID ATLANTIC ENVIRONMENTAL	
EMERGENCY REPAIRS FOR RED HILL TANKS	
Tank #7 RECOMMENDED REPAIR DRAWINGS	
Repair No. : 046	File: 7r046
Upper Dome	Quadrant: B
Course: A	Plate: 10
Drawn by: Tom Kitchen	Date: 5/4/98

Dames & Moore
Emergency Repairs For Red Hill Tanks at the Fleet Industrial & Supply Center
Contract No. N62742-96-C-1356

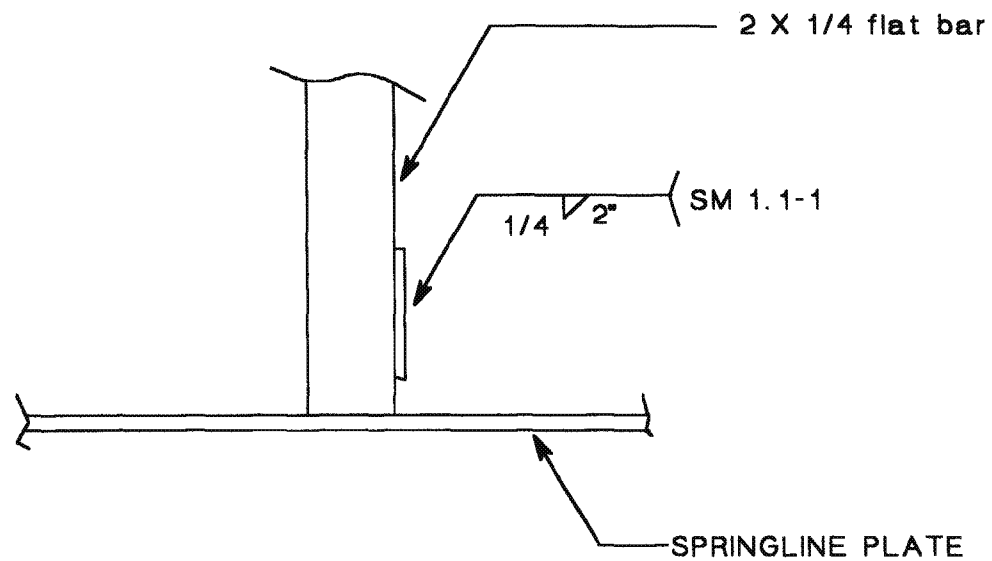
TYPE 10 REPAIR

Weld Repair

WPS No.: SM1.1-1

NDT Performed: Visual ☒ Vacuum Box ☐ Dye Penetrant ☒

Coating Type: EPOXY

NDT Performed: Visual: ☒ DFT: ☒ Average DFT: 8-15 mils

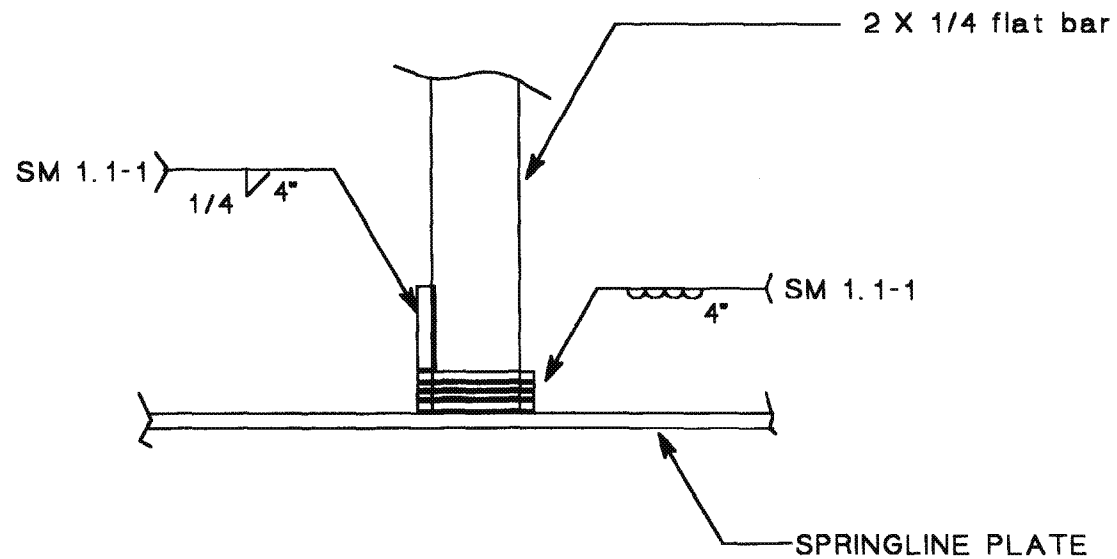
MID ATLANTIC ENVIRONMENTAL	
EMERGENCY REPAIRS FOR RED HILL TANKS	
Tank #7 RECOMMENDED REPAIR DRAWINGS	
Repair No. : 047	File: 7r047
Upper Dome	Quadrant: B
Course: A	Plate: 11
Drawn by: Tom Kitchen	Date: 5/4/98

TYPE 10 REPAIR

Weld Repair

WPS No.: SM 1.1-1

NDT Performed: Visual ☒ Vacuum Box ☐ Dye Penetrant ☒

Coating Type: EPOXY

NDT Performed: Visual: ☒ DFT: ☒ Average DFT: 8-15 mils

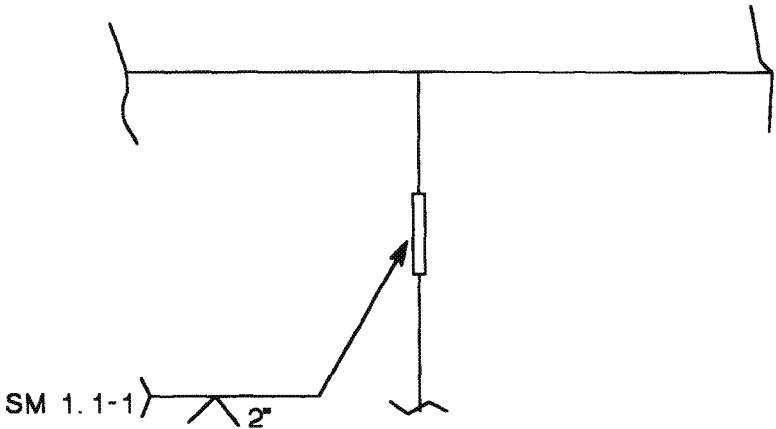
MID ATLANTIC ENVIRONMENTAL	
EMERGENCY REPAIRS FOR RED HILL TANKS	
Tank #7 RECOMMENDED REPAIR DRAWING	
Repair No.: 048	File: 7R048
CYLINDER	Quadrant: B
Course: 18	Plate: 11
Drawn by: Tom Kitchen	Date: 5/4/98

TYPE 9 REPAIR

Weld Repair

WPS No.: SM 1.1-1

NDT Performed: Visual ☒ Vacuum Box ☐ Dye Penetrant ☒

Coating Type: EPOXY

NDT Performed: Visual: ☒ DFT: ☒ Average DFT: 8-15 m.l.s

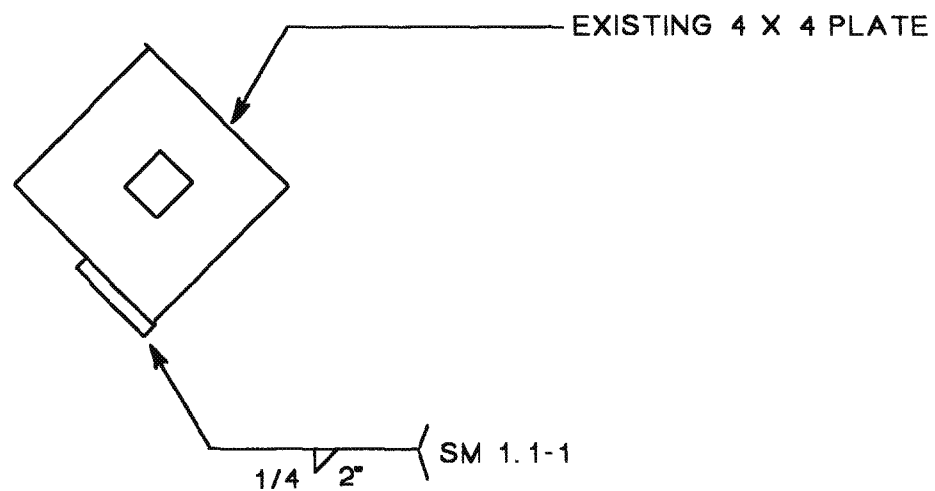
MID ATLANTIC ENVIRONMENTAL	
EMERGENCY REPAIRS FOR RED HILL TANKS	
Tank #7 REPAIR DRAWING	
Repair No. : 049	File: 7R049
CYLINDER	Quadrant: B
Course: 15	Plate: 9
Drawn by: Tom Kitchen	Date: 5/4/98

TYPE 10 REPAIR

Weld Repair

WPS No.: SM1.1-1

NDT Performed: Visual ☒ Vacuum Box ☐ Dye Penetrant ☒

Coating Type: EPOXY

NDT Performed: Visual: ☒ DFT: ☒ Average DFT: 8-15 mils

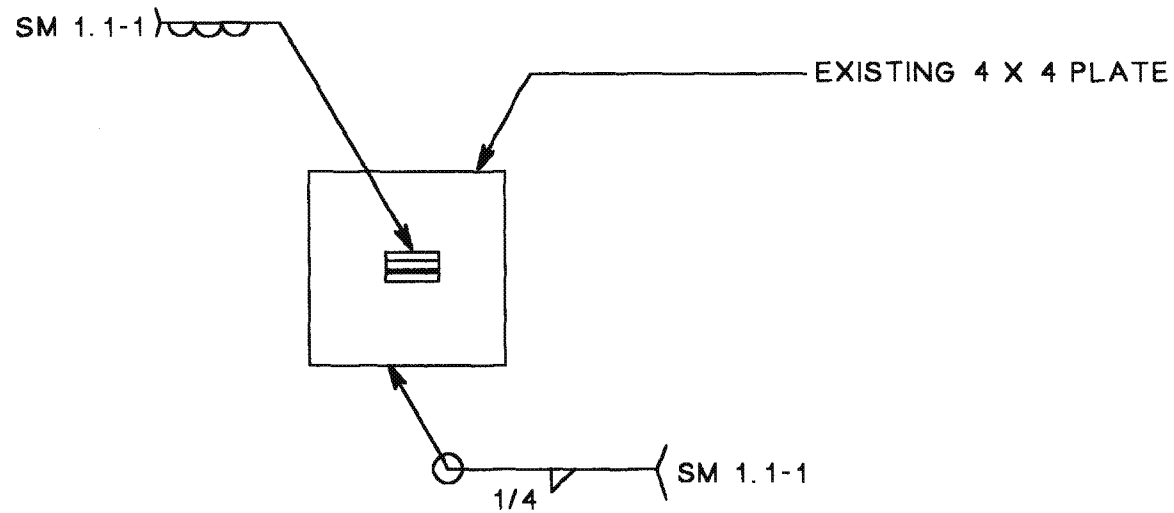
MID ATLANTIC ENVIRONMENTAL	
EMERGENCY REPAIRS FOR RED HILL TANKS	
Tank #7 REPAIR DRAWING	
Repair No.: 050	File: 7R050
CYLINDER	Quadrant: B
Course: 28	Plate: 11
Drawn by: Tom Kitchen	Date: 5/4/98

TYPE 10 REPAIR

Weld Repair

WPS No.: SM 1.1-1

NDT Performed: Visual ☒ Vacuum Box ☐ Dye Penetrant ☒

Coating Type: EPOXY

NDT Performed: Visual: ☒ DFT: ☒ Average DFT: 8-15 m/s

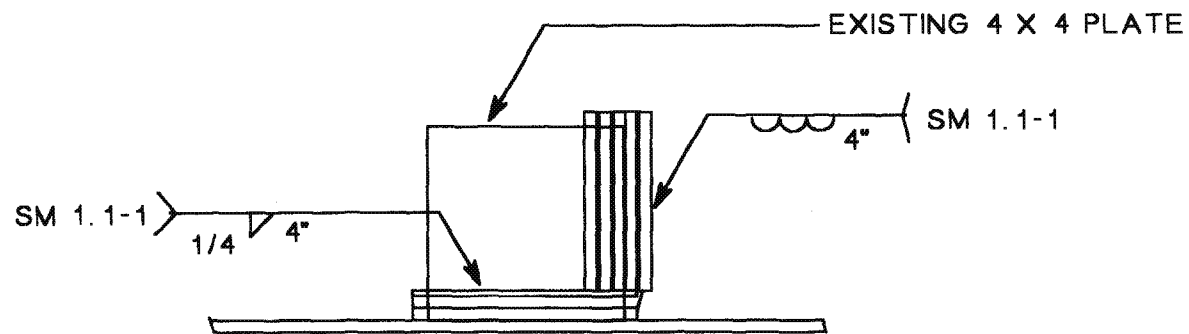
MID ATLANTIC ENVIRONMENTAL	
EMERGENCY REPAIRS FOR RED HILL TANKS	
Tank #7 REPAIR DRAWING	
Repair No.: 051	File: 7R051
CYLINDER	Quadrant: B
Course: 28	Plate: 8
Drawn by: Tom Kitchen	Date: 5/4/98

TYPE 10 REPAIR

Weld Repair

WPS No.: SM 1.1-1

Coating Type: EPOXY

Average DFT: 8-15 mils

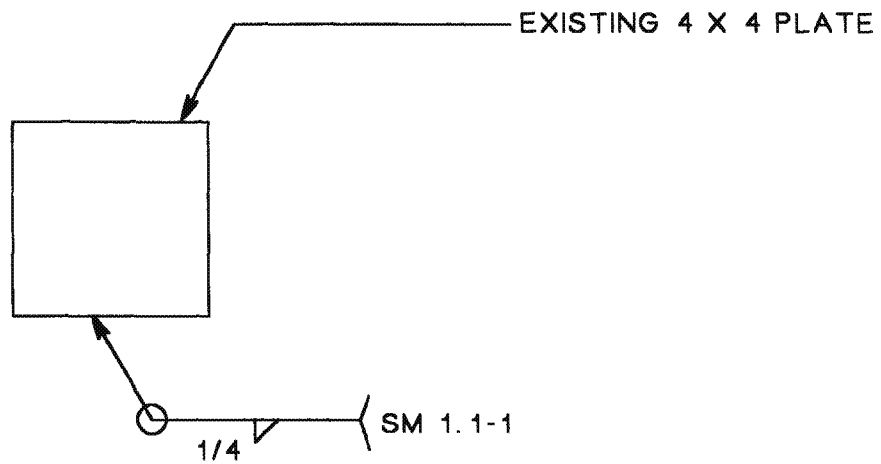
MID ATLANTIC ENVIRONMENTAL	
EMERGENCY REPAIRS FOR RED HILL TANKS	
Tank #7 REPAIR DRAWING	
Repair No.: 052	File: 7R052
CYLINDER	Quadrant: B
Course: 28	Plate: 7
Drawn by: Tom Kitchen	Date: 5/4/98

TYPE 10 REPAIR

Weld Repair

WPS No.: SM 1.1-1

NDT Performed: Visual ☒ Vacuum Box ☐ Dye Penetrant ☒

Coating Type: EPOXY

NDT Performed: Visual: ☒ DFT: ☒ Average DFT: 8-15 mils

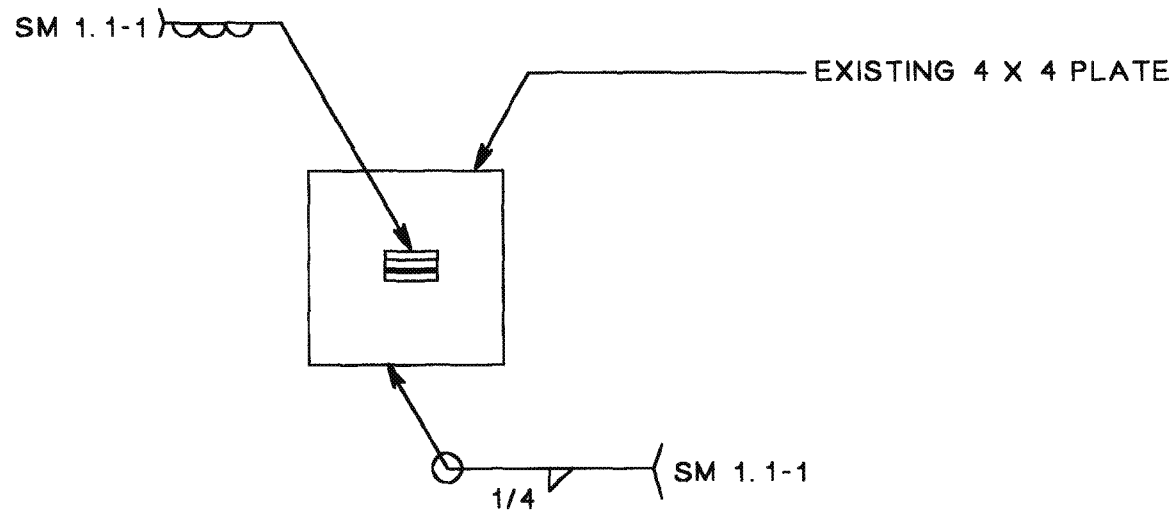
MID ATLANTIC ENVIRONMENTAL	
EMERGENCY REPAIRS FOR RED HILL TANKS	
Tank #7 RECOMMENDED REPAIR DRAWING	
Repair No. 053	File 7R053
CYLINDER	Quadrant B
Course 28	Plate 6
Drawn by Tom Kitchen	Date 5/4/98

TYPE 10 REPAIR

Weld Repair

WPS No.: SM1.1-1

NDT Performed: Visual ☒ Vacuum Box ☐ Dye Penetrant ☒

Coating Type: EPoxy

NDT Performed: Visual: ☒ DFT: ☒ Average DFT: 8-15 mls

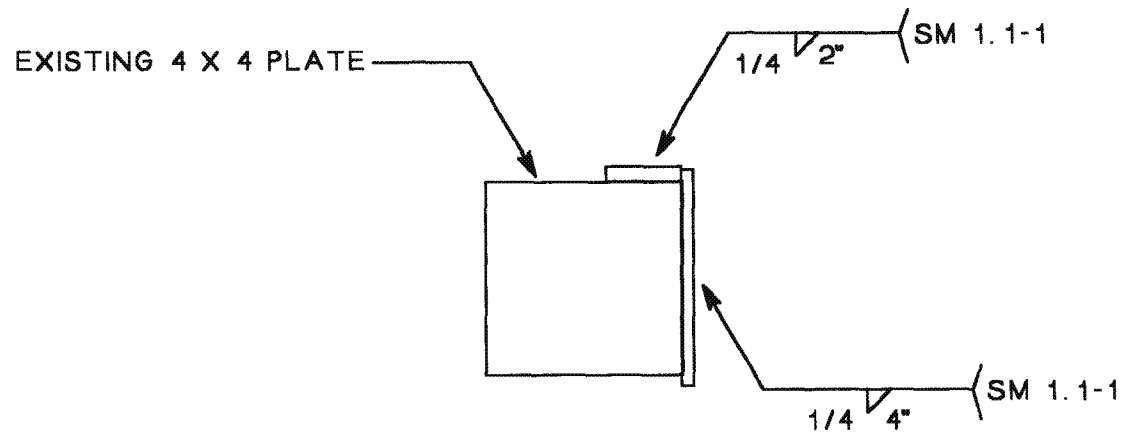
MID ATLANTIC ENVIRONMENTAL	
EMERGENCY REPAIRS FOR RED HILL TANKS	
Tank #7 RECOMMENDED REPAIR DRAWING	
Repair No.: 054	File: 7R054
CYLINDER	Quadrant: B
Course: 28	Plate: 5
Drawn by: Tom Kitchen	Date: 5/4/98

TYPE 10 REPAIR

Weld Repair

WPS No.: SM 1.1-1

Coating Type: EPOXY

Average DFT: 8-15 mils

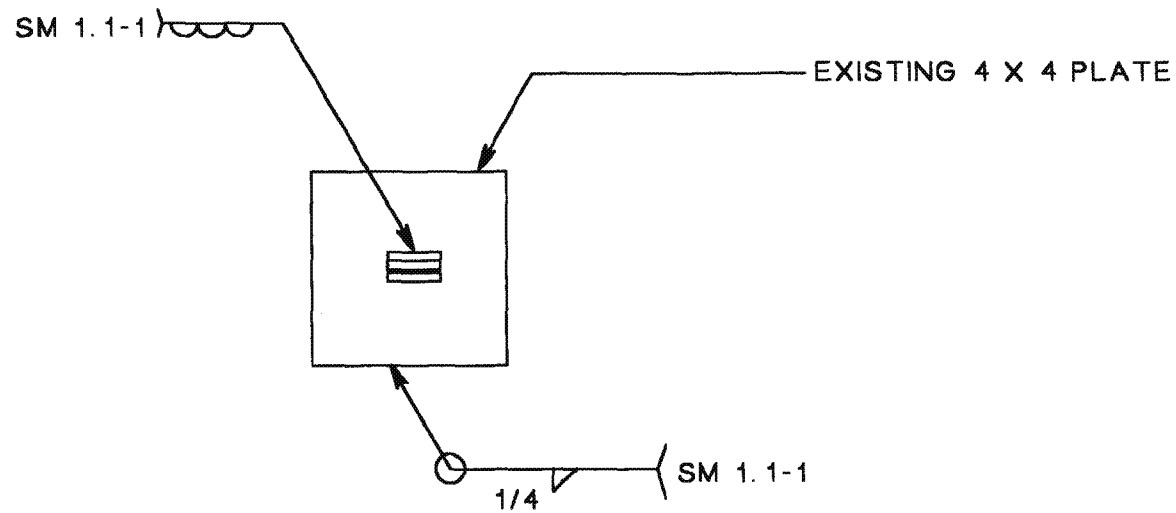
MID ATLANTIC ENVIRONMENTAL	
EMERGENCY REPAIRS FOR RED HILL TANKS	
Tank #7 RECOMMENDED REPAIR DRAWING	
Repair No.: 055	File: 7R055
CYLINDER	Quadrant: A
Course: 28	Plate: 4
Drawn by: Tom Kitchen	Date: 5/4/98

TYPE 10 REPAIR

Weld Repair

WPS No.: SM 1.1-1

NDT Performed: Visual ☒ Vacuum Box ☐ Dye Penetrant ☒

Coating Type: EPOXY

NDT Performed: Visual: ☒ DFT: ☒ Average DFT: 8-15

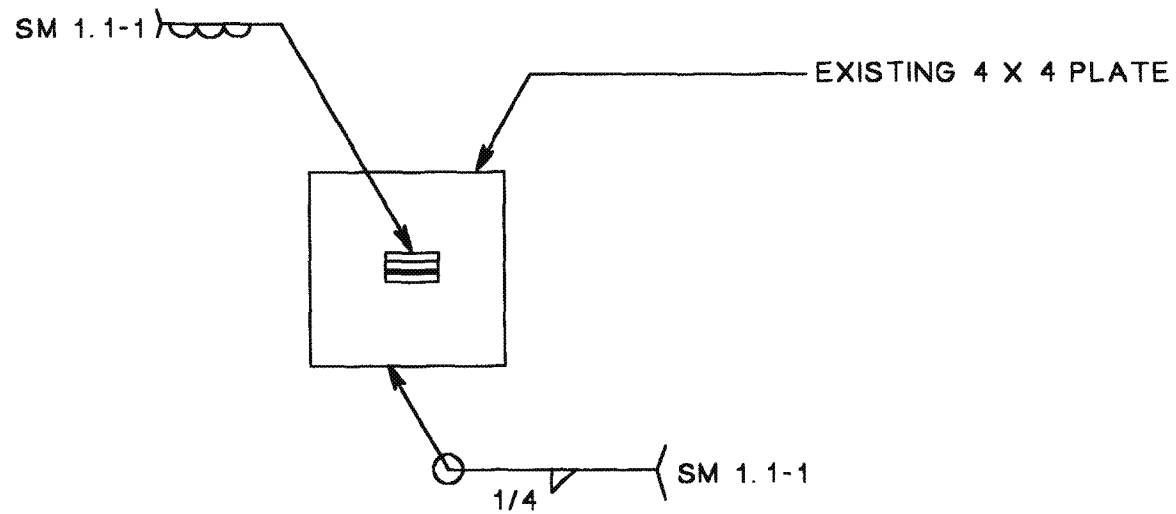
MID ATLANTIC ENVIRONMENTAL	
EMERGENCY REPAIRS FOR RED HILL TANKS	
Tank #7 RECOMMENDED REPAIR DRAWING	
Repair No. 056	File 7R056
CYLINDER	Quadrant A
Course 28	Plate 2
Drawn by Tom Kitchen	Date 5/4/98

TYPE 10 REPAIR

Weld Repair

WPS No.: SM 1.1-1

NDT Performed: Visual ☒ Vacuum Box ☐ Dye Penetrant ☒

Coating Type: EPOXY

NDT Performed: Visual: ☒ DFT: ☒ Average DFT: 8-15 mils

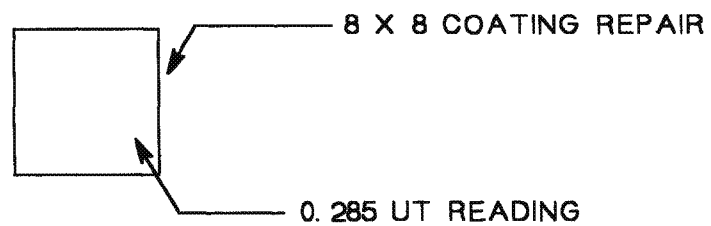
MID ATLANTIC ENVIRONMENTAL	
EMERGENCY REPAIRS FOR RED HILL TANKS	
Tank #7 RECOMMENDED REPAIR DRAWING	
Repair No.: 057	File: 7R057
LOWER DOME	Quadrant: B
Course: 3	Plate: 11
Drawn by: Tom Kitchen	Date: 5/4/98

TYPE 8 REPAIR

Coating Type: EPOXY

Surface Preparation: ☒ Primer Coat: ☒ Intermediate Coat: ☒ Final Coat: ☒

NDT Performed: Visual: ☒ DFT: ☒ Average DFT: 8-15 mils

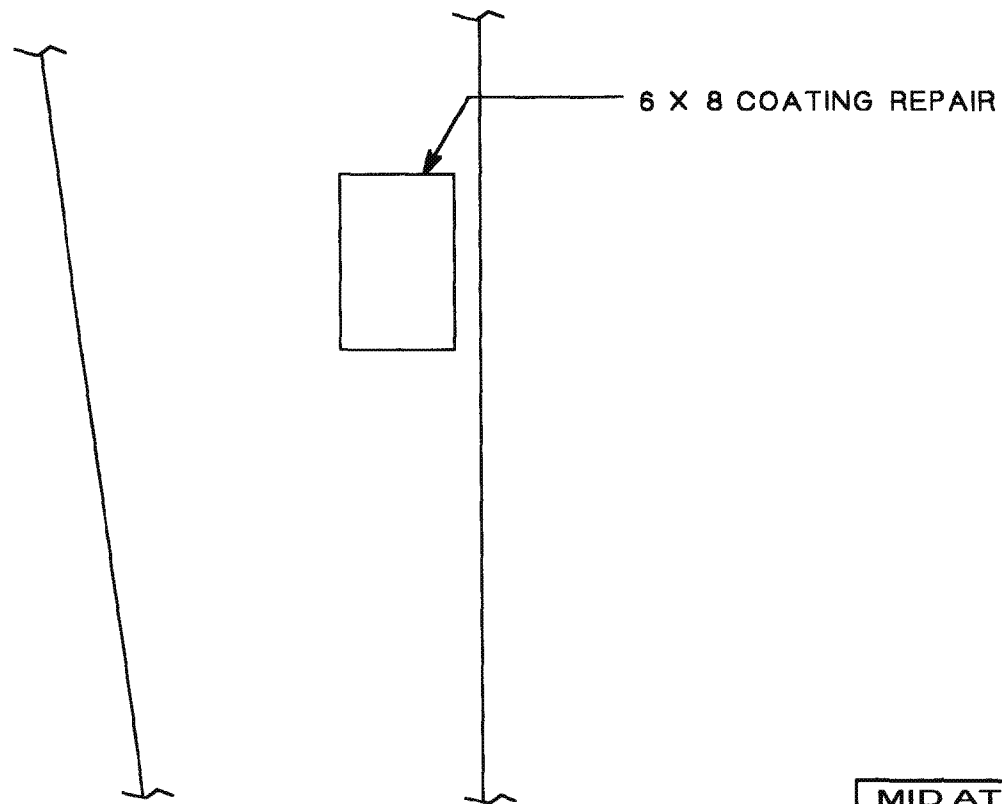
MID ATLANTIC ENVIRONMENTAL	
EMERGENCY REPAIRS FOR RED HILL TANKS	
Tank #7 RECOMMENDED REPAIR DRAWING	
Repair No.: 058	File: 7R058
Lower Dome	Quadrant: B
Course: 3	Plate: 11
Drawn by: Tom Kitchen	Date: 5/4/98

TYPE 8 REPAIR

Coating Type: EPOXY

Surface Preparation: ☒ Primer Coat: ☒ Intermediate Coat: ☒ Final Coat: ☒

NDT Performed: Visual: ☒ DFT: ☒ Average DFT: 8-15 m.l.s

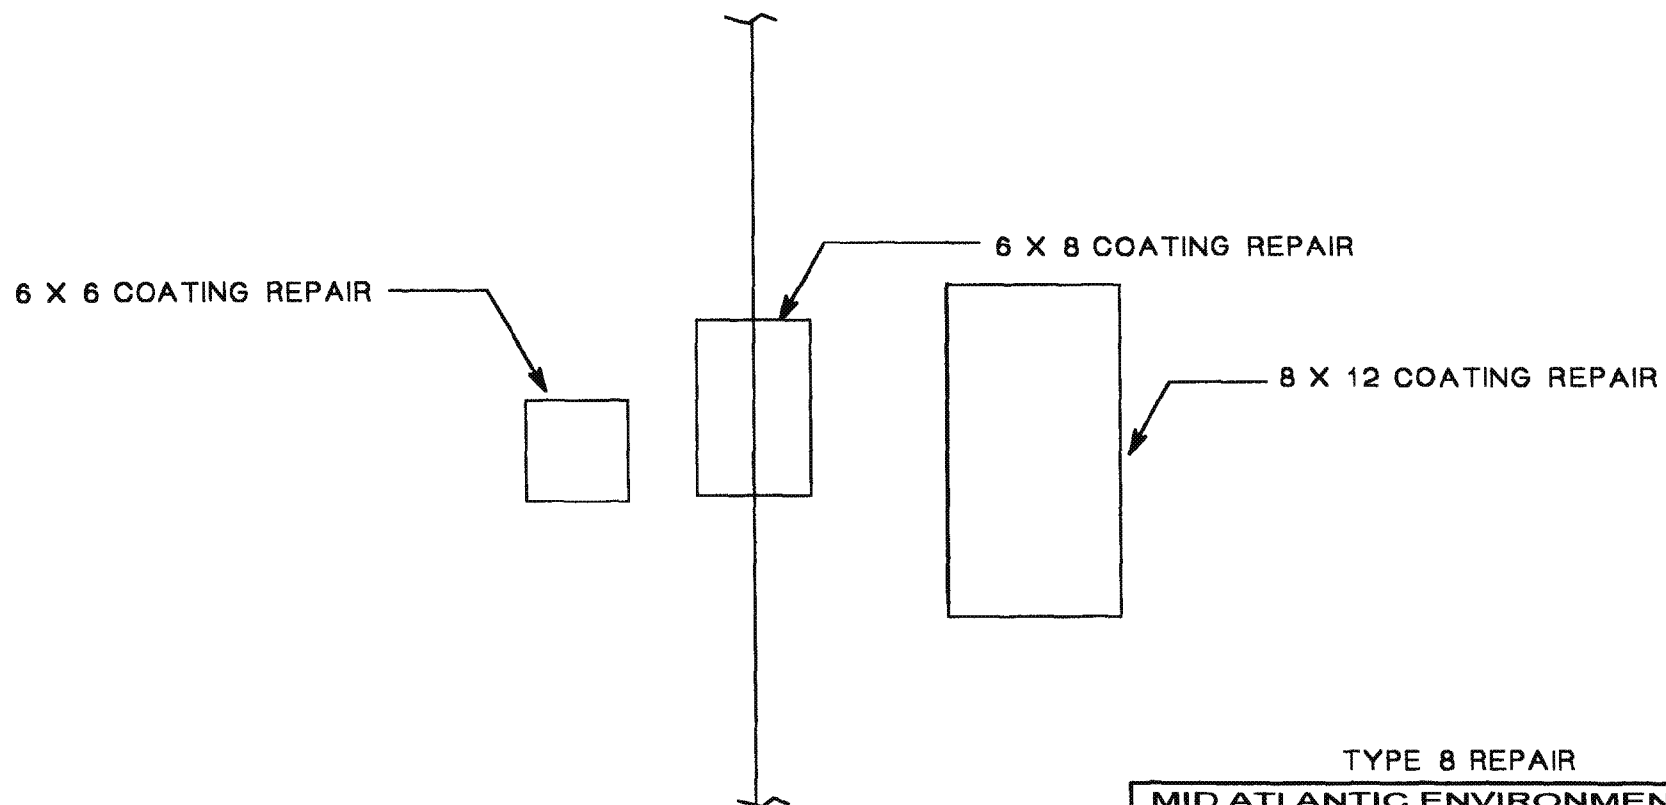
MID ATLANTIC ENVIRONMENTAL	
EMERGENCY REPAIRS FOR RED HILL TANKS	
Tank #7 RECOMMENDED REPAIR DRAWING	
Repair No.: 059	File: 7R059
Lower Dome	Quadrant: A
Course: 3	Plate: 3
Drawn by: Tom Kitchen	Date: 5/4/98

TYPE 8 REPAIR

Coating Type: EPOXY

Surface Preparation: ✓ Primer Coat: ✓ Intermediate Coat: ✓ Final Coat: ✓

NDT Performed: Visual: ✓ DFT: ✓ Average DFT: 8-15 mils

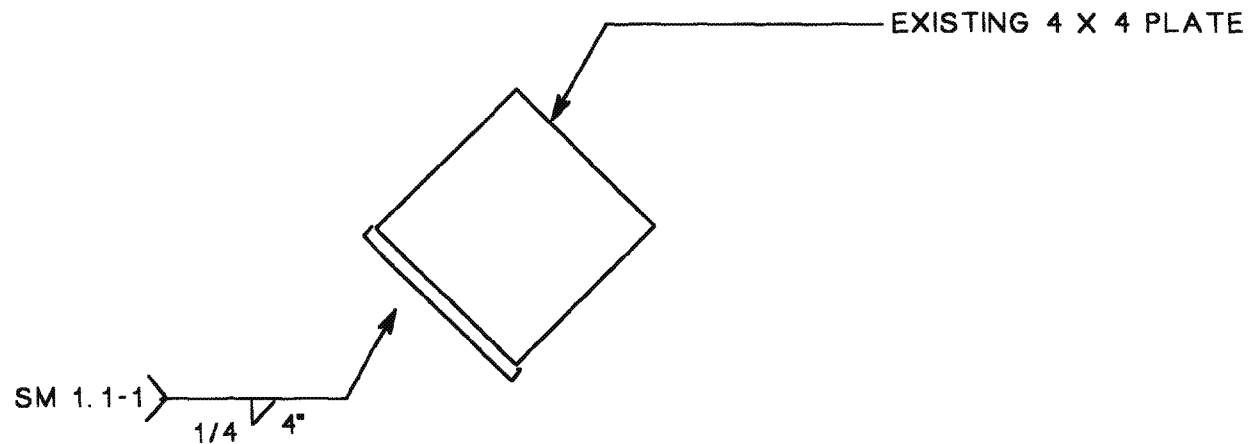
MID ATLANTIC ENVIRONMENTAL	
EMERGENCY REPAIRS FOR RED HILL TANKS	
Tank #7 RECOMMENDED REPAIR DRAWING	
Repair No. 060	File 7R060
CYLINDER	Quadrant A
Course 17	Plate 1
Drawn by Tom Kitchen	Date 5/4/98

TYPE 10 REPAIR

Weld Repair

WPS No.: SM1.1-1

NDT Performed: Visual ☒ Vacuum Box ☐ Dye Penetrant ☒

Coating Type: Epoxy

NDT Performed: Visual: ☒ DFT: ☒ Average DFT: 8-15 mils
