TYPE 8 REPAIR	
MID ATLANTIC ENVIRONMENTAL	
EMERGENCY REPAIRS FOR RED HILL TANKS	
Tank #7 RECOMMENDED REPAIR DRAWING	
Repair No.: 062	File: 7R062
Lower Dome	Quadrant: A
Course: 3	Plate: 1
Drawn by: Tom Kitchen	Date: 5/4/98

**Dames & Moore**  
Emergency Repairs For Red Hill Tanks at the Fleet Industrial & Supply Center  
Contract No. N62742-96-C-1356

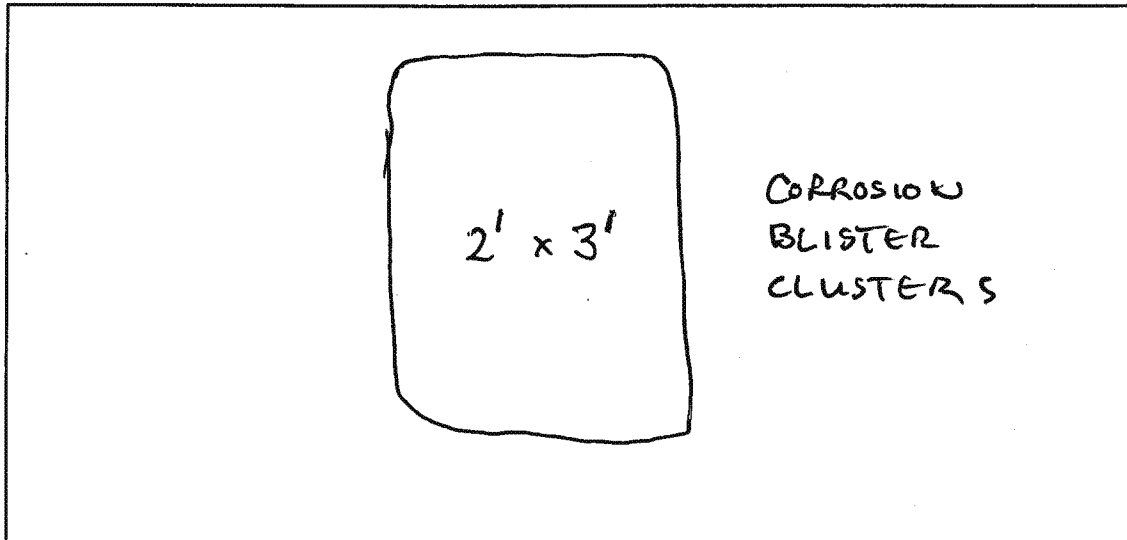
24 X 36 COATING REPAIR

Coating Type: EPOXY

Surface Preparation: ✓ Primer Coat: ✓ Intermediate Coat: ✓ Final Coat: ✓

NDT Performed: Visual: ✓ DFT: ✓ Average DFT: 8-15 mils

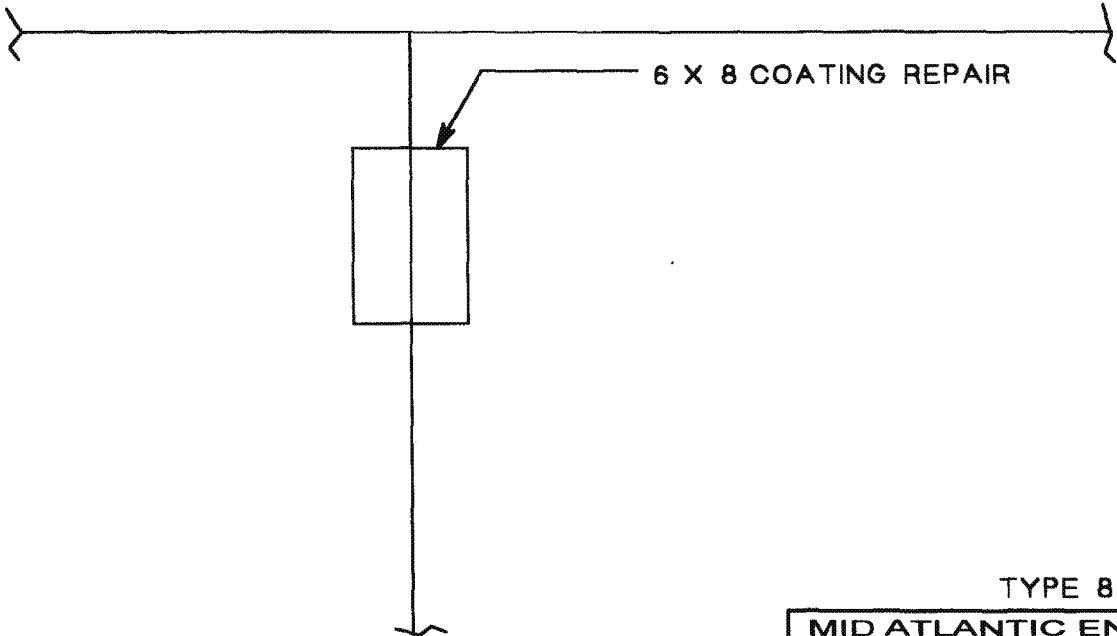
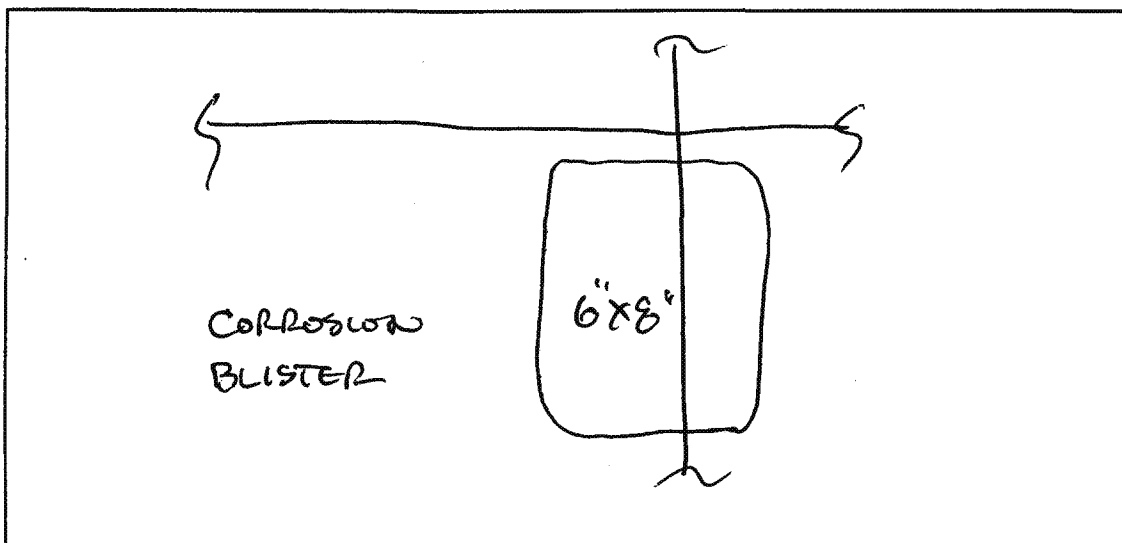
TYPE 8 REPAIR

MID ATLANTIC ENVIRONMENTAL	
EMERGENCY REPAIRS FOR RED HILL TANKS	
Tank #7 RECOMMENDED REPAIR DRAWING	
Repair No.: 063	File: 7R063
Lower Dome	Quadrant: A
Course: 2	Plate: 7
Drawn by: Tom Kitchen	Date: 5/4/98

Coating Type: EPOXY

Surface Preparation: ✓ Primer Coat: ✓ Intermediate Coat: ✓ Final Coat: ✓

NDT Performed: Visual: ✓ DFT: ✓ Average DFT: 15-22 mils

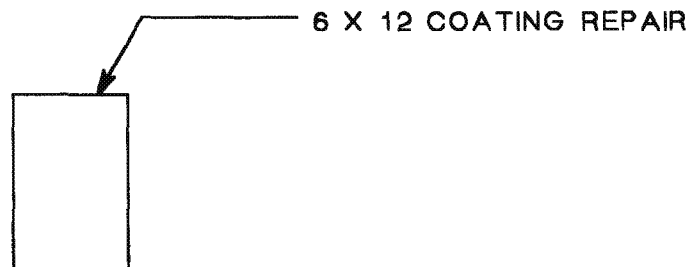
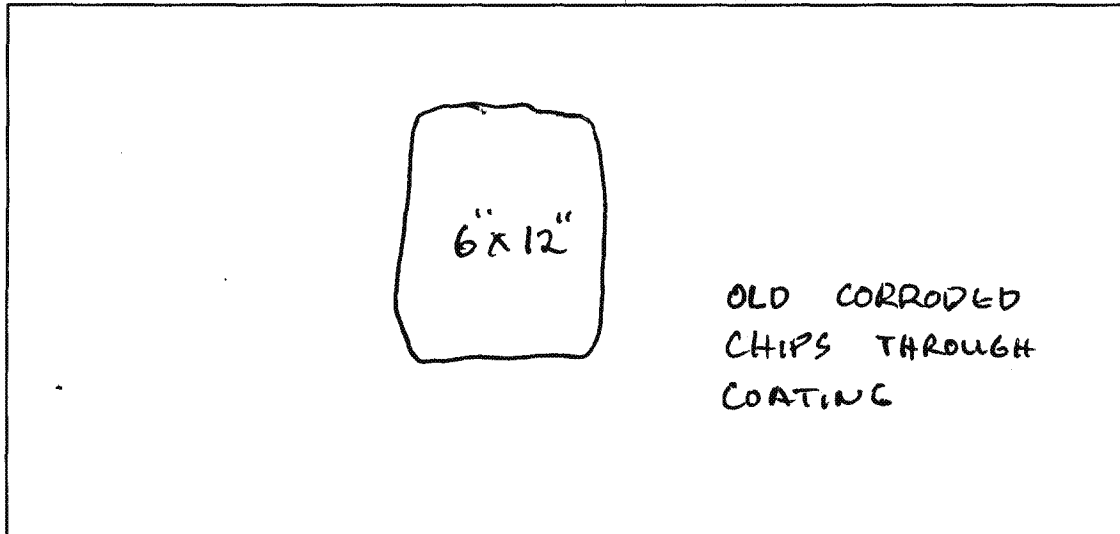
TYPE 8 REPAIR

MID ATLANTIC ENVIRONMENTAL	
EMERGENCY REPAIRS FOR RED HILL TANKS	
Tank #7 RECOMMENDED REPAIR DRAWING	
Repair No.: 064	File: 7R064
Lower Dome	Quadrant: A
Course: 2	Plate: 1
Drawn by: Tom Kitchen	Date: 5/4/98

Coating Type: EPOXY

Surface Preparation: ☒ Primer Coat: ☒ Intermediate Coat: ☒ Final Coat: ☒

NDT Performed: Visual: ☒ DFT: ☒ Average DFT: 15-22 mils

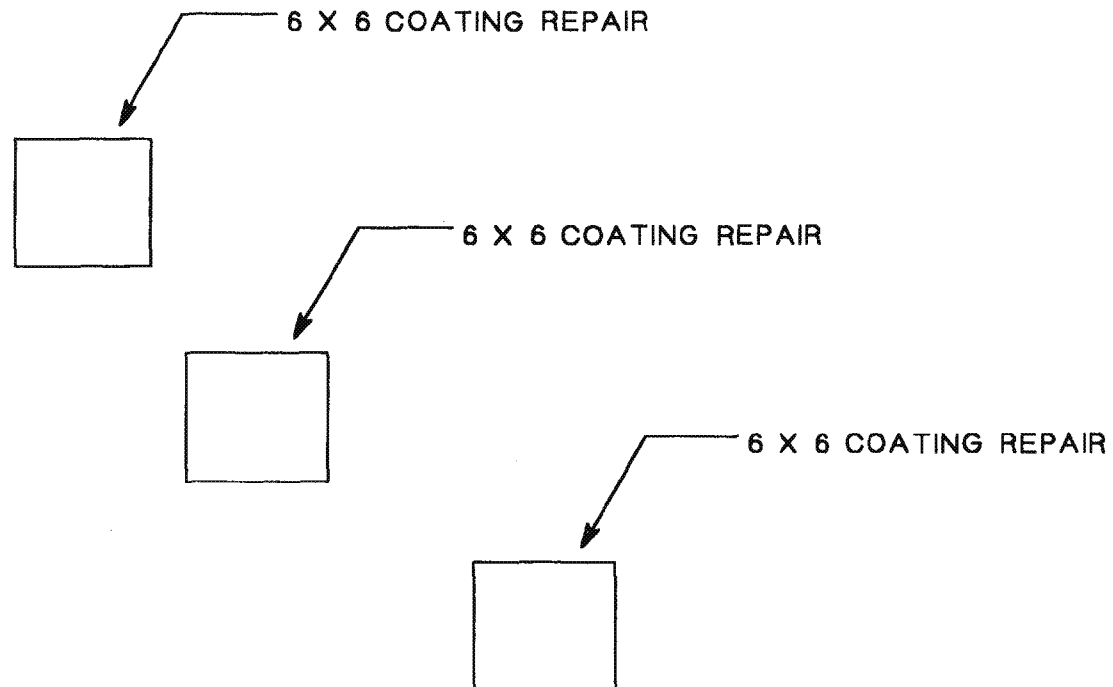
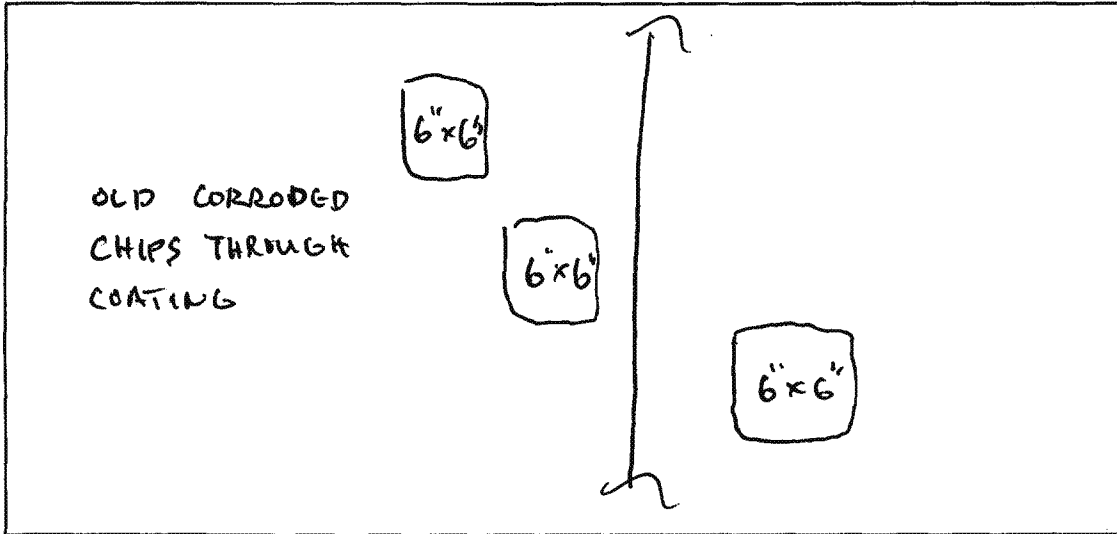
TYPE 8 REPAIR

MID ATLANTIC ENVIRONMENTAL	
EMERGENCY REPAIRS FOR RED HILL TANKS	
Tank #7 RECOMMENDED REPAIR DRAWING	
Repair No.: 065	File: 7R065
Lower Dome	Quadrant: A
Course: 1	Plate: 1
Drawn by: Tom Kitchen	Date: 5/4/98

Coating Type: EPOXY

Surface Preparation: ✓ Primer Coat: ✓ Intermediate Coat: ✓ Final Coat: ✓

NDT Performed: Visual: ✓ DFT: ✓ Average DFT: 15-22 mils

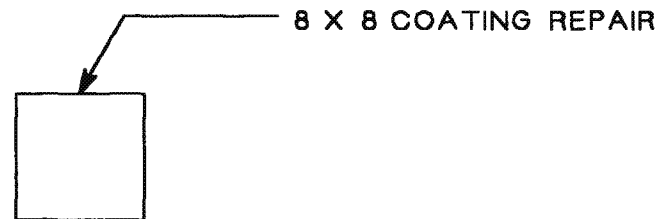
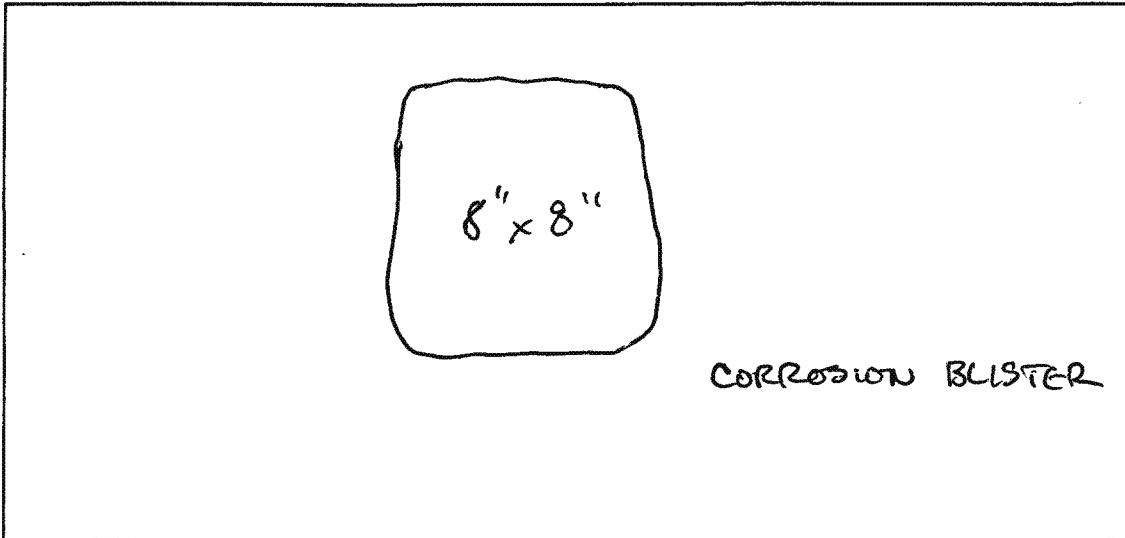
TYPE 8 REPAIR

MID ATLANTIC ENVIRONMENTAL	
EMERGENCY REPAIRS FOR RED HILL TANKS	
Tank #7 RECOMMENDED REPAIR DRAWING	
Repair No. 066	File 7R066
Lower Dome	Quadrant B
Course 1	Plate 9
Drawn by Tom Kitchen	Date 5/4/98

Coating Type: EPOXY

Surface Preparation: ✓ Primer Coat: ✓ Intermediate Coat: ✓ Final Coat: ✓

NDT Performed: Visual: ✓ DFT: ✓ Average DFT: 15-22 mils
