2.1 Mid Atlantic Environmental, Inc. conducted an inspection on Tank #6 at the Red Hill Underground Storage Facility, Pearl Harbor, Hawaii. This inspection was conducted in accordance with the scope of work identified by Contract Number N00604-97-R-0013, PRL 96-21, titled "Emergency Repair for Red Hill Tanks."

RED HILL TANK NO. 6  
PRODUCT: JP-5

MID ATLANTIC ENVIRONMENTAL	
EMERGENCY REPAIRS FOR RED HILL TANKS	
Tank #6 RECOMMENDED REPAIR DRAWING	
Repair No.: 001	File# 001
UPPER DOME	Quadrant: D
Course: A	PLATE: 20
Drawn by: Tom Kitchen	Date: 7/1/98

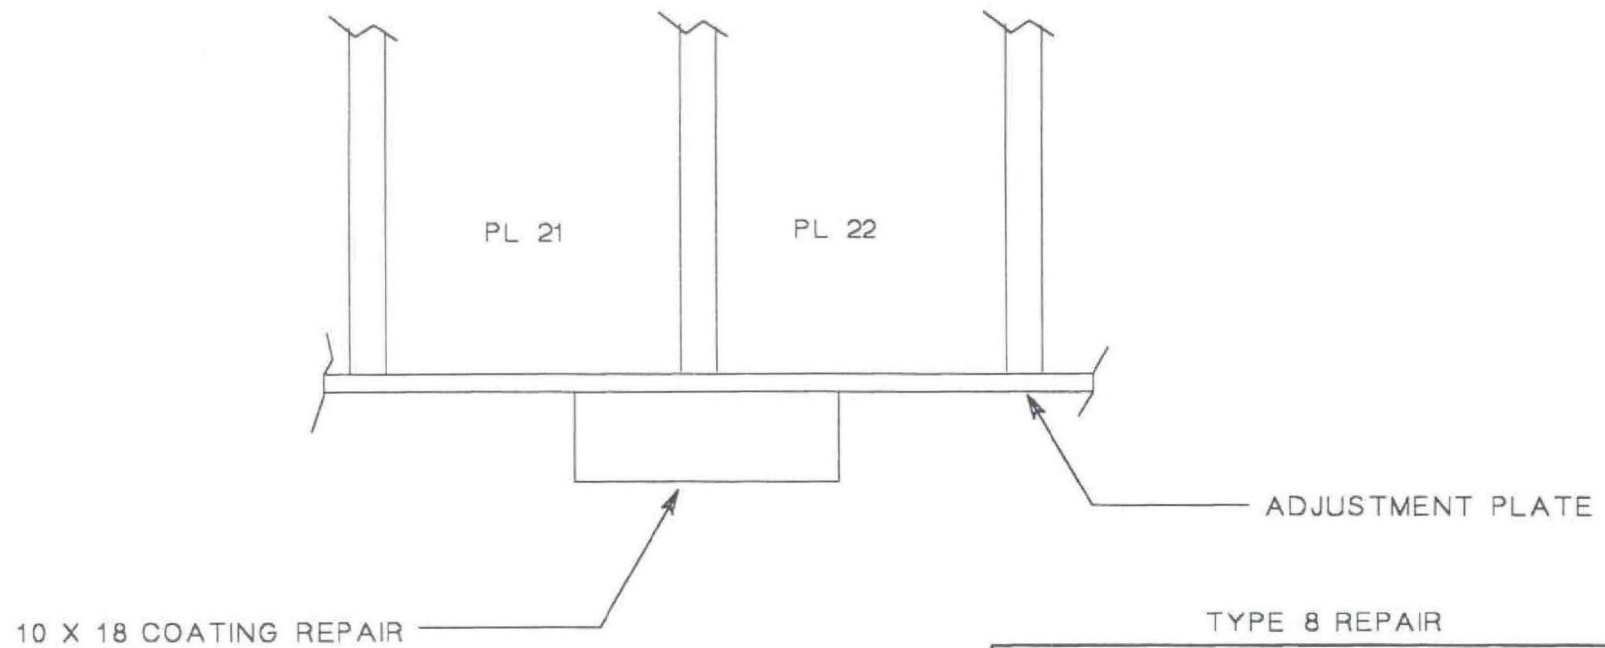
MID ATLANTIC ENVIRONMENTAL	
EMERGENCY REPAIRS FOR RED HILL TANKS	
Tank #6 RECOMMENDED REPAIR DRAWING	
Repair No.: 003	File#r003
UPPER DOME	Quadrant: D
Course: EXTENSION	PLATE: 21 & 22
Drawn by: Tom Kitchen	Date: 7/1/98

DEFECT INSPECTED BY TK & JF 7/1/98

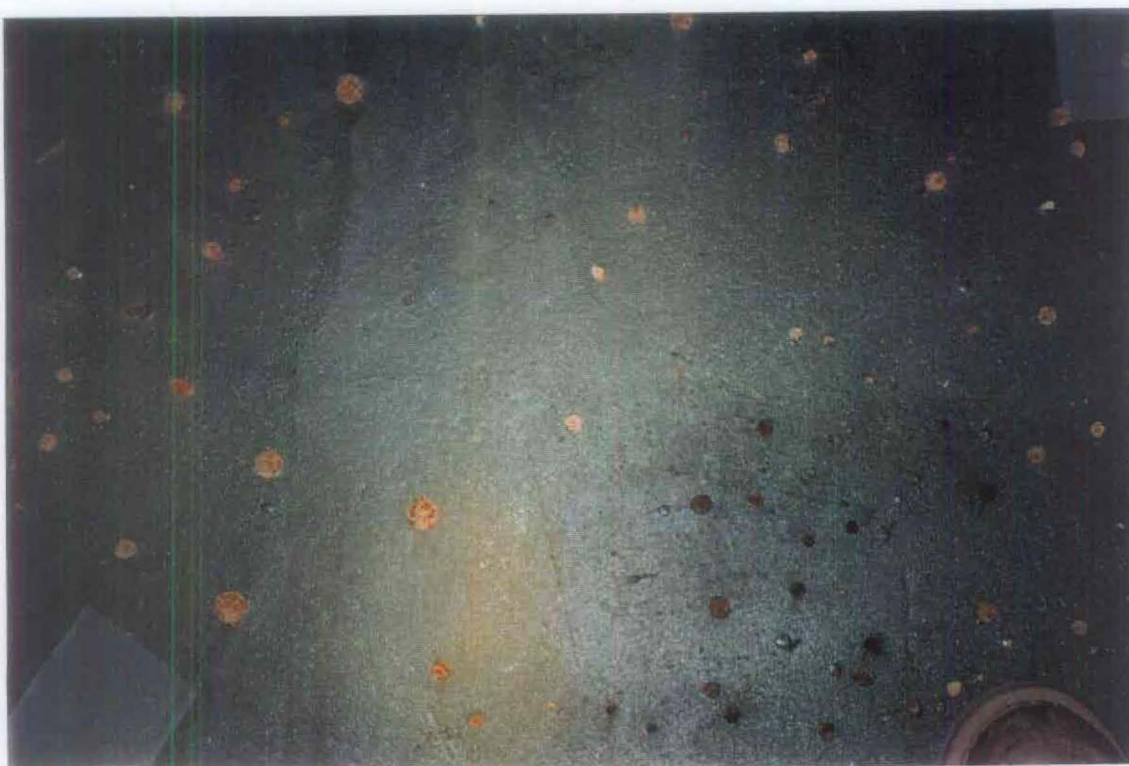
7.1.2 Blisters in the coating of the lower dome was widespread. Because these defects would require work outside the scope of work for this contract, they were ignored for the time being. Pictures of these blisters are included with this report.

**PICTURES OF BLISTERS IN COATING OF LOWER DOME**
