**MODIFIED API-653 OUT-OF-SERVICE
TANK 20
RED HILL**

Subject: Tank No. 20 Red Hill Fuel Facility

SYNOPSIS

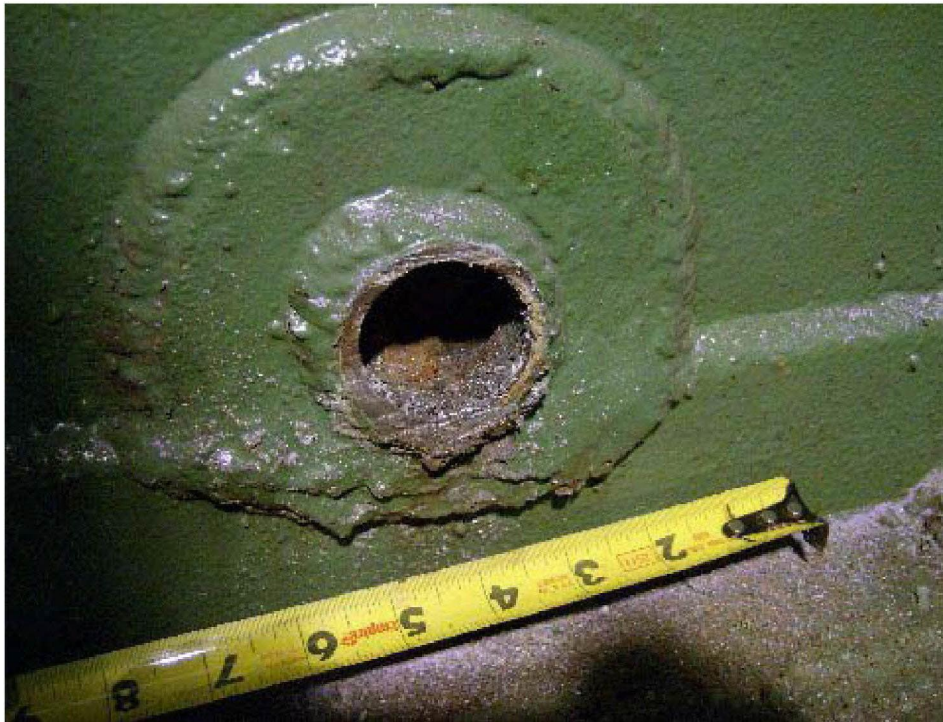
Transition from tank floor to the lower dome section

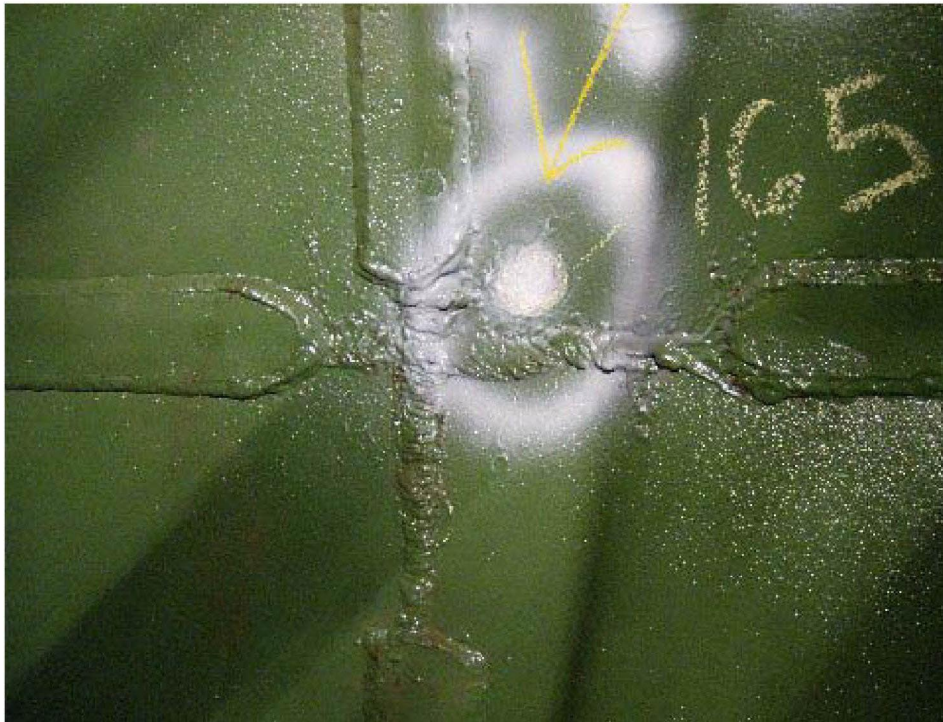
Location of Flaw 334 Underside corrosion at .137" requiring a 16" X 16" Lap Welded Patch

Flaw #329	Base Metal Arc Gouge; Expansion Joint; Repair by welding
Flaw #330	Base Metal Arc Gouge; Expansion Joint; Repair by welding
Flaw #334	Loss of Wall @ .137"; Expansion Joint; Repair by use of lap patch plate .250" thick, 16" x 16" with radius corners
Flaw #337	Lack of Fusion in weld; Upper Dome; Repair by welding
Flaw #341A/C	Lack of Fusion in weld; Upper Dome; Repair by welding
Flaw #345	Lack of Fusion in weld; Upper Dome; Repair by welding
Flaw #346A/B	Lack of Fusion in weld; Upper Dome; Repair by welding
Flaw #347	Through Hole on Strap; Upper Dome; Repair by welding
Flaw #351	Base Metal Arc Gouge; Upper Dome; Repair by welding

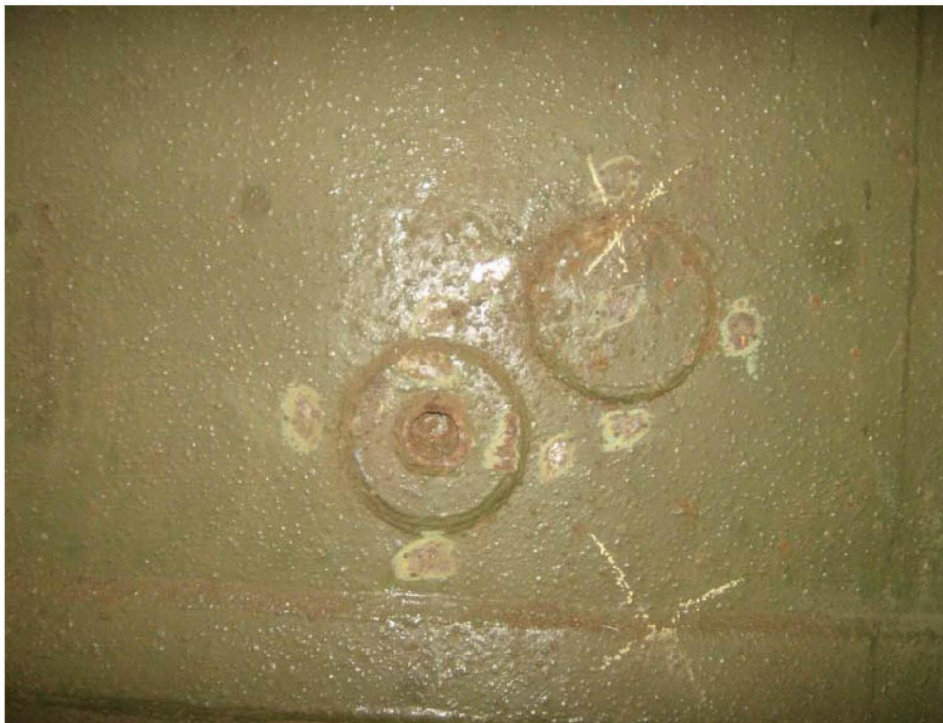
Flaw 304 Loss of Wall measured .165"

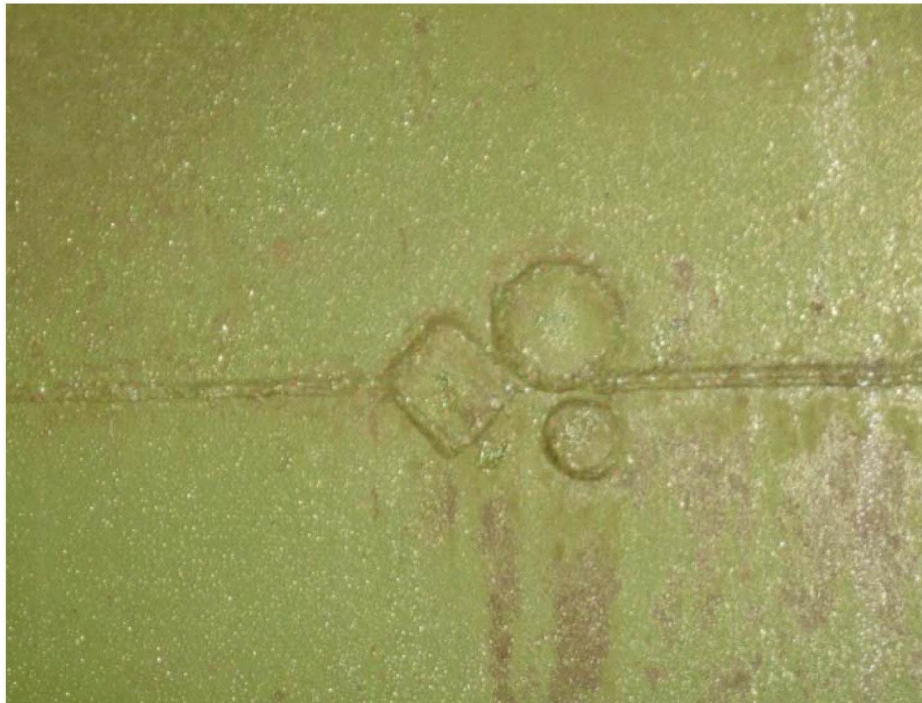
The tank has numerous areas of coating failure. Numerous areas of positive corrosion blooms were also noticed during this inspection. Some of the corrosion blooms were 1½" in diameter with visible pitting beneath the corrosion. The entire lower dome is affected by active corrosion holidays or coating holidays making proper inspection difficult. The area referenced as the tank lower dome has approximately 40% coating failure with exposure of the tank steel liner. The area known as the tank Barrel section was noted to have smaller areas of coating failure. The tank upper dome was noted to have the best areas of coating with only minimal failure.

Location of piping penetration removal; **Note:** Condition of Coating

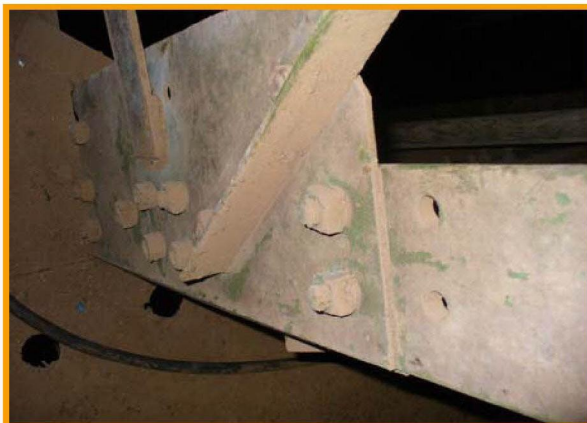
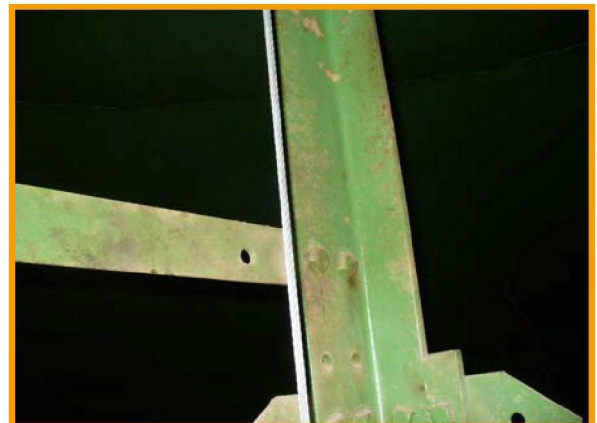
Upon inspection of the tower frame and boom, some horizontal and diagonal members were found to be missing, some bolts were found to be missing and some holes were found that needed to be covered by plates (see image #1 & #2)). The recommendations for the frame are summarized in the image #3 below:

Image 1: *Showing Tank #20 Tower frame and boom missing members and bolts*

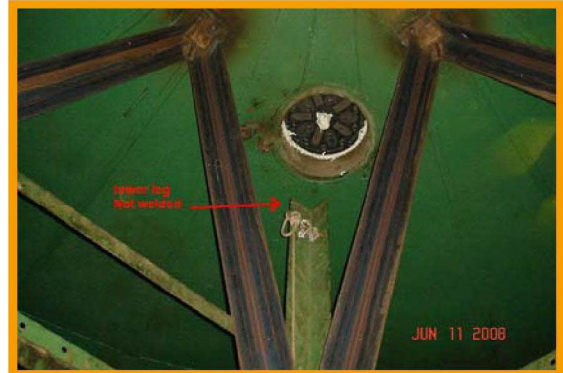
Image# 2: *Showing Tank #20 Tower leg not welded to the tank.*

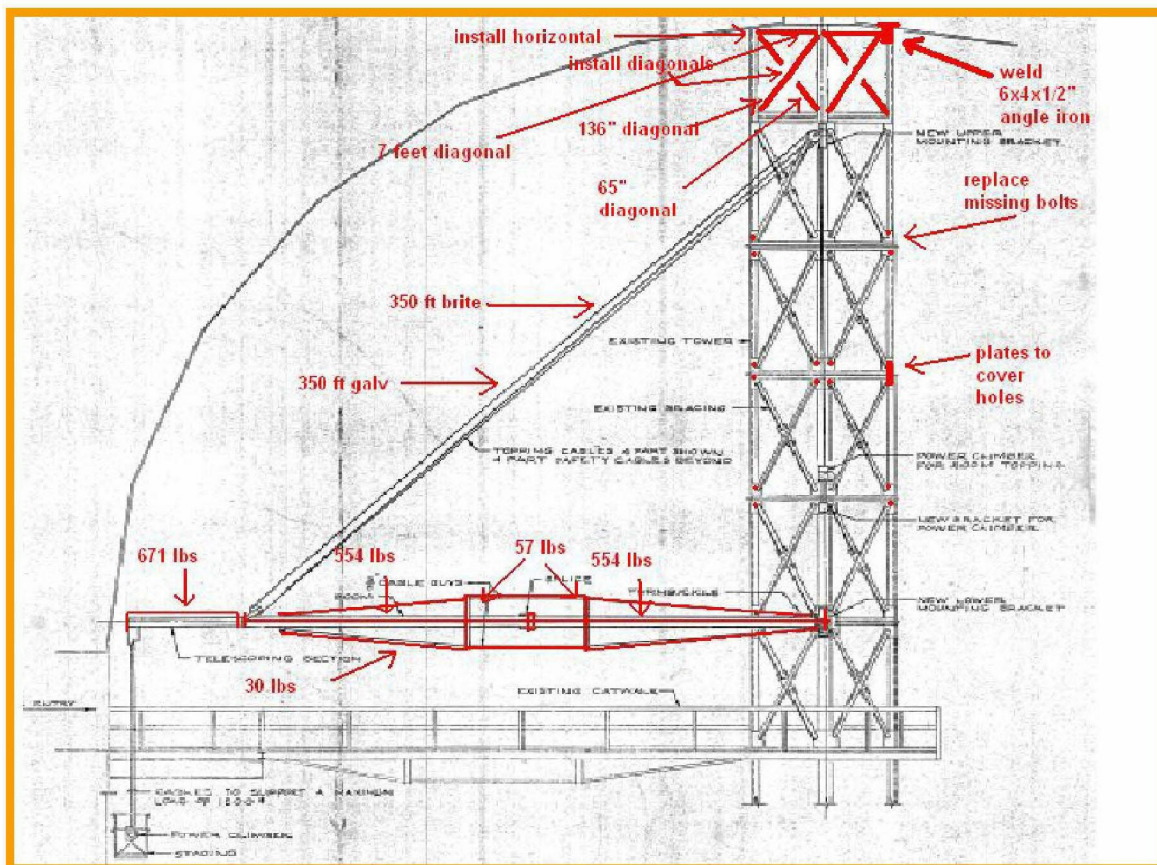
Image# 3: Showing Tank #20 Tower frame and boom recommendations

All above proposed changes were accomplished safely.

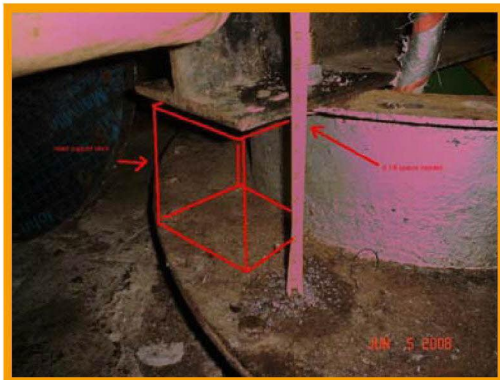
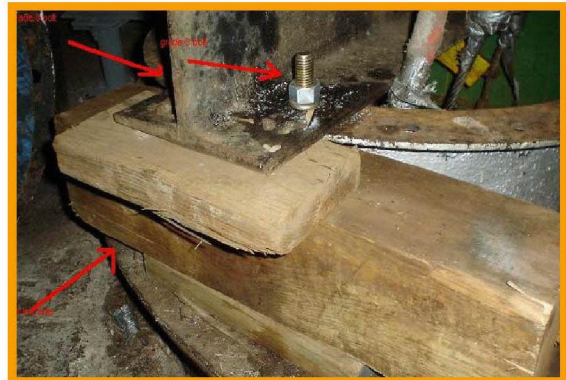
The beam supporting the spider hoist assembly was supported by the flange around the opening. This condition could produce buckling in the flange. Our recommendation was to cut off the excess length of the supporting beam and to provide blocking under the beam to avoid loading the flange. This was safely accomplished as seen in Image #5

Image# 5: Showing Tank #20 Top Anchor I-Beam shortened and supported.

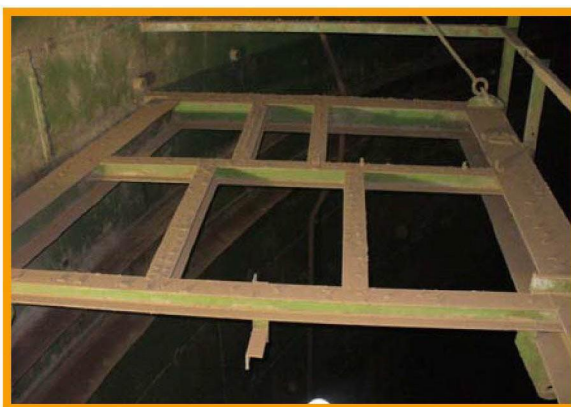
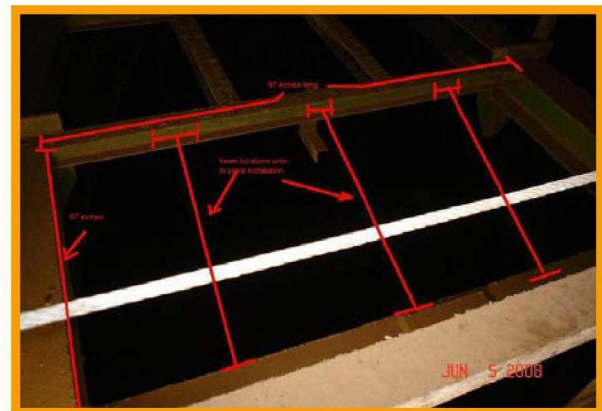
To use the framing adjacent to the entrance of the tank as a work platform, our recommendation was to install four horizontal beams prior to installing floor sheathing. The proposed beams would match the existing beam sizes. The platform condition and the recommendations are shown in Image #6 below.

Image# 6: Showing Tank #20 Work Platform and new beam installation recommendation .

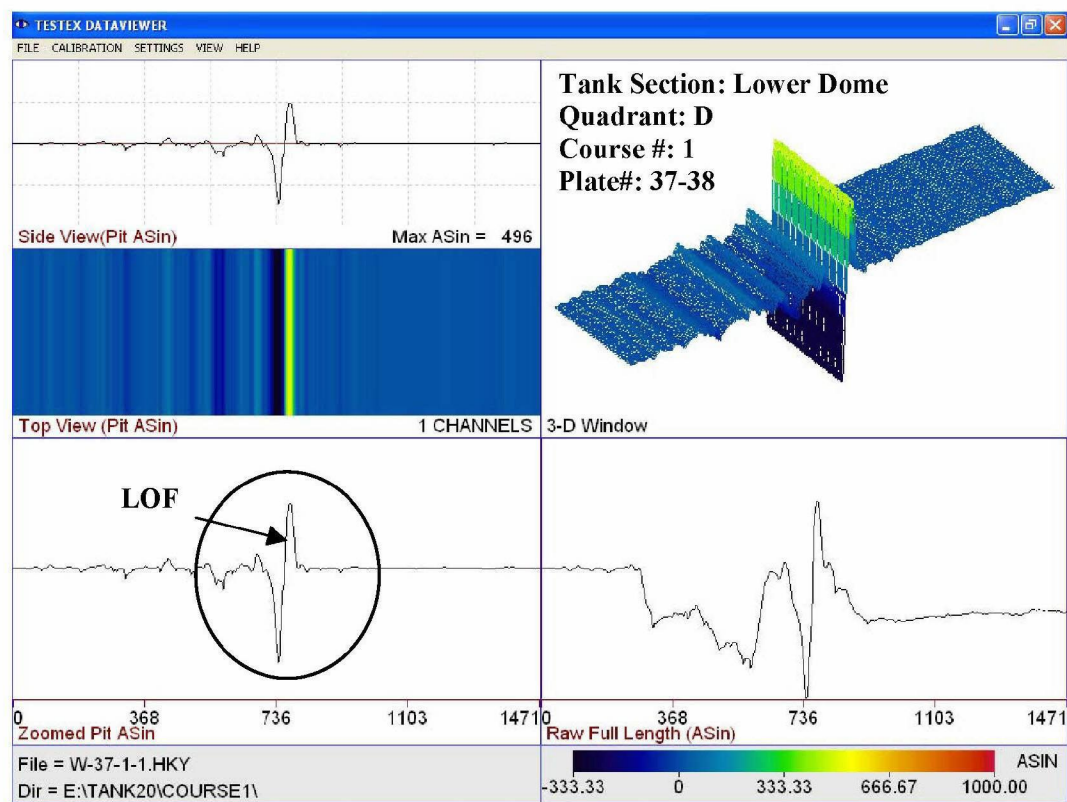
Flaw # 47: The waveform above depicts lack of fusion on the vertical weld at a depth of .120”.

Flaw #47A-C	Lack of Fusion in weld; Lower Dome; Repair by Welding
Flaw #50	Lack of Fusion in weld; Lower Dome; Repair by Welding
Flaw #51	Lack of Fusion in weld; Lower Dome; Repair by Welding
Flaw #146	Lack of Fusion in weld; Barrel; Repair by Welding
Flaw #166	Mechanical Gouge; Barrel; Repair by Welding
Flaw #173	Mechanical Gouge; Barrel; Repair by Welding
Flaw #174A/B	Lack of Fusion in weld; Barrel; Repair by welding
Flaw #212	Lack of Fusion in weld; Expansion Joint; Repair by welding
Flaw #215	Mechanical Gouge; Expansion Joint; Repair by Welding
Flaw #219	Lack of Fusion in weld; Barrel; Repair by welding
Flaw #221	Mechanical Gouge; Expansion Joint; Repair by Welding
Flaw #227	Mechanical Gouge; Expansion Joint; Repair by Welding
Flaw #258	Lack of Fusion in weld; Expansion Joint; Repair by welding

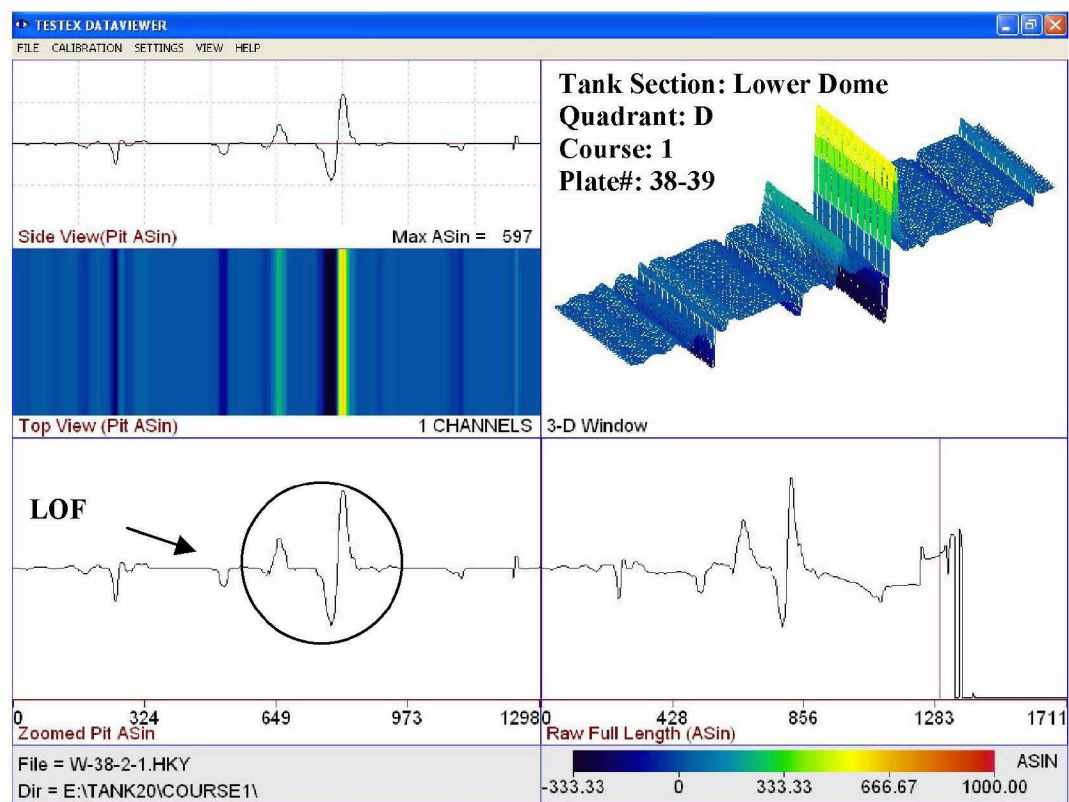
Flaw # 50: The waveform above depicts lack of fusion on the vertical weld at a depth of .089”.

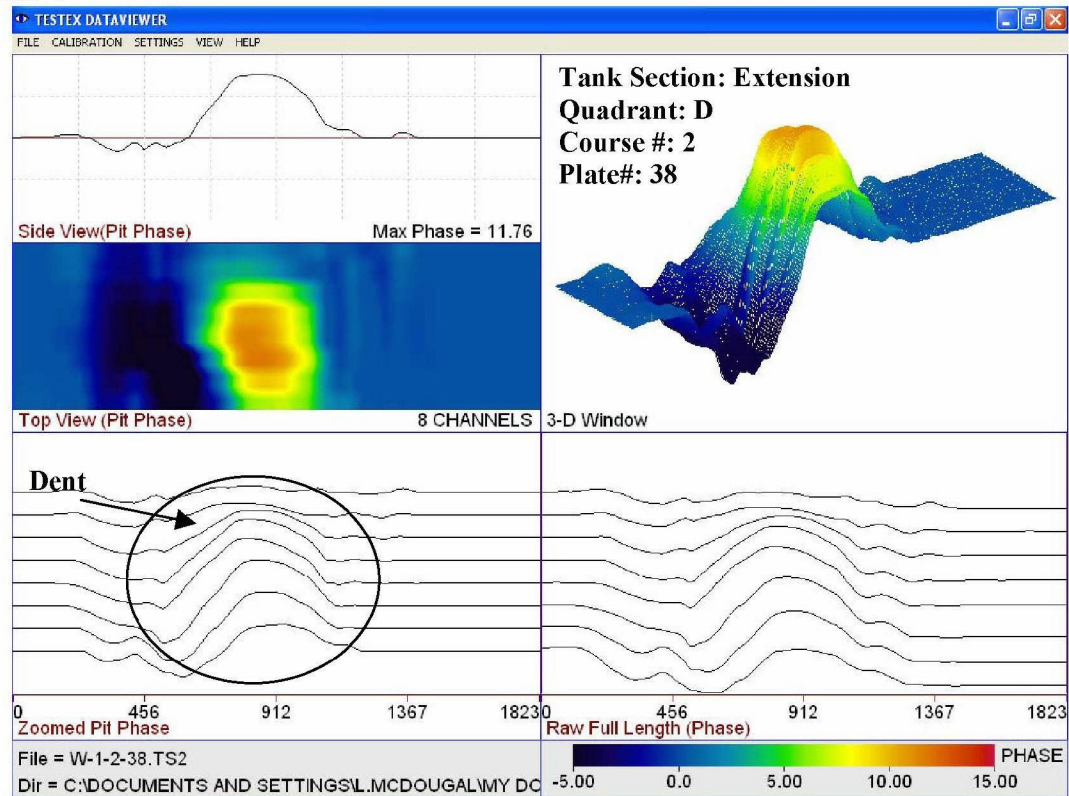
Flaw # 263: The waveform above depicts a dent that is .200” deep.

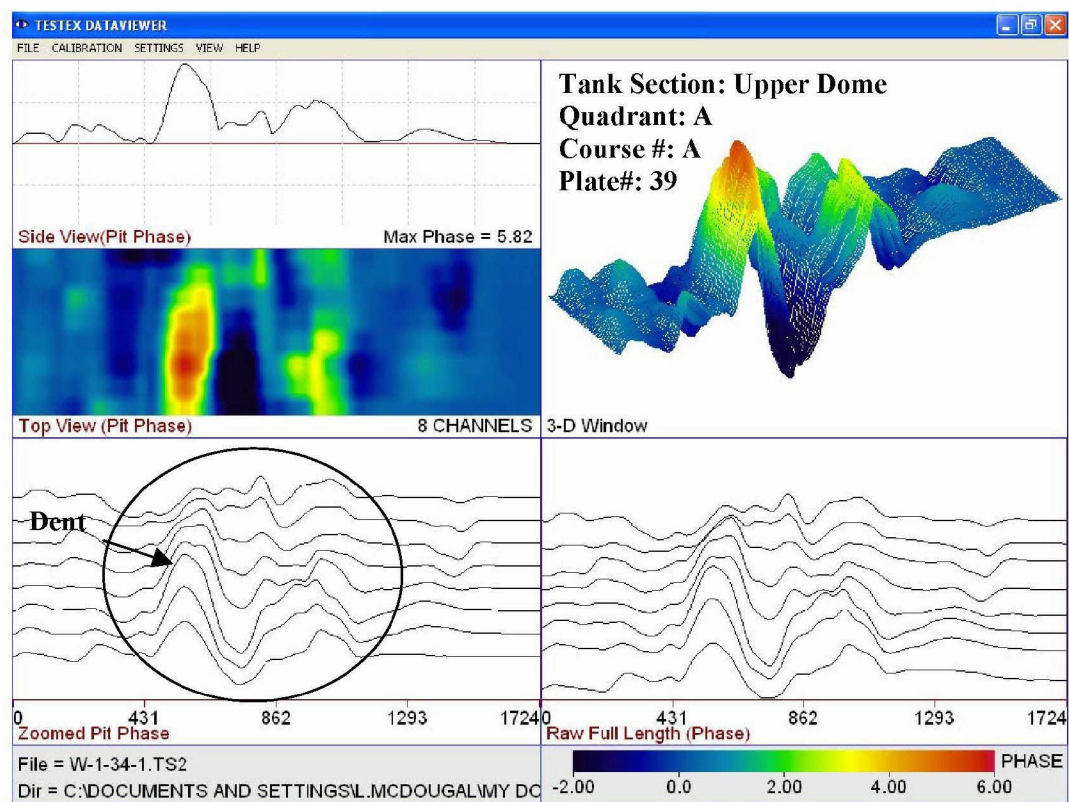
Flaw # 317: The waveform above depicts a dent that is .200” deep.

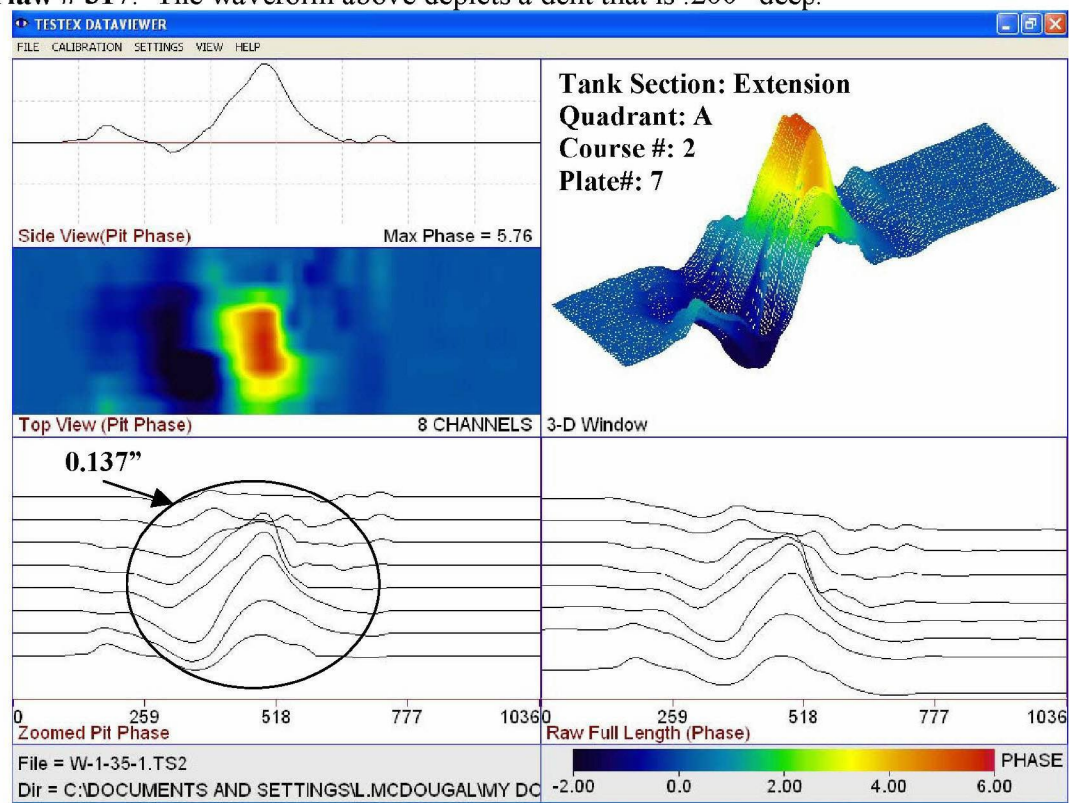
Flaw # 334: The waveform above depicts underside corrosion exhibiting 0.137” wall remaining.

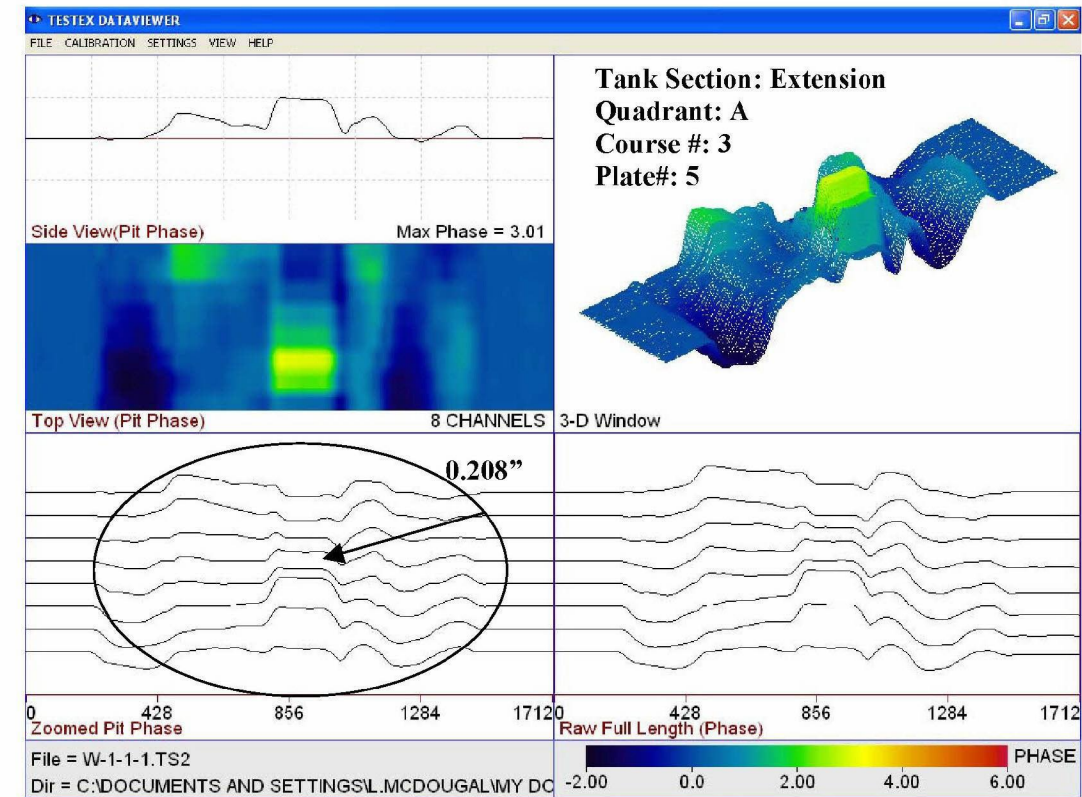
Flaw # 335: The waveform above depicts underside corrosion exhibiting 0.208" wall remaining.

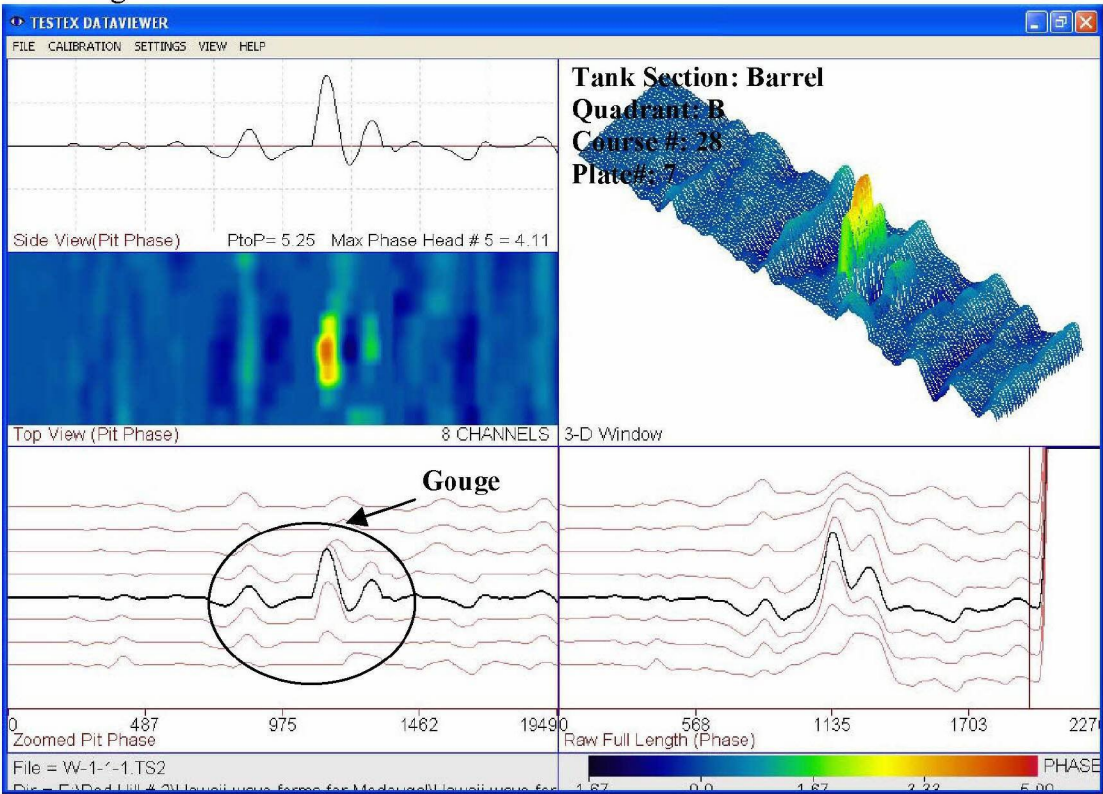
Flaw # 173: The waveform above depicts a gouge that is 0.140" deep.

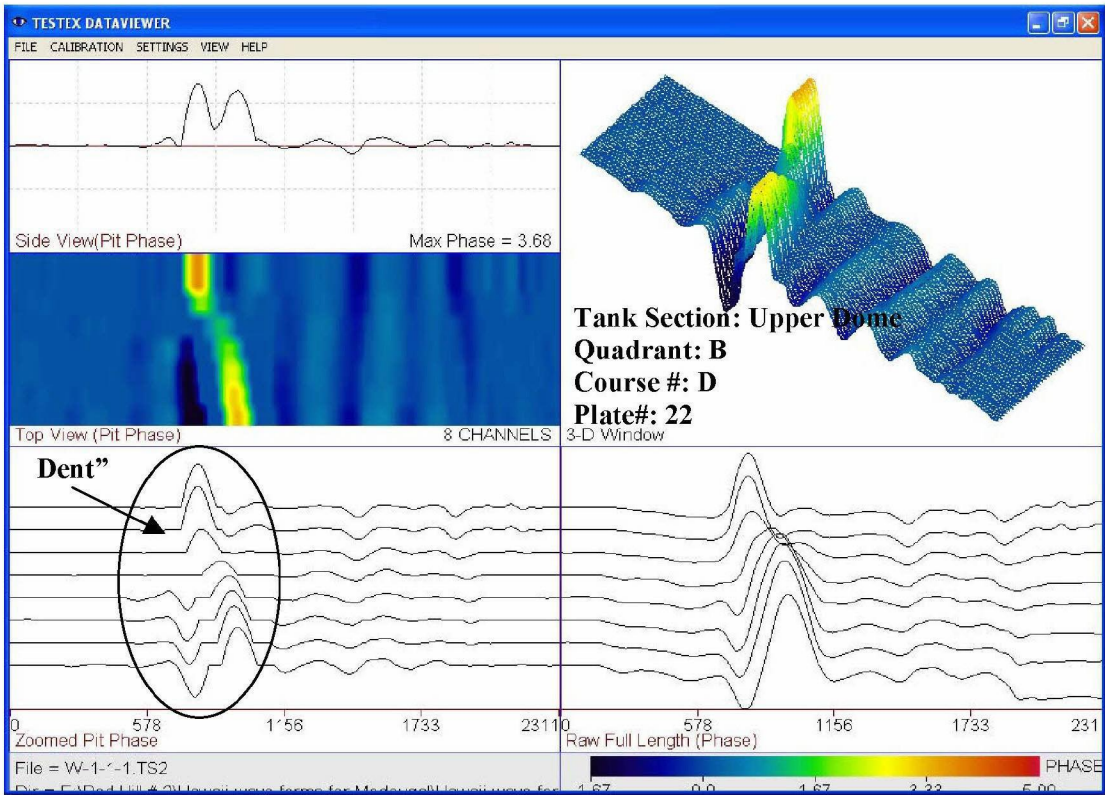
Flaw # 446: The waveform above depicts a dent that is .180” deep.

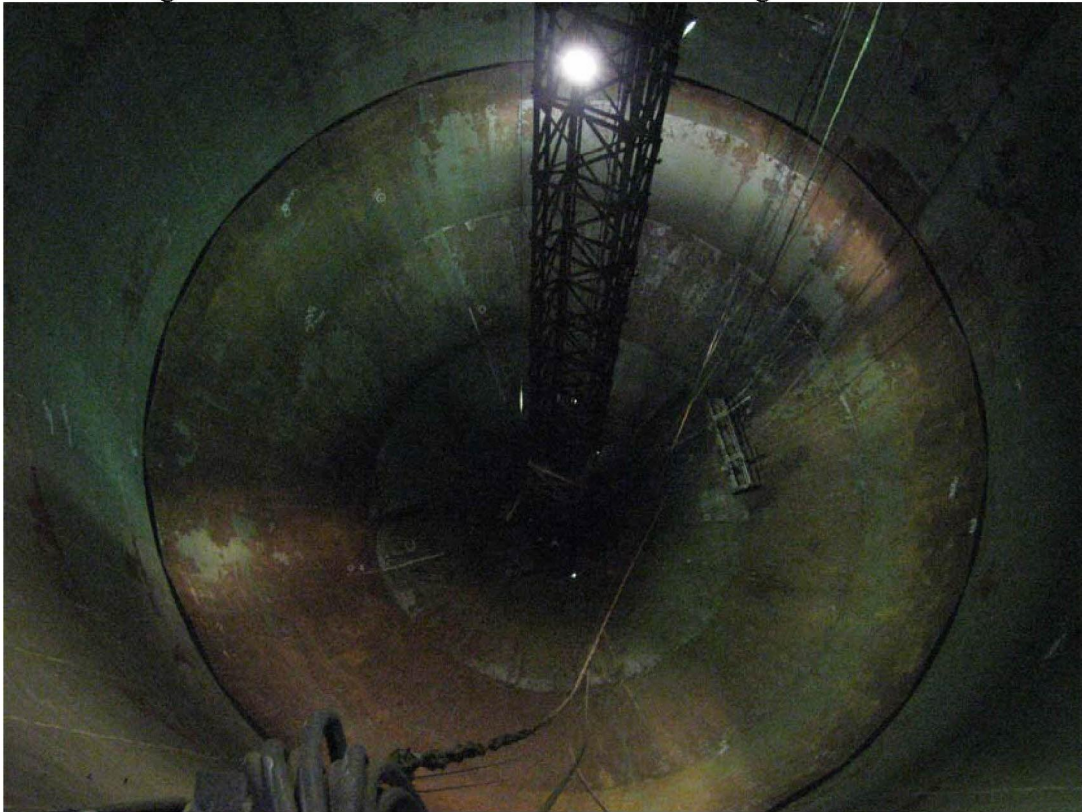
Lower dome view from above showing extensive coating failure.
