Subject: Tank No. 2 Red Hill Fuel Facility

SYNOPSIS

Tank Data

Tank No. 2
Year Built: 1942 - 1943
Design: Engineered Underground Storage Tank
Constructed: Morrison Knudsen
Product: JP-8
Capacity: 302,000 Bbls.
Size 100' Dia. x 250' High

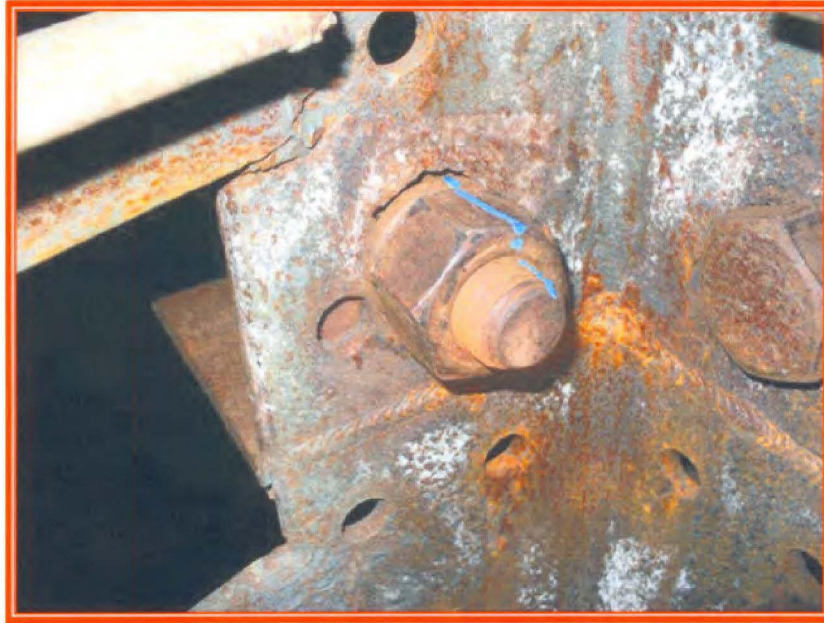
1. Hoist Connection at Top: visible slippages were typically observed on bolt connection. Proper sized washers are recommended to be added. (photo #1, #2)
2. Unused Hoist Connection: Large holes in the vertical legs of the tower which had been drilled for some connection should be covered and welded with plate of same thickness as the tower leg (photo #3 and #4)
3. Missing bolts were observed. Should be installed. (photo #5)

Photo #1: *Visible slippage of the bolt connection*

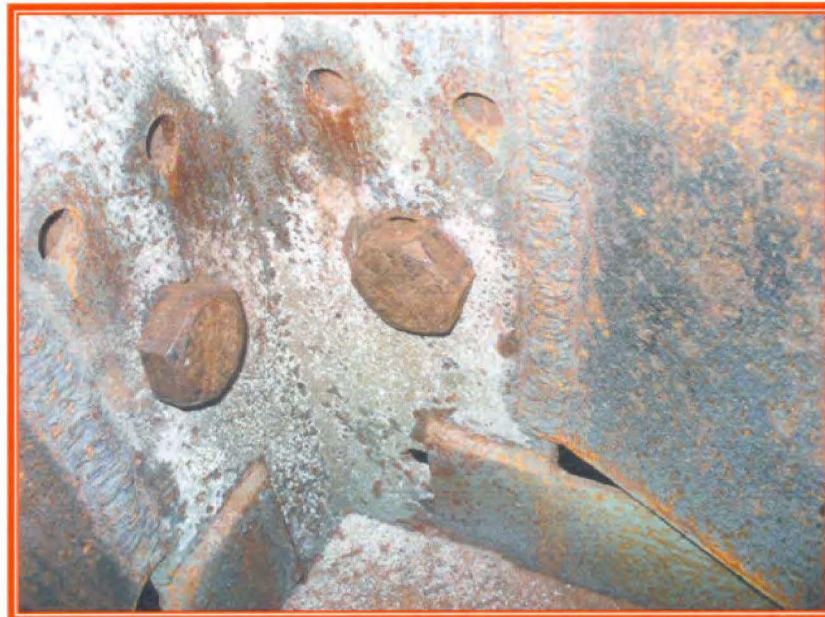
Photo #2: *Visible slippage of the bolt connection*

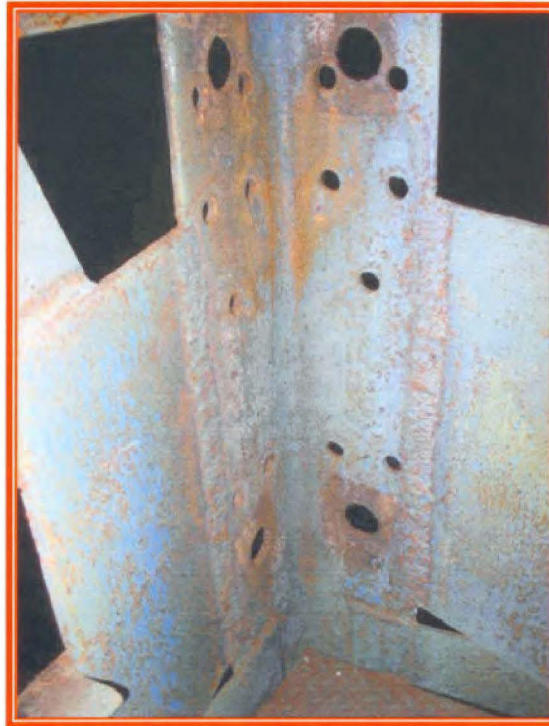
Photo #3: *Big holes on the framing members*

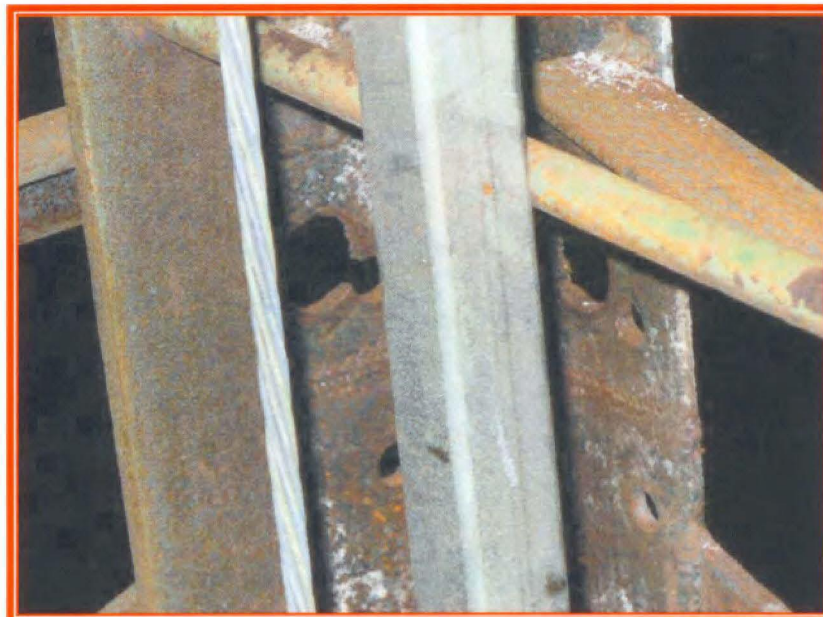
Photo #4: *Big holes on the framing members*

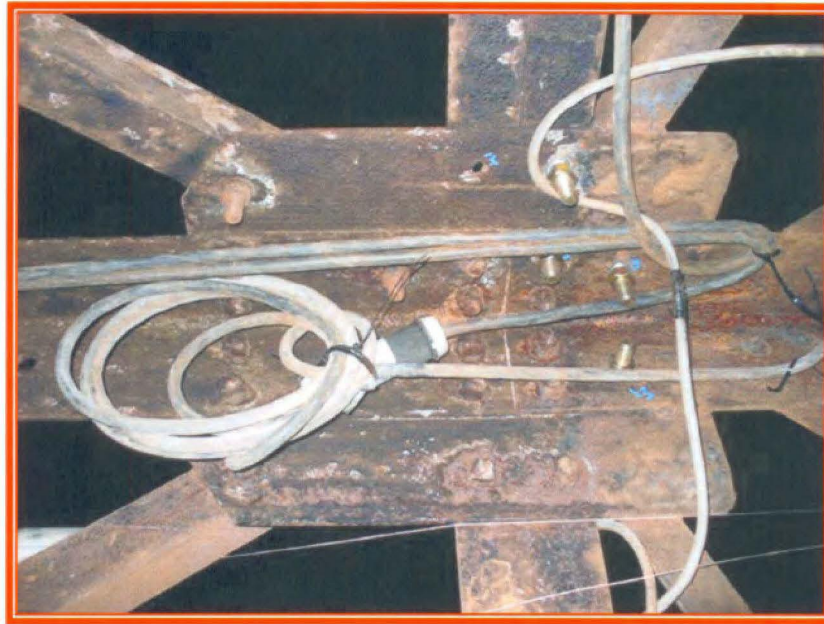
Photo #5: *Missing bolts*

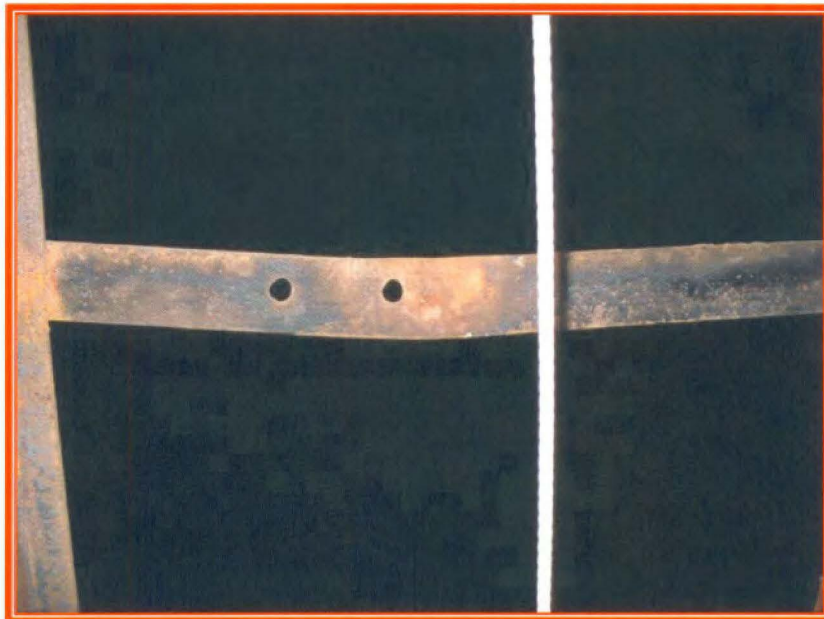
4. Bent framing members were observed. Should be fixed by adding a straight member adjacent to the existing bent member. (photo #6)
5. Missing diagonals were observed. Should be installed. (photo #7)

Photo #6: *Bent framing member*

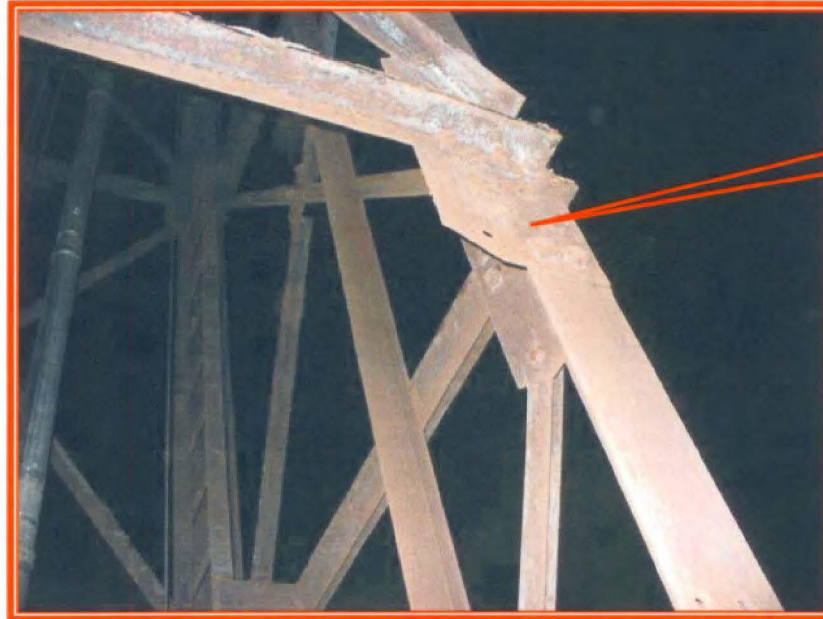
Missing
diagonal

Photo #7: *Missing diagonal.*

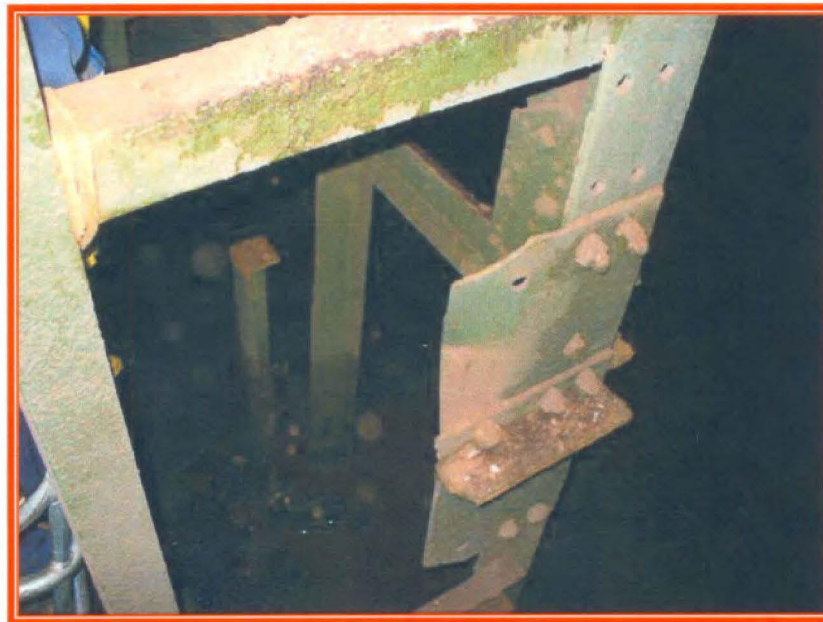
Photo #8: *Missing diagonal*

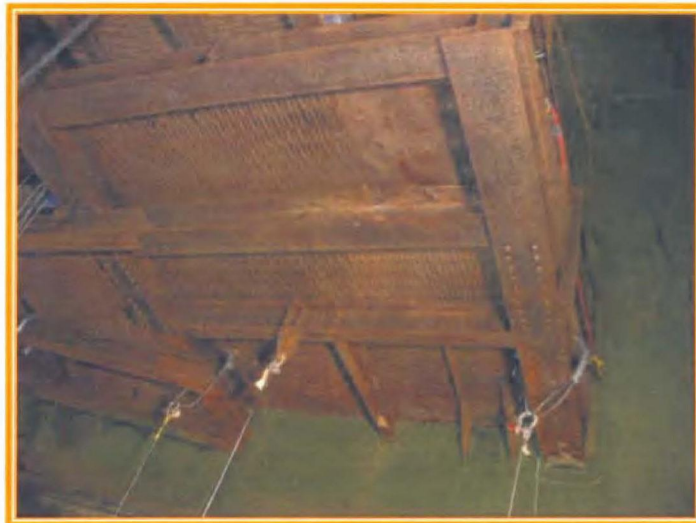
All framing members of the cat walk are in good condition (see photo #1 and #2). The welding of the major framing members to the tower steel wall are all in good condition (see photo #3 and #4) and are capable of providing fixed condition.

Photo #1: Cat walk framing by the tank entrance

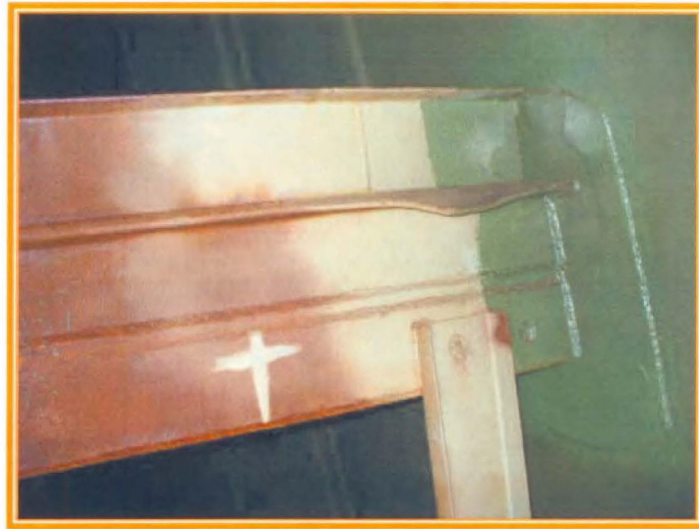
Photo #4: *Weld of the major I-beam is in good condition*

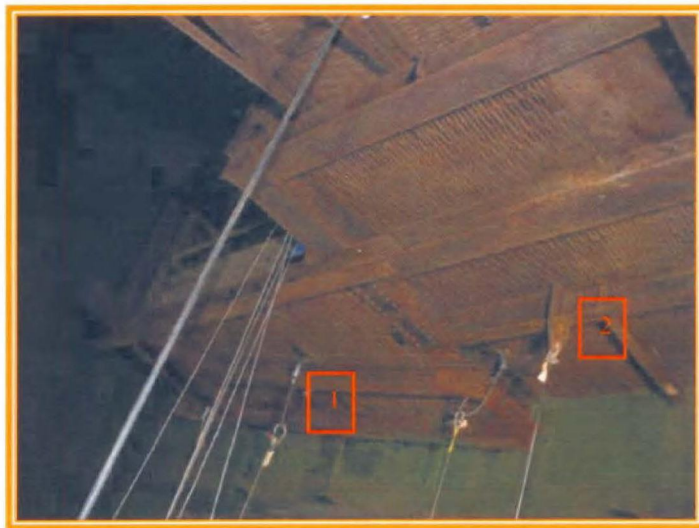
Photo #5: *Proposed scaffold will be hung on points 1 & 2*

However, we suggest that loading of the cat walk framing be limited to no more than 4 persons at any one time while the scaffold is hung from the cat walk framing and is in use. We also recommend that loading of the scaffold hung on this platform framing be limited to 2000lbs and no more than 2 persons at any one time.

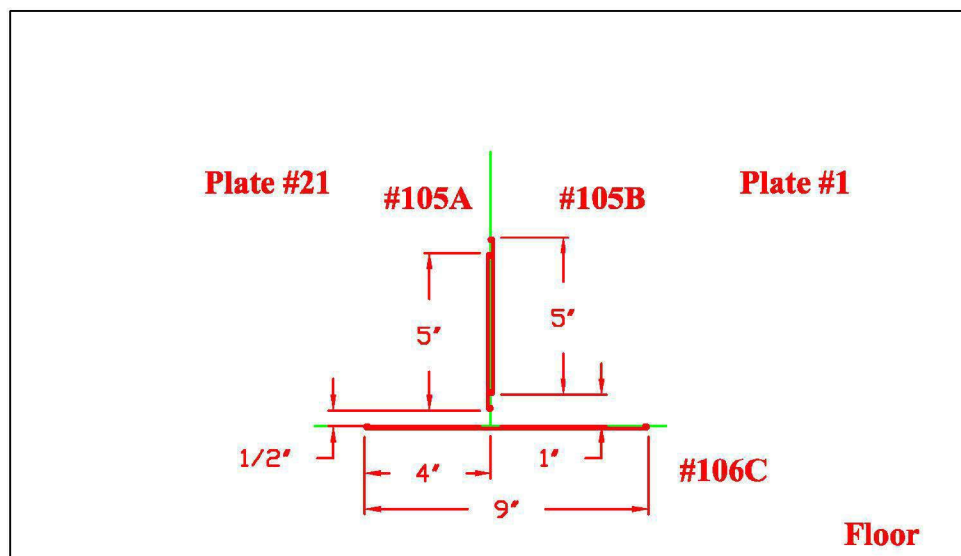
Tank Section: Floor/Shell
Quadrant: A
Course:
Plate: # 21 - 1

Flaw # 105A - Lack of fusion
.094 depth 5" long (left)
Flaw # 105B - Lack of fusion
.081 depth 5" long (right)
Flaw # 105C - Lack of fusion
.100 depth 9" long (bottom)

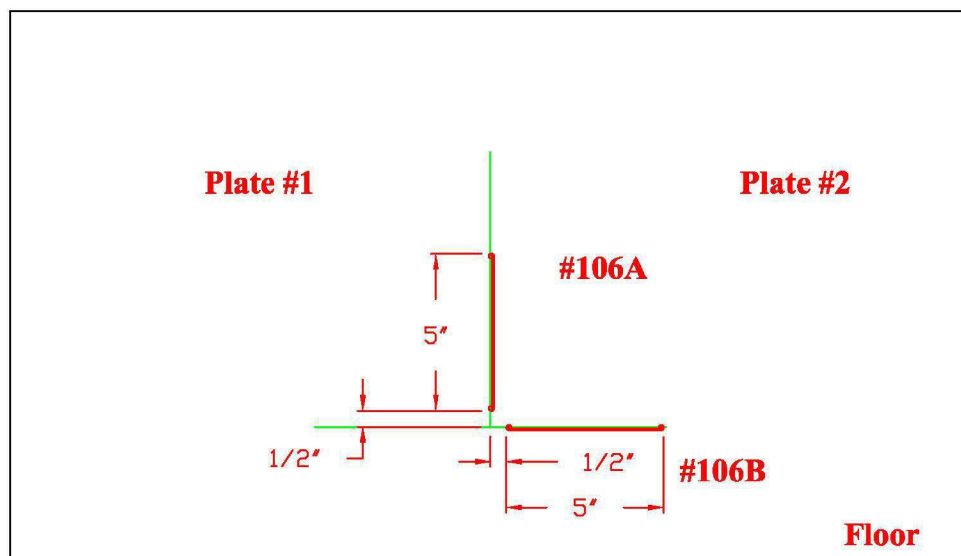
Tank Section: Floor/Shell
Quadrant: A
Course:
Plate: # 1 - 2

Flaw # 106A - Lack of fusion
.086 depth 5" long (right)
Flaw # 106B - Lack of fusion
.084 depth 5" long (bottom)

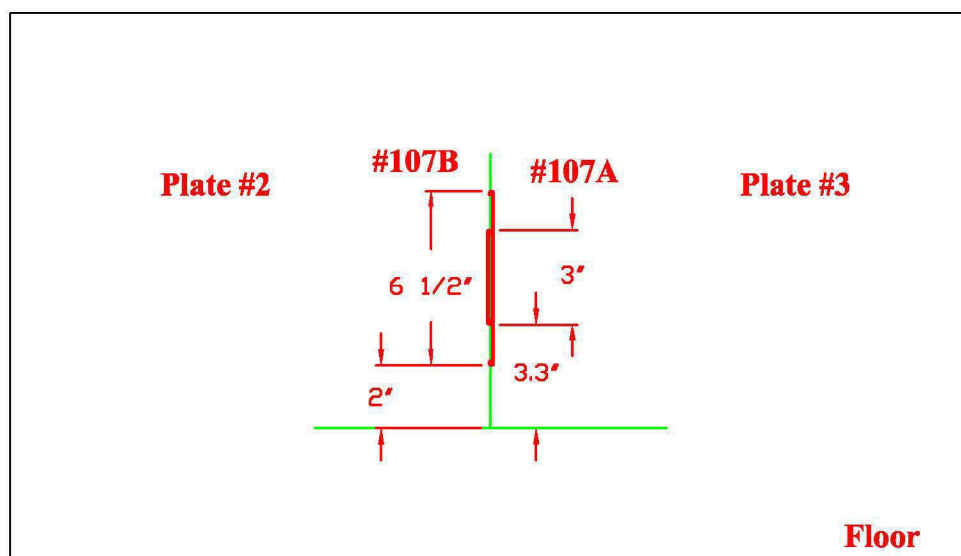
Tank Section: Floor/Shell
Quadrant: A
Course:
Plate: # 2 - 3

Flaw #107A - Lack of fusion
.201 depth 6 1/2" long (right)
Flaw #107B - Lack of fusion
.217 depth 3" long (left)

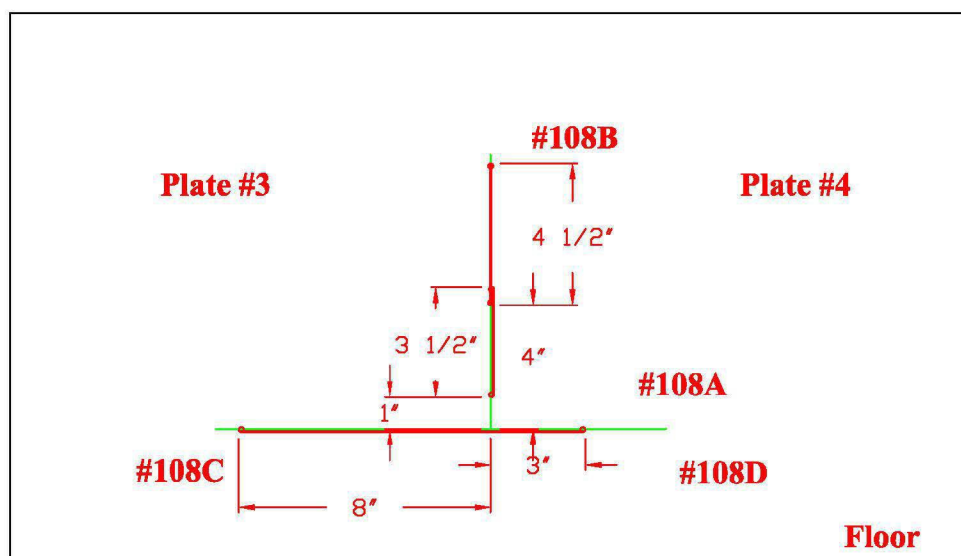
Tank Section: Floor/Shell
Quadrant: A
Course:
Plate: # 3 - 4

Flaw #108A - Lack of fusion
.206 depth 3 1/2" long (right)
Flaw #108B - Lack of fusion
.200 depth 4 1/2" long (center)
Flaw #108C - Lack of fusion
.080 depth 8" long (bottom)
Flaw #108D - Lack of fusion
.135 depth 3" long (bottom)

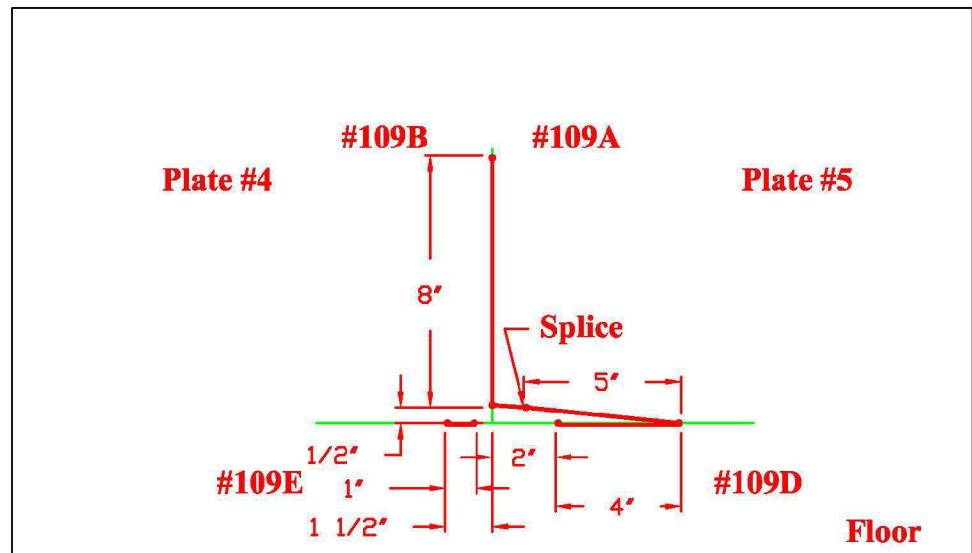
Tank Section: Floor/Shell
Quadrant: A
Course:
Plate: # 4 - 5

Flaw #109A,B - Lack of fusion
.201 depth 8" long (right)
.212 depth 8" long (left)
Flaw #109C - Lack of fusion
.201 depth 5" long (center)
Flaw #109D,E - Lack of fusion
.086 depth 4" long (bottom)
.162 depth 1" long (bottom)

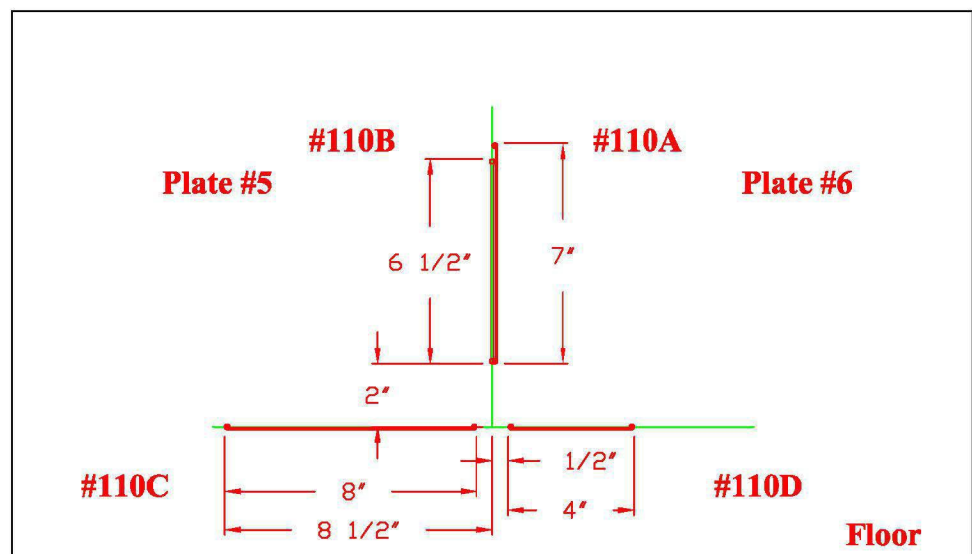
Tank Section: Floor/Shell
Quadrant: A
Course:
Plate: # 5 - 6

Flaw #110A - Lack of fusion
.193 depth 7" long (right)
Flaw #110B - Lack of fusion
.198 depth 6 1/2" long (left)
Flaw #110C - Lack of fusion
.065 depth 8" long (bottom)
Flaw #110D - Lack of fusion
.148 depth 4" long (bottom)

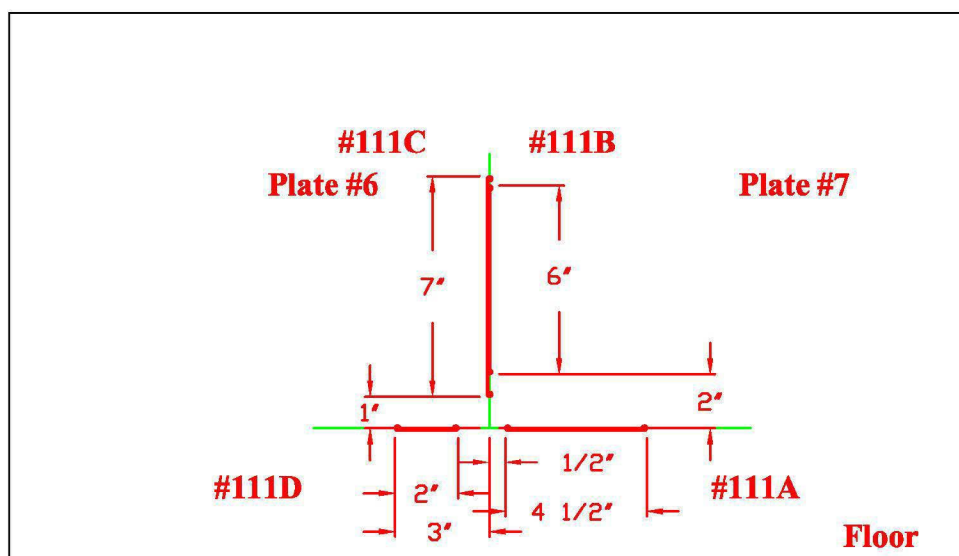
Flaw #111 D - Leak of fusion

.195" depth 2" long (bottom)

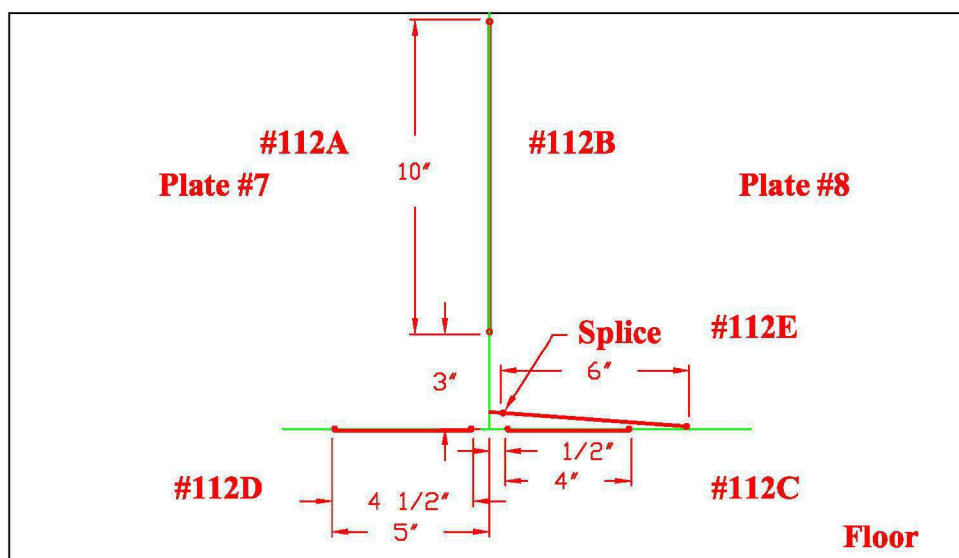
Flaw #112E - Splice - Intermittent crack

.218" depth 6" long (center)

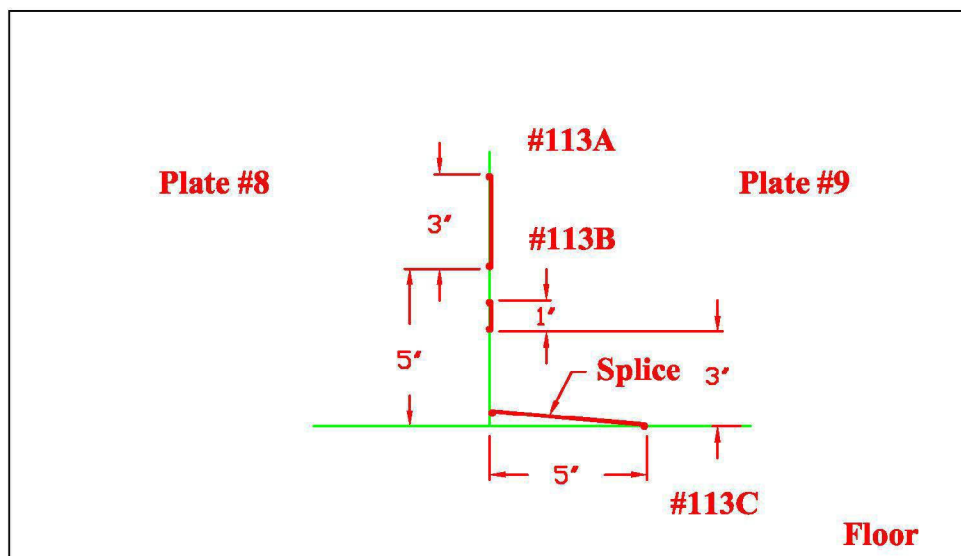
Flaw #113B - Lack of fusion
.207" depth 1" long (right)

Flaw #113C - Lack of fusion
.086" depth 5" long (top)

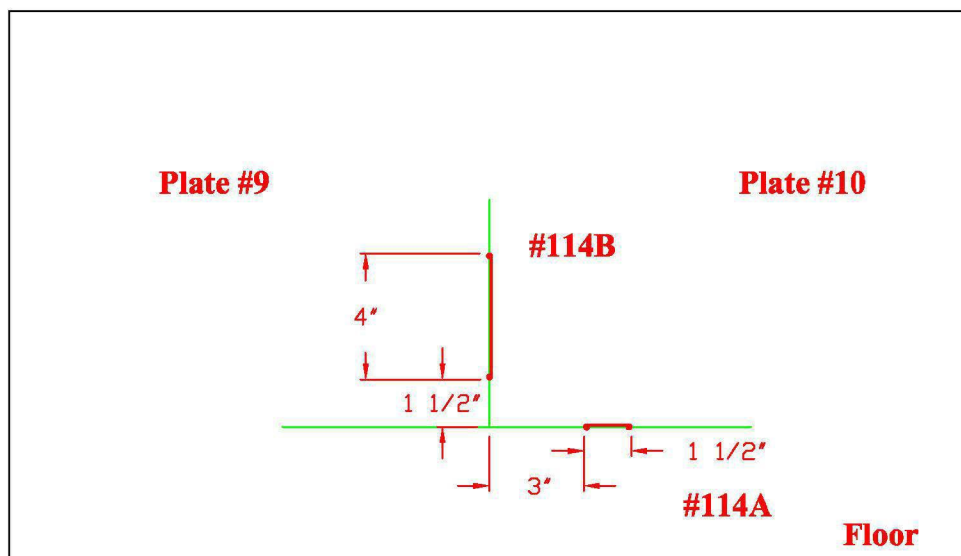
Flaw #114A - Lack of fusion
.133" depth 1 1/2" long (top)

Flaw #114B - Lack of fusion
.216" depth 4" long (right)

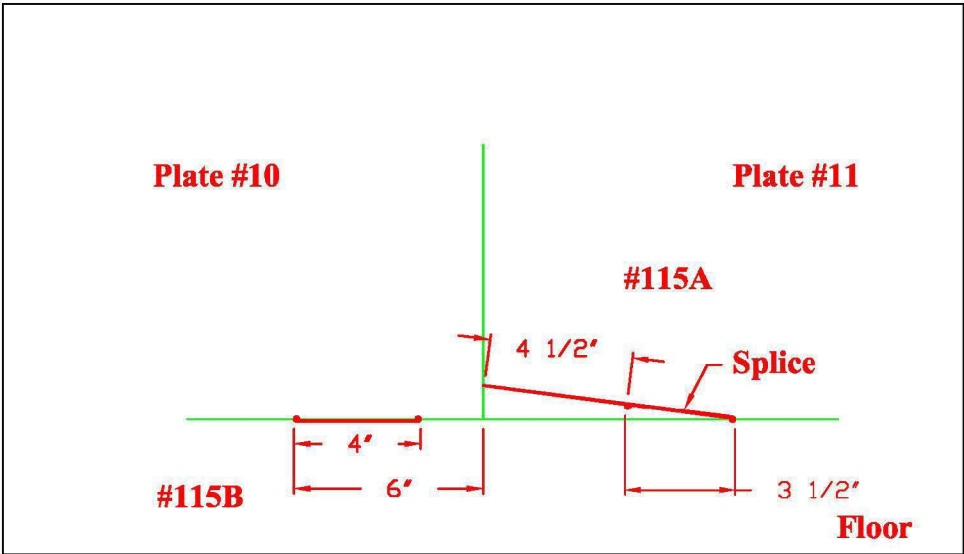
Tank Section: Floor/Shell
Quadrant: B
Course:
Plate: # 10 - 11

Flaw # 115A - Splice - LOF
.082" depth 3 1/2" long (top)
Flaw # 115B - Lack of fusion
.080" depth 4" long (bottom)

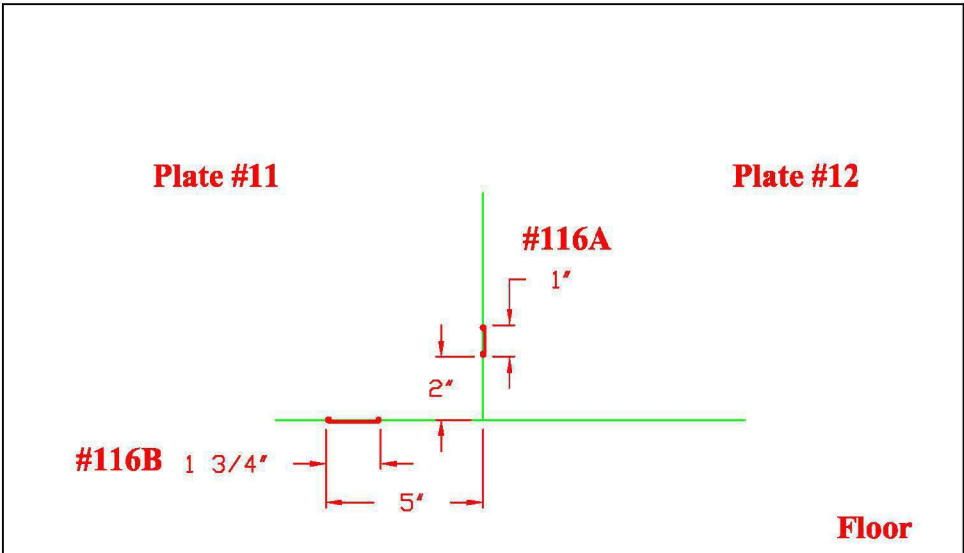
Tank Section: Floor/Shell
Quadrant: BC
Course:
Plate: # 11 - 12

Flaw # 116A - Lack of fusion
.216" depth 1" long (right)
Flaw # 116B - Lack of fusion
.071" depth 1 3/4" long (bottom)

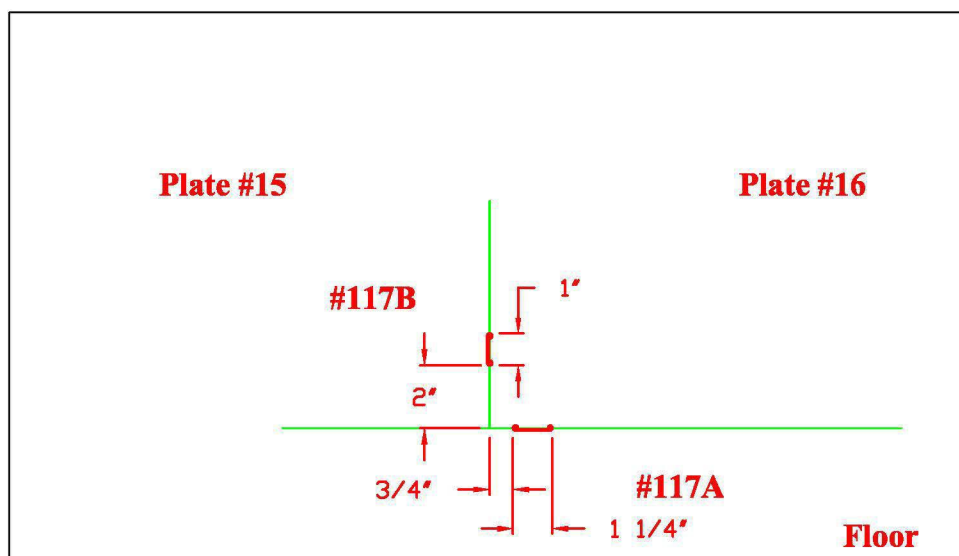
Flaw #117A - Lack of fusion
.102" depth 1 1/4" long (bottom)

Flaw #117B - Lack of fusion
.197" depth 1" long (left)

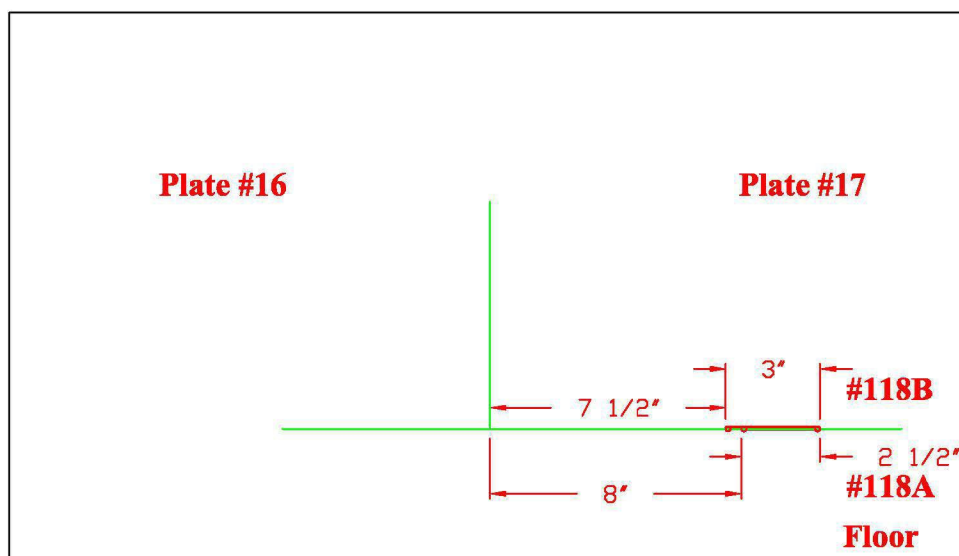
Flaw #118A - Lack of fusion
.080" depth 2 1/2" long (bottom)

Flaw # 118B - Lack of fusion
.085" depth 3" long (top)
