TANK #2 - QUADRANT D

**3.0 TANK MAPS**  
Dunkin & Bush, Inc.  
Honolulu, HI  
Tank #2 - Quadrant C

### 3.0 TANK MAPS

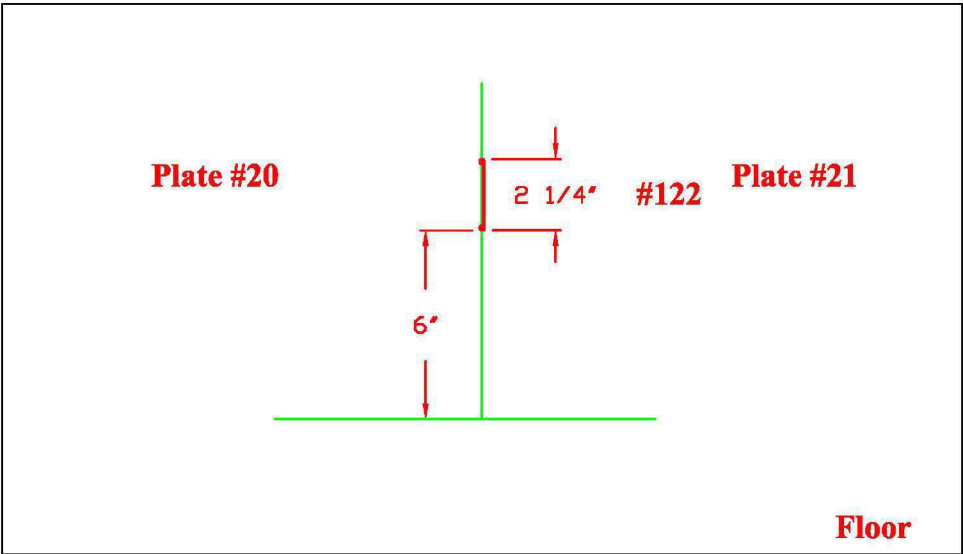
**Tank Section: Floor/Shell**  
**Quadrant: D**  
**Course:**  
**Plate: # 20 - 21**

**Flaw #122 - Lack of fusion**  
**.192 depth 2 1/4" long (Right)**

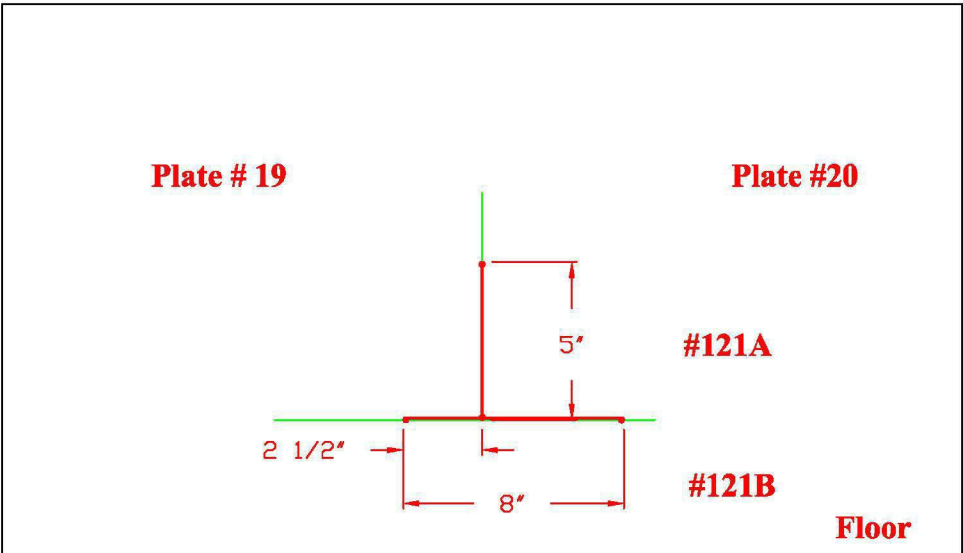
**Tank Section: Floor/Shell**  
**Quadrant: D**  
**Course:**  
**Plate: # 19 - 20**

**Flaw #121A - Intermittent crack**  
**.238 depth 5" long (center)**

**Flaw #121B - Intermittent crack**  
**.231 depth 8" long (top)**

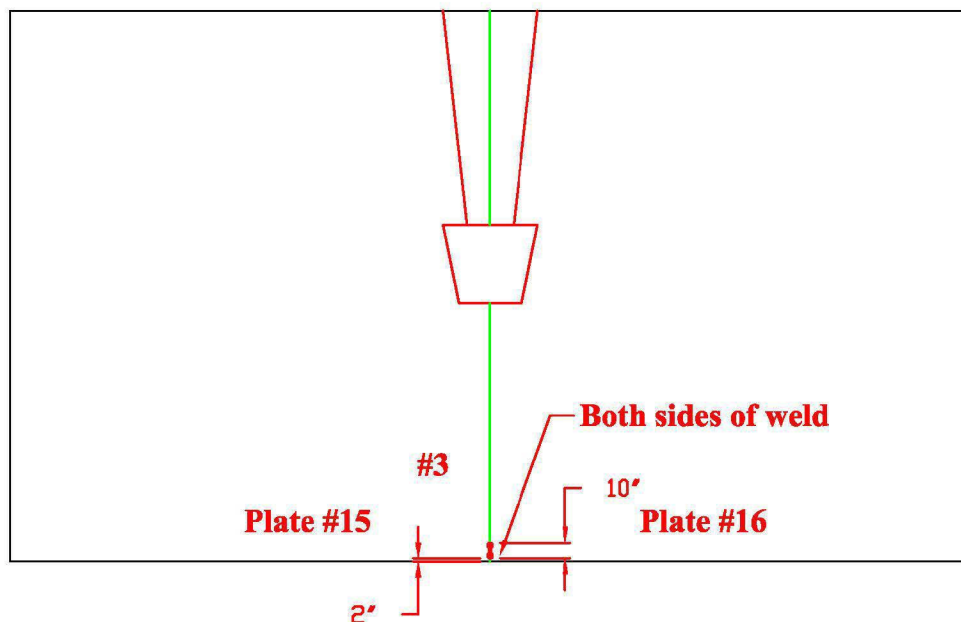
**Tank Section: Lower dome**  
**Quadrant: C**  
**Cours: 1**  
**Plate: # 15 - 16**

**Flaw #3 - Intermittent crack**  
**3A - .223" depth 10" long**  
**(left side)**  
**3B - .214" depth 10" long**  
**(right side)**

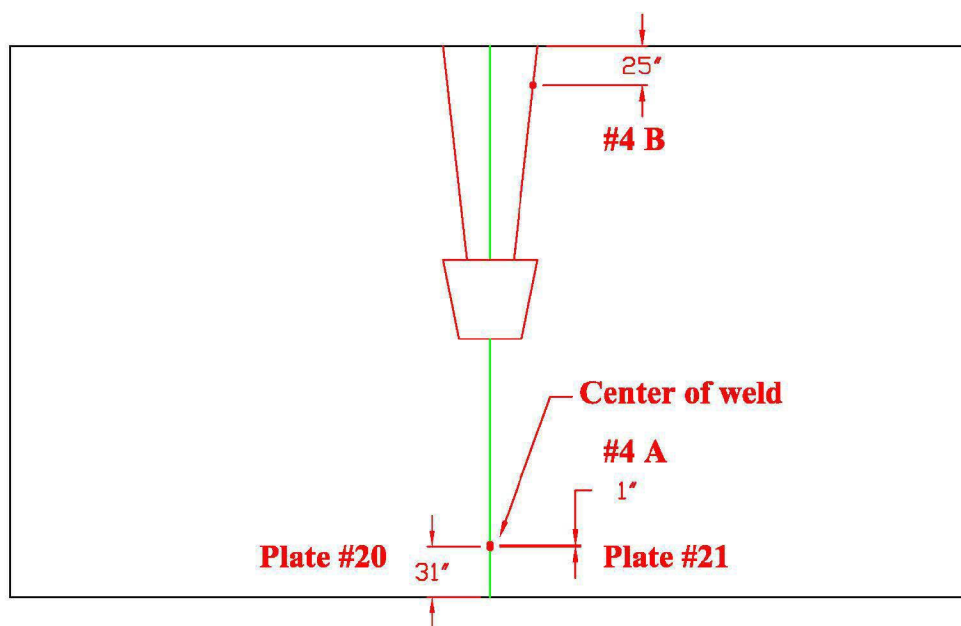
**Tank Section: Lower dome**  
**Quadrant: D**  
**Course: 1**  
**Plate: # 20 - 21**

**Flaw #4A - Incomplete**  
**.222" depth 1" long**  
**Flaw #4B - Arc strike at toe**  
**.069" depth 2" long**

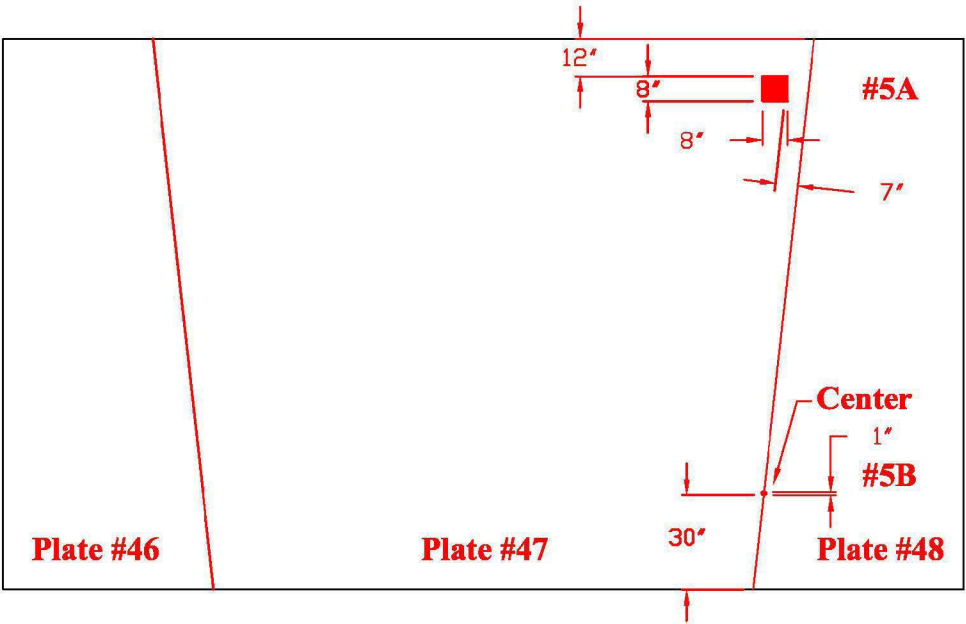
Tank Section: Lower dome  
Quadrant: D  
Course: 2  
Plate: # 47

Flaw # 5A - W.L.  
.147" - .210" Remaining  
Flaw # 5B - Incomplete Pen.  
.215" depth 1" long

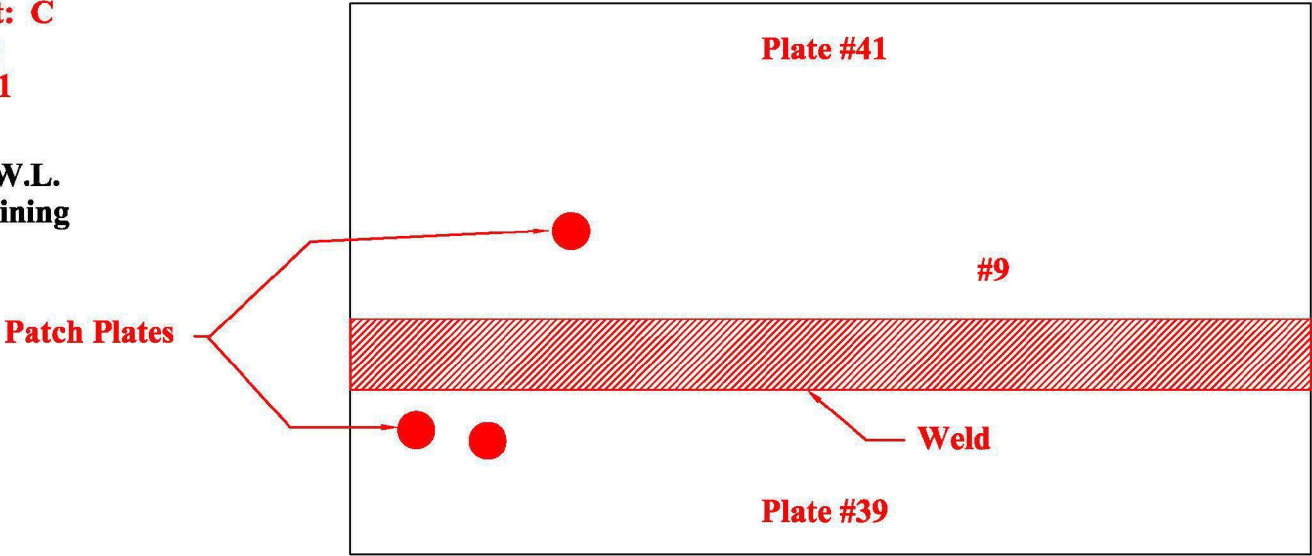
Tank Section: Lower dome  
Quadrant: C  
Course: 3  
Plate: #41

Flaw #9 - W.L.  
.230 Remaining

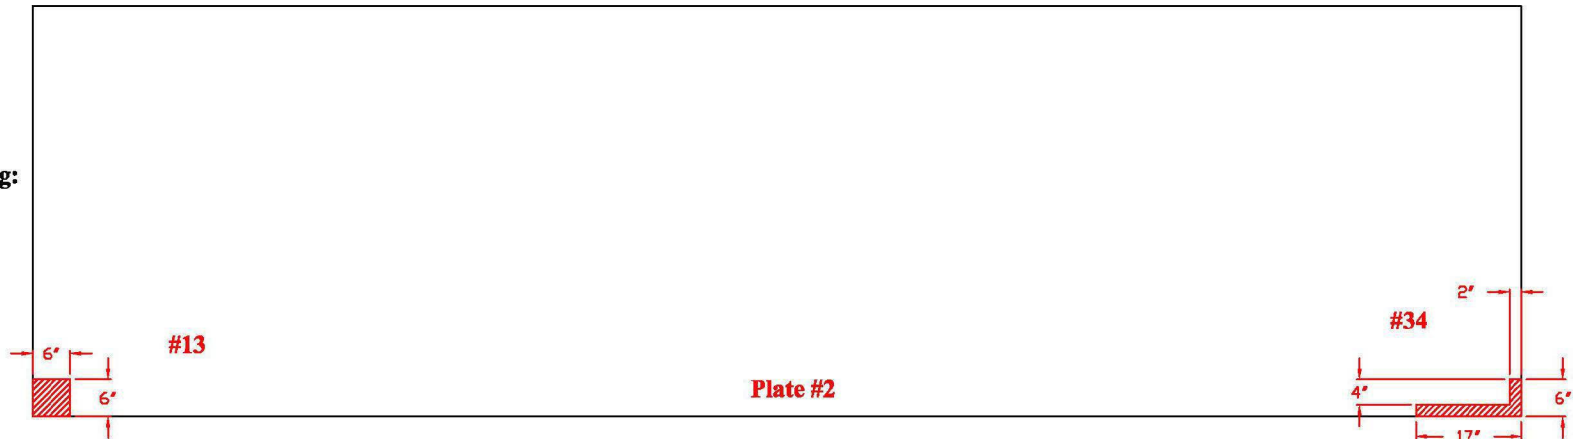
**Course: 25**  
**Plate #: 2**

**#13 - W.L. - .231"**

**#34 - W.L. - .219"**

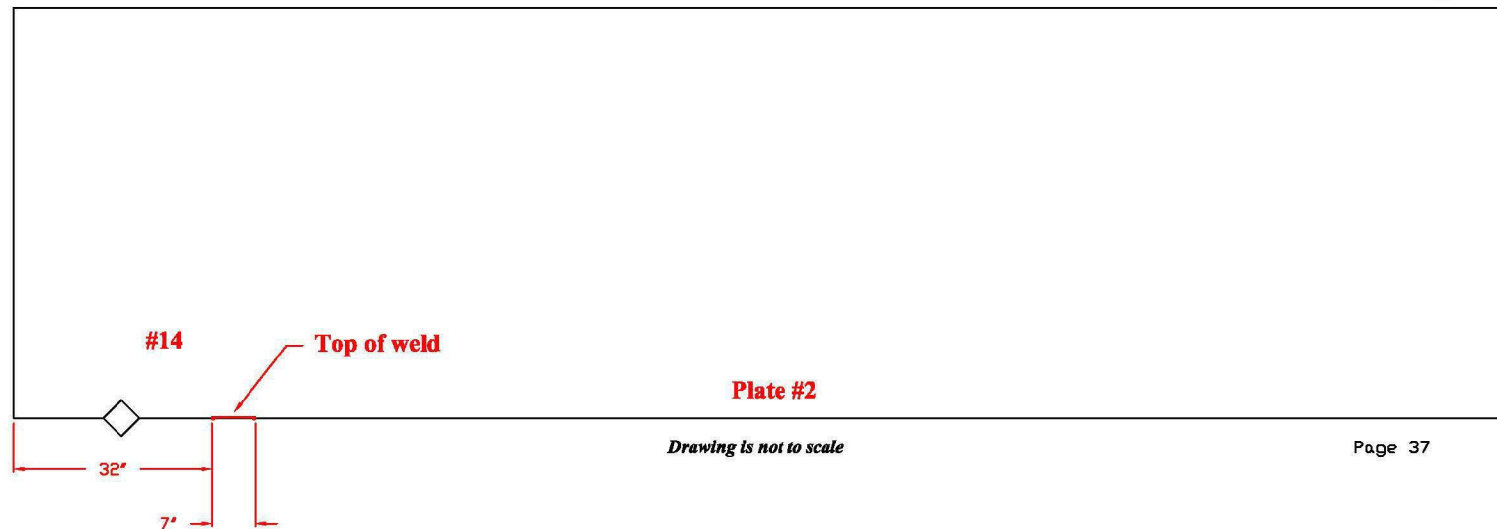
**Course: 2**  
**Plate #: 2**

**#14 - Lack of fusion**

**.125" depth 7" long**  
**Top of weld**

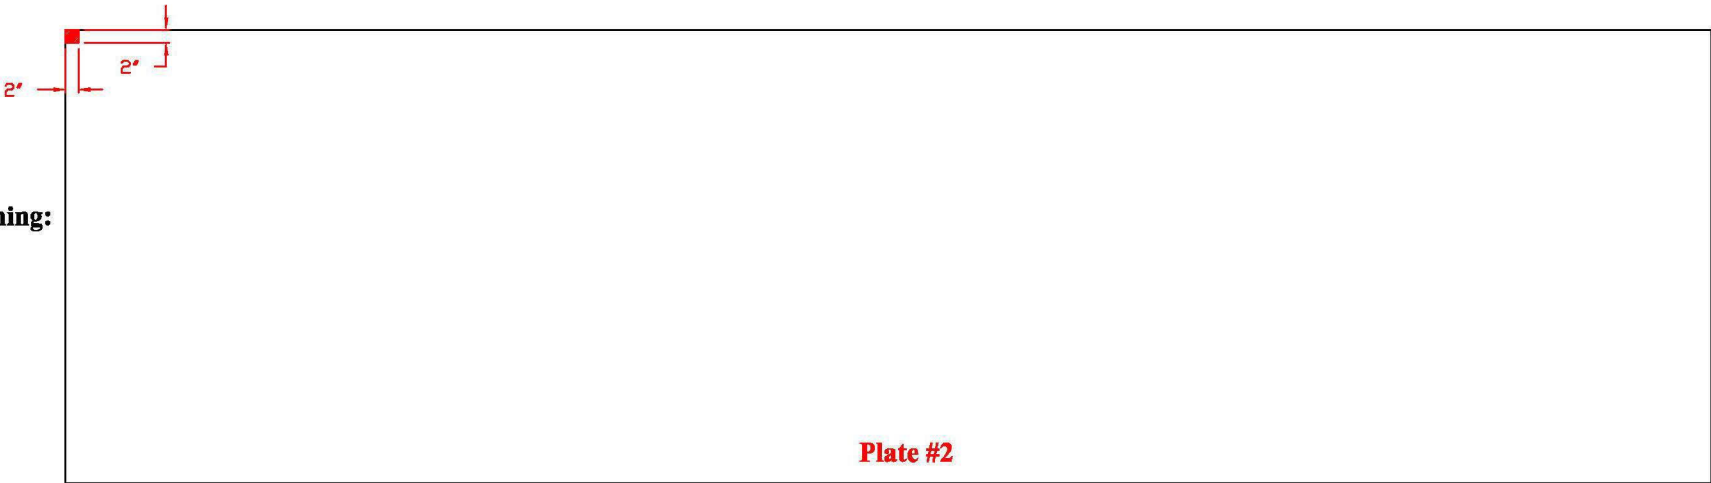
Course: 21  
Plate #: 2

Flaw # - Type - Remaining:  
#15 - W.L. - .233"

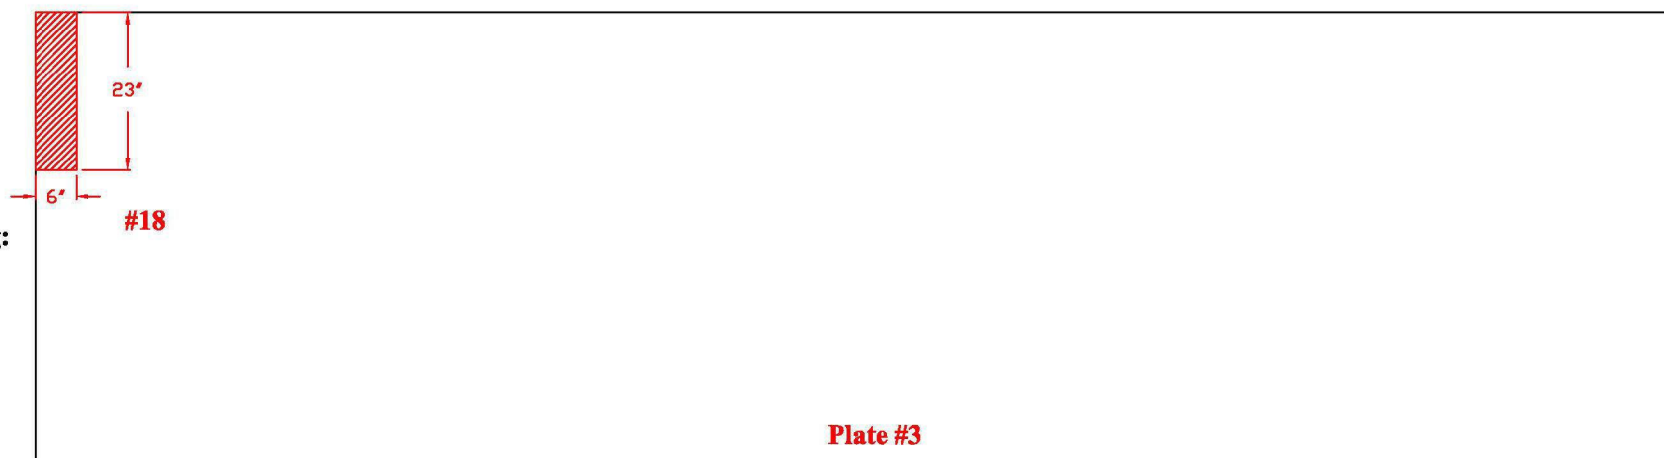
**Course: 7**  
**Plate #: 3**

#18 - W.L. - .228"

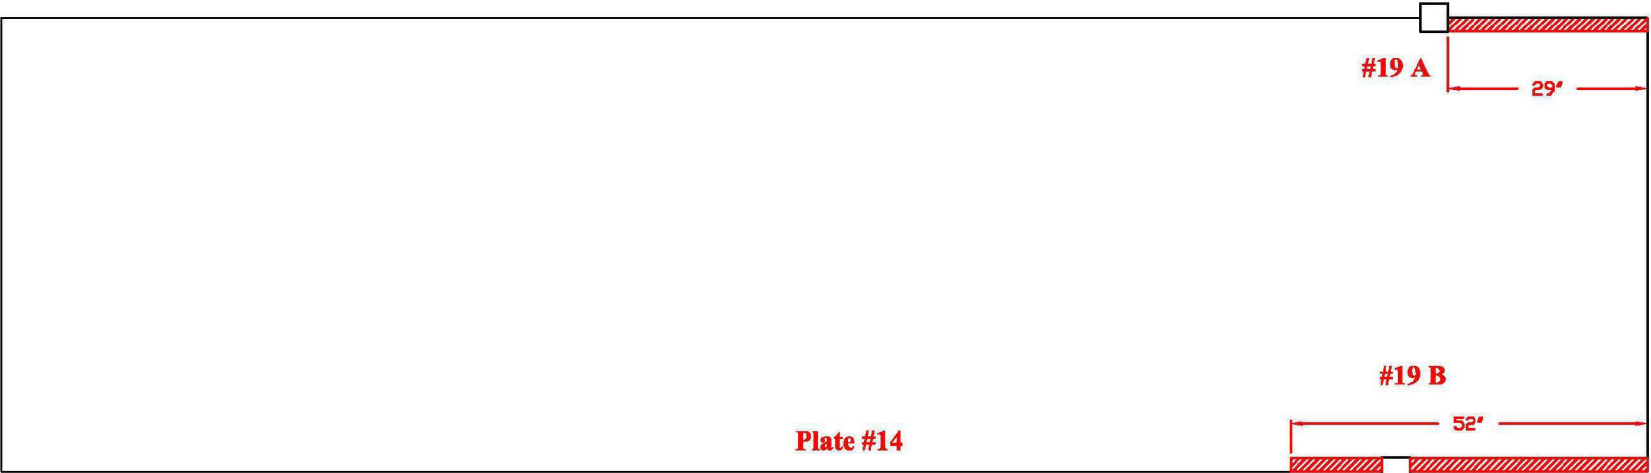
Course: 24  
Plate #: 14

#19A - W.L. - .227"  
#19B - W.L. - .232"

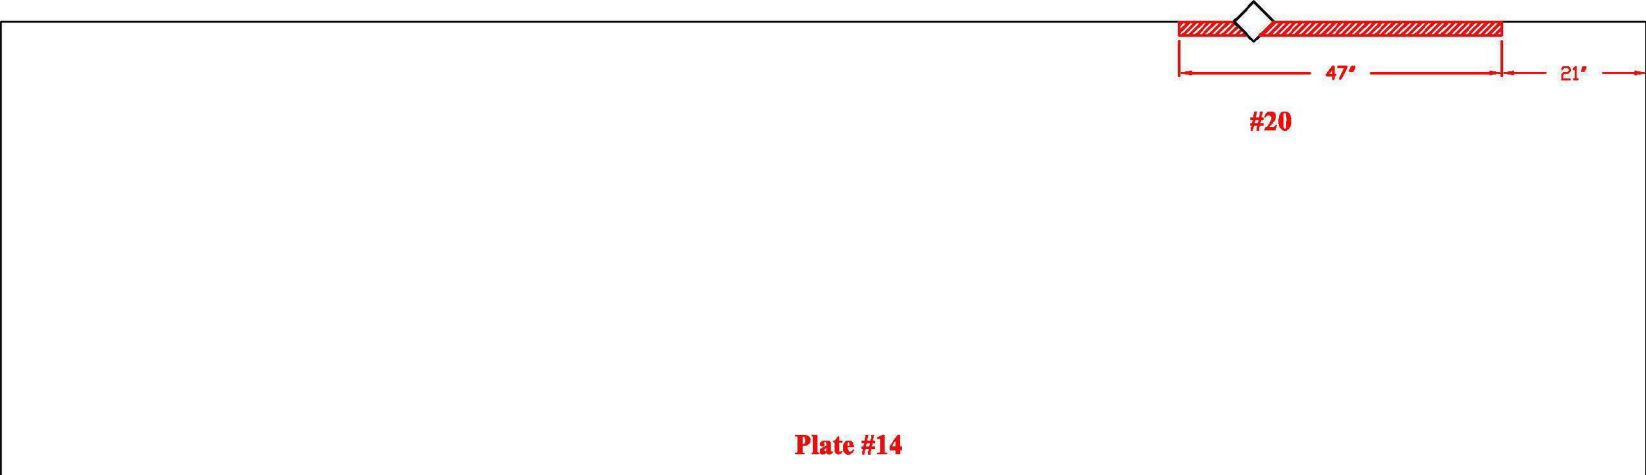
Course: 22  
Plate #: 14

#20 - W.L. - .234"

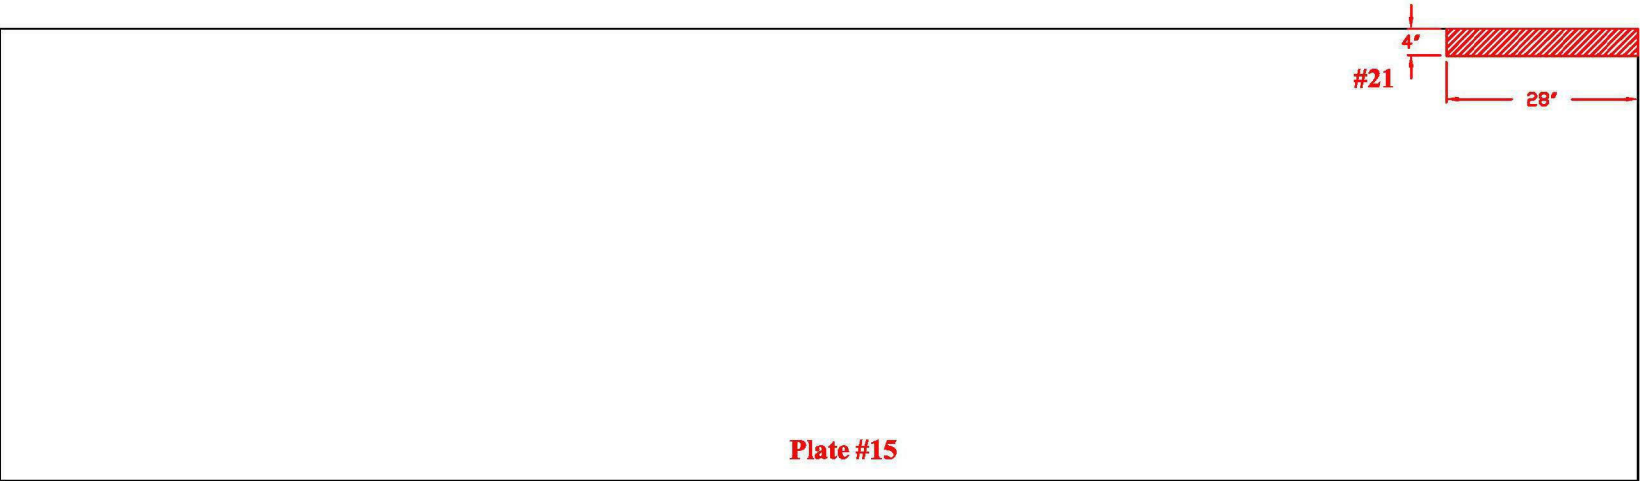
Course: 4  
Plate #: 15  
Flaw # - Type - Remaining:  
#21 - W.L. - .235"

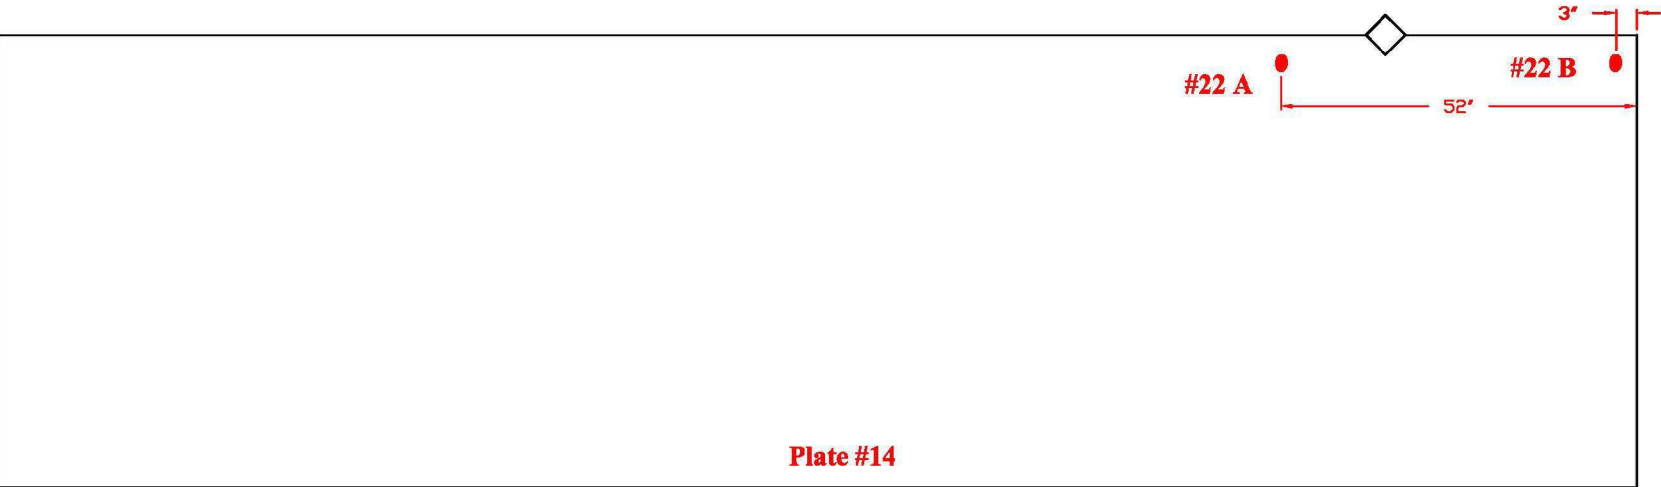
Course: 8  
Plate #: 14  
Flaw # - Type - Remaining:  
#22A - W.L./Pit - .230"  
#22B - W.L./Pit - .221"

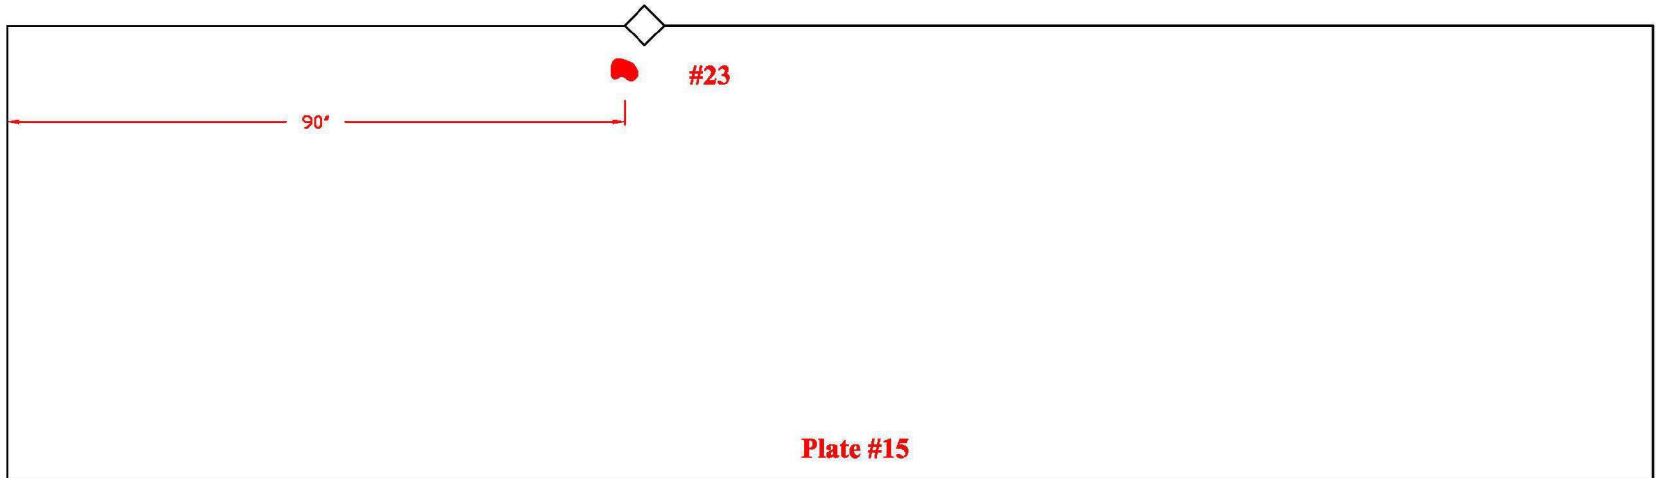
Course: 8  
Plate #: 15

#23 - W.L./Pit - .228"

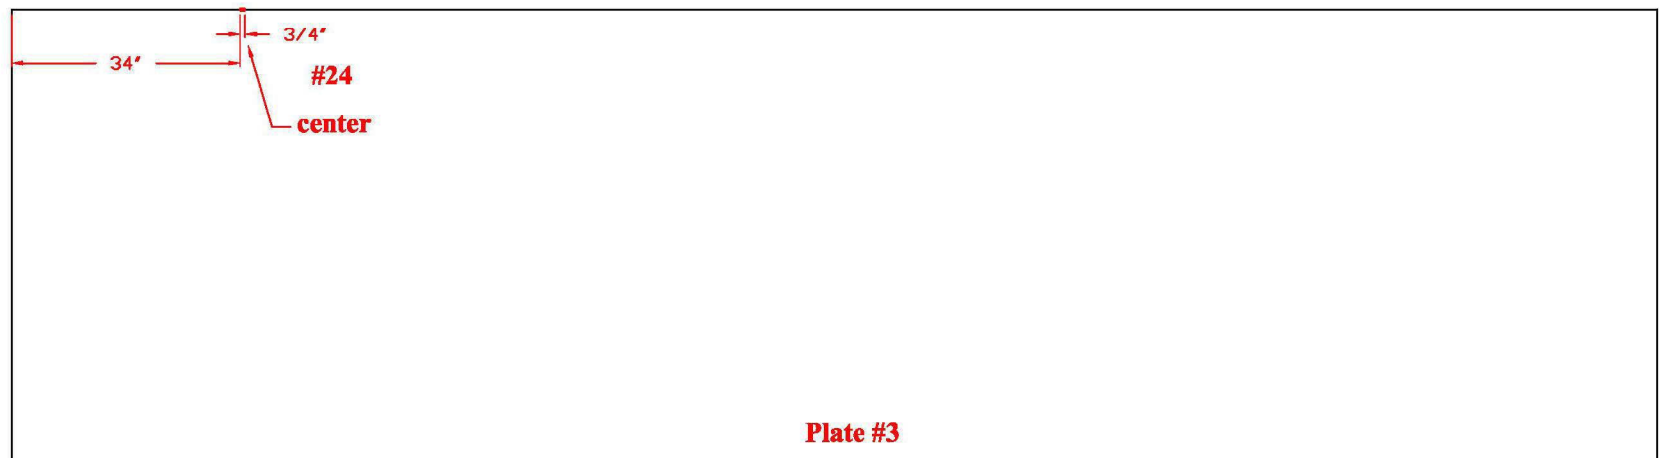
Course: 26  
Plate #: 3

#24 - Porosity  
.210" depth  $\frac{3}{4}$ " long  
(center of weld)

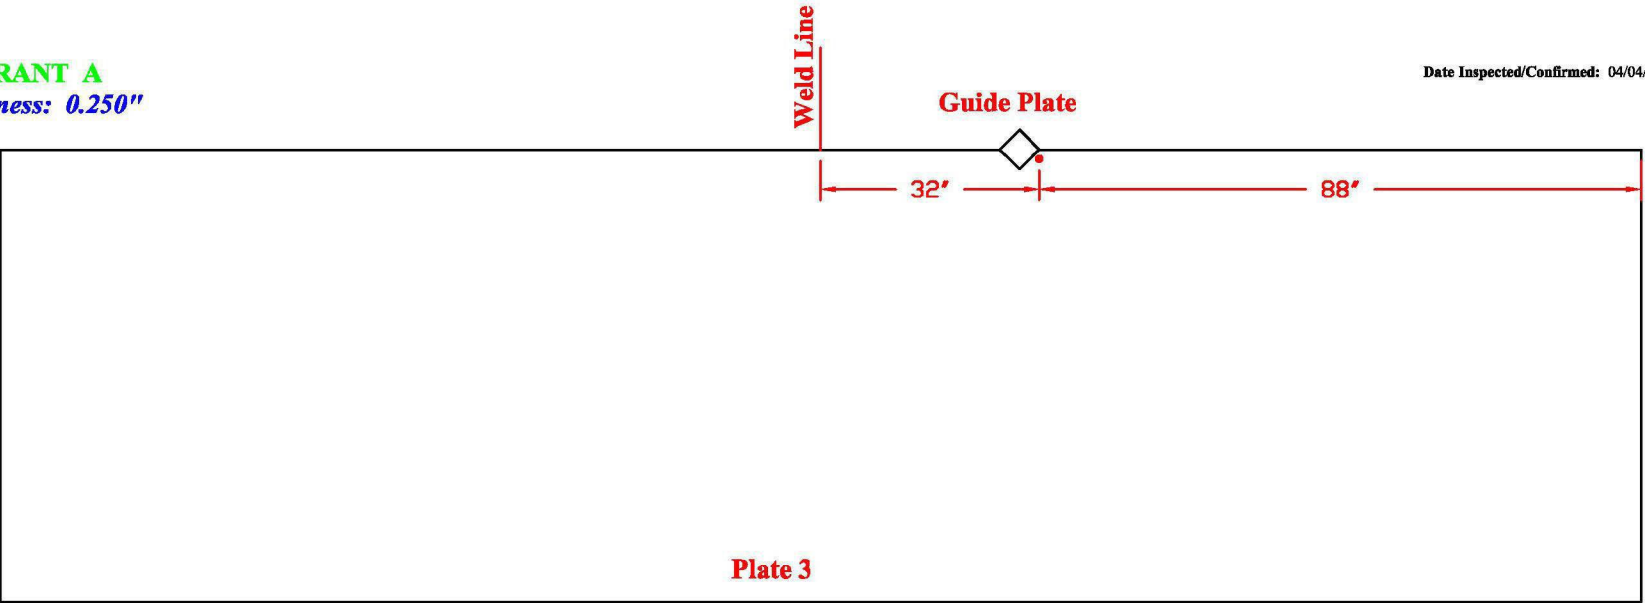
Course: 17  
Plate #: 3

Flaw # - Type - Remaining:  
#25 - Toe Arc Strikes  
.063" depth  
5½" L x 3" W

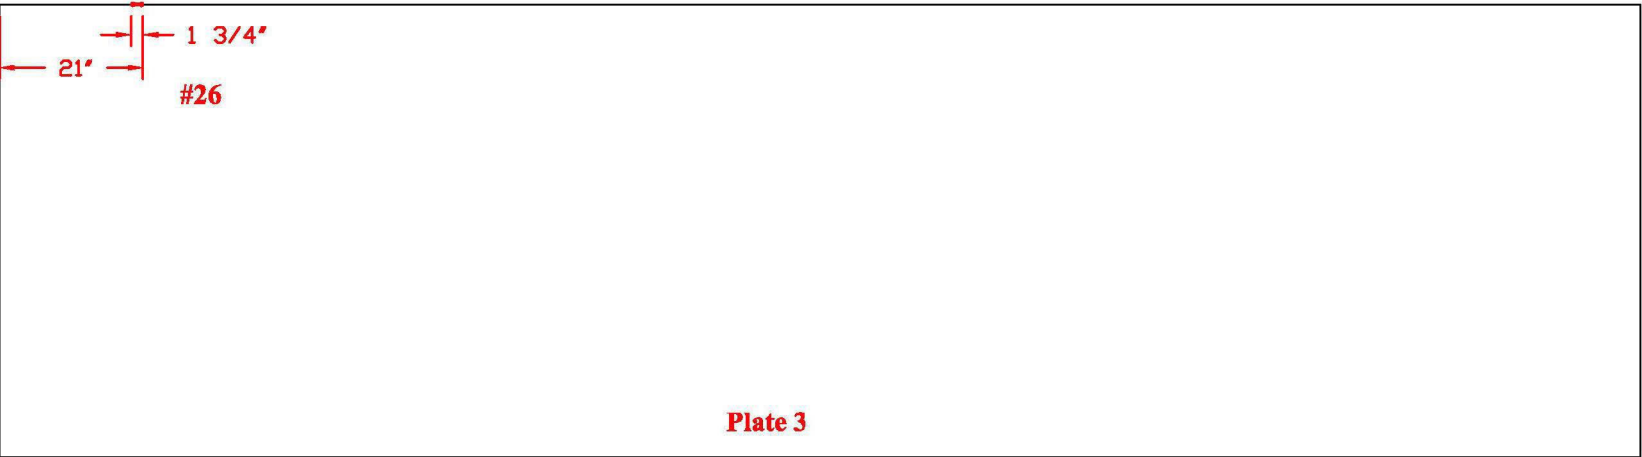
Course: 20  
Plate #: 3

Flaw # - Type - Remaining:  
#26 - Porosity  
.181" depth 1¾" long  
(bottom of weld)

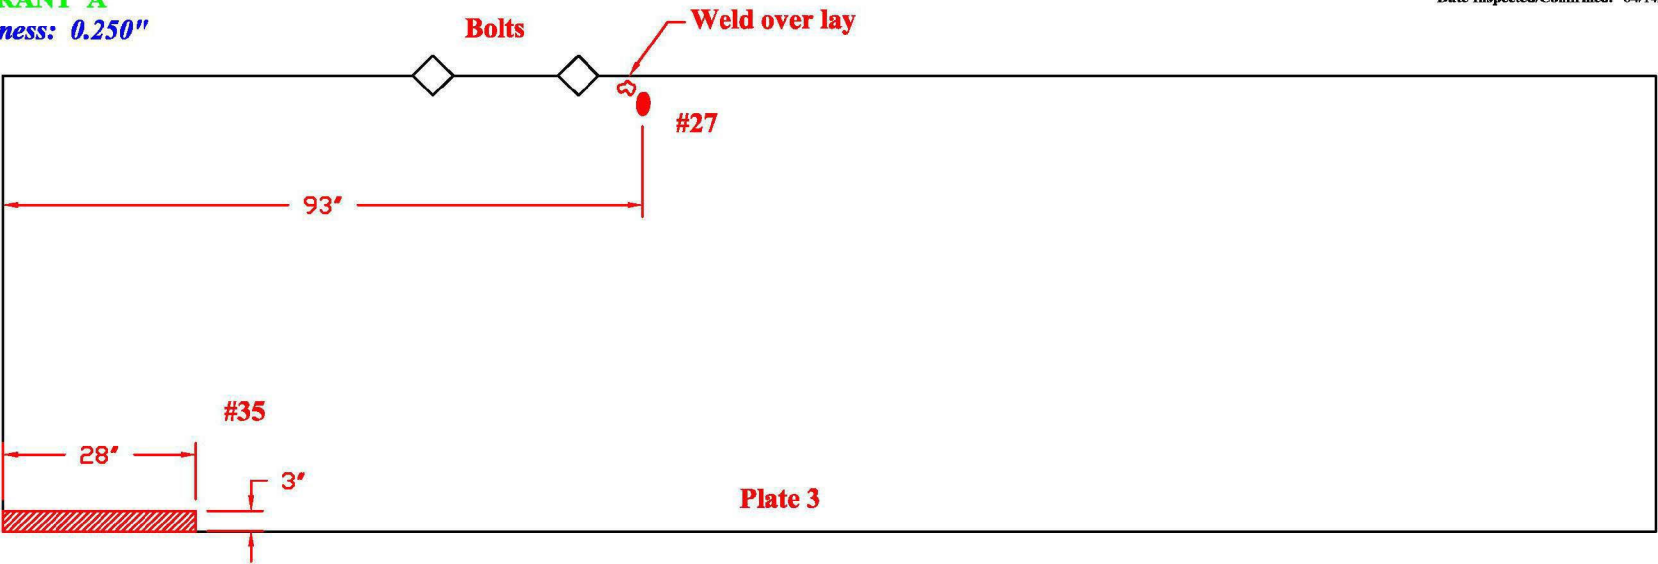
Course: 25  
Plate #: 3

#27 - Pit - .234"

#35 - W.L. - .221"

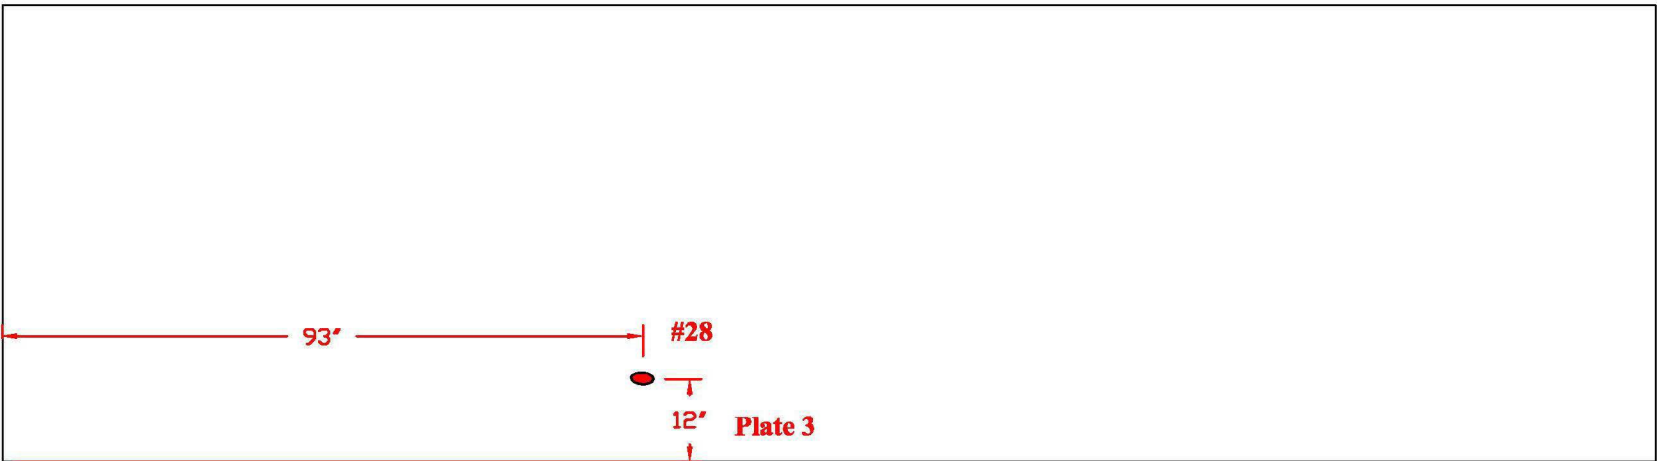
Course: 8  
Plate #: 3

#28 - Pit - .220"

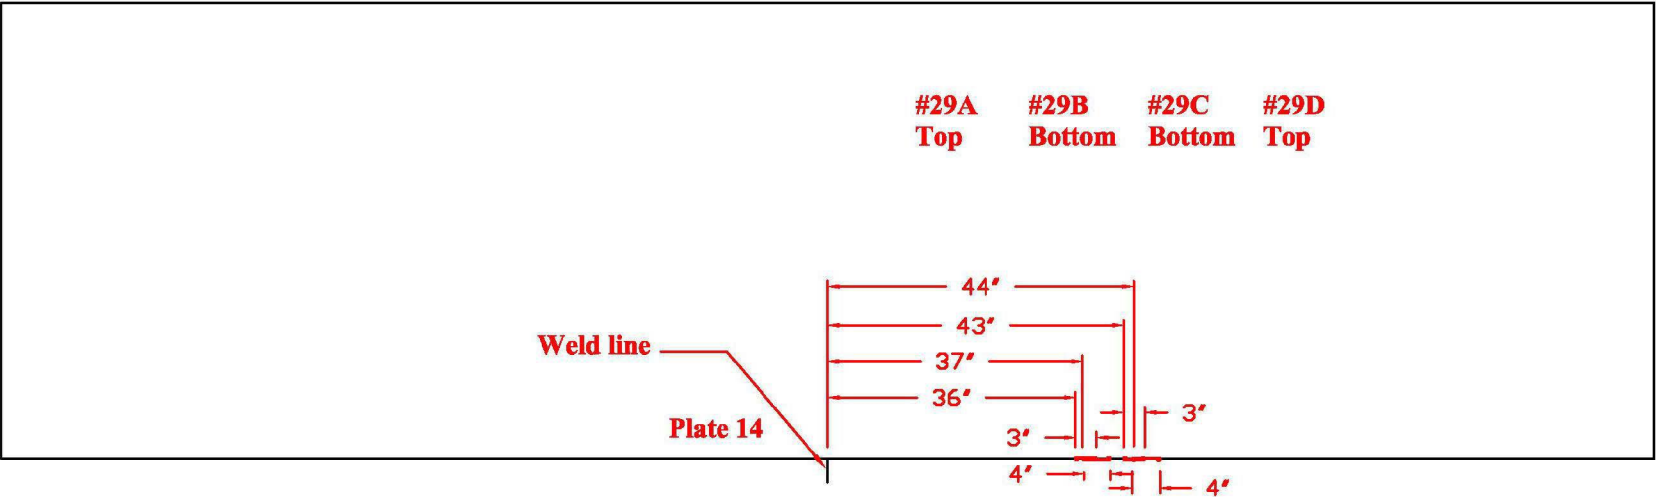
Course: 13  
Plate #: 14

Flaw # - Type - Remaining:  
#29 - Lack of fusion  
A- .173" depth 3" long  
(top)  
B- .112" depth 4" long  
(bottom)  
C- .205" depth 3" long  
(bottom)  
C- .206" depth 4" long  
(top)

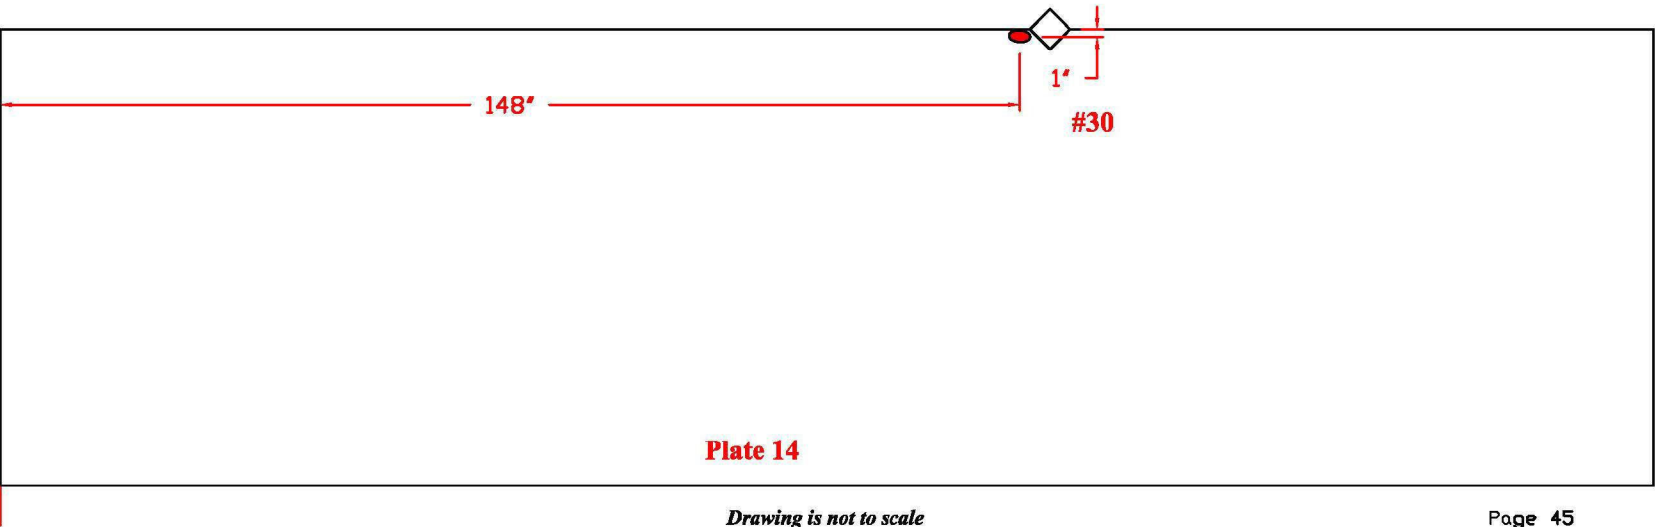
Course: 4  
Plate #: 14

Flaw # - Type - Remaining:  
#30 - Pit -.226"

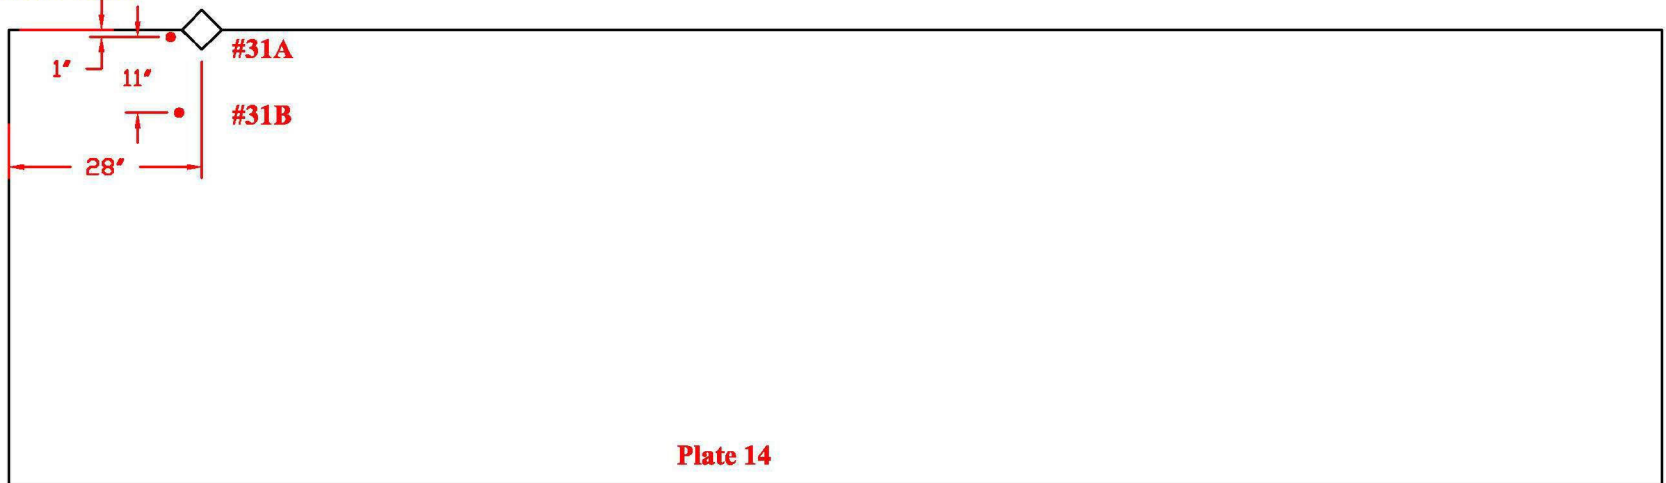
Course: 5  
Plate #: 14

#31A - W.L./Pit - .235"

#31B - W.L./Pit - .235"

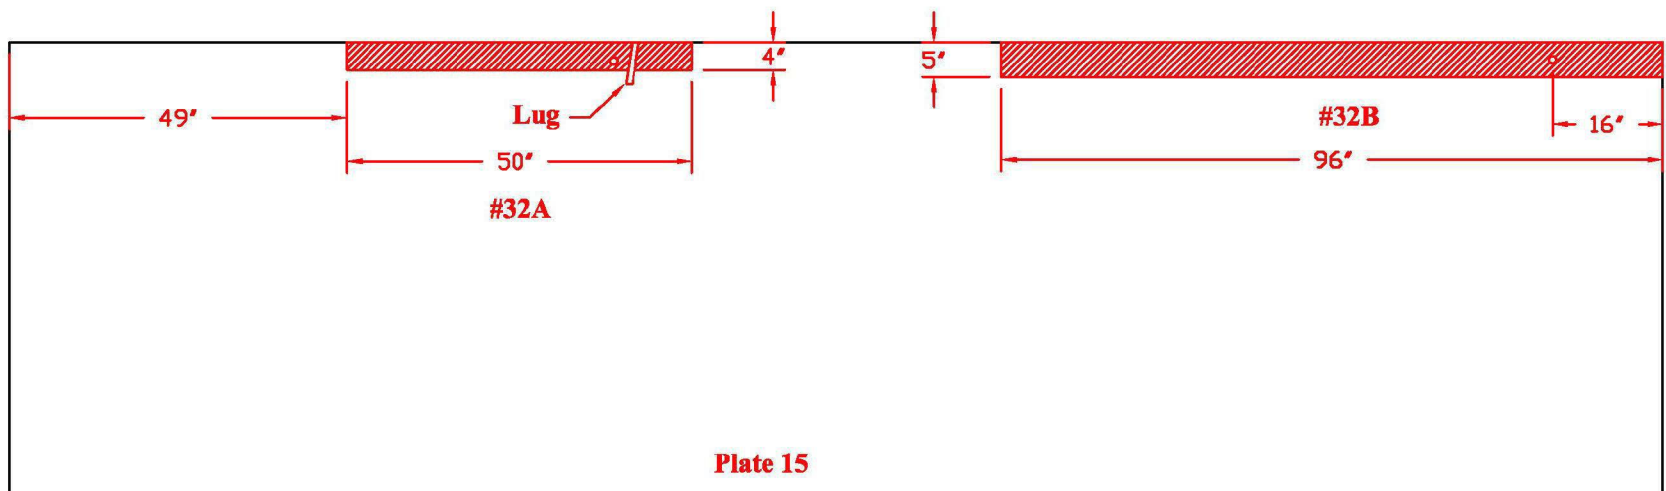
Course: 21  
Plate #: 15

#32A - W.L. - .230"

#32B - W.L. - .219"

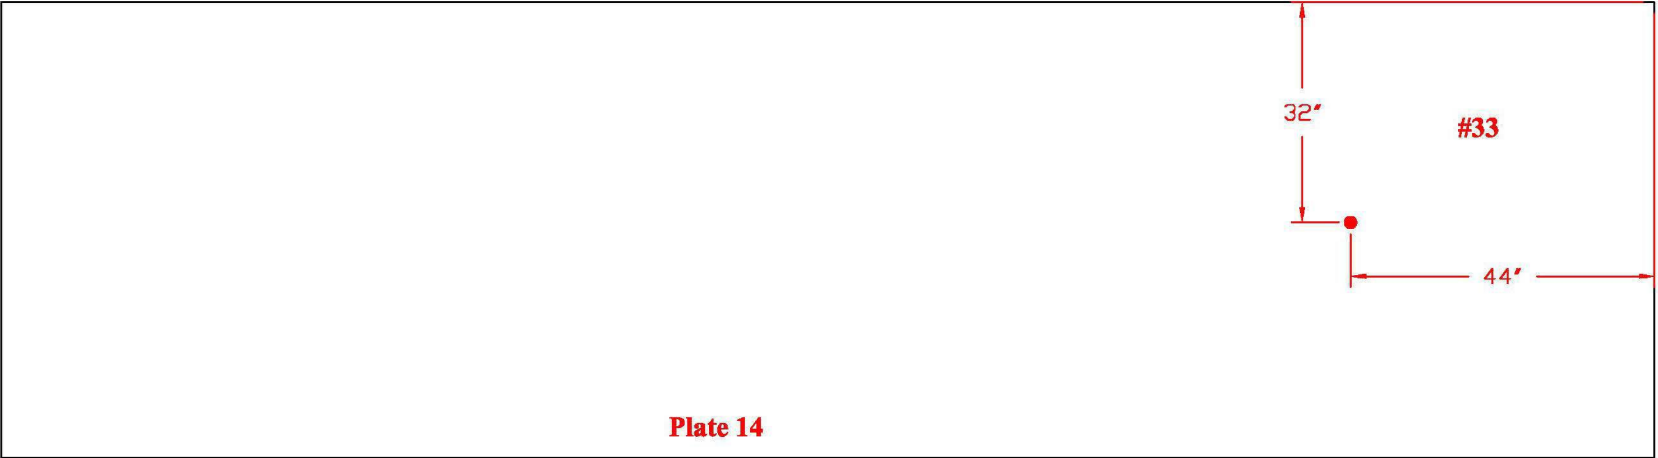
Course: 20  
Plate #: 14

#33 - Tack weld  
.082" depth  
1½" L x ¼" W

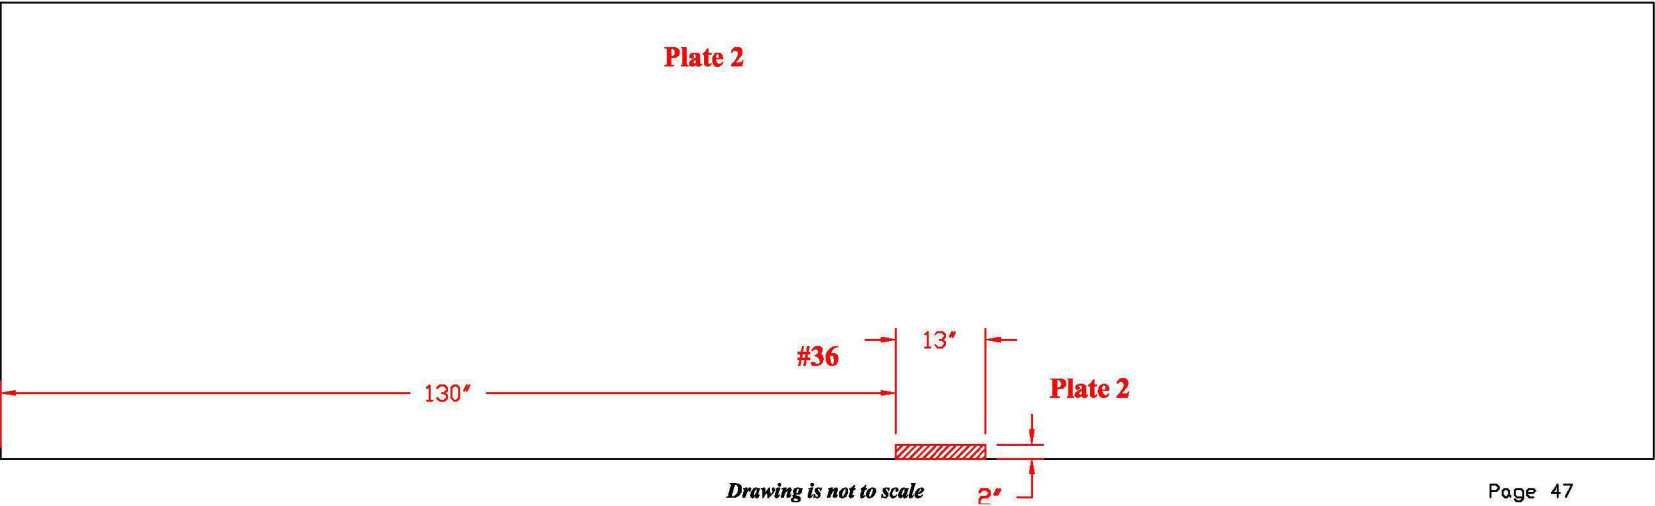
Course: 10  
Plate #: 2

#36 - W.L. - .218"

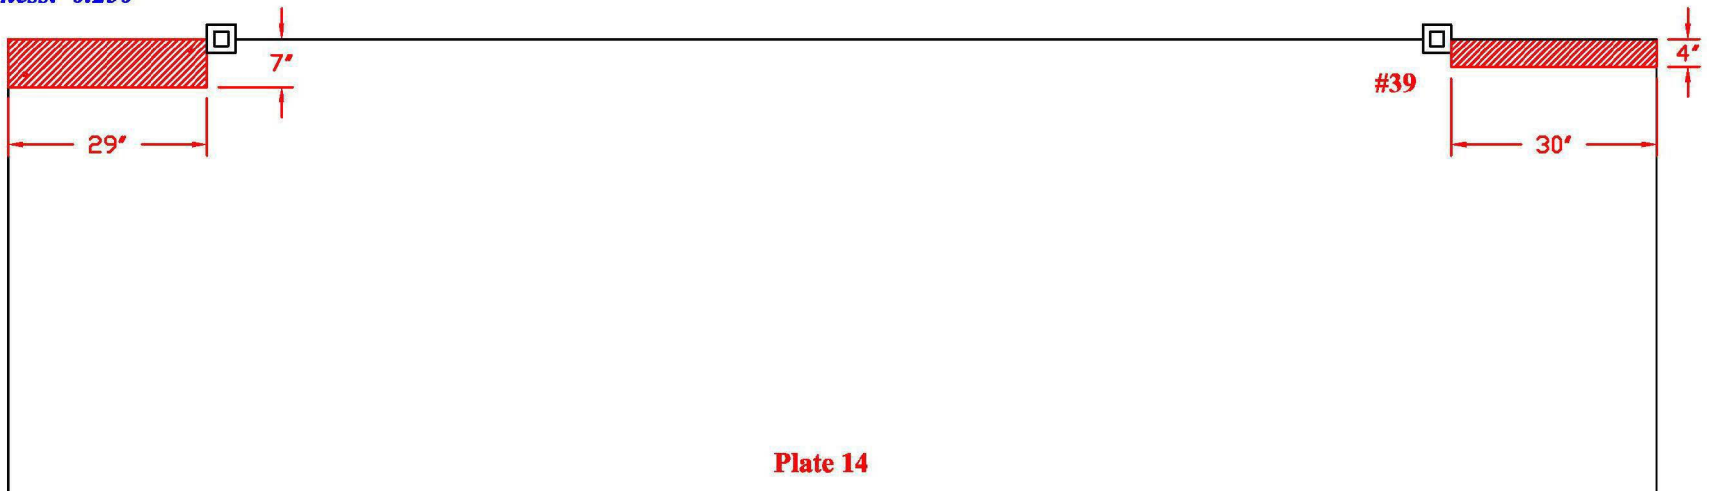
**Course: 25**  
**Plate #: 14**

#39 - W.L. - .230"  
#42 - W.L. - .234" A  
.223" B

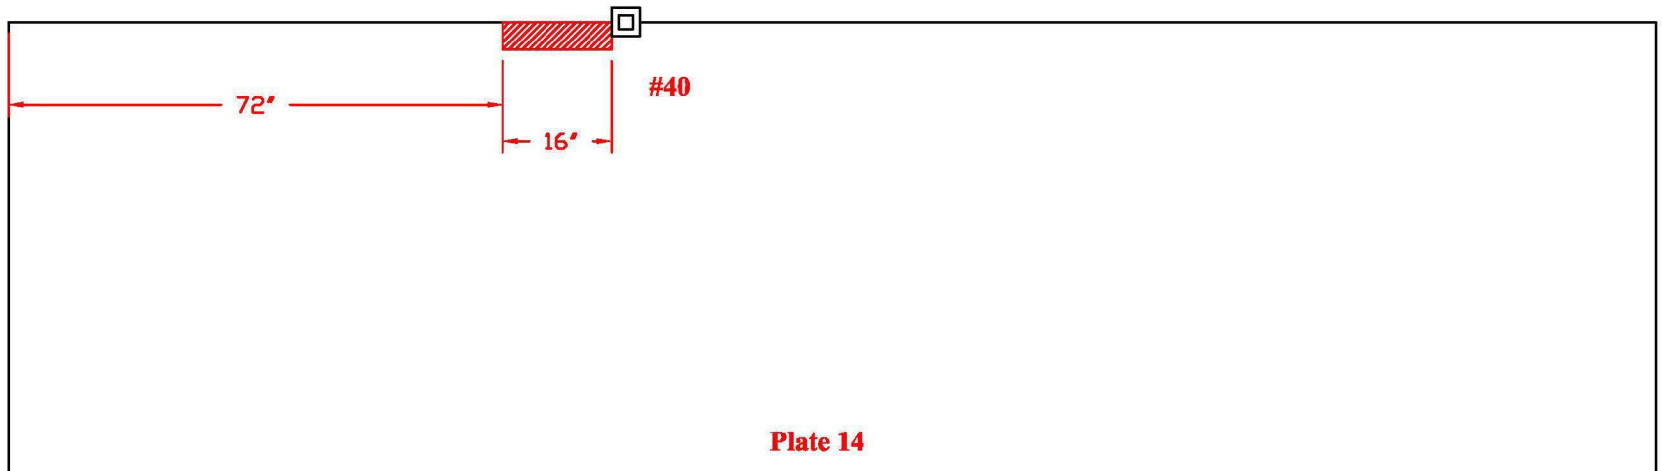
**Course: 26**  
**Plate #: 14**

#40 - W.L. - .214"

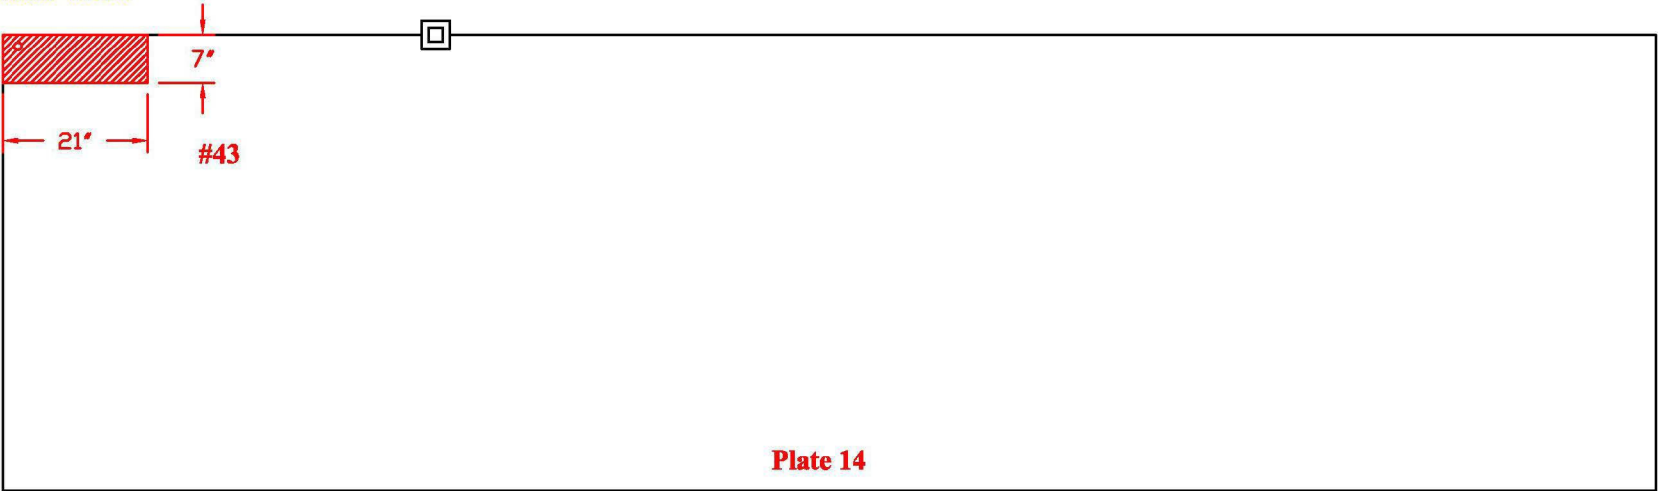
Course: 27  
Plate #: 14

Flaw # - Type - Remaining:  
#43 - W.L. - .229"
