TANK #2 - QUADRANT D

**3.0 TANK MAPS**  
Dunkin & Bush, Inc.  
Honolulu, HI  
Tank #2 - Quadrant C

### 3.0 TANK MAPS

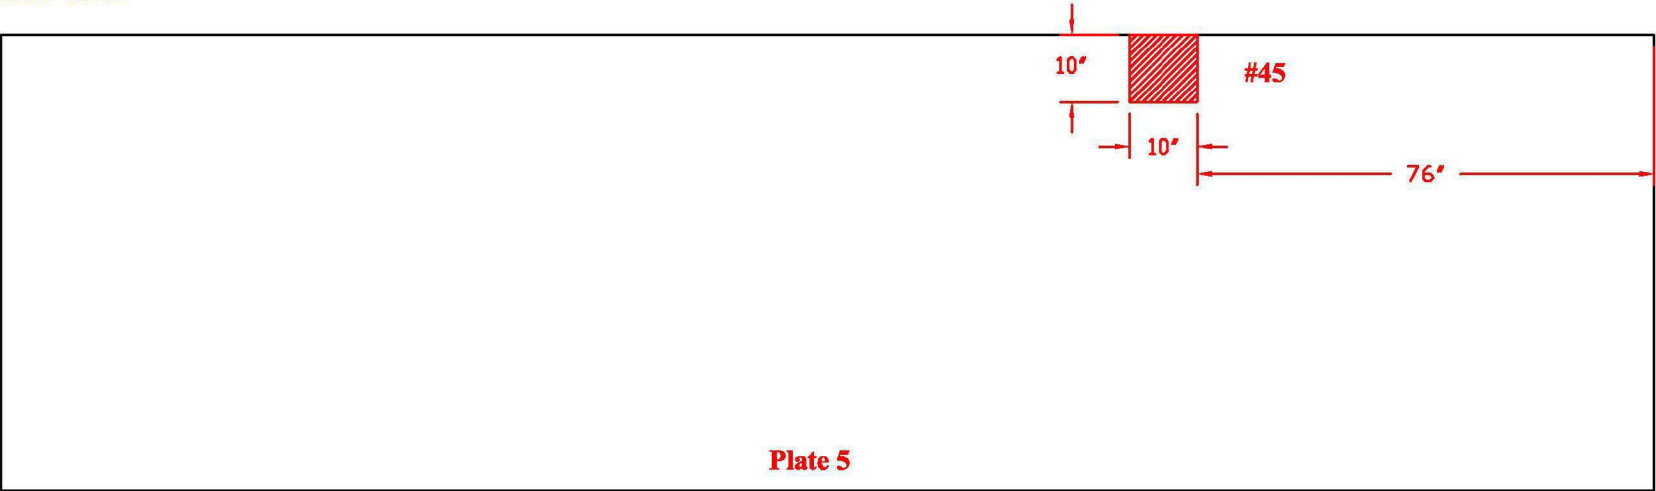
Course: 2  
Plate #: 5  
Flaw # - Type - Remaining:  
#45 - W.L. - .225"

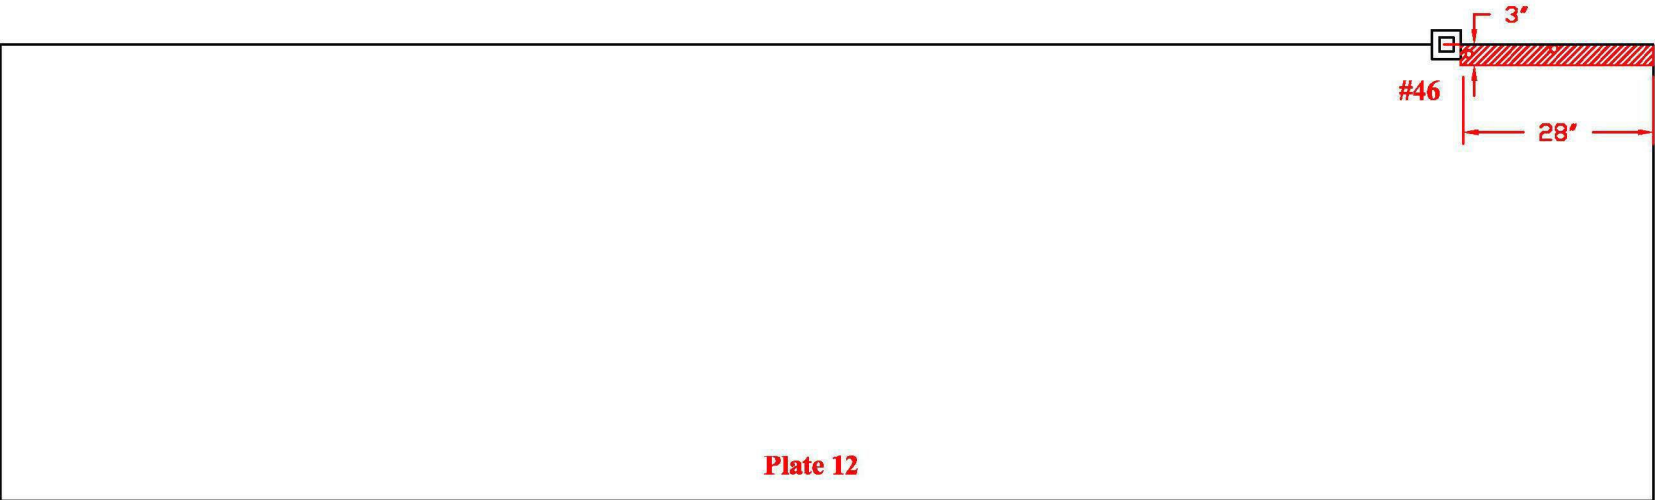
Course: 25  
Plate #: 12  
Flaw # - Type - Remaining:  
#46 - W.L. - .230"

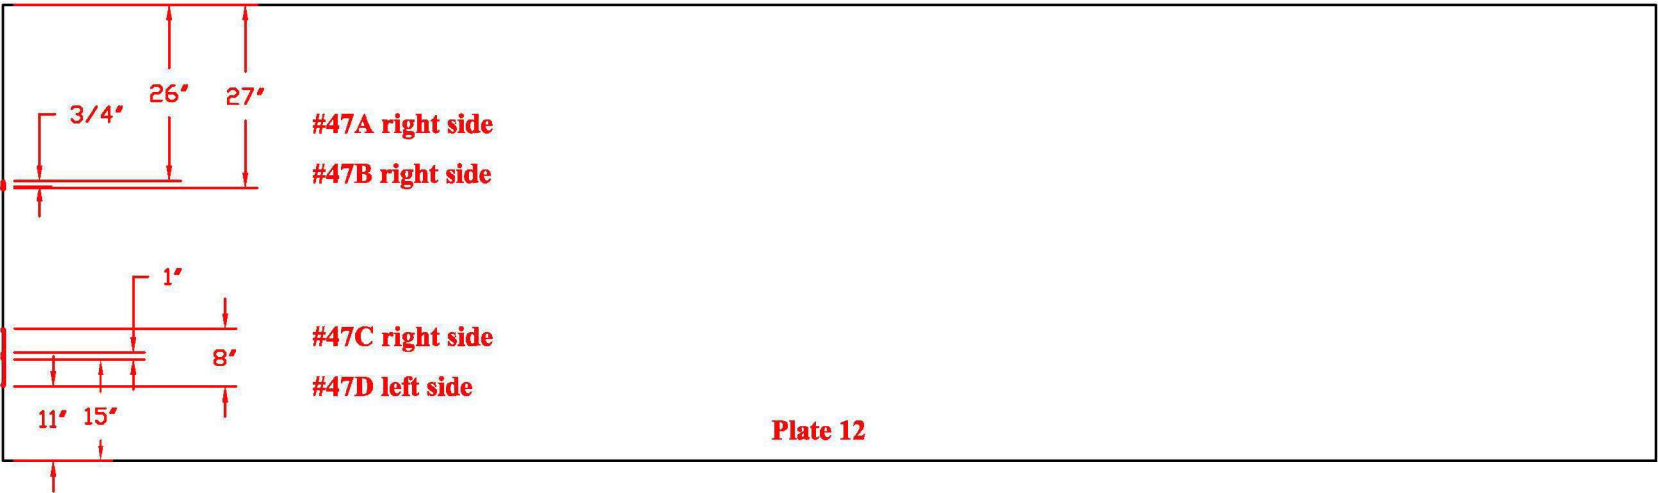
Course: 20  
Plate #: 12

Flaw # - Type - Remaining:  
#47A - Lack of fusion  
.211" depth ¾"long (right)  
#47B - Pin hole  
.088" depth ⅝"dia (right)  
#47C - Lack of fusion  
.219" depth 8"long (right)  
#47C - Lack of fusion  
.221" depth 1"long (left)

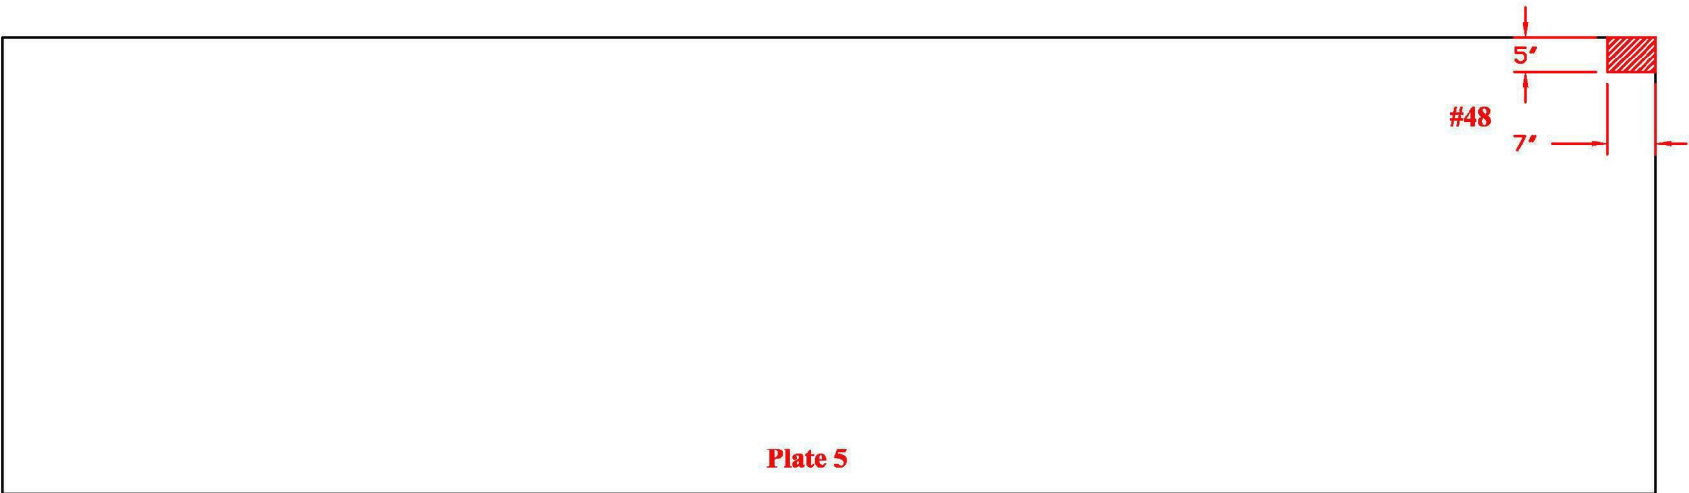
Course: 17  
Plate #: 5

Flaw # - Type - Remaining:  
#48 - W.L. - .232"

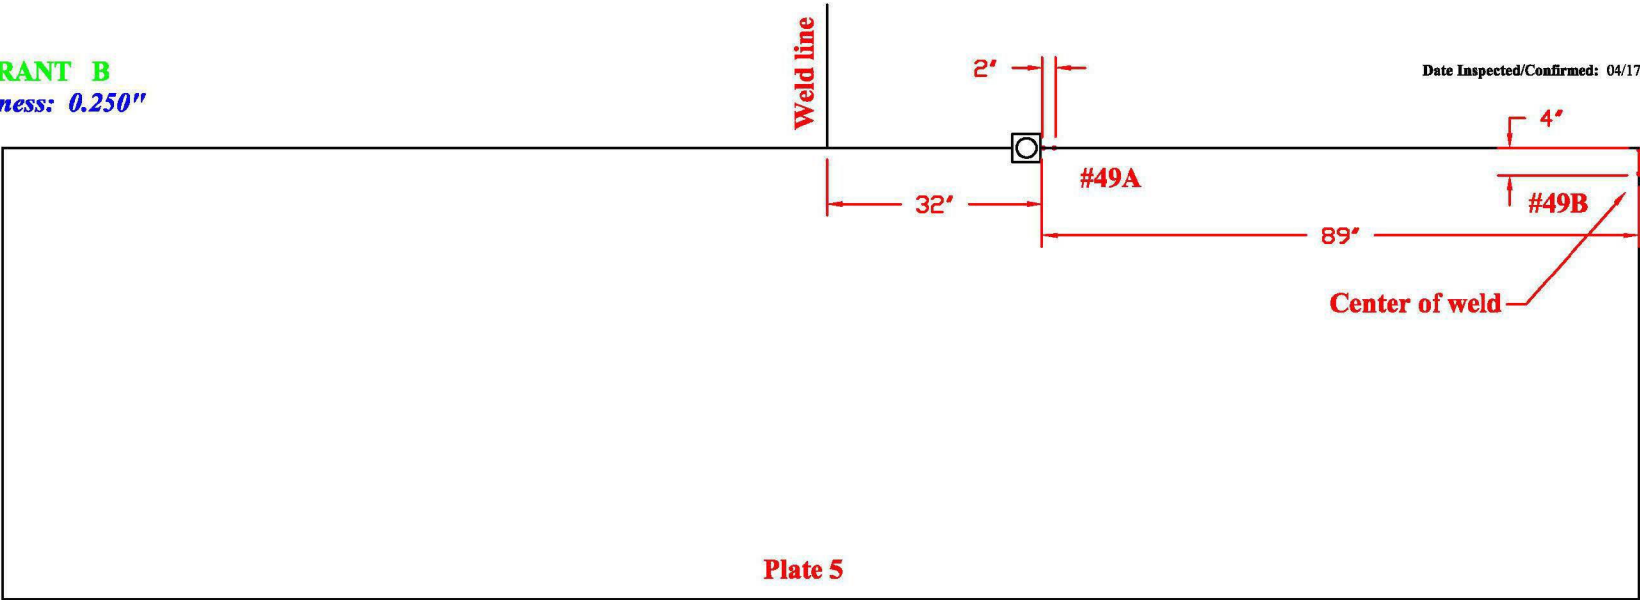
Course: 26  
Plate #: 5

#49A - Slag line  
.114" depth 2"long

#49B - Lack of fusion  
.083" depth 4" long

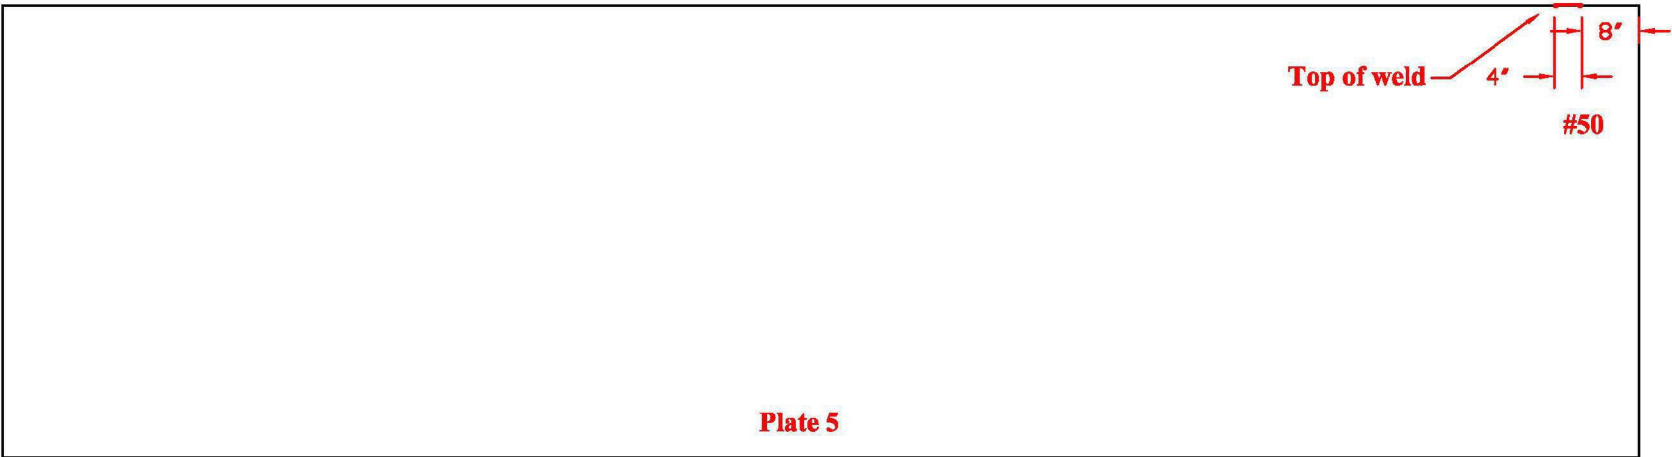
Course: 28  
Plate #: 5

#50 - Lack of fusion  
.104" depth 4" long

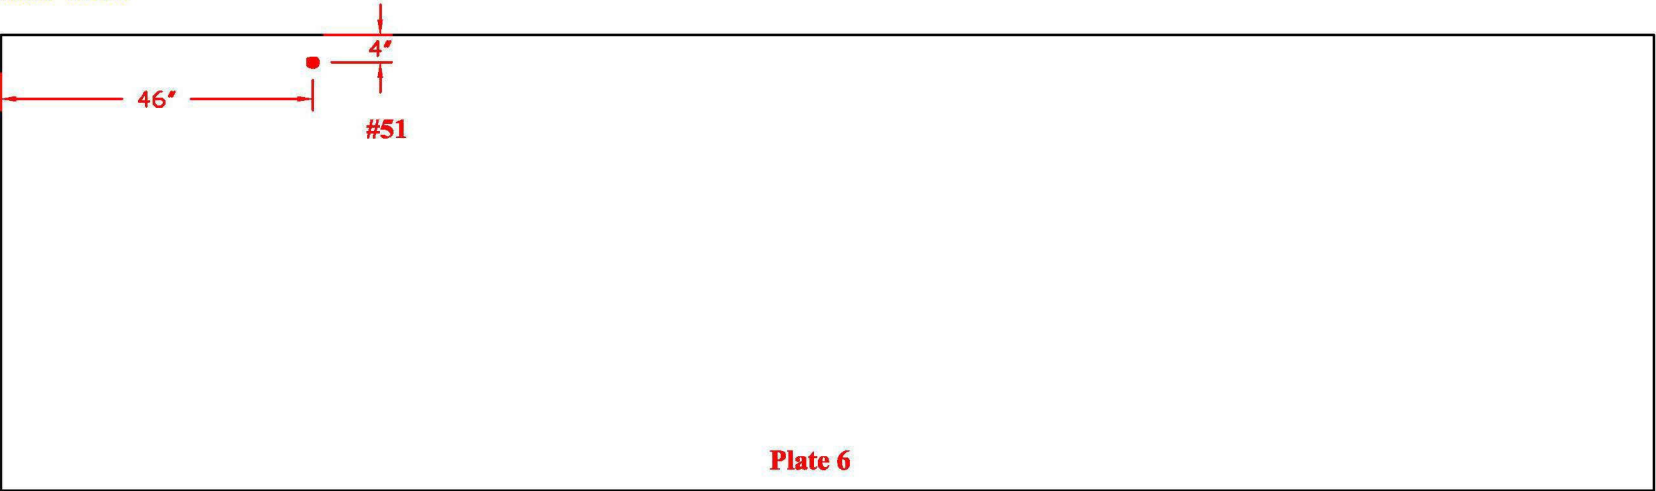
Course: 26  
Plate #: 6

Flaw # - Type - Remaining:  
#51 - W.L./Pit - .220"

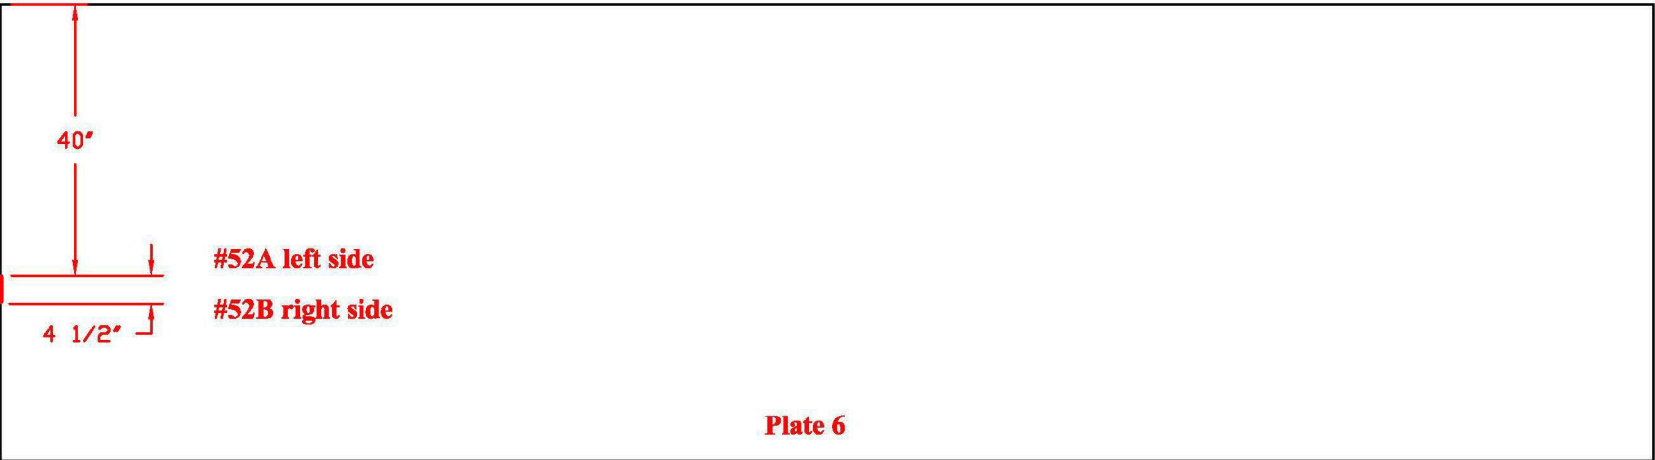
Course: 22  
Plate #: 6

Flaw # - Type - Remaining:  
#52A - Lack of fusion  
.169" depth 4 1/2" long  
(left side)  
#52B - Lack of fusion  
.154" depth 4 1/2" long  
(right side)

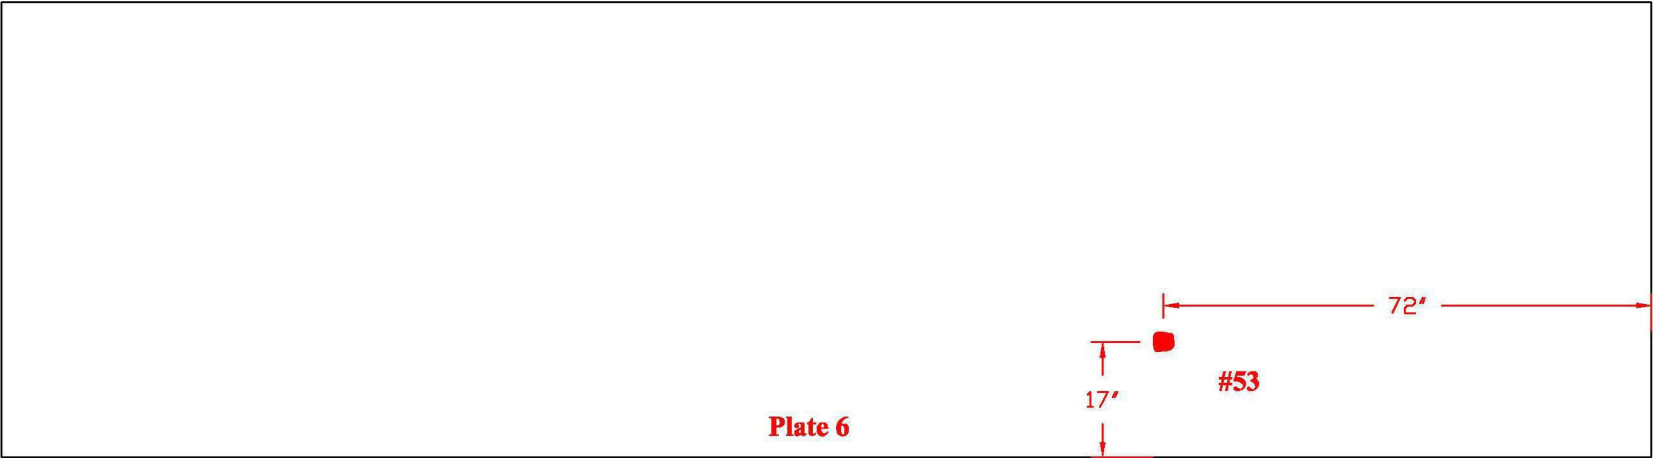
Course: 19  
Plate #: 6  
Flaw # - Type - Remaining:  
#53 - W.L./Pit - .220"

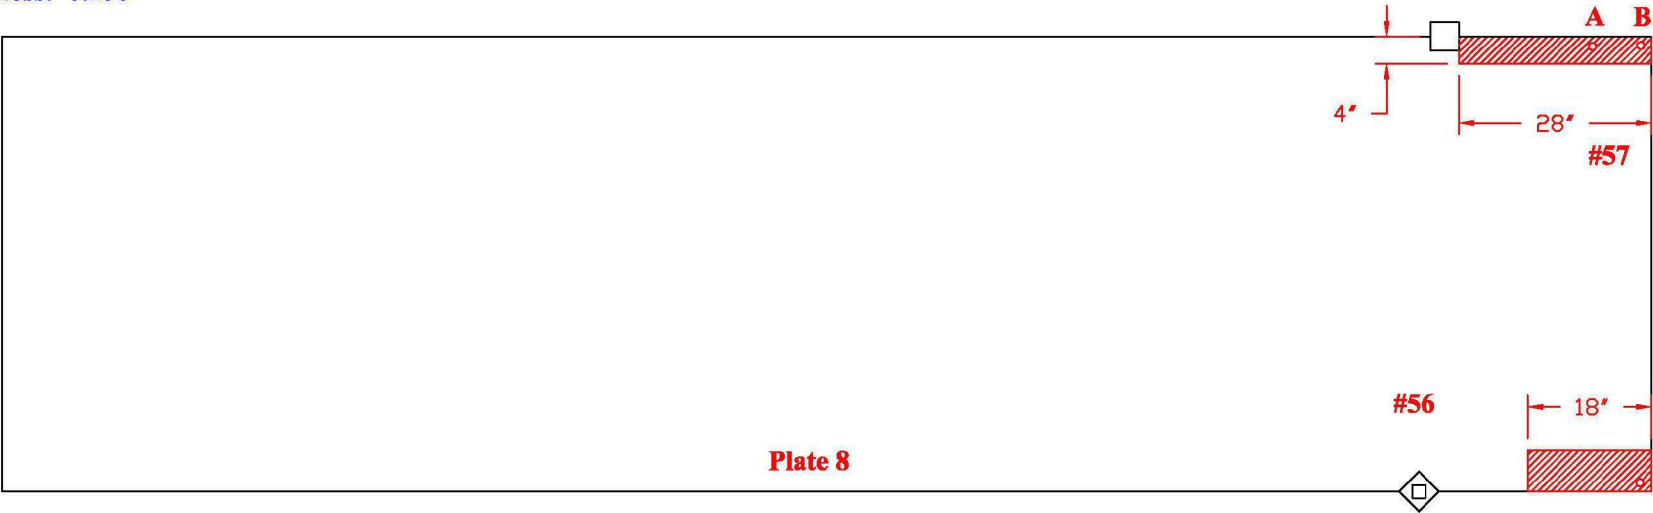
Course: 6  
Plate #: 8  
Flaw # - Type - Remaining:  
#56 - W.L. - .225"  
#57 - W.L. - .229" A  
.231" B

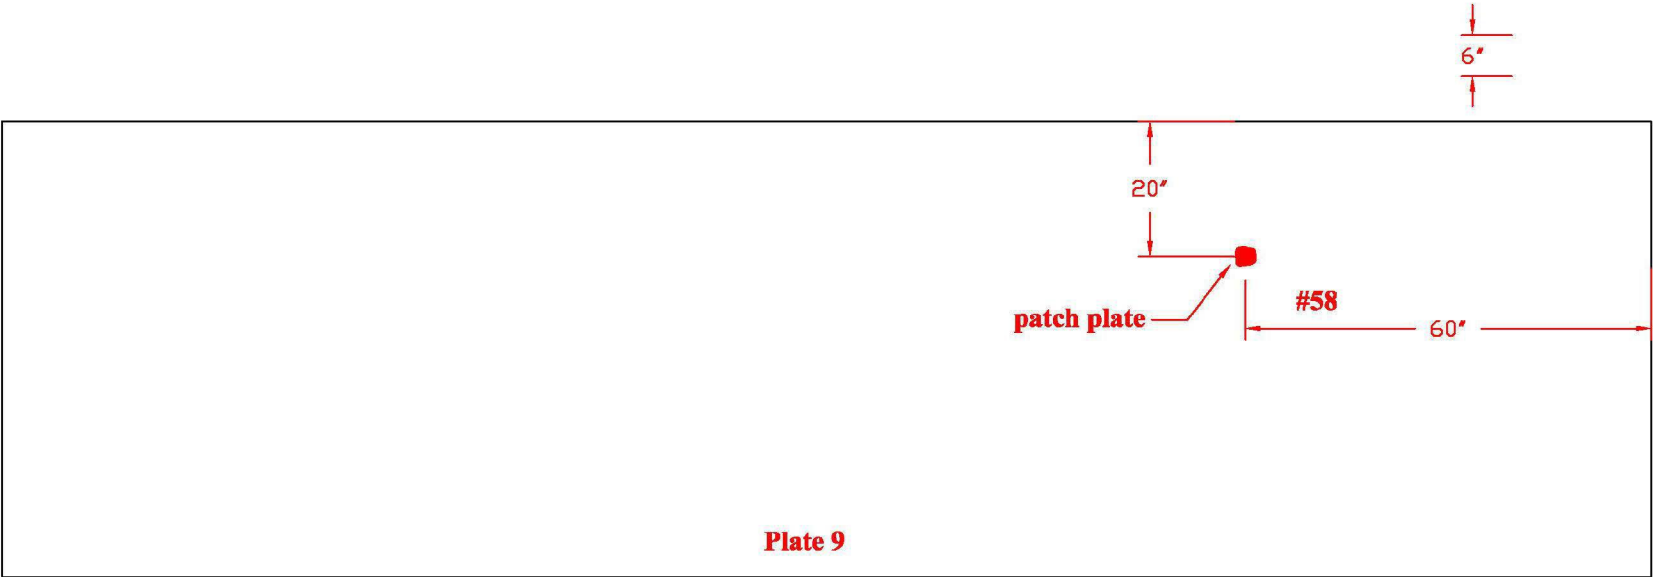
Course: 1  
Plate #: 9  
Flaw # - Type - Remaining:  
#58 - W.L. - .200"  
on patch plate

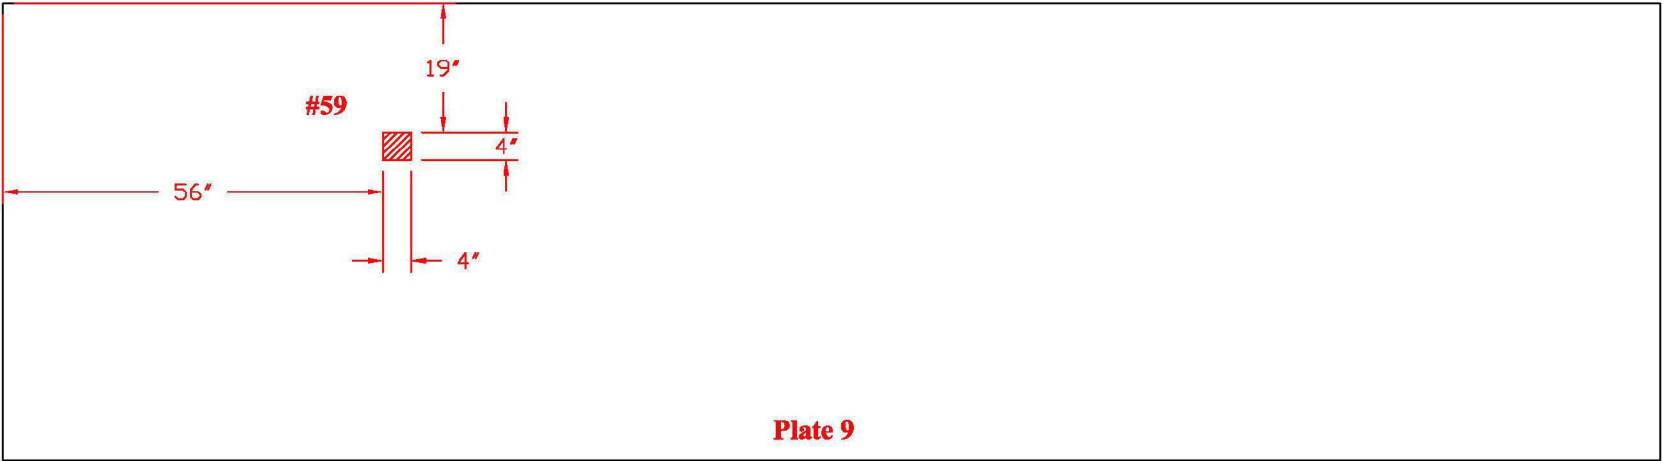
Course: 22  
Plate #: 9

Flaw # - Type - Remaining:  
#59 - W.L. - .186"

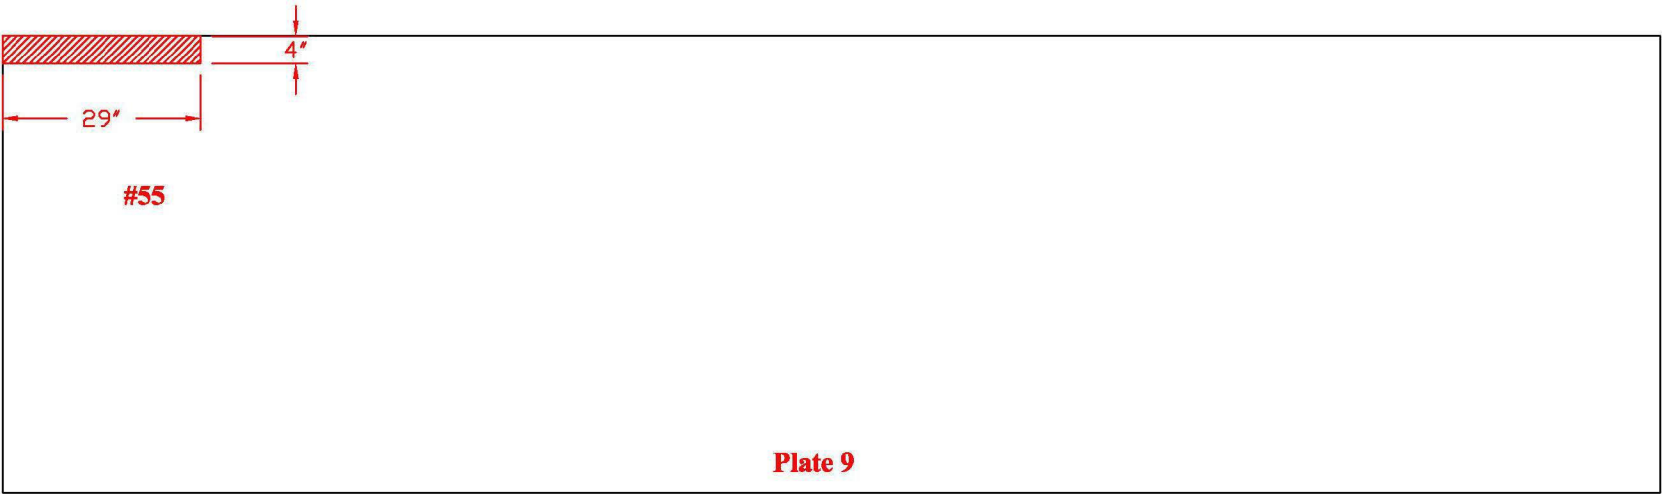
Course: 23  
Plate #: 9

Flaw # - Type - Remaining:  
#55 - W.L. - .228"

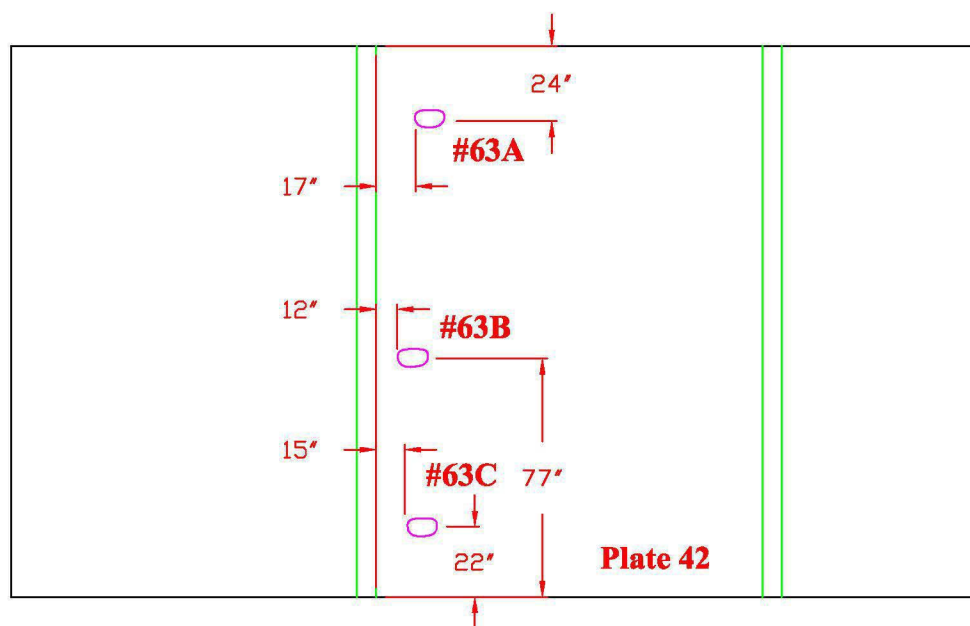
**Tank Section: Upper dome**  
**Quadrant: C**  
**Course: A**  
**Plate: # 42**

**Flaw # 63A - Dent**  
**.130 deep 1½"-2" dia N.S.W.L.**

**Flaw # 63B - Dent**  
**.170 deep 1½"-2" dia N.S.W.L.**

**Flaw # 63C - Dent**  
**.155 deep 1½"-2" dia N.S.W.L.**

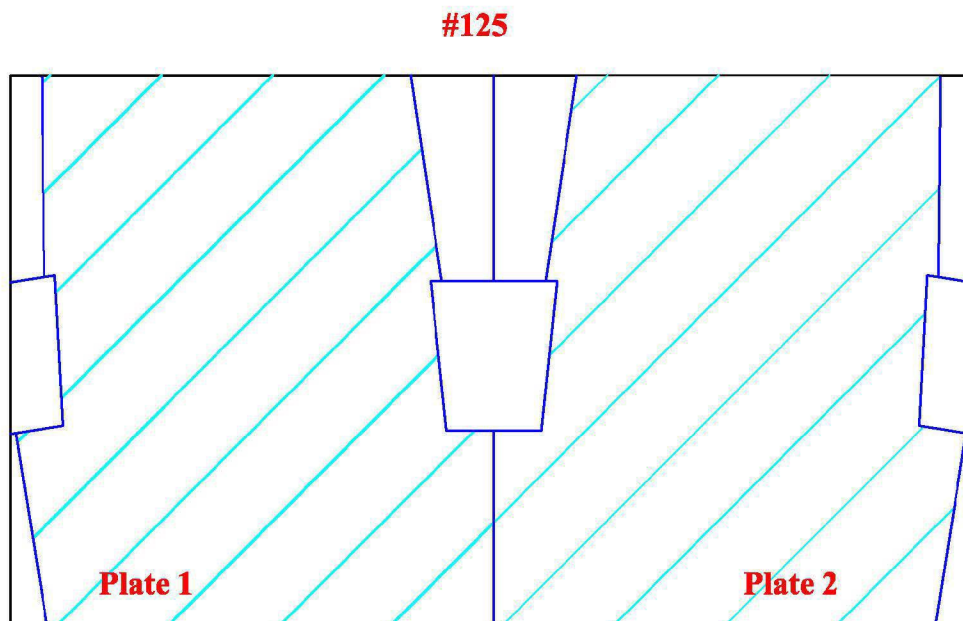
**Tank Section: Lower Dome**  
**Quadrant: A**  
**Course: 1**  
**Plate: # 1-2**

**Flaw # 125 - Bulge - N.S.W.L.**  
Shear wave technique was  
performed on all welds in  
bulge area.

**\* Note: This bulge encompassed  
both plates thru entire lengths.**

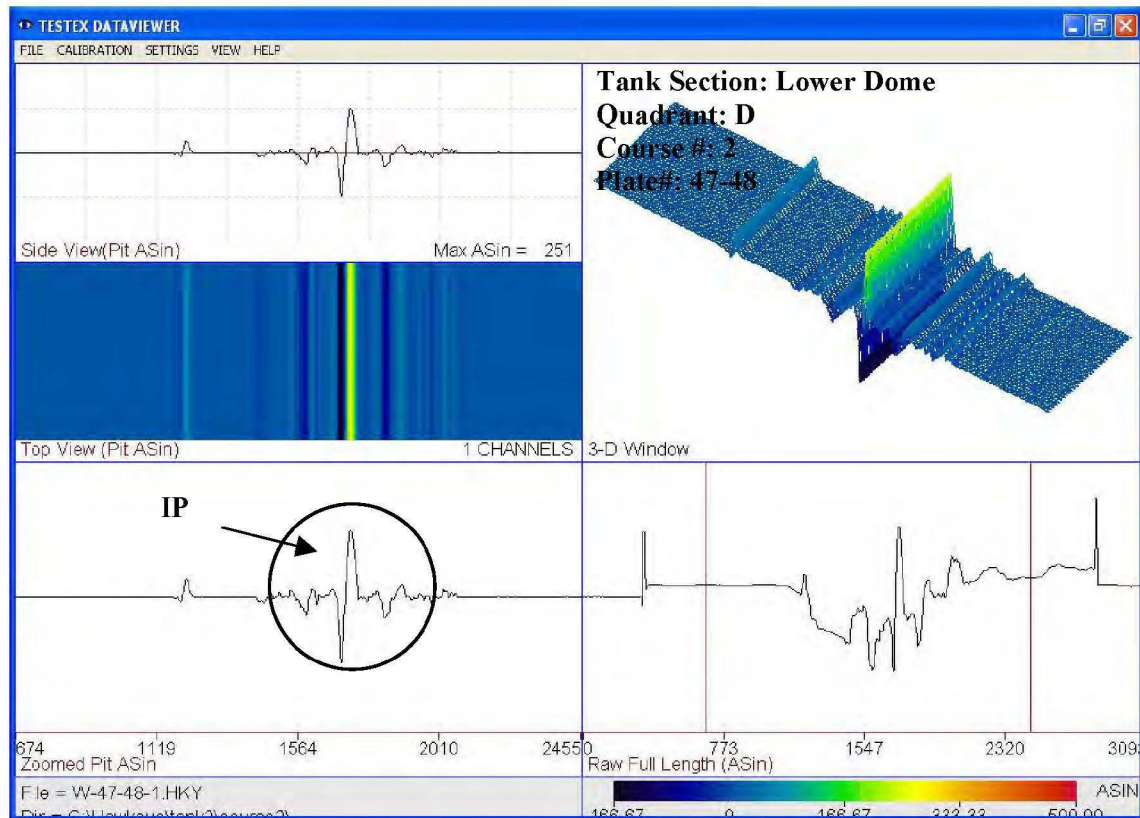
**Flaw # 5B:** The waveform above depicts incomplete penetration on the vertical weld, 1” long, at a depth of .215”.

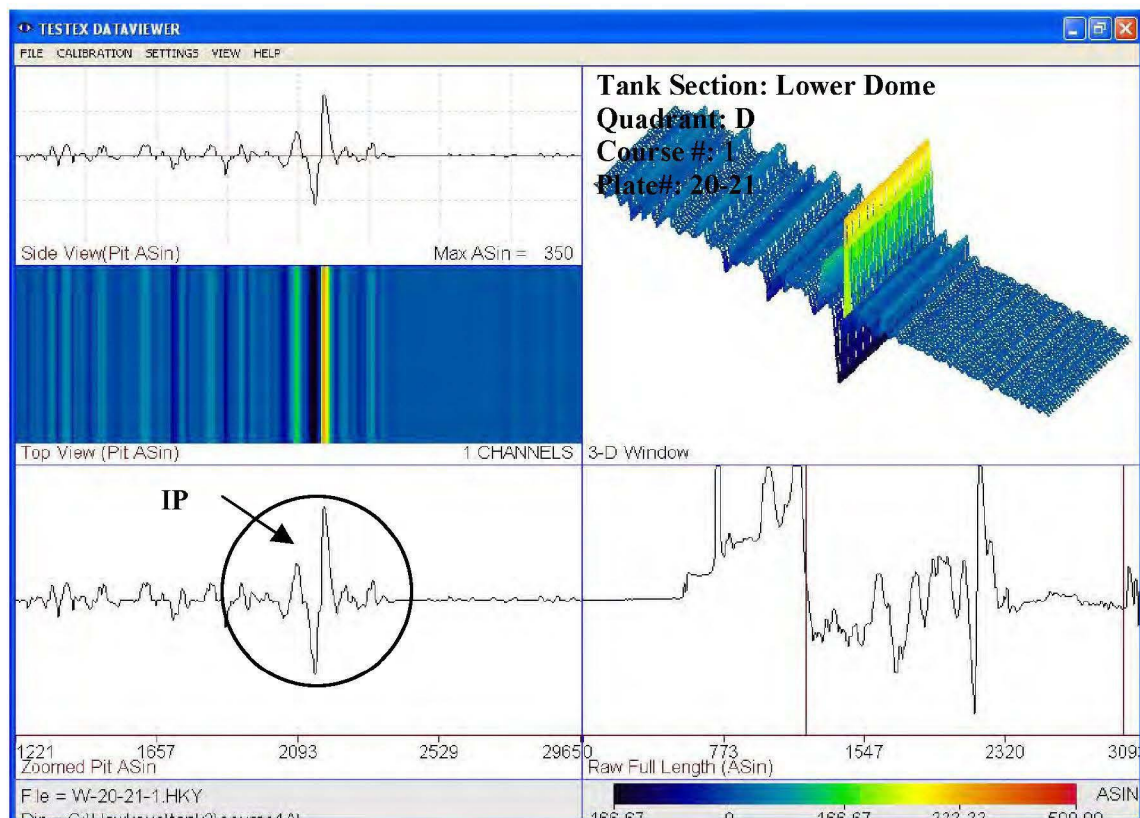
**Flaw # 4A:** The waveform above depicts incomplete penetration on the vertical weld, 1” long, at a depth of .222”.

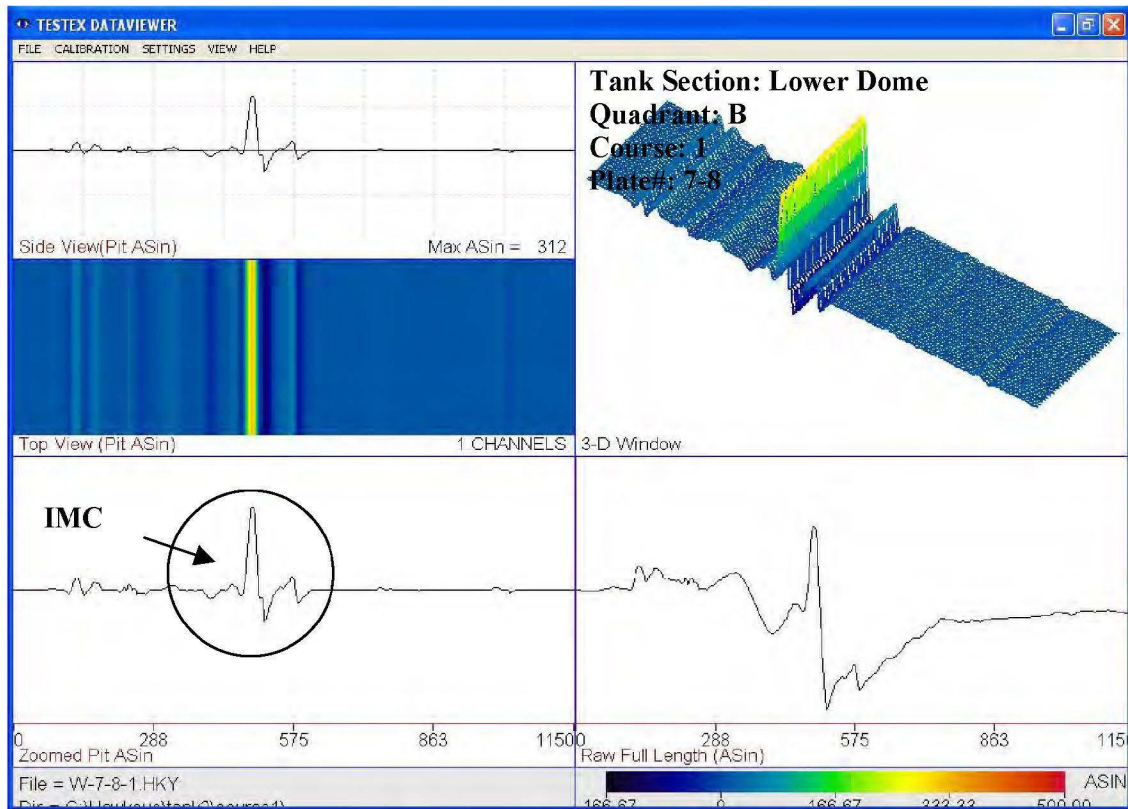
**Flaw # 2A,B:** The waveform above depicts intermittent cracking on both sides of the vertical weld, 10" long, at depths of .229" and .154".

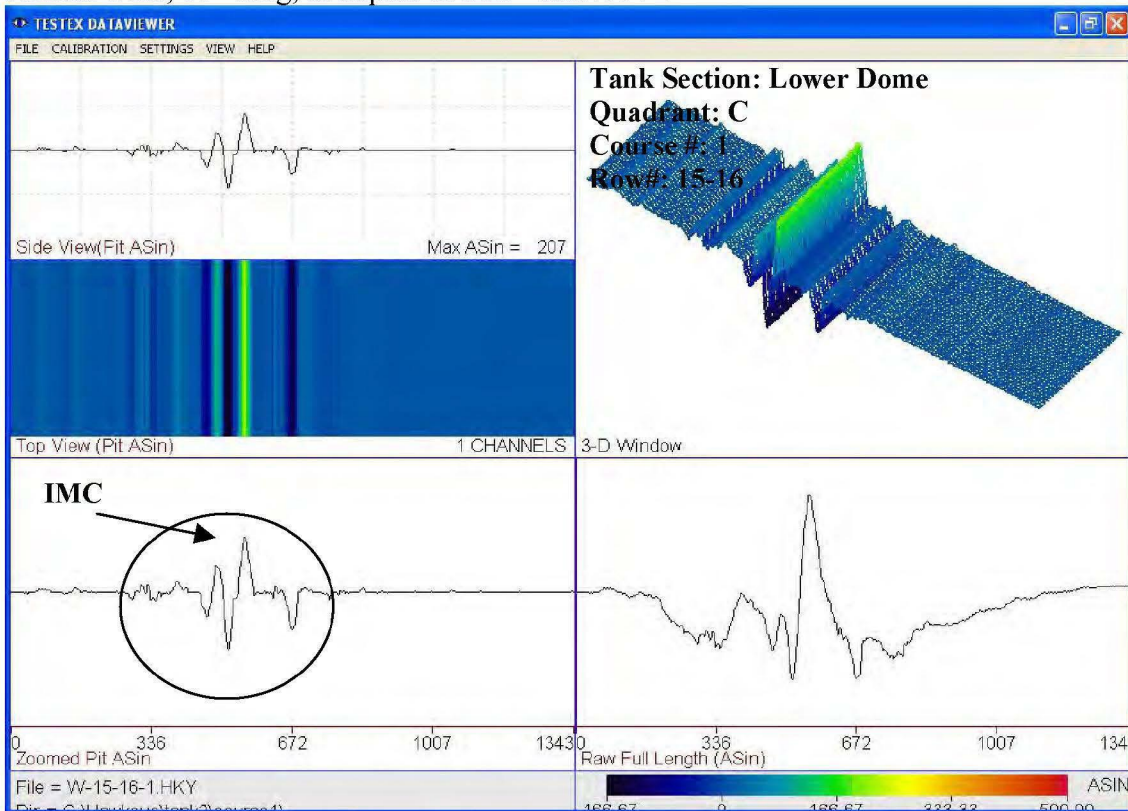
**Flaw # 3A,B:** The waveform above depicts intermittent cracking on both sides of the vertical weld, 10" long, at depths of .223" and .214".

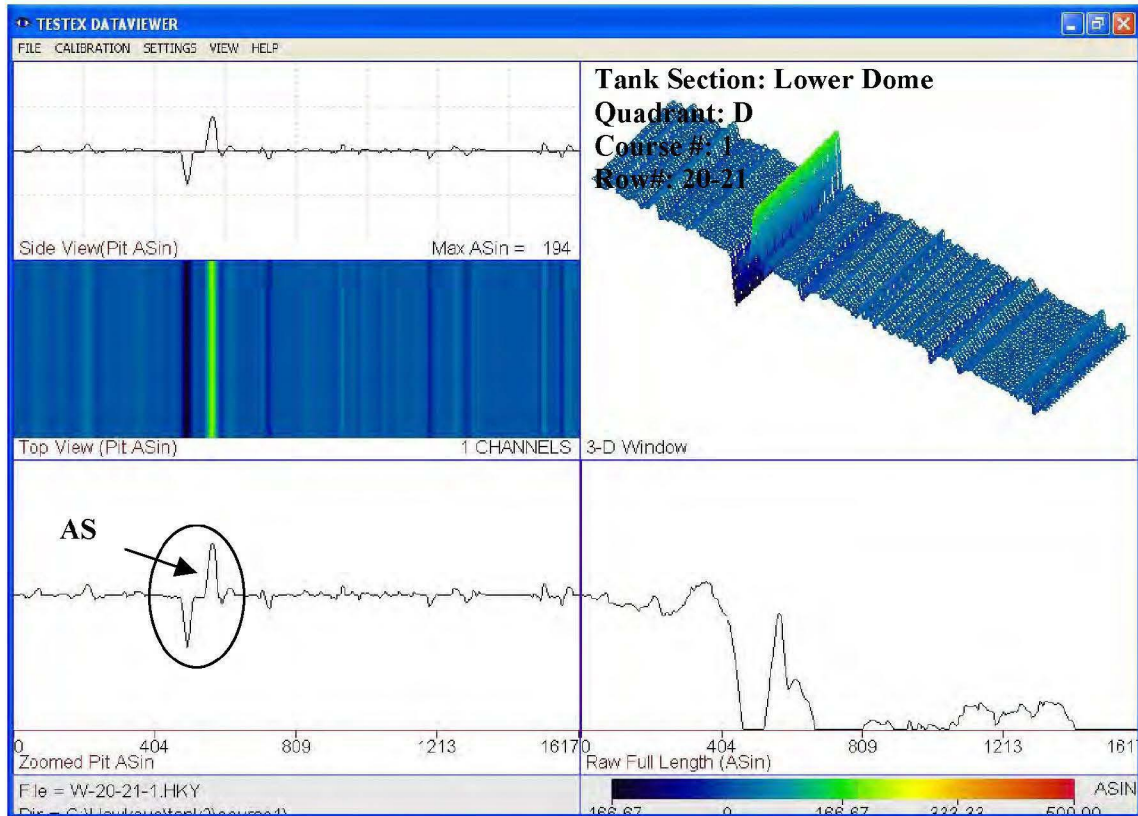
**Flaw # 4B:** The waveform above depicts arc strike at the toe on the vertical weld, 2" long, at a depth of .069".

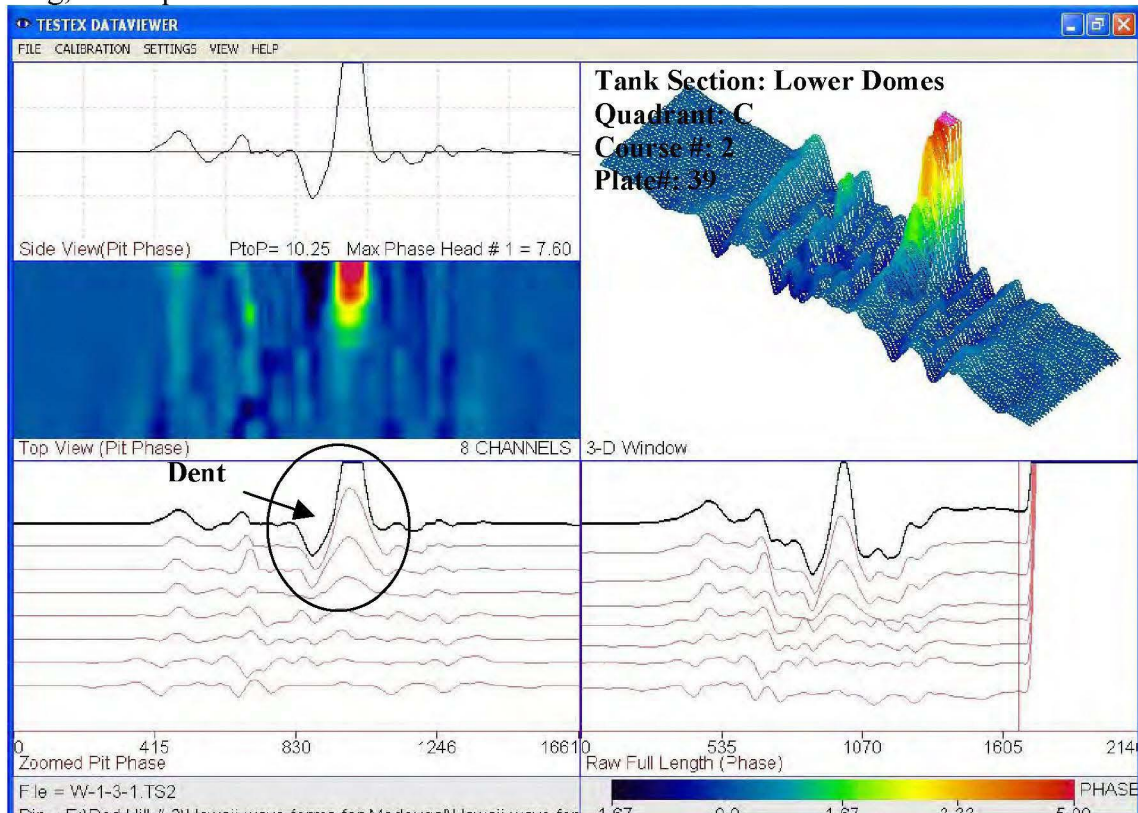
**Flaw # 6:** The waveform above depicts a dent with no significant wall loss (NSWL).

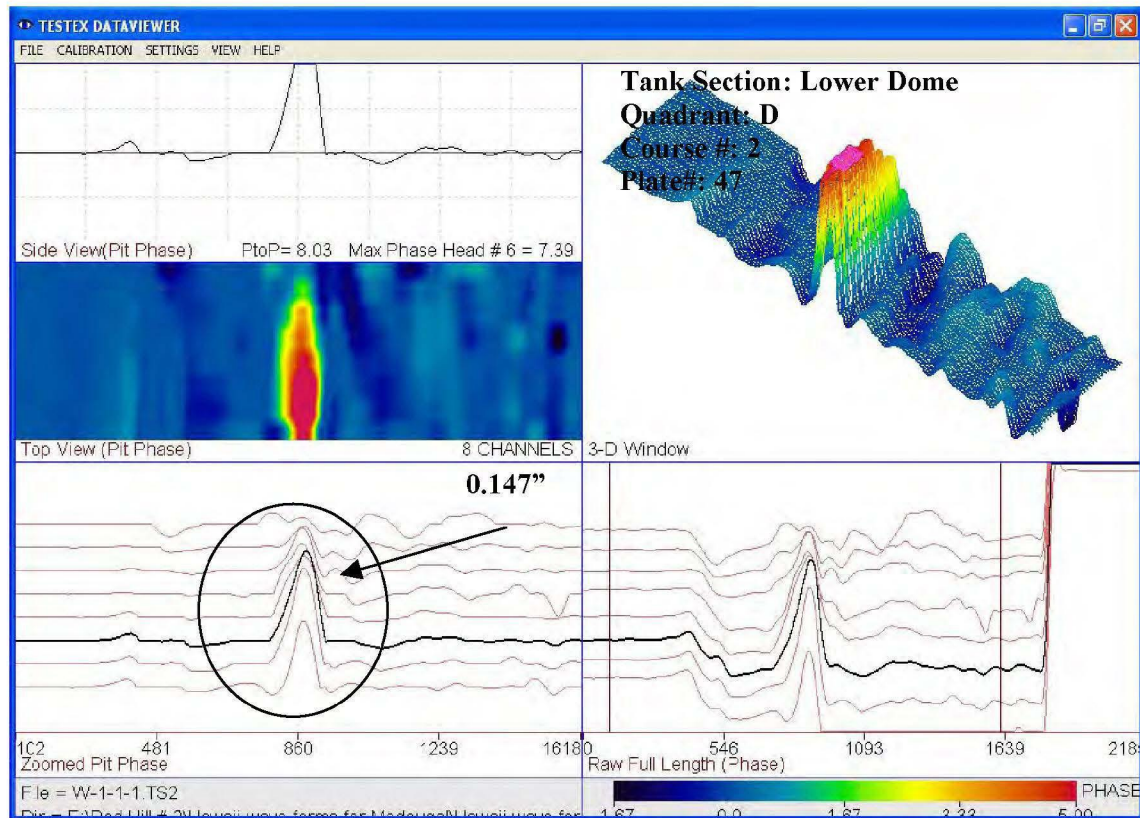
**Flaw # 5A:** The waveform above depicts underside corrosion exhibiting 0.147" wall remaining.

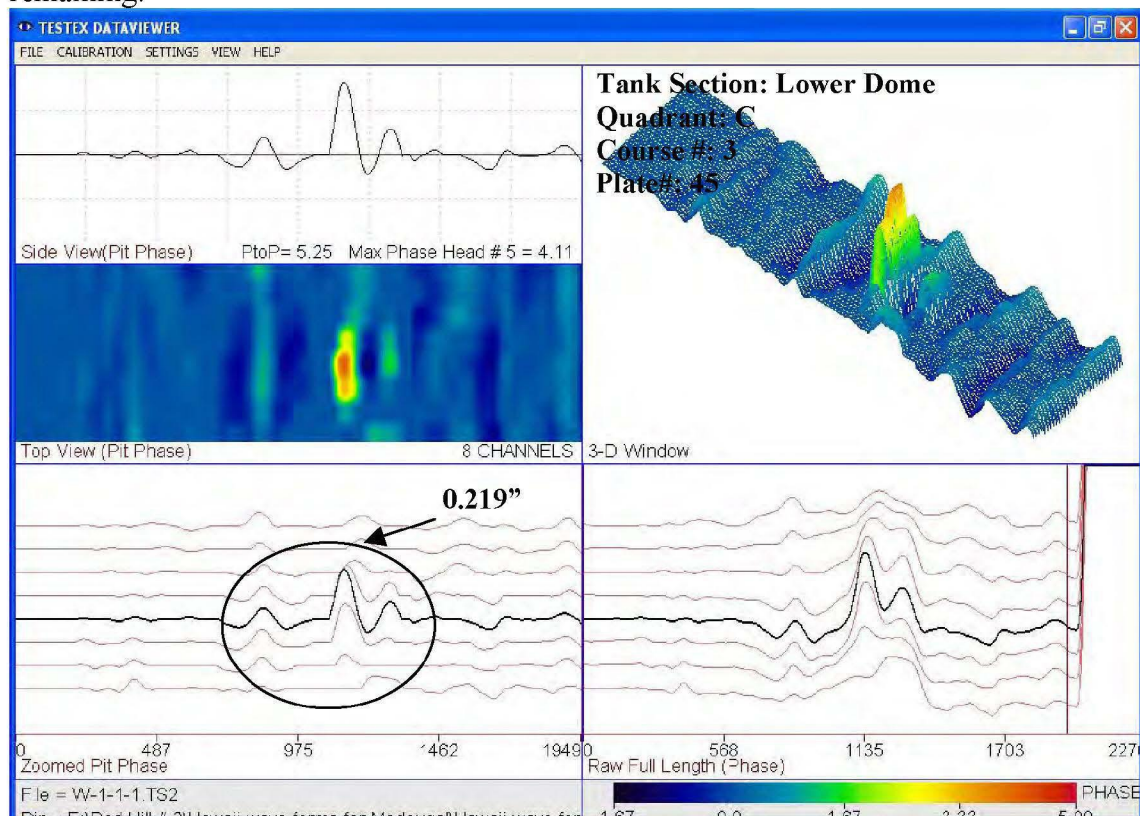
**Flaw # 10:** The waveform above depicts underside corrosion exhibiting 0.219" wall remaining.

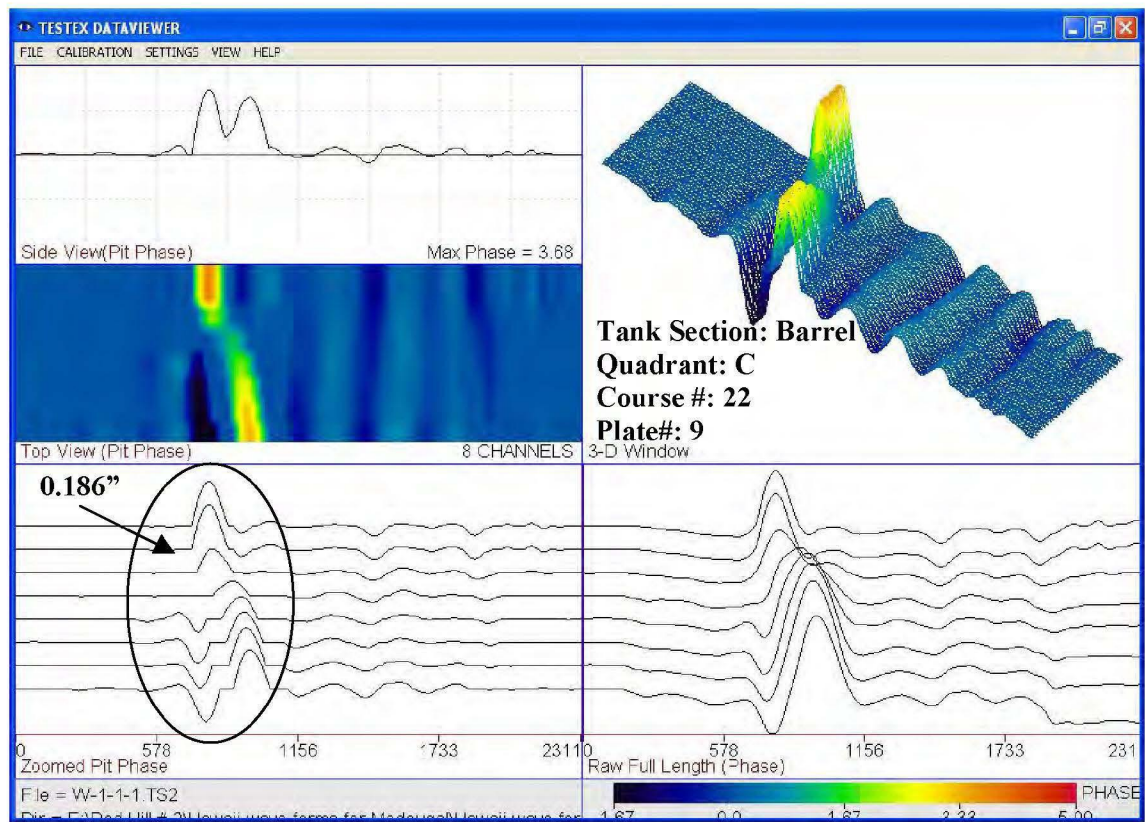
**Flaw # 59:** The waveform above depicts underside corrosion exhibiting 0.186" wall remaining.
