INTRODUCTION

2.1 Mid Atlantic Environmental, Inc. conducted an inspection on Tank #6 at the Red Hill Underground Storage Facility, Pearl Harbor, Hawaii. This inspection was conducted in accordance with the scope of work identified by Contract Number N00604-97-R-0013, PRL 96-21, titled "Emergency Repair for Red Hill Tanks."

| EMERGENCY REPAIRS FOR RED HILL TANKS | |

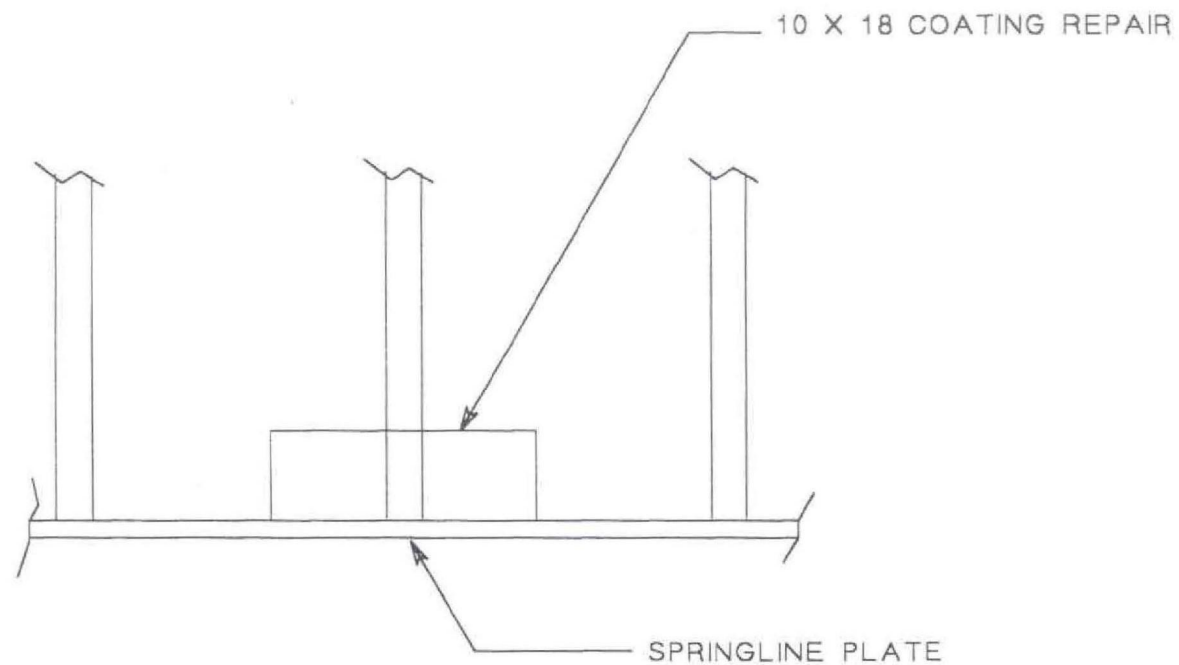
| Repair No.: 001 | File# 001 |

| 1 | | 8 | 180 | | | Upper Dome | D | A | 20 |

TYPE 8 REPAIR

| UPPER DOME | Quadrant: D |
| Course: A | PLATE: 20 |

| REPAIR TYPE # | TYPE OF DAMAGE | REPAIR PROCEDURE<br>(SEE NOTE 4) | APPROX. SIZE |
|---|---|---|---|
| 8 | COATING FAILURE | REMOVE COATING TO BARE METAL, RECOAT. | 1.0 SQ. M. |

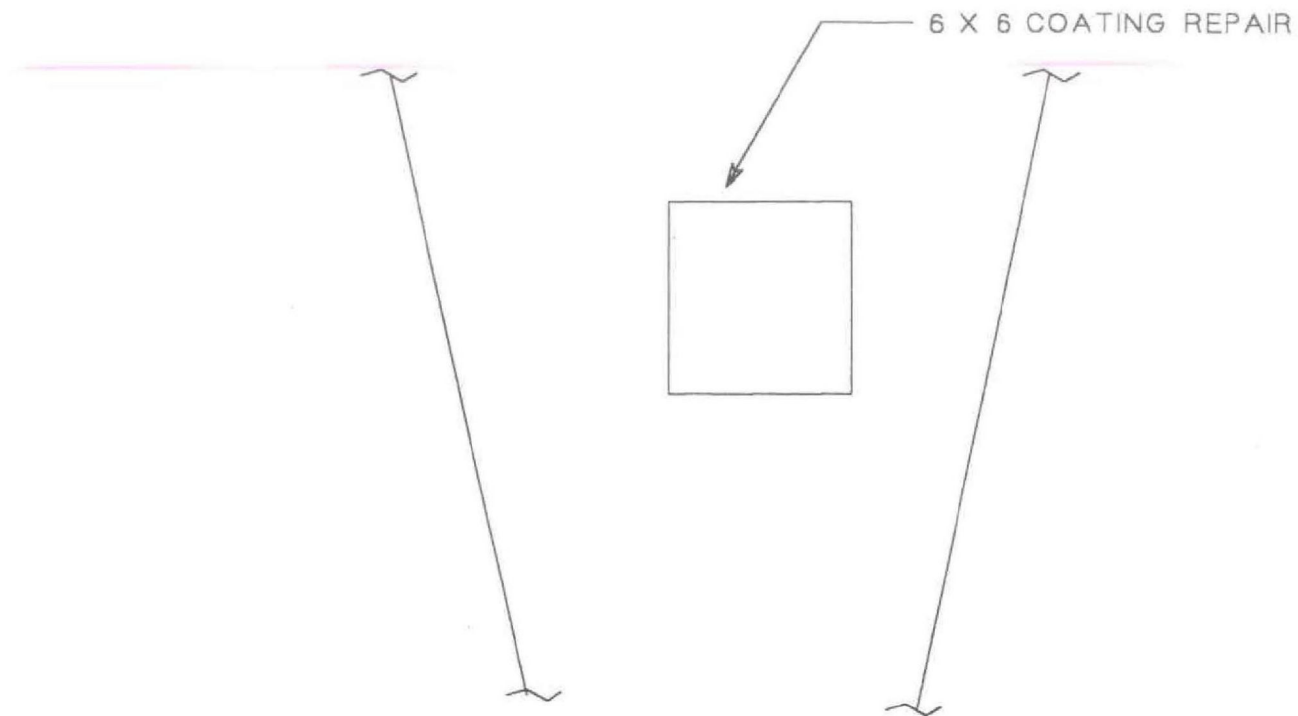
| Repair No.: 002 | File: 6r002 |

| 2 | | 8 | 36 | | | Lower Dome | D | 2 | 19 |

TYPE 8 REPAIR

| LOWER DOME | Quadrant: D |
| Course: 2 | PLATE: 19 |

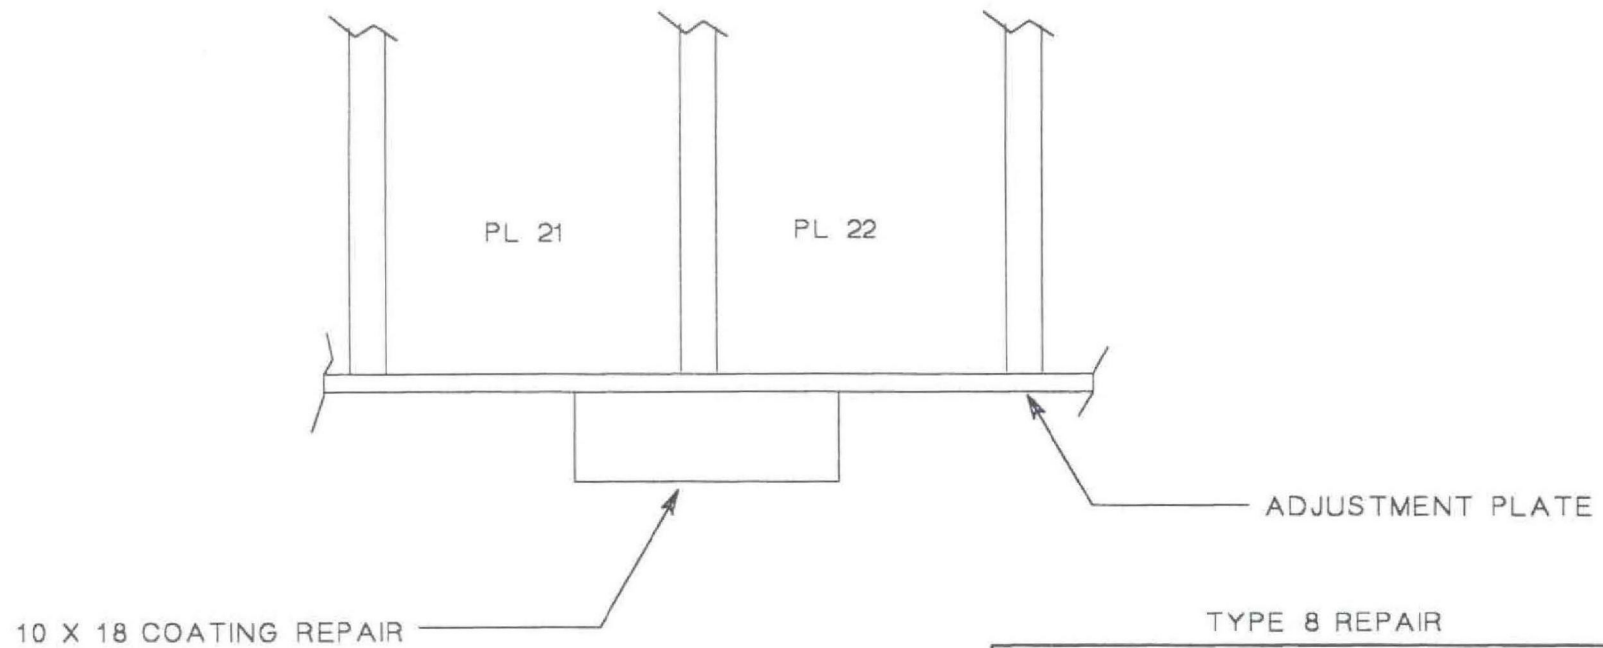
| Repair No.: 003 | File#r003 |

| 3 | | 8 | 180 | | | Upper Dome | D | EXT | 21&22 |

TYPE 8 REPAIR

| UPPER DOME | Quadrant: D |
| Course: EXTENSION | PLATE: 21 & 22 |

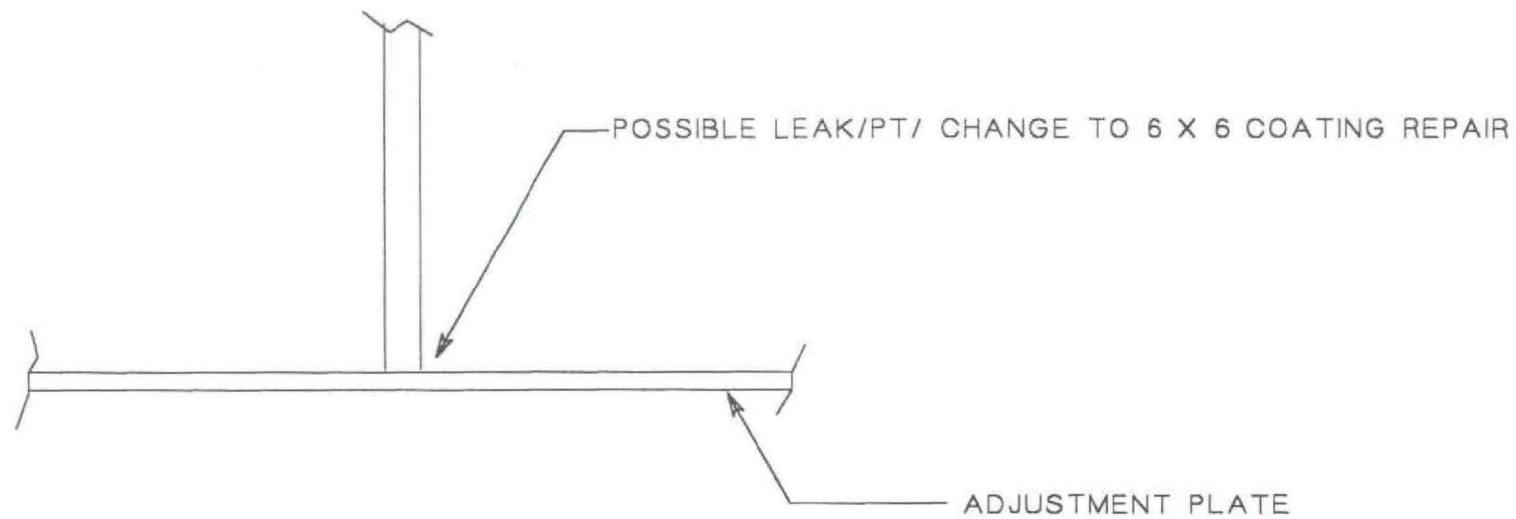
| Repair No.: 004 | File: 6R004 |

| 4 | | 8 | 36 | | | Upper Dome | D | EXT | 16 |

TYPE 8 REPAIR

| UPPER DOME | Quadrant: D |
| Course: EXTENSION | PLATE: 16 |

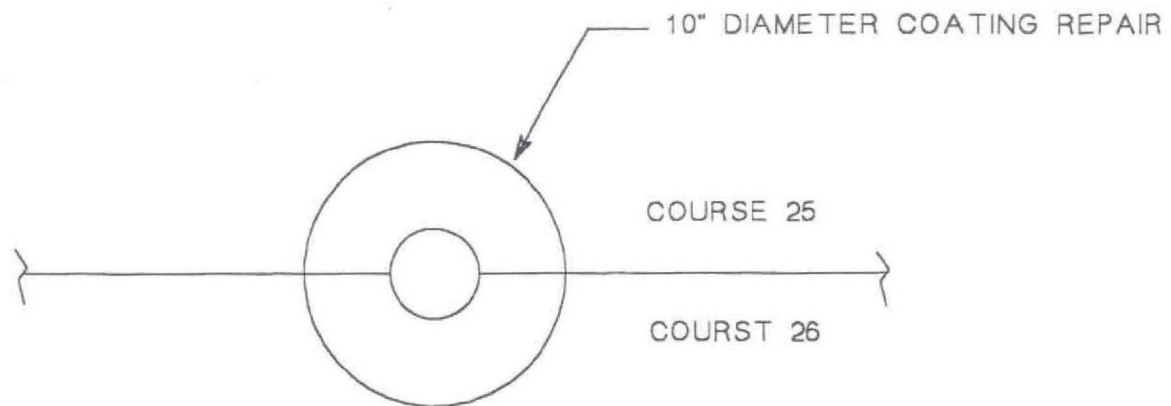
| Repair No.: 005 | File: 6R005 |

| 5 | | 8 | 80 | | | Cylinder | C | 25 & 26 | 13 |

TYPE 8 REPAIR

| CYLINDER | Quadrant: C |
| Course: 25 & 26 | PLATE: 13 |

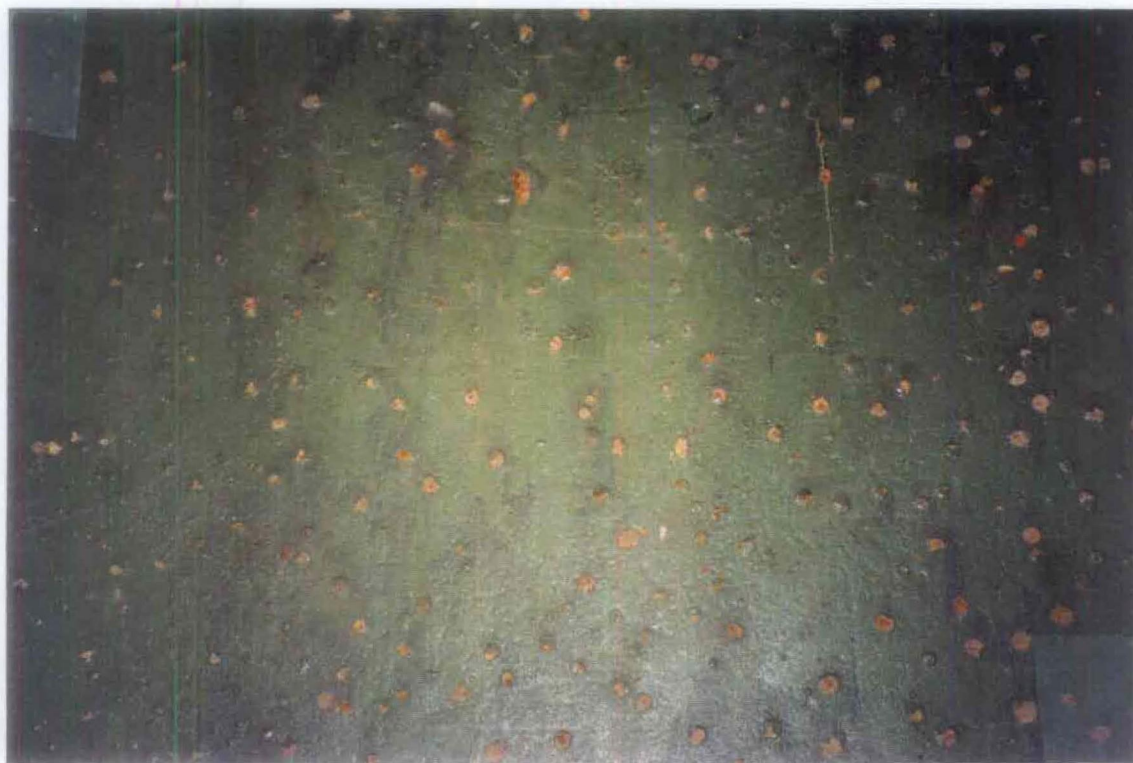
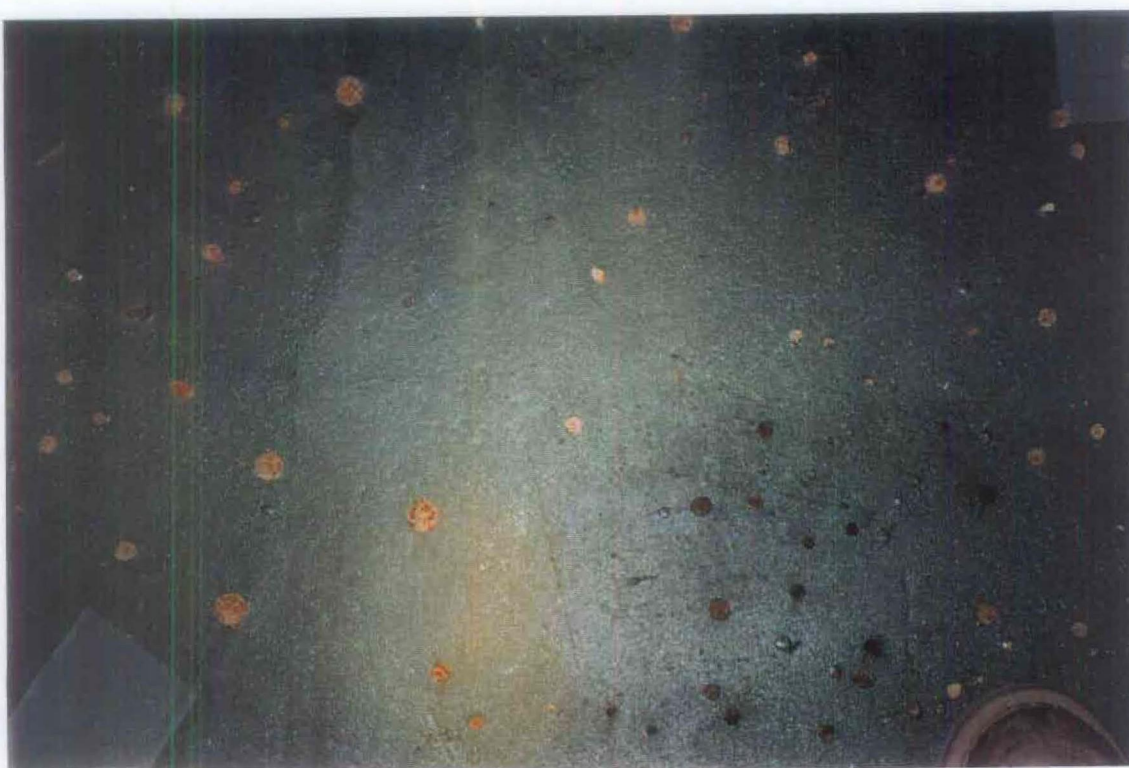
7.1.2 Blisters in the coating of the lower dome was widespread. Because these defects would require work outside the scope of work for this contract, they were ignored for the time being. Pictures of these blisters are included with this report.

**PICTURES OF BLISTERS IN COATING OF LOWER DOME**
