Underground Storage Tank System Evaluation Final Report

Red Hill Bulk Fuel Storage Facility Joint Base Pearl Harbor-Hickam

June 2017

Date of Report: June 13, 2017

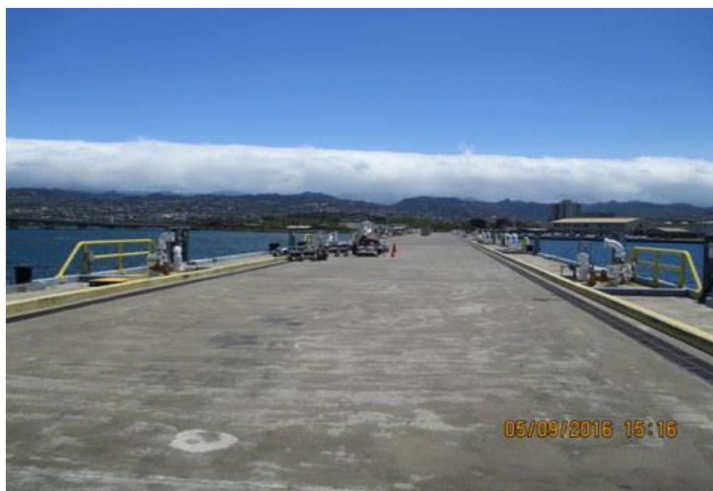
Figure 2. Overview Photo of the Hotel Pier

ERG observed multiple visible and audible alarms on the Hotel Pier, but did not test the alarms during the evaluation.

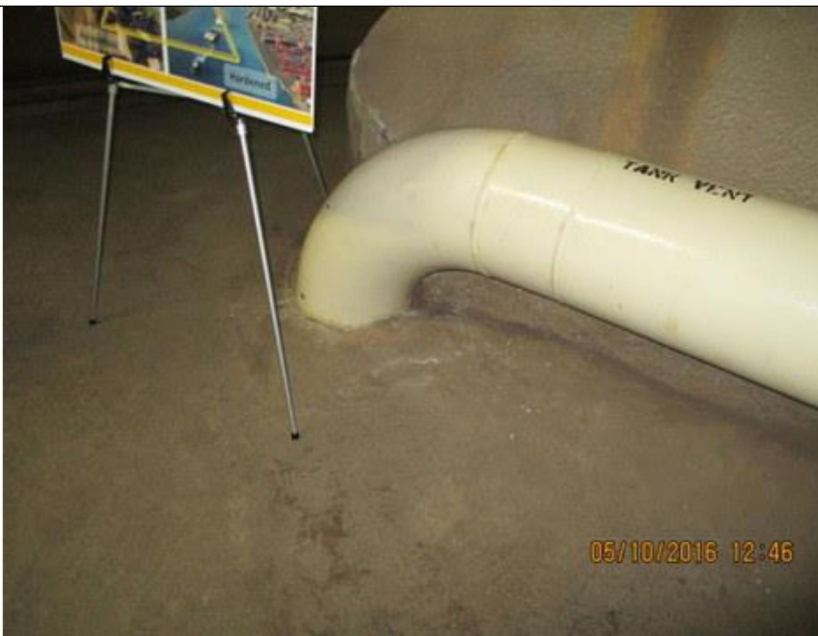
DATE TAKEN: 5/10/2016	
TAKEN BY: Chris Krejci	SITE LOCATION: Red Hill Facility
PHOTO #: 34	
COMMENTS: Minor cracking in tunnel floor

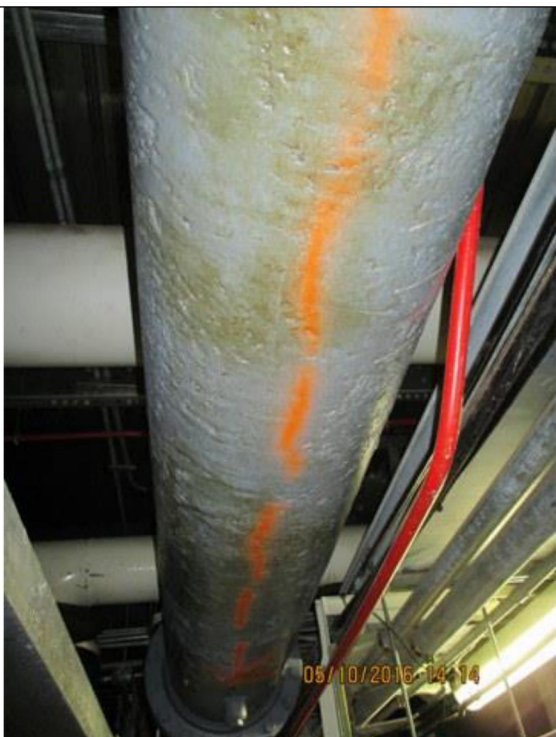
DATE TAKEN: 5/10/2016	
TAKEN BY: Chris Krejci	SITE LOCATION: Red Hill Facility
PHOTO #: 43	
COMMENTS: Typical surface defects on pipeline

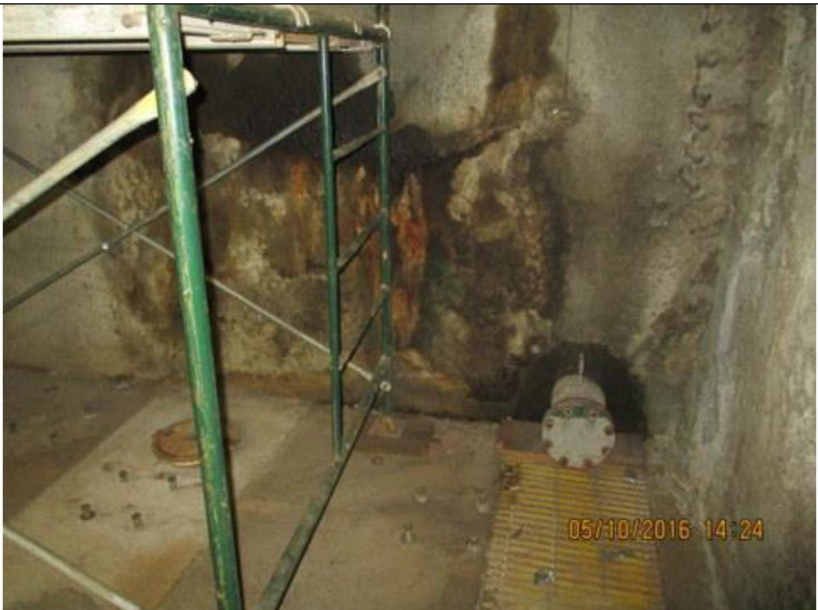
DATE TAKEN: 5/10/2016	
TAKEN BY: Chris Krejci	SITE LOCATION: Red Hill Facility
PHOTO #: 44	
COMMENTS: Staining on Tank 5, just below and to the right of the nozzle.

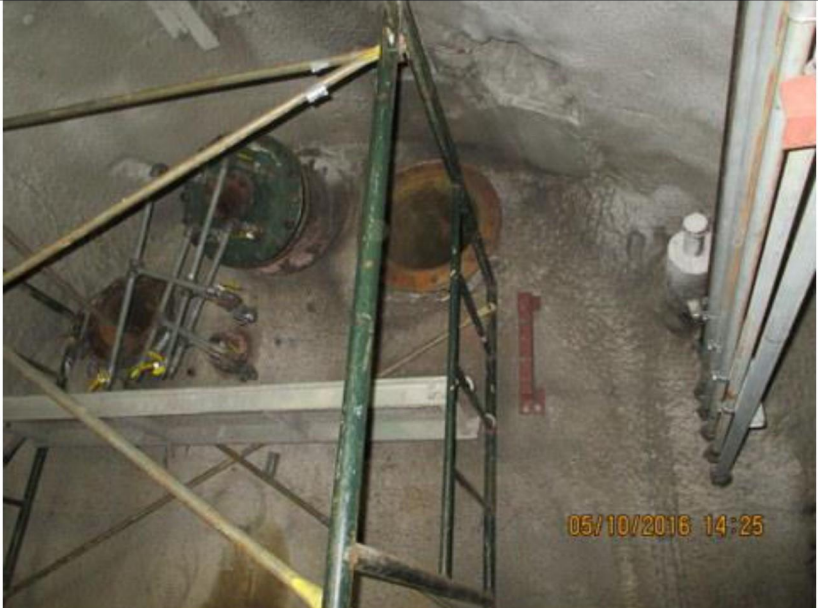
DATE TAKEN: 5/10/2016	
TAKEN BY: Chris Krejci	SITE LOCATION: Red Hill Facility
PHOTO #: 46	
COMMENTS: Staining on tunnel wall (appearance similar to bunker oil)

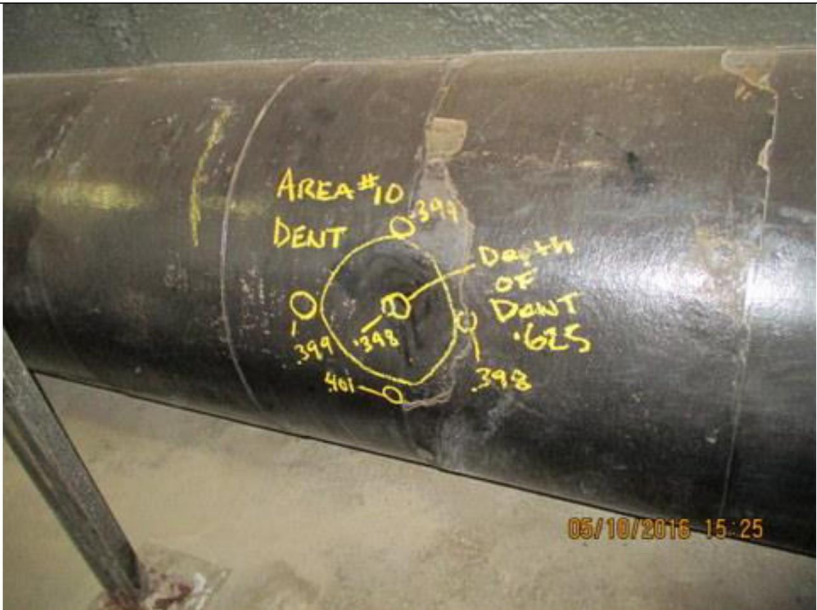
DATE TAKEN: 5/10/2016	
TAKEN BY: Chris Krejci	SITE LOCATION: Red Hill Facility
PHOTO #: 56	
COMMENTS: Markings describing pipe defects
