## Report On Tank 15 Phase 2 As Built Repairs

March, 2006

Dunkin & Bush, Inc.

**CONTRACT NUMBER N62742-03-C-1402**  
**CLEAN AND REPAIR TANKS 1, 6, 15, AND 16, AT RED HILL**  
**FLEET AND INDUSTRIAL SUPPLY CENTER, PEARL HARBOR, HAWAII**

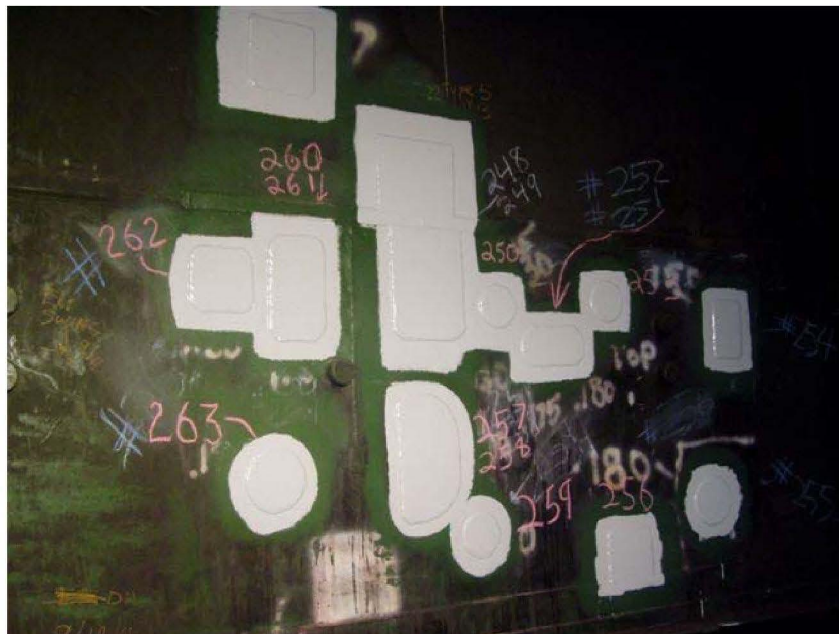
89 repairs covering 104 flaws are described in the table. Each phase 2 repair has been assigned a Dunkin & Bush repair number from 15074 to 15162. Dunkin & Bush also assigned a unique number to each of the flaws identified for repair by Weston to keep them in sequence. The Dunkin & Bush assigned flaw numbers can be seen in repair photographs.

Typical patch plate repairs (note the Dunkin & Bush assigned flaw numbers)

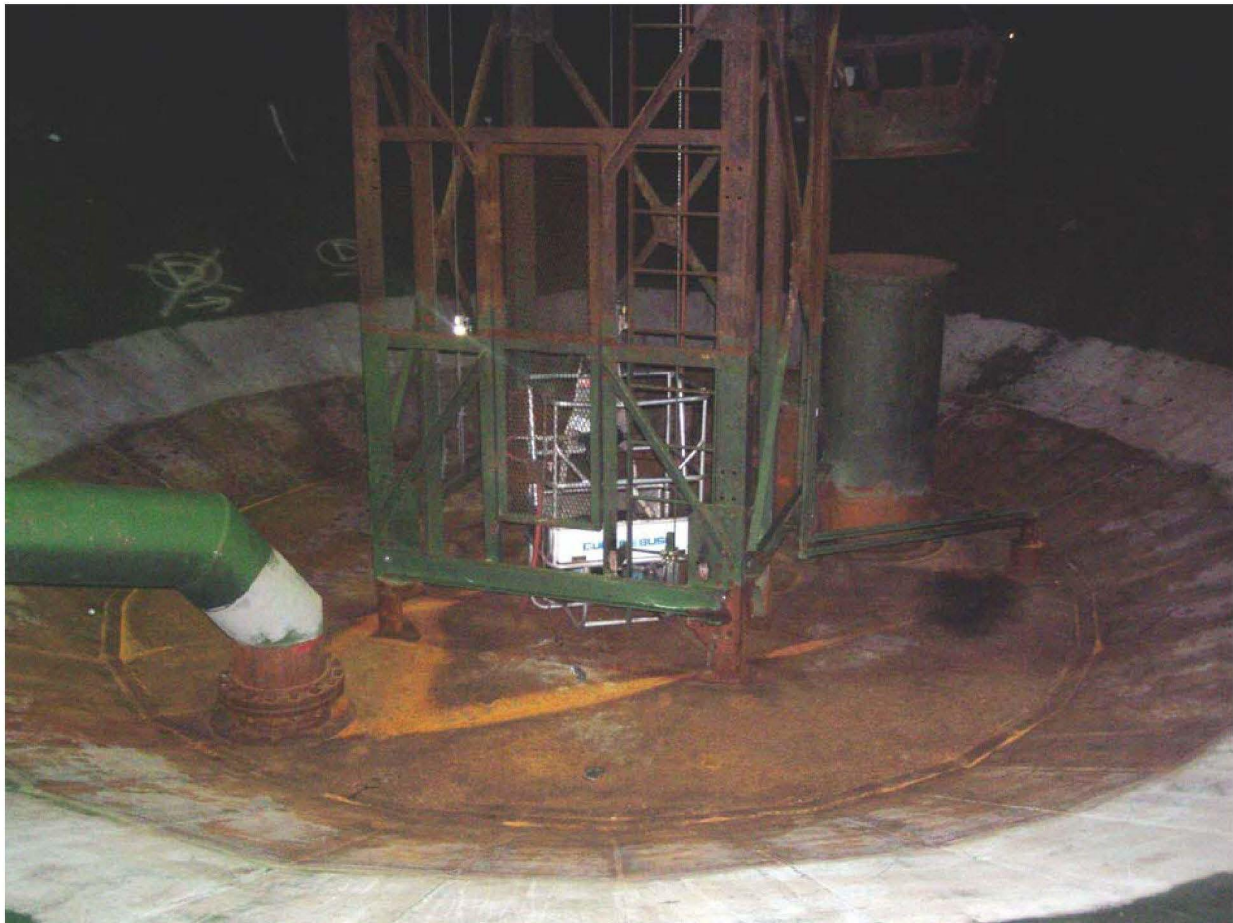
Tank 15 bottom after anchors and clips were removed. Also note where the elevator landing platform and steps were removed from the facing side of the tower structure.

Unused anchors, clips, and angles were removed from the tank bottom as recommended by Weston Solutions. Areas where these attachments were removed were ground smooth and vacuum box tested (if removed from the bottom plates).

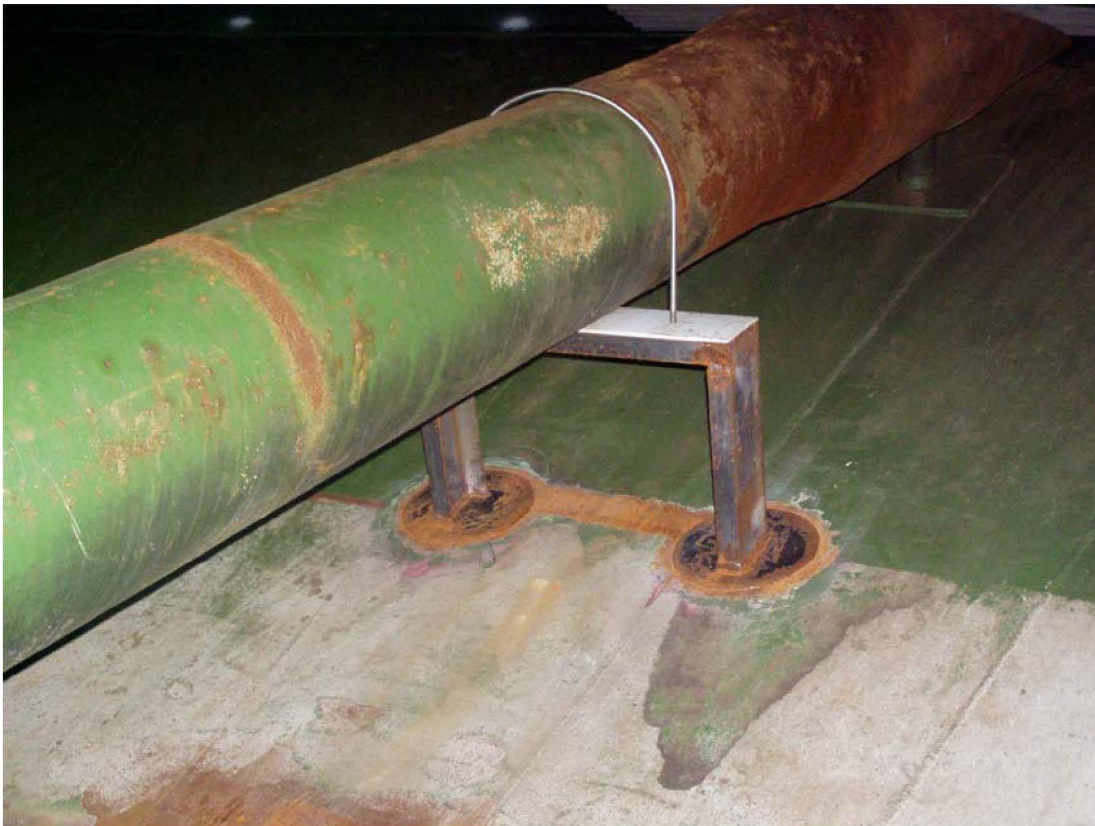
New 18" line support with re-pads

The 18" line supports were removed and replaced as recommended by Weston Solutions. Two existing supports were removed, areas where they were attached to the tank bottom were ground smooth and vacuum box tested.

One new support was installed shown in the photograph below. Reinforcing plates attached to the tank bottom were PT'd and vacuum box tested.

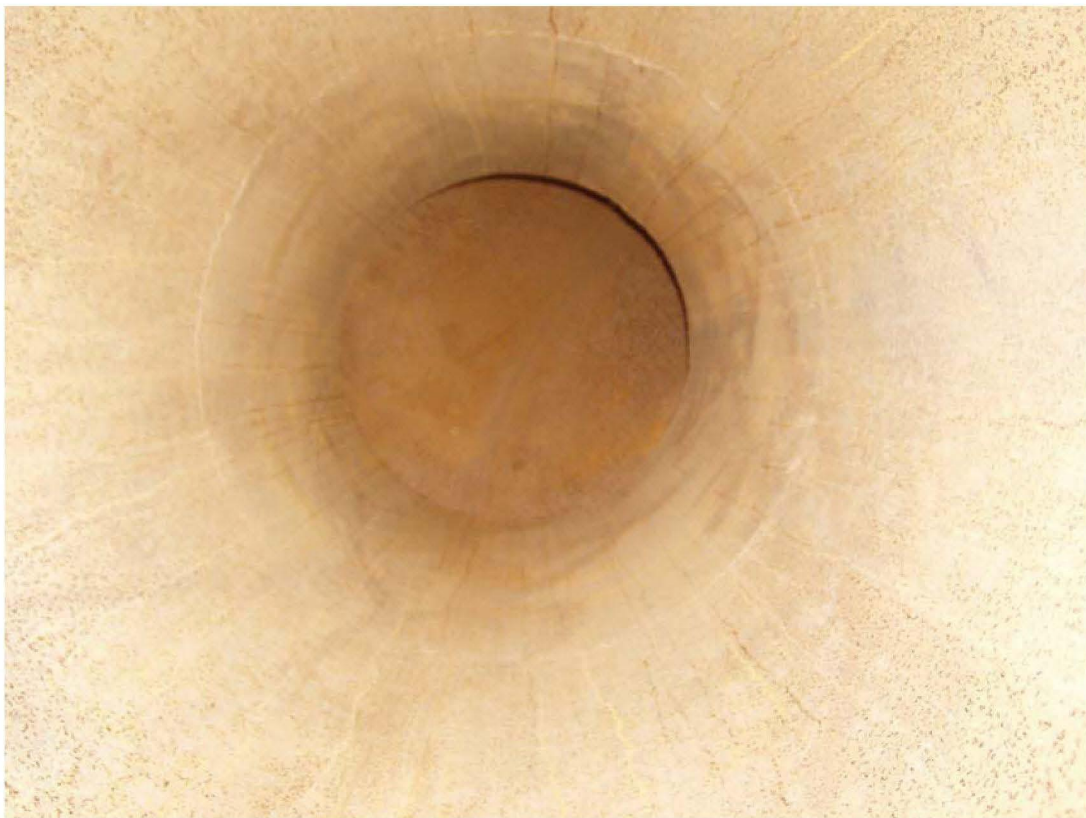
View looking down the 32" line from inside tank 15. Note the circumferential weld before the bend. This is weld repair "A" identified in the Weston Solutions sketch.

A - Lack of Penetration  
Throughout  
(Repair Needed)

Five internal circumferential weld joints of the 32" line beneath the tank bottom were weld repaired and PT'd as recommended by Weston Solutions. Locations are shown on the Weston Solutions sketch dated 12/29/5.

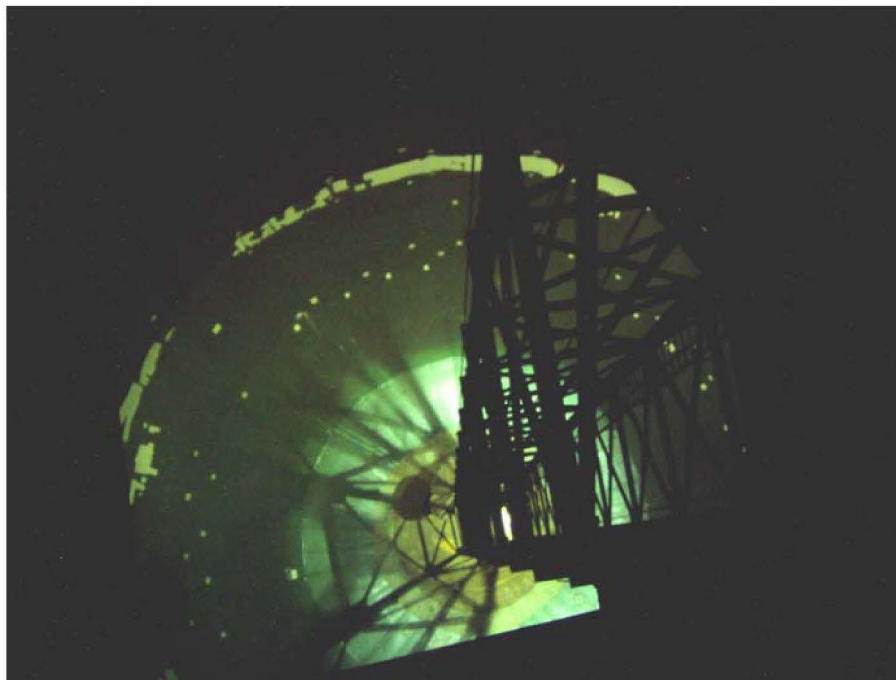
Tank 15 Lower Dome Coating Repairs

Coating repairs were completed using the approved single coat paint system with surface preparation done in accordance with manufacturers recommendations.

1. 89 weld and patch plate repairs.
2. 112 grout nozzles.
3. Scattered areas of the lower dome and barrel totaling approximately 82 square meters. Coating repair areas in the lower dome were described in the Dunkin & Bush Report on Coating Failure Observations dated September 30, 2005.

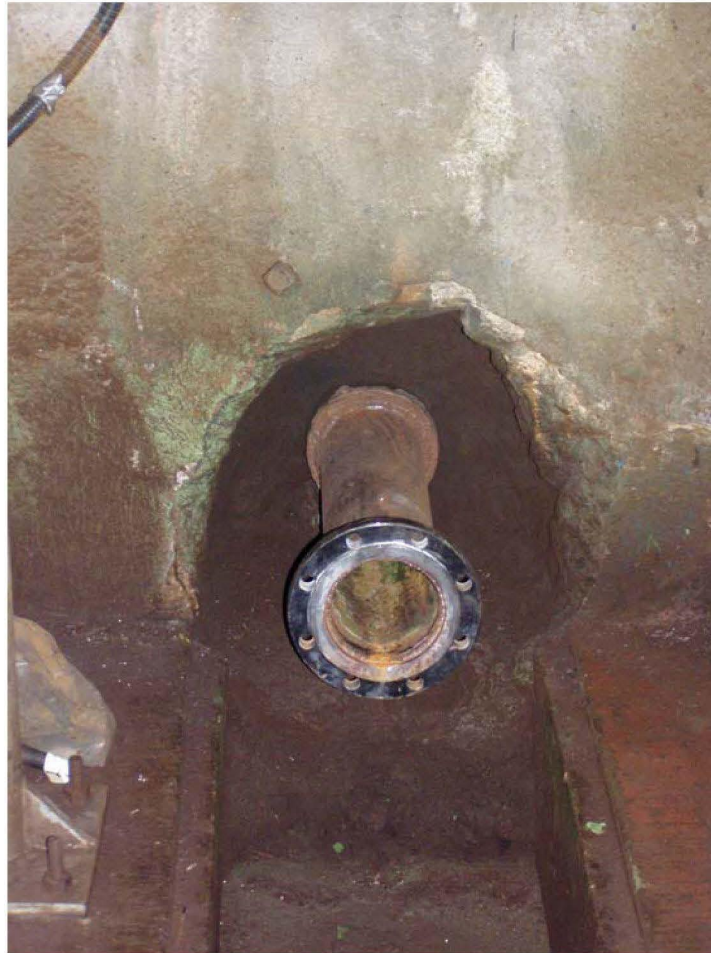
View of new slop line from lower tunnel before installation of 6" valve.

1. **Removal, repair, reinstallation and testing of the 6" slop line.** The existing slop was removed as directed by the government. The flexible stainless steel portion of the line was found to be leaking at weld joints and was replaced with a 24 foot section of new 5" diameter flexible stainless steel tubing. The existing carbon steel slop line pipe was re used, with a new flange installed at the lower tunnel.

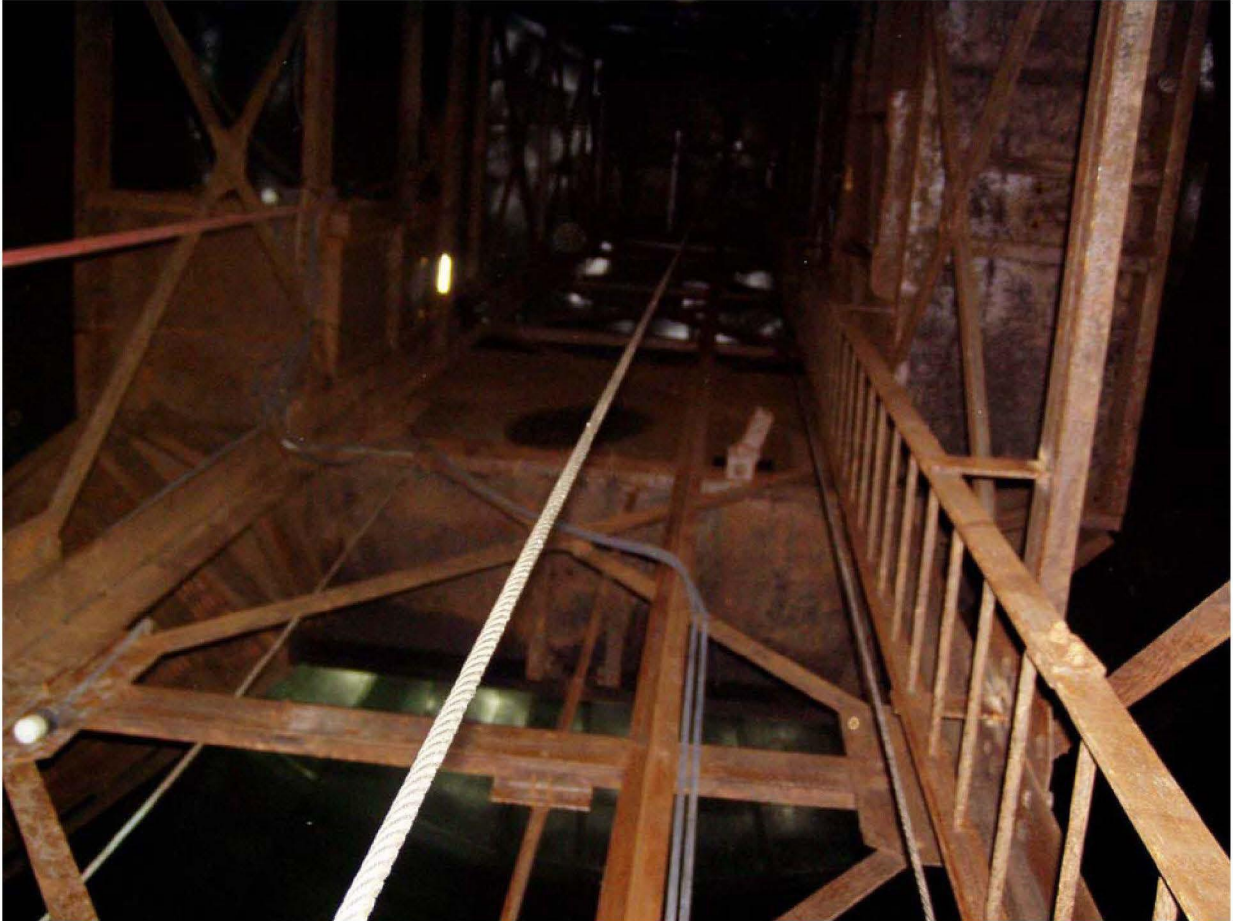
Tank 15 relocated ladder – note the clips attaching the ladder to the tower.

2. **Relocation of the ladder** in the central tower from the quadrant "A" side (facing) to the quadrant "D" side (right side of photograph). This required cutting and re welding clips connecting the ladder over the full height of the tower.

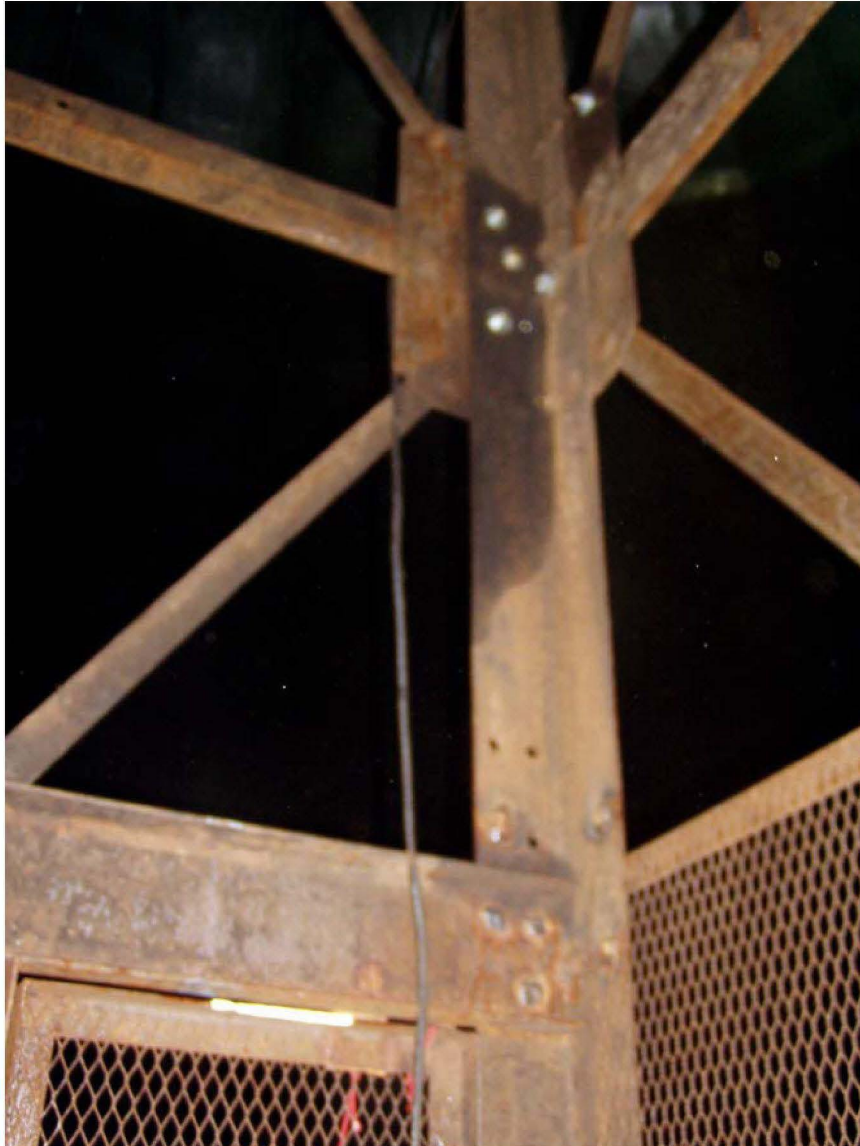
Typical area of replaced fasteners - note plug weld repair of flame cut holes.

3. **Central tower structural repairs** including the installation of 48 missing fasteners, and repairs to cracked weld joints below the catwalk platform on the tower structure.

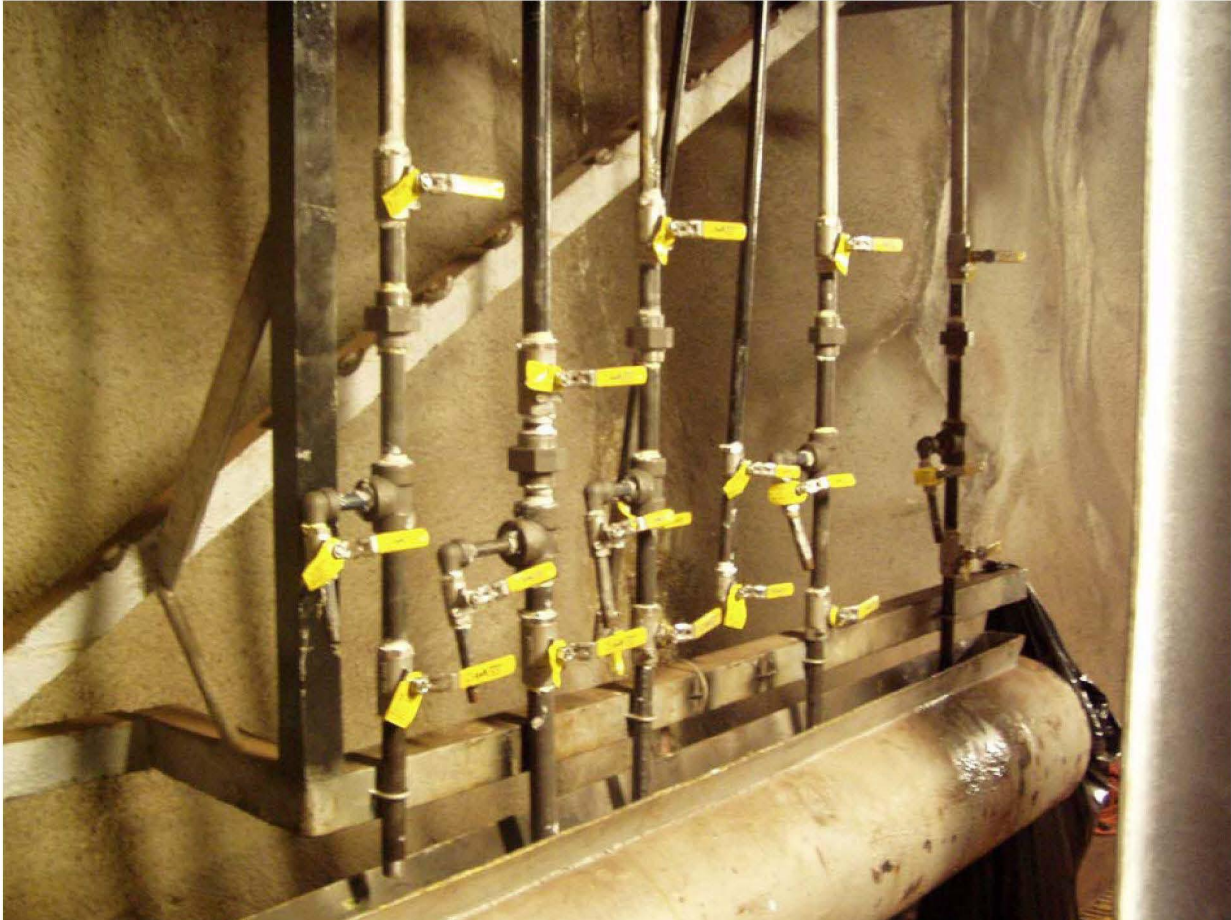
Tank 15 sample line valves at lower tunnel – note added branch and valve for filling sample bottles.

4. **Replacement of sample line valves** in the lower tunnel.

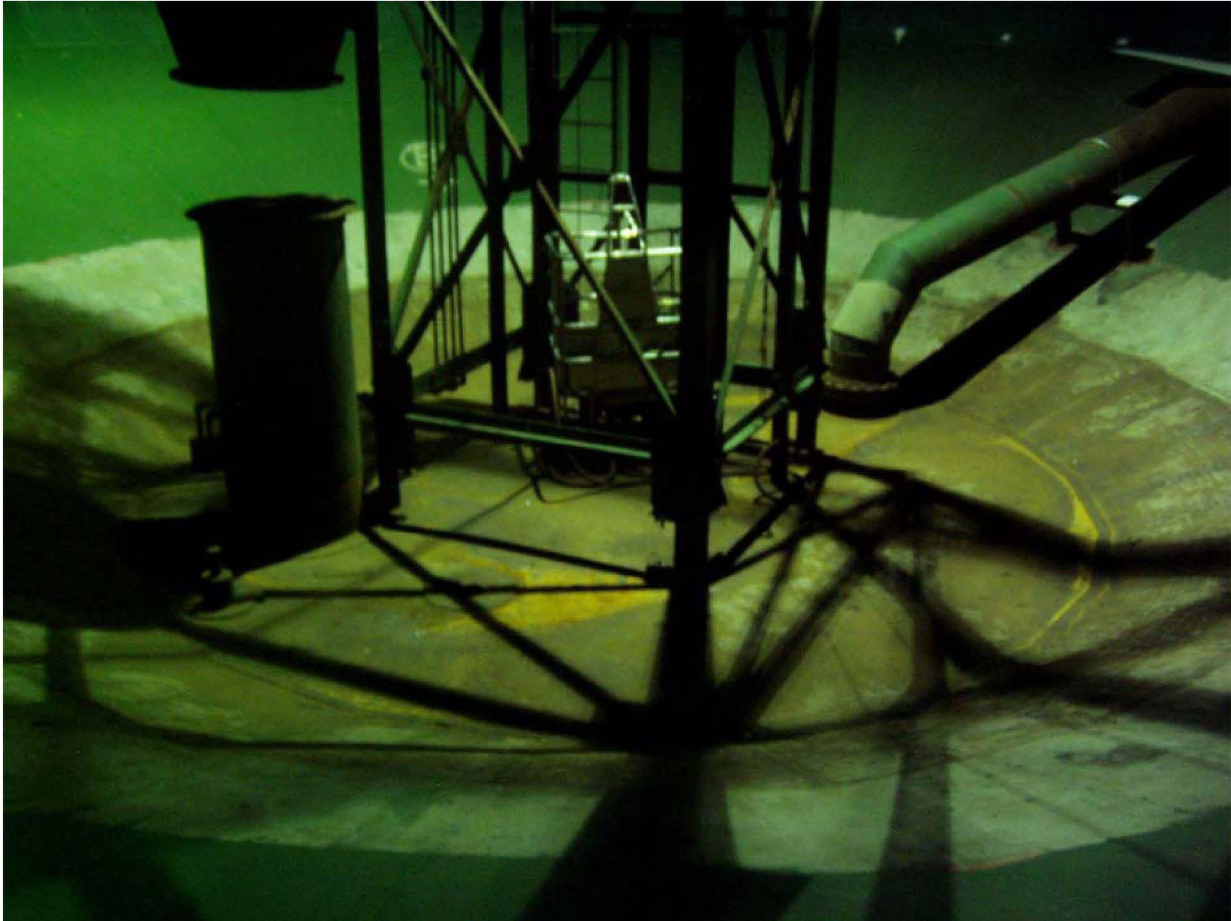
View of tank 15 bottom area where gauging equipment and attachments were removed

5. **Removal of the existing counterweight tube, gauge float, guy wires and attachments.**

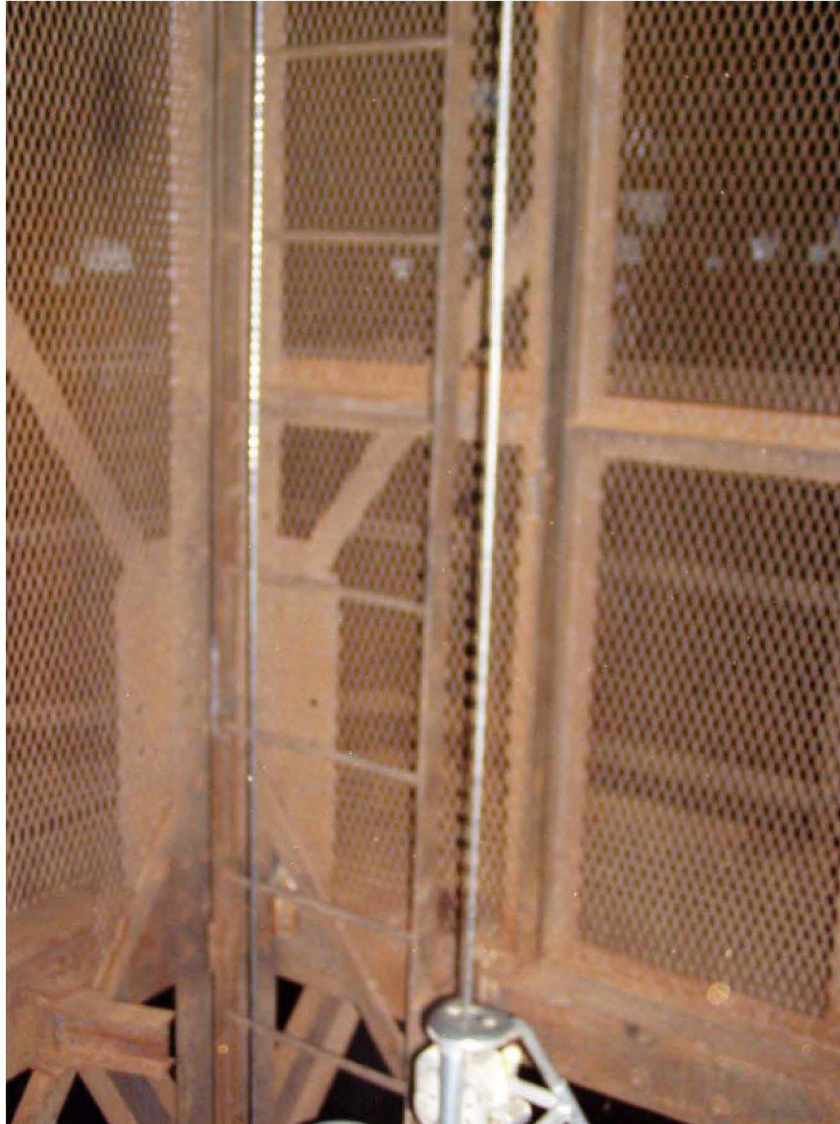
Area where elevator cage was removed at the platform level – note the relocated ladder.

6. **Removal of the elevator cage** and lower landing & steps from the central tower structure.

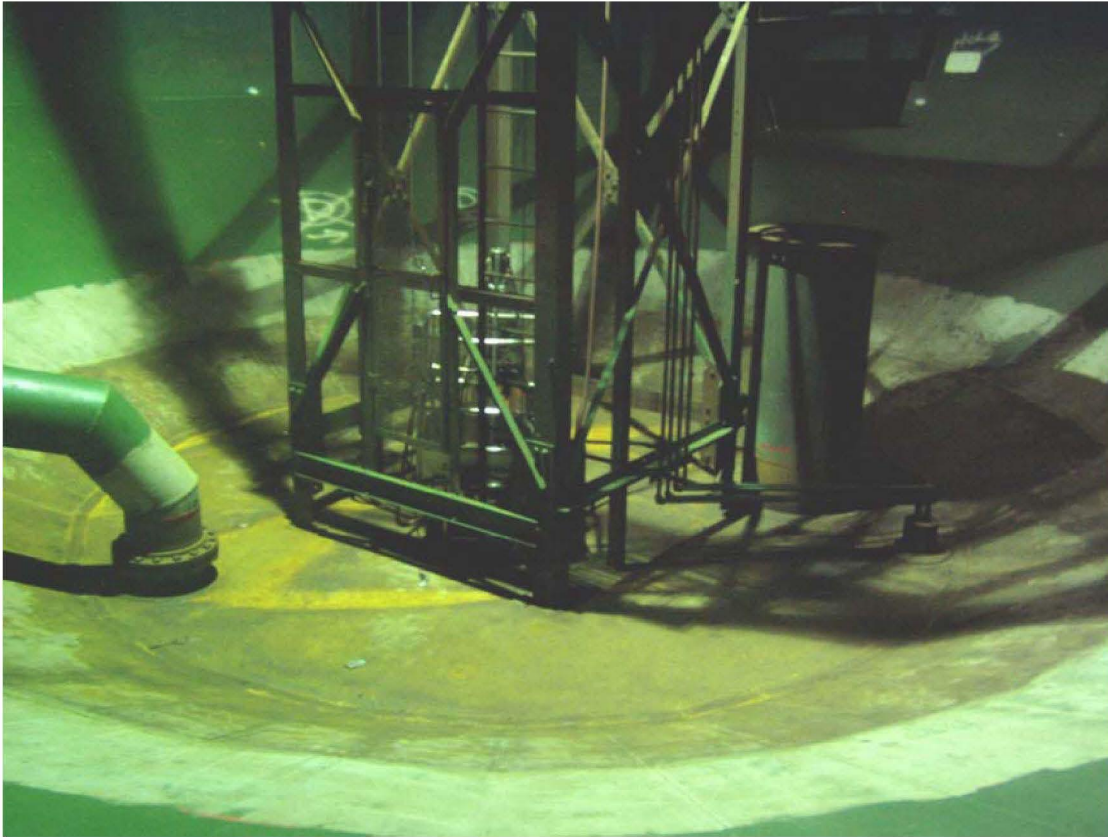
View of tank 15 bottom area where the elevator platform and steps were removed.
