Red Hill Administrative Order on Consent, Attachment A Scope of Work Deliverable

Section: 5.2 Corrosion and Metal Fatigue Practices Report

RED HILL FACILITY

CORROSION AND METAL FATIGUE

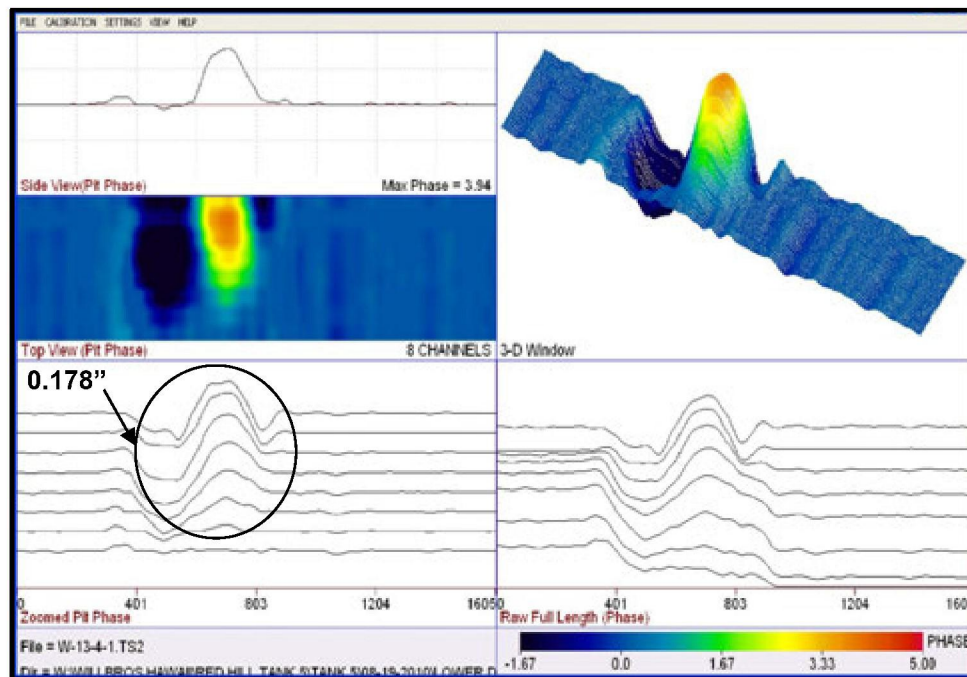
Figure 2-3. Example of an LFET scan indicating underside corrosion exhibiting 0.178 inch remaining wall thickness.

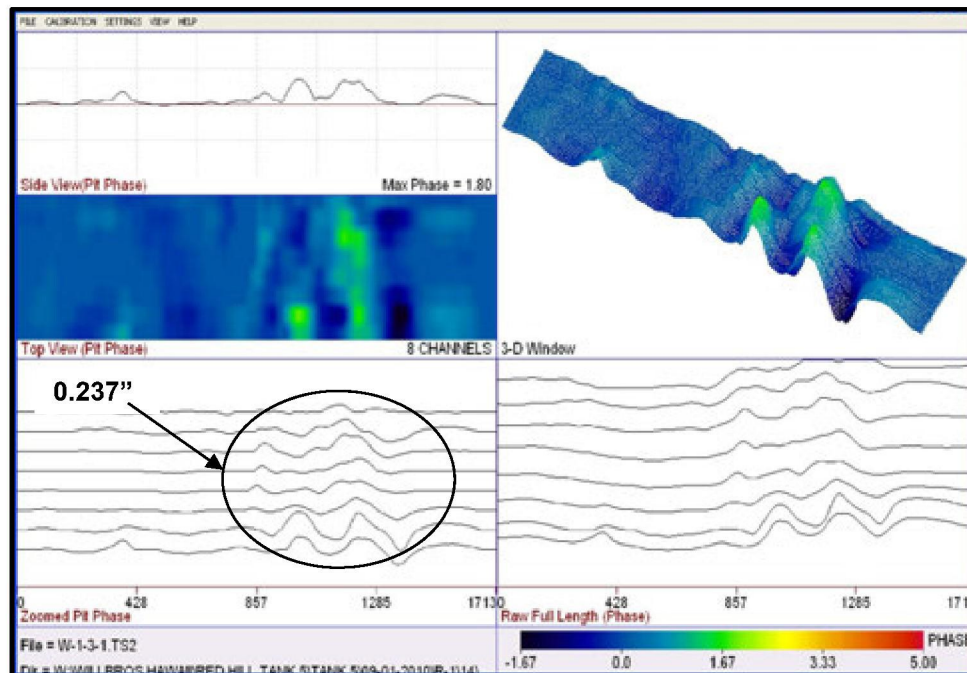
Figure 2-4. Example of an LFET scan indicating underside corrosion exhibiting 0.237 inch remaining wall thickness.

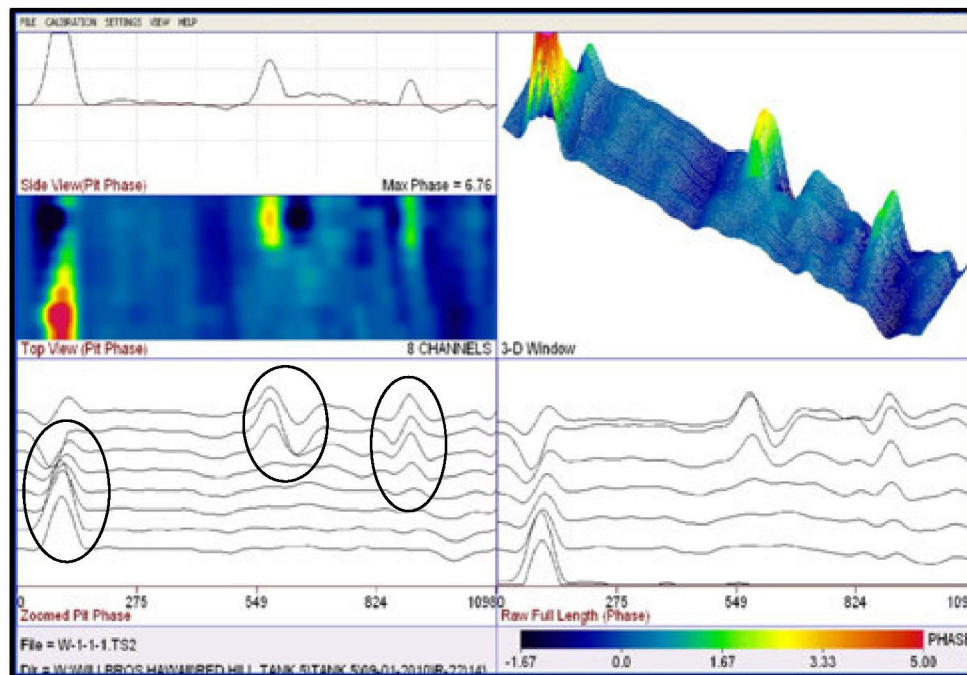
Figure 2-5. LFET scan indicating three dents between 0.200 and 0.240 inch deep.

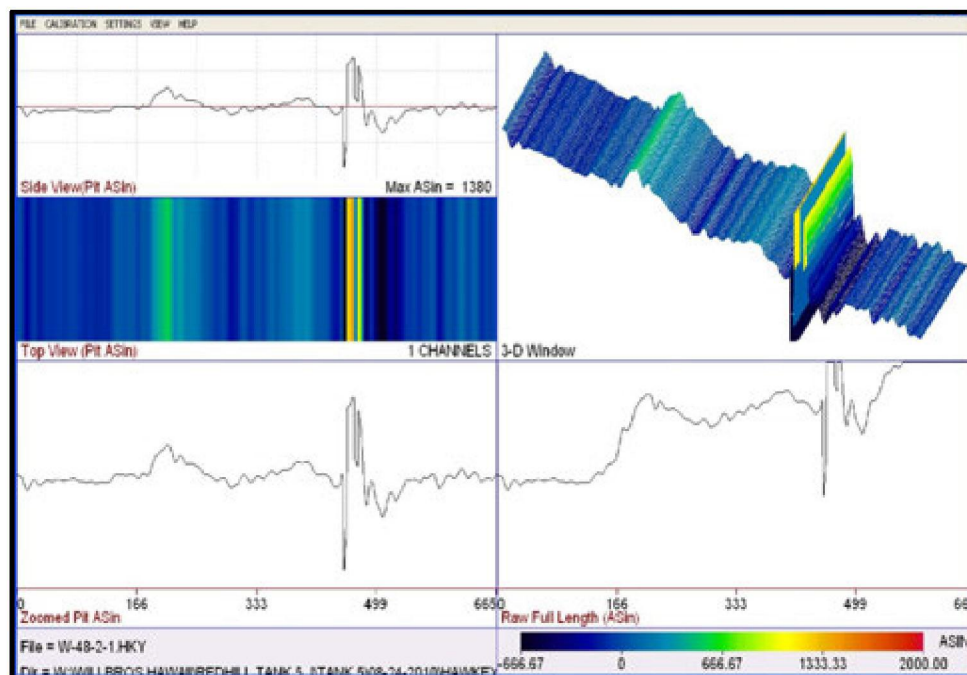
Figure 2-6. Waveform indicating undercutting of a weld 0.125 inch deep and 5.0 inches long.

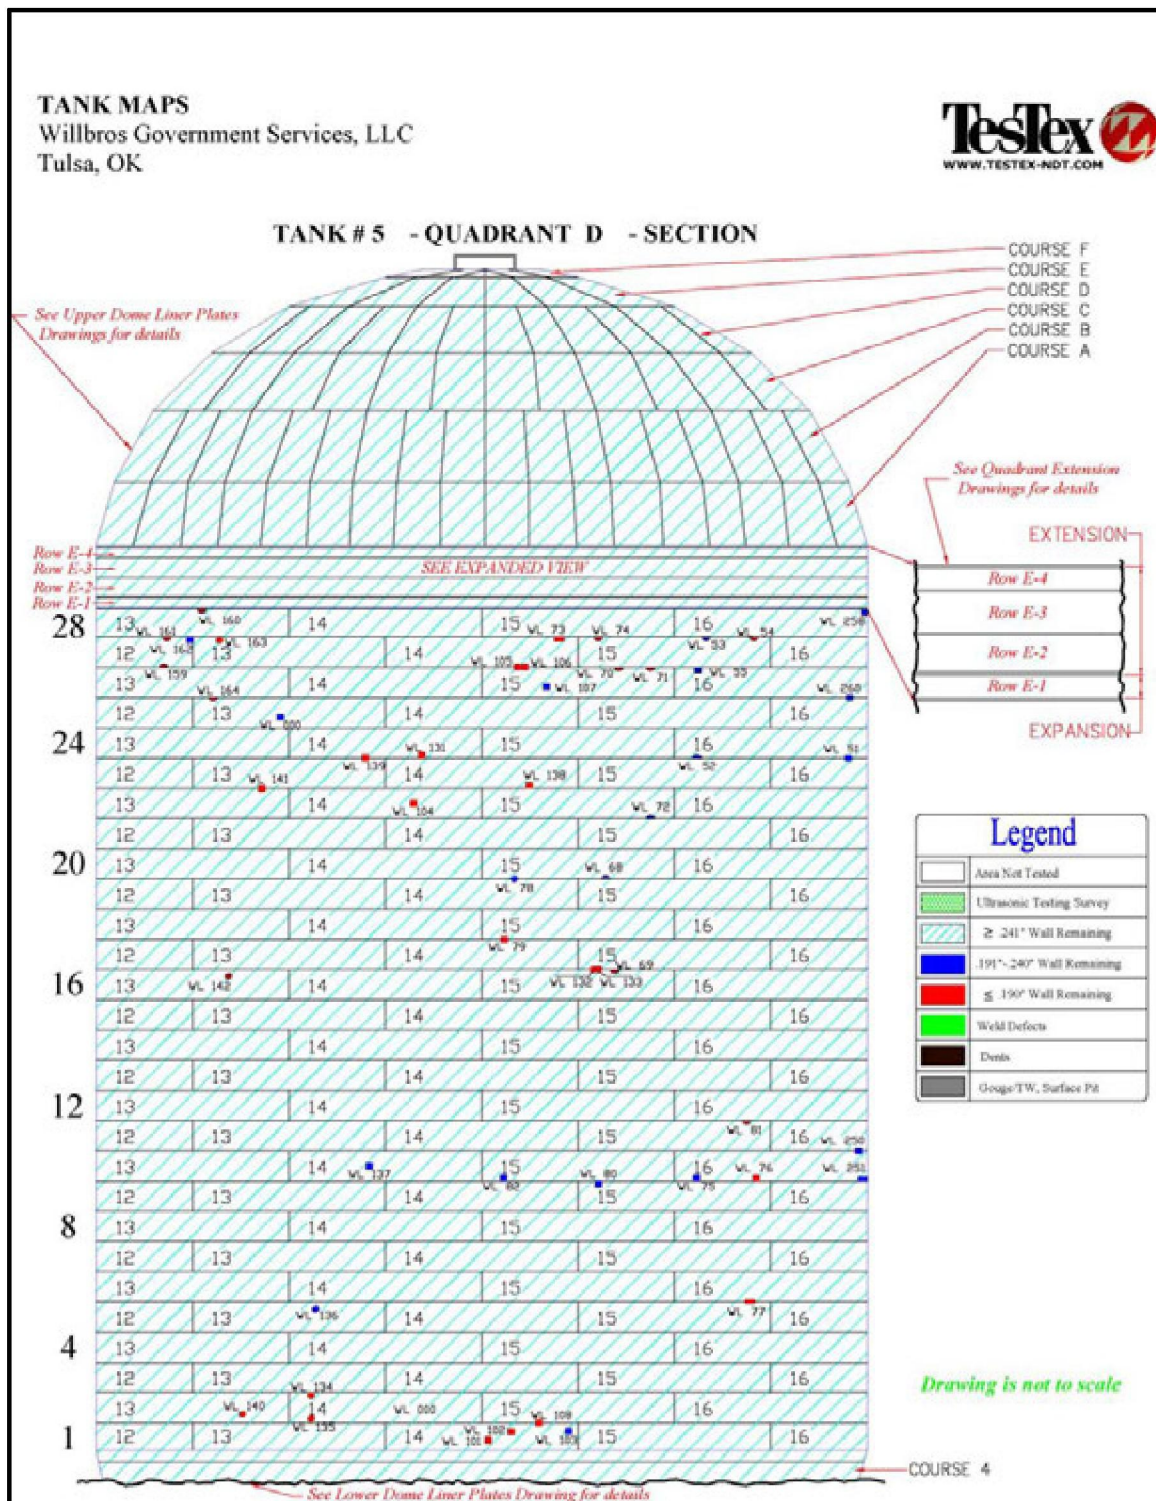
Figure 4-2. Example schematic drawing showing locations of flaws.

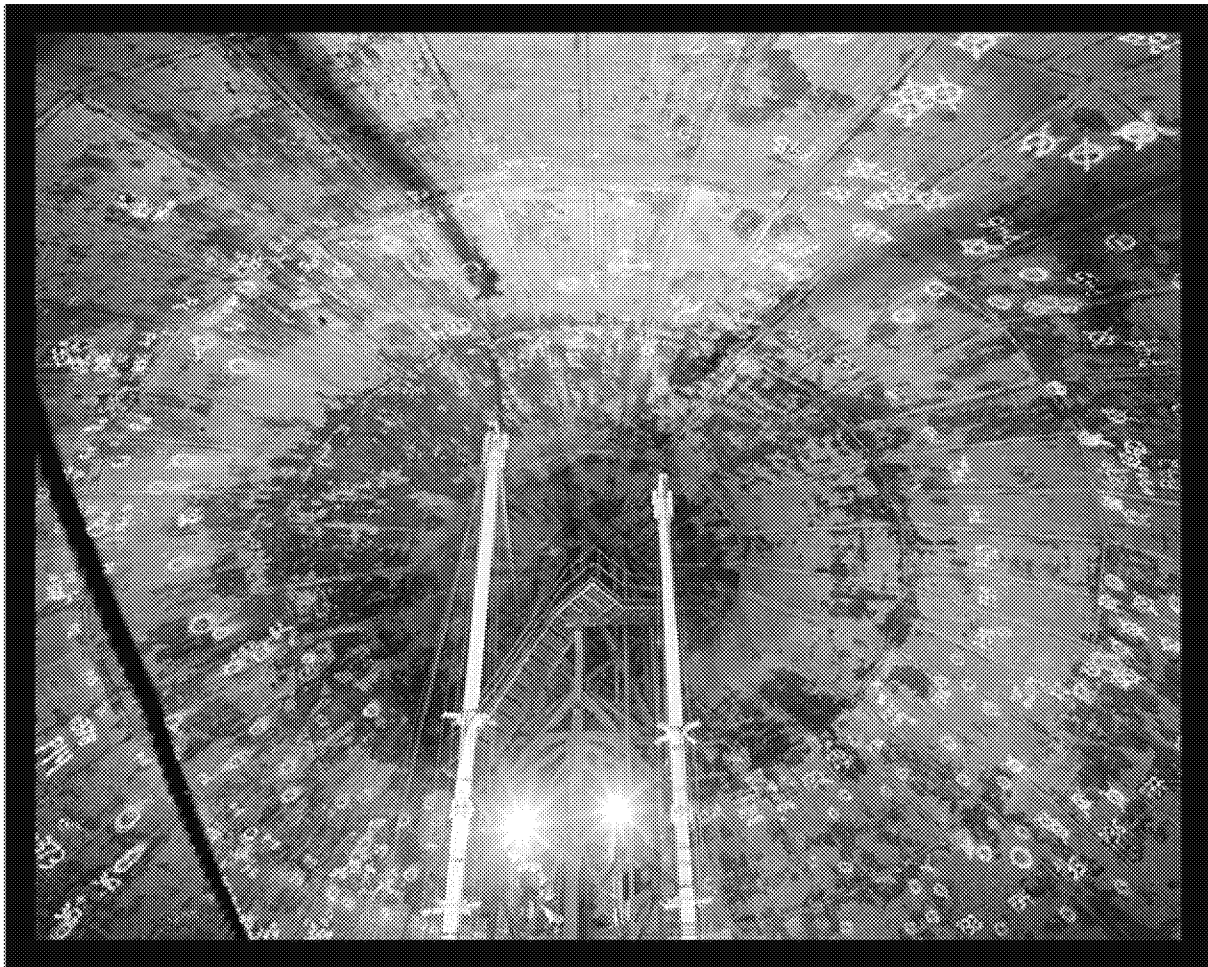
Figure 4-3. Example photo (black and white copy) of noted defects in tank upper dome
