**UNITED STATES ENVIRONMENTAL
PROTECTION AGENCY
REGION IX
75 Hawthorne Street
San Francisco, CA 94105**

**STATE OF HAWAII
DEPARTMENT OF HEALTH
P. O. BOX 3378
HONOLULU, HI 96801-3378**

Re: Response to Corrosion and Metal Fatigue Practices, Destructive Testing Results Report, Red Hill Bulk Fuel Storage Facility (Red Hill), Joint Base Pearl Harbor-Hickam, Oahu, Hawaii

Corrosion Report on Red Hill Bulk Fuel Storage Facility

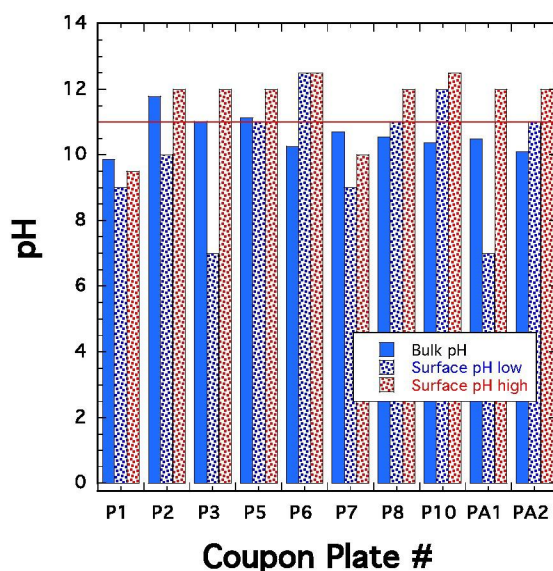
- i. Tables 15 and 16 of the Results Report Appendix A show measured pH is less than ($<$) 11 for concrete samples behind seven out of ten coupons, whereas pH for fresh concrete is around 13 or 14. When $\text{pH} < 11$, the concrete’s ability to protect steel from corrosion decreases and corrosion rates start to increase and accelerates as the pH levels drops.

Figure 1: Bulk and surface pH of concrete corresponding to the removed steel coupon plates. Bulk pH data and surface pH from DT Results Report [1].

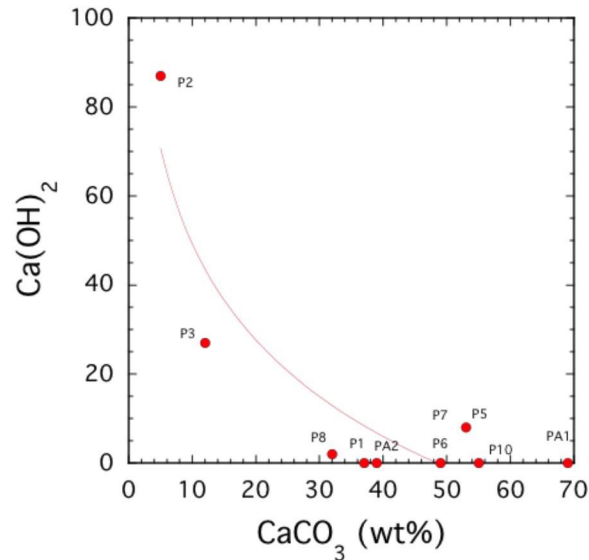
X-ray diffraction results (Table 2) [1] of the concrete powdered samples showed an average calcium carbonate content of 40.0 wt% with a standard deviation of 19.7%. The large variation in concrete composition (Table 2) could be accentuated by the small sample size. The general trend of increasing calcium carbonate with decreasing calcium hydroxide (Figure 2) was also observed. The origin of the high levels of calcium carbonate is not exactly known, but could be the result of carbonation, where carbonic acid from dissolved CO₂ gas in water reacts with calcium hydroxide in the concrete to form calcium carbonate [5]. This reaction can generally increase the strength of concrete [4, 6], but decrease its alkalinity and adversely affect the

Figure 2: $\text{Ca}(\text{OH})_2$ vs CaCO_3 content in concrete behind the removed steel coupon plates. $\text{Ca}(\text{OH})_2$ and CaCO_3 data from the DT Results Report [1].

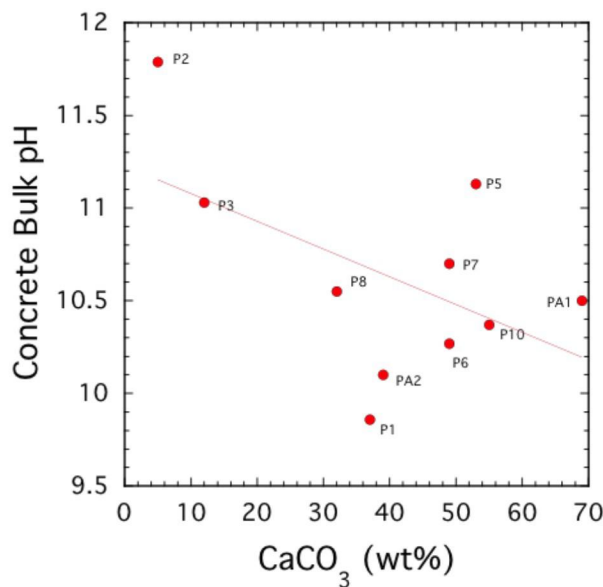
corrosion resistance of imbedded steel [4]. The pH measurements coupled with the X-ray diffraction results [1] showed 1) decreasing concrete bulk pH with increasing calcium carbonate (Figure 3) and 2) decreasing concrete bulk pH with decreasing calcium hydroxide content (Figure 4).

Figure 3: Concrete bulk pH vs CaCO_3 content in concrete behind removed steel coupon plates. Bulk pH and CaCO_3 data from the DT Results Report [1].

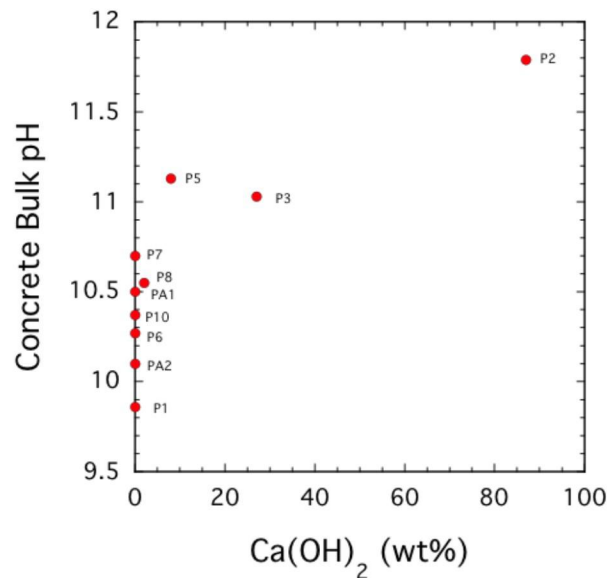
Figure 4: Concrete bulk pH vs $\text{Ca}(\text{OH})_2$ content in concrete behind removed steel coupon plates. Bulk pH and $\text{Ca}(\text{OH})_2$ data from the DT Results Report [1].

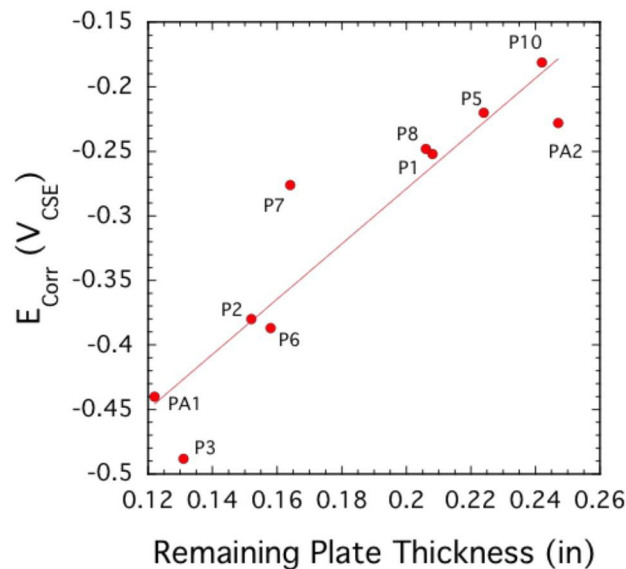
Of the potential measurements corresponding to the back side of the tank wall, only one potential was more positive than -0.2 V_{CSE}, indicating low probability of corrosion; five potentials were in the potential range of -0.20 to -0.35 V_{CSE}, indicating uncertainty of corrosion; and four potentials were more negative than -0.35 V_{CSE}, indicating high likelihood of corrosion. The reported minimum remaining plate thickness values for each plate was plotted vs the corrosion potentials (Figure 5), showing strong correlation. The more negative the corrosion potential (indicating a

higher tendency to corrode), the lower the measured remaining plate thickness. Plates P5, P10, and PA2 corresponding to the three most positive corrosion potentials ($> -0.23 \text{ V}_{\text{CSE}}$) showed no or only very light surface rust (Figure 6) [1]. Plates P1 and P8 (with potentials $\approx -0.25 \text{ V}_{\text{CSE}}$) showed mostly mild surface rust (Figure 6) [1]; whereas, the remaining plates PA1, P2, P3, P6, and P7 (with potentials $< -0.27 \text{ V}_{\text{CSE}}$) showed significantly more severe rusting (Figure 6) [1].

Figure 5: Corrosion potential vs minimum remaining plate thickness. Data summarized from the DT Results Report [1]. Since two corrosion potential values were given for plates A1 ($-0.448 \text{ V}_{\text{CSE}}$ and $-0.432 \text{ V}_{\text{CSE}}$) and A2 ($-0.226 \text{ V}_{\text{CSE}}$ and $-0.230 \text{ V}_{\text{CSE}}$), the average value for each plate was plotted.

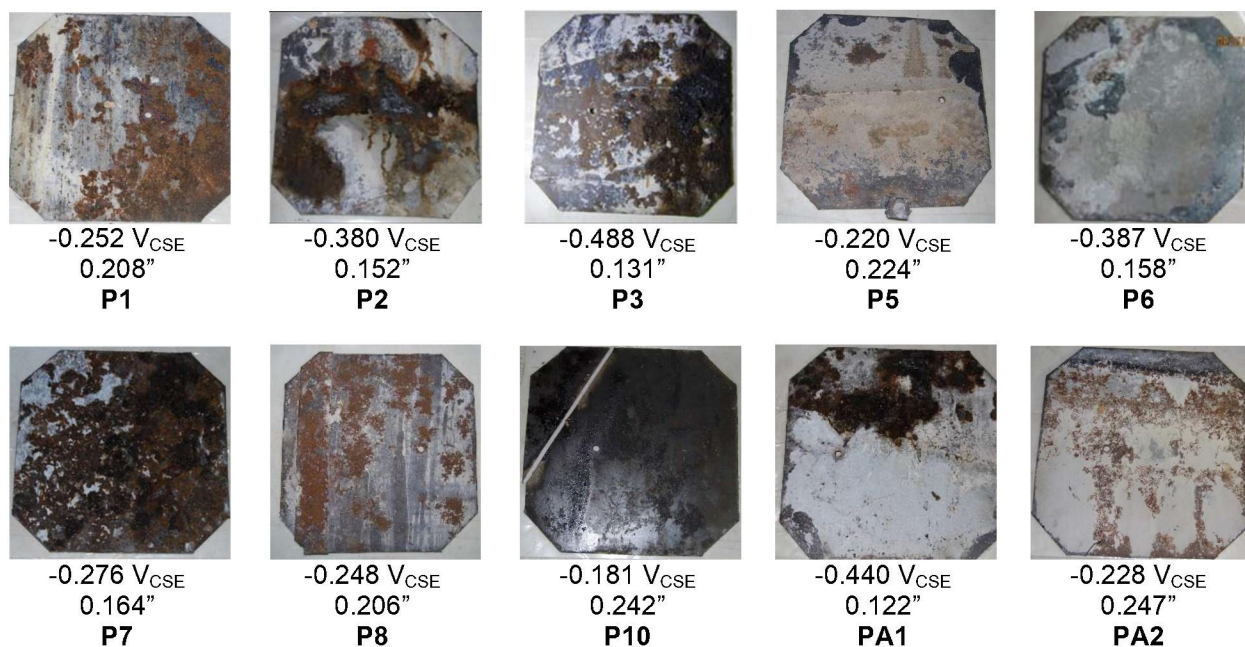
Generally, the formation of the visible red-brown rust (Figure 6) on plain-carbon steel indicates that the passivation in that local region has been lost. The gray regions of the plates (excluding the adhering concrete or grout) are regions where the steel is in the passive state (Figure 6). Passivation can be lost when the pH of the concrete drops below approximately pH 11 [7], or chloride (Cl) ions are present in sufficient concentration [4, 7]. The NACE Standard Practice SP0308-2008 [9] indicates that acid-soluble chlorides in excess of approximately 0.2 % (by weight of cement) can initiate corrosion of steel in concrete. The ion chromatography analyses of the concrete powder samples showed that the chloride concentration in the concrete ranged from 50 ppm (0.005 % by weight of cement) to 171 ppm (0.017 wt%), which is much lower than the threshold. The concentration of chlorides detected in the corrosion

products using energy dispersive X-ray analyses (EDXA), however, was significantly higher: The maximum value of 1.7 wt% (17,000 ppm by weight of corrosion product) was detected in the corrosion product of plate PA1; 0.6 wt% (6,000 ppm) in plates P2 and P7; 0.3 wt% (3,000 ppm) in plates P3, P5, P6, and P10; and none in plates P1, P8, and PA2. The detection limit of EDXA is on the order of 0.1 wt% (1,000 ppm). The maximum concentration of the chlorides in the corrosion products were up to approximately 100 times higher than the maximum concentration in the concrete. Chlorides at these levels as well as the drop in concrete alkalinity below approximately pH 11 are likely to breakdown passivation and cause increasing corrosion rates of the steel.

Figure 6: The back side of the steel coupons, structure-to-electrolyte corrosion potentials (in V_{CSE}), and the minimum remaining thickness (in inches) that was measured for each plate. From DT Results Report [1]

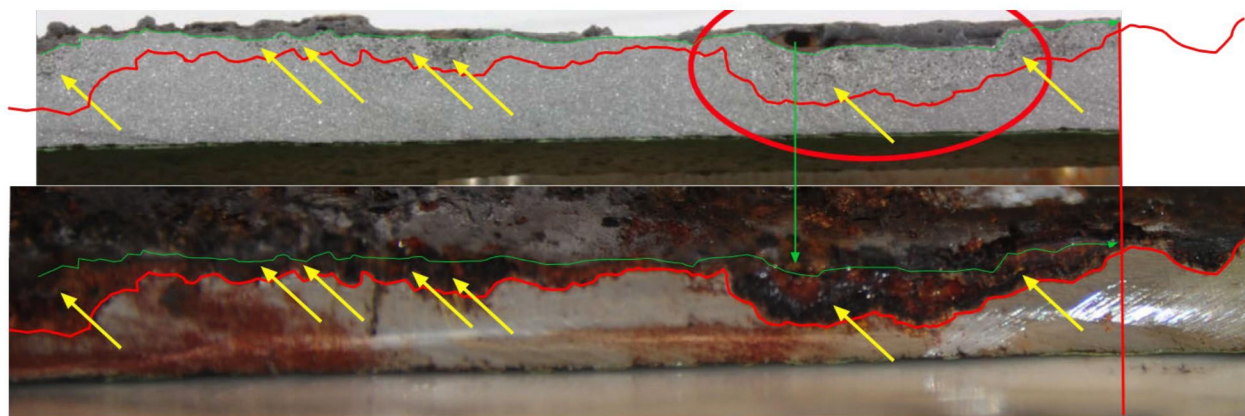
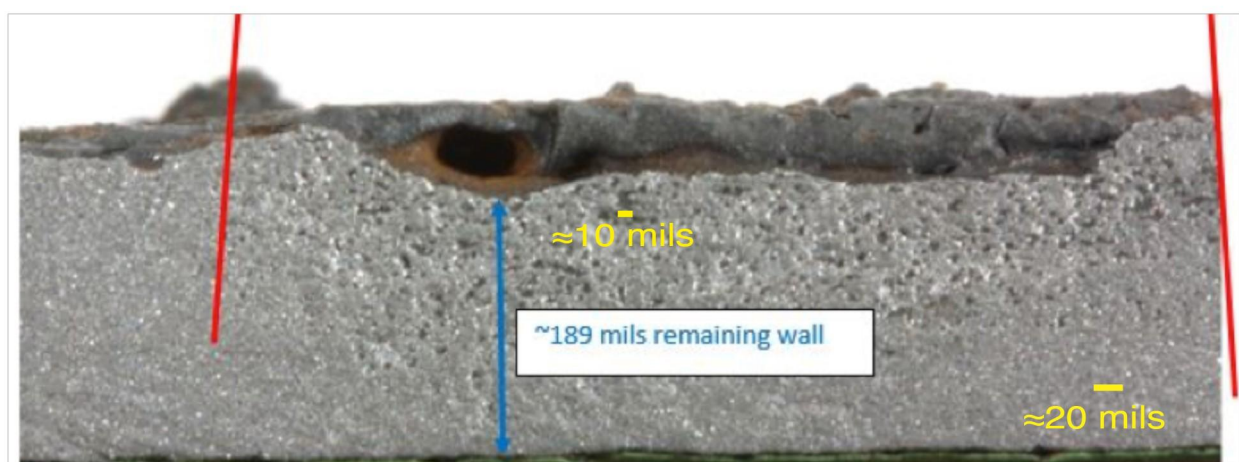
The electrolyte in the corrosion product at the corrosion front can become very corrosive due to acidification and accumulation of chlorides. This may have been observed on the cut edge of coupon plate P7 [11]. A photograph of the cut edge of plate P7 was taken on June 25, 2018 (bottom photo in Fig. 9a), approximately one week after coupon plate P7 was cut and removed from Tank 14. The image showed what was initially thought to be significant corrosion (dark brown rust) penetration into the thickness of the plate. To verify if the corrosion had actually penetrated into the plate, the edge of the specimen was cleaned by sandblasting [11] (approximately in March 2019, or six months after the coupon was extracted). The photo of the cleaned edge of coupon plate P7 was compared (Figure 9) to the photo of the un-cleaned edge. The demarcation between the cleaned steel plate and the free surface was highlighted with a thin green line (Figure 9a top), and the demarcation between the shiny cut edge of the corroded un-cleaned plate and the apparent corroded regions were highlighted with a thicker red line (Figure 9a bottom). Both lines were superposed on the cleaned and uncleaned plates (Figure 9a). The darker corroded regions on the edge of the uncleaned plate (Figure 9a bottom) corresponded to the areas that appeared to be porous (yellow arrows) on the cleaned plate (Figure 9a top and Figure 9b). The apparent porosity (Figure 9a top and Figure 9b) could be due to corrosion caused by corrosive electrolyte that leached out of the corrosion products onto the cut edge. Some of the pores appeared to be on the order of 5 to 10 mils in width (Figure 9b). If it is assumed that the pits are as deep as they are wide, the rate of corrosion would be on the order of (5 to 10 mils)/6 months or 10 to 20 mils/yr, which is much higher than passive corrosion rates. It is also recommended that the surface porosity be further investigated to verify whether the region is only superficially pitted or is actually porous.

Figure 9: Optical images (a) of cleaned (top) and uncleaned (bottom) edge of coupon plate P7. Magnified view (b) of the cleaned edge of coupon plate P7 showing pitted surface. Wavy red and green lines, yellow arrows, and 10 and 20 mils scale bars were superposed on original photos of the cleaned edge [11].

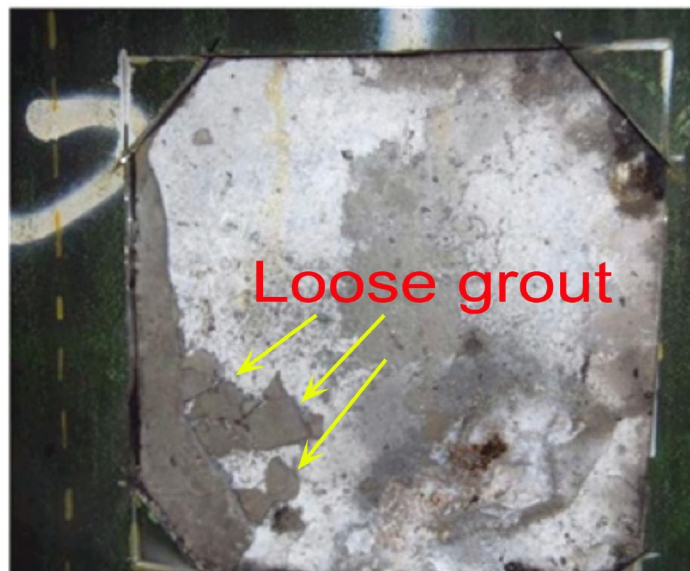
Since the grout was pressurized to 350 psi, it could have likely found its way to the steel-concrete interface from the concrete-Gunitite interface through any crevice or crack that may have formed. In one case, grout was found as far as 200 ft away from the tanks in an upper access tunnel [13]. The description of the tell-tale system, also indicates that crevices could exist between the tank wall and concrete layer [13]:

Figure 10: Loose grout behind coupon plate P6. From DT Results Report [1].

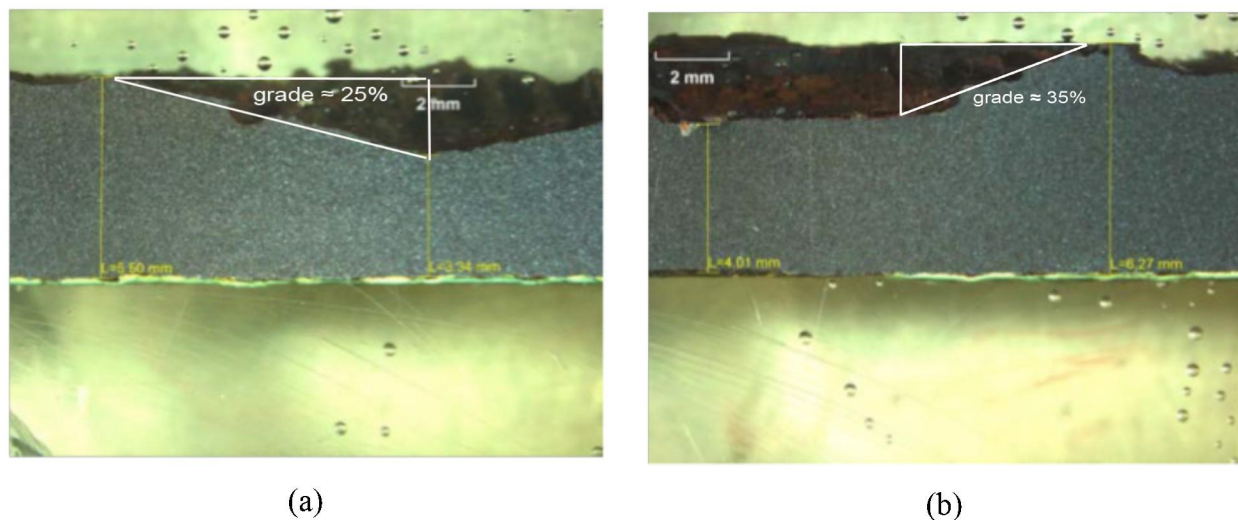
Figure 11: Cross section of coupon plate P3 (a) at the area of maximum wall loss (p. 18 of DT Results Report [1]) out of four sections examined, and cross section of coupon plate P6 (b) at area of maximum wall loss out of three sections examined (p. 24 of DT Results Report [1])

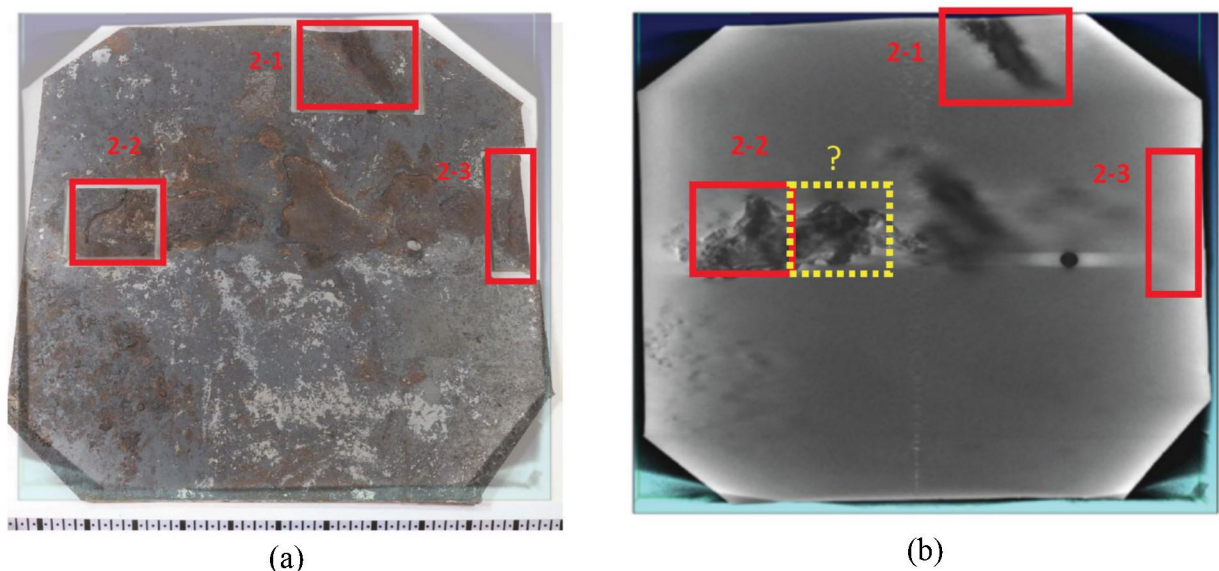
There are also concerns of whether or not the sites with the deepest pits were sampled during the destructive testing. The steel coupons were specified to be cleaned and subjected to three-dimensional profilometry (as specified on p. 8 of the DT Results Report, [1]) to document the

surface profile of the remaining steel substrate. The steel coupons were cleaned with a CO₂ dry ice blast, but all of the corrosion products were not removed; hence, the regions of the deepest pits would be difficult to determine. The three-dimensional profilometry data was not provided in the DT Results Report [1], but the results would likely not have characterized the bare steel substrate since the corrosion products were not thoroughly removed. X-ray computed tomography (CT) was used to aid in selecting the regions with the deepest pits, but in some cases, regions with potential deep pits were apparently not sampled (e.g., Figures 12, 13, and 14). The DT Results Report [1] did not describe if other methods were used to confirm the location of the deepest pits.

Figure 12: Coupon plate P2. Possible deep pit in yellow box region not sampled. Original images from DT Results Report [1].

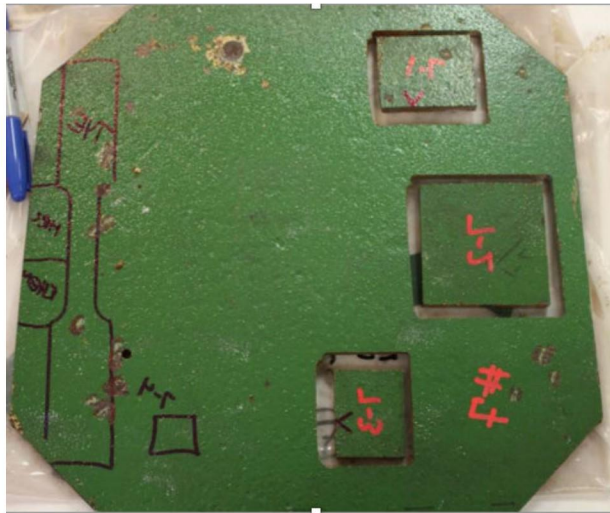
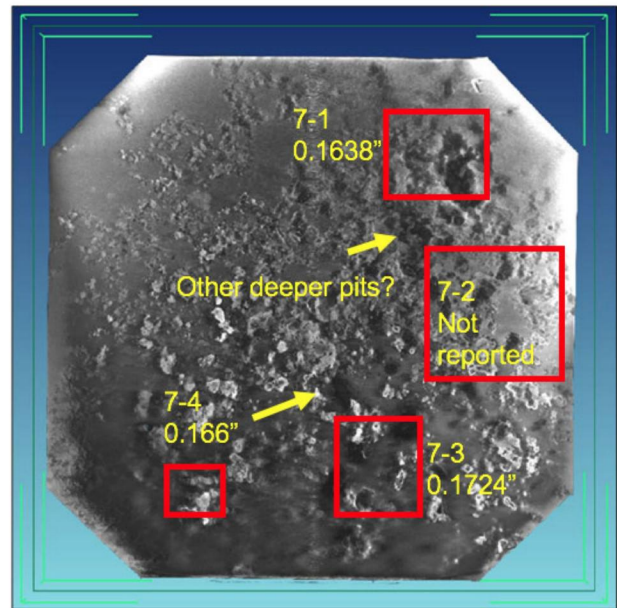
Figure 13: Coupon plate P7. Possible deep pits in region of yellow arrows not sampled. Original images from DT Results Report [1].

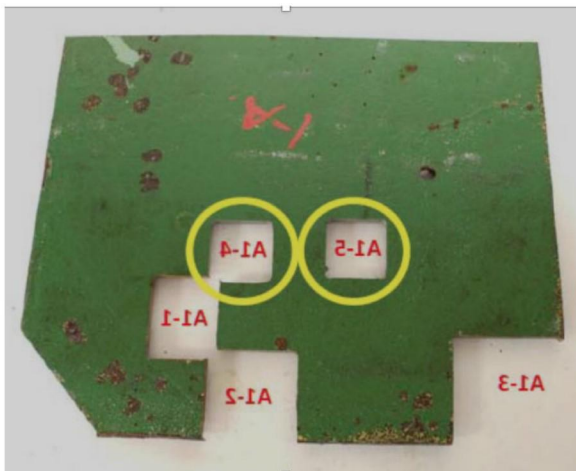
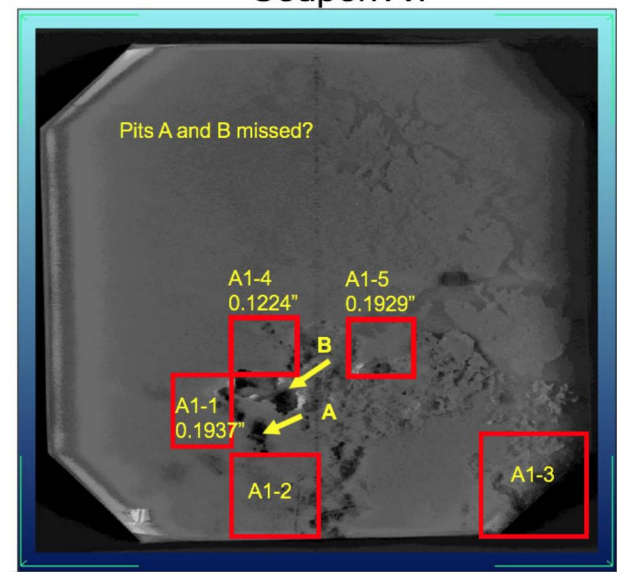
Figure 14: Coupon plate PA1. Possible deep pits in region of yellow arrows not sampled. Original images from DT Results Report [1].

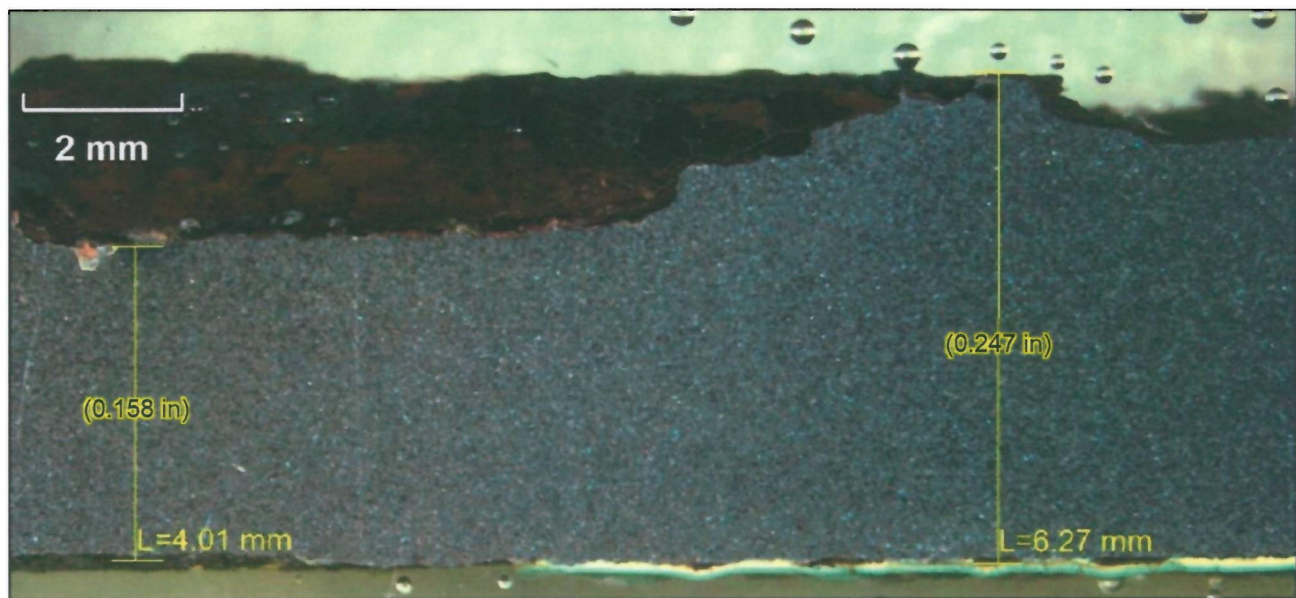
Figure 1 – Destructive Testing Cross-section from Sample 6-1

A pit of concern was found through laboratory analysis at Coupon 6. This pit was deep, but of small volume. The Results Report claiming that this miss was caused by an instrumentation miss and not a technician error. The Results Report does not provide sufficient information to allow the Regulatory Agencies to validate the cause of this error. The Regulatory Agencies were assured that all areas of metal thickness below 200 mils would have been recorded during a first pass low frequency electromagnetic scan. The Regulatory Agencies also note that at 0.158 inches that this site should have been repaired. Page 61 of the Results Report also states that a repair was not needed which is not consistent with the repair criteria.

1. The larger, TesTex Falcon Mark II 2000 device should have been able to detect the pit in Coupon 6. According to the Navy this device has a probability of detection (POD) of 100% at 25% wall loss on pits with an aspect ratio of 3:1. The deepest pit in Coupon 6 amounted to ~37% wall loss and aspect ratio of greater than 3:1 (width to depth ratio). Figure 1 shows the cross-section through the deepest pit in Coupon 6 where the size and depth of the pit is obvious.
2. The smaller, TesTex TS-2000 device should have been able to detect the pit in Coupon 6 as the Navy stated this device can detect pits with a diameter of 1.57 mm. The width of the corrosion pit in Coupon 6 was much, much wider than 1.57 mm as is shown in Figure 1.

Second, the BWS believes Figure 1 clearly demonstrates this pit cannot be described as a “*pit of very small volume.*” This figure clearly shows a broad pit of considerable volume.

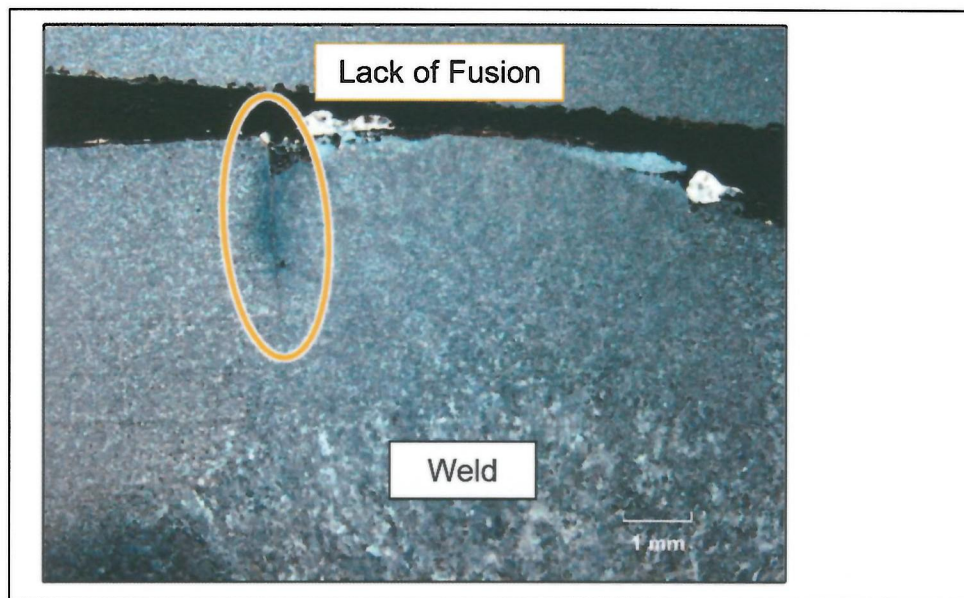
Figure 2 -- (Image from: IMR Test Labs. 2018)

4. The DT inspection did find weld defects. The one coupon that actually had a weld contained a linear defect that was found by destructive testing. This lack of fusion linear weld defect is shown below.

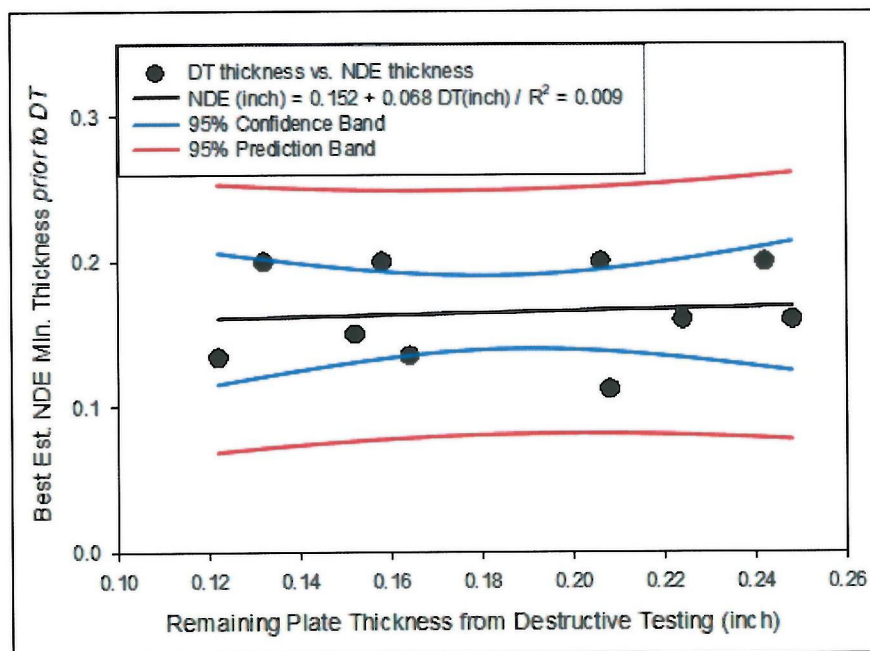
We have also plotted the actual minimum plate thickness determined from the DT against the best estimate of the coupon minimum thickness determined prior to the DT, Figure 4. To simplify, we conservatively assume the NDE-measured thickness in censored cases (i.e., the coupons for which thickness is reported as known only to be either greater or less than a specified value) were the specified bounding values. Similar analyses were also done for each NDE method treating those cases as interval-censored, and the results did not change significantly.

Figure 4 – Relationship between NDE thickness estimate prior to DT and the actual remaining thickness determined from DT.

Figure 4 clearly indicates the NDE techniques are neither accurate nor reliable. First, the slope (0.068) of the line drawn through the DT vs NDE data is very flat (close to zero), indicating the NDE results are essentially insensitive to actual corrosion depth. For comparison, if NDE was perfectly accurate, then the DT thickness would be equal to the NDE thickness and the slope of the line drawn through the data would be 1.0. Instead, the calculated slope is consistent with what one would expect if the NDE results were simply chosen at random without regard to the actual coupon thickness. Another indication is the coefficient of determination (R^2), which measures NDE accuracy by comparing the variation in NDE results to the residual variation after accounting for the actual coupon thickness (using the regression line). As noted in Figure 4, the R^2 value is effectively zero (0.009), indicating none of the observed variation in NDE-measured thickness is attributable to corresponding variation in the actual thickness of the test coupons.

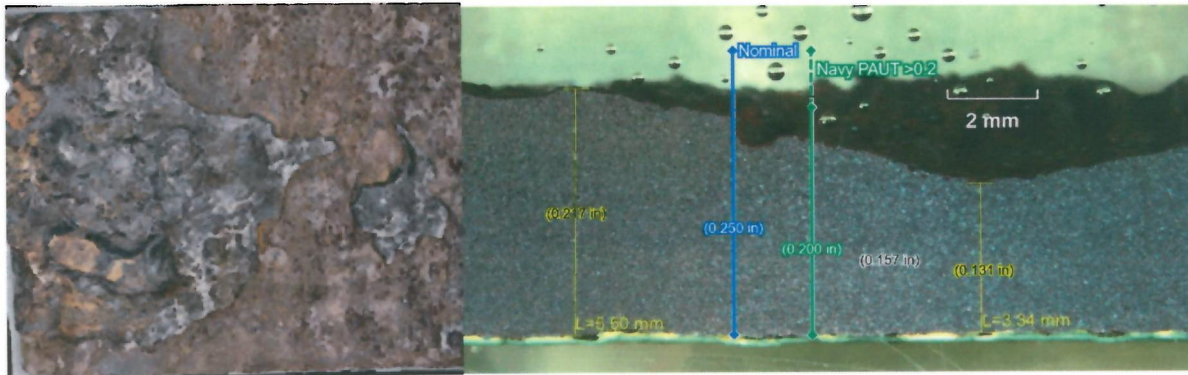
A more graphic illustration of the error in the NDE methodology is shown in Figure 5. The image on the left-hand side of Figure 5 shows the extensive backside corrosion on Coupon 3. The right-hand side of Figure 5 shows the plate's reported thinnest area in cross-section after destructively testing. While it is unclear from the DT and IMR reports, this thinned region

(0.131-inch-thick) was presumably located by CT scanning of the entire coupon. The Navy NDE predicted that this area had little to no backside corrosion.

Figure 5 – Destructive Testing Cross-section from Sample 3-3.

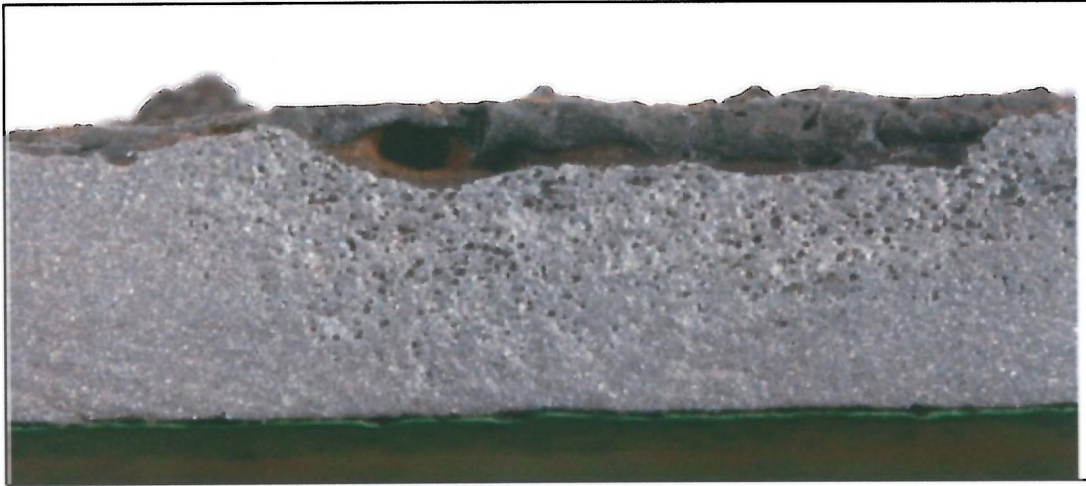
1. There was pitting observed as shown in their Figure A-4
2. It is not surprising that corrosion was not found as this area had been sandblasted.
3. The explanation that the area of concern "had been superficially altered by heat associated with sectioning or some other post-sectioning reaction (atmospheric corrosion or corrosive media attack)" is not credible. Atmospheric corrosion would be uniformly distributed along the cut surface, but the area of concern is localized. Secondly, the porosity is not consistent with heat associated with sectioning. Finally, we are unaware of any corrosive media used during coupon removal that could have locally attacked the edge in the area of concern.

Figure A-4. Detail of the sandblasted edge on 3/20/19 in the same location as shown in the picture below. The sandblasting revealed that the feature was not a corrosion pit, as shiny metal was revealed when the red-colored staining was removed. There was an unusual appearance to the edge in this location, as though the sectioned edge had been superficially altered by heat associated with sectioning or some other post-sectioning reaction (atmospheric corrosion or corrosive media attack). That alteration gave the appearance of a deep corrosion pit.

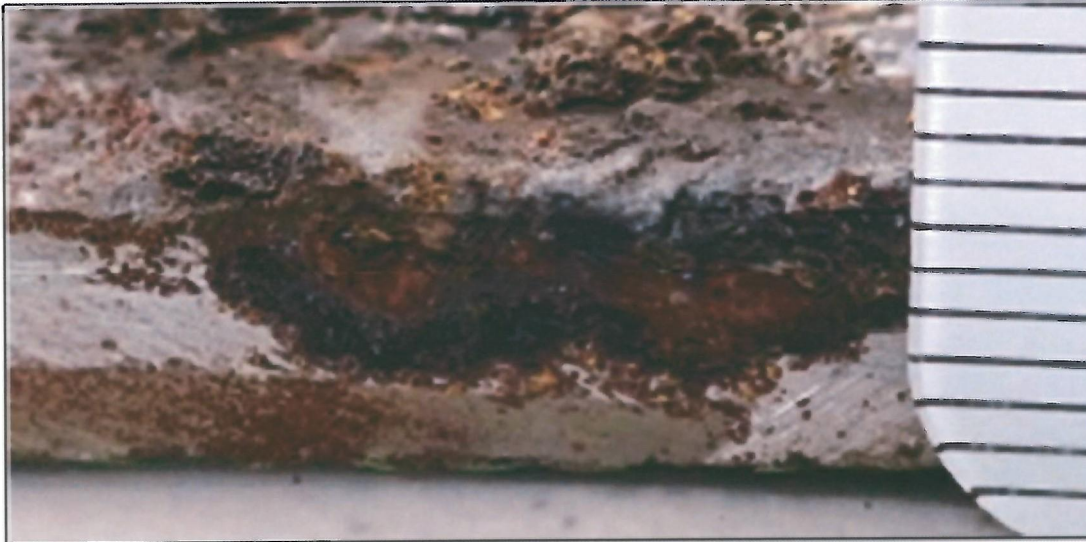
Figure A-5. The same area is shown in an image provided prior to shipping Coupon #7 to IMR (provided to IMR on March 13, 2019). What appeared to be a deep corrosion pit was actually rust-colored staining of the edge surface
