TANK 5 API 653 OUT-OF-SERVICE INSPECTION AND SUITABILITY FOR SERVICE EVALUATION FINAL CONDITION ASSESSMENT REPORT (PRE-REPAIR)

Joint Base Pearl Harbor-Hickam, HI (JBPHH)

August 20, 2020

Date of Inspection: October 2017 - January 2018

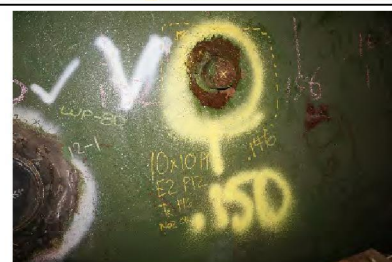
2. Thinning of 3-inch pipe caps covering the existing grout pipe and strain gauge at 5 locations was found in the extension ring.	Remove existing 3-inch pipe caps and provide patch plates. See Attachment F for quantity and locations

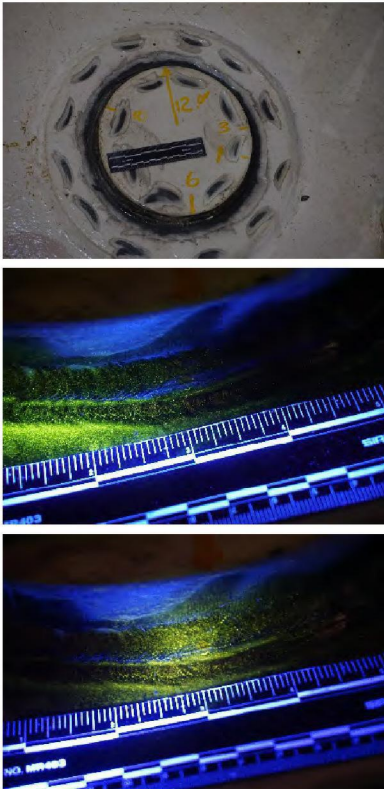
<p>4. The 8-inch drain line cover plate had 4 linear weld defects. The defects were found at the 3, 4, 6 and 10 o'clock positions and were approximately 1/8-inch in length.</p>	<p>Grind out defects and provide weld repair.</p>

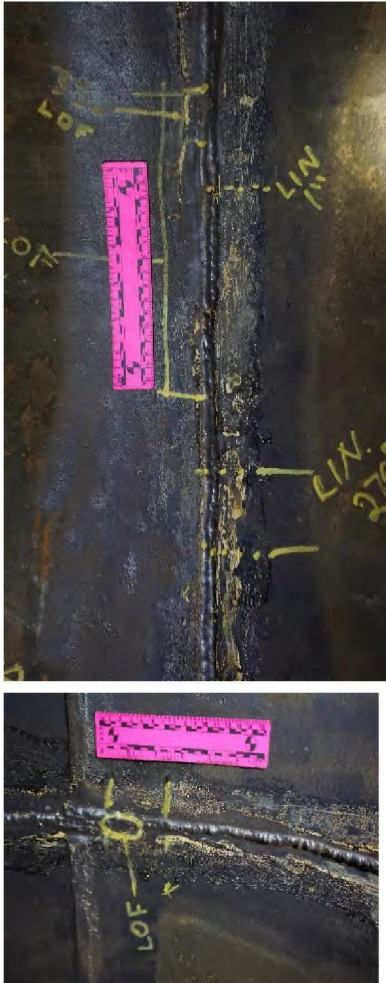
Table 5-1 Mandatory Repairs		
Finding	Repair	Photo
5. The 32-inch product line contains 10 linear weld defects throughout the line in its girth welds.	Grind out defects and provide weld repair.

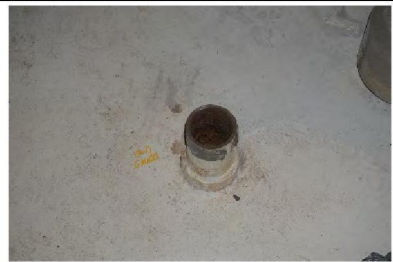
1. Approximately 6 inches of the old stilling well is still welded to the floor.	Cut off the old stilling well flush with the tank floor and provide a 6-inch patch plate over the location.

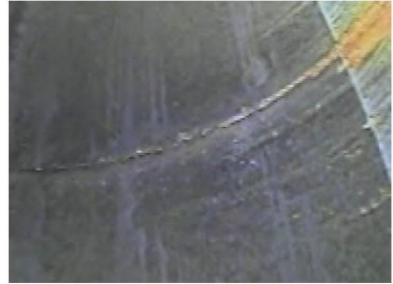
2. The 18-inch tank product line passed strength and leak tightness tests, but the pipe wall thickness could not be evaluated for the entire pipe length. Welds could only be examined using a camera.	Remove 18-inch line from service. Modify piping in lower tunnel to reconnect tank 32-inch line to tunnel 18-inch line. Provide half-inch closure plate inside tank to isolate 18-inch tank line from tank

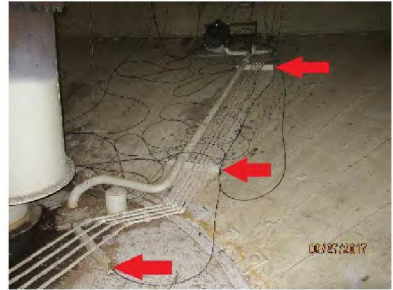
3. The steel channel supports for the drain line and sample piping are not welded to the tank all the way around the support. This allows product to fill under this area and is not accessible to inspect.	Seal weld all supports to the tank.

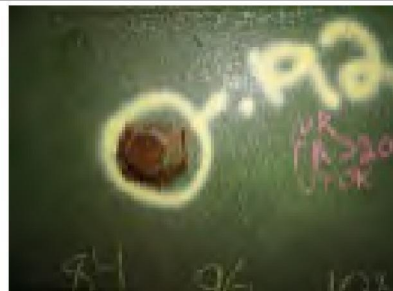
Table 5-3 Repairs For Long Term Serviceability		
Finding	Repair	Photo
1. The grout nozzles and strain gauges are covered by 3-inch pipe caps instead of ½-inch patch plates as noted on design drawings.	Remove pipe caps and provide patch plates to cover all locations. Location in tank, and overall quantities can be found in Attachment F.

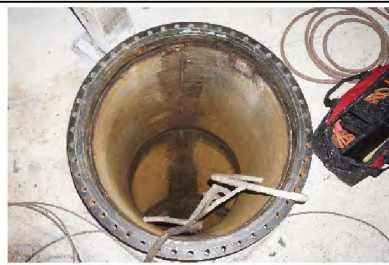
Table 5-3 Repairs For Long Term Serviceability		
Finding	Repair	Photo
2. The inside of the 32-inch line is not currently coated.	Once the 32-inch line is repaired, coat the inside of the line with Polysulfide modified Epoxy Novolac coating system used for lower dome coating. By doing so the line will be subject to less corrosion potential.

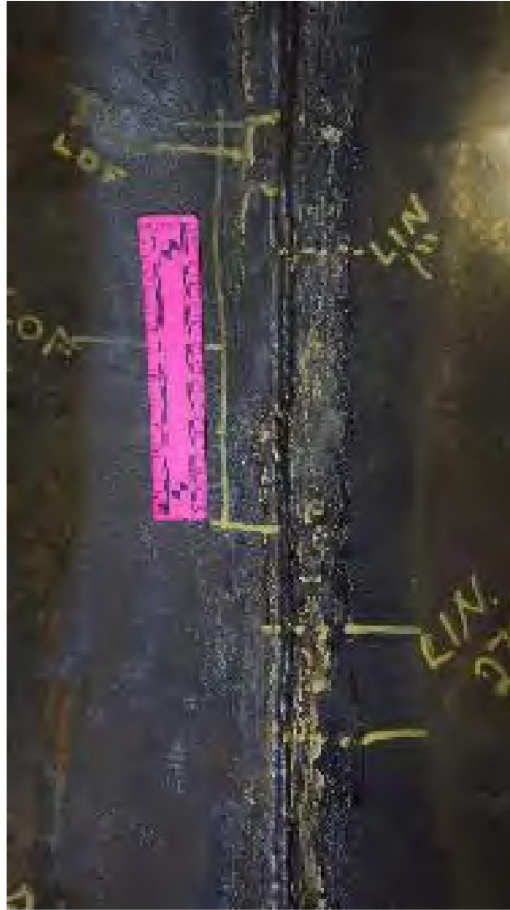
Photo 16: 32-inch piping interior pitting

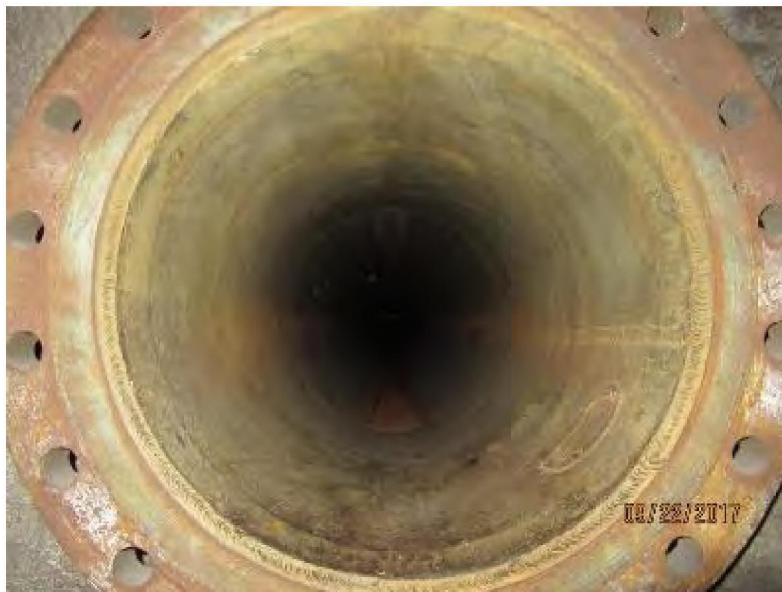
Photo 17: 32-inch pipe circumferential weld defects

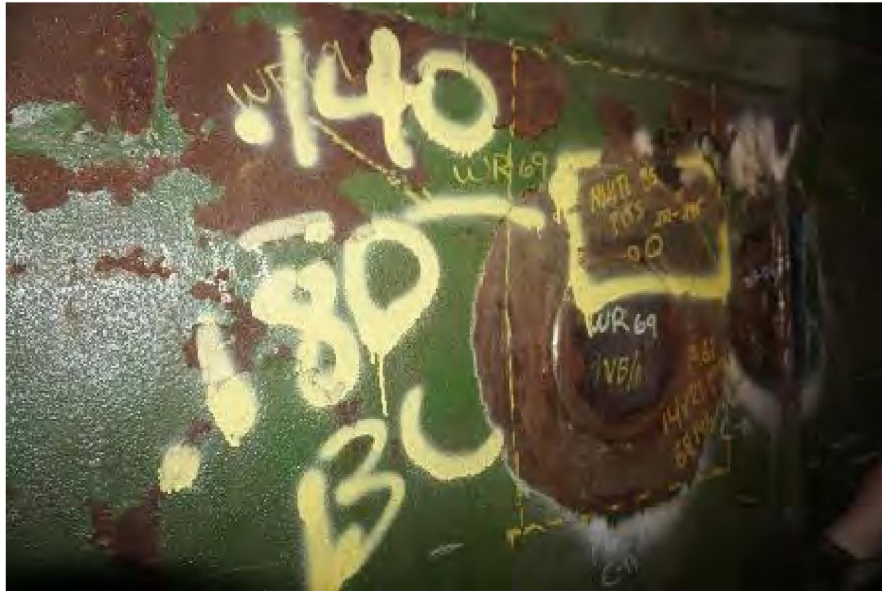
Photo 28: Backside Corrosion on existing ground areas

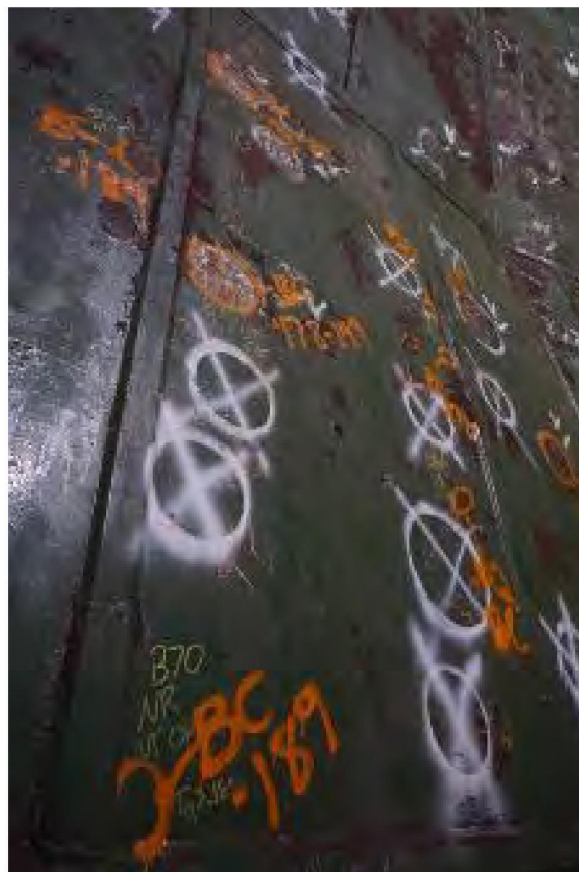
Photo 29: Backside Corrosion around existing patch plates

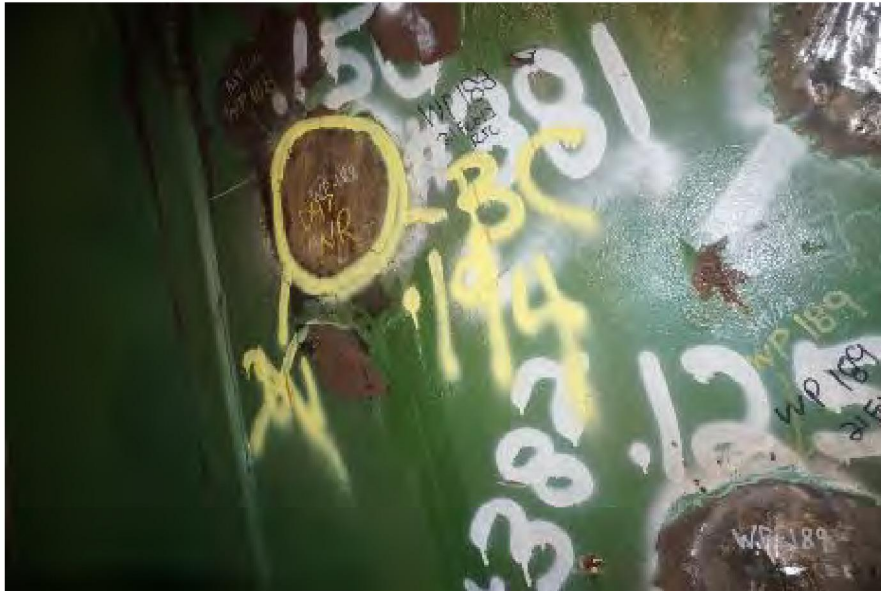
Photo 30: Multiple Backside Corrosion Indications on B Course Plate

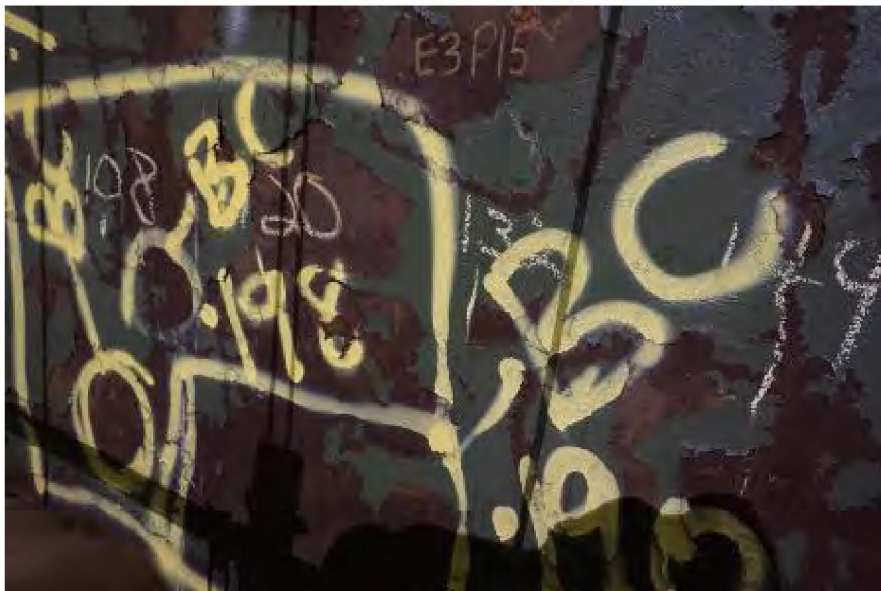
Photo 31: Typical Backside Corrosion Indication in D Course

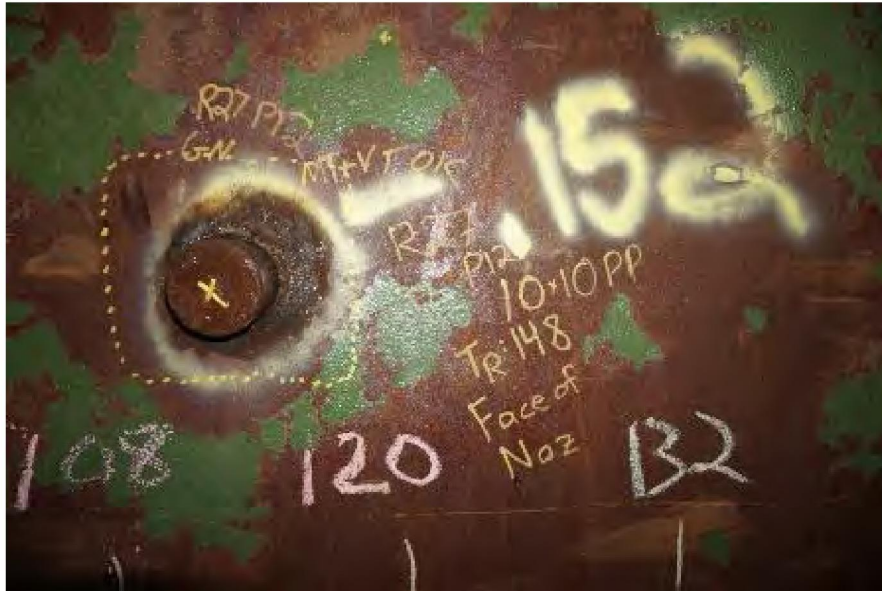
Photo 32: Larger Backside Corrosion Indications in Extension Ring Plates

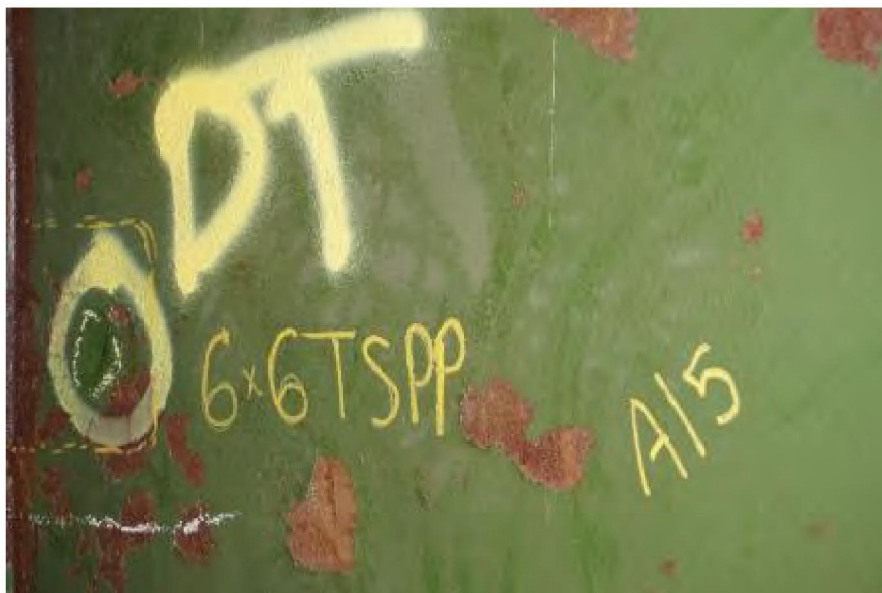
Photo 33: Pipe Cap covering existing grout nozzle with Backside Corrosion

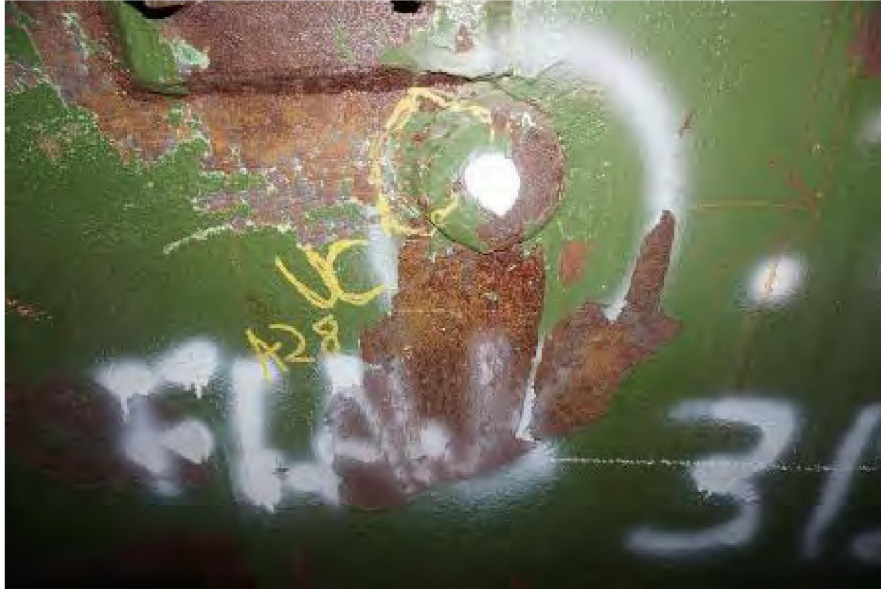
Photo 34: Dent requiring repair in A Course

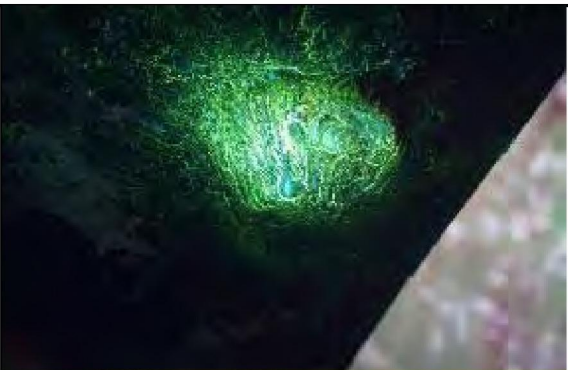
TK5-PW-103B	EXPANSION JOINT

R	Multiple L W Cracks	Grind and Re-weld 6" WR	Located on E1 P9
TK5-PW-121	Adjustment Plate

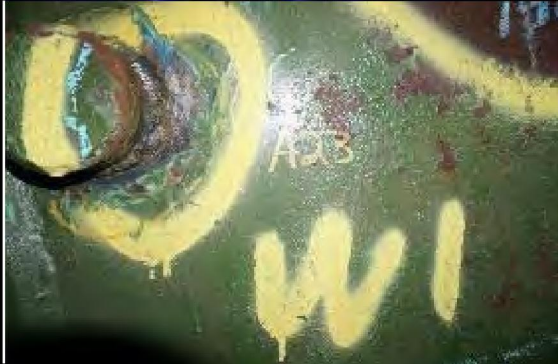
R	1/8" LW	Grind out and re-weld nozzle, failed on visual	Small indication, went away after burring out

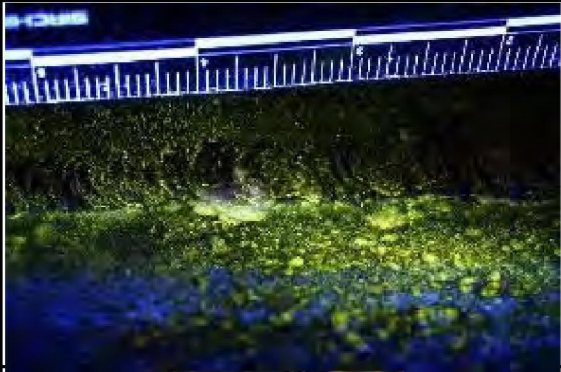
5-UD-A-24-0-27	A24

R	1/4" LT	Grind out and re-weld	Still present after burring out
5-UD-A-26-34-127	A26
