**Consolidated Construction Projects For FISC, Pearl Harbor, Hawaii**  
**Contract No. N62742-C-02-1402**  
**Clean And Repair Tanks 1 And 15, 6 And 16**  
**Weld Repair As Built Record**

**Tank 15**

**Quadrant A, B, D, Tank Floor, and Lower Dome**  
**Weld Repairs Completed June 2005**  
**Reference TESTEX Report Dated 2-18-2005**  
**And Government Provided Repair Procedure Spreadsheet**

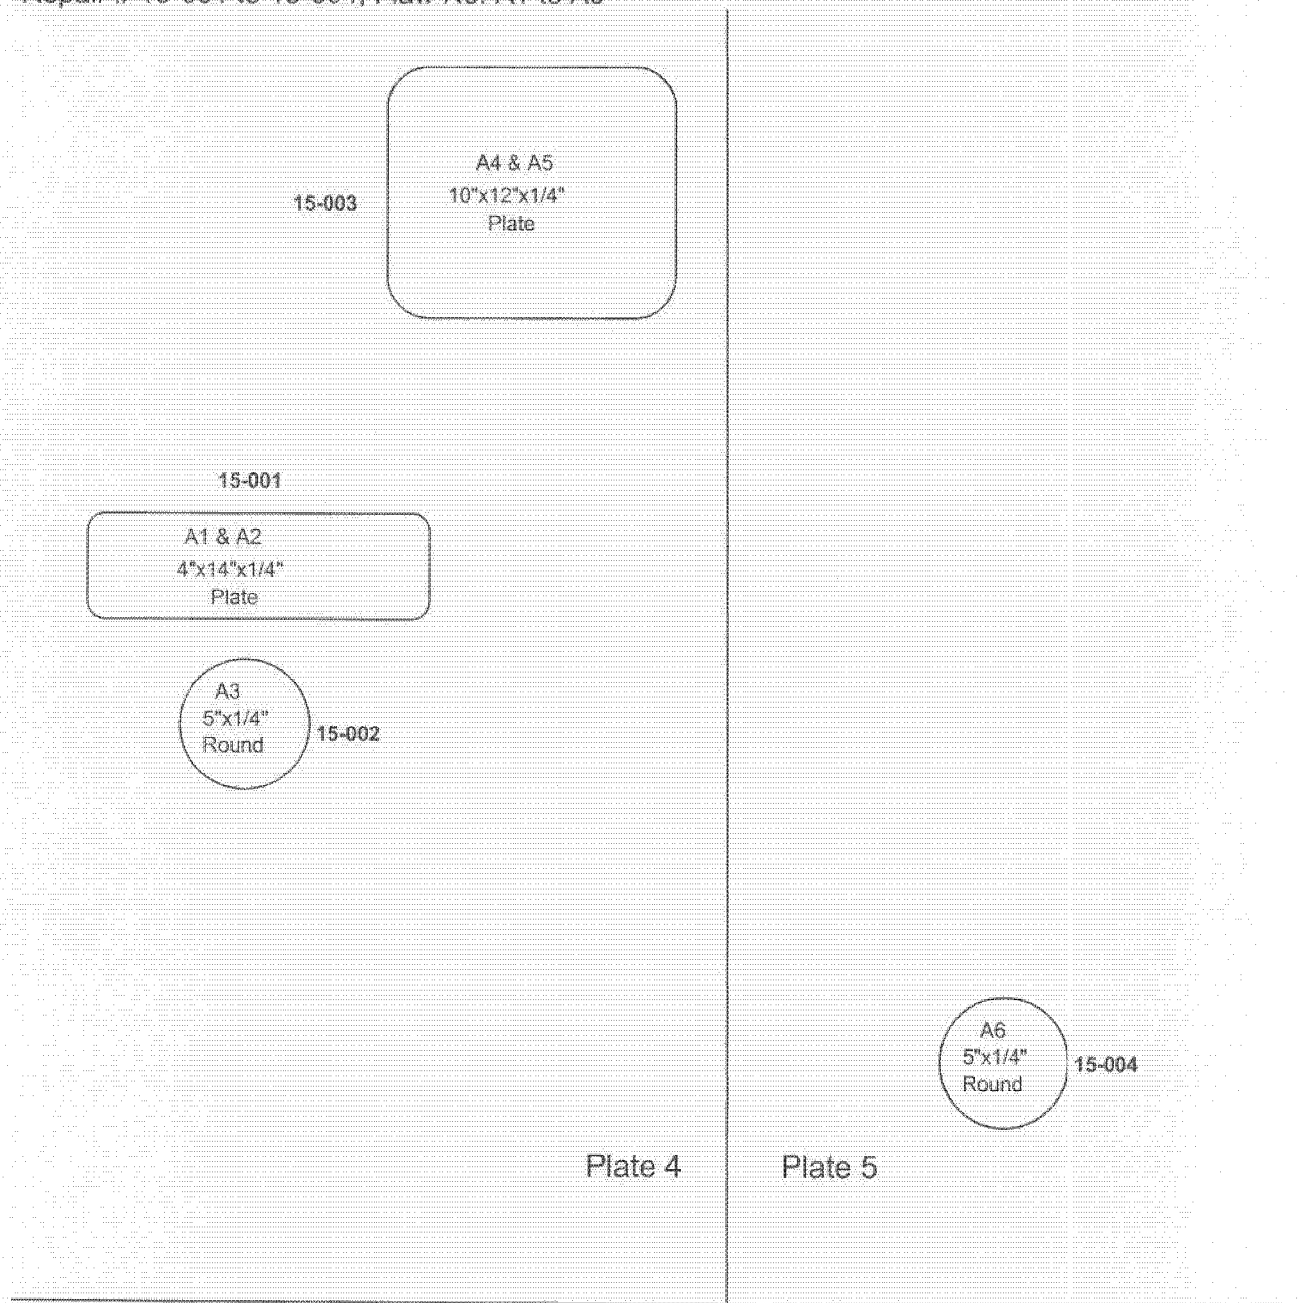
Quadrant A

Upper Dome Course A

Plates 4 & 5

Repair # 15-001 to 15-004, Flaw No. A1 to A6

| D&B Repair No. | Repair Location | Plate Number | Testex Flaw Number | E&I Repair Flaw Number | As Built Repair |
|---|---|---|---|---|---|
| 15001 | Upper Dome<br>Quadrant A | 4 | 1 | A1 | One 4"x14"x1/4" patch plate to cover A1 & A2 |
| 15002 | | 4 | 3 | A3 | 5"x1/4" round patch plate |
| 15003 | | 4 | 4 | A4 | One 10"x12"x1/4" patch plate to cover A4 & A5 |
| 15004 | | 5 | 1 | A6 | 5"x1/4" round patch plate |

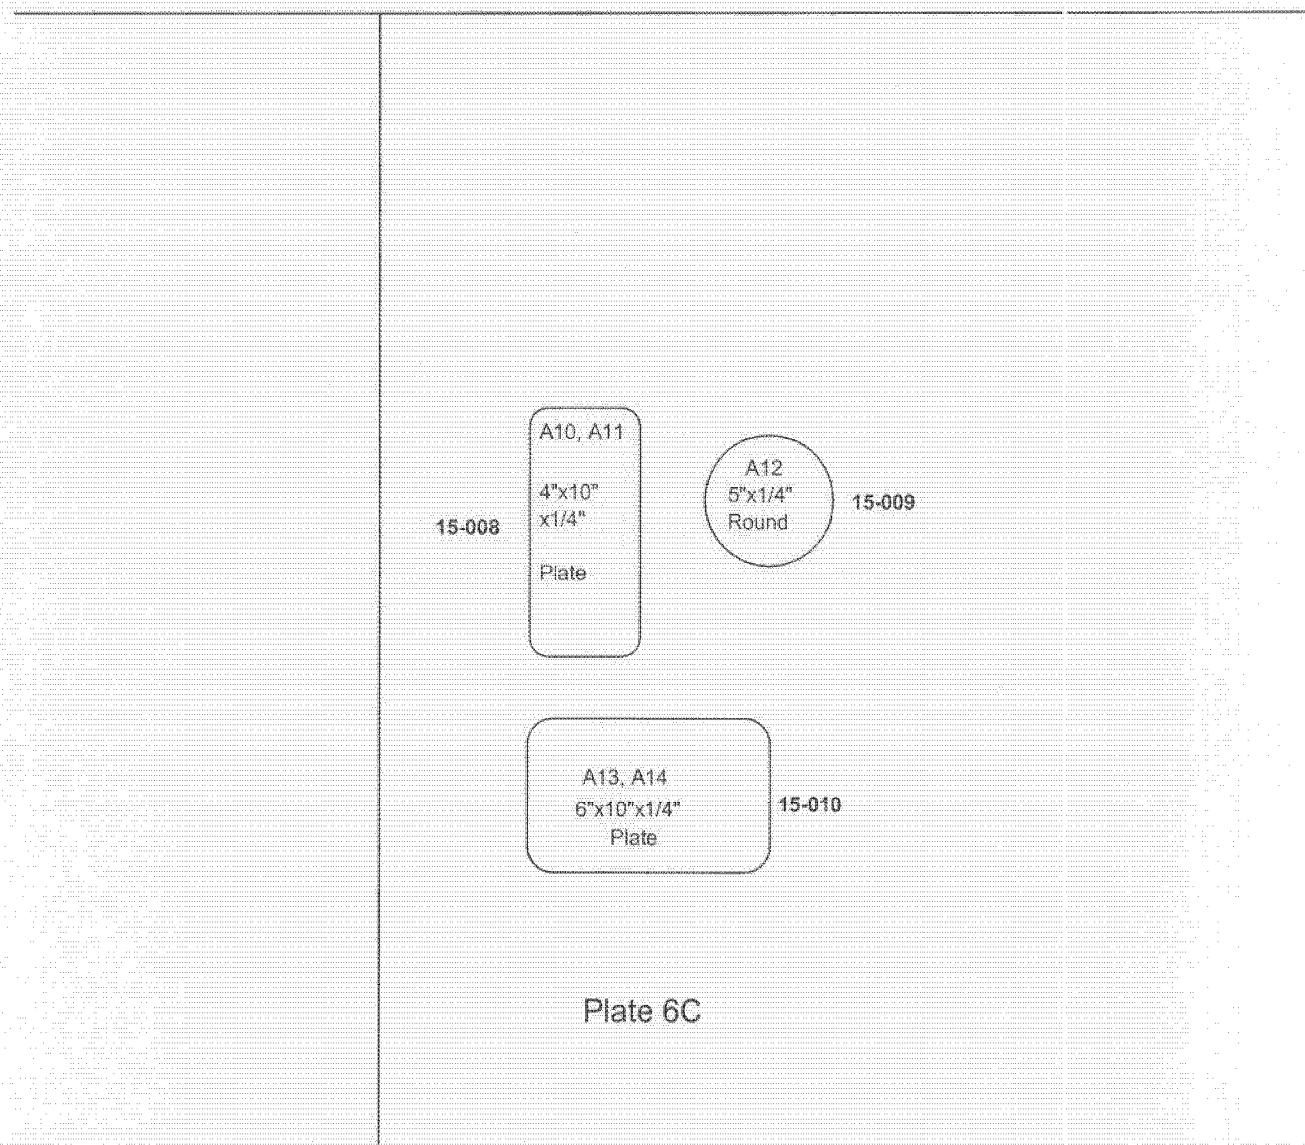
Tank 15  
Quadrant A  
Upper Dome Extension Course Row 2  
Plate 6C  
Reference TESTEX Report 2-18-2005 Page 10 Figure 8  
Repair # 15-008 to 15-010, Flaw No. A10 - A14

| D&B Repair No. | Repair Location | Plate Number | Testex Flaw Number | E&I Repair Flaw Number | As Built Repair |
|---|---|---|---|---|---|
| 15008 | | 6C | 10 | A10 | One 4"x10"x1/4" patch plate to cover A10 & A11 |
| 15010 | | 6C | 13 | A13 | One 6"x10"x1/4" patch plate to cover A13 & A14 |

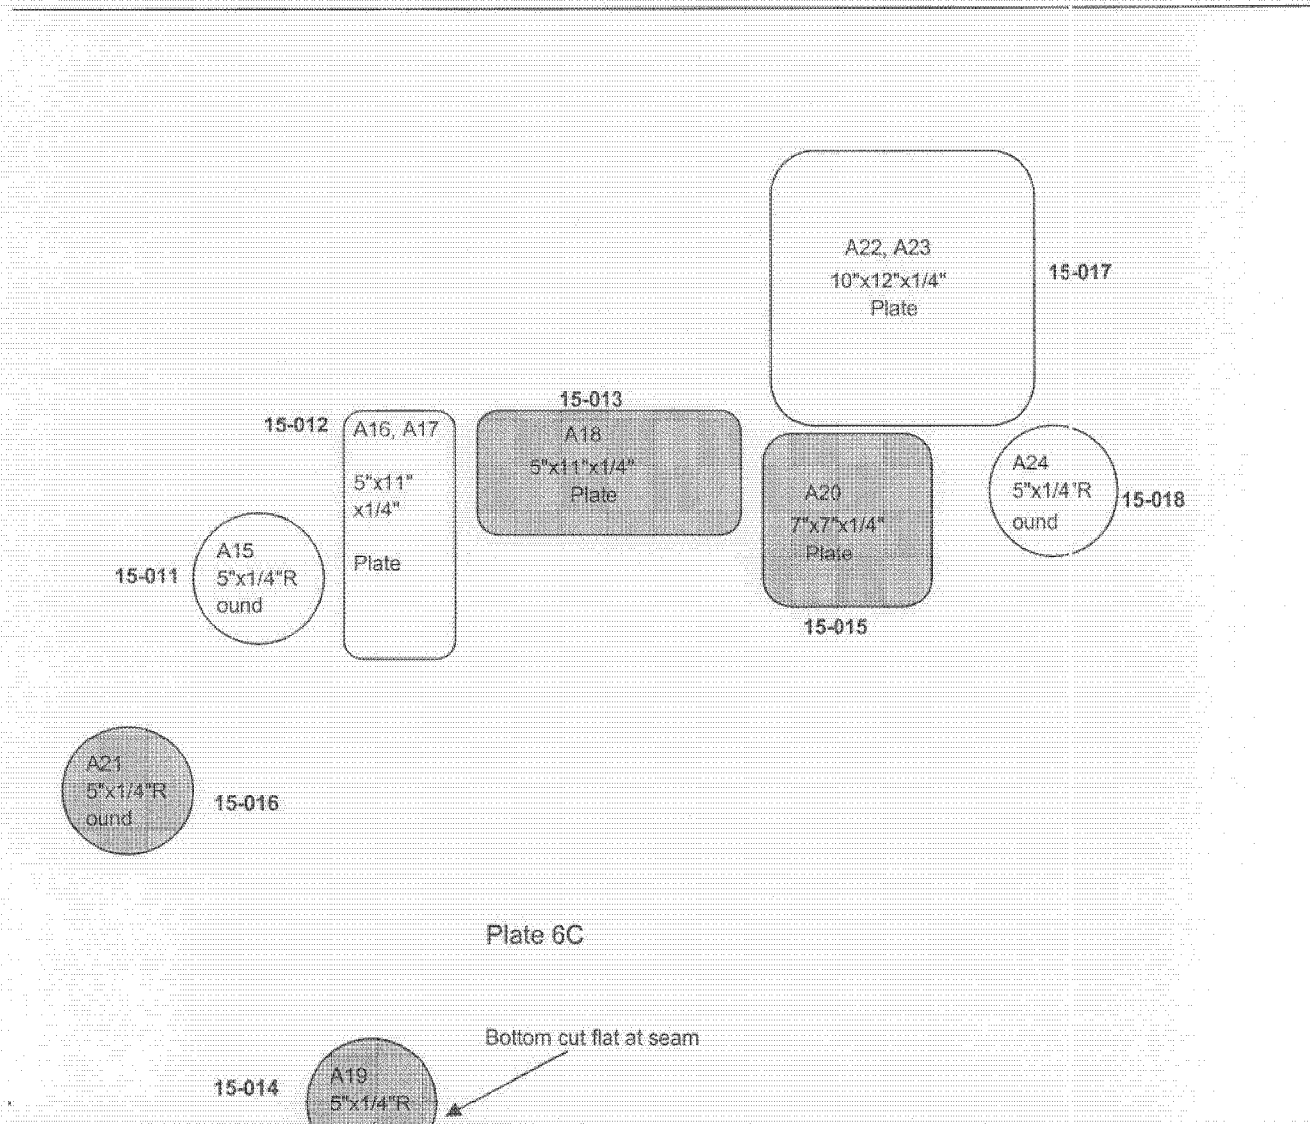
Tank 15  
Quadrant A  
Upper Dome Extension Course Row 2  
Plate 6C  
Reference TESTEX Report 2-18-2005 Page 10 Figure 8  
Repair # 15-011 to 15-018, Flaw No. A15 - A24  
Modified plate size due to field conditions

| D&B Repair No. | Repair Location | Plate Number | Testex Flaw Number | E&I Repair Flaw Number | As Built Repair |
|---|---|---|---|---|---|
| 15011 | | 6C | 15 | A15 | 5"x1/4" round patch plate |
| 15012 | | 6C | 16 | A16 | One 5"x11"x1/4" patch plate to cover A16 & A17 |
| 15013 | | 6C | 18 | A18 | 5"x11"x1/4" patch plate |
| 15014 | | 6C | 19 | A19 | 5"x1/4" round patch plate |
| 15015 | | 6C | 20 | A20 | 7"x7"x1/4" patch plate |
| 15016 | | 6C | 21 | A21 | 5"x1/4" round patch plate |
| 15017 | | 6C | 22 | A22 | One 10"x12"x1/4" patch plate to cover A22 & A23 |
| 15018 | | 6C | 24 | A24 | 5"x1/4" round patch plate |

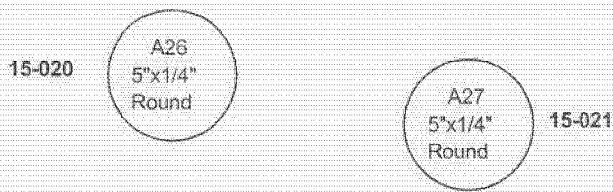
Tank 15  
Quadrant A  
Upper Dome Extension Course Row 2  
Plate 9C  
Reference TESTEX Report 2-18-2005 Page 12 Figure 11  
Repair # 15-020 to 15-021 Flaw No. A26, A27

| D&B Repair No. | Repair Location | Plate Number | Testex Flaw Number | E&I Repair Flaw Number | As Built Repair |
|---|---|---|---|---|---|
| 15020 | | 9C | 26 | A26 | 5"x1/4" round patch plate |
| 15021 | | 9C | 27 | A27 | 5"x1/4" round patch plate |

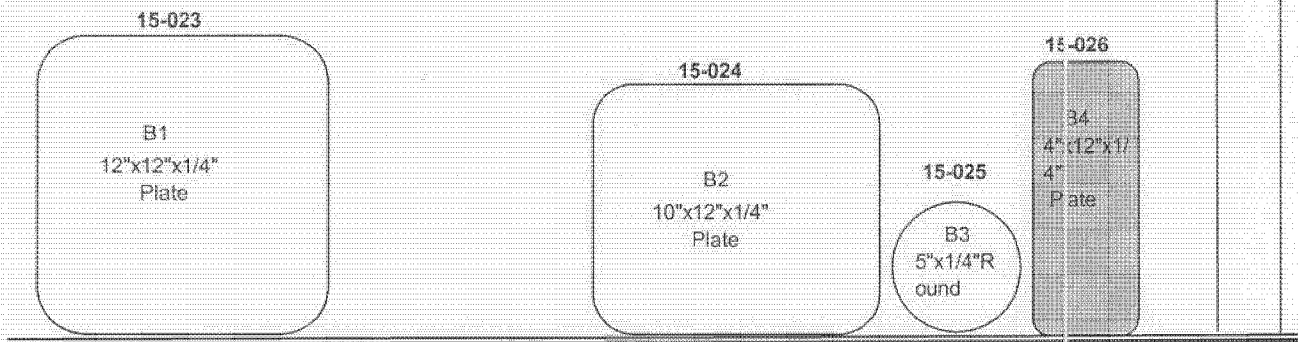
Tank 15  
Quadrant B  
Upper Dome Course A  
Plate 22  
Reference TESTEX Report 2-18-2005 Page 15 Figure 14  
Repair # 15-023 to 15-026, Flaw No. B1-B4  
Modified plate size due to field conditions

| D&B Repair No. | Repair Location | Plate Number | Testex Flaw Number | E&I Repair Flaw Number | As Built Repair |
|---|---|---|---|---|---|
| 15023 | Quadrant B | 22 | 1 | B1 | 12"x12"x1/4" patch plate |
| 15024 | | 22 | 2 | B2 | 10"x12"x1/4" patch plate |
| 15025 | | 22 | 3 | B3 | 5"x1/4" round patch plate |
| 15026 | | 22 | 4 | B4 | 4"x12"x1/4" patch plate |

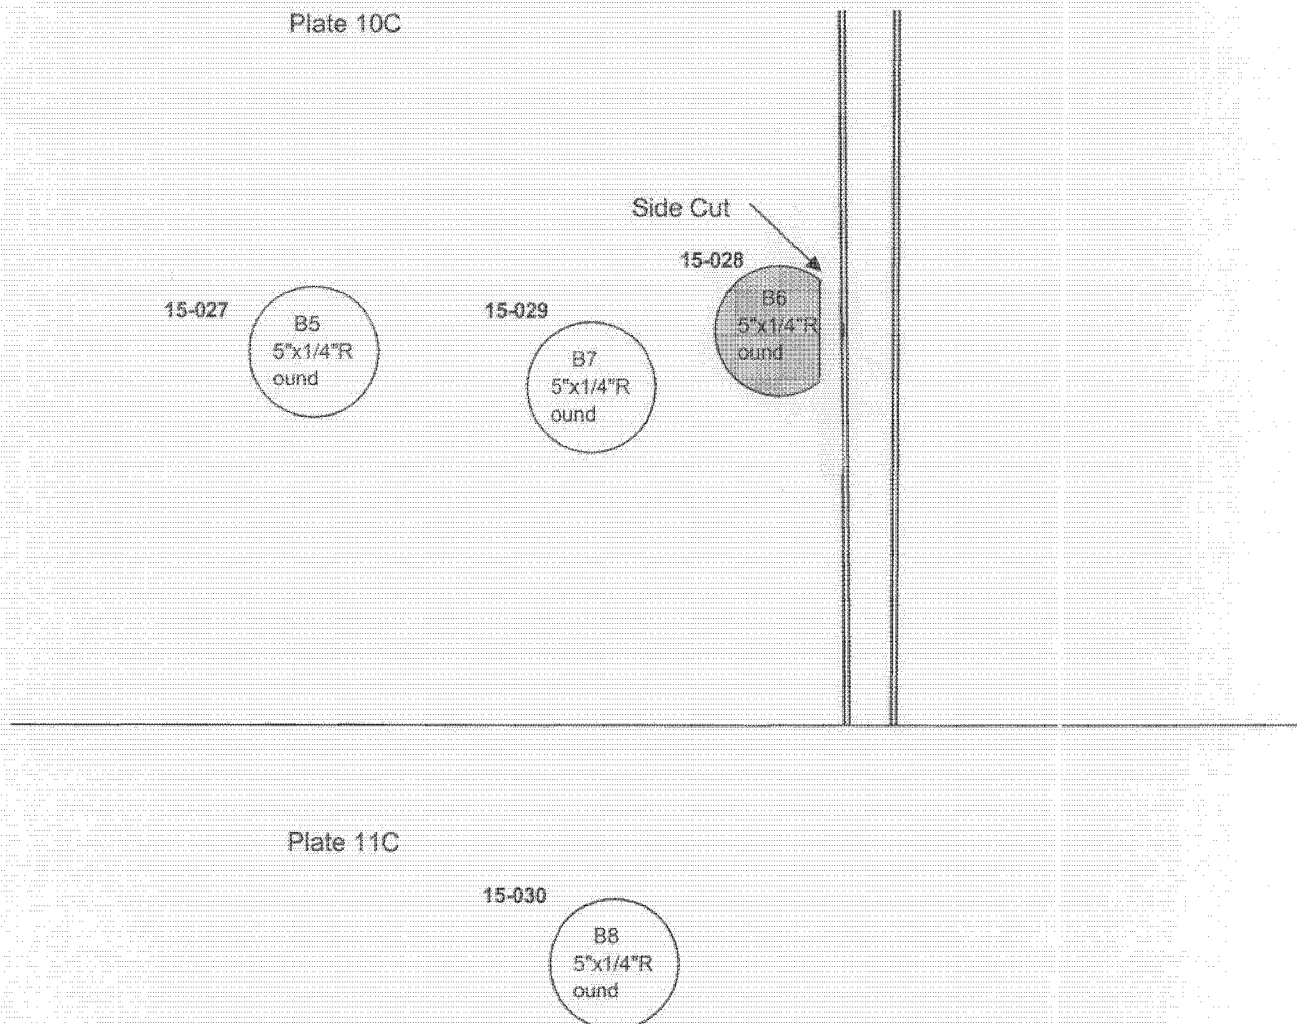
Plates 10C and 11C

Repair # 15-027 to 15-030, Flaw No. B5-B8

Plate Modified Due To Field Conditions

| D&B Repair No. | Repair Location | Plate Number | Testex Flaw Number | E&I Repair Flaw Number | As Built Repair |
|---|---|---|---|---|---|
| 15027 | | 10C | 1 | B5 | 5"x1/4" round patch plate |
| 15028 | | 10C | 2 | B6 | 5"x1/4" round patch plate |
| 15029 | | 10C | 3 | B7 | 5"x1/4" round patch plate |
| 15030 | | 11C | 1 | B8 | 5"x1/4" round patch plate |

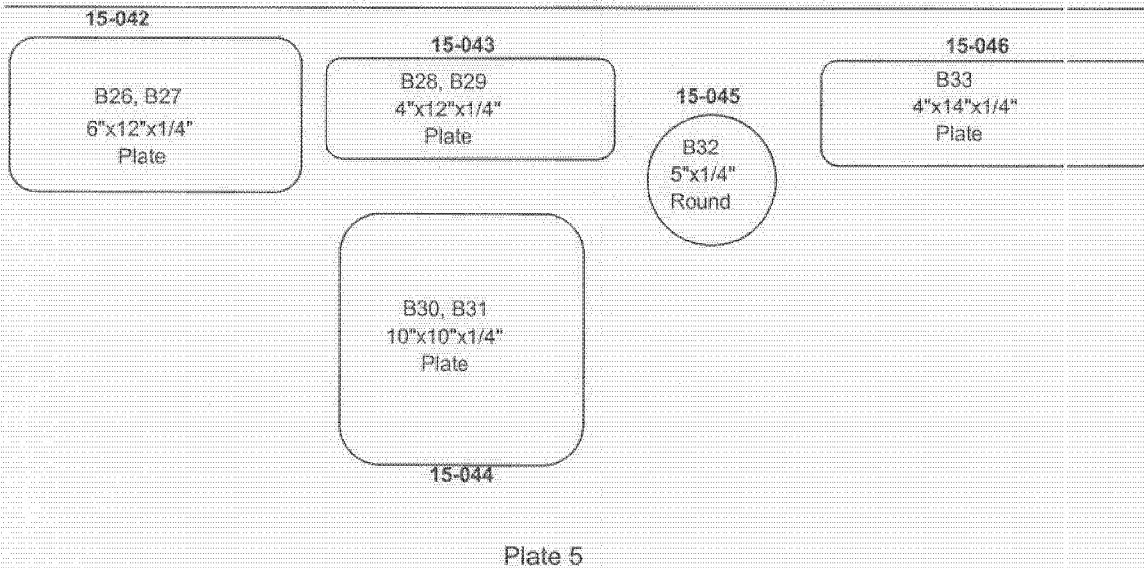
Plate 5

Repair # 15-042 to 15-046, Flaw No. B26-B33

| Tank 15 As Built Repair Summary | | | Testex | E&I | |
|---|---|---|---|---|---|
| 15042 | | 5 | 1 | B26 | One 6"x12"x1/4" patch plate to cover B26 & B27 |
| 15043 | | 5 | 3 | B28 | One 4"x10"x1/4" patch plate to cover B28 & B29 |
| 15044 | | 5 | 5 | B30 | One 6"x12"x1/4" patch plate to cover B30 & B31 |
| 15045 | | 5 | 7 | B32 | 5"x1/4" round patch plate |
| 15046 | | 5 | 8 | B33 | 4"x14"x1/4" patch plate |

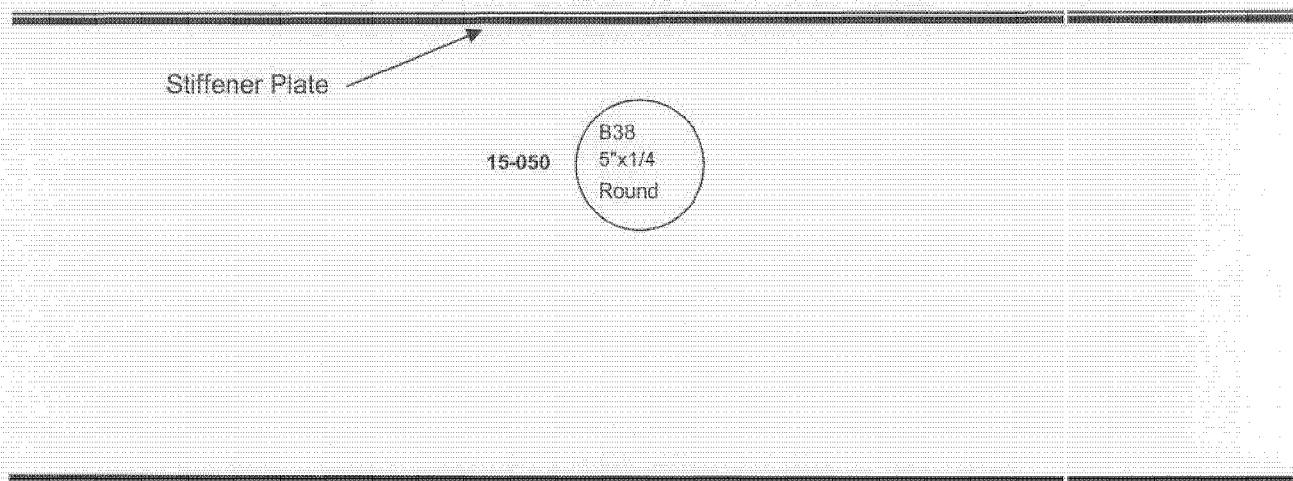
Tank 15  
Quadrant B  
Extension Course Row 4 Stiffener Plate  
Above Vertical Scan 3  
Reference TESTEX Report 2-18-2005 Page 21 Figure 24  
Repair # 15-050, Flaw No. B38

| Tank 15 As Built Repair Summary | | | Testex | E&I | |
|---|---|---|---|---|---|
| 15050 | | Vert Scan 3 | 1 | B38 | 5"x1/4" round patch plate |

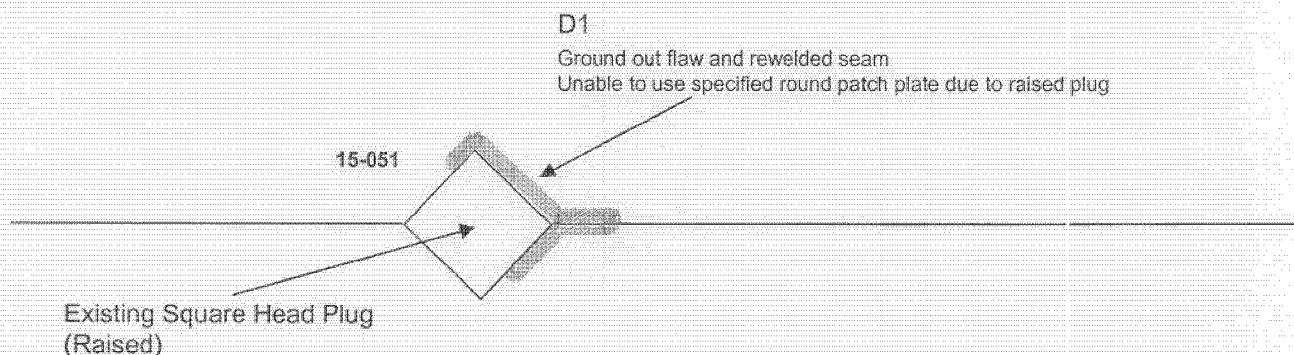
Tank 15  
Quadrant D  
Barrel Row 23  
Vertical Scan 5  
Reference TESTEX Report 2-18-2005 Page 24 Figure 27  
Repair # 15-051, Flaw No. D1  
Modified Due To Field Conditions

| Tank 15 As Built Repair Summary | | | Testex | E&I | |
|---|---|---|---|---|---|
| 15051 | Quadrant D | Vert Scan 5 | 1 | D1 | Weld repair around plug approximately 6" |

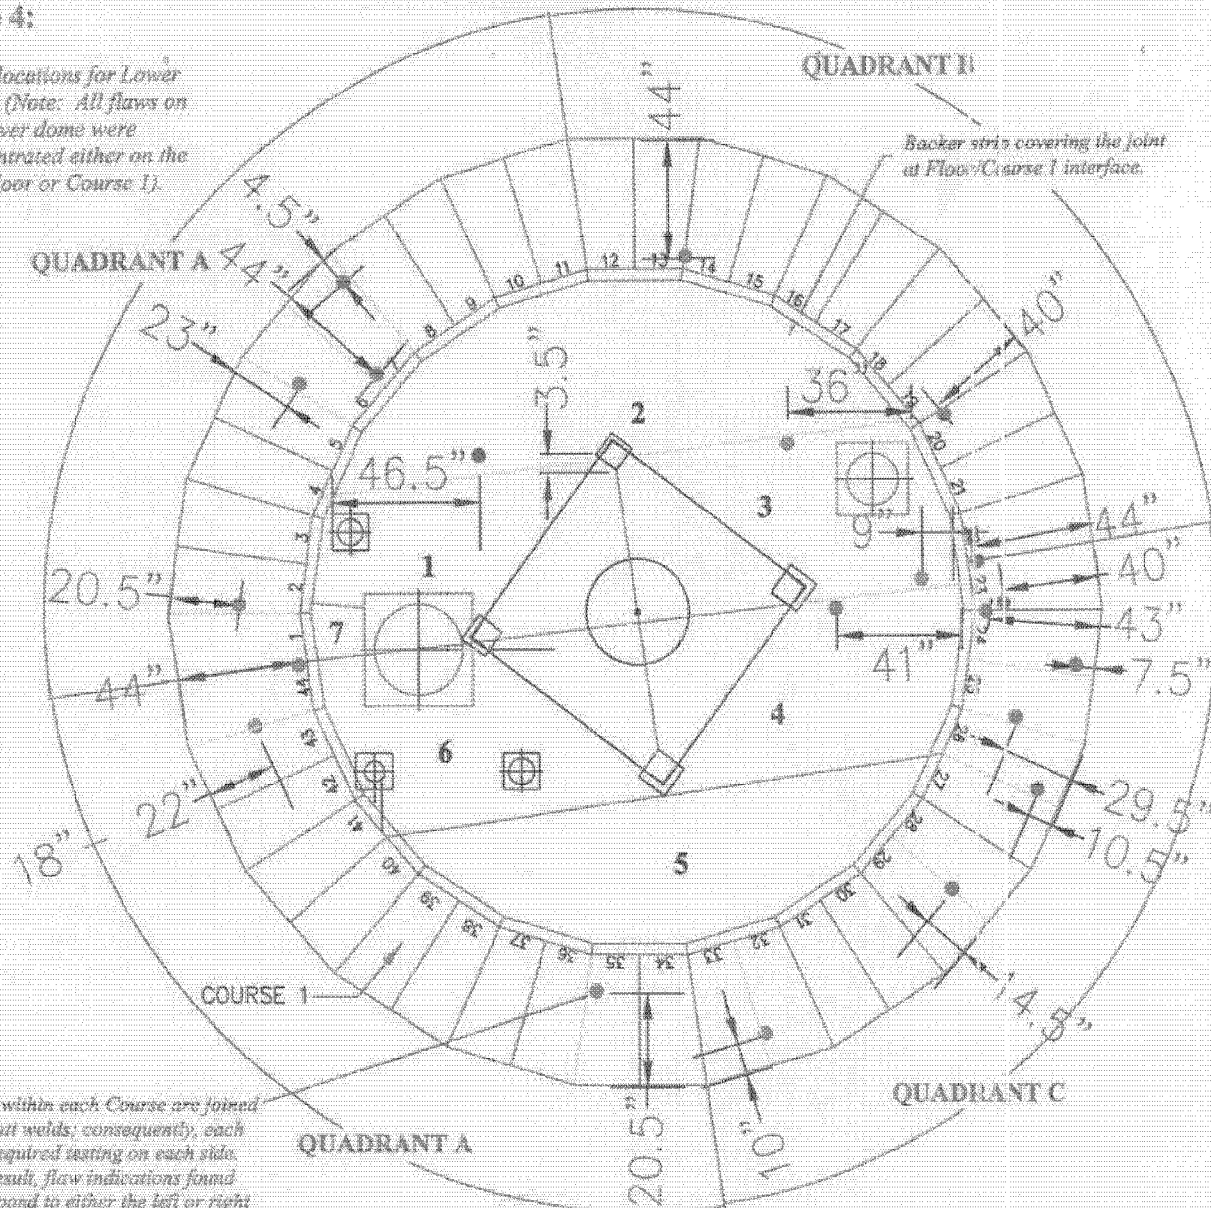
Figure 4:

Flaw locations for Lower Dome (Note: All flaws on the lower dome were concentrated either on the tank floor or Course 1).

Plates within each Course are joined with butt welds; consequently, each weld required testing on each side. As a result, flaw indications found correspond to either the left or right side of the weld line as depicted here.

Reference TESTEX Report 2-18-2005 Page 7 Figure 4  
Repair # 15-053 to 15-073, Flaw No. As Indicated

Each repair includes 2 Inert holes that were plugged, seal welded, and tested after repair work was completed. Repair 15-056 inert holes were repaired with 5" diameter round plates. Repairs 15-064 and 15-065 had common inert holes.

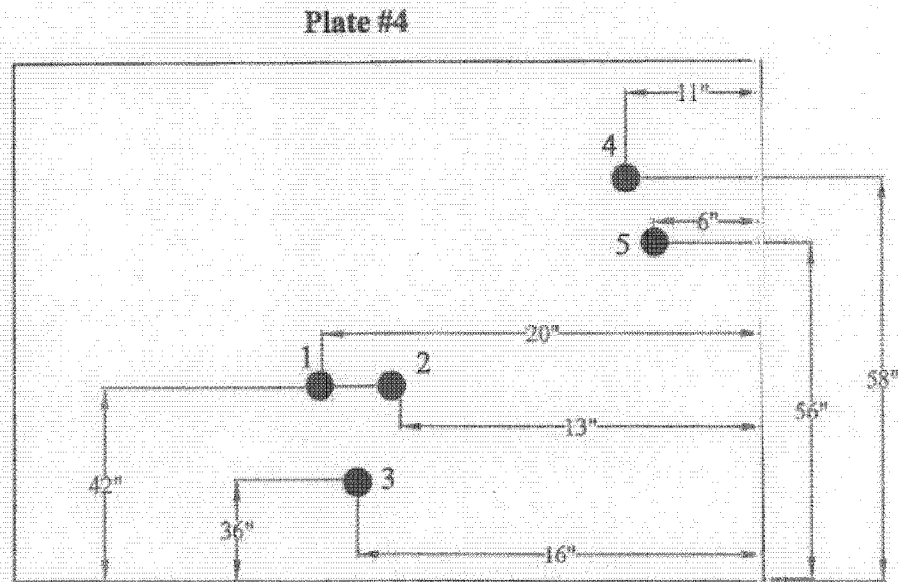
**Figure 6:**

**Thickness:**  
 1 - 0.156"  
 2 - 0.098"  
 3 - 0.146"  
 4 - Thru-hole  
 5 - 0.119"

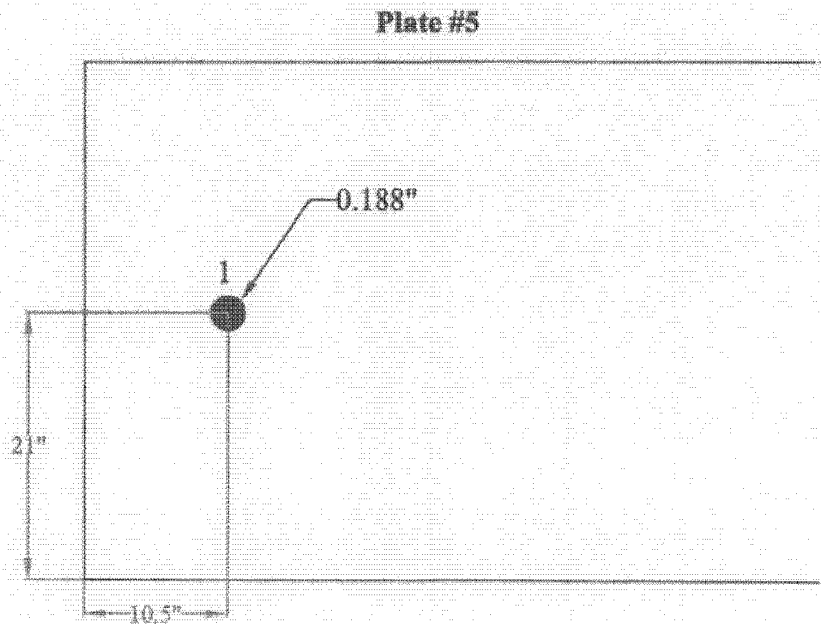
**Figure 7:**

**Thickness:**  
 1 - 0.188"

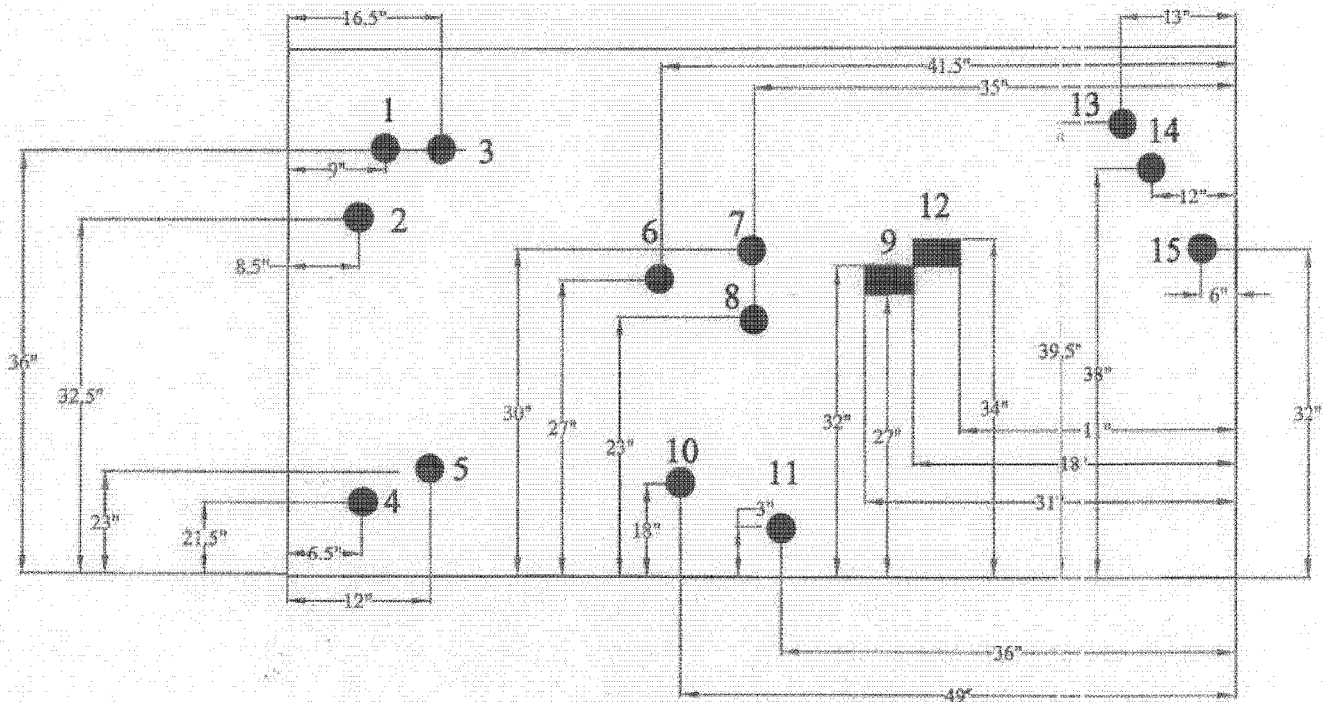
Figure 8:

Plate # 6C

| 1 - 0.178" | 6 - 0.101" | 11 - 0.175" |

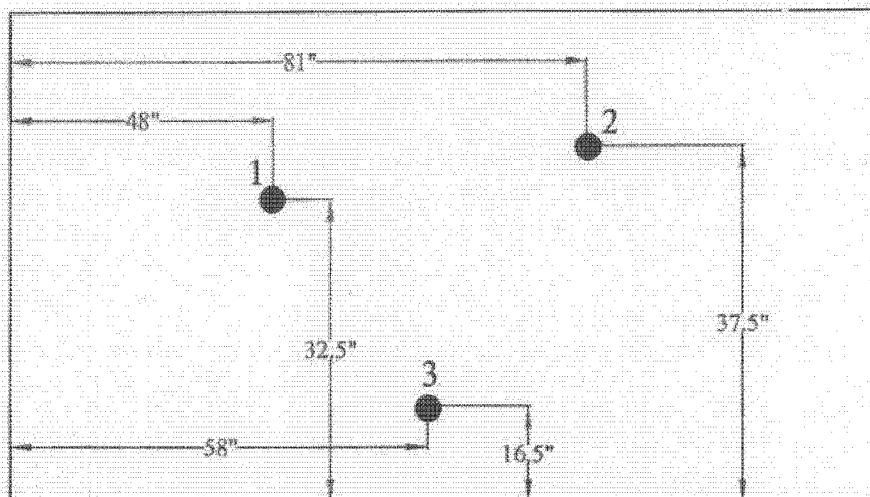
**Plate # 5C**

**Thickness:**  
 1 - 0.159"  
 2 - Gouge  
 3 - Dent &  
 Gouge

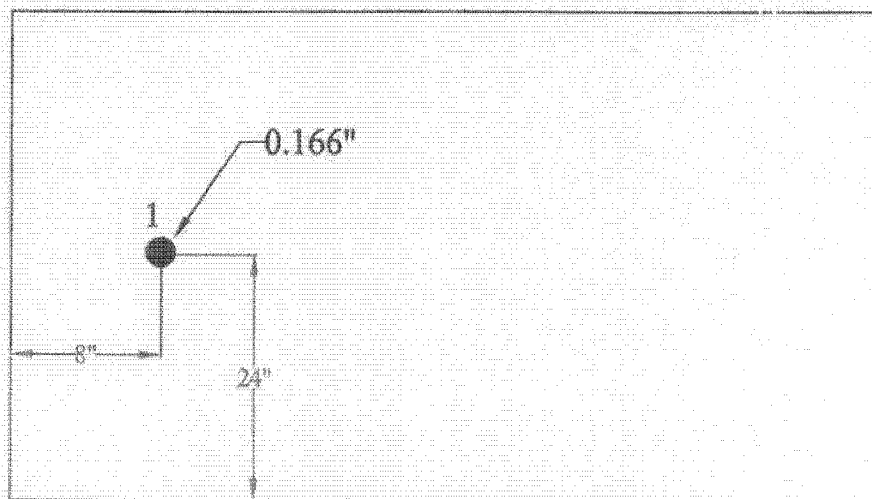
**Figure 10:**

**Thickness:**  
 1 - 0.166"

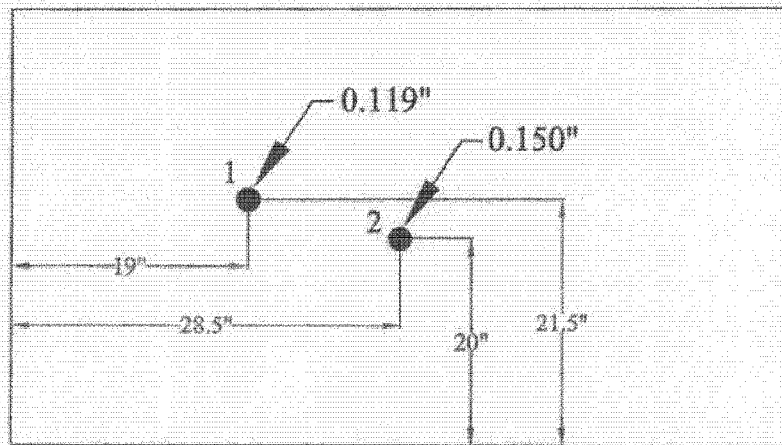
1 - 0.119"

2 - 0.150"

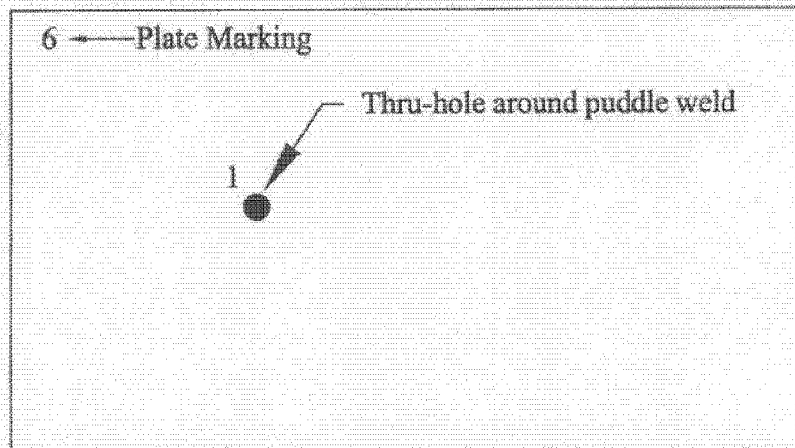
**Figure 12:**

**Thickness:**  
**1 - Thru-hole**

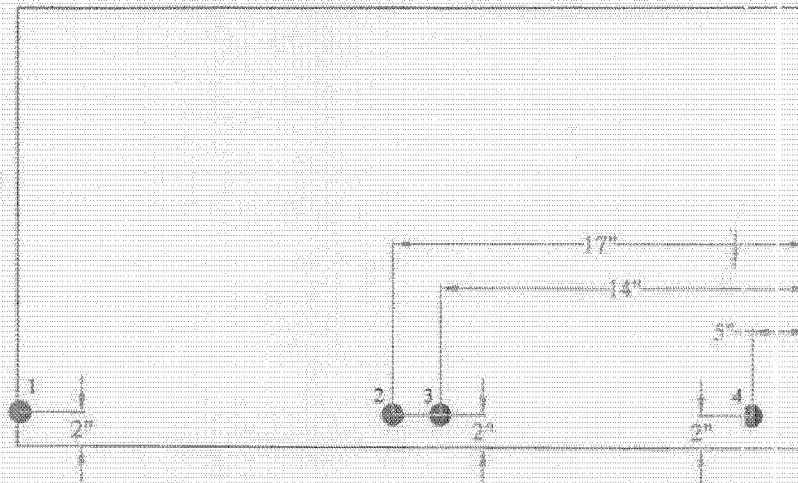
**Plate # 22**

**Thickness:**  
1 - 0.090"  
2 - Thru-hole  
3 - 0.196"  
4 - 0.183"

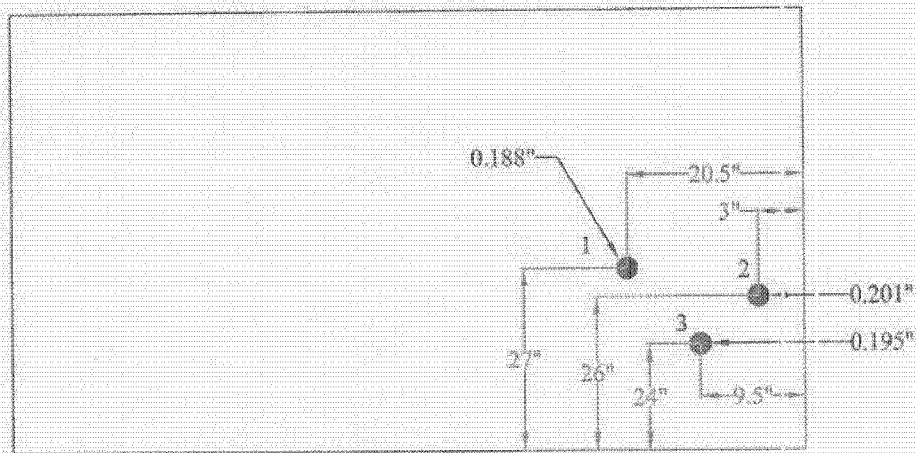
2 - 0.201"

3 - 0.195"

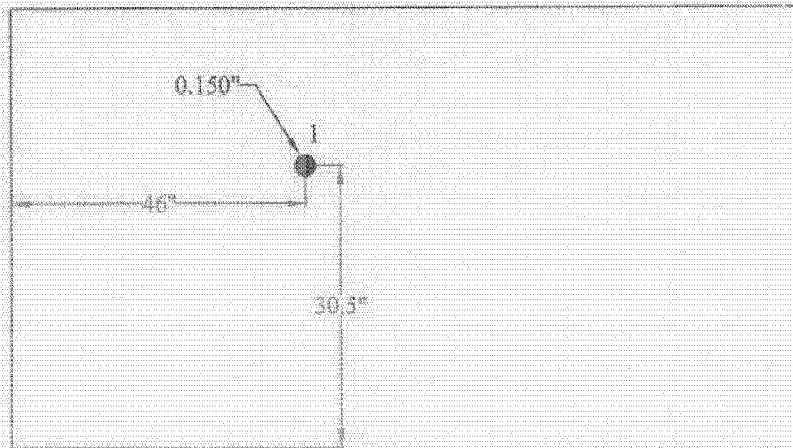
Figure 16:

1 - 0.150"

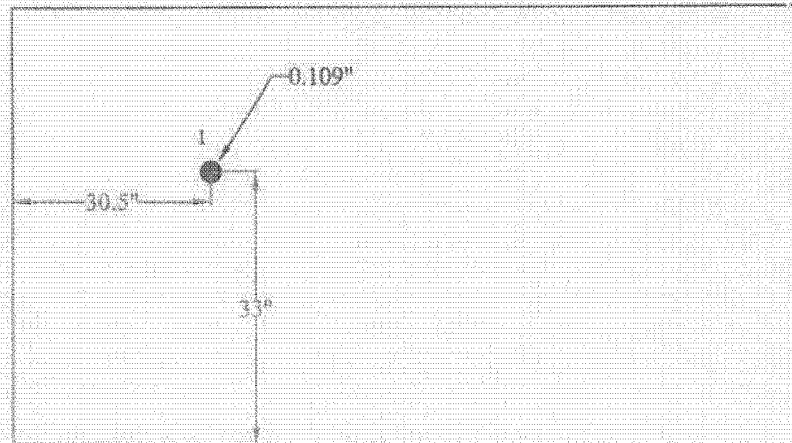
Figure 17:

Thickness:  
 1 - 0.109"

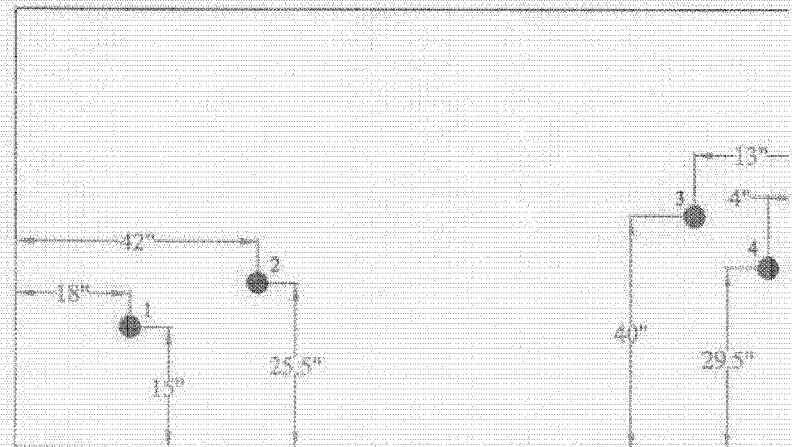
Figure 18:

Thickness:  
 1 - 0.199"  
 2 - 0.175"  
 3 - 0.186"  
 4 - 0.177"

| Quadrant B Upper Dome Repairs | | | | | |
|---|---|---|---|---|---|
| 14C | 4 | B-13 | .177" | | Field verify extent of corrosion |

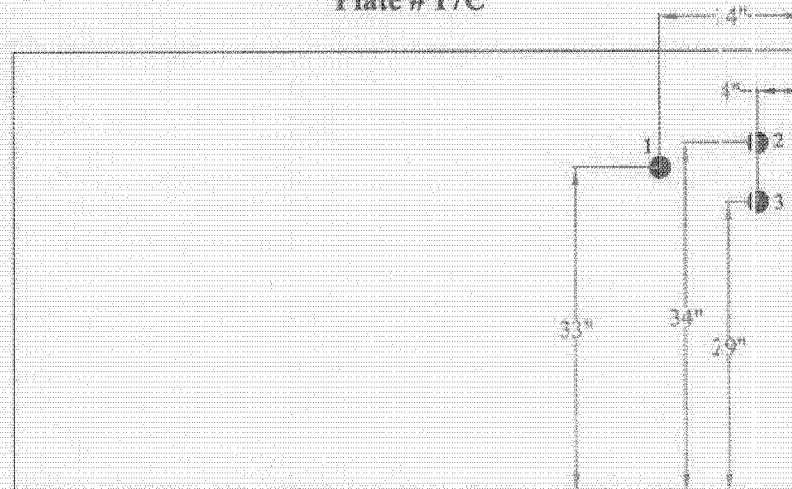
Figure 19:

Thickness:  
 1 - 0.145"  
 2 - 0.180"  
 3 - 0.150"

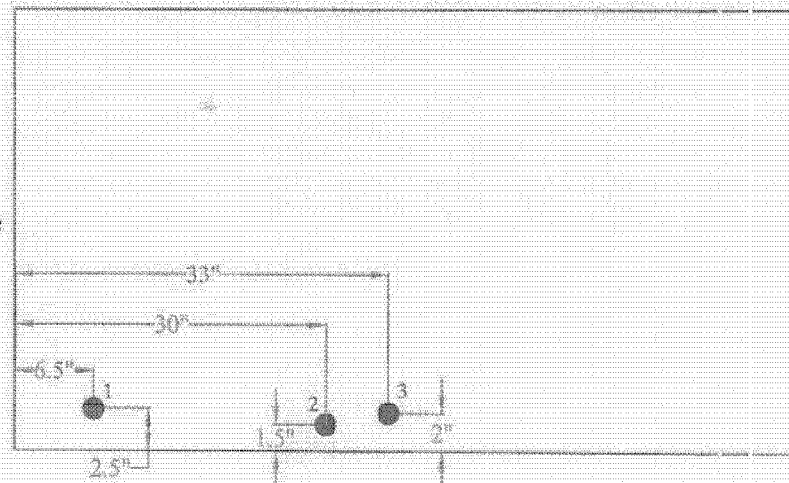
Figure 20:

Thickness:  
 1 - 0.150"  
 2 - 0.139"  
 3 - Thru-hole

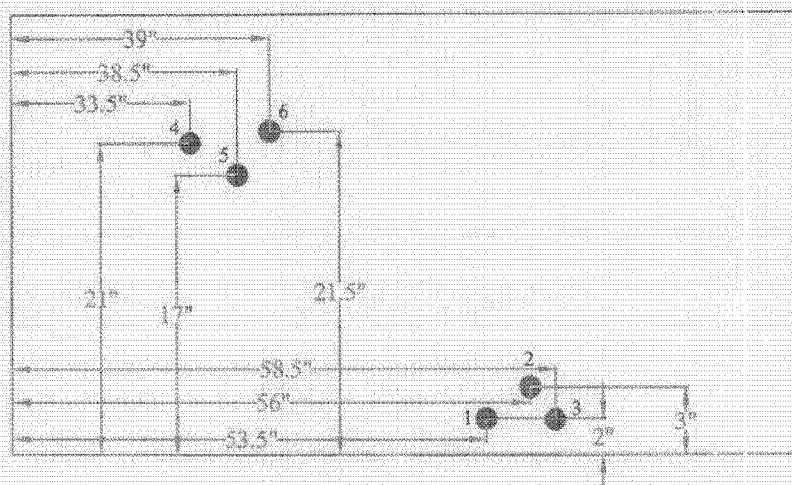
Figure 21:

Thickness:  
 1 - 0.220"  
 2 - Thru-hole  
 3 - 0.230"  
 4 - 0.108"  
 5 - 0.133"  
 6 - 0.157"

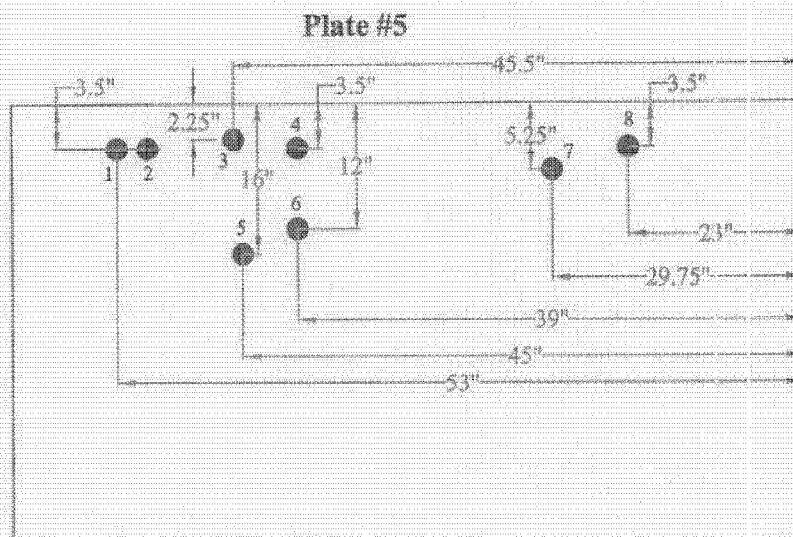
- 1 - 0.200"
- 2 - 0.193"
- 3 - Thru-hole
- 4 - 0.160"
- 5 - 0.161"
- 6 - 0.120"
- 7 - Thru-hole
- 8 - 0.150"

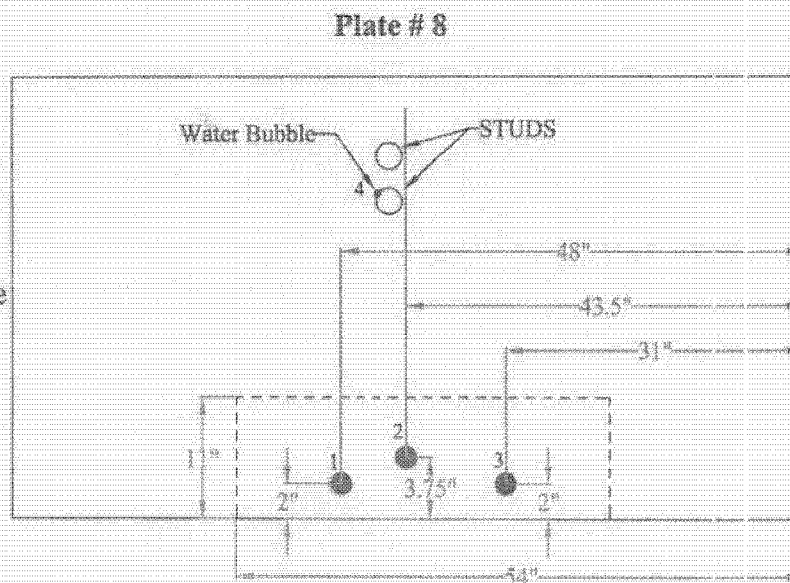
Figure 23:

- 1 - Thru-hole
- 2 - 0.150"
- 3 - Thru-hole
- 4 - Water Bubble

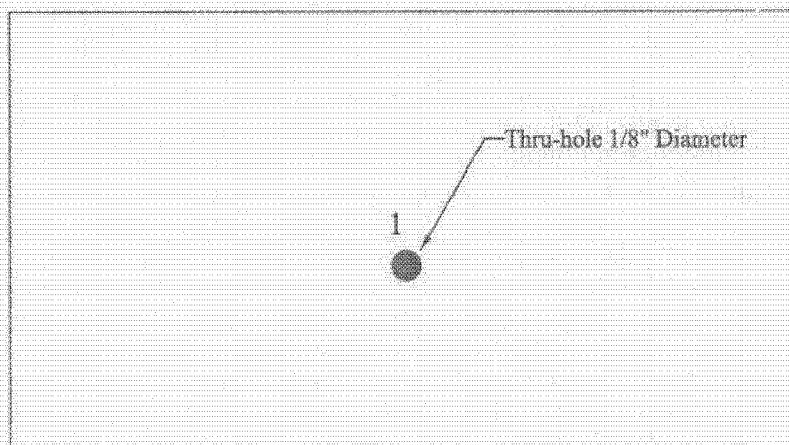
**Figure 24:**  
**Thickness:**  
**1 - Thru-hole**

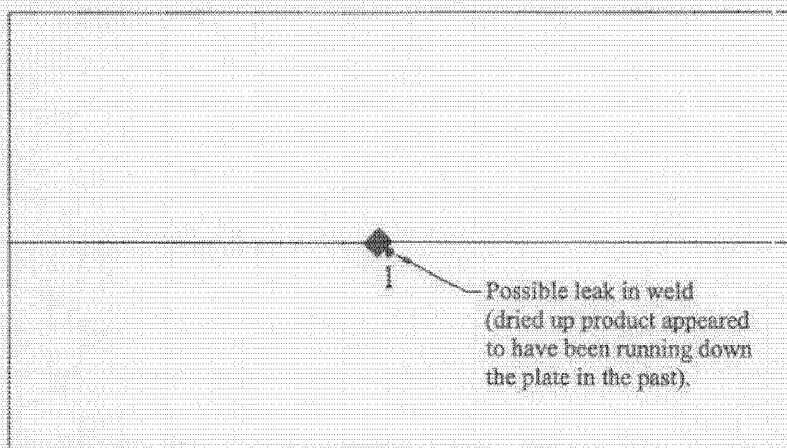
Figure 27:

Thickness:  
1 - Possible  
Leak

| Quadrant D Upper Dome Repairs | | | | | |
|---|---|---|---|---|---|
| In Vertical Scan #5 | 1 | D-1 | Possible leak in weld (dried up product apparent on plate) | - | 4" x 1/4" Round Patch Plate |

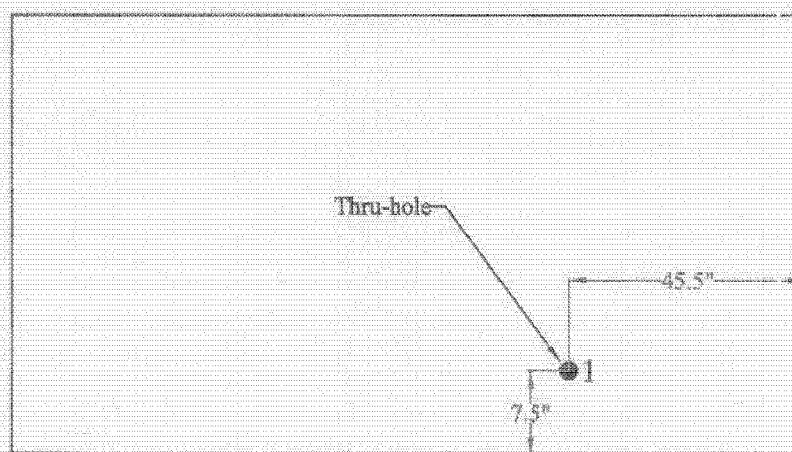
**Figure 28:**

**Thickness:  
1 - Thru-hole**
