Red Hill Administrative Order on Consent, Attachment A Scope of Work Deliverable

Section: 5.2 Corrosion and Metal Fatigue Practices Report

RED HILL FACILITY

CORROSION AND METAL FATIGUE PRACTICES REPORT

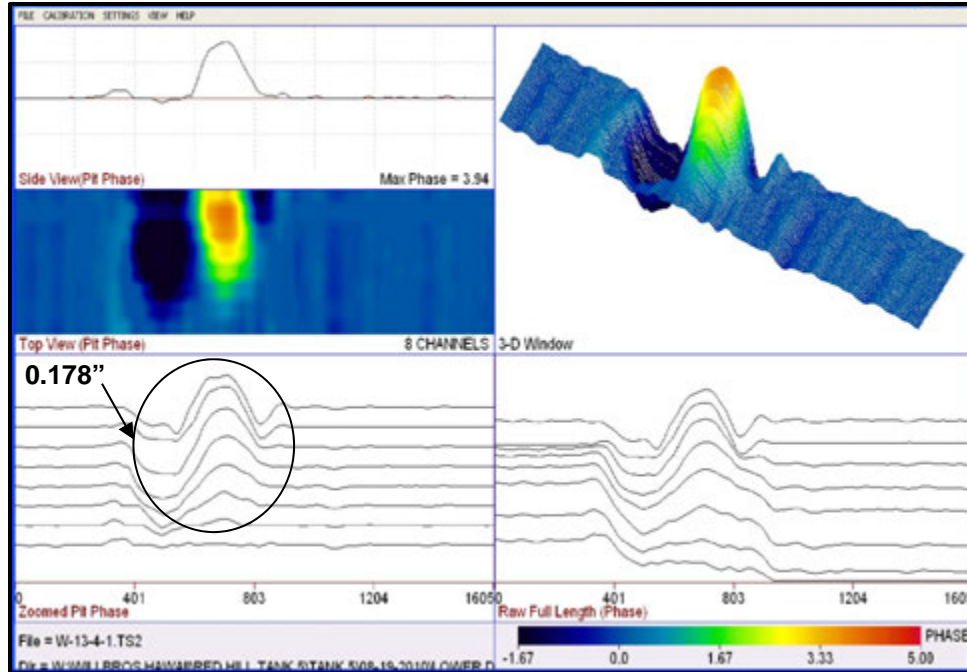
Figure 2-3. Example of an LFET scan indicating underside corrosion exhibiting 0.178 inch remaining wall thickness.

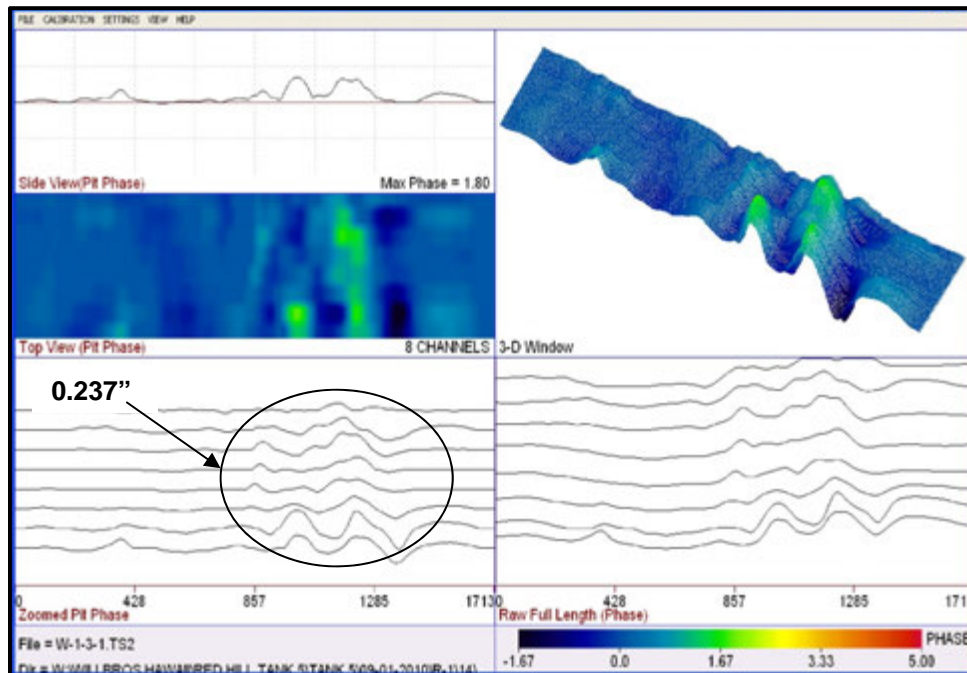
Figure 2-4. Example of an LFET scan indicating underside corrosion exhibiting 0.237 inch remaining wall thickness.

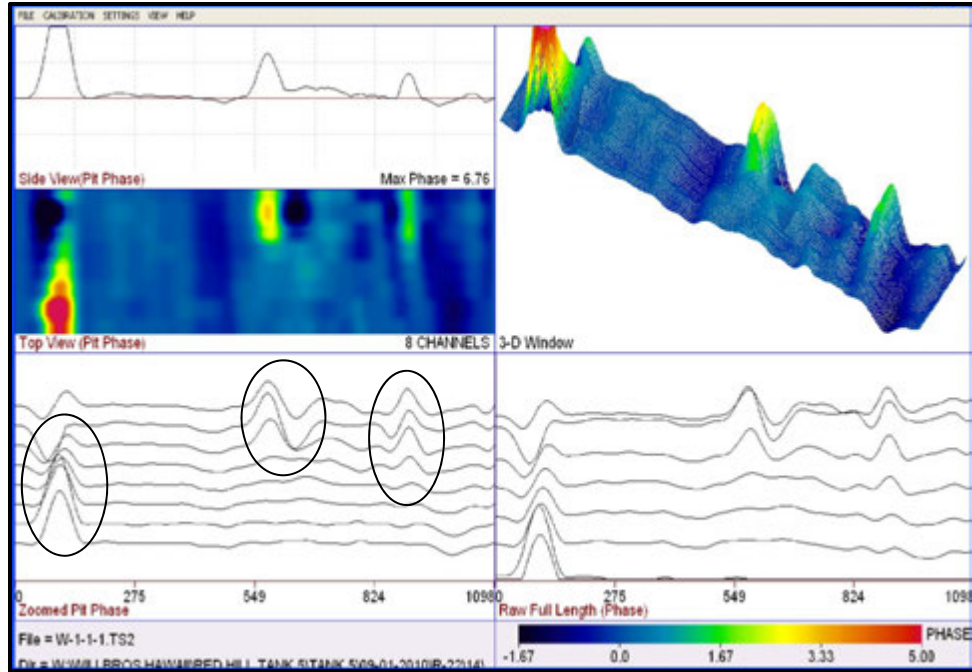
Figure 2-5. LFET scan indicating three dents between 0.200 and 0.240 inch deep.

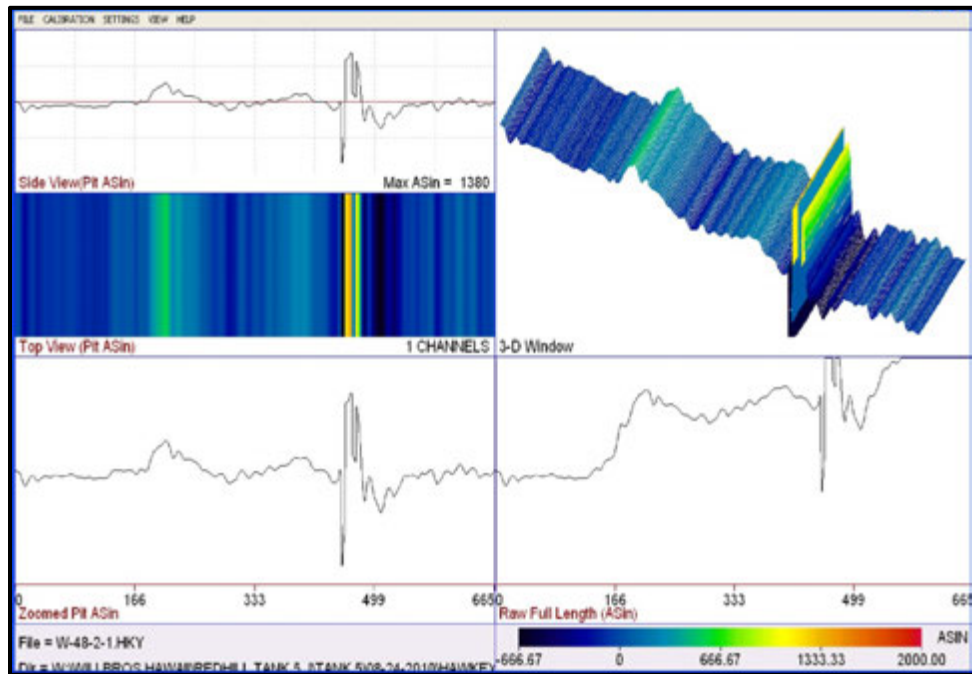
Figure 2-6. Waveform indicating undercutting of a weld 0.125 inch deep and 5.0 inches long.

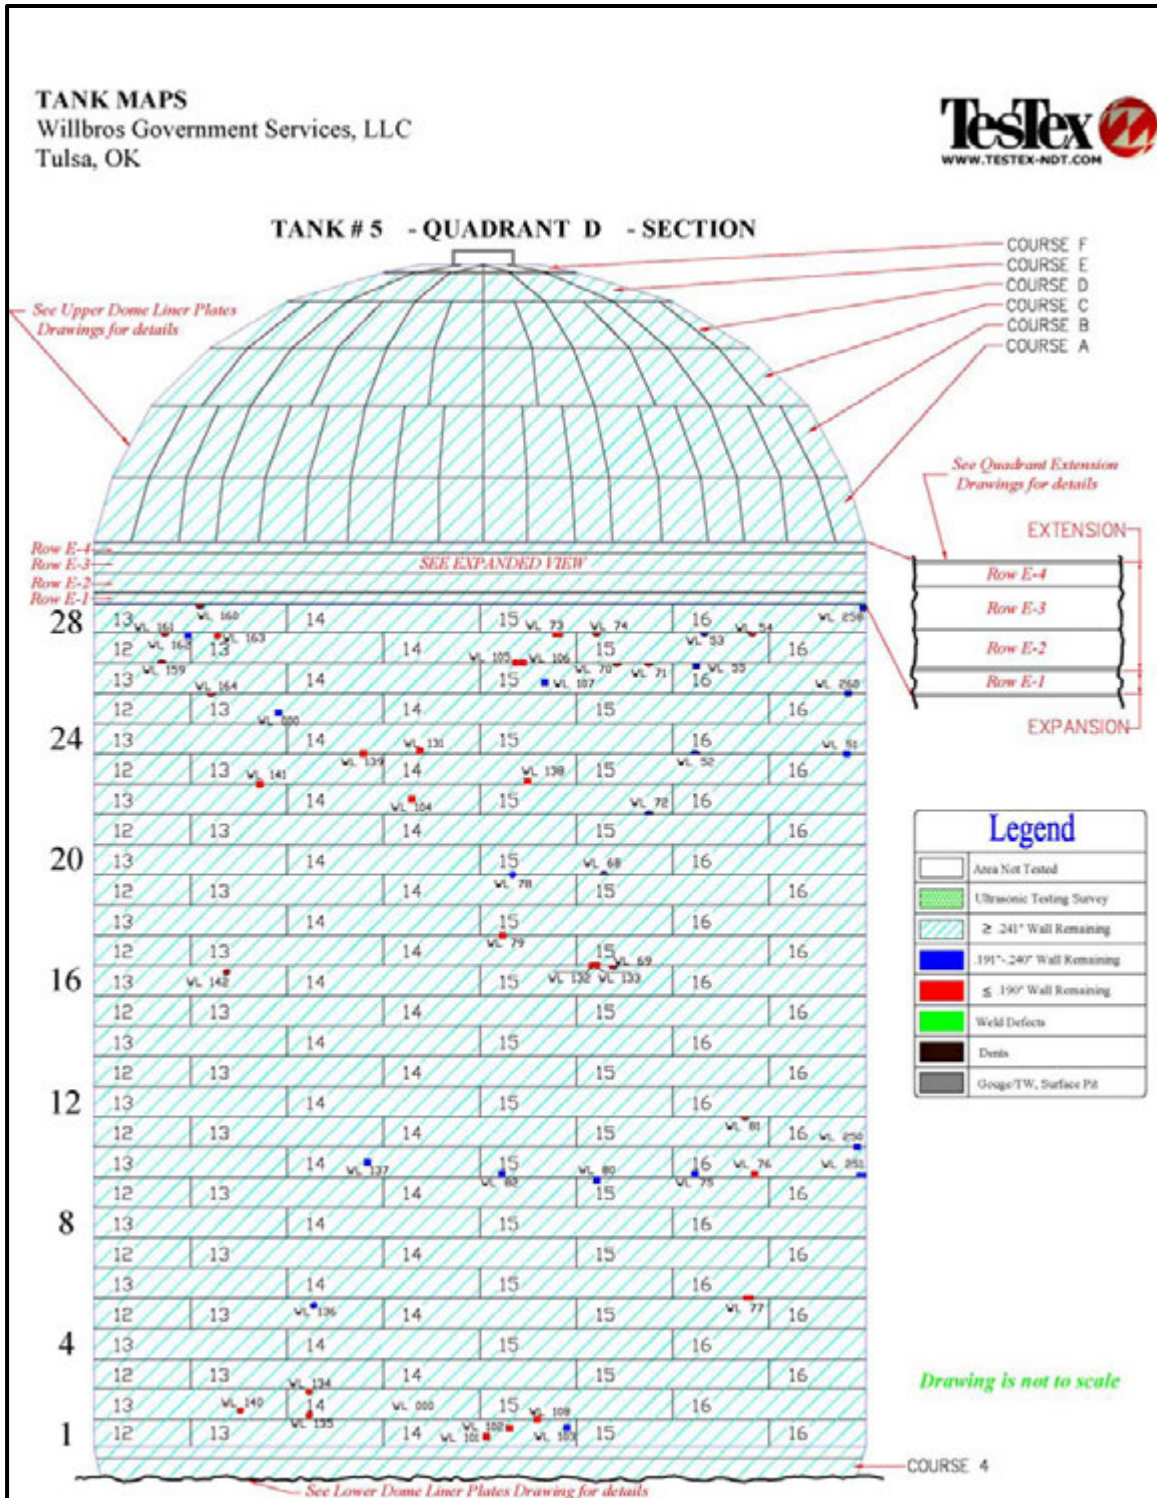
Figure 4-2. Example schematic drawing showing locations of flaws.

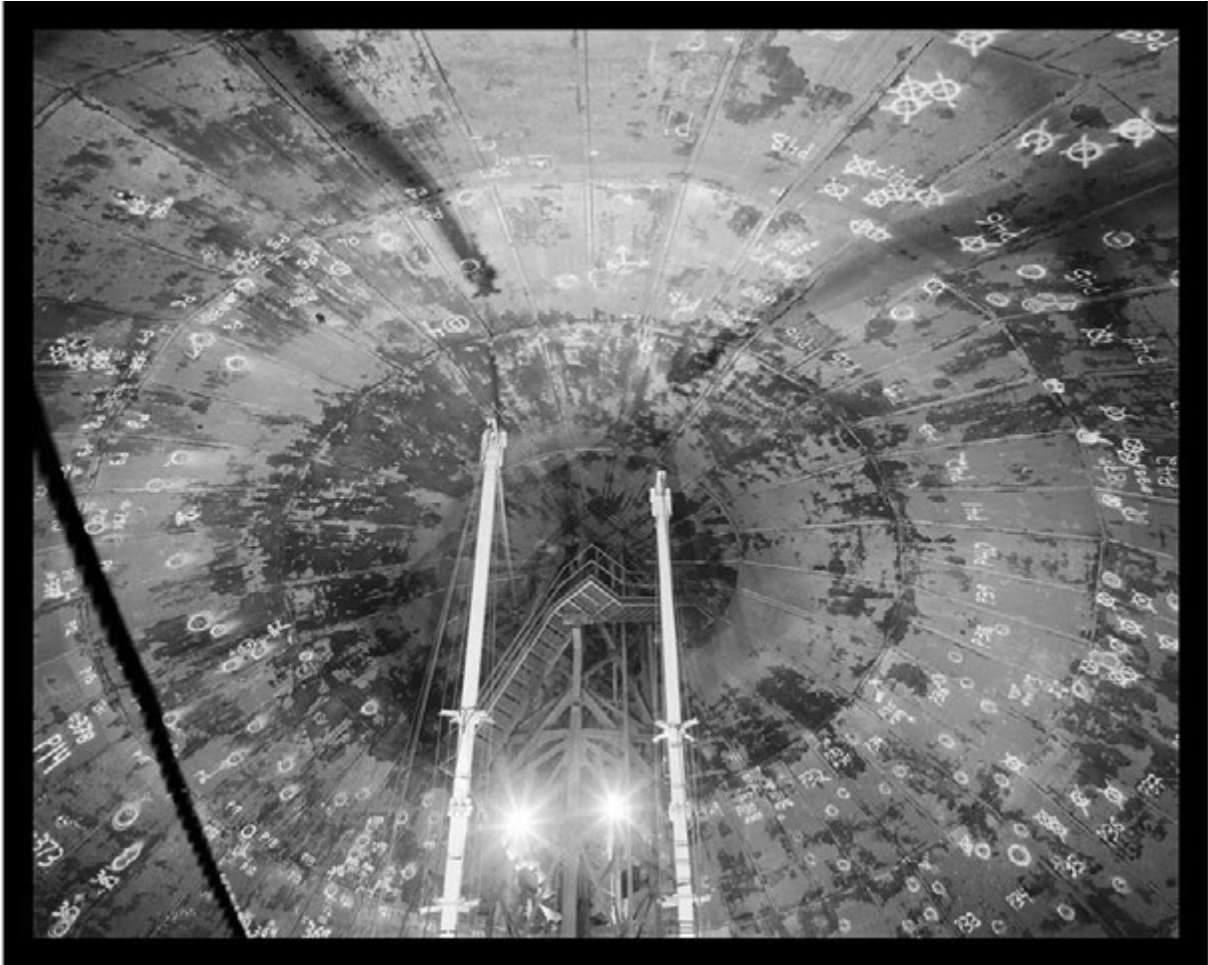
Figure 4-3. Example photo (black and white copy) of noted defects in tank upper dome
