SUBJECT: ADMINISTRATIVE ORDER ON CONSENT (AOC) STATEMENT OF WORK (SOW) SECTION 5 CORROSION AND METAL FATIGUE PRACTICES, DESTRUCTIVE TESTING RESULTS REPORT, RED HILL BULK FUEL STORAGE FACILITY (RED HILL), JOINT BASE PEARL HARBOR-HICKAM, OAHU, HAWAII

In 2018, ten coupons were removed from Tank 14, so that a metallurgical and corrosion analysis of the coupons could be undertaken, with the primary aim of validating non-destructive examination (NDE) results. The steel coupons, concrete powder samples, and corrosion product were submitted to a certified third-party laboratory to perform this analysis.

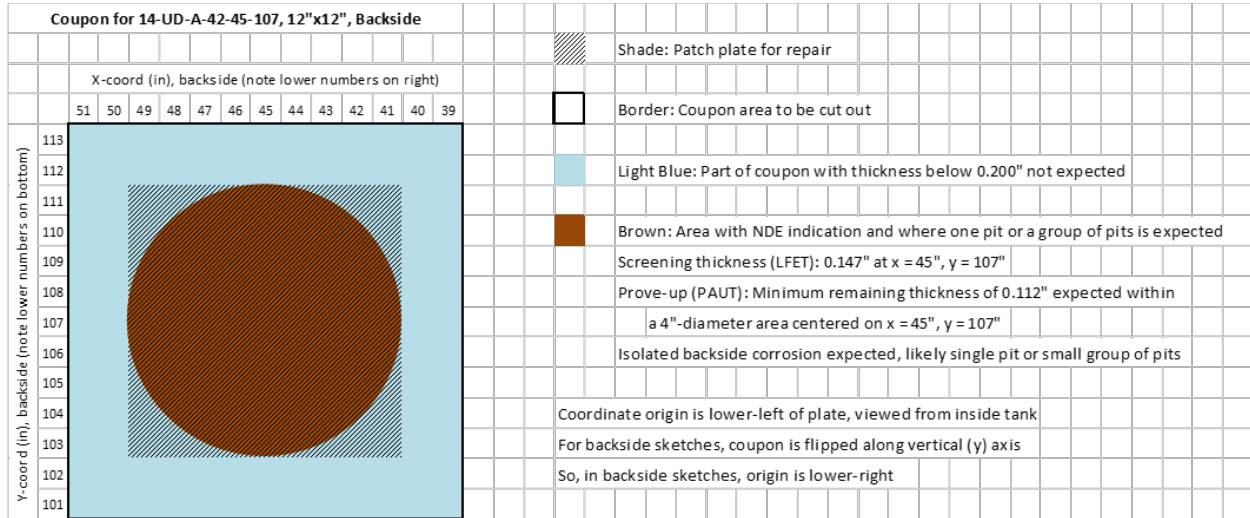
**Figure 4-1 Expected Results from NDE Spreadsheet Data, Coupon 1**

Destructive testing found pitting and minimum wall thickness of 0.208 inch. Remaining wall thickness greater than expected (208 mils vs. 112 mils). This deviation exceeded the 20 mils accuracy range for pitting.

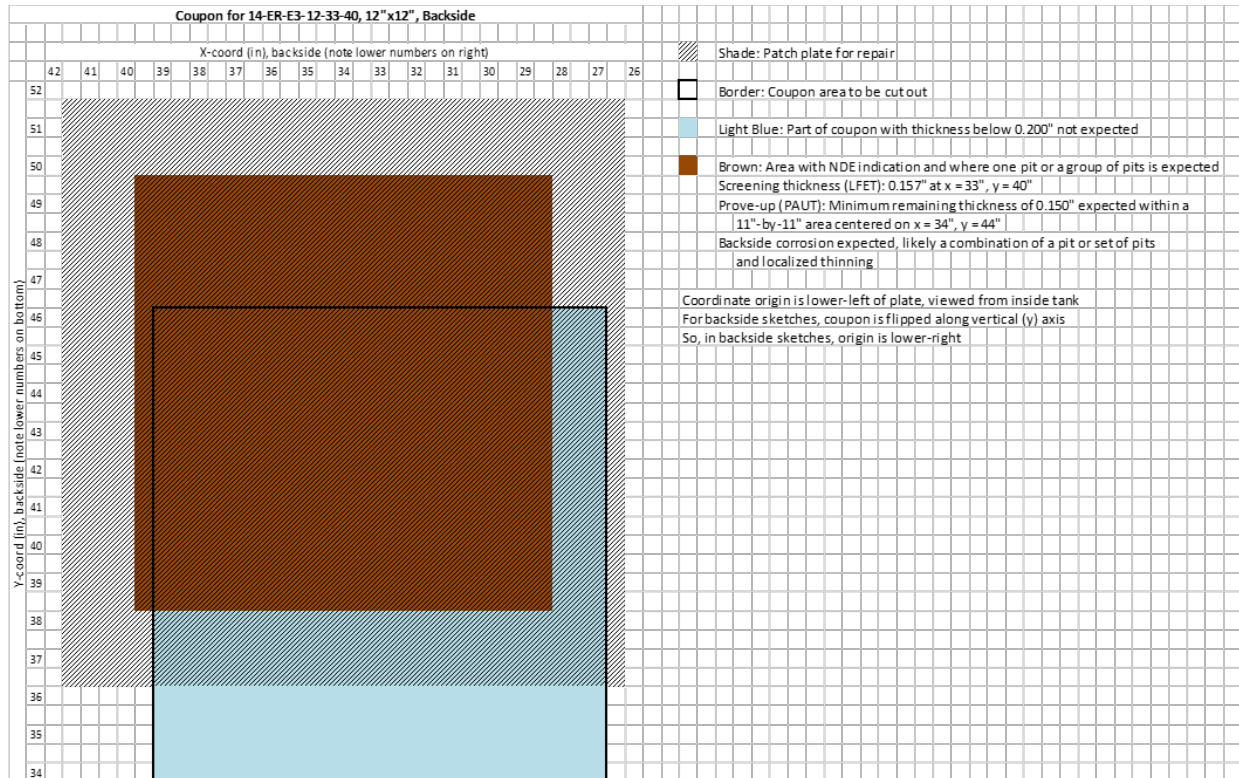
**Figure 4-3 Expected Results from NDE Spreadsheet Data, Coupon 2**

Remaining wall thickness as expected (152 mils vs. 150 mils). The LFET result fell within the 20 mils accuracy range for pitting.

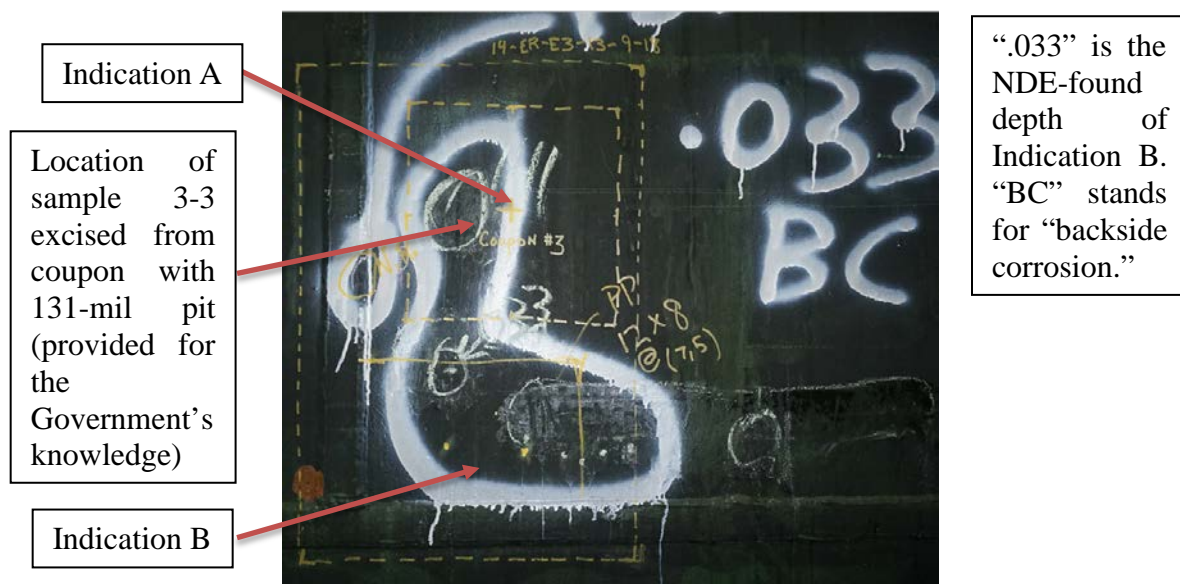
**Figure 4-7 Location of Coupon 3 Prior to Removal**

Laboratory results from Coupon 3 showed an area of remaining thickness of 131 mils, which is actionable. This thickness is within the layout area of Indication B.

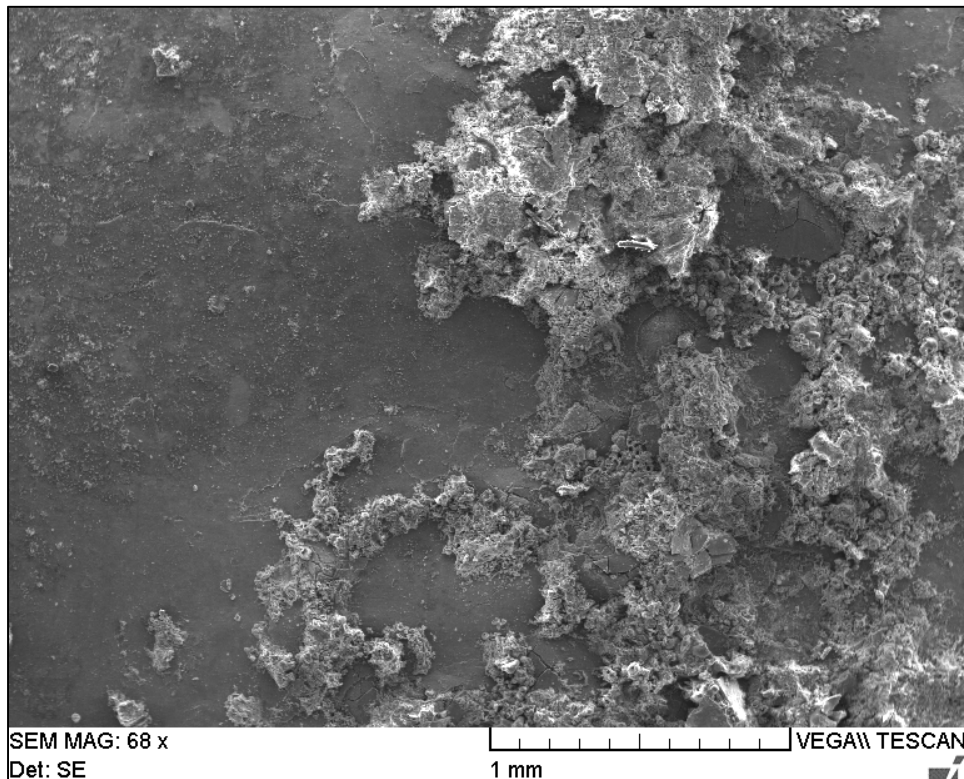
**Figure 50.** A representative SEM image of the specimen excised from Coupon 5 labeled as 5-1, prior to cleaning. No pits observed. (SEM, 40X)

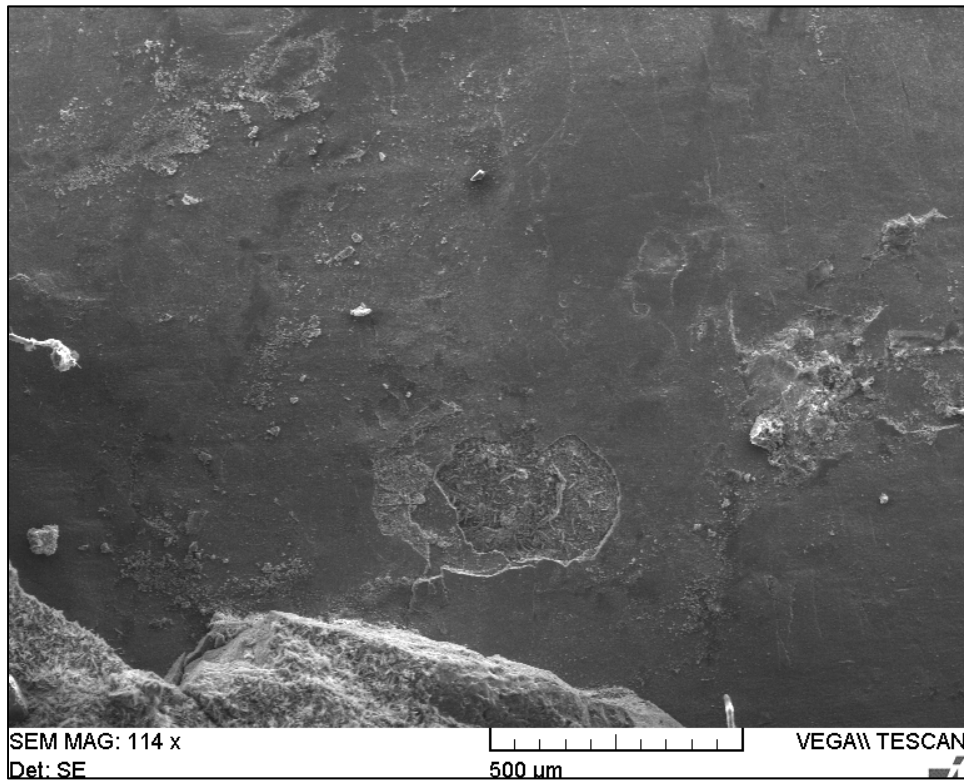
**Figure 51.** A representative SEM image of a pit on a specimen excised from Coupon 5 labeled as 5-2, prior to cleaning. (SEM, 67X)

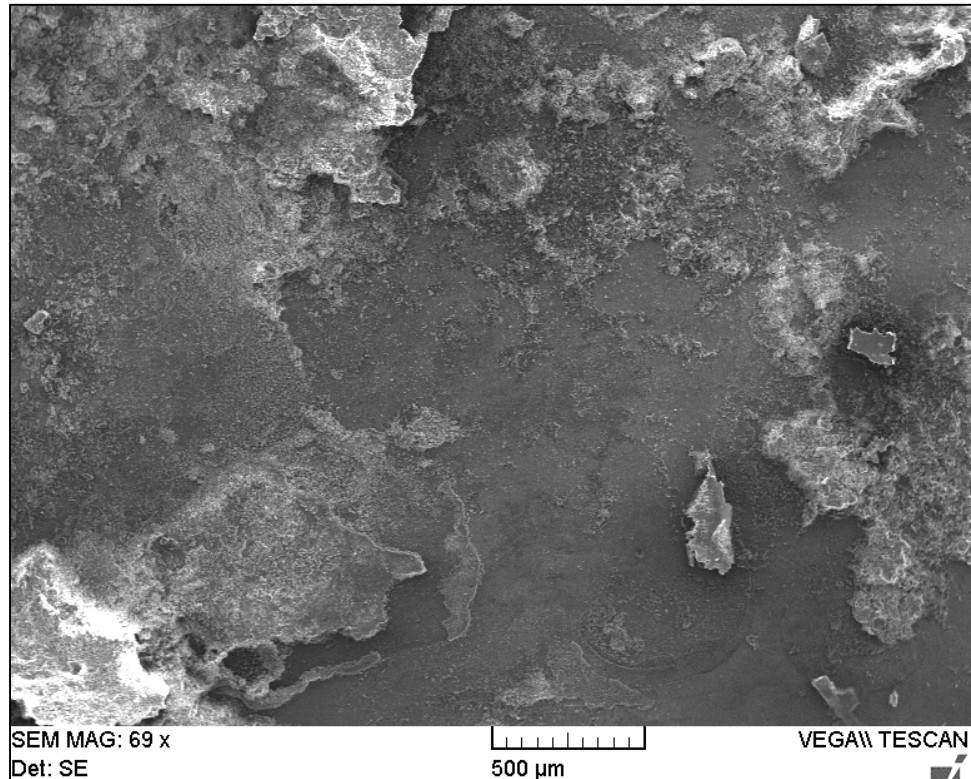
**Figure 54.** A representative SEM image the surface of a specimen excised from Coupon 6 labeled as 6-2, prior to cleaning. No pit was observed in this location. (SEM, 40X)

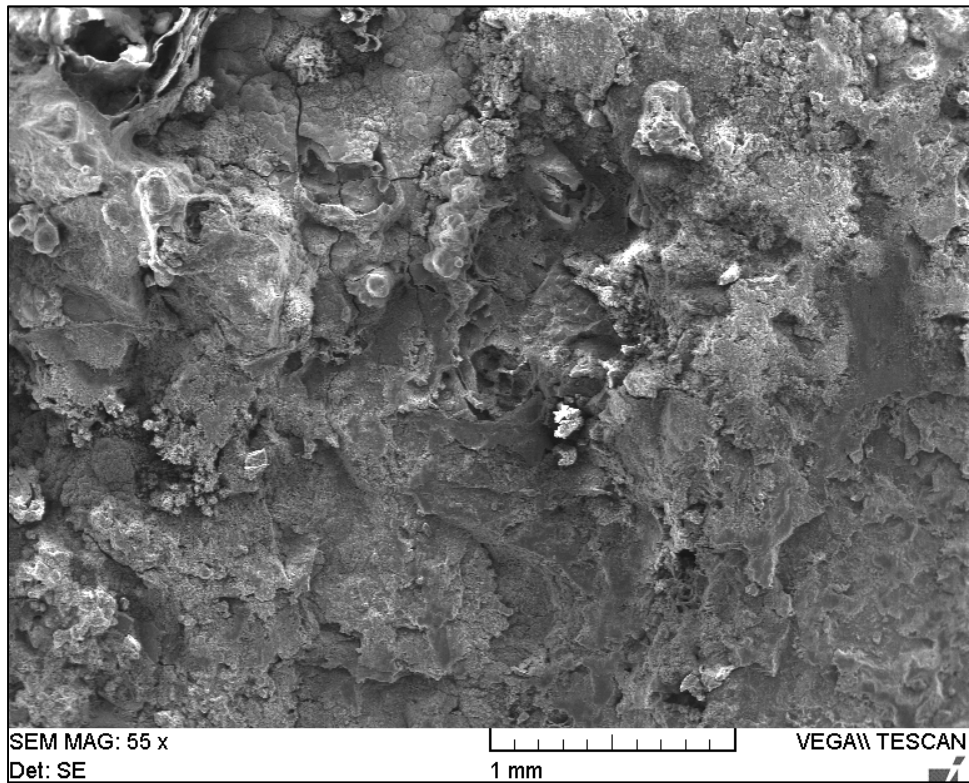
**Figure 55.** A representative SEM image of a pit on a specimen excised from Coupon 6 labeled as 6-3, prior to cleaning. (SEM, 32X)

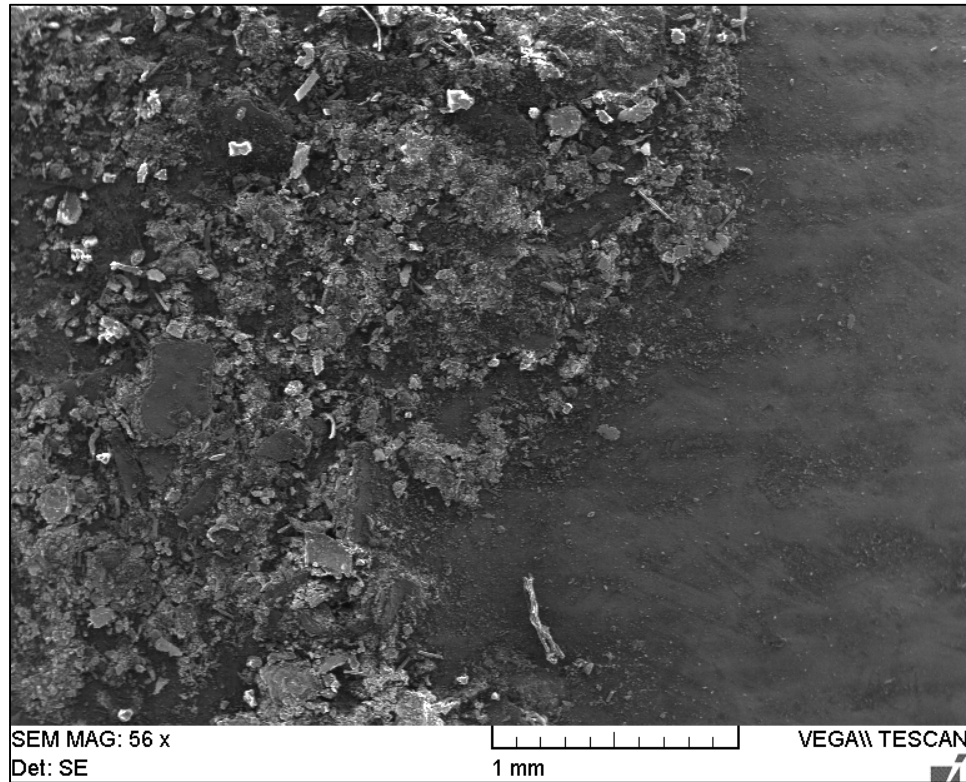
**Figure 62.** A representative SEM image of the surface of a specimen excised from Coupon 10 labeled as 10-1, prior to cleaning. No pit was observed in this location. (SEM, 33X)

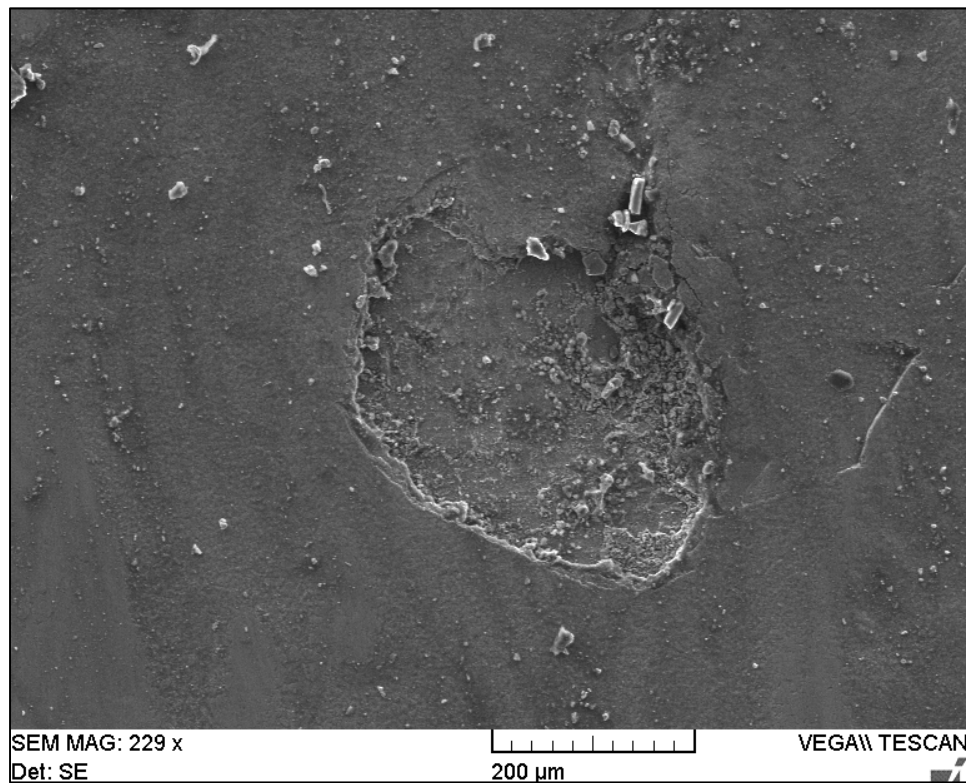
**Figure 63.** A representative SEM image of a pit on a specimen excised from Coupon 10 labeled as 10-2, prior to cleaning. (SEM, 135X)

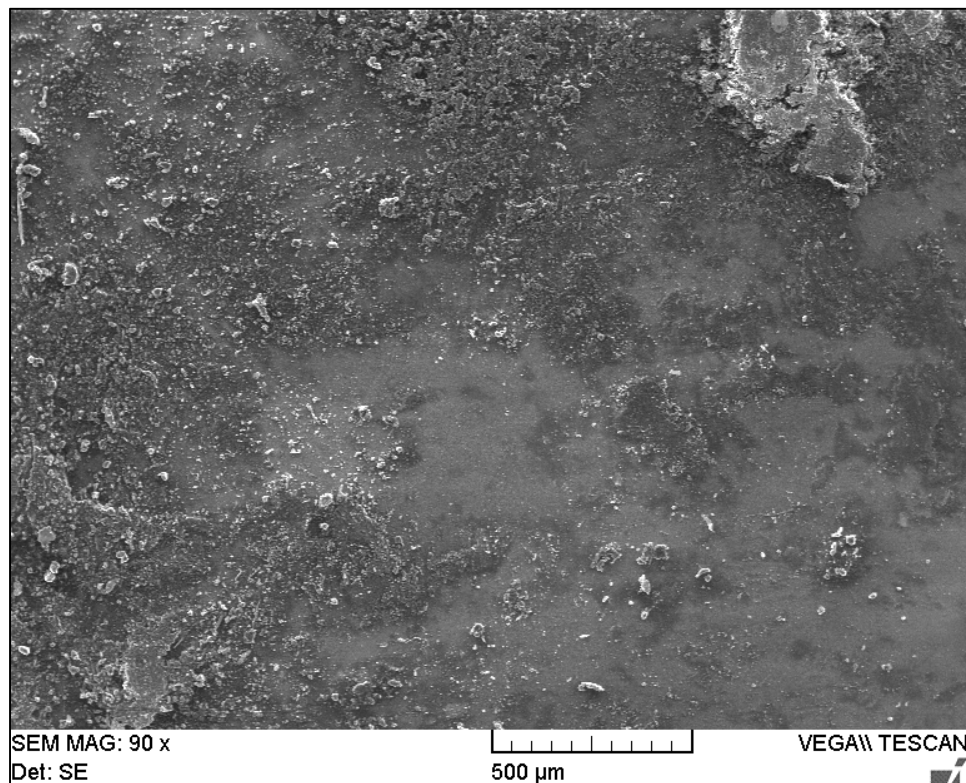
**Figure 64.** A representative SEM image of the surface on a specimen excised from Coupon 10 labeled as 10-3, prior to cleaning. No pit was observed in this location. (SEM, 53X)

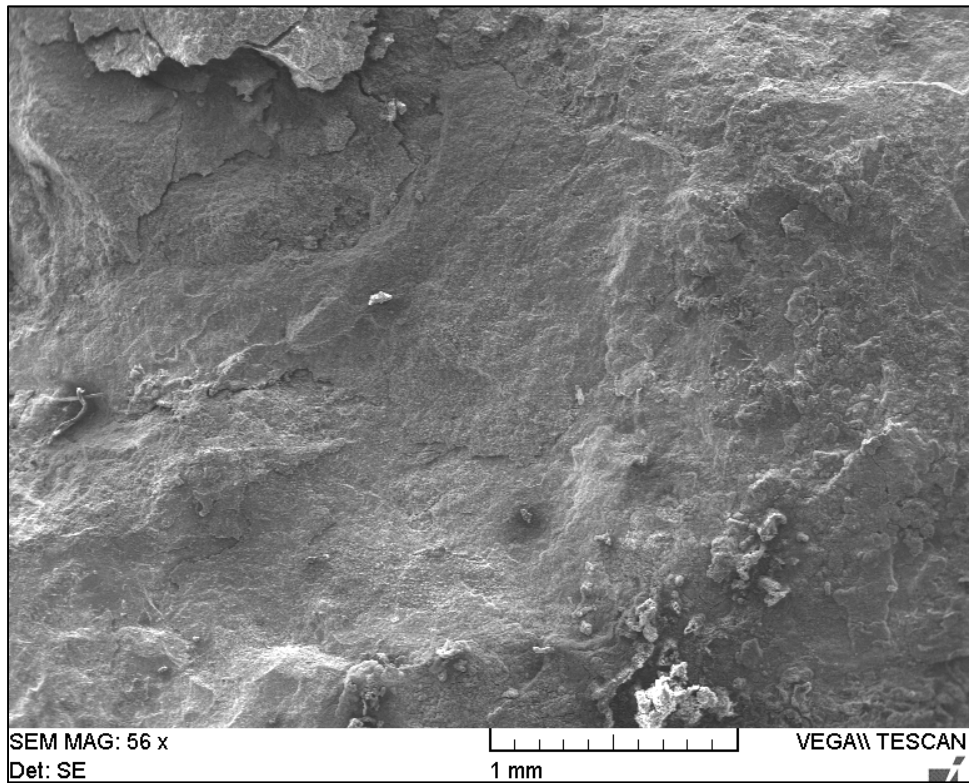
**Figure 65.** A representative SEM image of a pit on a specimen excised from Coupon A-1 labeled as A1-1, prior to cleaning. (SEM, 33X)

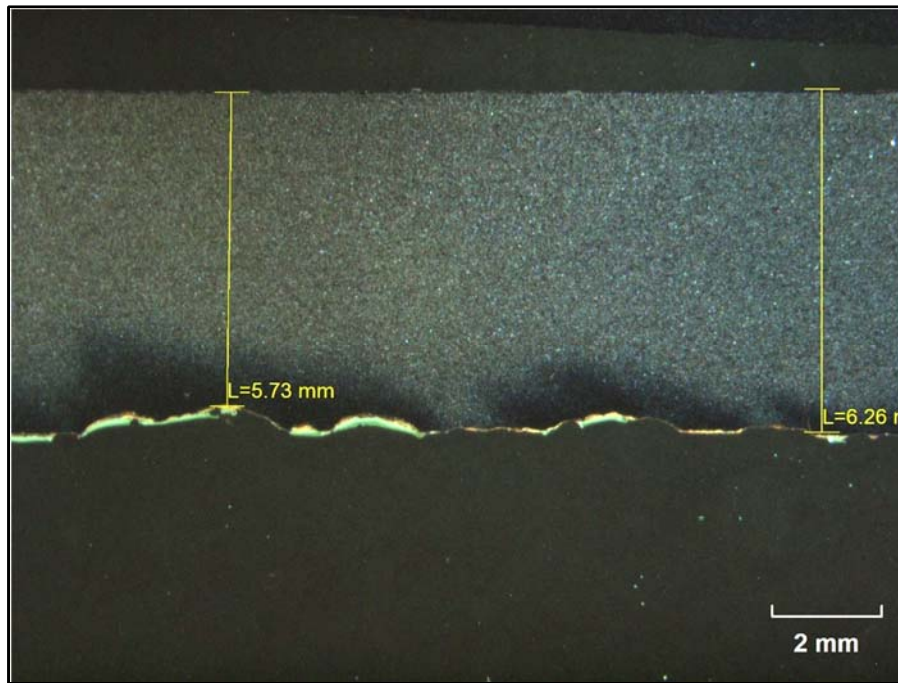
**Figure 191.** The prepared metallographic cross-section from Sample 5-4 is shown during examination with a stereomicroscope. The thickest remaining wall is shown. Note that the reduction in wall thickness was due to a depression on the painted face of the specimen. (7X)

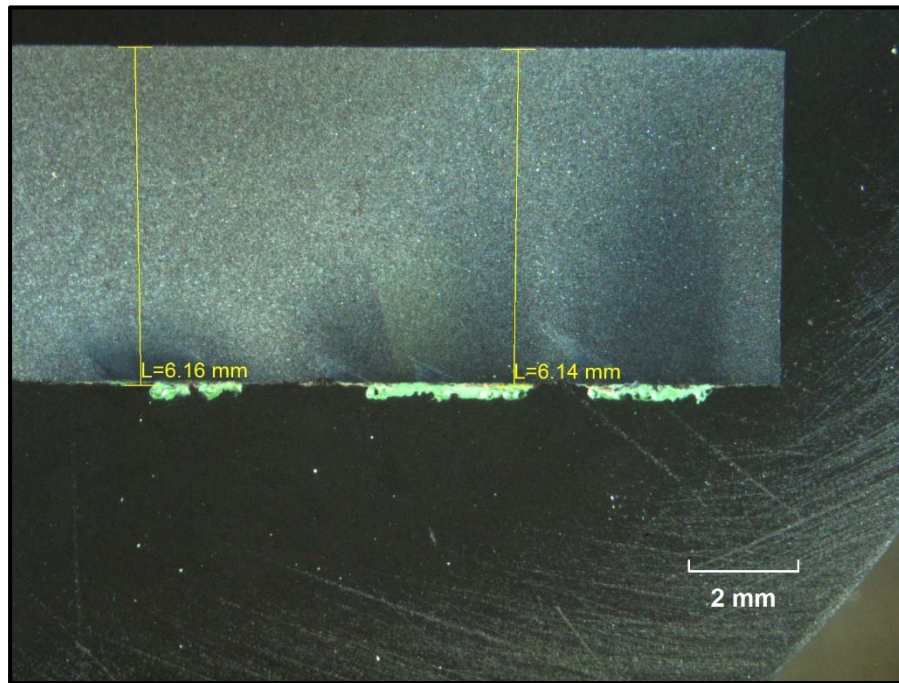
**Figure 201.** The prepared metallographic cross-section from Sample 10-2 is shown during examination with a stereomicroscope. The thickest location(s) are shown. No pitting was observed. (7X)

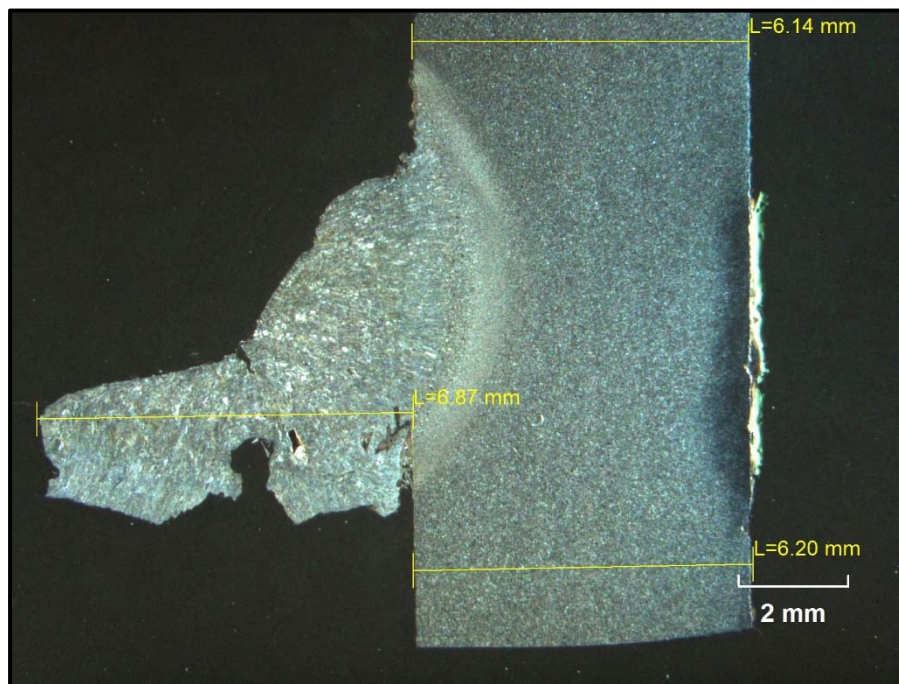
**Figure 202.** The prepared metallographic cross-section from Sample 10-4 is shown during examination with a stereomicroscope. Image is rotated 90° from other images. The anomaly detected during NDE was likely the weld nugget on the interior surface of the coupon (left). No pitting or significant wall loss was observed. (7X)

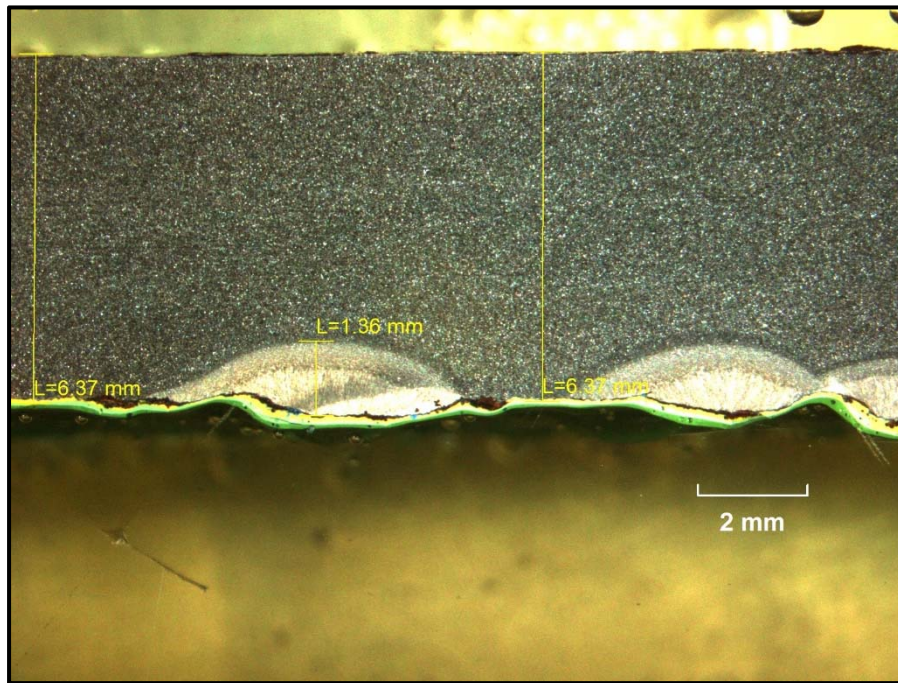
**Figure 207.** The prepared metallographic cross-section from Sample A2-4 is shown during examination with a stereomicroscope. The NDE indication was most likely locations of melting/re-solidification underneath the painted surface. No pitting was observed. (7X)

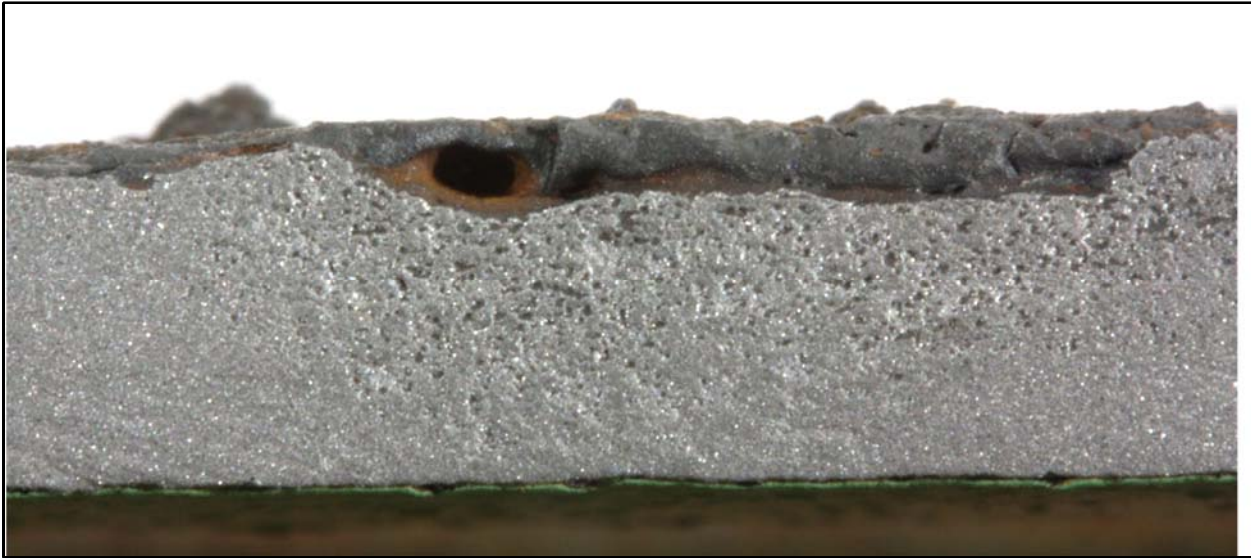
**Figure A-4.** Detail of the sandblasted edge on 3/20/19 in the same location as shown in the picture below. The sandblasting revealed that the feature was not a corrosion pit, as shiny metal was revealed when the red-colored staining was removed. There was an unusual appearance to the edge in this location, as though the sectioned edge had been superficially altered by heat associated with sectioning or some other post-sectioning reaction (atmospheric corrosion or corrosive media attack). That alteration gave the appearance of a deep corrosion pit.

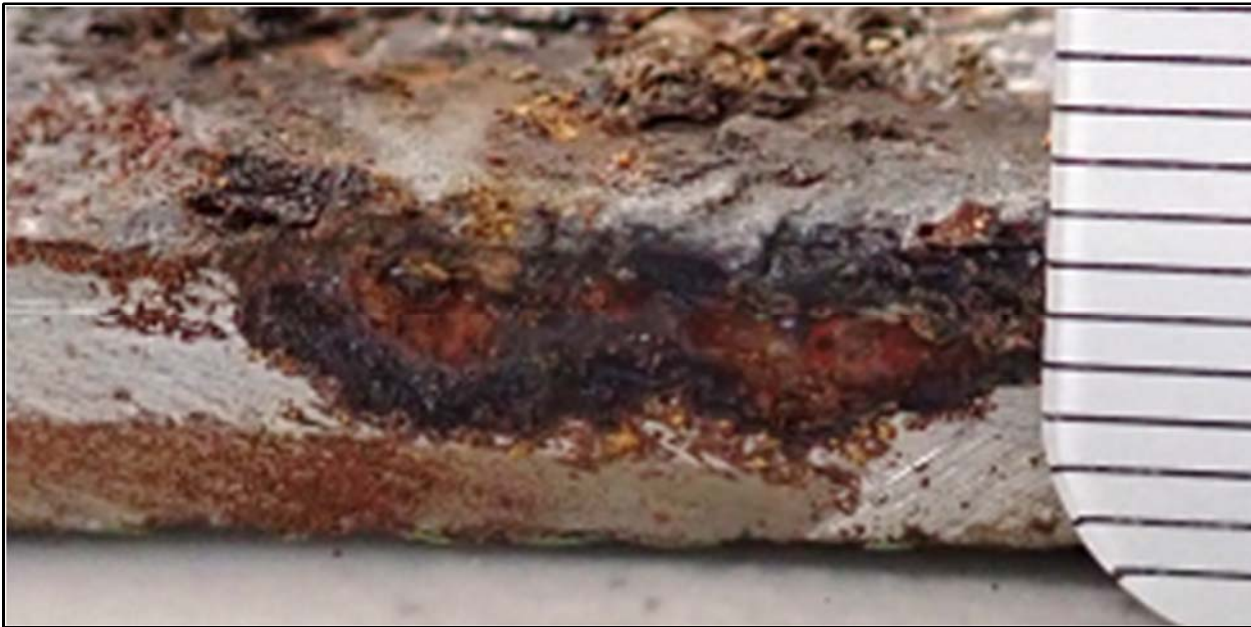
**Figure A-5.** The same area is shown in an image provided prior to shipping Coupon #7 to IMR (provided to IMR on March 13, 2019). What appeared to be a deep corrosion pit was actually rust-colored staining of the edge surface
