UNITED STATES ENVIRONMENTAL
PROTECTION AGENCY
REGION IX
75 Hawthorne Street
San Francisco, CA 94105

STATE OF HAWAII
DEPARTMENT OF HEALTH
P. O. BOX 3378
HONOLULU, HI 96801-3378

Re: Response to Corrosion and Metal Fatigue Practices, Destructive Testing Results Report, Red Hill Bulk Fuel Storage Facility (Red Hill), Joint Base Pearl Harbor-Hickam, Oahu, Hawaii

Corrosion Report on Red Hill Bulk Fuel Storage Facility

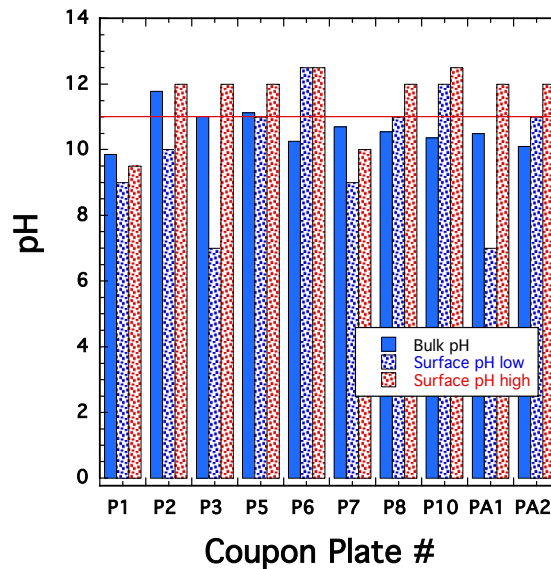
- i. Tables 15 and 16 of the Results Report Appendix A show measured pH is less than ($<$) 11 for concrete samples behind seven out of ten coupons, whereas pH for fresh concrete is around 13 or 14. When $\text{pH} < 11$, the concrete’s ability to protect steel from corrosion decreases and corrosion rates start to increase and accelerates as the pH levels drops.

Figure 1: Bulk and surface pH of concrete corresponding to the removed steel coupon plates. Bulk pH data and surface pH from DT Results Report [1].

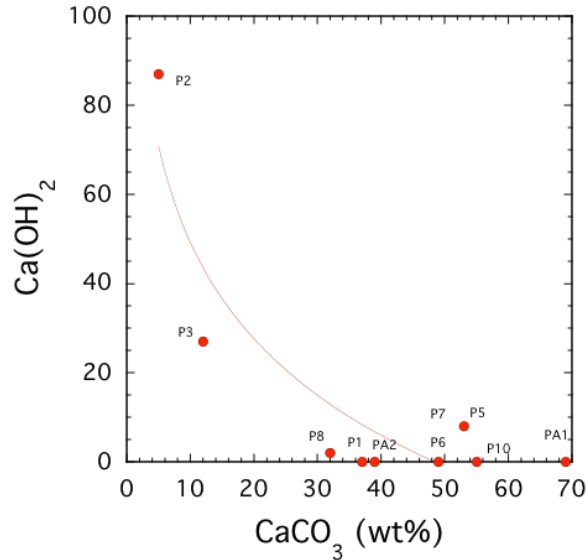
X-ray diffraction results (Table 2) [1] of the concrete powdered samples showed an average calcium carbonate content of 40.0 wt% with a standard deviation of 19.7%. The large variation in concrete composition (Table 2) could be accentuated by the small sample size. The general trend of increasing calcium carbonate with decreasing calcium hydroxide (Figure 2) was also observed. The origin of the high levels of calcium carbonate is not exactly known, but could be the result of carbonation, where carbonic acid from dissolved CO₂ gas in water reacts with calcium hydroxide in the concrete to form calcium carbonate [5]. This reaction can generally increase the strength of concrete [4, 6], but decrease its alkalinity and adversely affect the

corrosion resistance of imbedded steel [4]. The pH measurements coupled with the X-ray diffraction results [1] showed 1) decreasing concrete bulk pH with increasing calcium carbonate (Figure 3) and 2) decreasing concrete bulk pH with decreasing calcium hydroxide content (Figure 4).

Figure 2: Ca(OH)_2 vs CaCO_3 content in concrete behind the removed steel coupon plates. Ca(OH)_2 and CaCO_3 data from the DT Results Report [1].

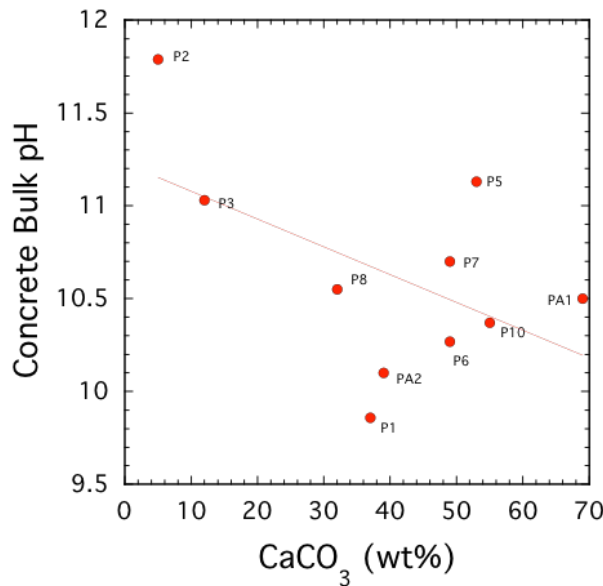
Figure 3: Concrete bulk pH vs CaCO_3 content in concrete behind removed steel coupon plates. Bulk pH and CaCO_3 data from the DT Results Report [1].

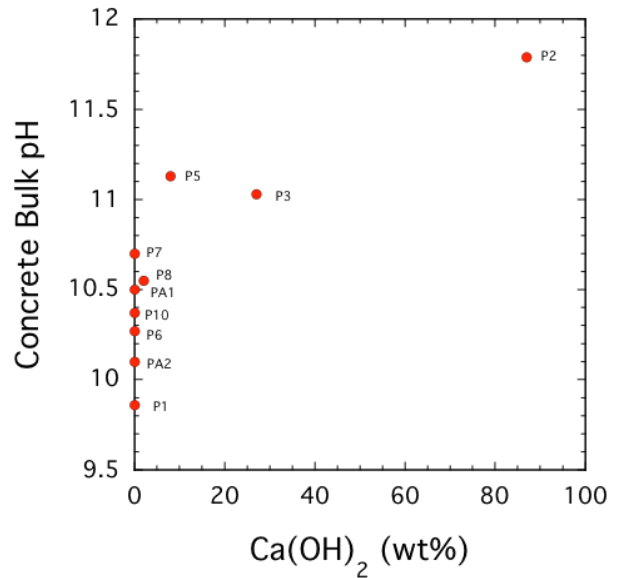
Figure 4: Concrete bulk pH vs Ca(OH)_2 content in concrete behind removed steel coupon plates. Bulk pH and CaCO_3 data from the DT Results Report [1].

The alkalinity of pore solution in fresh cement and concrete is approximately pH 13 – pH 14 [4]. As the concrete ages, the alkalinity is maintained at the pH 12 - pH 13 level [5] until the calcium hydroxide is consumed by the carbonation reaction. Once the calcium hydroxide is consumed and calcium carbonate precipitates, the pH drops further to levels where imbedded steel can corrode [4, 5]. In non-carbonated, highly alkaline concrete, the corrosion rate of steel is extremely low [4]. When the pH of the concrete falls below approximately pH 11, however, such as by carbonation, corrosion rates begin to increase [7] and passivation is lost at approximately pH 10 [3, 5]. The plot of pH values (Figure 1) shows that many values dropped below pH 11, where plain-carbon steel begins to lose passivity and its corrosion rate begins to increase [3, 5, 7].

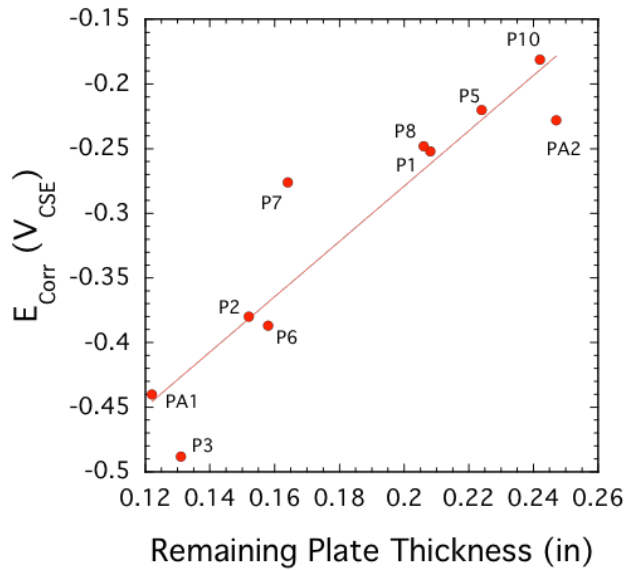
Of the potential measurements corresponding to the back side of the tank wall, only one potential was more positive than -0.2 V_{CSE}, indicating low probability of corrosion; five potentials were in the potential range of -0.20 to -0.35 V_{CSE}, indicating uncertainty of corrosion; and four potentials were more negative than -0.35 V_{CSE}, indicating high likelihood of corrosion. The reported minimum remaining plate thickness values for each plate was plotted vs the corrosion potentials (Figure 5), showing strong correlation. The more negative the corrosion potential (indicating a

higher tendency to corrode), the lower the measured remaining plate thickness. Plates P5, P10, and PA2 corresponding to the three most positive corrosion potentials ($> -0.23 \text{ V}_{\text{CSE}}$) showed no or only very light surface rust (Figure 6) [1]. Plates P1 and P8 (with potentials $\approx -0.25 \text{ V}_{\text{CSE}}$) showed mostly mild surface rust (Figure 6) [1]; whereas, the remaining plates PA1, P2, P3, P6, and P7 (with potentials $< -0.27 \text{ V}_{\text{CSE}}$) showed significantly more severe rusting (Figure 6) [1].

Figure 5: Corrosion potential vs minimum remaining plate thickness. Data summarized from the DT Results Report [1]. Since two corrosion potential values were given for plates A1 ($-0.448 \text{ V}_{\text{CSE}}$ and $-0.432 \text{ V}_{\text{CSE}}$) and A2 ($-0.226 \text{ V}_{\text{CSE}}$ and $-0.230 \text{ V}_{\text{CSE}}$), the average value for each plate was plotted.

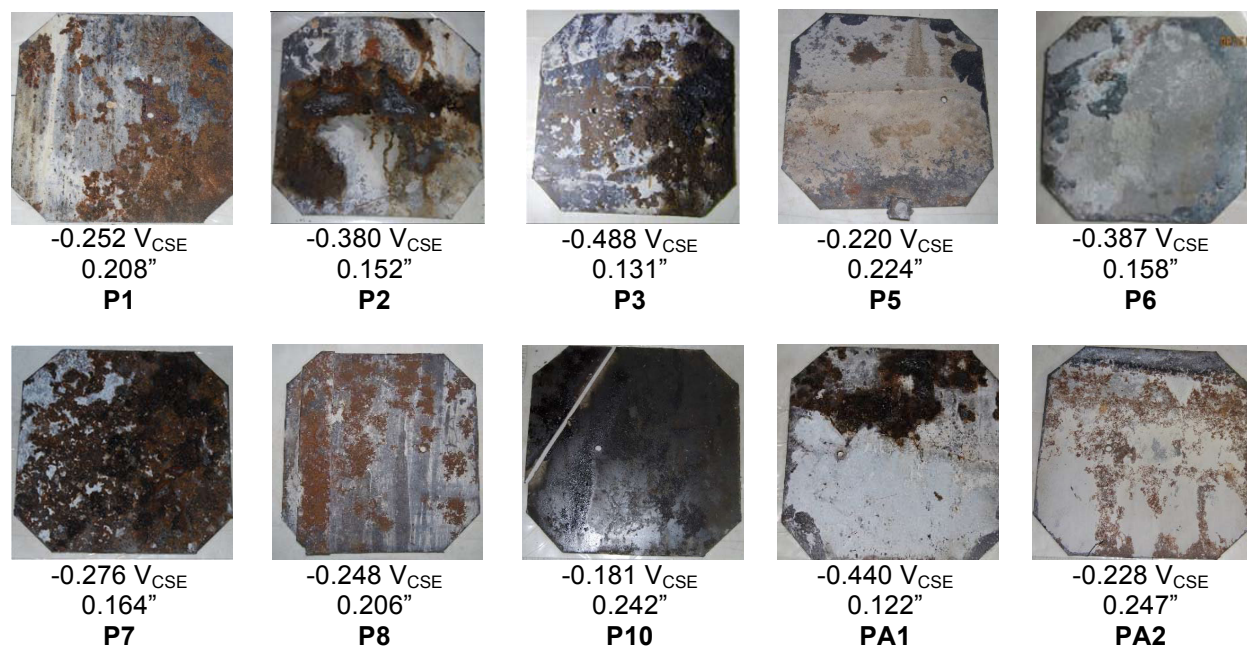
Generally, the formation of the visible red-brown rust (Figure 6) on plain-carbon steel indicates that the passivation in that local region has been lost. The gray regions of the plates (excluding the adhering concrete or grout) are regions where the steel is in the passive state (Figure 6). Passivation can be lost when the pH of the concrete drops below approximately pH 11 [7], or chloride (Cl^-) ions are present in sufficient concentration [4, 7]. The NACE Standard Practice SP0308-2008 [9] indicates that acid-soluble chlorides in excess of approximately 0.2 % (by weight of cement) can initiate corrosion of steel in concrete. The ion chromatography analyses of the concrete powder samples showed that the chloride concentration in the concrete ranged from 50 ppm (0.005 % by weight of cement) to 171 ppm (0.017 wt%), which is much lower than the threshold. The concentration of chlorides detected in the corrosion

products using energy dispersive X-ray analyses (EDXA), however, was significantly higher: The maximum value of 1.7 wt% (17,000 ppm by weight of corrosion product) was detected in the corrosion product of plate PA1; 0.6 wt% (6,000 ppm) in plates P2 and P7; 0.3 wt% (3,000 ppm) in plates P3, P5, P6, and P10; and none in plates P1, P8, and PA2. The detection limit of EDXA is on the order of 0.1 wt% (1,000 ppm). The maximum concentration of the chlorides in the corrosion products were up to approximately 100 times higher than the maximum concentration in the concrete. Chlorides at these levels as well as the drop in concrete alkalinity below approximately pH 11 are likely to breakdown passivation and cause increasing corrosion rates of the steel.

Figure 6: The back side of the steel coupons, structure-to-electrolyte corrosion potentials (in V_{CSE}), and the minimum remaining thickness (in inches) that was measured for each plate. From DT Results Report [1]

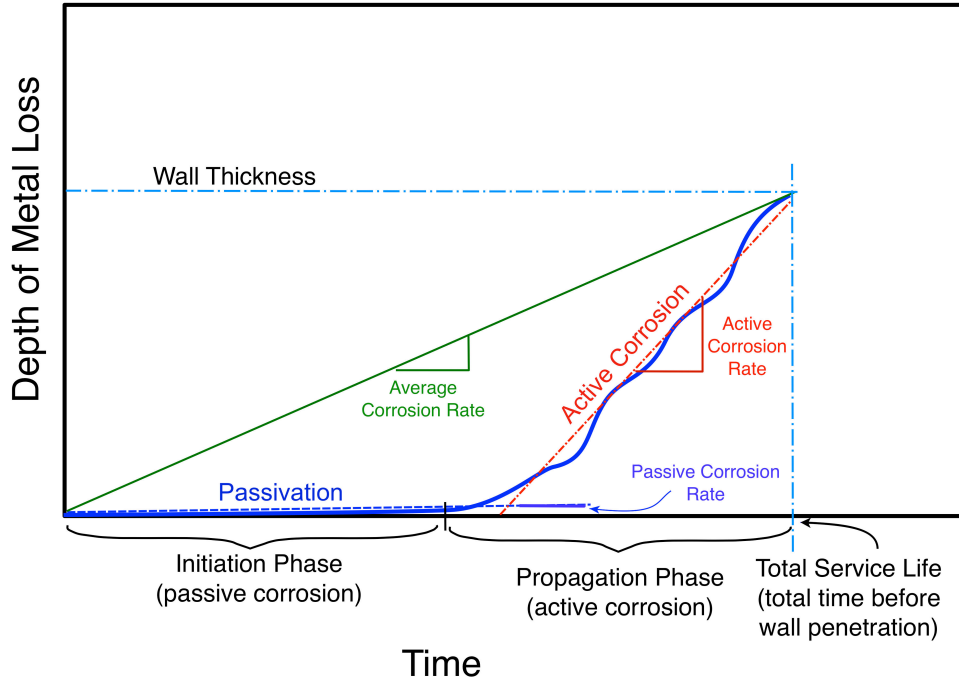
When steel corrodes in concrete, there is an initiation phase and a propagation phase (Figure 7) [4]. During the initiation phase, the steel is passive and corrodes at a very low rate. When the concrete becomes carbonated or contaminated with chlorides, the steel loses passivity and corrosion rates begin to increase in the propagation phase (Figure 7). In Figure 6, regions of the coupons that were bonded to the concrete or grout and not corroded (e.g., gray regions) were still in the initiation phase (Figure 7) and have a very low passive corrosion rate. Regions that show rust (e.g., red or brown corrosion products) are in the propagation phase and have higher

Figure 7: Initiation and propagation phases of steel corrosion in concrete. Modeled after Tuutti [10] in [4].

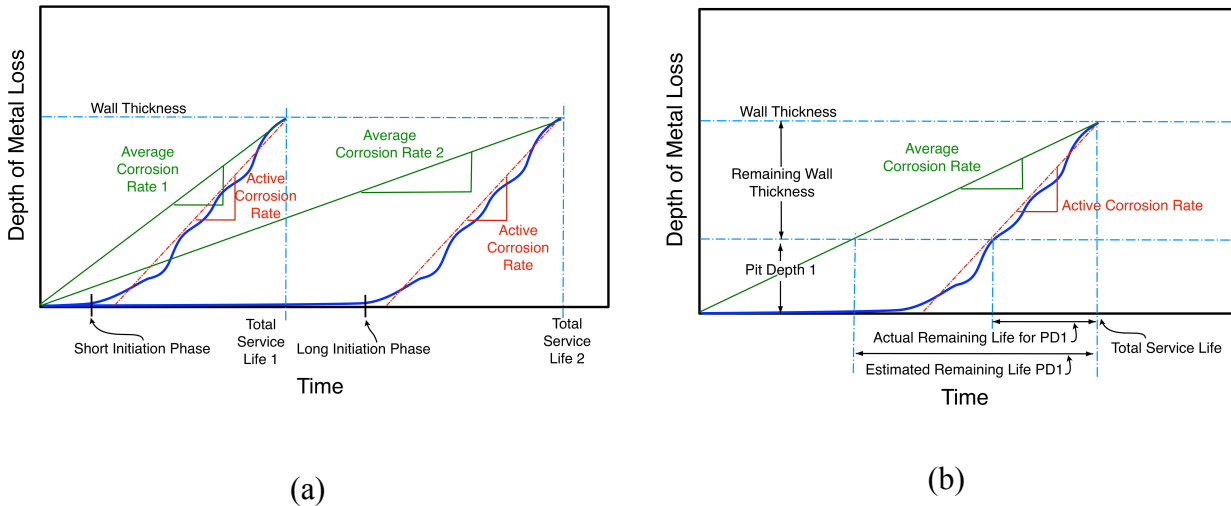
active corrosion rates. Unfortunately, knowledge of the active corrosion rate cannot be used to determine the total service life or time before penetration as the initiation phase can dominate the service life (Figure 7 and 8a) [10]. However, if the remaining wall thickness and the active corrosion rate are known, the remaining time before wall penetration can be estimated (Figure 8b).

Figure 8: Effect of initiation phase on average corrosion rates (a). Remaining life (b) based on active and average corrosion rates and pit depth 1 (PD1).

The higher historical corrosion rates could be associated with short initiation phases (Figure 8a) from regions where steel lost passivation in the early stages. Regions where the steel remain passivated and have long initiation phases (Figure 8a) will result in low average corrosion rates. Currently, any region of the tank that has back-side corrosion (i.e., rusting and remaining thickness less than the original plate thickness of 0.25") is likely not passivated, and in the propagation stage (Figure 7). To obtain an accurate remaining life before wall penetration, realistic corrosion rates are needed. Therefore, in regions of the tank that are no longer passivated, actual measured active corrosion rates or historical corrosion rate data with a short initiation phases (Figure 8a) are needed to more accurately estimate the remaining life

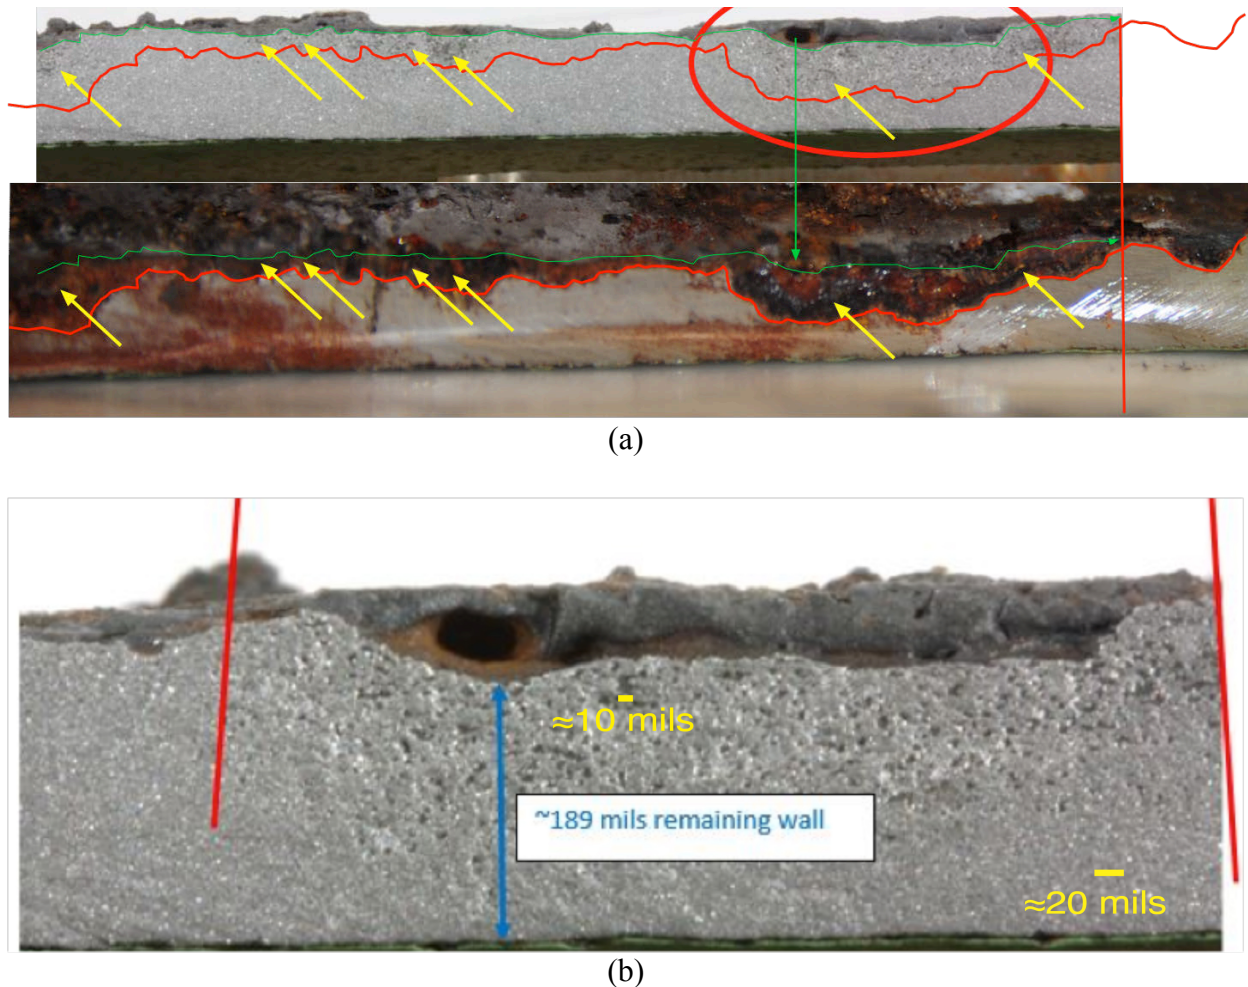
The electrolyte in the corrosion product at the corrosion front can become very corrosive due to acidification and accumulation of chlorides. This may have been observed on the cut edge of coupon plate P7 [11]. A photograph of the cut edge of plate P7 was taken on June 25, 2018 (bottom photo in Fig. 9a), approximately one week after coupon plate P7 was cut and removed from Tank 14. The image showed what was initially thought to be significant corrosion (dark brown rust) penetration into the thickness of the plate. To verify if the corrosion had actually penetrated into the plate, the edge of the specimen was cleaned by sandblasting [11] (approximately in March 2019, or six months after the coupon was extracted). The photo of the cleaned edge of coupon plate P7 was compared (Figure 9) to the photo of the un-cleaned edge. The demarcation between the cleaned steel plate and the free surface was highlighted with a thin green line (Figure 9a top), and the demarcation between the shiny cut edge of the corroded un-cleaned plate and the apparent corroded regions were highlighted with a thicker red line (Figure 9a bottom). Both lines were superposed on the cleaned and uncleaned plates (Figure 9a). The darker corroded regions on the edge of the uncleaned plate (Figure 9a bottom) corresponded to the areas that appeared to be porous (yellow arrows) on the cleaned plate (Figure 9a top and Figure 9b). The apparent porosity (Figure 9a top and Figure 9b) could be due to corrosion caused by corrosive electrolyte that leached out of the corrosion products onto the cut edge. Some of the pores appeared to be on the order of 5 to 10 mils in width (Figure 9b). If it is assumed that the pits are as deep as they are wide, the rate of corrosion would be on the order of (5 to 10 mils)/6 months or 10 to 20 mils/yr, which is much higher than passive corrosion rates. It is also recommended that the surface porosity be further investigated to verify whether the region is only superficially pitted or is actually porous.

For moist concrete that is carbonated or contaminated by chlorides, the literature suggests that the corrosion rate can be of the order of 100 $\mu\text{m/yr}$ (4 mils/yr) [4]. The corrosion rate can be less if the moisture level decreases, but can also increase by an order of magnitude with heavy chloride contamination [4]. Since the corrosion rates are difficult to predict, historical corrosion data from all of the Red Hill tanks should be analyzed to help bracket realistic values. Additionally, if possible, active corrosion rates should be determined by measuring changes in the remaining wall thicknesses of known pit sites while tanks are out of service. This could be accomplished using, for example, ultrasonic testing.

Figure 9: Optical images (a) of cleaned (top) and uncleaned (bottom) edge of coupon plate P7. Magnified view (b) of the cleaned edge of coupon plate P7 showing pitted surface. Wavy red and green lines, yellow arrows, and 10 and 20 mils scale bars were superposed on original photos of the cleaned edge [11].

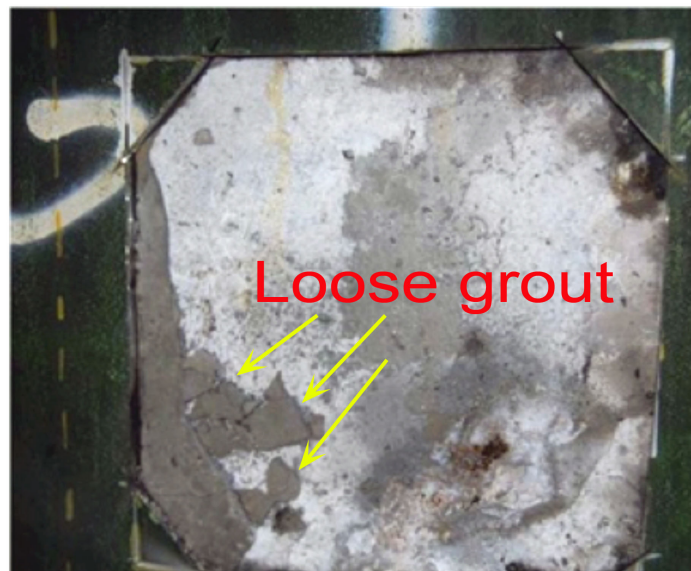
Since the grout was pressurized to 350 psi, it could have likely found its way to the steel-concrete interface from the concrete-Gunitite interface through any crevice or crack that may have formed. In one case, grout was found as far as 200 ft away from the tanks in an upper access tunnel [13]. The description of the tell-tale system, also indicates that crevices could exist between the tank wall and concrete layer [13]:

Figure 10: Loose grout behind coupon plate P6. From DT Results Report [1].

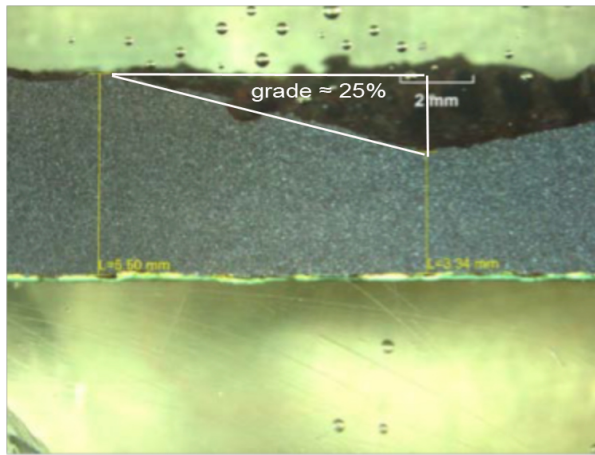
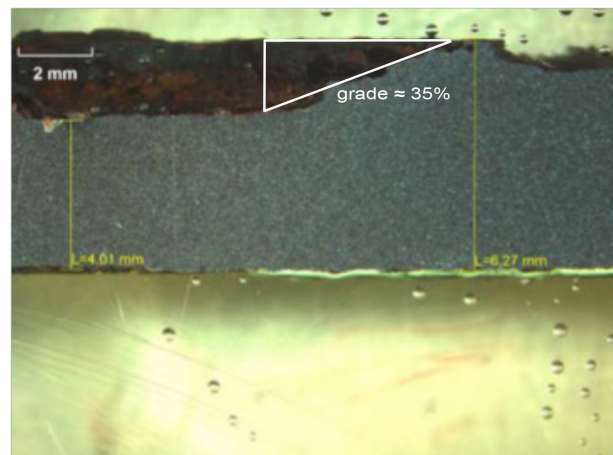
Figure 11: Cross section of coupon plate P3 (a) at the area of maximum wall loss (p. 18 of DT Results Report [1]) out of four sections examined, and cross section of coupon plate P6 (b) at area of maximum wall loss out of three sections examined (p. 24 of DT Results Report [1])

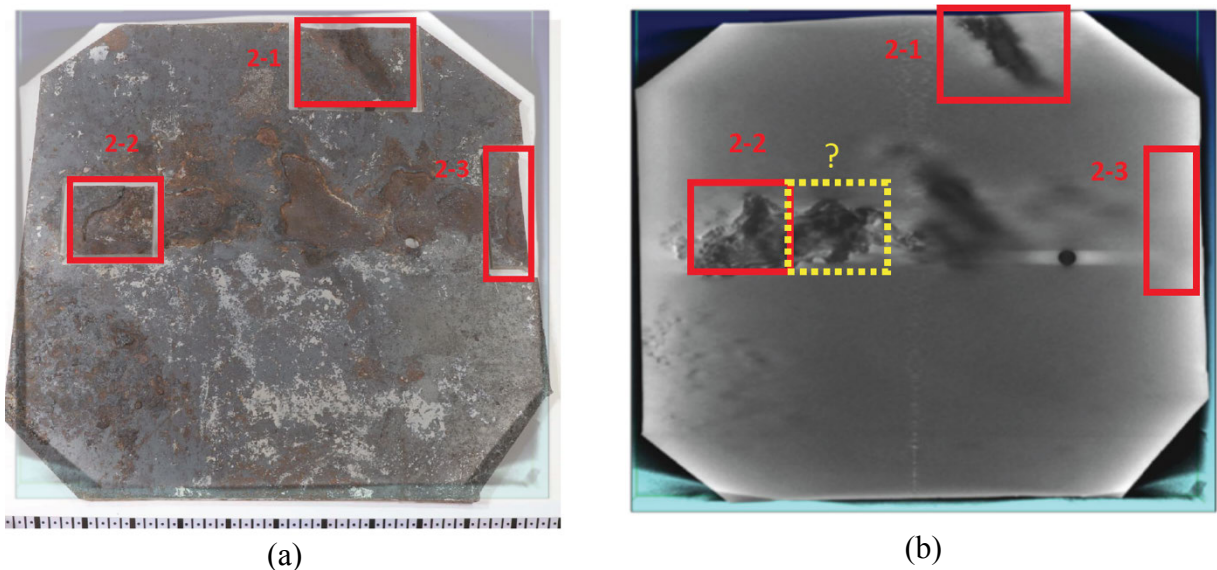
There are also concerns of whether or not the sites with the deepest pits were sampled during the destructive testing. The steel coupons were specified to be cleaned and subjected to three-dimensional profilometry (as specified on p. 8 of the DT Results Report, [1]) to document the

surface profile of the remaining steel substrate. The steel coupons were cleaned with a CO₂ dry ice blast, but all of the corrosion products were not removed; hence, the regions of the deepest pits would be difficult to determine. The three-dimensional profilometry data was not provided in the DT Results Report [1], but the results would likely not have characterized the bare steel substrate since the corrosion products were not thoroughly removed. X-ray computed tomography (CT) was used to aid in selecting the regions with the deepest pits, but in some cases, regions with potential deep pits were apparently not sampled (e.g., Figures 12, 13, and 14). The DT Results Report [1] did not describe if other methods were used to confirm the location of the deepest pits.

Figure 12: Coupon plate P2. Possible deep pit in yellow box region not sampled. Original images from DT Results Report [1].

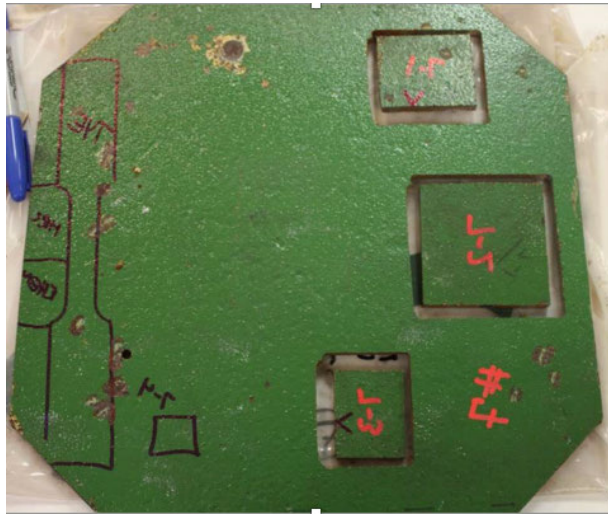
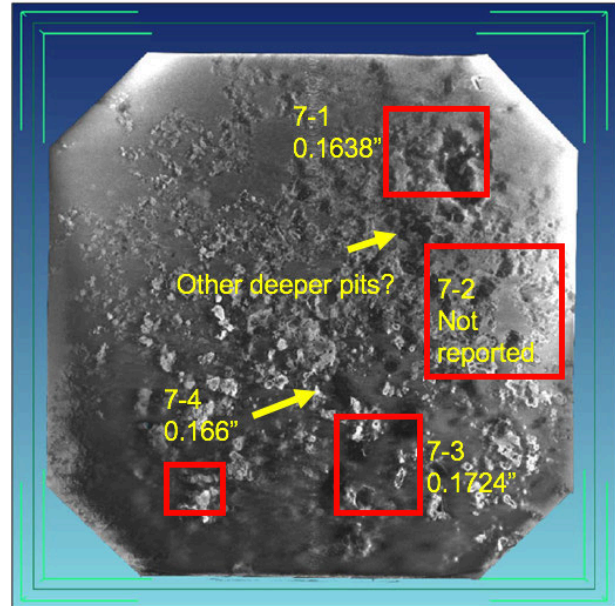
Figure 13: Coupon plate P7. Possible deep pits in region of yellow arrows not sampled. Original images from DT Results Report [1].

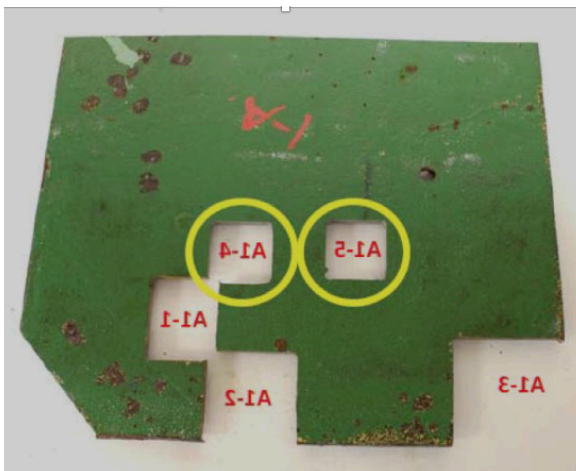
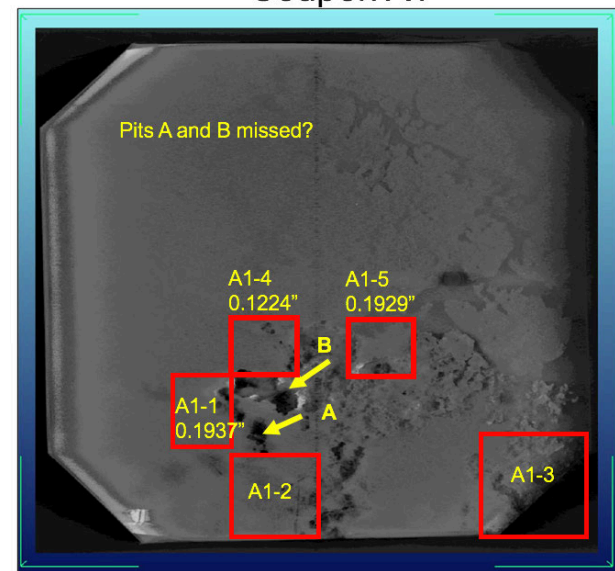
Figure 14: Coupon plate PA1. Possible deep pits in region of yellow arrows not sampled. Original images from DT Results Report [1].

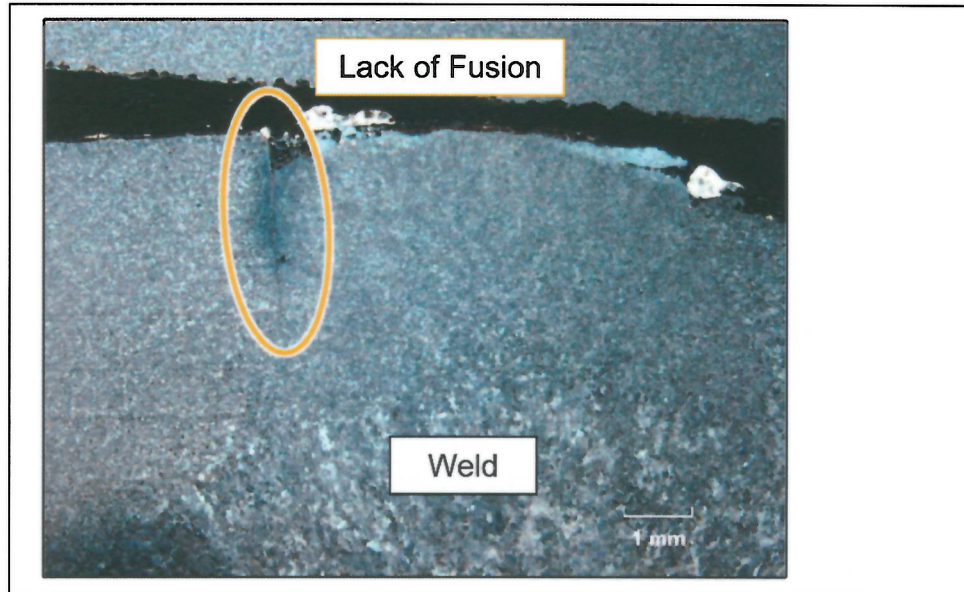
Figure 2 -- (Image from: IMR Test Labs. 2018)

4. The DT inspection did find weld defects. The one coupon that actually had a weld contained a linear defect that was found by destructive testing. This lack of fusion linear weld defect is shown below.

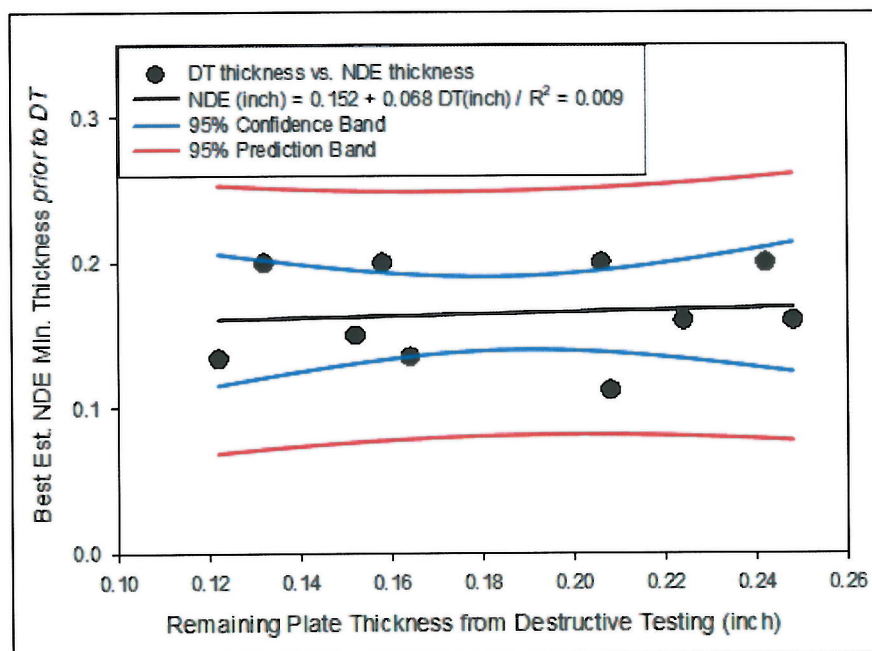
We have also plotted the actual minimum plate thickness determined from the DT against the best estimate of the coupon minimum thickness determined prior to the DT, Figure 4. To simplify, we conservatively assume the NDE-measured thickness in censored cases (i.e., the coupons for which thickness is reported as known only to be either greater or less than a specified value) were the specified bounding values. Similar analyses were also done for each NDE method treating those cases as interval-censored, and the results did not change significantly.

Figure 4 – Relationship between NDE thickness estimate prior to DT and the actual remaining thickness determined from DT.

Figure 4 clearly indicates the NDE techniques are neither accurate nor reliable. First, the slope (0.068) of the line drawn through the DT vs NDE data is very flat (close to zero), indicating the NDE results are essentially insensitive to actual corrosion depth. For comparison, if NDE was perfectly accurate, then the DT thickness would be equal to the NDE thickness and the slope of the line drawn through the data would be 1.0. Instead, the calculated slope is consistent with what one would expect if the NDE results were simply chosen at random without regard to the actual coupon thickness. Another indication is the coefficient of determination (R^2), which measures NDE accuracy by comparing the variation in NDE results to the residual variation after accounting for the actual coupon thickness (using the regression line). As noted in Figure 4, the R^2 value is effectively zero (0.009), indicating none of the observed variation in NDE-measured thickness is attributable to corresponding variation in the actual thickness of the test coupons.

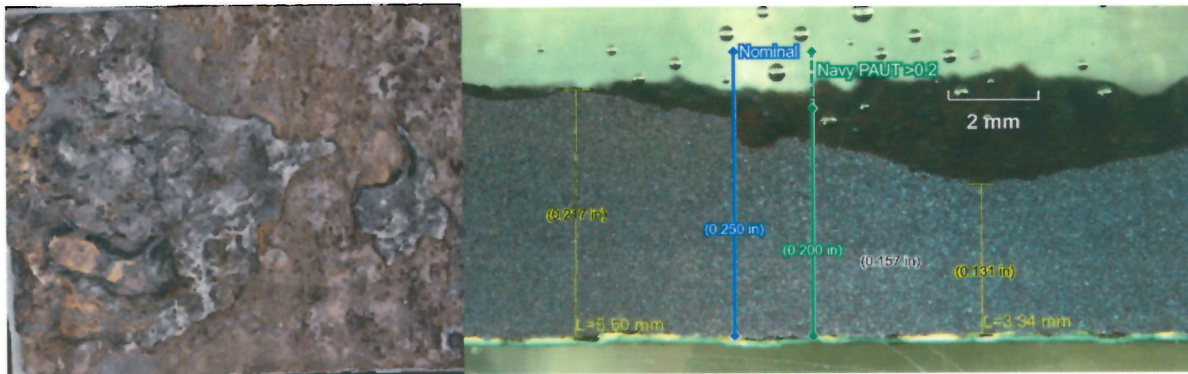
A more graphic illustration of the error in the NDE methodology is shown in Figure 5. The image on the left-hand side of Figure 5 shows the extensive backside corrosion on Coupon 3. The right-hand side of Figure 5 shows the plate's reported thinnest area in cross-section after destructively testing. While it is unclear from the DT and IMR reports, this thinned region

(0.131-inch-thick) was presumably located by CT scanning of the entire coupon. The Navy NDE predicted that this area had little to no backside corrosion.

Figure 5 – Destructive Testing Cross-section from Sample 3-3.

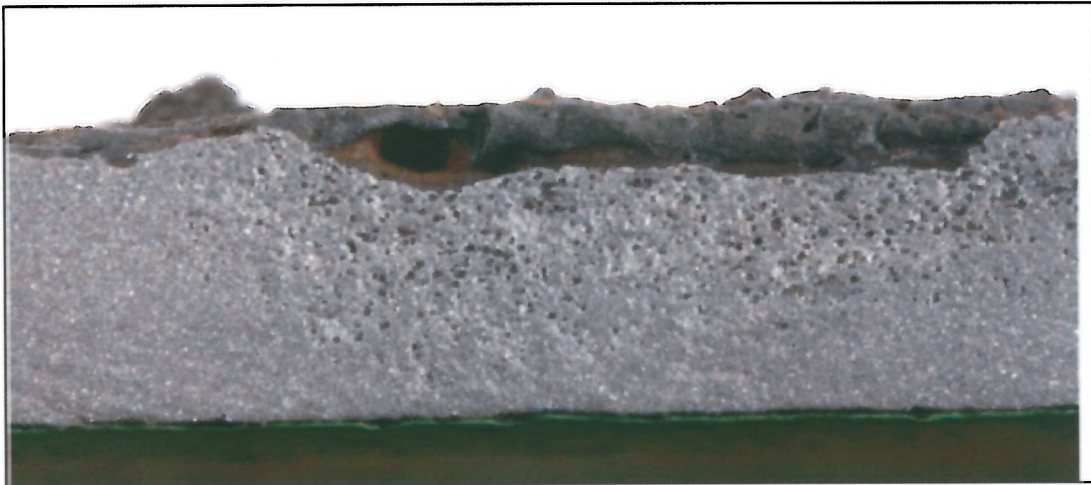
1. There was pitting observed as shown in their Figure A-4
2. It is not surprising that corrosion was not found as this area had been sandblasted.
3. The explanation that the area of concern "had been superficially altered by heat associated with sectioning or some other post-sectioning reaction (atmospheric corrosion or corrosive media attack)" is not credible. Atmospheric corrosion would be uniformly distributed along the cut surface, but the area of concern is localized. Secondly, the porosity is not consistent with heat associated with sectioning. Finally, we are unaware of any corrosive media used during coupon removal that could have locally attacked the edge in the area of concern.

Figure A-4. Detail of the sandblasted edge on 3/20/19 in the same location as shown in the picture below. The sandblasting revealed that the feature was not a corrosion pit, as shiny metal was revealed when the red-colored staining was removed. There was an unusual appearance to the edge in this location, as though the sectioned edge had been superficially altered by heat associated with sectioning or some other post-sectioning reaction (atmospheric corrosion or corrosive media attack). That alteration gave the appearance of a deep corrosion pit.

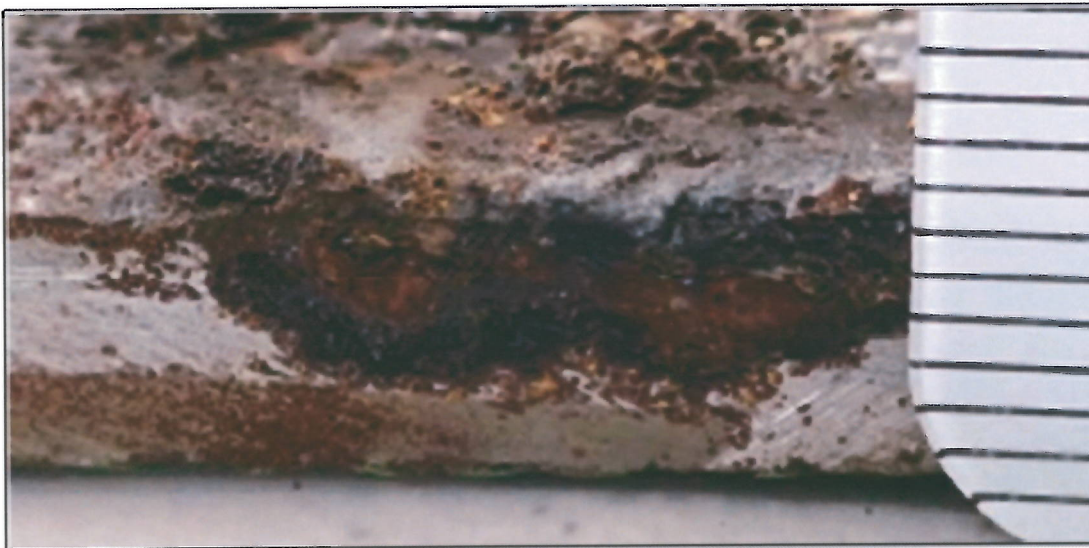
Figure A-5. The same area is shown in an image provided prior to shipping Coupon #7 to IMR (provided to IMR on March 13, 2019). What appeared to be a deep corrosion pit was actually rust-colored staining of the edge surface
