# Naval Audit Service

## Audit Report

### Department of the Navy Red Hill and Upper Tank Farm Fuel Storage Facilities

**N2010-0049**  
**16 August 2010**

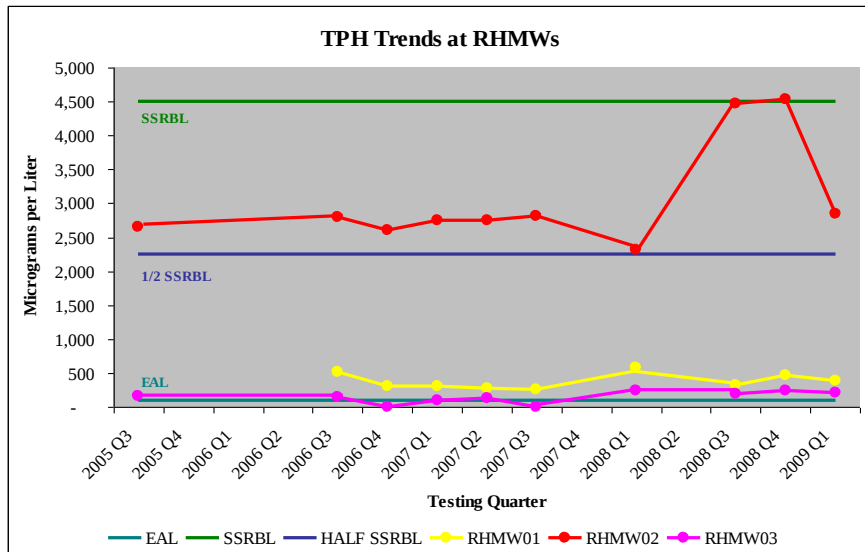
Figure 2

*U.S. Navy Well 2254-01*

In the 1<sup>st</sup> quarter of 2009, TPH contaminants were also detected at the Navy Well. Although the concentration that was detected was below the EAL,<sup>11</sup> this sampling event was the first time that TPH had been detected since the Navy began testing for the contaminant in 2006. As mentioned above, the recent detection of contaminants at the Navy Well may indicate migration

of fuel released from RH. The detection of contaminants at the Navy Well pumping station poses an immediate risk to the potable water sources in the RH area. If the Navy Well becomes contaminated beyond acceptable levels, the Navy and the island of Oahu could potentially lose an important source of drinking water. If this occurs, the Pearl Harbor Water System would be reduced by approximately 24 percent. Further, the Navy would be responsible for providing an alternate water source at the Navy Well as indicated in the GPP.

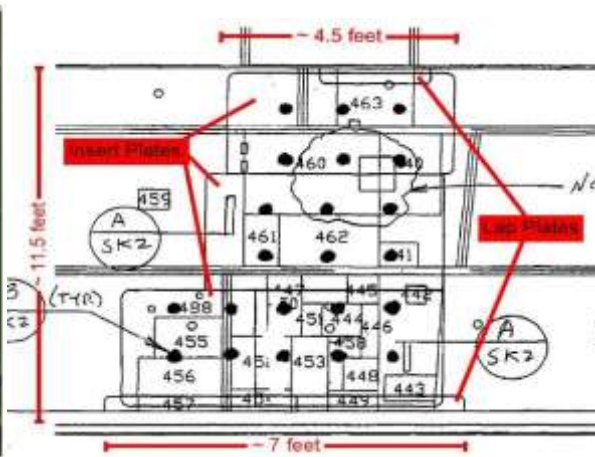
Figure 4: Tank 16 Repair Schematic

Figure 4: Repair schematic displays numbered flaws in figure 3, which required replacing the corroded original plates with four insert plates and three lap plates covering an area approximately 11.5 feet high and between 4.5 to almost 7 feet wide. Anchoring rods (represented by the black dots) are used to connect the plates to the concrete. Note: All insert and lap plates are not depicted in the schematic.

applying patch plates to the interior or by removing the corroded plates (see Figures 3 and 4). Until the current inspection cycle is completed, any previously undetected areas of exterior corrosion may continue to worsen, may cause the remaining tanks to be susceptible to through-holes, and could potentially result in future fuel releases.
